Component Repair Experiment-1: An Experiment Evaluating Electronic Component-Level Repair During Spaceflight

The Component Repair Experiment-1 (CRE-1) examines the capability for astronauts to perform electronics repair tasks in space. The goal is to determine the current capabilities and limits for the crew, and to make recommendations to improve and expand the range of work that astronauts may perform. CRE-1 provided two-layer, functional circuit boards and replacement components, a small tool kit, written and video training materials, and 1 hr of hands on training for the crew slated to perform the experiment approximately 7 months prior to the mission. Astronauts Michael Fincke and Sandra Magnus performed the work aboard the International Space Station (ISS) in February and March 2009. The astronauts were able to remove and replace components successfully, demonstrating the feasibility of performing component-level electronics repairs within a spacecraft. Several unsuccessful tasks demonstrated areas in need of improvement. These include improved and longer training prior to a mission, an improved soldering iron with a higher operating temperature and steady power source, vide

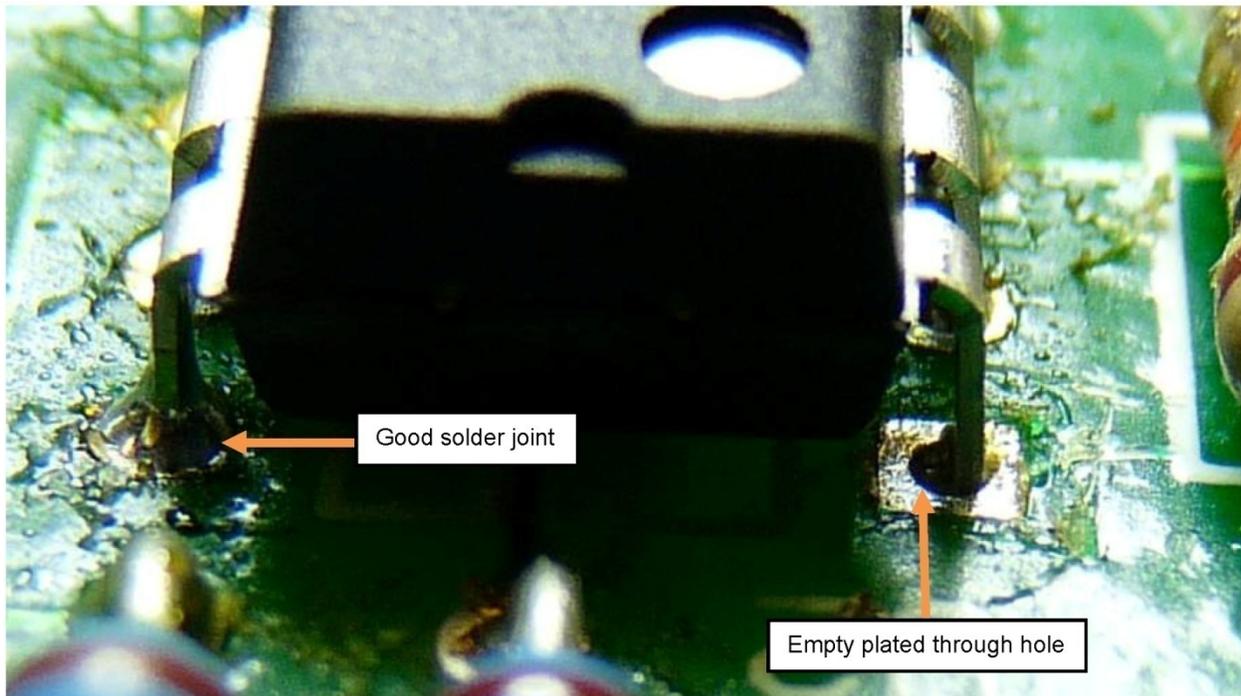
Figure 10 shows some of the soldering issues found in the initial inspection. This figure shows both a good solder joint, and a solder joint that failed inspection and would require rework. The good solder joint shows a fillet on the top side of the circuit board, wetting the leg of the component. The second solder joint does not have sufficient solder filling the plated through hole; in practice, this solder joint would require rework to ensure proper wetting of the solder and a functional circuit. Figure 10 also shows some yellow residue on the circuit board near the soldering joints. This residue is believed to be from the flux used in the soldering wick which was not a no-clean type flux. The flux used in the solder and provided in the syringe was no-clean type and did not leaving significant residue during ground bench testing.

Figure 10.—A good solder joint (left) and solder joint where solder did not fill the plated through hole (right) from Board 01, component U2.

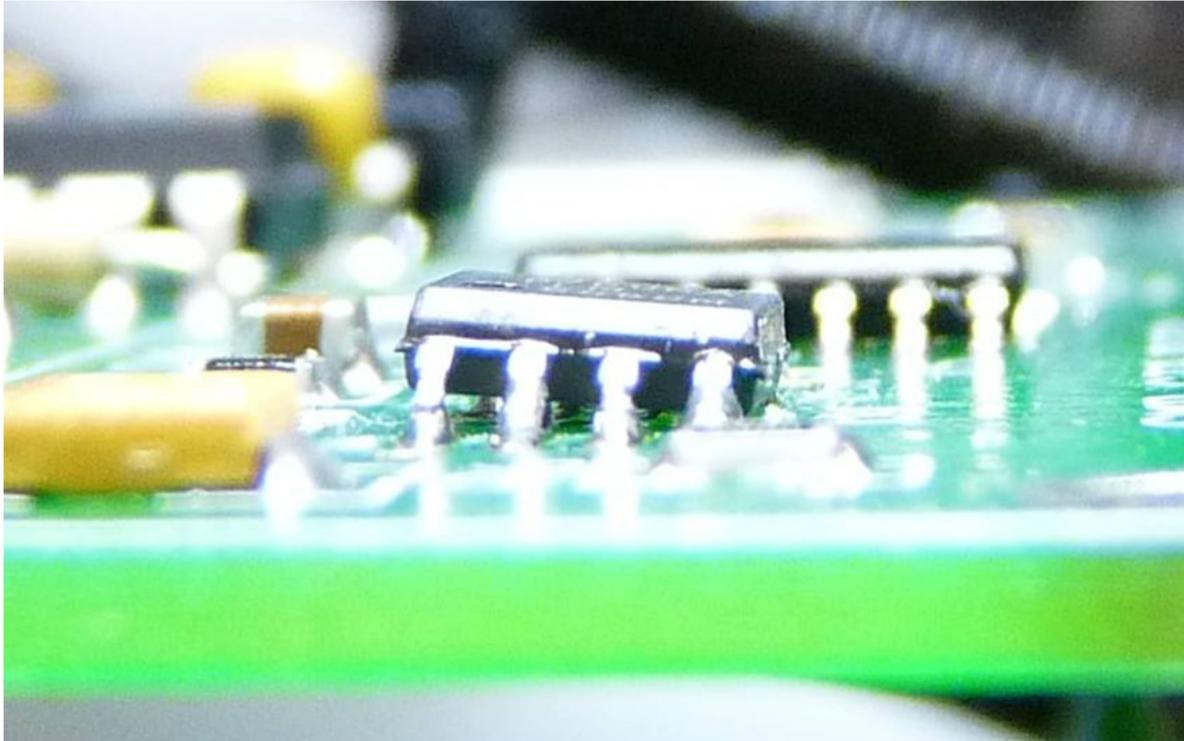
Figure 11.—Component U4, Board 02 where the component legs are not flat on the circuit board pads, but the solder joints bridge from the legs to the pads.

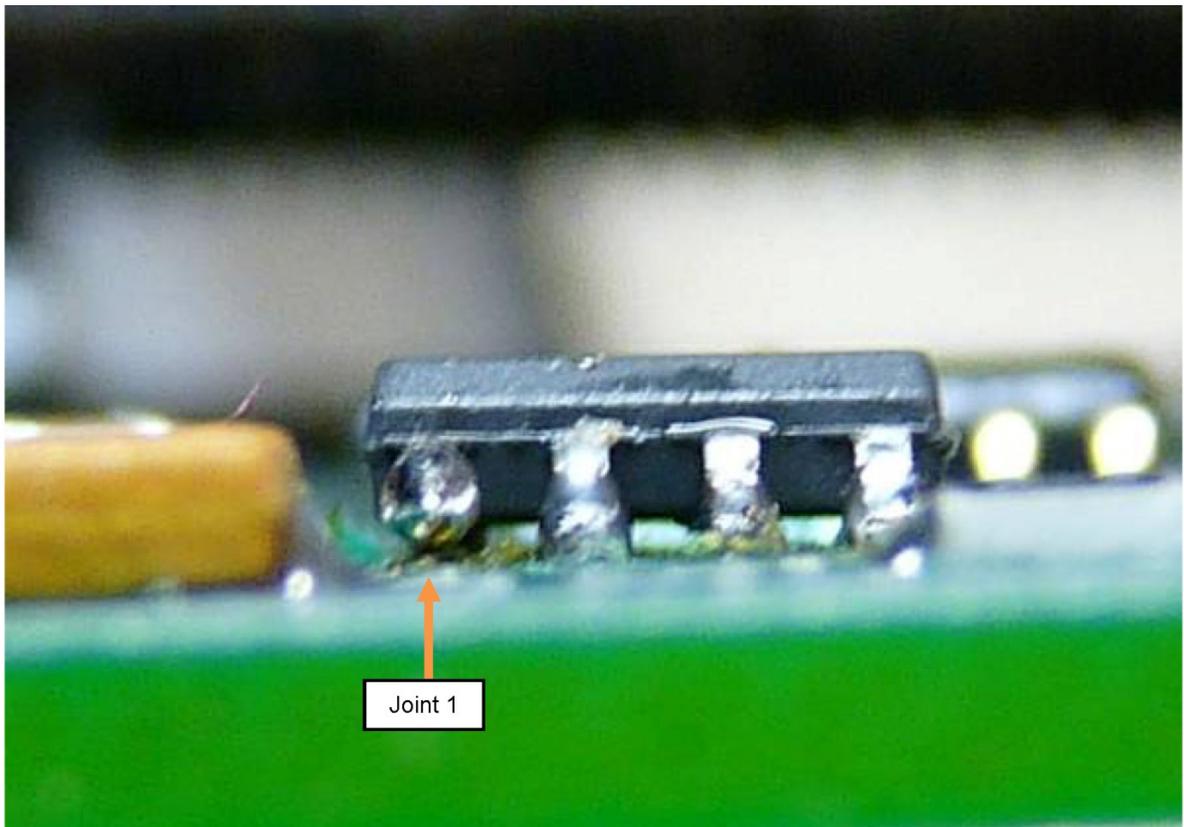
Figure 12.—Component U4, Board 10, again without all the component legs flat on the circuit board pads. In this case, a solder bridge between Leg 1 and pad 1 did not form.

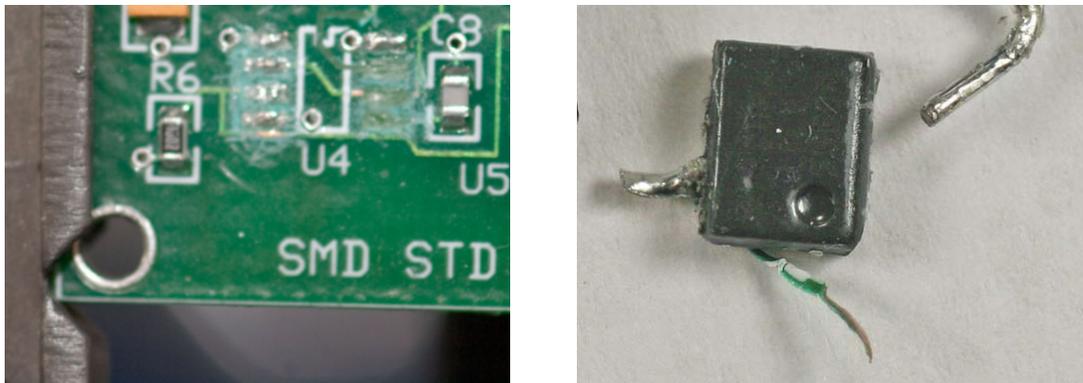
Astronaut Sandra Magnus worked on Board 3 during this session and this was her first session of CRE-1. She removed and replaced R1, U2, and U4. While removing the original U4 component, the astronaut pulled three pads from the circuit board. During operations, the team speculated that the pads were pulled during removal of the component. This was later confirmed by ground inspection (see App. C.3). Subsequently, Astronaut Magnus soldered the new U4 in place with the circuit board as-is, using only the five remaining circuit board pads. Table 6 lists these tasks and the time needed to complete them. During the process, Astronaut Magnus commented that the molten solder tended to wet and stay near the iron tip, rather than flow onto the pad area on the circuit board.

Figure 13.—The area surrounding component U4, Board 03 (left) after removing the original component. There is damage to pads 5, 6, and 7. The pulled leg and circuit board pad, attached to the original component, are seen on the right.

Photos of the original U4 component from circuit board 3 show the cause of the difficulties encountered during that removal and replacement (Figure 13). The returned chip shows circuit board pad and circuit board traces still attached to the original component leads. This indicates that the original leads were not completely cut, and the pads and trace were pulled off the circuit board with the original chip, under the assumption that the leads had been cut. This type of error can occur on the ground, and indicates a lack of experience working with these components and tools, which can only be remedied with practice.

Magnus believes the pad was lifted off the circuit board while lifting the old component off; she didn't know lifting the pads was a problem. She noted that she used both tweezers and solder wick to remove legs on U4; frequently she could see the leg debris and could pick it off with the tweezers. Magnus commented on the need for finer cutters, and Fincke commented that towards the end of his work he used the fine cutters exclusively. They commented on a need for the right tools, after discussing the limitations of the cutter sizes and solder tip limitations, and on the need for better magnification and better soldering iron tips.

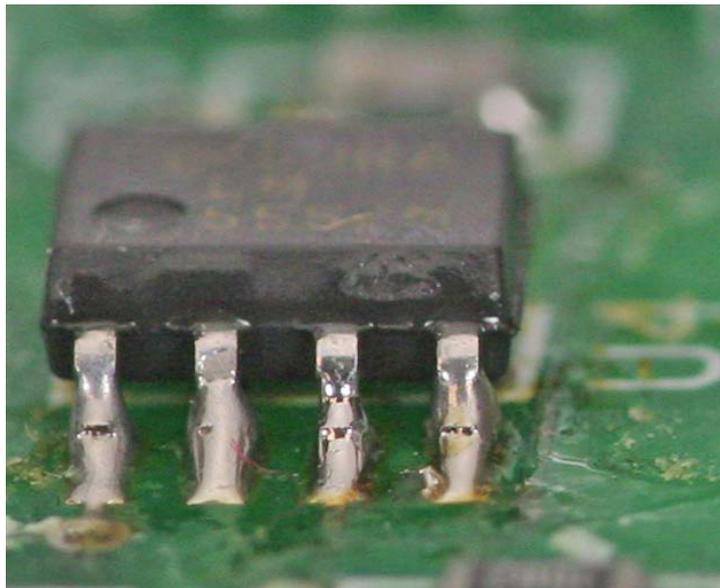
The visual inspection for R1 revealed good fillets on both the soldered side and flowed side of the component, passing the NASA Standard criteria. For component U2, all fillets on the soldered side of the circuit board passed inspection as well. On the flowed side, pins 1, 4, 5, 6, and 7 passed the NASA Standard without comments. Pin 2 passed, though no fillet formed; solder in the board through hole is sufficient for passing the NASA Standard. Pin 3 did not pass, with no solder in the board through hole. Figure 10 in the Section 3.0 shows this defect. Pin 8 passed, though no fillet formed on the flowed side of the circuit board. For component U4, generally there was good contact between the legs and the pads with good fillets, though there was excessive solder. While this would not pass the NASA standard, rework would not normally be required. Additionally, the left side (pins 1, 2, 3, and 4) were slightly elevated, with the legs not flat on the pads. Figure 16 shows both the elevated legs and excess solder. The legs on the right side of the component (pins 5, 6, 7, and 8) were flat on the circuit board pads, and acceptable. When powered, all LEDs on the circuit board blinked normally, with a peak current draw of approximately 40 mA.

Figure 16.—An image of pins 1 through 4 from component U4, board 01. This images shows both excess solder and the component legs floating above the board. This would not pass NASA inspections, but is usable.

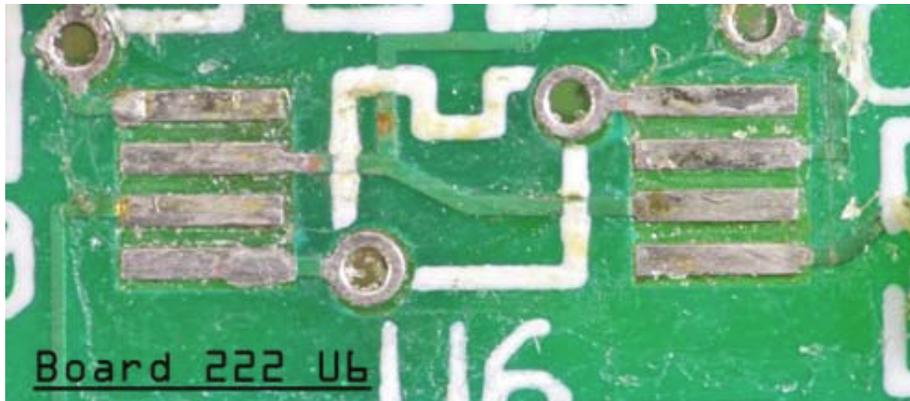
Figure 17.—Removal of component U6 from board 02. The removal was successful, with no damage to the circuit board.

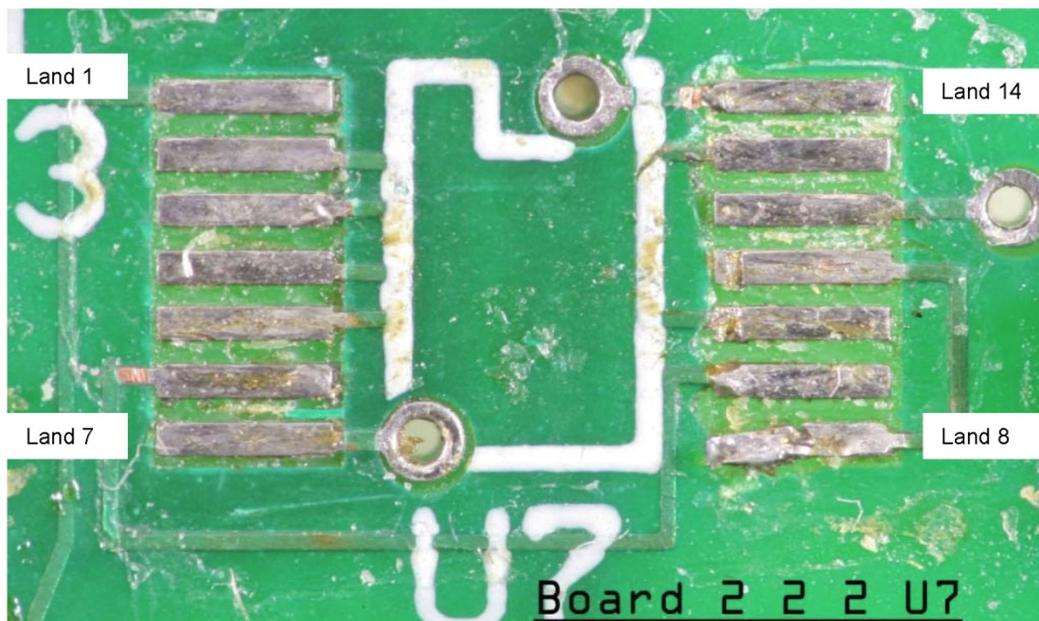
Both joints for component R1 passed inspection, as did the fillets on the soldered side of component U2. On the flowed side of U2, pins 1, 2, 3, 4, 5, 6, and 7 passed inspection. Pin 8 on the flowed side of component U2 was acceptable, but on the border of not passing due to insufficient solder, as no fillet formed though the plated through hole is filled with solder. The joints for component U4 were generally good, though all had too much solder. In addition, the part is tilted, with pins 1 and 8 higher than pins 4 and 5, which are flat on the circuit board pads, similar to the results seen for component U4 on board 01. This does not pass the NASA Standard, but the solder joints are functional. The removal of component U6 was acceptable, with no damage seen on the circuit board, as shown in Figure 17. The removal of component U7 did show some damage, as pad 8 was lifted from the circuit board, and other pads showed some damage from removing the component, as shown in Figure 18. The circuit board passed the powered functional test, with the LEDs in the plated through hole and standard pitch surface mount regions blinking as expected, drawing a peak current of approximately 20 mA. The LED in the fine pitch surface mount region did not blink as expected, due to the removal of components U6 and U7.

Figure 18.—Lands from removed component U7, board 02. Land 8 shows damage to the land, while lands 9, 10, and 11 show minor damage.

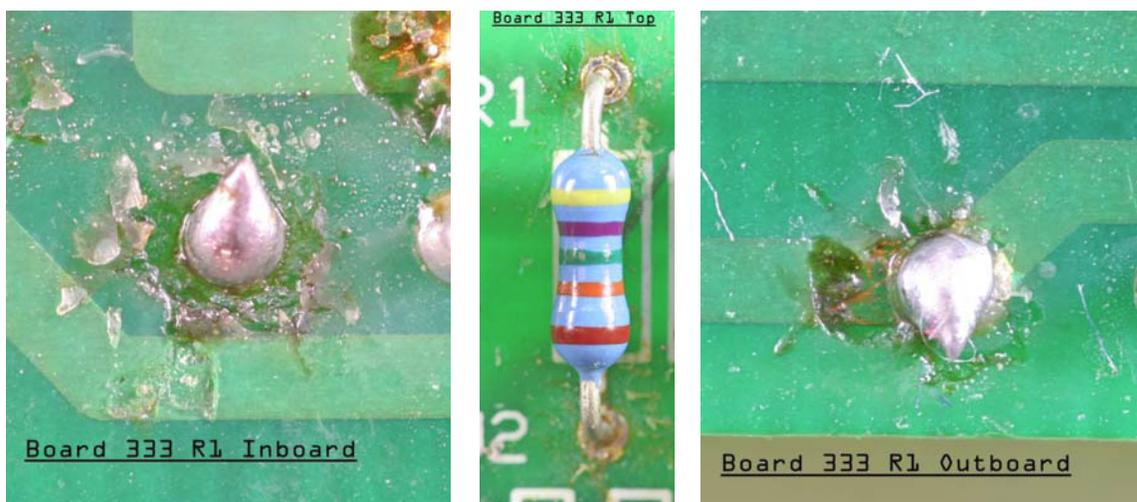
For component R1, the flowed-side solder joints show minimal but acceptable solder flow through. The soldered side joints show excessive solder, though possibly acceptable. The joints are functional. The excessive solder on the soldered side and minimal solder on the flowed side is due to insufficient heat to drive the solder through the circuit board and form a flowed side fillet. This is a technique problem and not indicative of a problem with the soldering iron. Figure 19 shows these problems. For component U2, the fillets on the soldered side of the circuit board all passed NASA Standards, though the leads were not clinched (that is acceptable). For the flowed side of the circuit board, pins 3, 4, 5, 6, and 8 passed the NASA Standard. Pins 1, 2, and 7 did not, due to insufficient solder, though the joints are functional. For component U4, pin 1 had solder on the component lead, but not on the pad, while pins 2, 3, and 4 were acceptable but with excessive solder. A trace near pad 4 is exposed, which may have occurred when removing solder. Pins 5, 6, 7, and 8 demonstrated some difficulties, arising largely from removing the original component and cleaning the pads. The pads for pins 5, 6, and 7 were removed from the circuit board, and traces from pads 6 and 7 were also removed. Much of this damage occurred during component removal because the component leads were not fully cut, and the component pulled from the board. Figure 13 shows the area around U4 after removing the component. The pad for pin 5 is still attached to the original component lead. Leg 5 on the original component was not cut completely, and the pad was pulled off the circuit board when removing the component, also seen in Figure 20. This also damaged the trace leading from pad 5, run under the component location. In functional testing, the LED in the plated through hole and fine pitch surface mount regions operated normally, drawing approximately 30 mA. The LED in the surface mount region did not blink normally, due to the issues described for component U4.

Figure 19.—Solder joints for R1, board 03. The images of flowed side joints (left, right) show excess solder, while the topside joints (middle) show problems with the solder flowing through the through-holes.

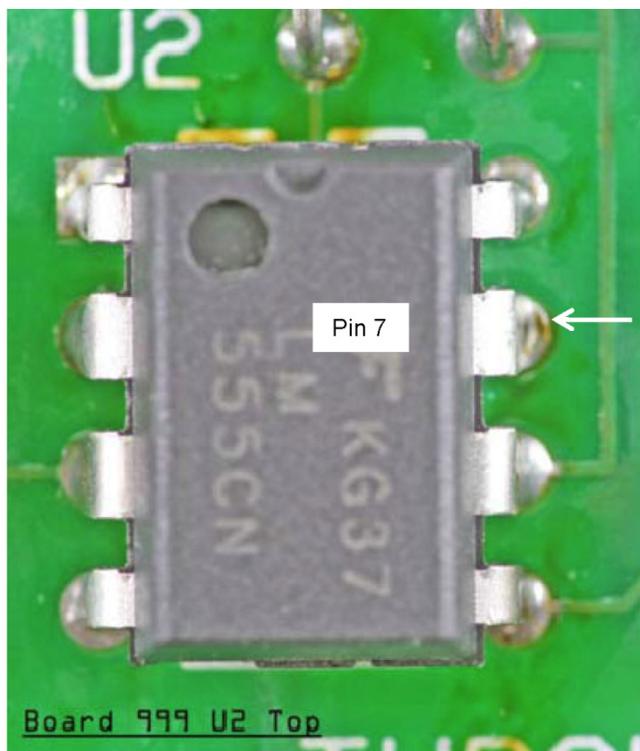
Figure 20.—Component U2 from board 09, showing poor wetting on pin 7. This defect would not pass inspection criteria, but the component is functional.

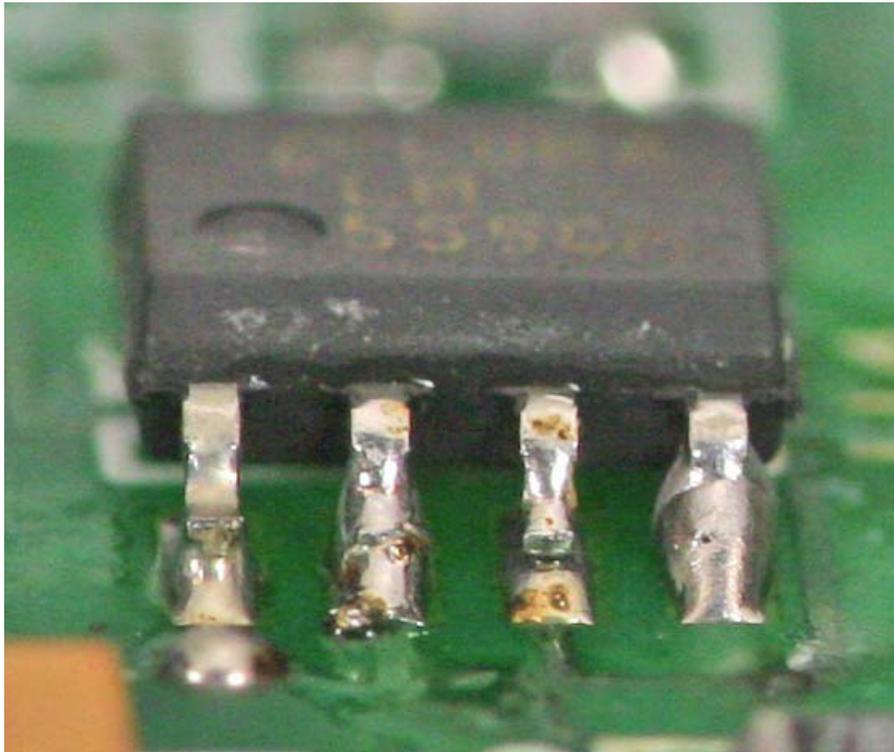
The inspection of component R1 showed that both the soldered and flowed fillets were good and passed NASA Standards, though the “outside” lead was cut short; this is still acceptable work. The soldered side fillets for component U2 all pass inspection, as do all the flowed side fillets except for pin 7, shown in Figure 20. This joint had insufficient solder, where the solder did not flow through the board’s plated through hole. Component U4 showed problems with coplanarity, where pin 5 was low and pin 1 was high. Pin 1 was not flat on the pad, though solder bridged from the pad to the lead. Pin 2 was also not on the pad, and showed excessive solder, with solder dabbed on the joint with the soldering iron. Pin 3 does not appear soldered to the pad, though both the pad and lead are wetted with solder. Pin 4 has excessive solder and was reheated, but is function. Figure 21 shows these four legs. Pin 5 passed inspection. Pins 6 and 7 had excessive solder, but were otherwise good. Pin 8 had very excessive solder, a solder spike, and overheated solder. The removal of components U6 and U7 also presented challenges to the crew. For U6, the pads show little damage; there is minor damage to the solder mask on land 7, as shown in Figure 22. The solder was not cleaned off the pads in any joint, as the solder was heated and lead debris removed or peeled from the pad. For component U7, pads 4 and 5 showed damage to traces from these pads which run under the component, shown in Figure 23. The damage may have arisen from use of the dental pick, which may have gotten under the trace and removed a piece of the circuit board. All other pads for this component pass visual inspection. The functional test showed only the plated through hole region of the circuit board operating normally, with a maximum current draw of approximately 30 mA. The fine pitch SMD section of the circuit is expected not to function, due to the removal of U6 and U7.

Figure 21.—Component U4, Board 09. Leg 3 is not soldered to the circuit board, while the other legs show excess solder and do not rest on the circuit board pad. This component would not work, due to the problems with leg 3.

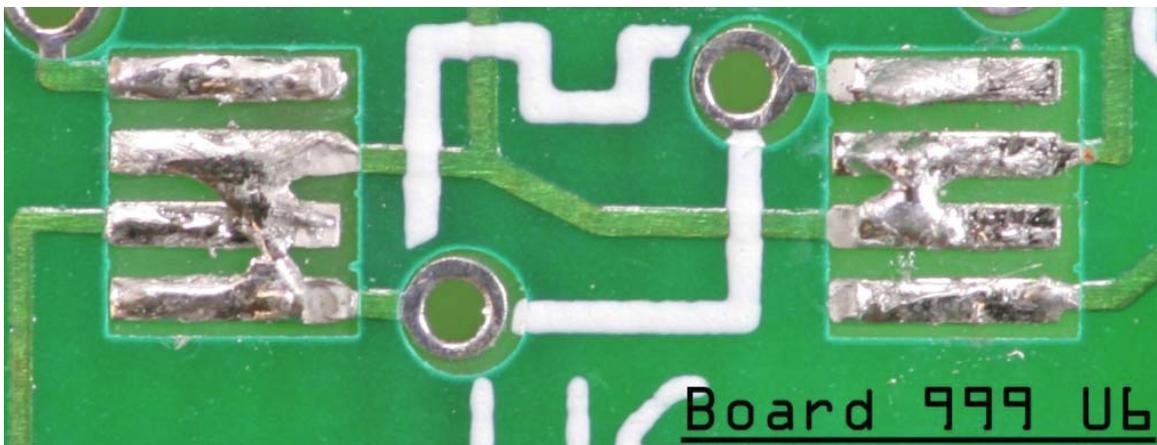
Figure 22.—A photo of the lands after removing component U6, board 09. Land 7 shows some minor removal of the solder mask. The original solder and leg debris remains on the pads.

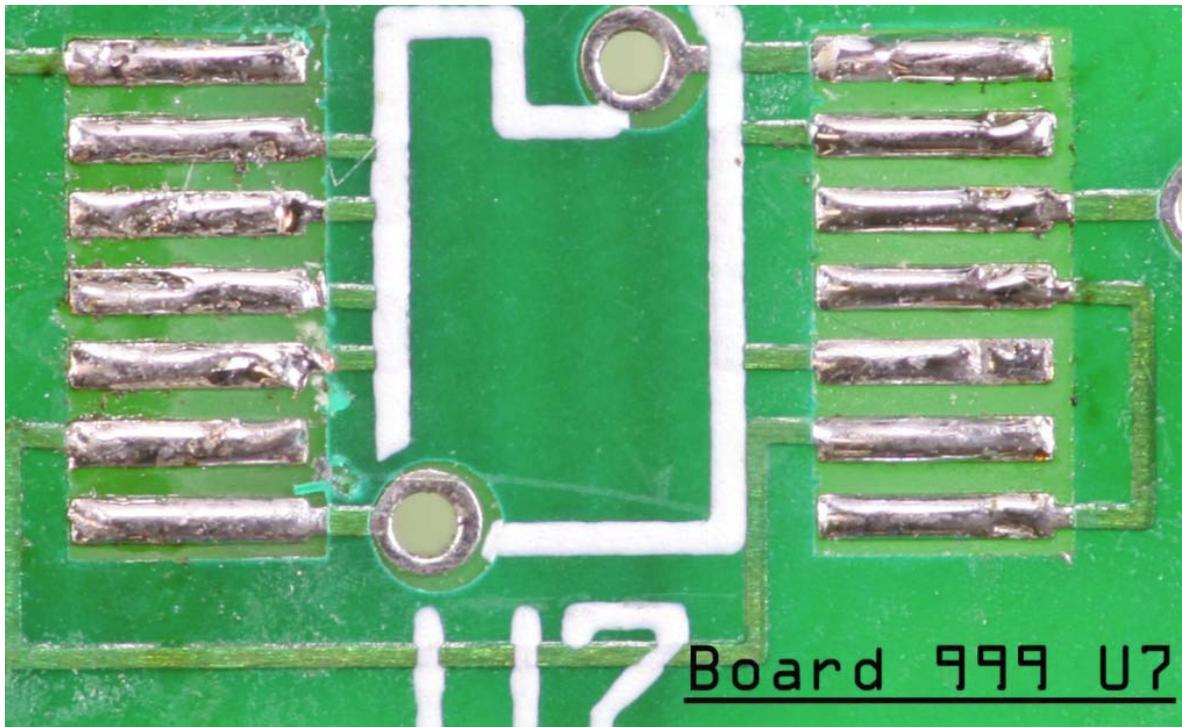
Figure 23.—Board 09 after removing component U7. Lands 4 and 5 show some damage to the traces.

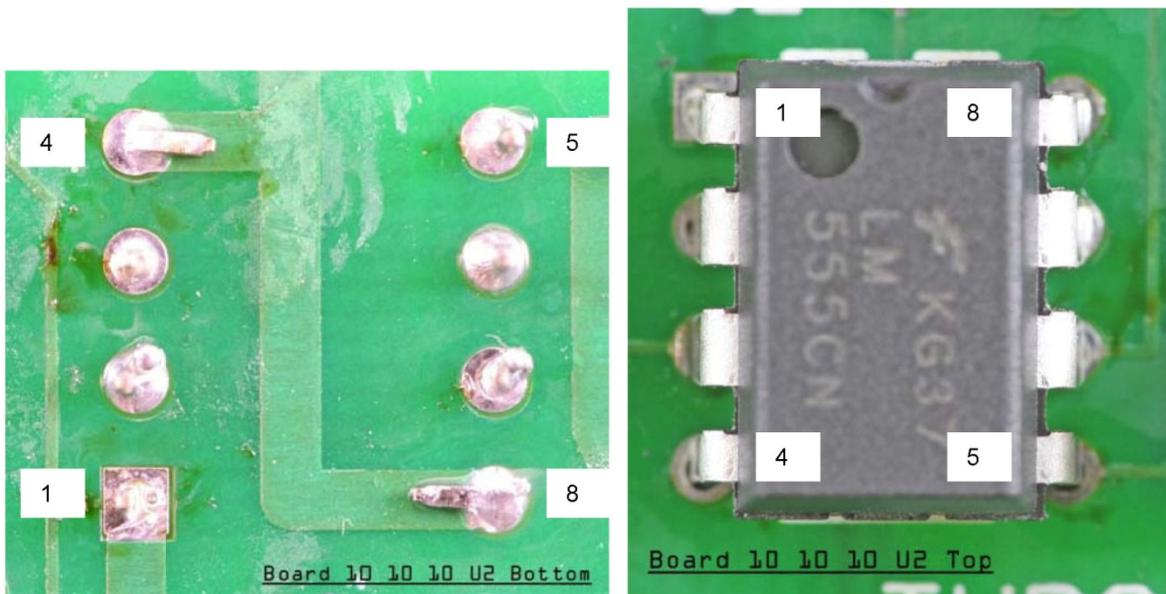
Figure 24.—Soldered (left) and flowed (right) views of component U2, board 10

The visual inspection of R1 showed good fillets on both sides of the circuit board, though the outside leg was cut short (as before, this is acceptable). For component U2, the visual inspection found some issues. On the soldered side of the circuit board, pin 1 showed insufficient solder, and pin 2 had a large solder ball where the solder attached to the joint, and reheating the joint formed a ball. Pins 3 and 4 passed inspection, while pin 5 showed evidence that the operator removed the soldering iron prior to removing the solder wire. Pin 6 passed, pin 7 had a piece of solder wire attached to the joint as in pin 5, and pin 8 passed, though had the same problem as pin 7 with a small piece of solder wire attached to the joint. On the flowed side of the circuit board, only pins 3 and 8 passed visual inspection. All other fillets showed evidence of insufficient solder, as described previously. These results are shown in Figure 24. Component U4 showed coplanarity problems, where leads 5, 6, 7, and 8 (the “right” side of the component) were flat on the circuit board pads, but leads 1, 2, 3, and 4 (the “left” side of the component) were off the board. Further, pin 1 was not soldered to the circuit board, and pin 2 was soldered with a reasonable amount of solder, but was overheated. Lead 3 was soldered, but there is no solder on the circuit board pad. The lead and pad for pin 4 were soldered together, forming a bridge; while functional, this is not ideal. Leads 5, 6, 7, and 8 passed the visual inspection. Figure 25 shows these results. The plated through hole and fine pitch surface mount section of the circuit functioned properly, while the standard pitch surface mount region did not. The circuit drew a peak current of approximately 40 mA.

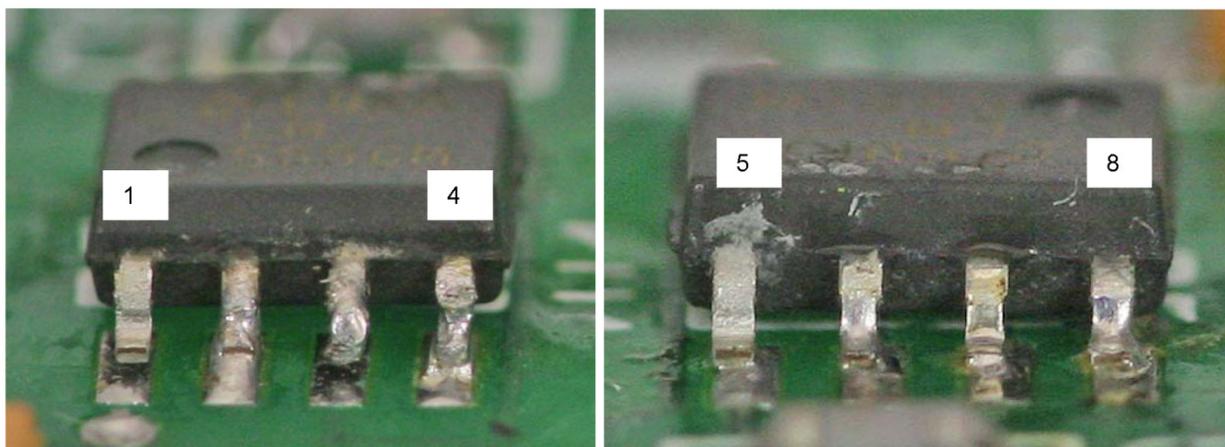
Figure 25.—Side views of component U4, board 10. Leads 1 and 3 are not soldered to the circuit board, while lead 4 shows the joint was remelted. Leads 5 through 8 are acceptable, though lead five has insufficient solder.
