High-R Walls for Remodeling: Wall Cavity Moisture Monitoring

J. Wiehagen and V. Kochkin
NAHB Research Center

December 2012

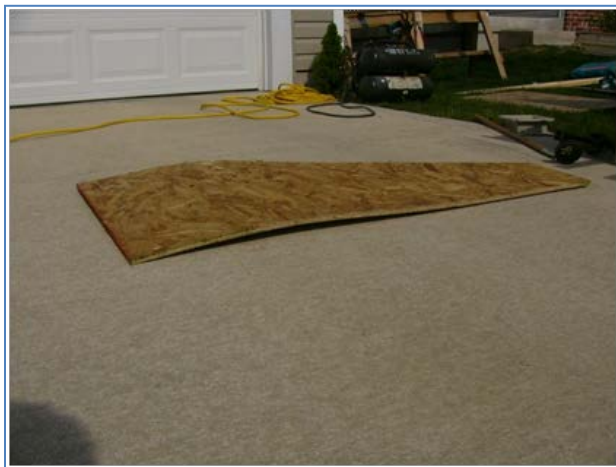
The team interviewed several builders who experienced this problem. The problem manifested itself as “wavy” vinyl siding (Figure 1 through Figure 4). The repairs typically involve removing the siding and replacing buckled OSB panels. Evidence of the panels having elevated moisture levels was observed during the repairs, including in some cases observations of a “mold-like substance” on the interior face of the panel. During repairs made in the winter months, in some cases, frost was also observed on the exterior face of the panel.

Figure 3. Removed buckled OSB panel

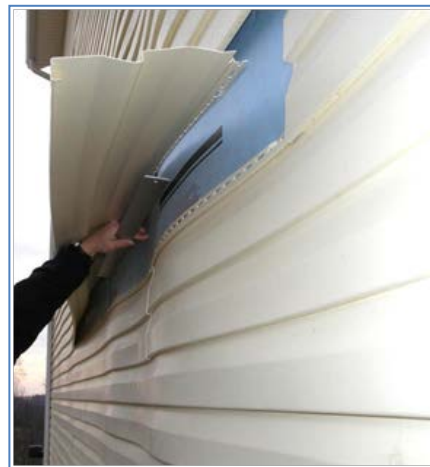
Figure 4. Wall with buckled OSB panels (siding removed exposing the weather-resistant barrier)

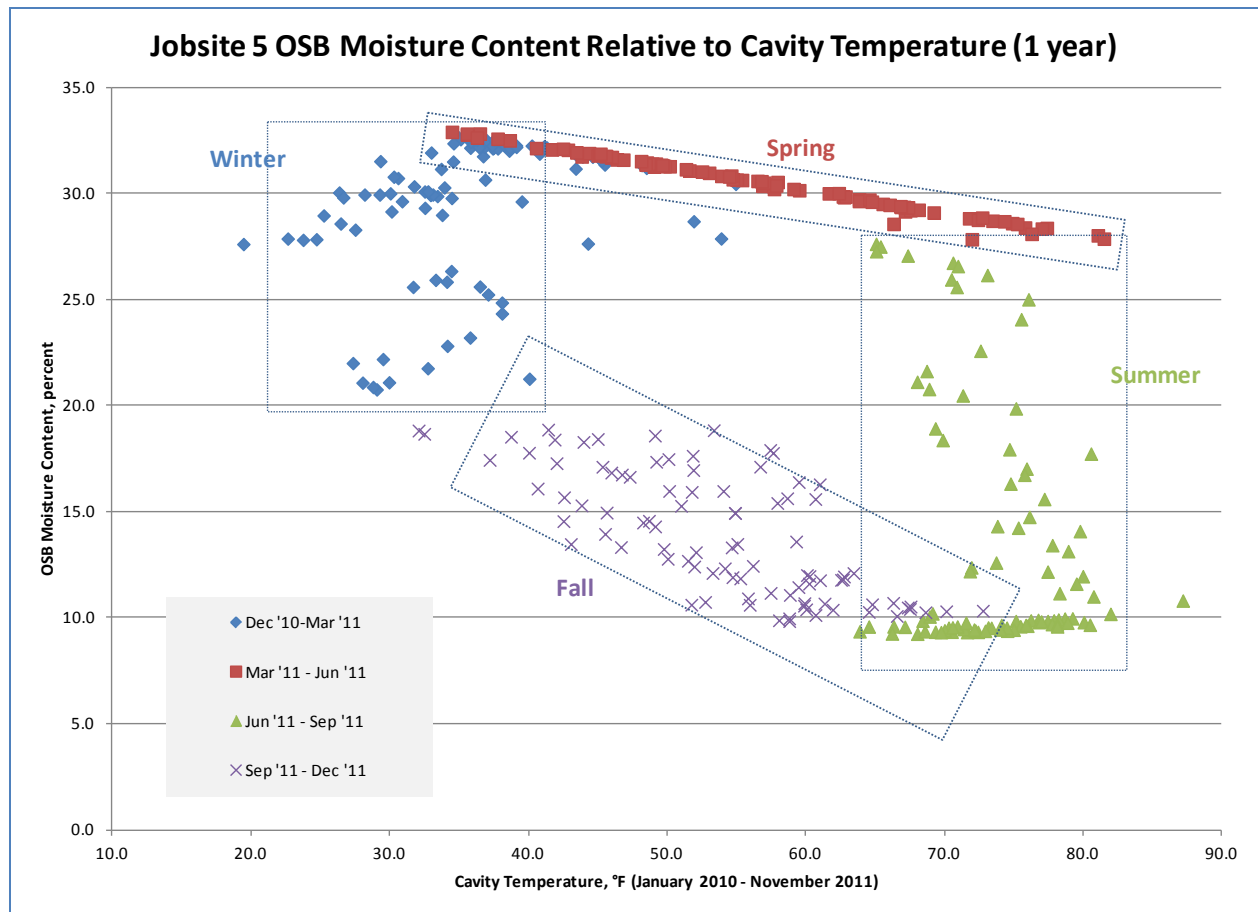
A number of wall cavities in Jobsite 5 show elevated MC readings for an extended time period, lasting into the early summer when the MC readings drop off quickly. Figure 22 represents data for a 1-year period in a wall cavity comparing the MC to the cavity temperature. The cyclic nature of the MC is clearly shown as well as the relationship between the cavity temperature and the MC where the MC levels greater than 20% span both warm and cold seasons (and cavities). This result is unique among the five jobsites where data are available for an extended period.

Figure 22. Example of an elevated OSB MC in one wall section showing seasonal changes in MC

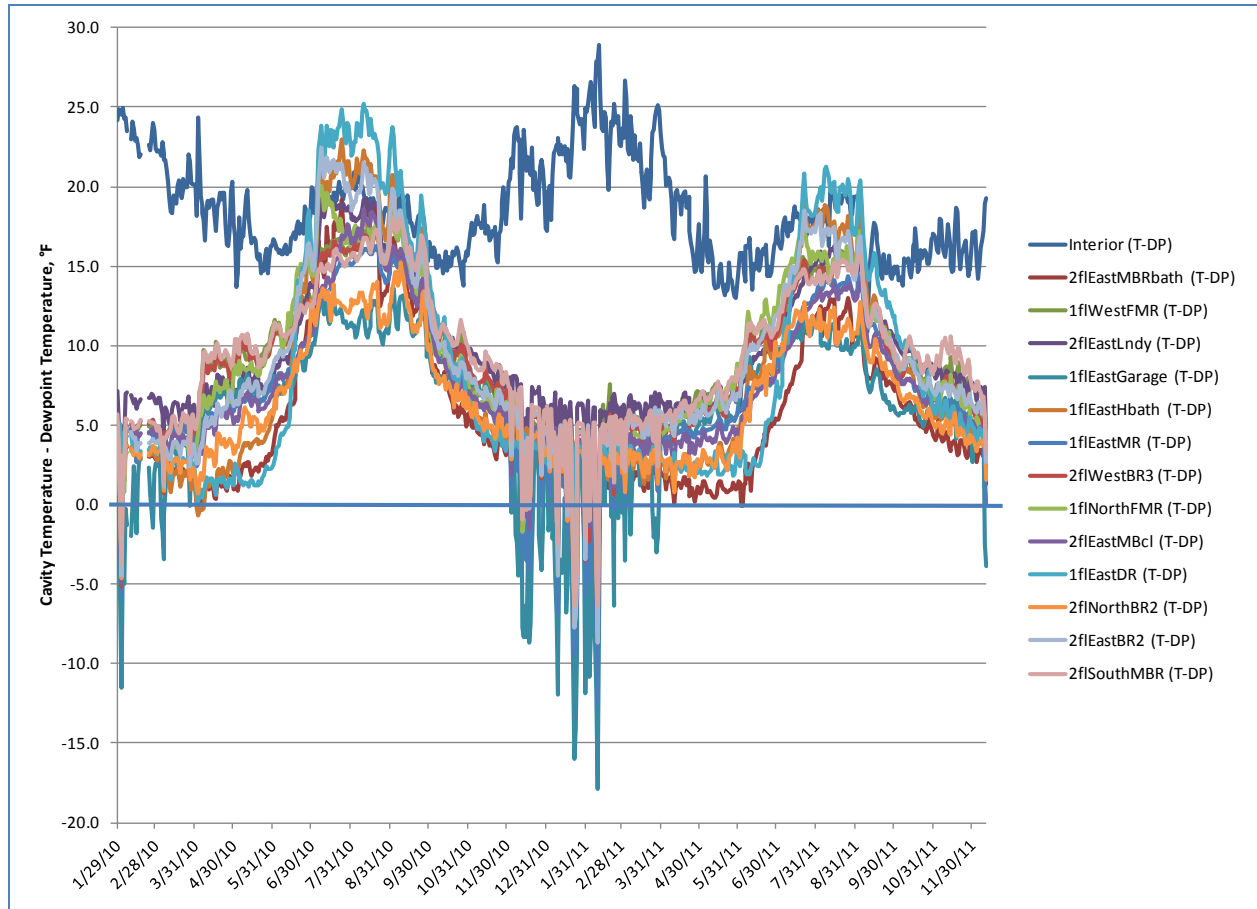
As RH increases in a wall cavity, the potential for condensation of water on the interior surface of OSB panels also increases. Figure 23 and Figure 24 are comparison plots for the test wall cavity temperature difference between the cavity temperature and the DP temperature for Jobsites 2 and 5. Negative values indicate a higher cavity DP than cavity air temperature near the OSB sheathing, resulting in the potential for condensation. Jobsite 2 has the most significant difference and Jobsite 5 has a much lesser degree of difference. The other jobsites have little or no calculated potential for condensation as measured.

Figure 23. Jobsite 2 delta cavity temperature minus DP temperature (negative values indicate condensation potential)

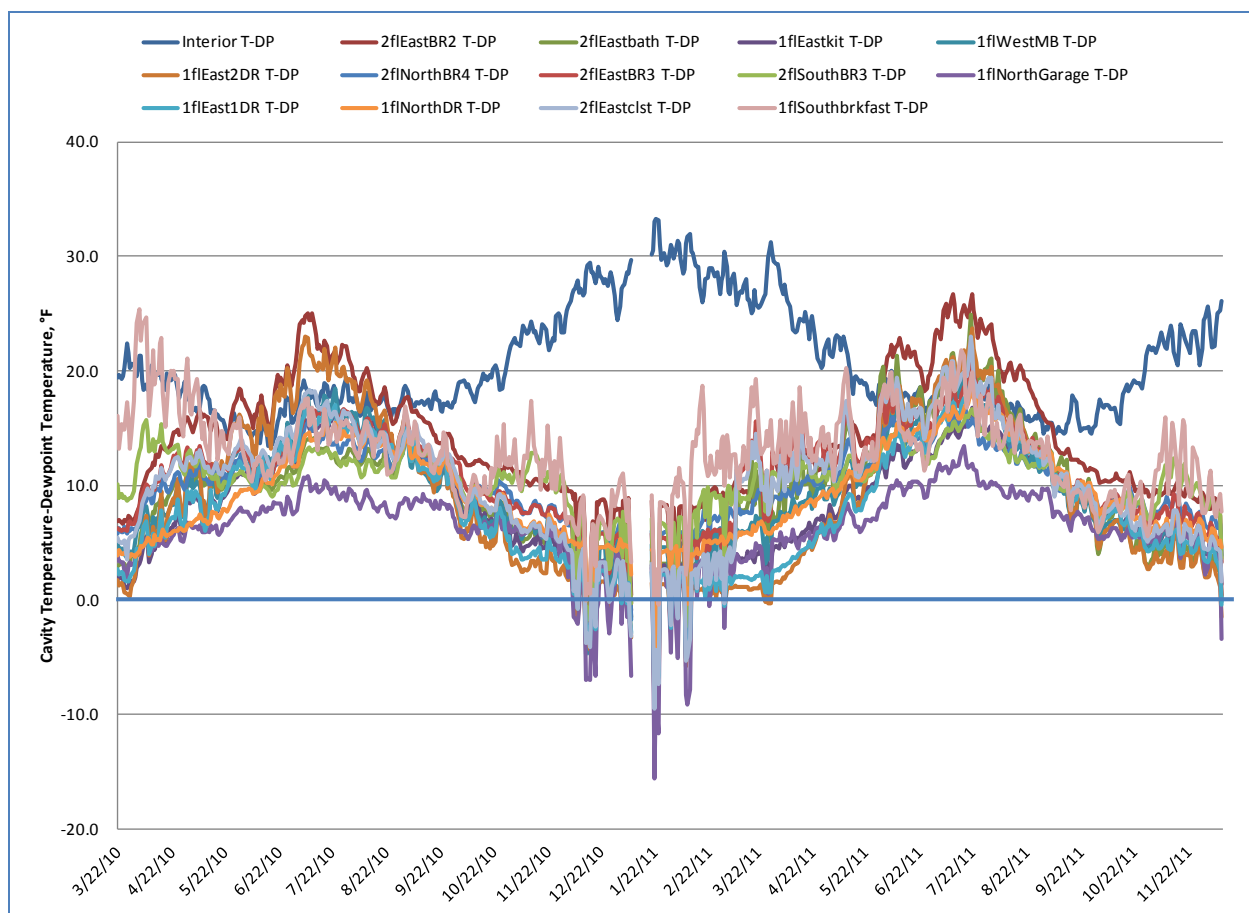
Figure 24. Jobsite 5 delta cavity temperature minus DP temperature (negative values indicate condensation potential)

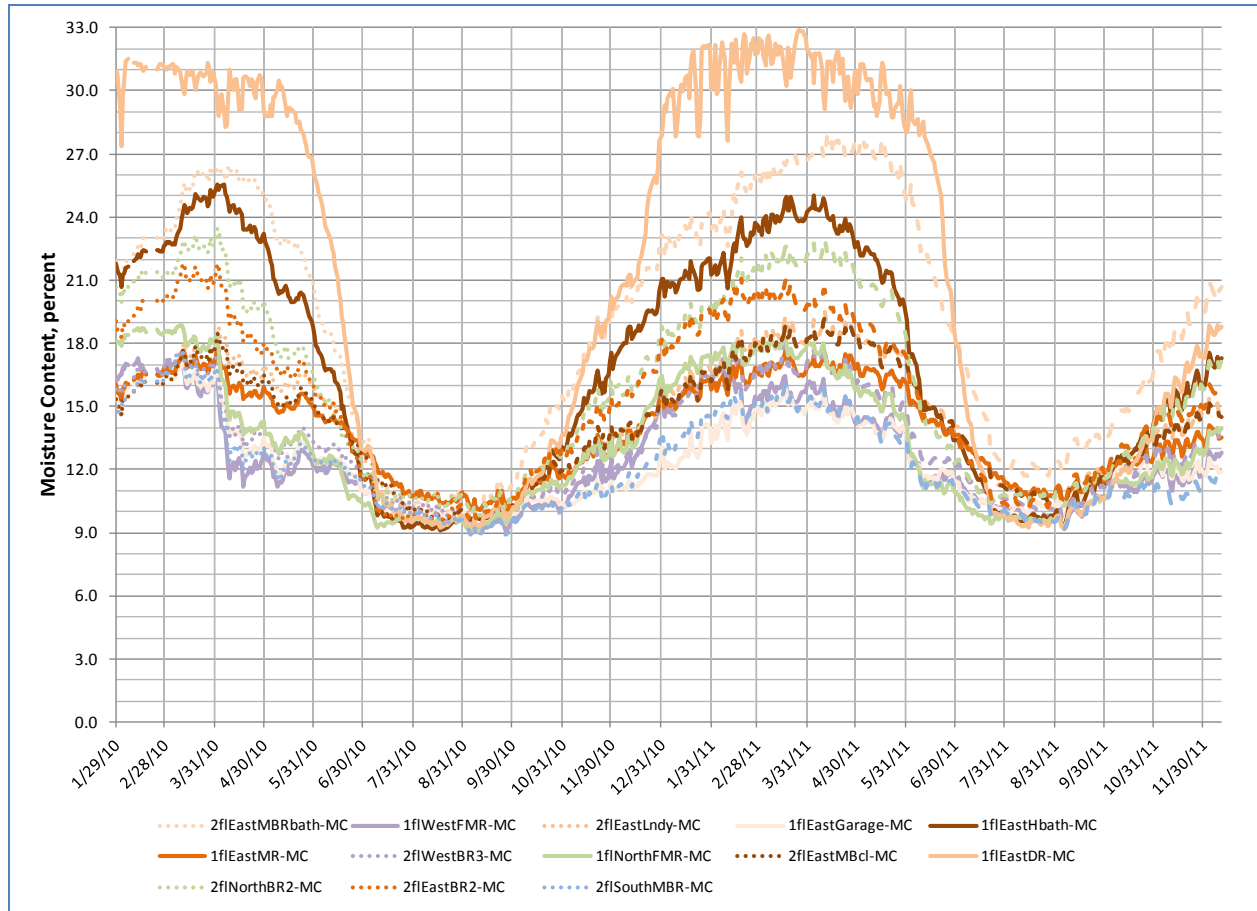
Furthermore, as shown in Figure 26, in this home where some cavities have higher levels of MC, the overall trends of all sections appear to track each other, although with different absolute levels of OSB MC. It does appear, however, that one or two cavities might have a source for air leakage (assumed from the interior), resulting in a much higher level of MC readings.

Figure 26. Jobsite 5 MC comparison of all wall cavities
