# Development of a Visual Inspection Data Collection Tool for Evaluation of Fielded PV Module Condition

## Technical Report

NREL/TP-5200-56154

August 2012

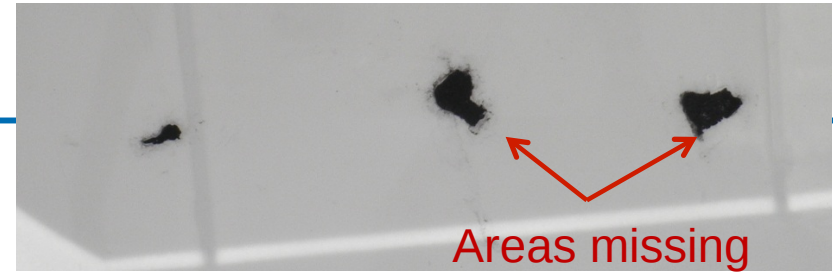
Areas missing  
(record as delamination)

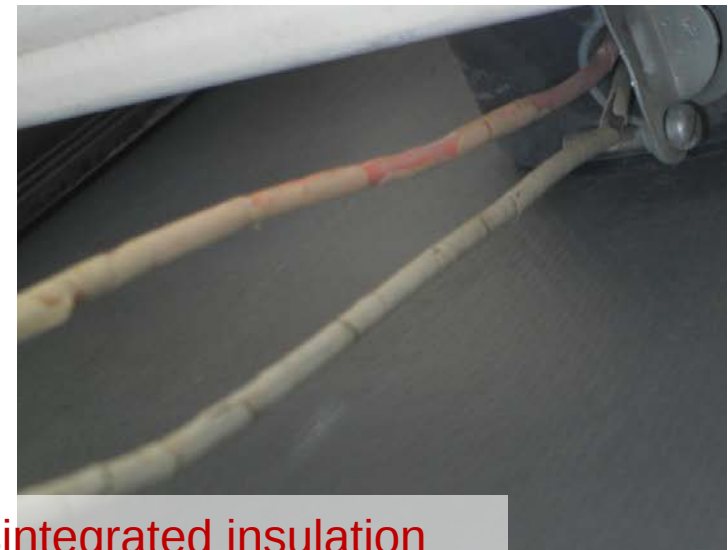
Cracked/disintegrated insulation

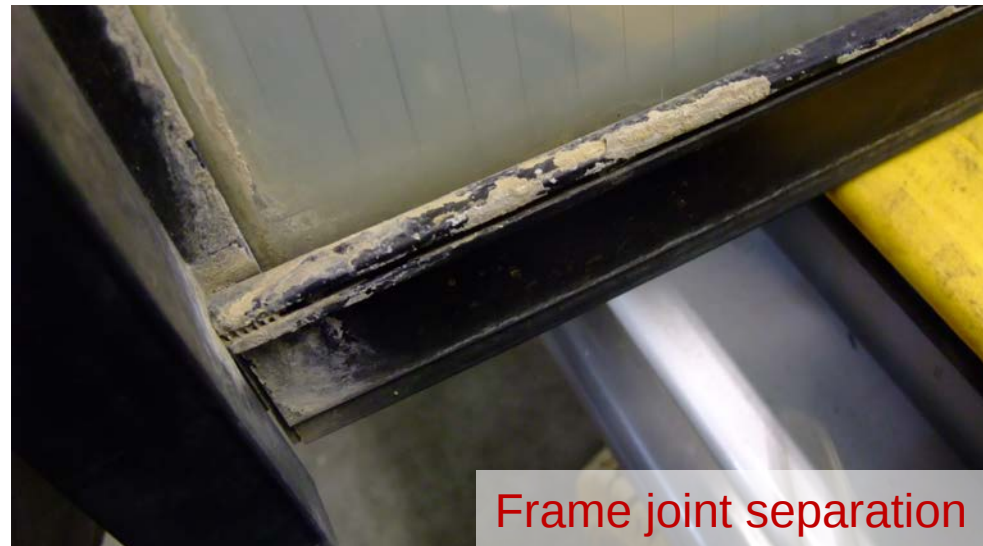
Frame joint separation

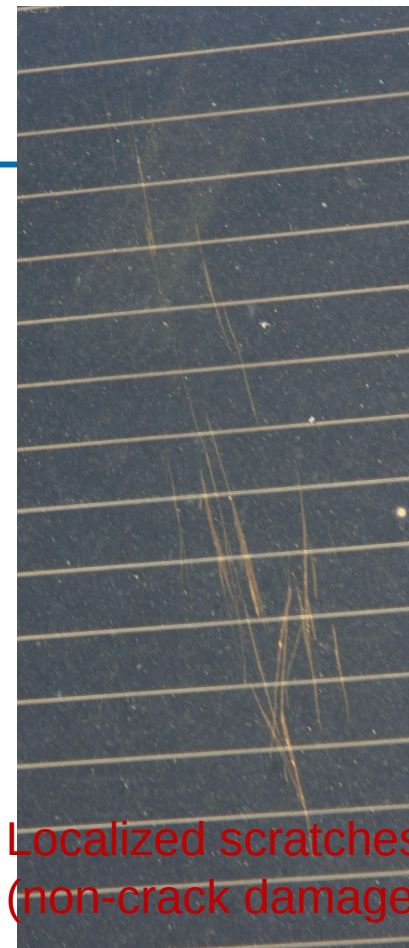
Localized scratches  
(non-crack damage)

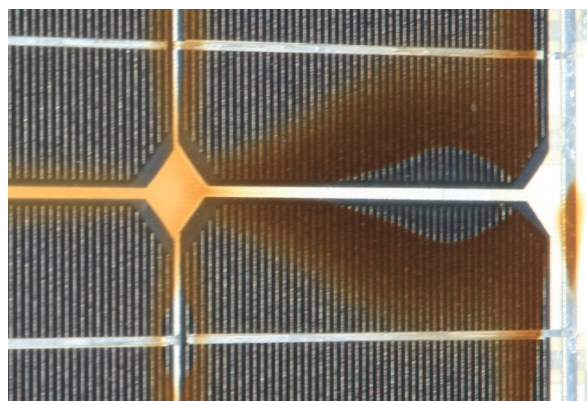
Dark discoloration at cell edges, between cells, and over gridlines and busbars

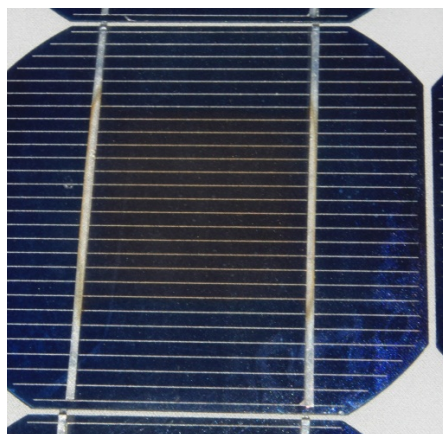
Light discoloration at cell center

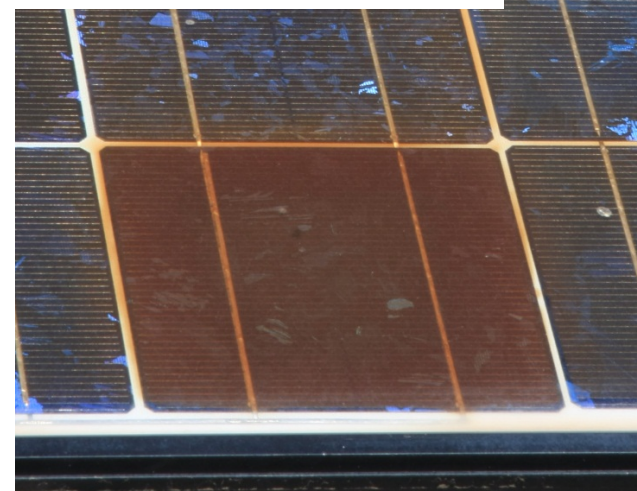
Light and dark discoloration with one individual cell darker than others

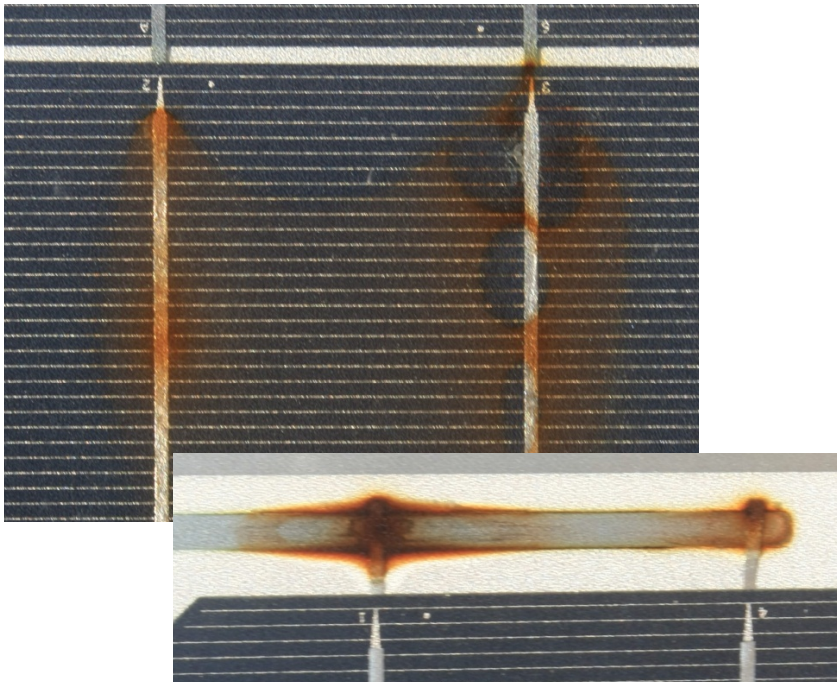
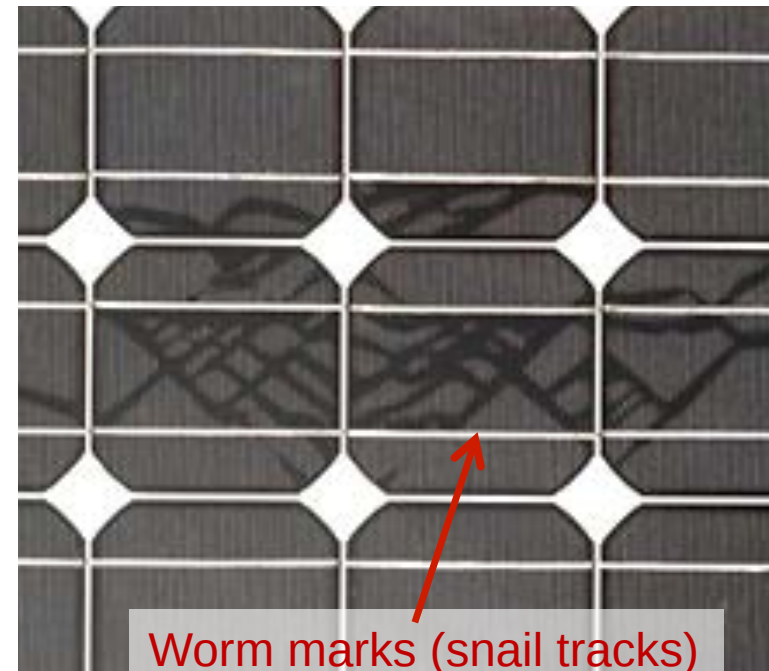
Worm marks (snail tracks)

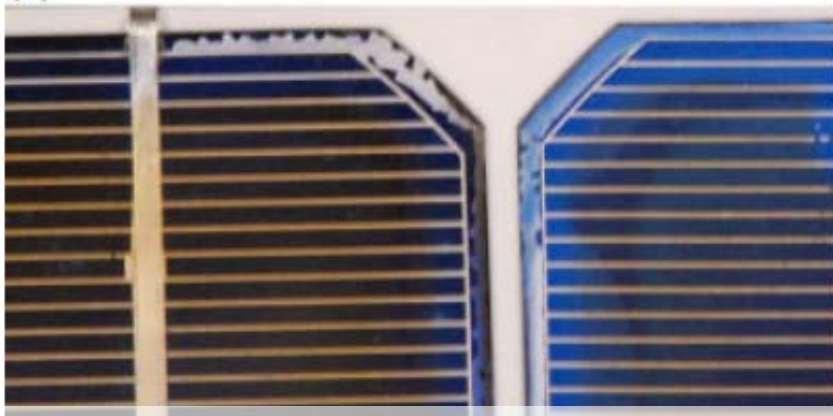
Semiconductor/Encapsulant delamination  
near edges

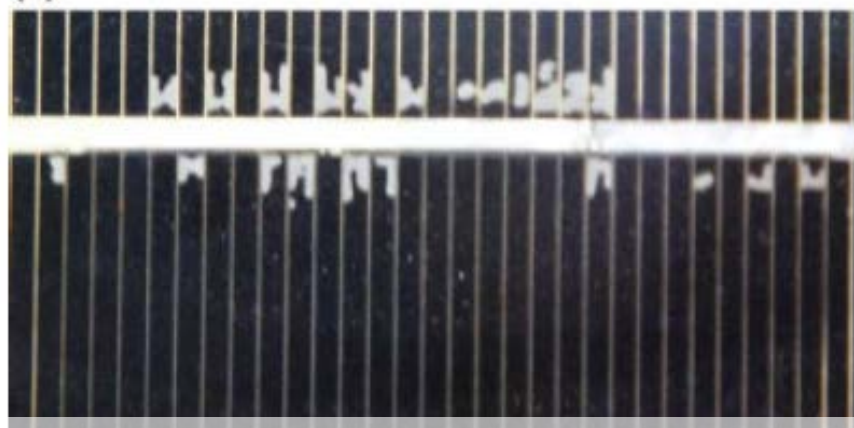
Semiconductor/Encapsulant delamination  
near busbar

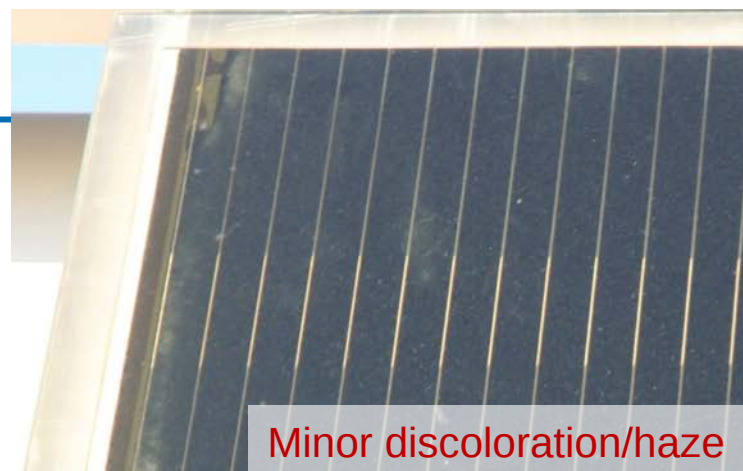
Minor discoloration/haze

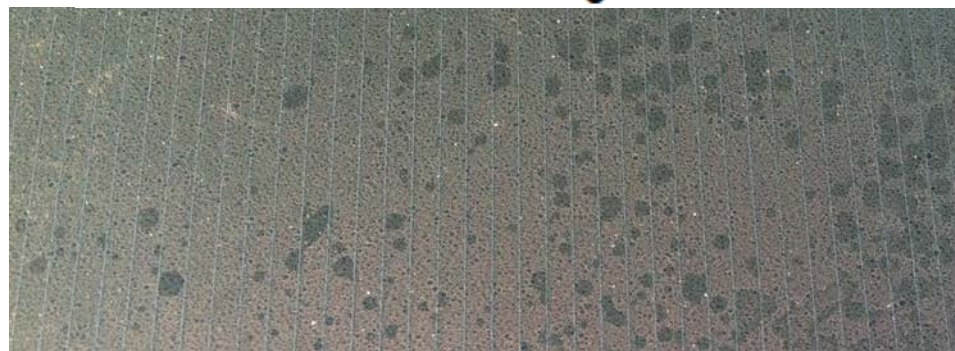
Major discoloration/spotted degradation/no pattern

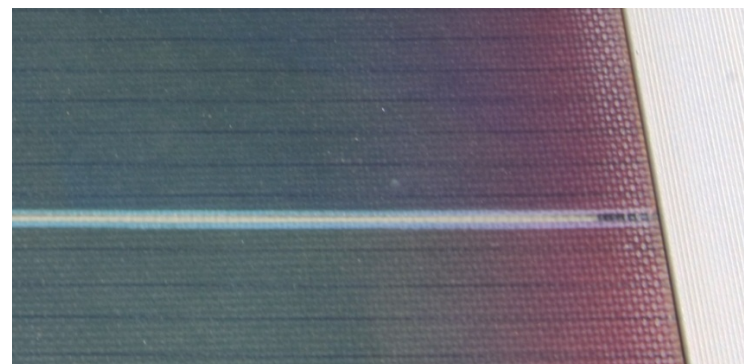
Major discoloration/other/module edges

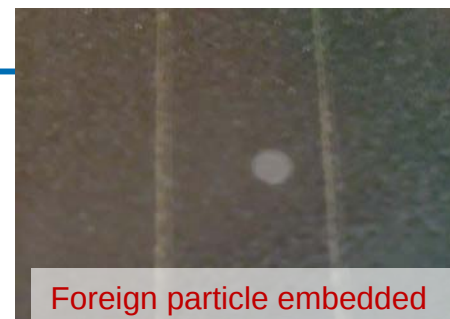
Foreign particle embedded

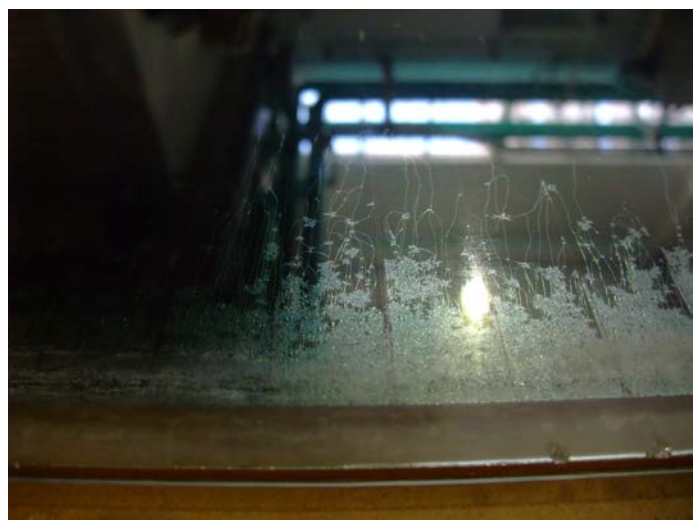
Absorber delamination

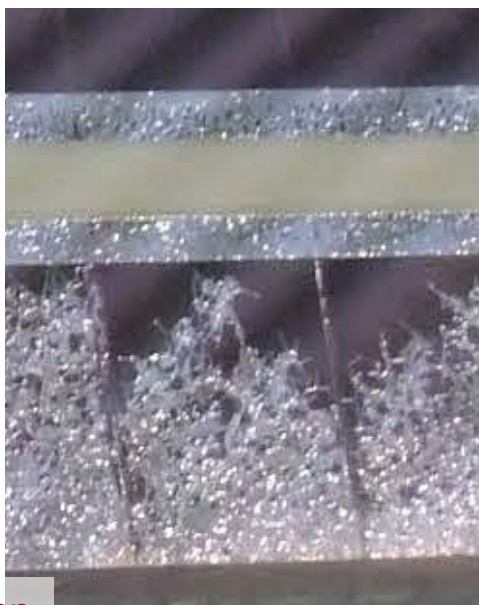
Small, localized damage/  
Possible moisture/cracking
