NASA/TM-2013-217799

Ultrasonic Nondestructive Evaluation of PRSEUS Pressure Cube Article in Support of Load Test to Failure

Patrick H. Johnston
Langley Research Center, Hampton, Virginia

May 2013

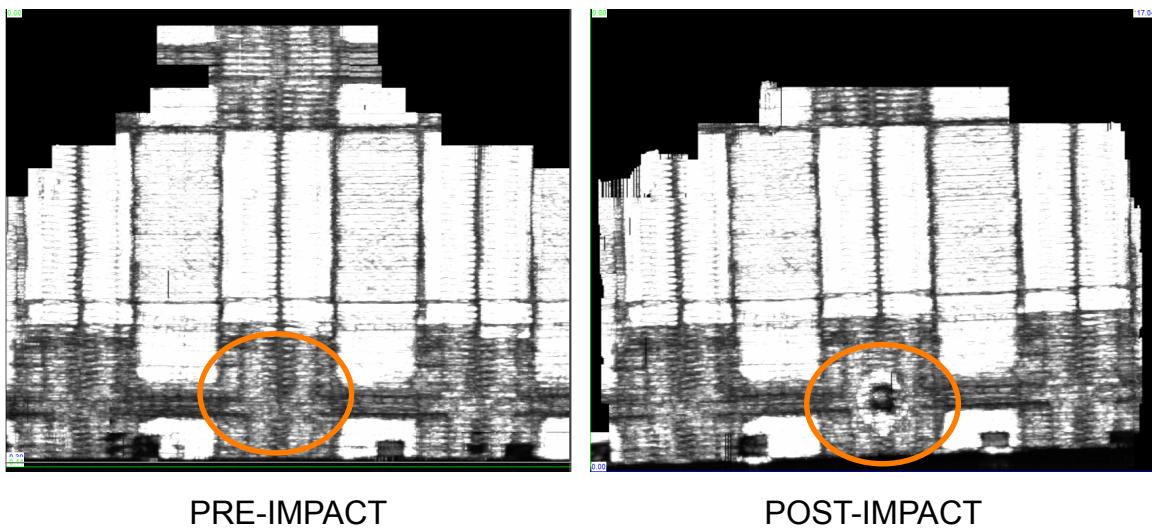
Figure 4.1 presents C-scan views of the impact site before and after the impact. An orange oval illustrates the site of impact. The post-impact data show an area of indentation, and a

surrounding brighter area, corresponding to delaminations, which were not observed in the pre-impact data.

Figure 4.1. Ultrasonic C-scan results from the site of impact before (left) and after (right) the impact was performed.

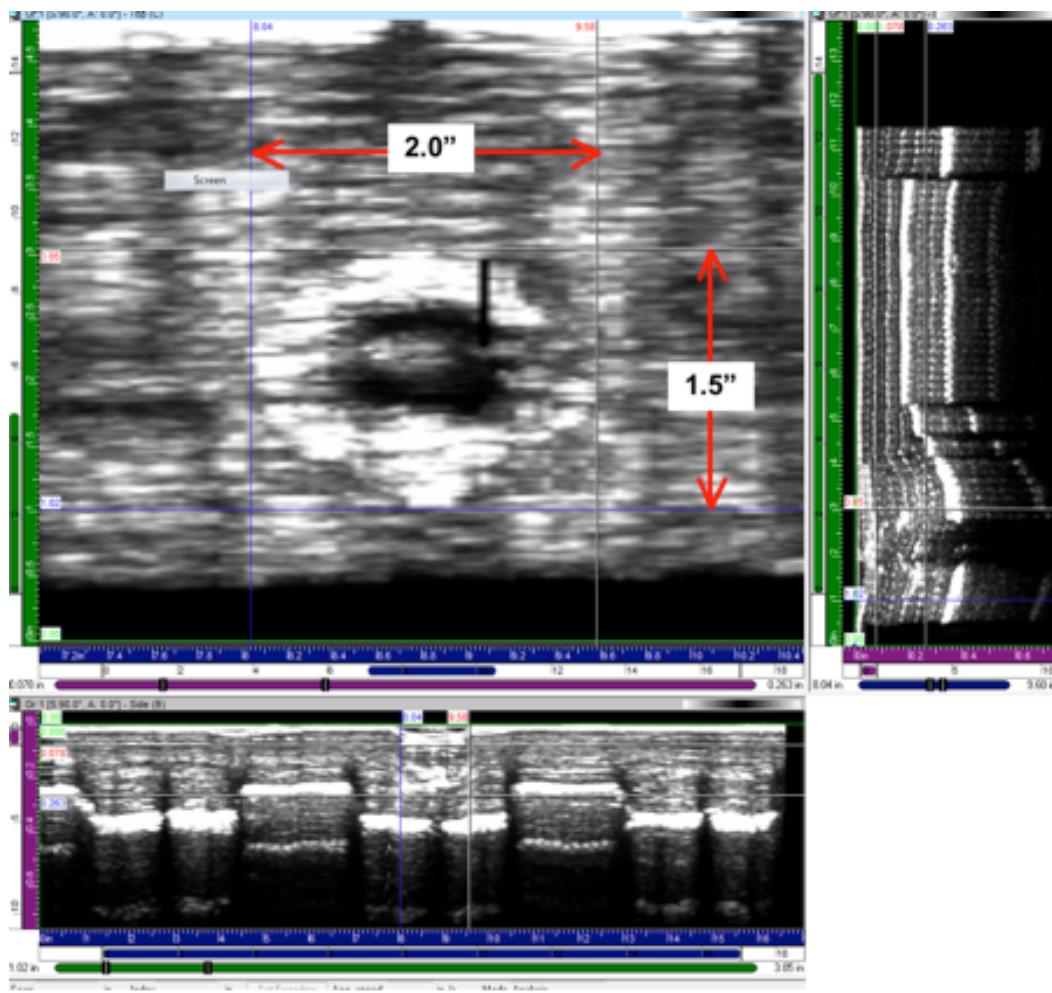
A close-up of the impact area is presented in Fig. 4.2. The lateral extent of the delamination is shown to be approximately 1.5 inches by 2.0 inches. A horizontally oriented B-scan (i.e., parallel to the outer edge of the rib panel) is presented in Fig. 4.3. Similarly, a vertically oriented B-scan (i.e., perpendicular to the outer edge of the rib panel) is presented in Fig. 4.4. These figures both indicate the lateral extent of delamination, and also illustrate that the delaminations penetrate to approximately 0.2 inches from the indented surface of the composite.

Figure 4.2. Close-up C-scan of the impact site (upper left) with vertically oriented B-scan (right) and horizontally oriented B-scan (bottom).

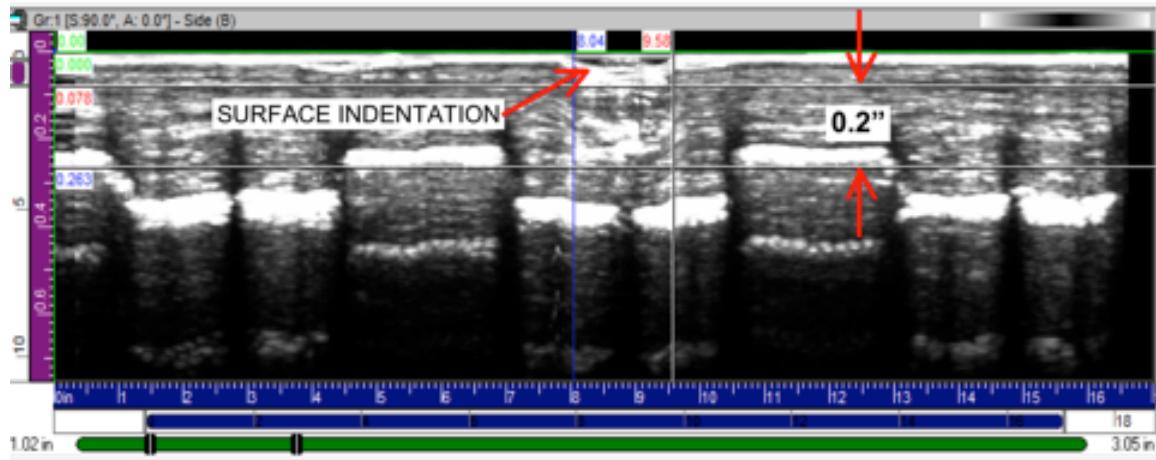
Figure 4.3. Horizontally oriented B-scan through the impact site, highlighting the indentation of the surface and indicating the depth of impact-generated delamination damage.

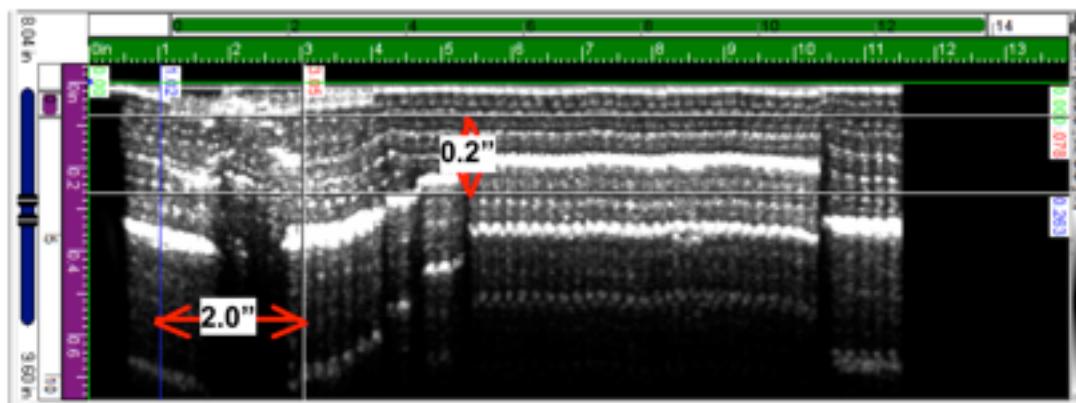
Figure 4.4. Vertically oriented B-scan through the impact site, indicating the width and depth of impact-generated delamination damage.

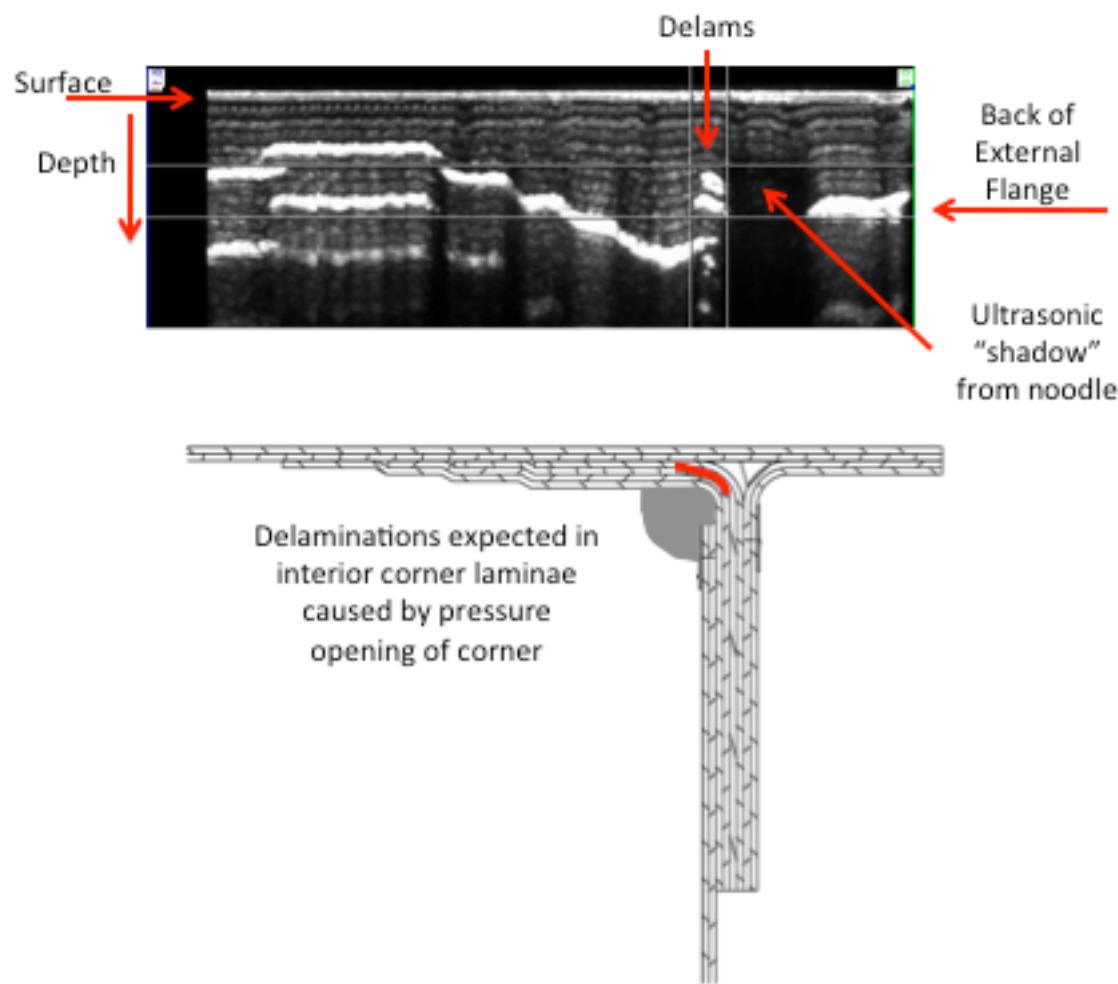
Nature of damage observed following 2P test

During the 2P pressure test case, some unexpected strain gage readings dictated that an inspection be performed of the crown panel end cap region centered between the frames. A B-scan from one of these inspections is presented in Fig 4.5. By comparison with the design drawing, in the lower panel, the strong back surface echoes can be identified as the number of fiber stacks is varied across the end cap flange. Also obvious is the ultrasonic “shadow” cast by the noodle material. To the inner side of the noodle appear several indications, apparently arising from delaminations in the stacks which form the curve of the inner corner of the end cap. Because of the shadow from the noodle, the only visible portions of the delaminations are those which extend beyond the arm of the noodle.

The occurrence of delaminations at this location was reasonable, given that pressurization of the cube would tend to open up the interior angle at the corner. This leads to stresses, which operate to separate the laminae in the corner.

Figure 4.5. Ultrasonic scans were taken following anomalous strain gage readings during the 2P pressurization test. Notice the ultrasonic shadow cast by the highly-attenuative nozzle material. It is likely that the delaminations extend further along the curve of the laminae, but are hidden from the inspection by the width of the nozzle.

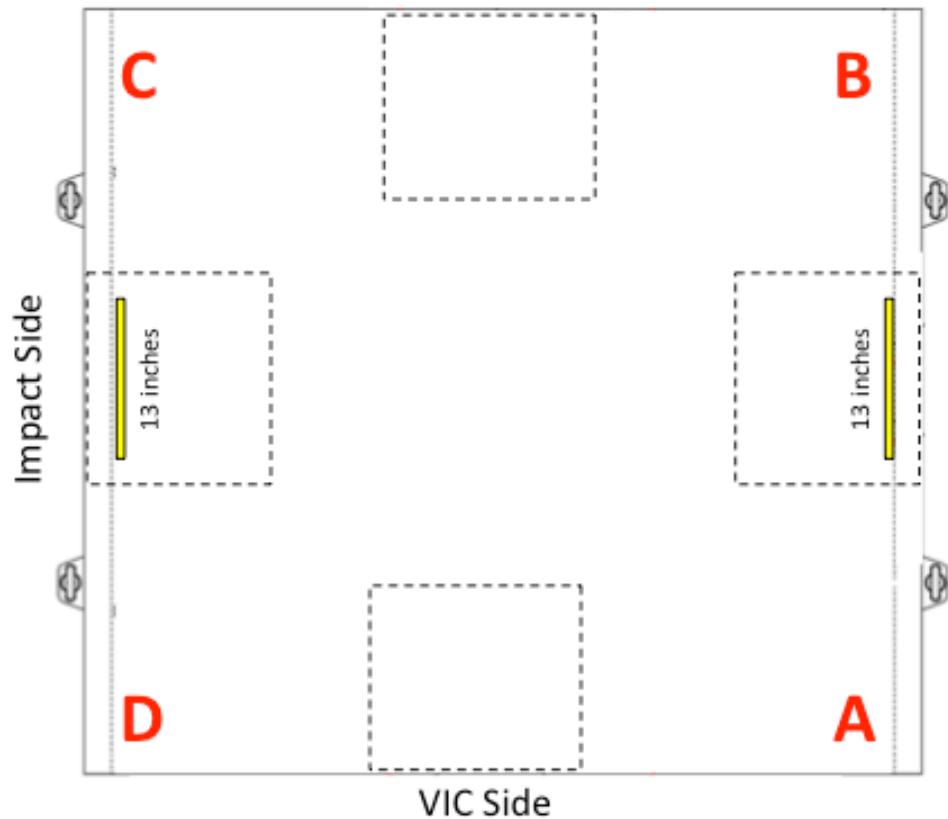
Crown Damage After 2P Test

Inspections were done on the central areas of all four edges of the crown panel, indicated by the dashed boxes in Fig. 4.6. Corner delaminations were observed on the opposite sides, between the frames, as indicated by yellow boxes in the figure, and were measured over 13 inches on each of these sides. Because of the shadow cast by the noodle, however, it could not be determined how far into the corner the delaminations extended. Furthermore, the interior surface of the corner was inaccessible for direct inspection because of sealant.

Figure 4.6. Summary of the crown panel damage observed following the 2P pressure test. Delaminations were observed adjacent to both end caps, at middle of crown panel, between the frames. The observable portion of the delaminations extended approximately 13 inches in length.

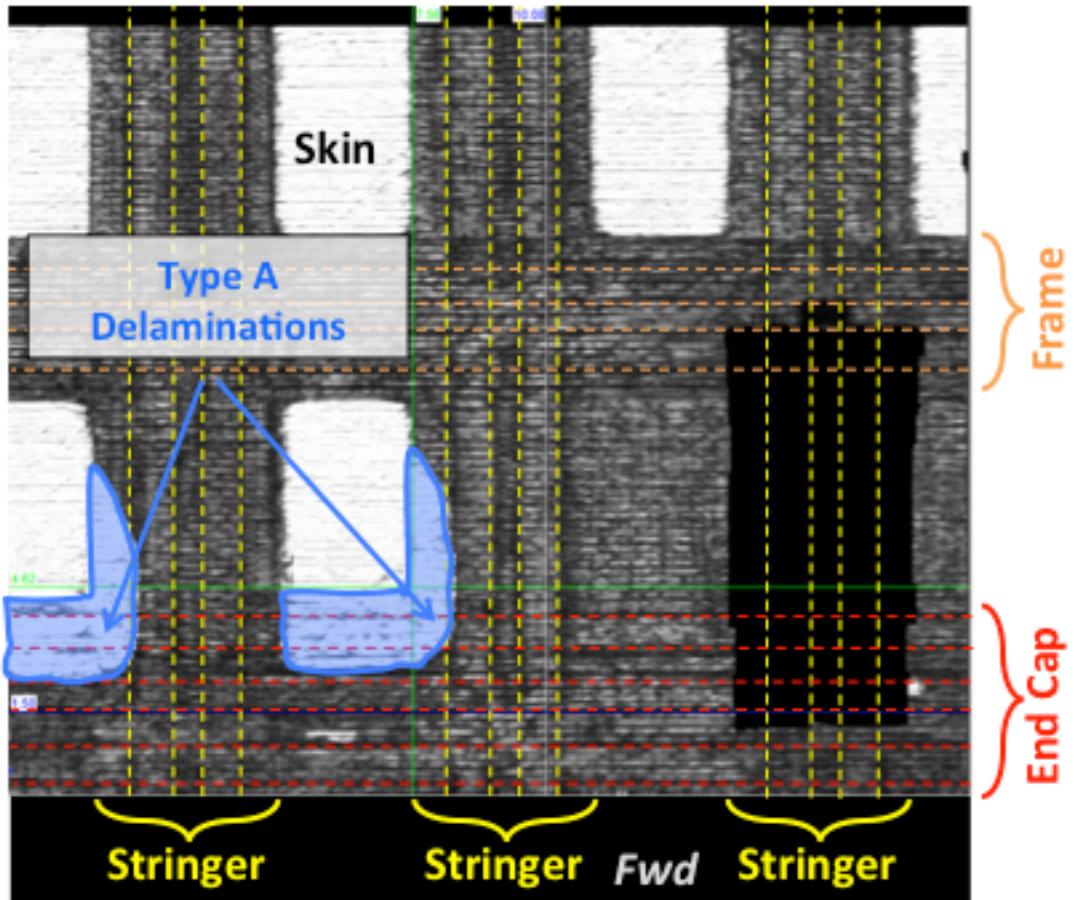
Type A Delaminations in Crown Panel

Type A: Delaminations between essentially flat laminae, most typically between the skin stacks and the stacks making up the flanges of stiffeners or end caps. There were also some Type A delaminations observed between tear strap stacks and the adjacent flange laminae. Two examples of Type A delaminations are shown in Fig. 4.8. Here, the unsupported flange tips

delaminated at the skin back surface. The delaminations terminated at the first row of stitches encountered under the stringer flange. In the end cap flange, the delamination extended past two stitch rows, before terminating at the third stitch row encountered. As will be discussed below, this particular end cap is the one to which the failed forward bulkhead had been attached.

Figure 4.8. Example of a Type A delamination, which is an extension of the inner skin surface underneath the stringer flange laminae.

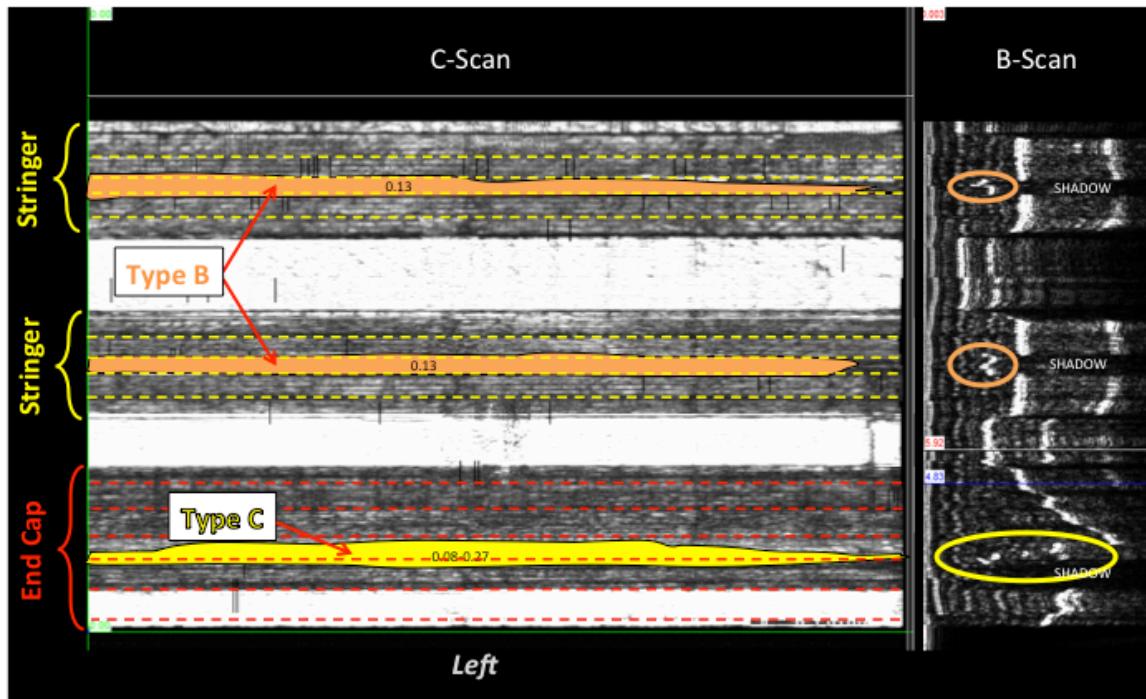
Type B and Type C Delaminations in Crown Panel

Type B: Some delaminations were observed to occur in the laminae lying above the noodes of both stringers and frames. These occurred between the stitch rows on either side of the noodle. Fig. 4.9 presents two examples of stringers containing Type B delaminations. Fig. 4.10 presents the occurrence of Type B delaminations at several different levels in the end of a crown frame. Depths of the delaminated areas from the surface are identified (in inches) in the figure.

Figure 4.9. Example of a Type B and Type C delaminations Type B damage is seen above the noodle of two stringers. Type C damage is observed to the side of the noodle of the end cap.

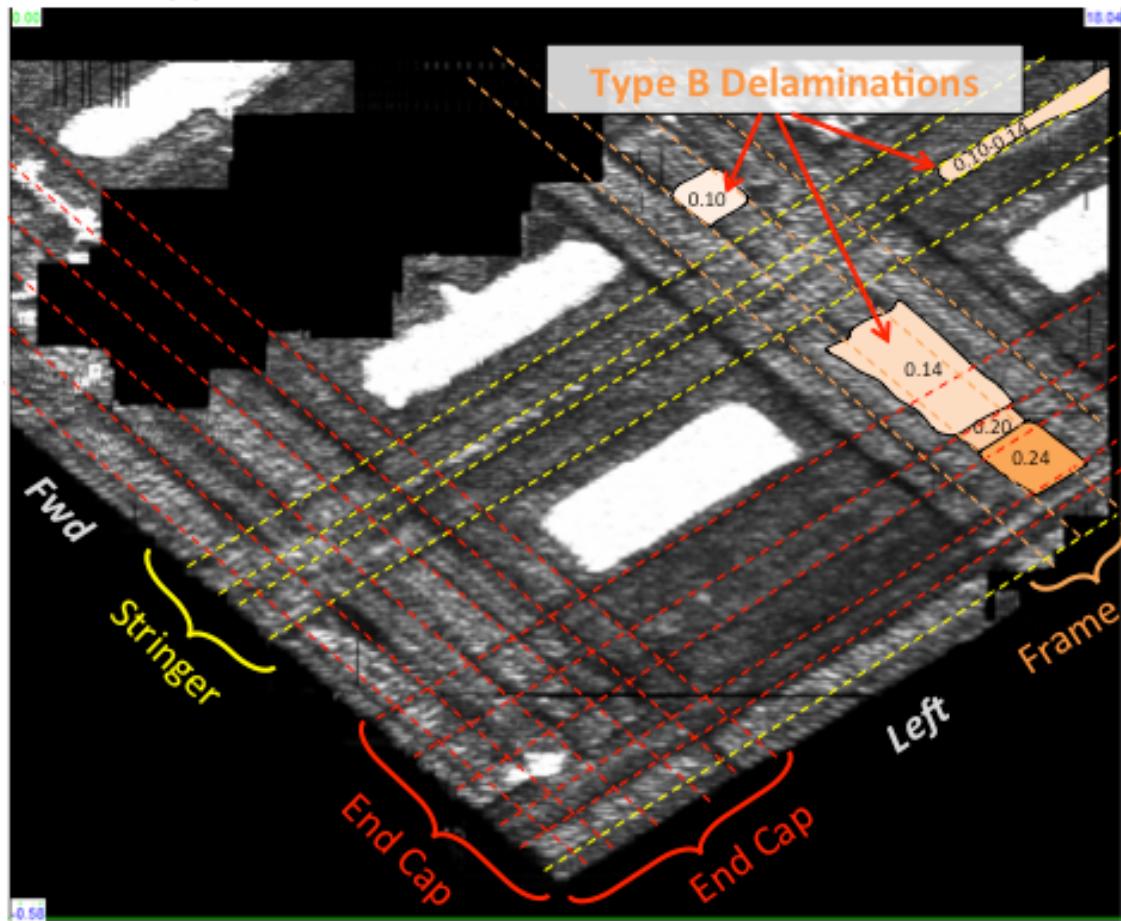
Type B Delaminations in Crown Panel

Figure 4.10. An example of Type B delaminations above the noodle of a frame.

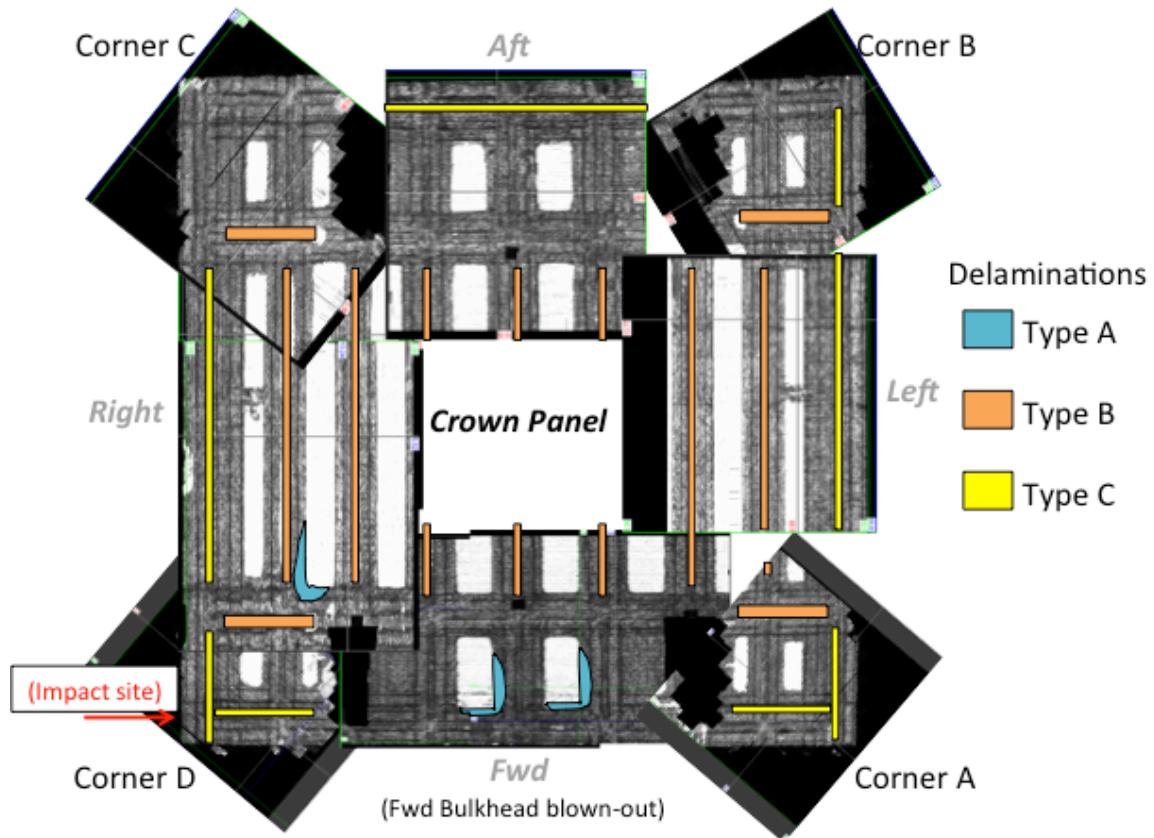
Crown Panel Delamination Summary

The results of inspection of the crown panel are presented in Fig. 4.11. Different colored areas indicate the three types of damage: Type A in blue, Type B in orange and Type C in yellow.

Only a small amount of flange delamination (Type A) was observed. Two areas were found adjacent to the end cap and central stringer along the connection with the failed bulkhead panel. A third area was observed at the first stringer and frame intersection. This is near the location proposed as the initiation site of ultimate failure: the metallic splice plates connecting the crown and rib frames [2, 4].

Type B delaminations were observed on all the stringers, between the frames. Patches of Type B flaws were observed at several depths in all the frames, typical of those presented in Fig. 4.10, near the corners where the frame intersects the end cap and stringer.

Type C corner delaminations were observed over approximately 2/3 of the length of the end caps. Because these results only include those parts of the fillet delaminations which extend beyond the limb of the noodle cross-section, some unknown amount of Type C damage might have gone undetected during these inspections.

Figure 4.11. Summary of the post-failure damage observed in the Crown panel.

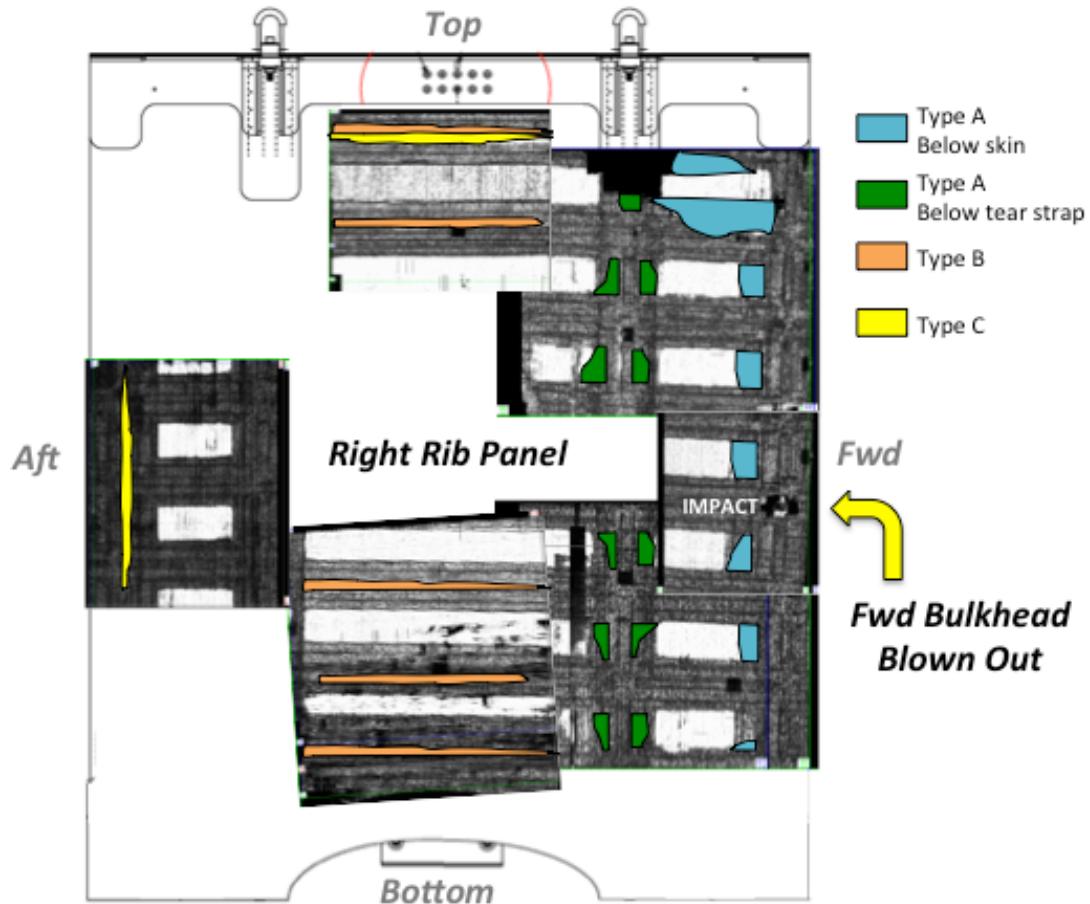
Right Rib Panel Delamination Summary

Figure 4.12 presents a summary of results obtained for the right rib panel containing the impact site. The area inspected includes the forward end cap, the vertical structure on the right hand side containing the BVID impact and to which the failed bulkhead panel had been attached, and the vertically-oriented rib frame. The uppermost part of the scan includes the interface with the crown panel, and the seven stringers are horizontal.

There were no observable changes in the damage surrounding the BVID impact site.

Type A delaminations were found along the end cap flange at each bay. These were at the level of the face sheet stacks, and fell within the area of the unsupported flange ends, terminating at the first row of stitches. A much larger area of delamination was found in the upper right corner of the panel, near the intersection of the rib frame with the crown frame, the suspected initiation site for the ultimate failure.

Delaminations of Type A were observed in the flange of the rib frame, at each bay scanned. These fell at the level between the tear strap and the frame flange laminae.

Type B delaminations were found in each of the stringers scanned in the central area of the panel, between the frames.

Lengths of Type C delaminations were observed along the uppermost stringer, between the frames, and along the central span of end cap adjacent to the Aft Bulkhead.

Figure 4.12. Summary of the post-failure damage in the Right Rib panel containing the impact site.

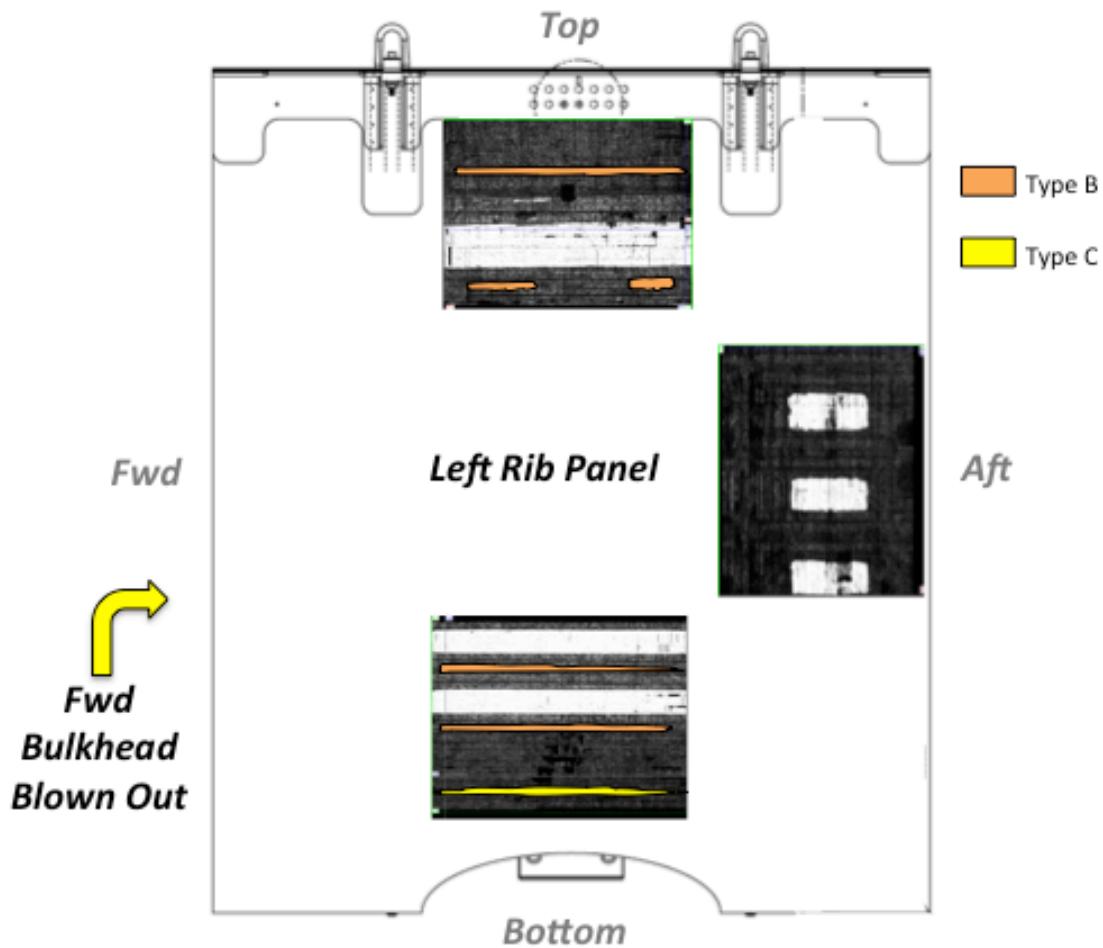
Left Rib Panel Delamination Summary

A summary of inspection results for the Left Rib Panel is given in Fig. 4.13. Type B delaminations were found in the stringers between the frames. Type C indications were observed in the central length of the bottom cap.

Figure 4.13. Summary of the post-failure damage in the Left Rib panel.

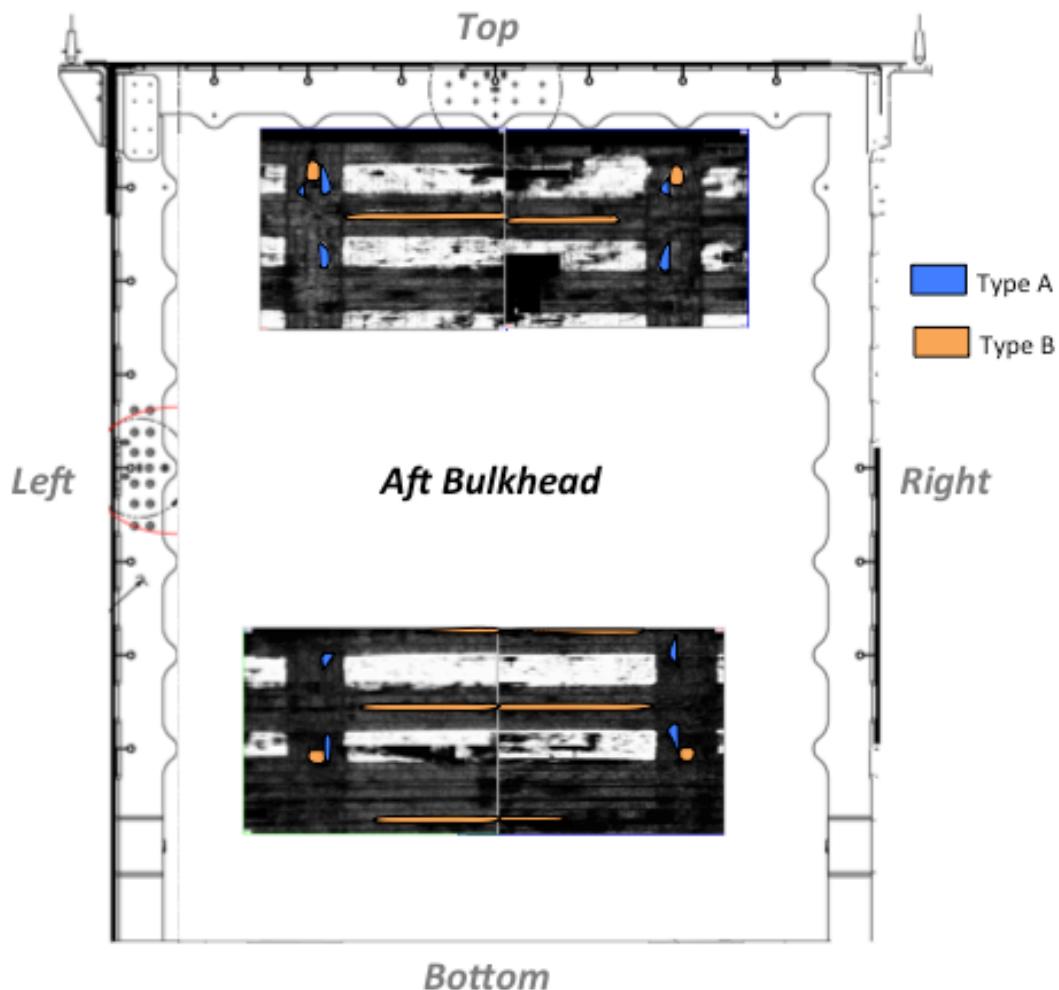
Aft Bulkhead Panel Delamination Summary

The inspection of the Aft Bulkhead is summarized in Fig. 4.14. Type B delaminations were identified in the bottom cap and in stringers between the vertical frames. Small areas of Type A and Type B delaminations were found in the frames, with notable symmetry in the size, shape and locations of the flaws.

Figure 4.14. Summary of the post-failure damage in the Aft Bulkhead panel.

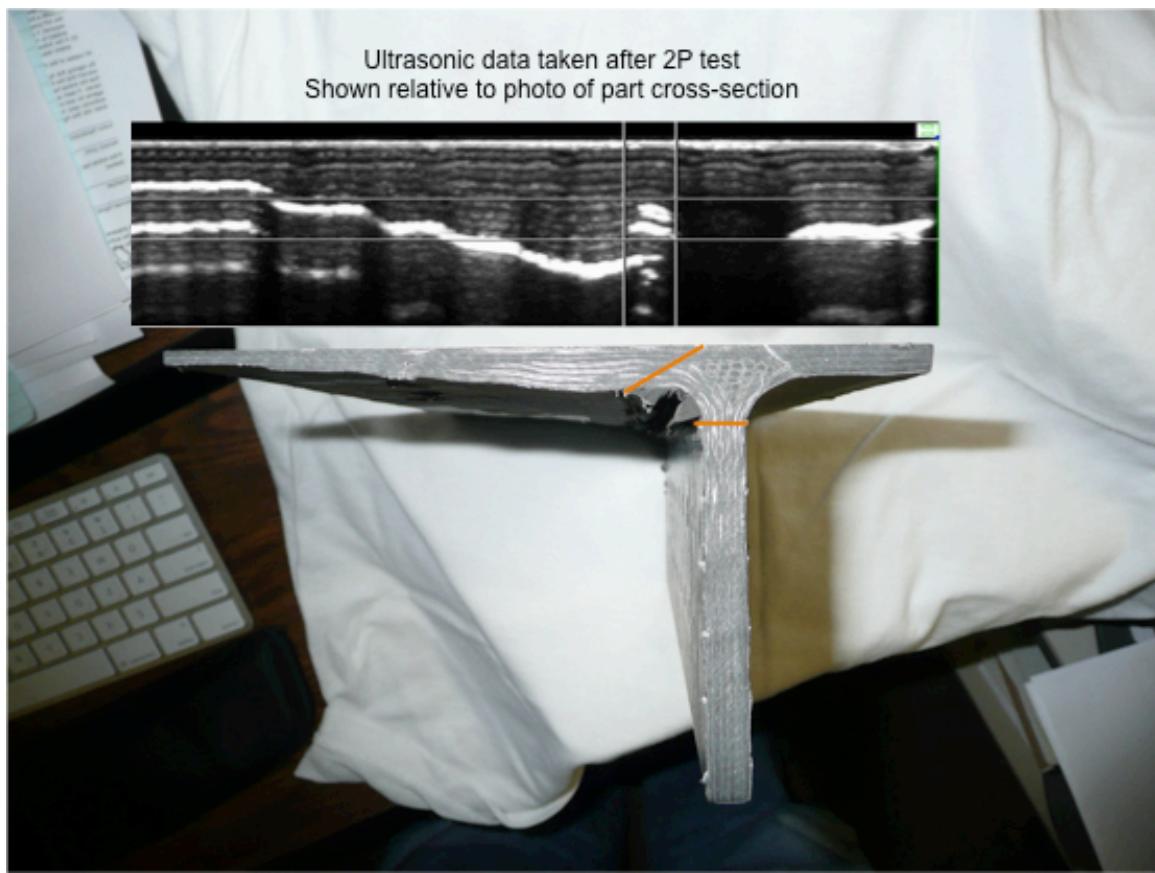
Examination of the end of the specimens is useful. In Fig. 4.17 an ultrasonic B-scan from this region, taken following the 2P load test (see Fig. 4.5), is overlaid onto a photograph of the end of specimen Side A. Some of the stitches are readily identifiable in the photograph; orange lines indicate others.

The broad, echo-free area in the B-scan is observed to correspond well to the crown edge of the “triangularly-shaped” noodle region, which was filled with a low density of bundled fibers during fabrication.

Figure 4.17. Photograph of the end of cut-out Side A, with ultrasonic B-scan data taken following the 2P test superimposed in approximate alignment.

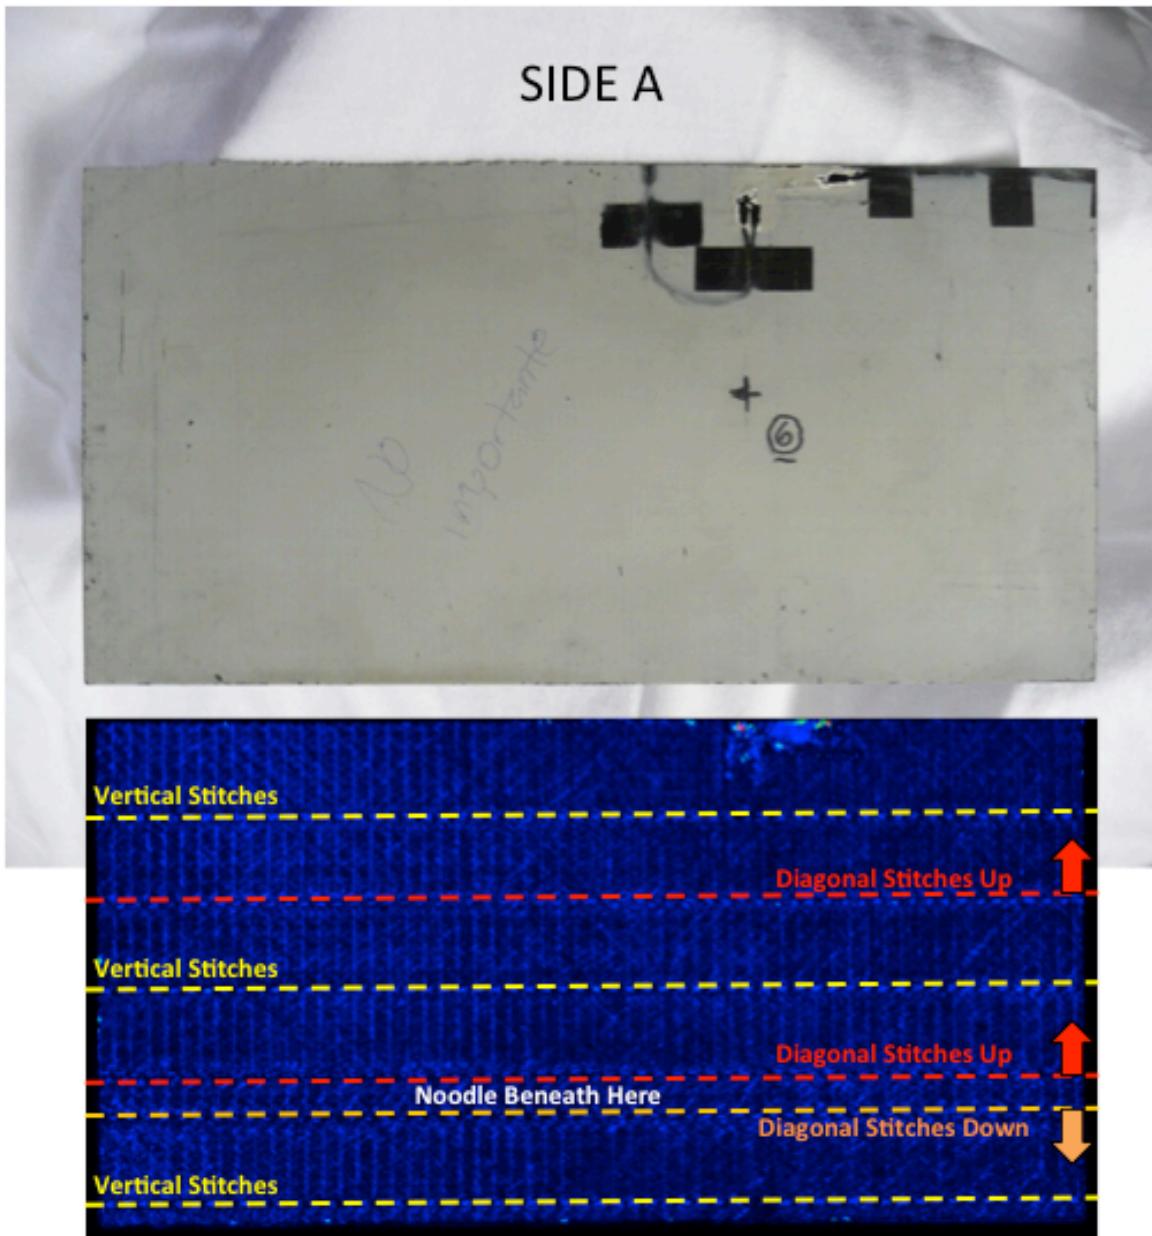
Figure 4.18. Photograph of the external surface of cutout Side A, above an ultrasonic C-scan. The C-scan was from data gated just below the surface of the part, where echoes were observed corresponding to the surface stitch material. Colored dashed lines indicate the stitch rows. Yellow lines correspond to vertically oriented stitches. Red and orange correspond to the angled stitch rows. Arrows indicate the lateral direction of the angled stitches: red in the inboard direction and orange in the outboard direction. The diagonal stitches on either side of the noodle angle away from the centerline of the end cap, as indicated in Fig. 4.17.

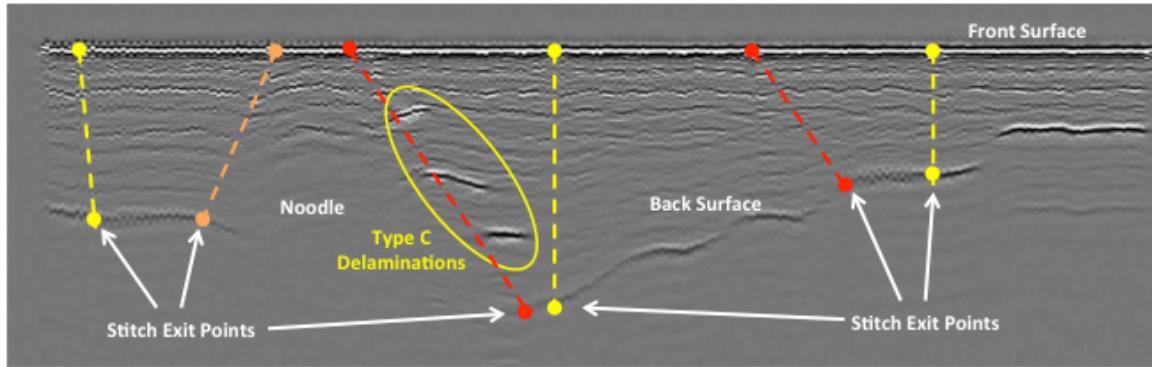
Figure 4.19. Ultrasonic B-scan through the noodle region of cut-out Side A. Using ultrasonic indications of the entry points of stitches at the top surface and bottom surface, lines are drawn to indicate approximate locations of stitches through the thickness of the specimen. Two observations of note can be made. Firstly, the Type C delaminations observed fall within the area between the red diagonal stitch and the yellow vertical stitch. Secondly, the extent of the very nearly echo-free area falls close to the diagonal stitch on either side of the noodle.

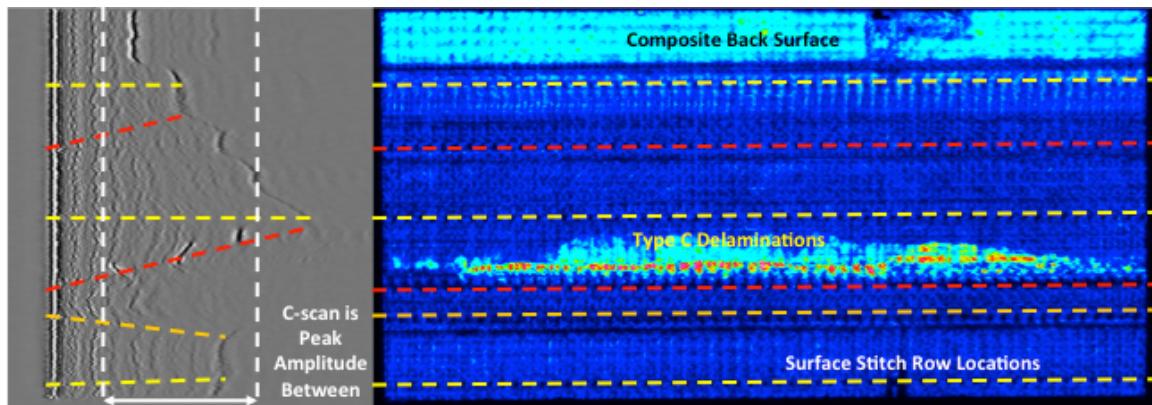
Figure 4.20 combines the B-scan from Fig. 4.19 (rotated 90° counterclockwise) with a C-scan of the specimen representing the peak echo amplitude from the interior of the specimen. The white dashed lines on the B-scan indicate the depth gate. The Type C delaminations are observed to extend the entire length of the specimen, and to be contained between the red stitch row and the adjacent yellow stitch row.

Figure 4.20. The B-scan from Fig. 4.19 rotated 90° CCW, is reproduced on the left hand side of this figure. To the right is a C-scan of the panel, made from the reflected data from the interior of the composite. The dashed colored lines, as in Fig. 4.18, represent the stitch rows at the skin surface. The indications of Type C delaminations are observed to fall within the volume of composite between the yellow vertical stitch and the red diagonal stitch line.

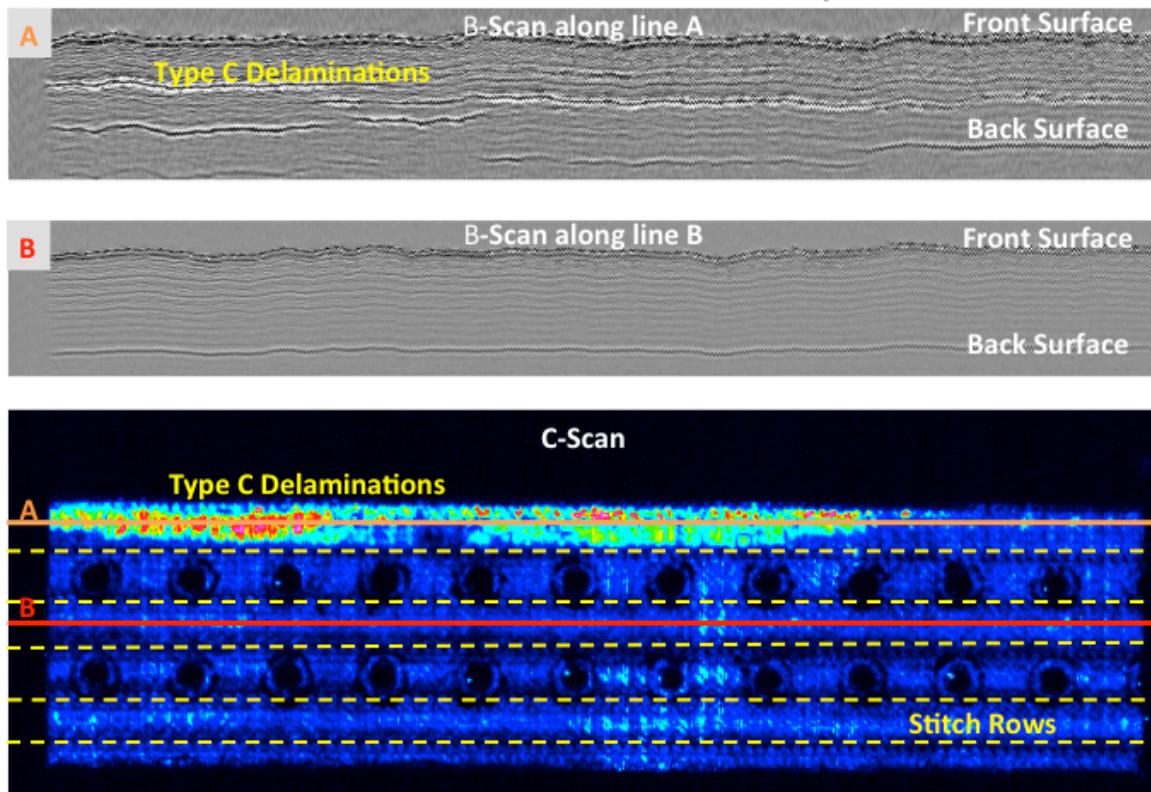
UT of Cutout End Cap

The end cap itself was also scanned. Figure 4.21 presents a C-scan and two B-scans of the cap. Again, on the C-scan, vertically oriented stitch rows are indicated by dashed yellow lines. A solid red line and a solid orange line indicate the locations of the B-scans presented in the figure. These fall in the area containing Type C delaminations adjacent to the internal fillet, and between two rows of stitches where no delamination indications are observed.

Figure 4.21. Ultrasonic scan of end cap.

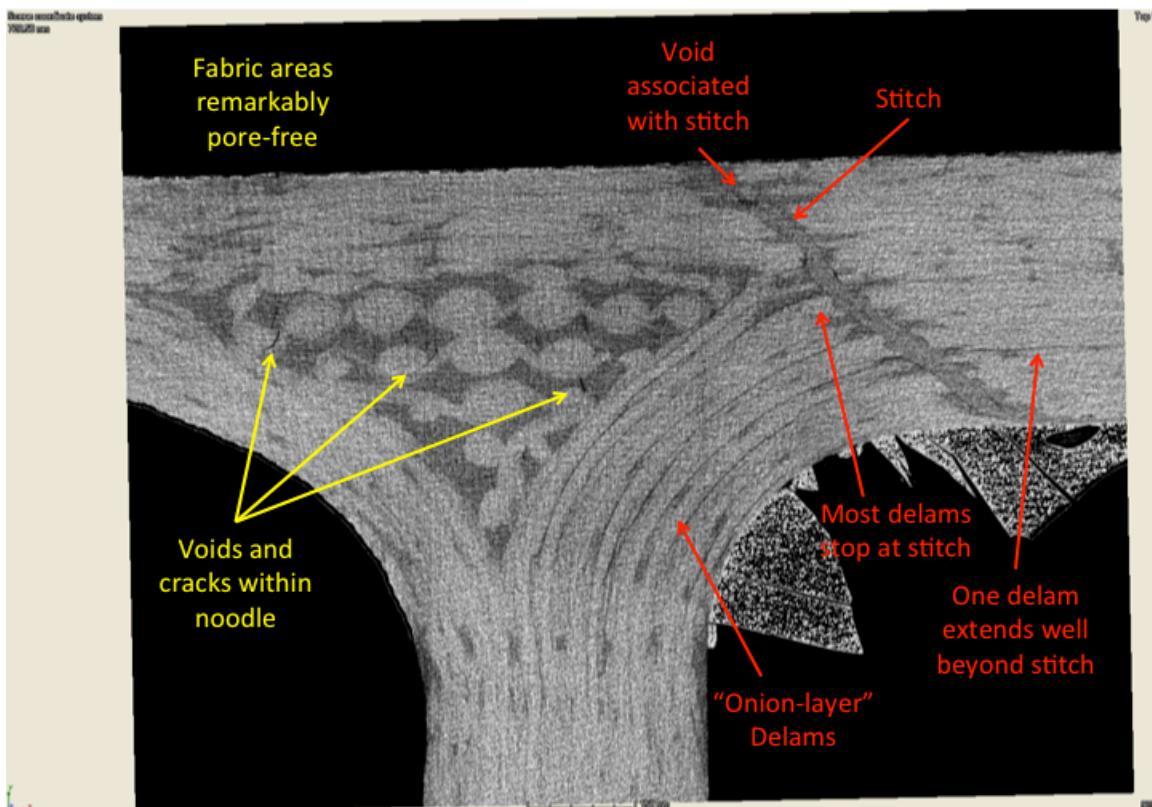
The interior fillet laminae are observed to be highly delaminated. It appears that the boundary between each pair of stacks (7-ply layers, held together by polymer knitting threads, stacked up to build the composite) is delaminated, causing an effect resembling the layering of an onion. These multilayer delaminations were observed to extend over the entire 1.5-inch length of the CT.

Almost all of the “onion-layer” delaminations in Fig. 4.22 end at the position of the diagonal stitch in the face sheet. Toward the end cap, the “onion-layer” delaminations end before or at the position of the first stitch row. At both ends of the curve, some small fraction of delaminations extends beyond the first stitches encountered. These are the portions of the delaminations found by ultrasonic inspection (Figs. 4.20 and 4.21), but all delaminations end before reaching the next row of stitching.

Figure 4.22. X-ray CT slice showing noodle and inner fillet region.

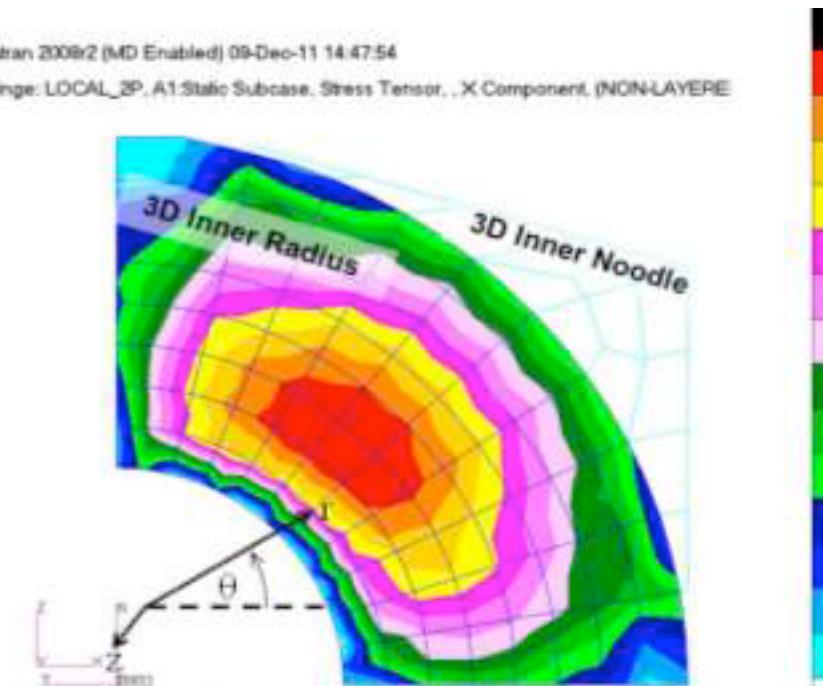
Figure 4.23 shows analysis results predicting high out-of-plane stresses in the inner fillet of the end cap, consistent with formation of the observed “onion-layer” delaminations. Interlaminar failures were predicted to occur at 12.4 psi, while the first indications of damage from strain gages occurred at approximately 16 psi during the 2P load test [4].

Figure 4.23. High out-out-plane stresses were predicted by analysis within inner fillet of end cap [4].
