NASA/TM-2013-217990
NESC-RP-10-00685

Composite Crew Module (CCM) Permeability Characterization

*Michael T. Kirsch/NESC
Langley Research Center, Hampton, Virginia*

May 2013

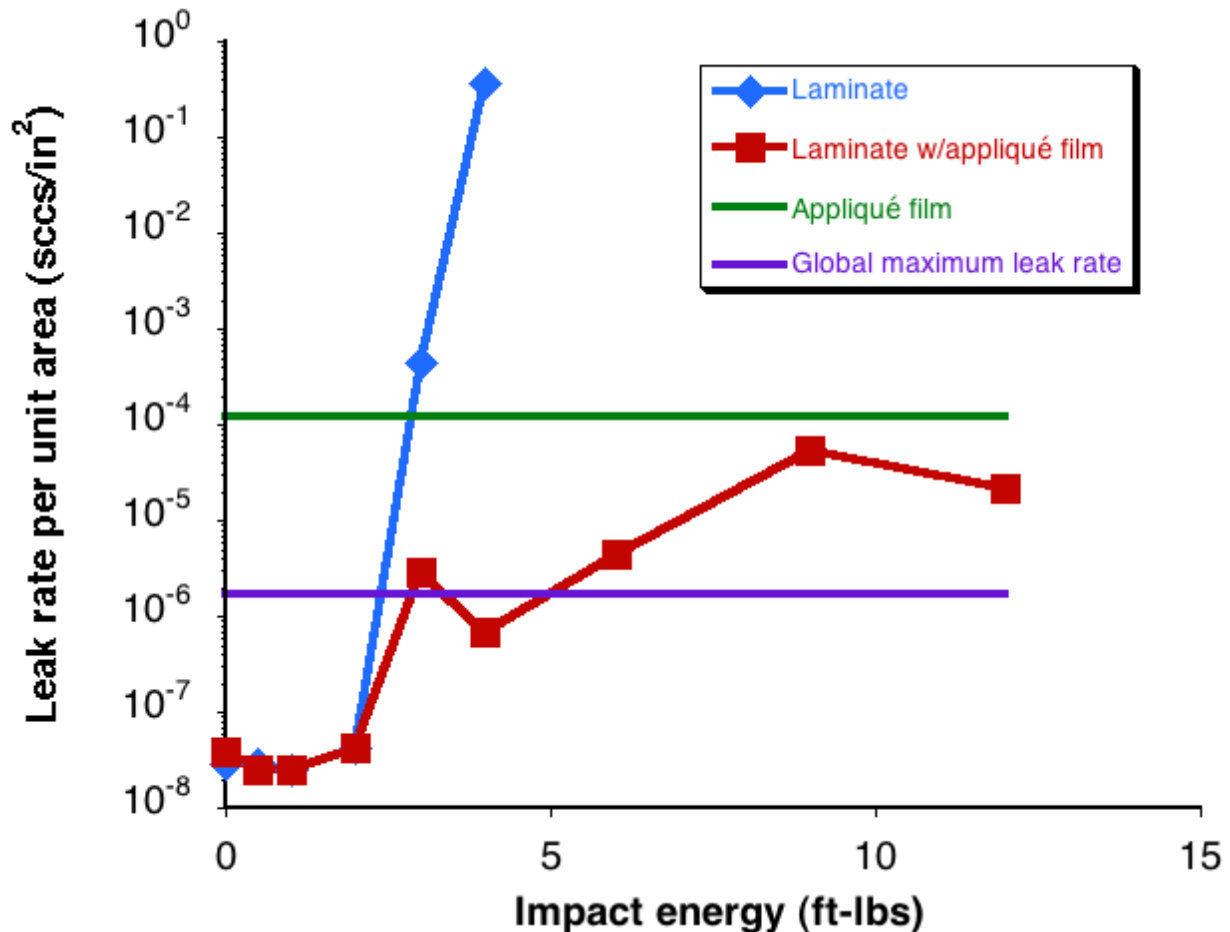
Figure 7.2-3. Effect of Appliqué Film and Impact Energy on the Leak Rate per Unit Area

Figure 7.2-3 contains two reference lines: a global maximum and appliqué film leak rates. The global leak rate is based on the CxP leak requirement (1e-1 sccs) divided by the CCM internal shell surface area (400 ft² = 57600 in²). The figure shows the appliqué film is not sufficient to act as the sole permeability barrier on the entire 400 ft². However, as discussed earlier, the permeability of the film to air may be significantly improved relative to the helium used in the leak measurement.

Figure 7.2-3 shows a permeability that is largely unaffected by impacts less than 2 ft-lb. This result is consistent with what was reported using the nitrogen flow technique [ref. 2] (i.e., there appears to be an impact threshold at ~2 ft-lb). However, this technique provides quantification below the impact threshold. The leakage rises rapidly with impact energy so that even one impact of the laminate at low energy (<6 ft-lb) would produce a leak that is in excess of the global maximum leak rate. In contrast, the laminate with the appliqué film shows the same impact threshold, but rather than showing a continued rise versus impact energy, displays a

shallow rise and appears to approach an asymptote below the leakage rate of the pure appliqué film.

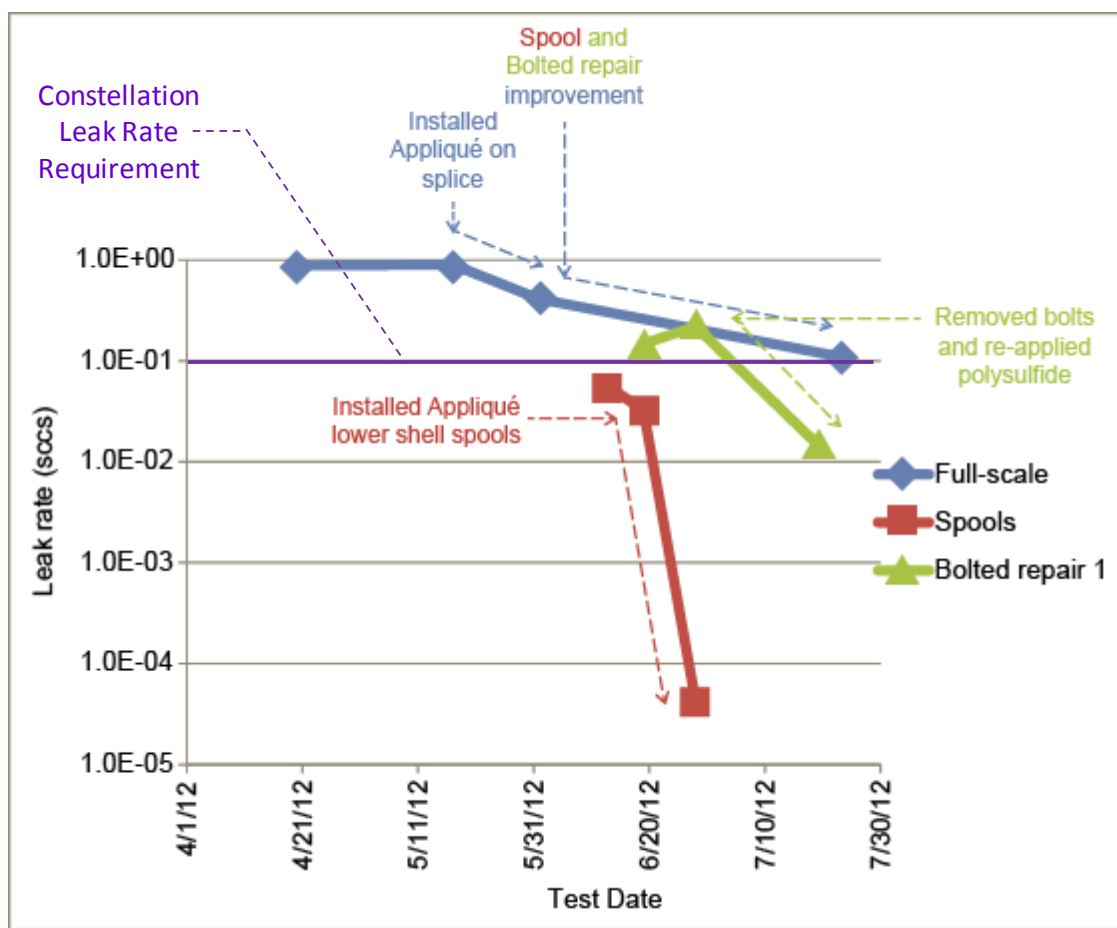
Figure 7.3-18. History of Leak Rate Measurements for Full-scale CCM and for Individual Features (modifications are identified)

1 (on lobed bottom) and the through-thickness inserts (spools) had leak rates that were of the same magnitude (i.e., $1\text{e-}1$ sccs) as the overall vehicle requirement. Figure 7.3-18 shows the overall CCM leak rate, the insert leak rate, and the bolted repair leak rate on a time line as modifications were made to reduce the leak rates. Figure 7.3-18 also illustrates the effect of the improvements on the feature and the overall leak rate. Again, the leak rates from the feature tests were adjusted for the 2-atm pressure differential. After modification, these features had a leak rate that was lowered by at least a factor of 10. However, the rate for the bolted repair remained higher than the rates for the other bolted fittings, suggesting that this feature was not appropriately prepared for managing leakage. With the modifications, the overall leak rate was reduced to $1.1\text{e-}1$ sccs, which is close to the maximum allowable leak rate of $1\text{e-}1$ sccs.

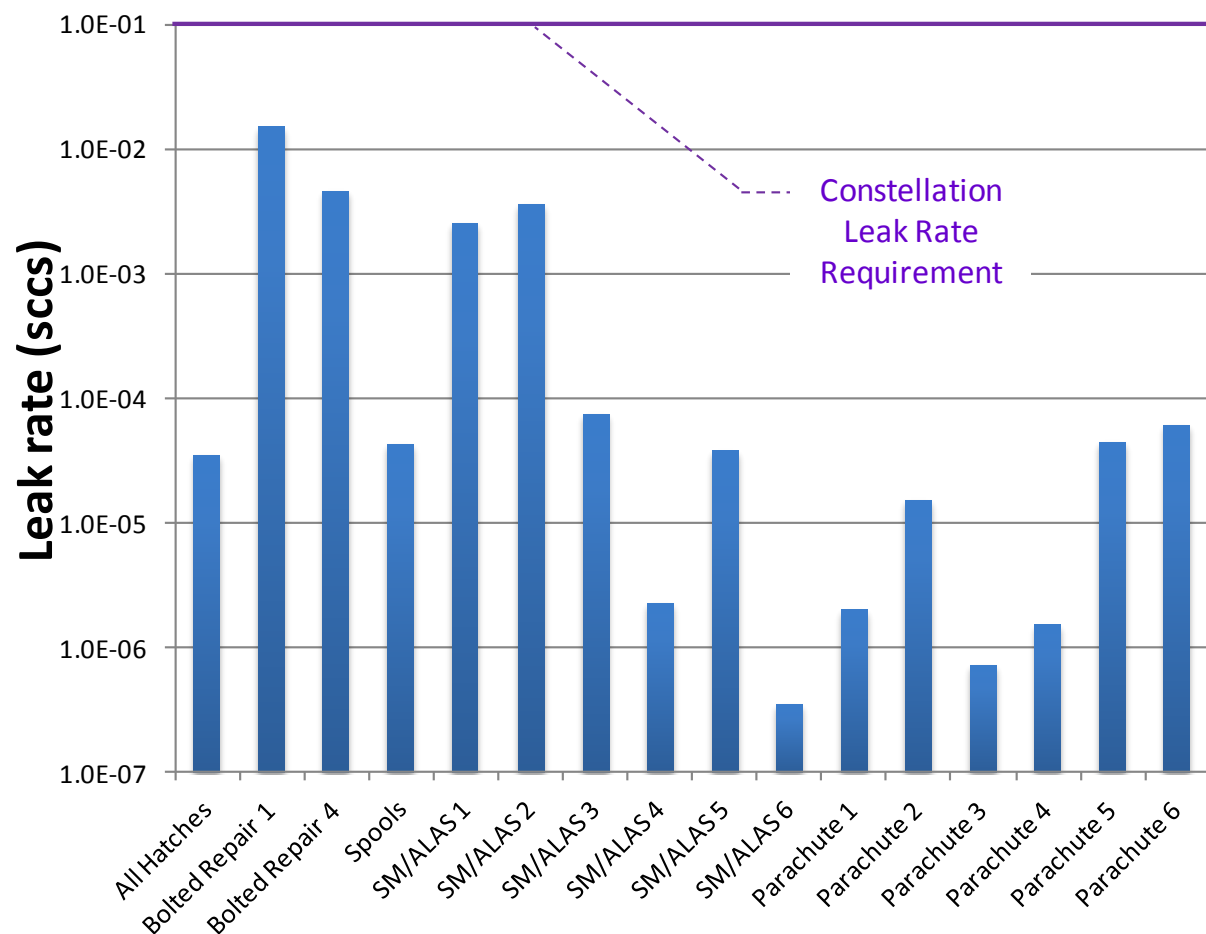
Figure 7.3-19. Local Leak Rate versus Feature

Figure 7.3-19 shows the leak rate for the local features studied with the results adjusted for a 2-atm pressure differential. Four features are noted as being significant contributors: the bolted repairs and SM/ALAS fittings #1 and #2. These features are out-of-family with the other bolted fittings and are significant contributors to the overall vehicle leak rate. It is clear from the remainder of the fittings that significant improvement in the leak rate of a bolted fitting is possible through the adoption of sealing method process improvements.

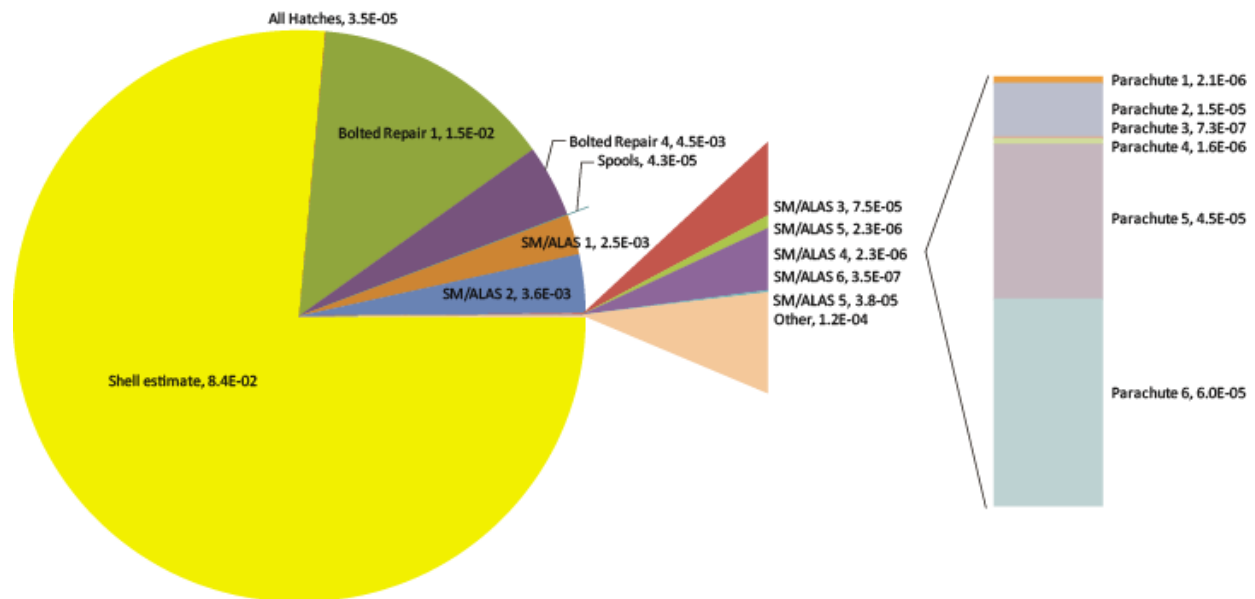
Figure 7.3-20. Global Leak Rate of 1.1e-1 sccs (separated by contribution)

The magnitude of the leakage from the composite shell was estimated by subtracting the local leak rates, summarized in Figure 7.3-19, from the final global leak rate of 1.1×10^{-1} sccs. The shell leak rate is estimated at 8.4×10^{-2} sccs. Figure 7.3-20 shows a pie chart where the global leak rate of 1.1×10^{-1} sccs is divided into the contributing leak factors. While this figure shows that the shell

is the largest contributor to the overall leak rate, it suggests there may be a discrete leak source on the shell (i.e., the scaling of the coupon result suggests that this rate should be much lower). Possible sources for discrete leaks are the impact sites from the damage tolerance test investigation [ref. 3] that were not covered with appliqué film, the damage created by the test-to-failure, and other undetected regions of damage.
