High Pressure Electrolyzer System Evaluation

Kevin Prokopius and Anthony Colozza
Analex Corporation, Cleveland, Ohio

This report documents the continuing efforts to evaluate the operational state of a high pressure PEM based electrolyzer located at the NASA Glenn Research Center. This electrolyzer is a prototype system built by General Electric and refurbished by Hamilton Standard (now named Hamilton Sunstrand). It is capable of producing hydrogen and oxygen at an output pressure of 3000 psi. The electrolyzer has been in storage for a number of years. Evaluation and testing was performed to determine the state of the electrolyzer and provide an estimate of the cost for refurbishment. Pressure testing was performed using nitrogen gas through the oxygen ports to ascertain the status of the internal membranes and seals. It was determined that the integrity of the electrolyzer stack was good as there were no appreciable leaks in the membranes or seals within the stack. In addition to the integrity testing, an itemized list and part cost estimate was produced for the components of the electrolyzer system. An evaluation of the system's present state and an estimate of the cost to bring

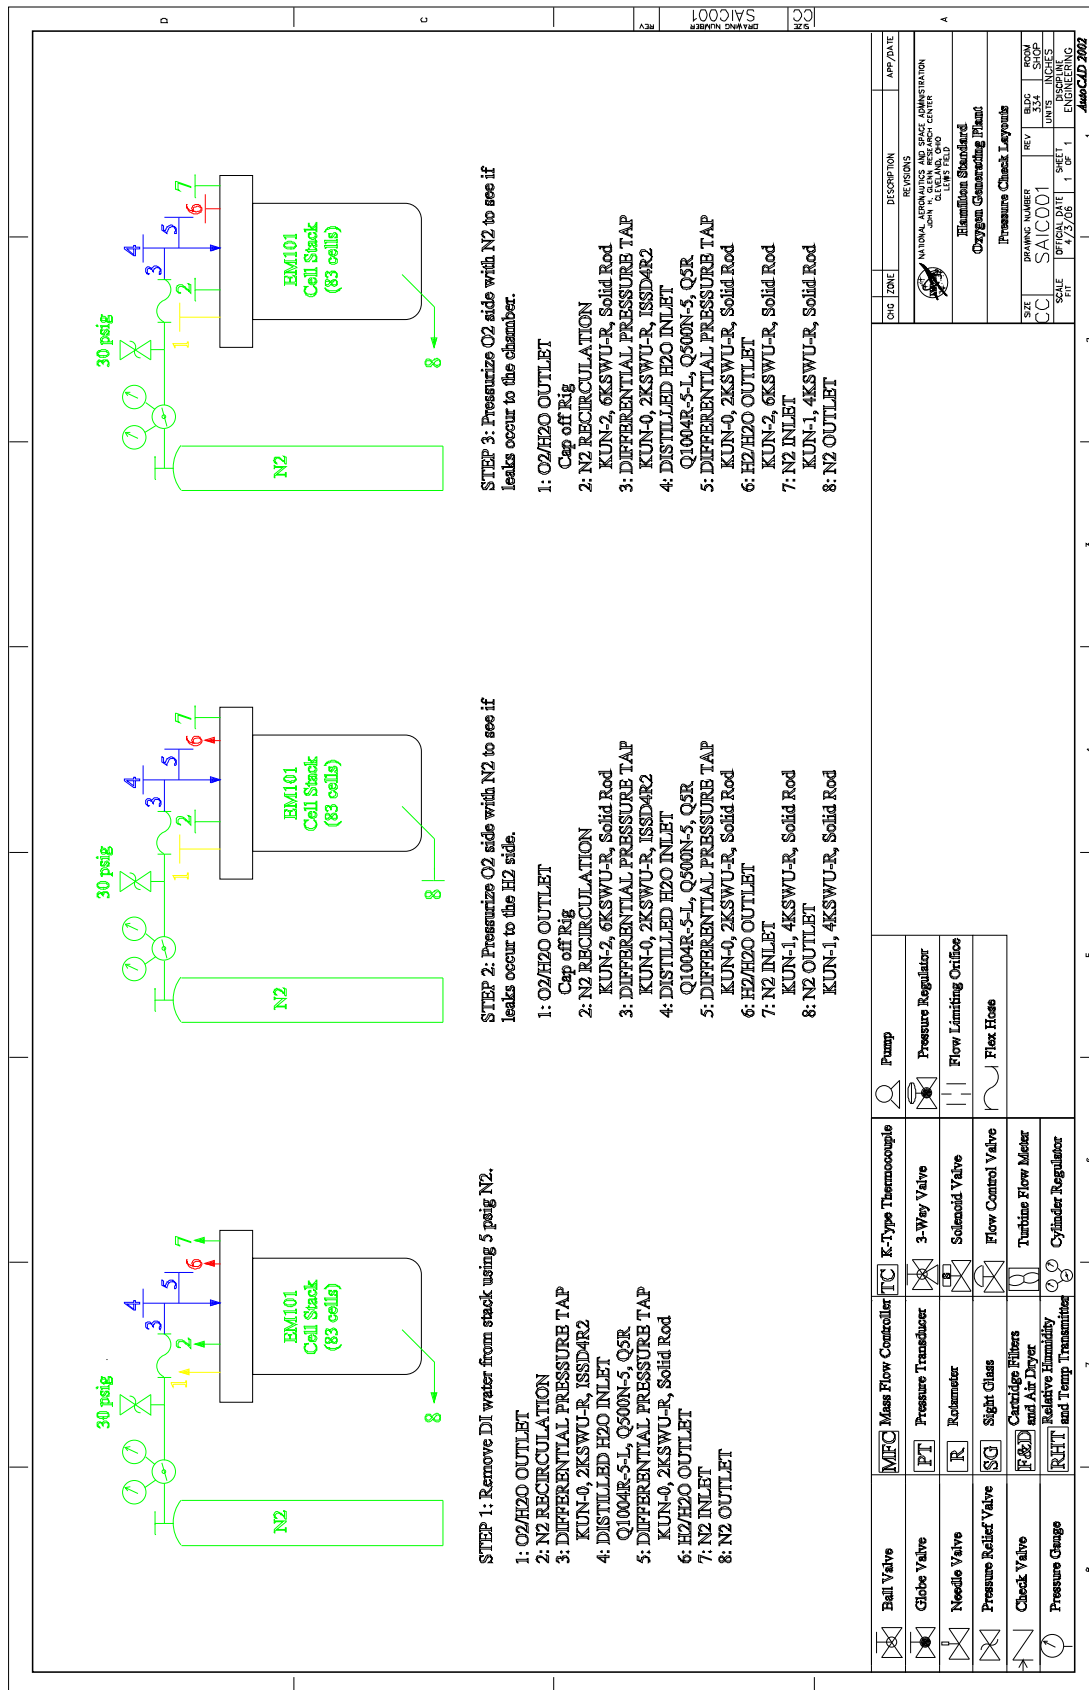
Figure 1.—Individual electrolyzer stack checkout steps.

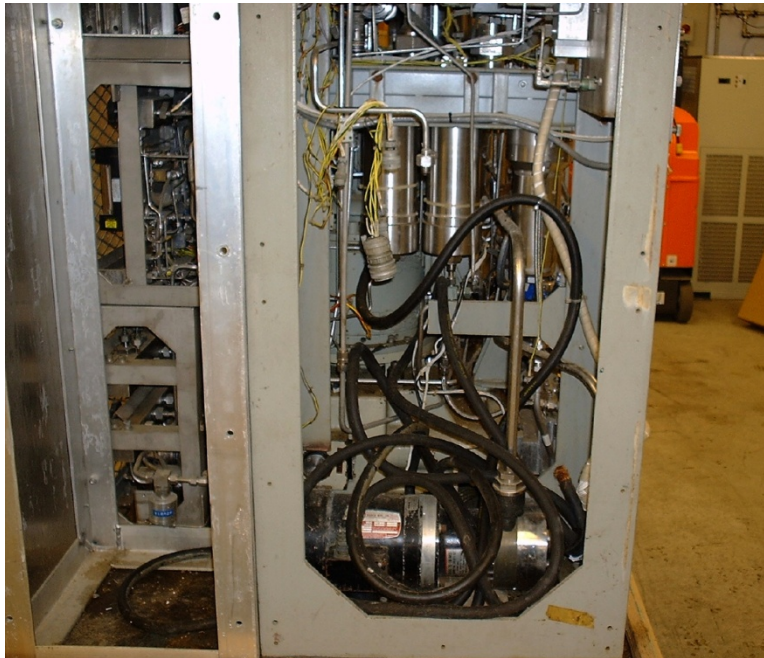
There are a number of open lines and severed electrical connections that would need to be completely replaced. The open lines are of particular concern since the cleanliness of the system is critical to the operation of the electrolyzer stack and with the use of oxygen in the process lines. Figures 2 through 7 provide examples of the present state of the system components.

Figure 2.—System cabinet.

The above figures show an example of the state of the system's mechanical and electrical components. Although some components may be salvageable, it is recommended that the system be completely rebuilt utilizing the electrolyzer stack and containment vessel. The containment vessel was sealed off from the fluid lines and therefore should be contaminant free and based on the results of the pressure testing the stack should be in good operational condition. Table 2 gives a summary of the estimated replacement cost for most of the major system components.

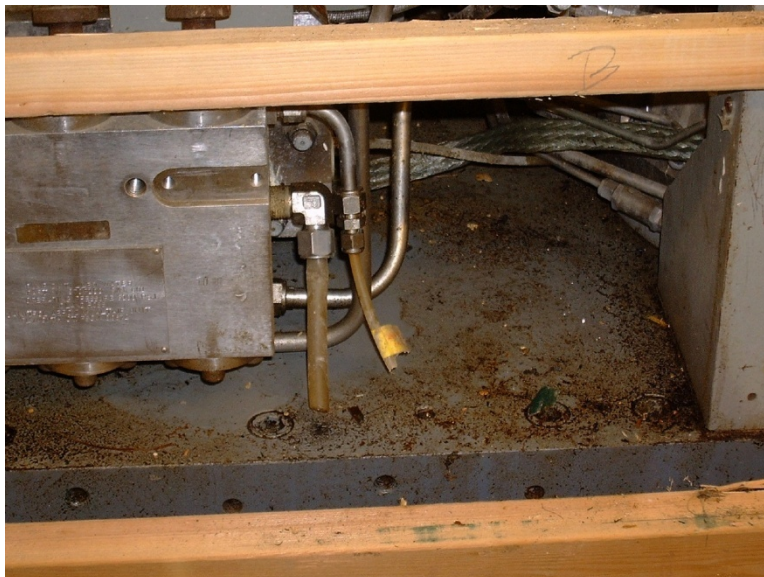
Figure 3.—Electrolyzer system cabinet base.

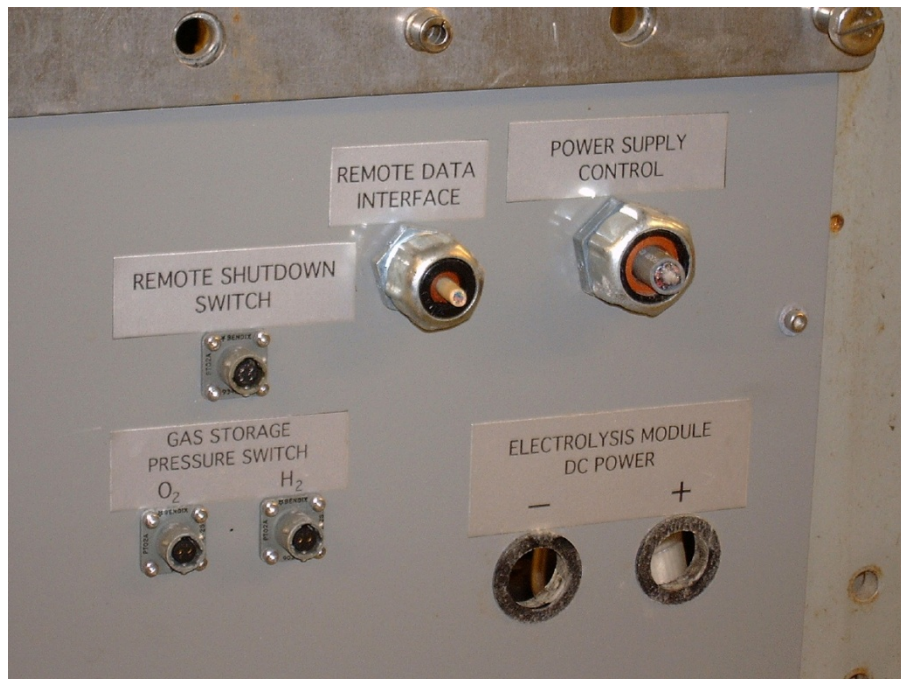
Figure 4.—Cut power and data cable interfaces.

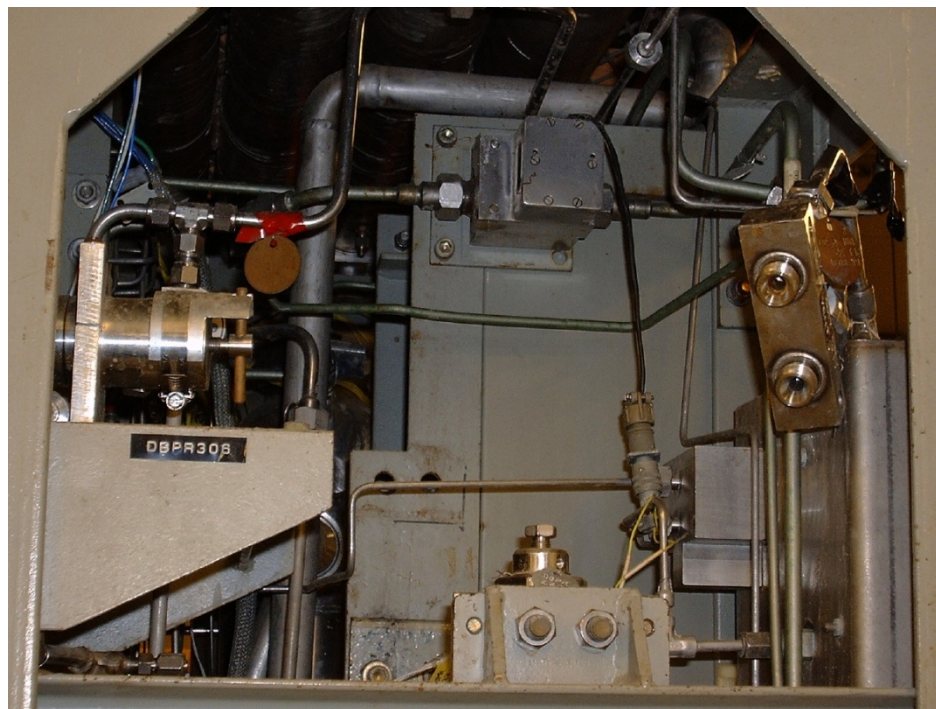
Figure 5.—Disconnected internal components.

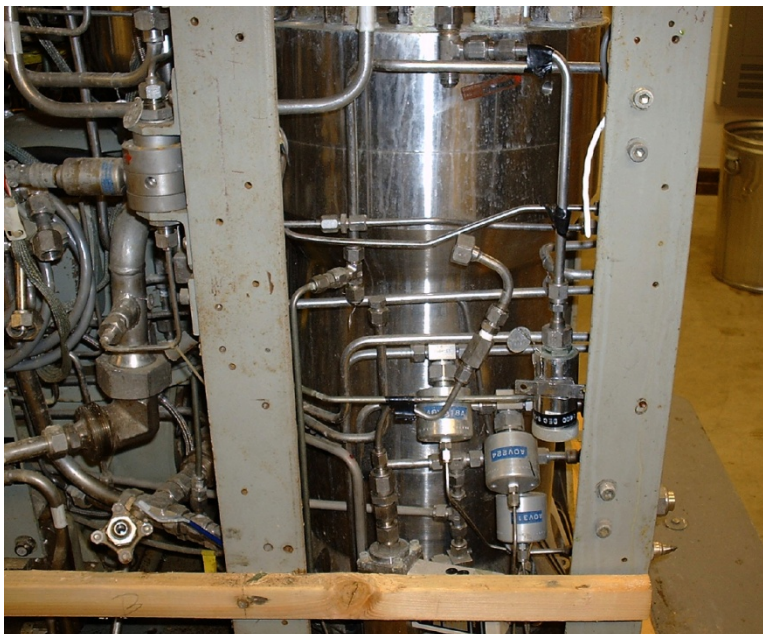
Figure 6.—Electrolyzer stack pressure vessel with disconnected fluid lines.

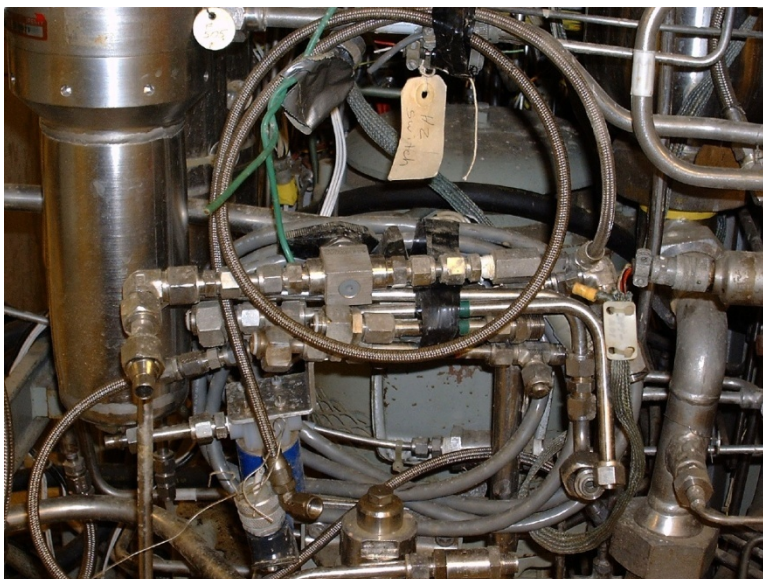
Figure 7.—Disconnected internal fluid lines.
