Boiling Experiment Facility (BXF): Post Flight Assessment Anomaly Investigation Report

ZIN Technologies, Incorporated, Middleburg Heights, Ohio

Prepared under Contract NNC09BA02B

National Aeronautics and
Space Administration

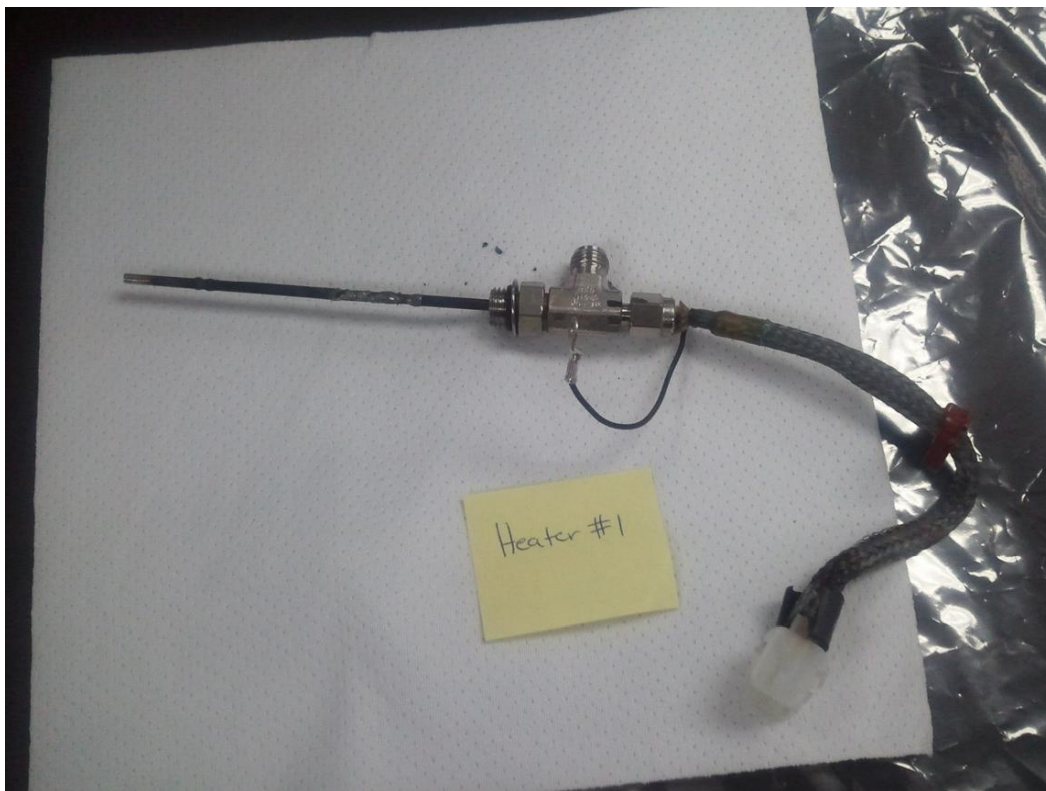
Disassembly of the CV revealed the presence of burnt/melted wiring. The wiring leading to Cartridge Heater Assembly S/N 010, utilized for Bulk Fluid Heater 1, exhibited a dark black and brown discoloration in and around connector J215. Some of the discoloration was observed on nearby wires. The overall internal insulation sleeving of the cartridge heater wiring appeared to have melted and protruded through the shield braid near connector J215. A red tie wrap that held the cartridge heater wiring in place was damaged, melted, and fused to the shield braid.

The damage observed on Bulk Fluid Heater 1 proves that temperatures in excess of 1400 °C were achieved on-orbit.

Figure D.35.—Heater 1 assembly, note melted areas on heater and damage to power harness.

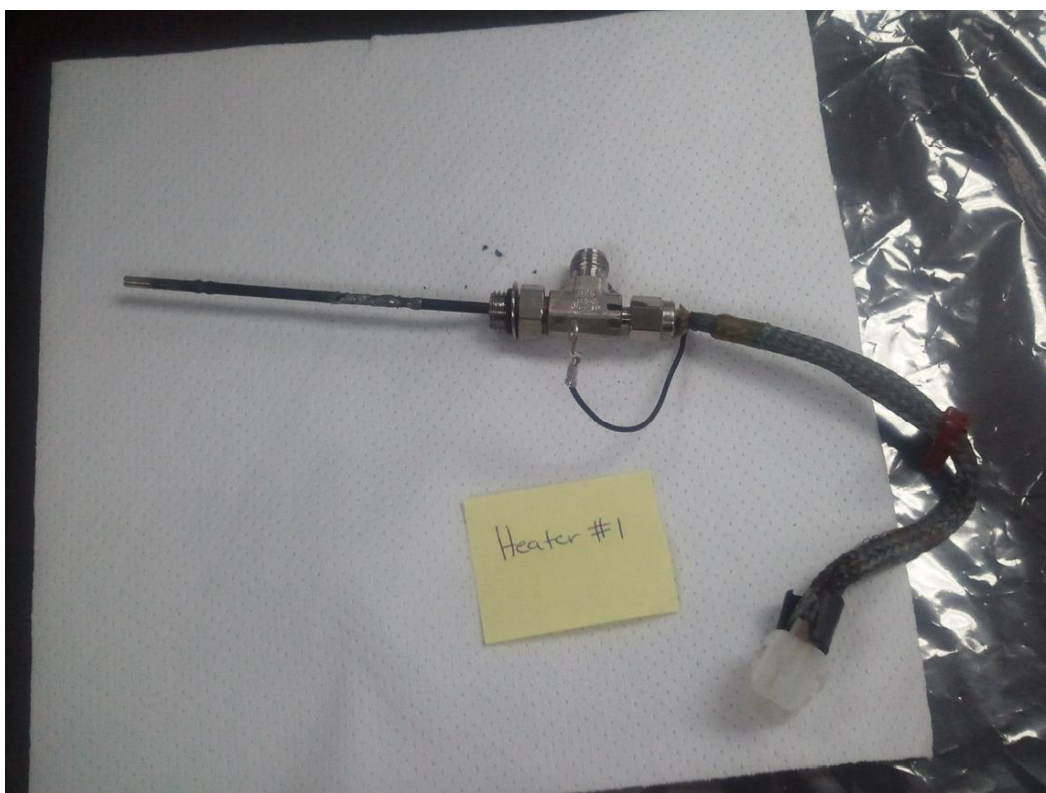
Figure D.36.—Heater 1 assembly, note melted areas on heater and damage to power harness.

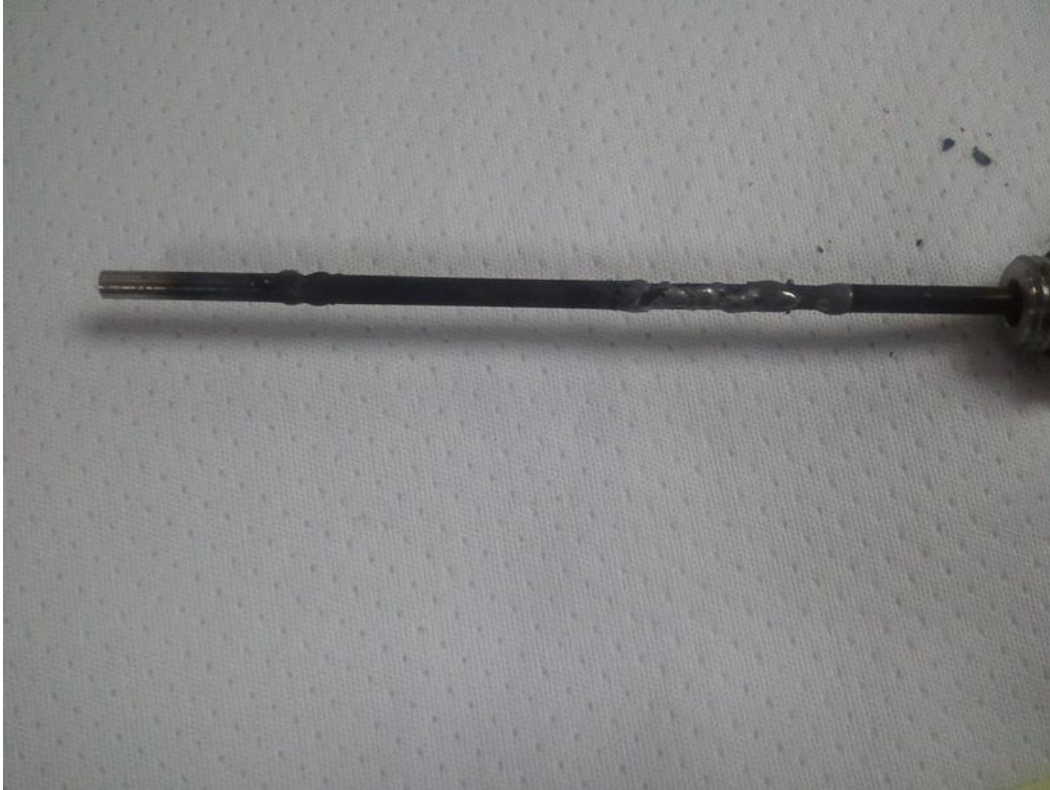
Figure D.37.—Fluid immersed portion of Heater 1: Note two melted areas.

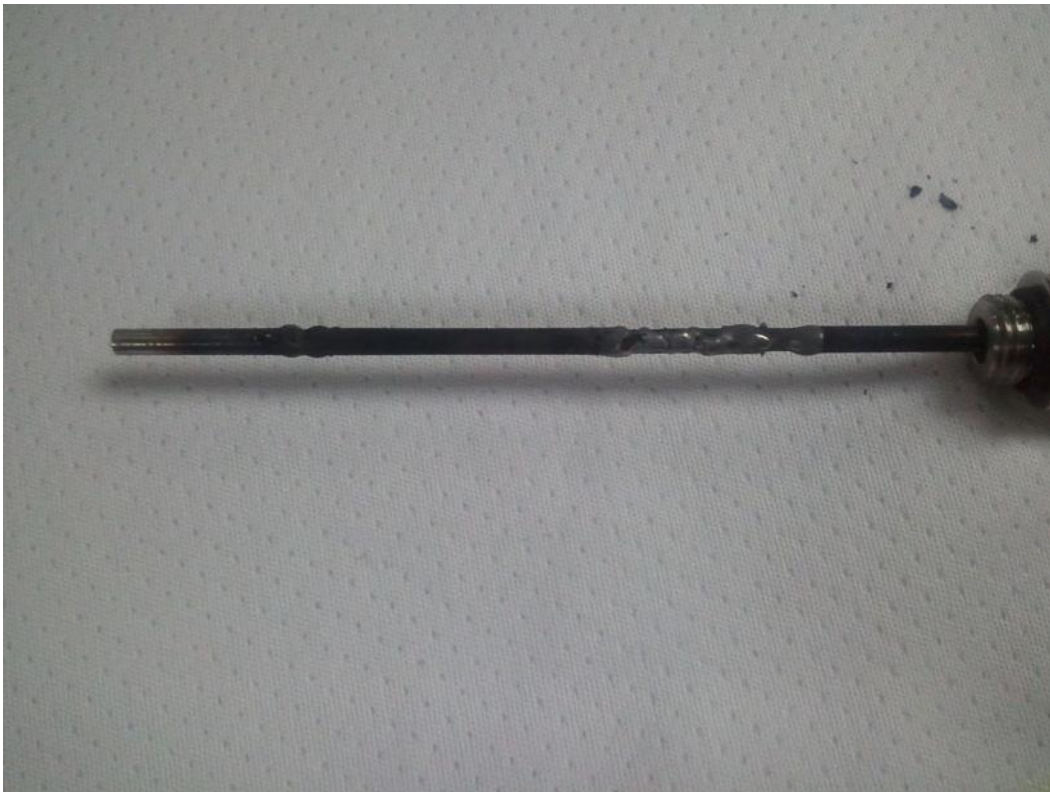
Figure D.38.—Fluid immersed portion of Heater 1: Note two melted areas.

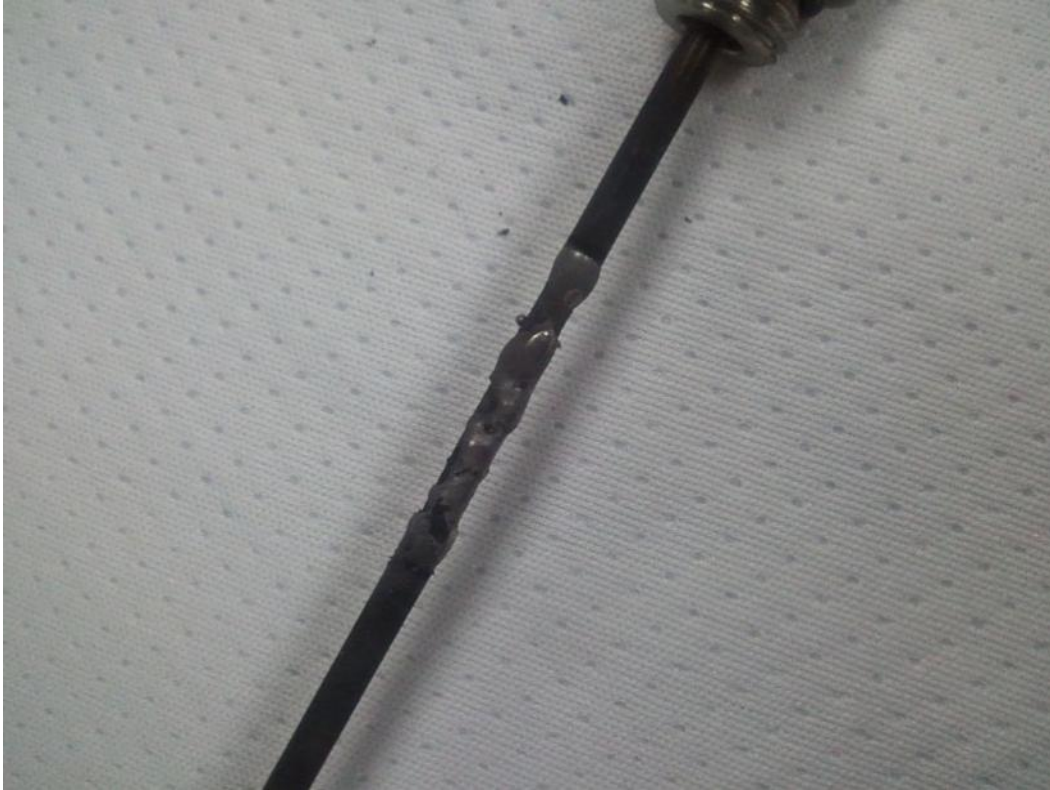
Figure D.39.—Heater 1: Note melted area.

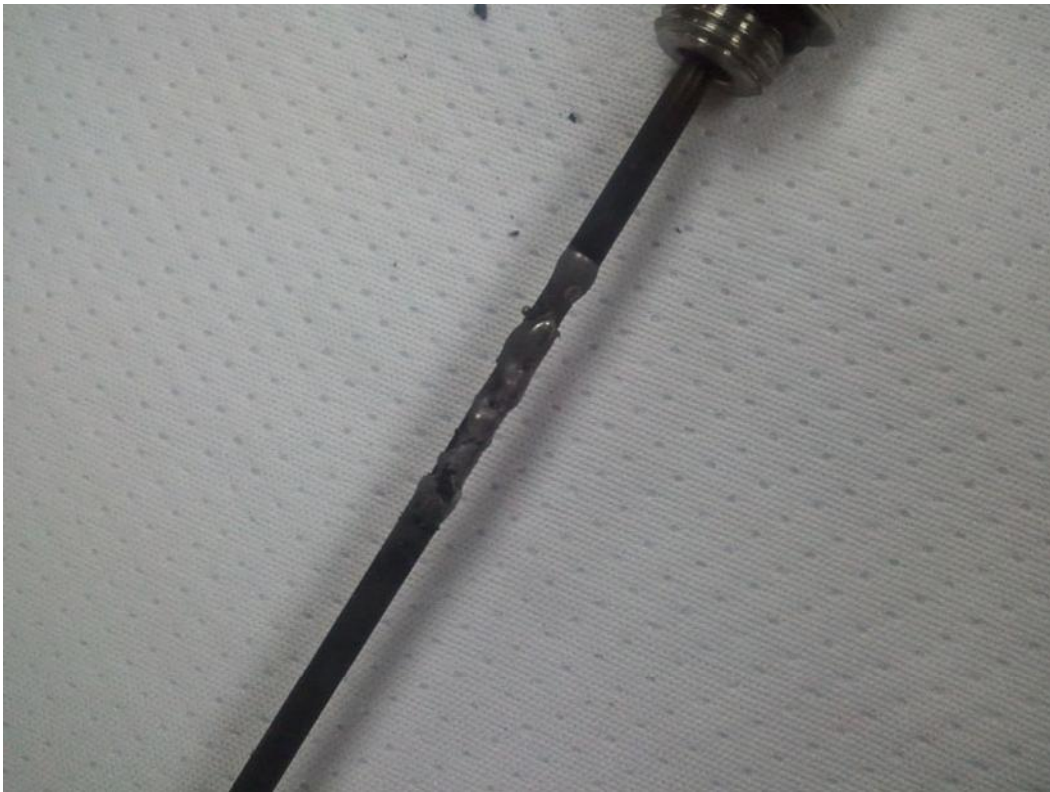
Figure D.40.—Heater 1: Note melted area.

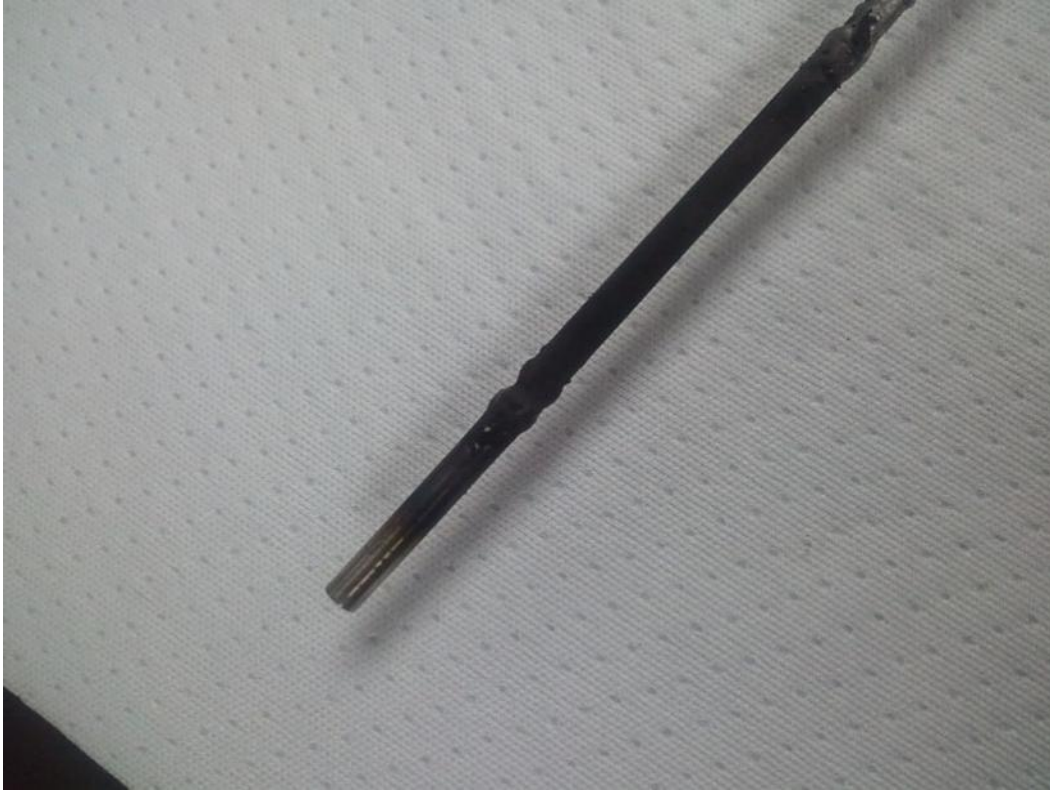
Figure D.41.—Heater 1: Note melted area.

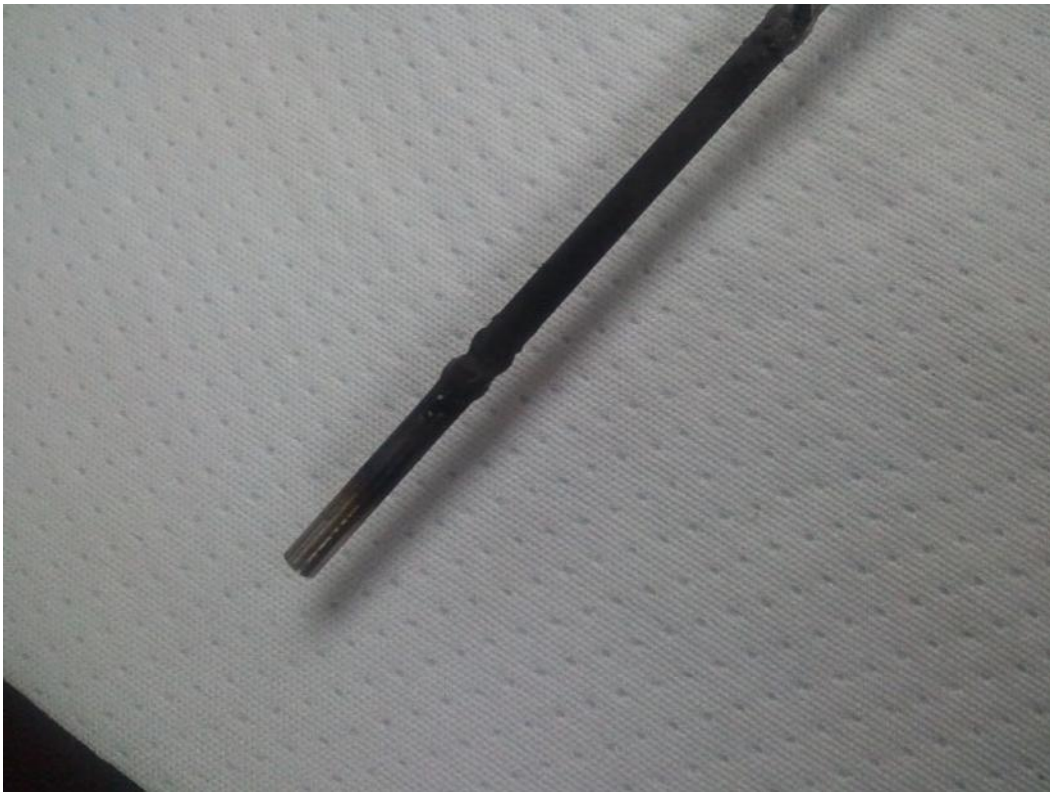
Figure D.42.—Heater 1: Note melted area.

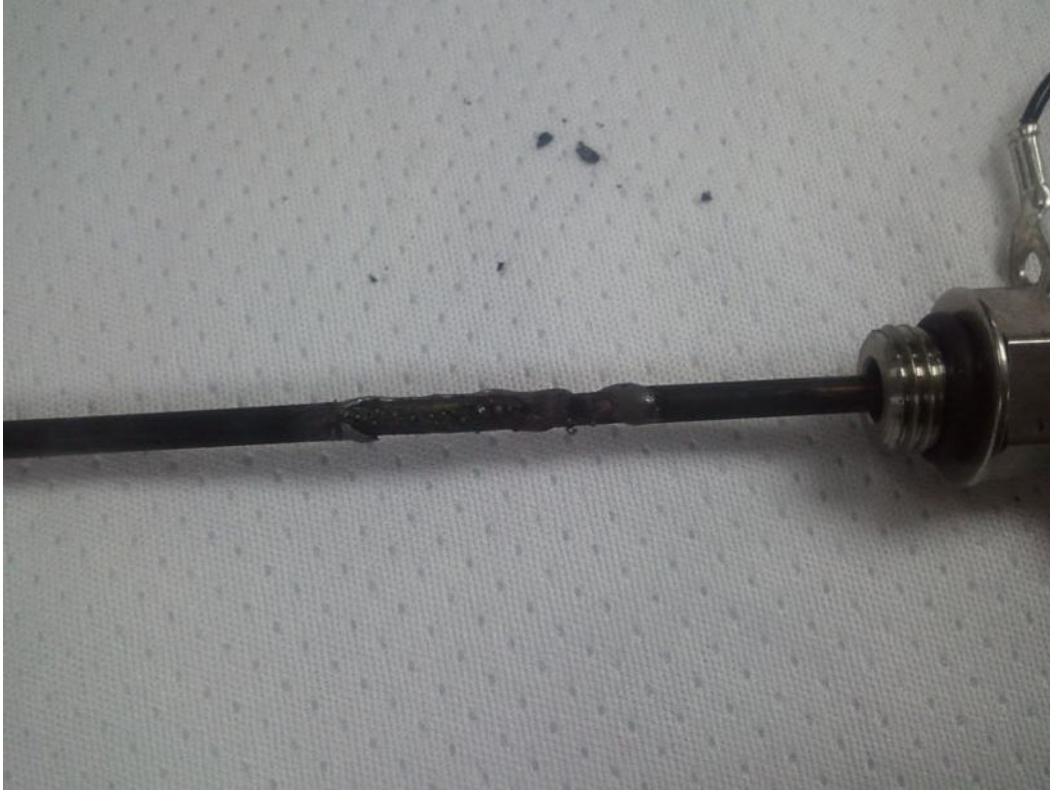
Figure D.43.—Heater 1: Note melted area.

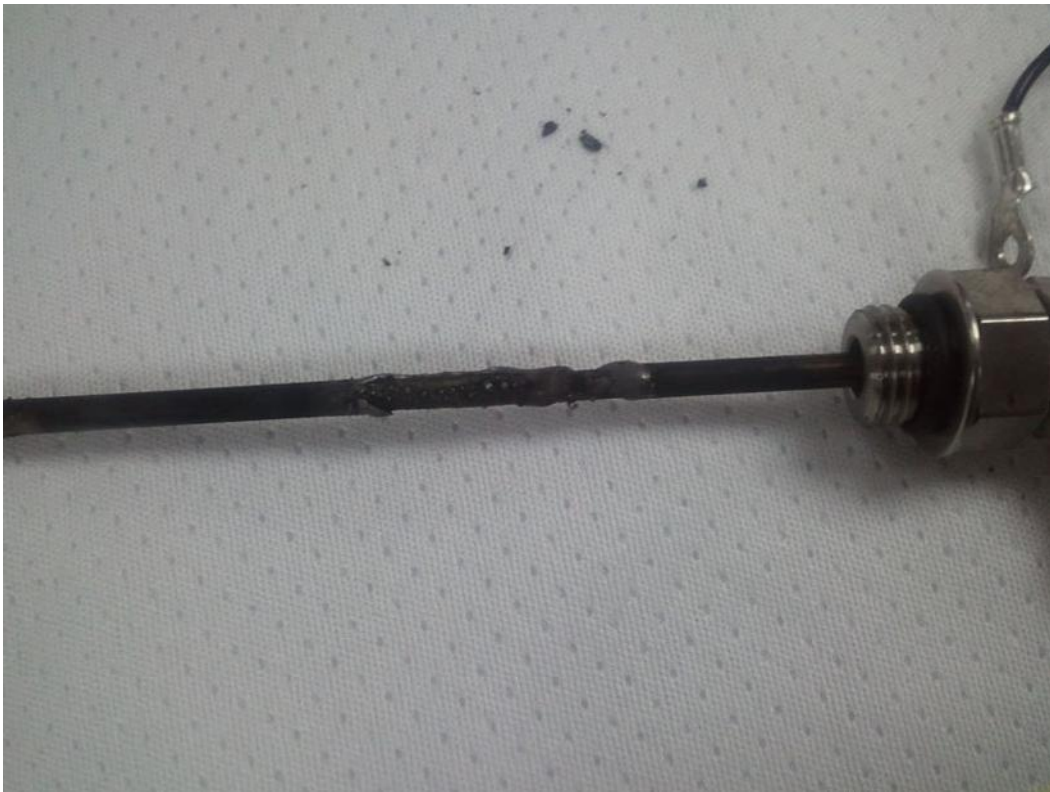
Figure D.44.— Heater 1: Note melted area

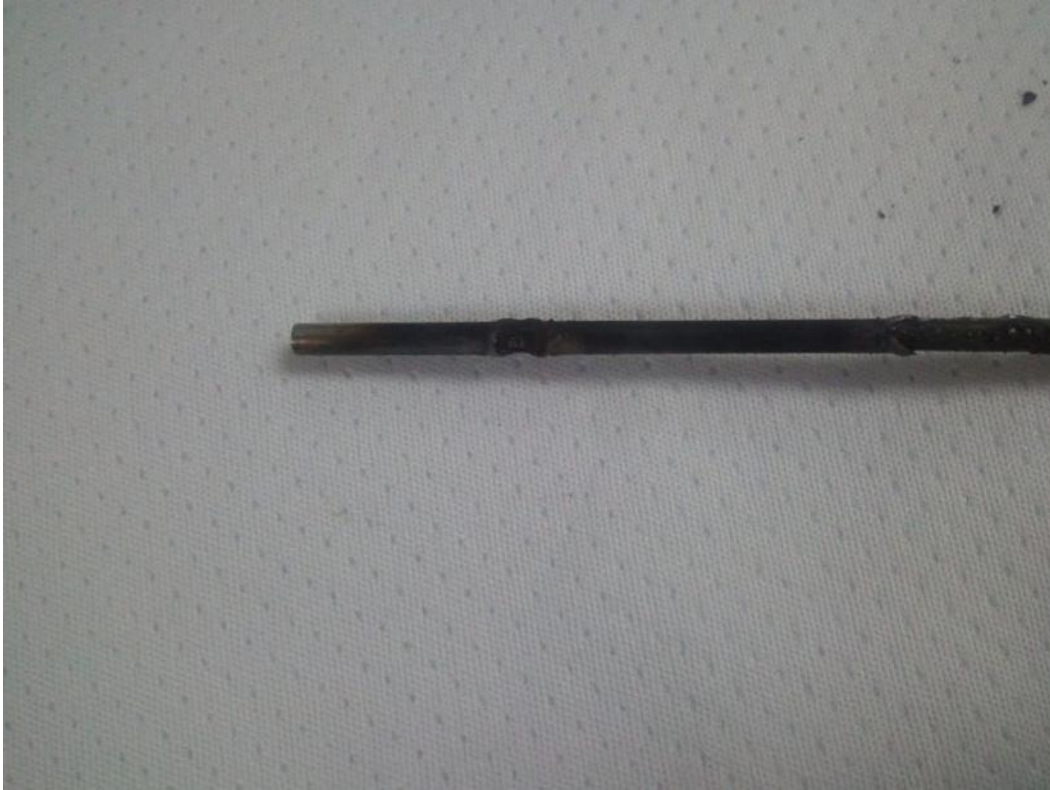
Figure D.45.—Heater 1: Note melted areas.

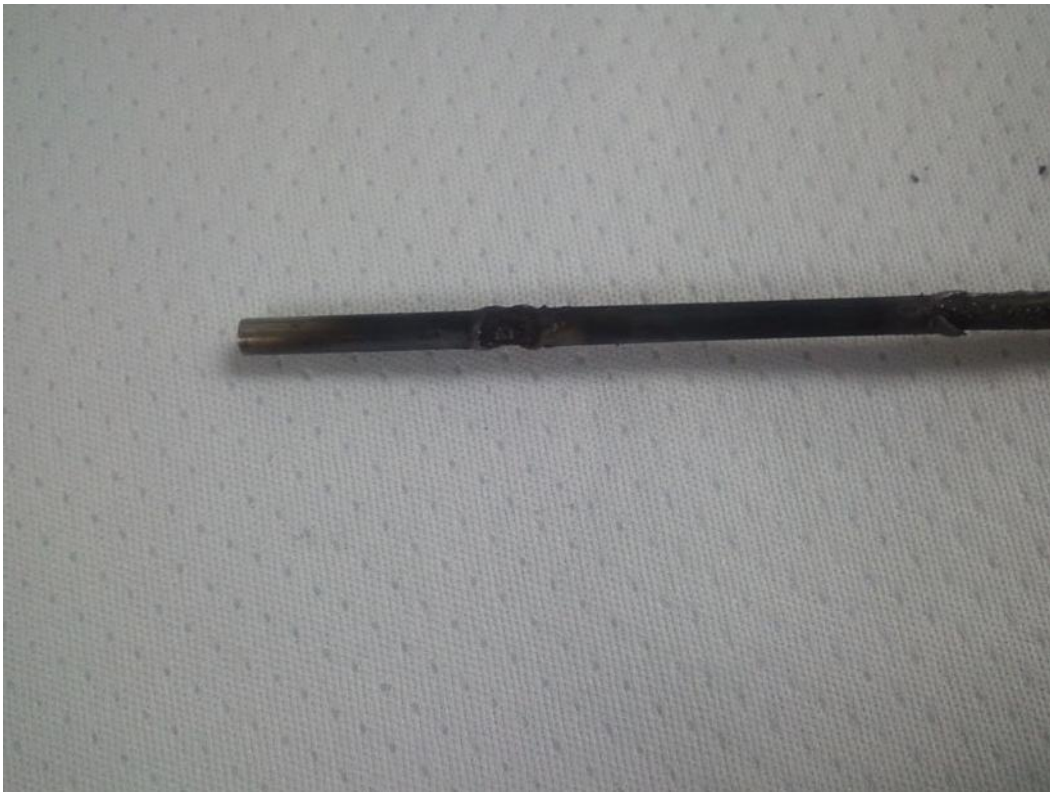
Figure D.46.—Heater 1: Note melted areas.

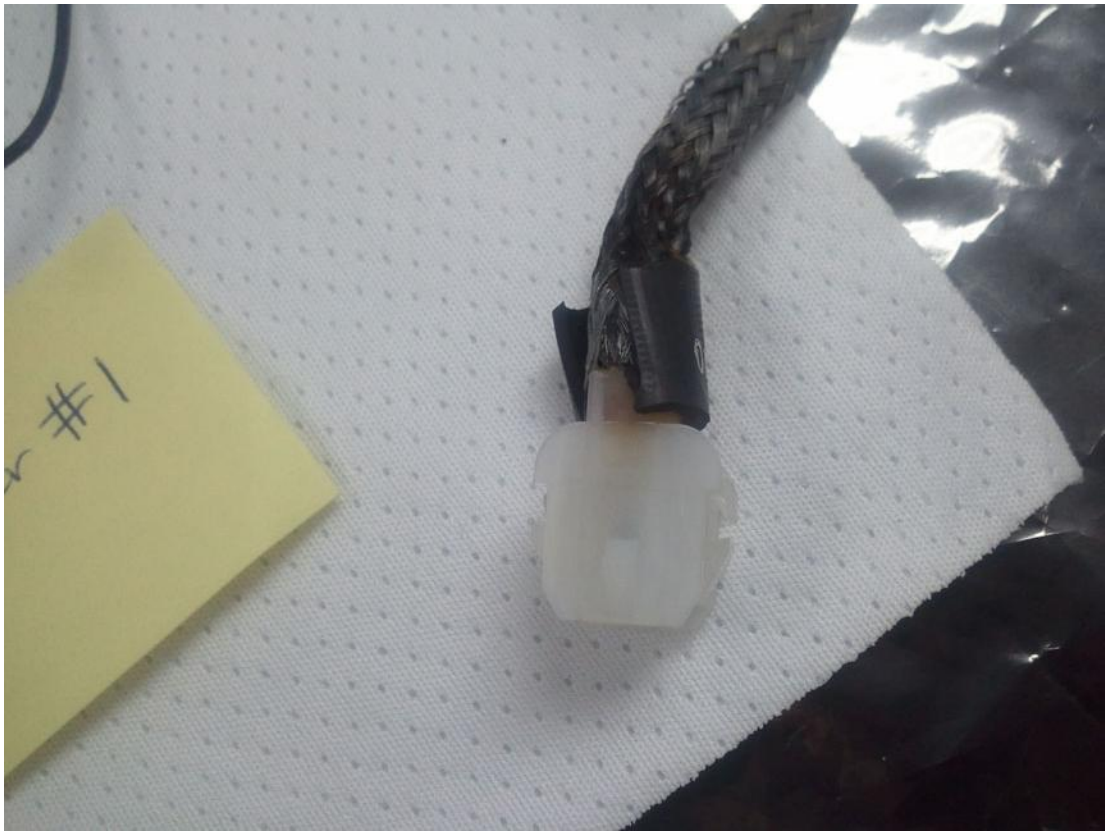
Figure D.47.—Heater 1 Molex connector, note discoloration on wire braid.

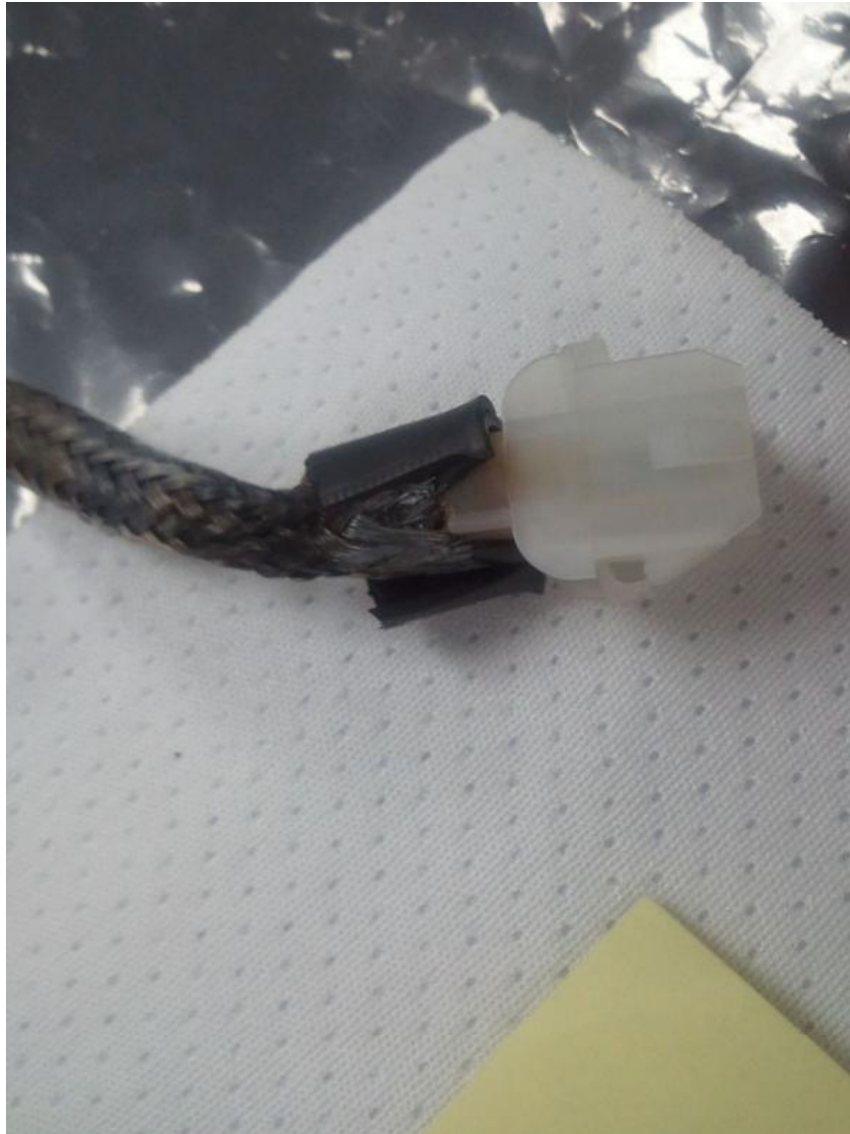
Figure D.48.—Heater 1 Molex connector, note discoloration on wire braid.

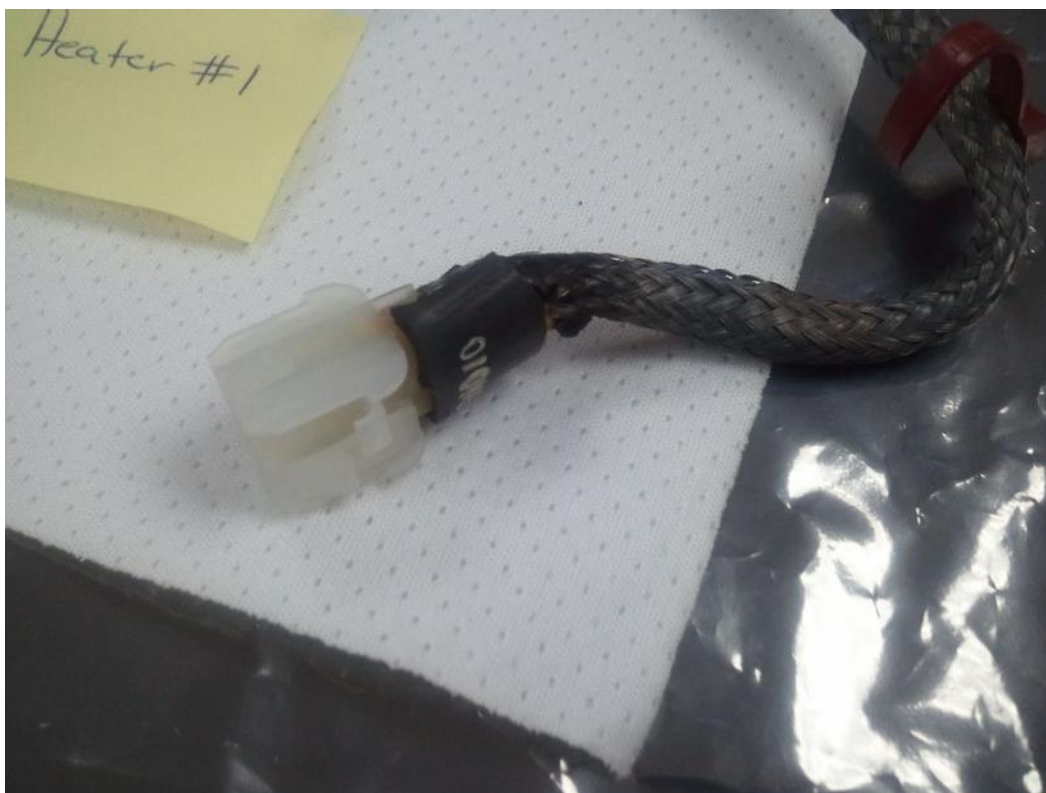
Figure D.49.—Heater 1 Molex connector, note discoloration on wire braid.

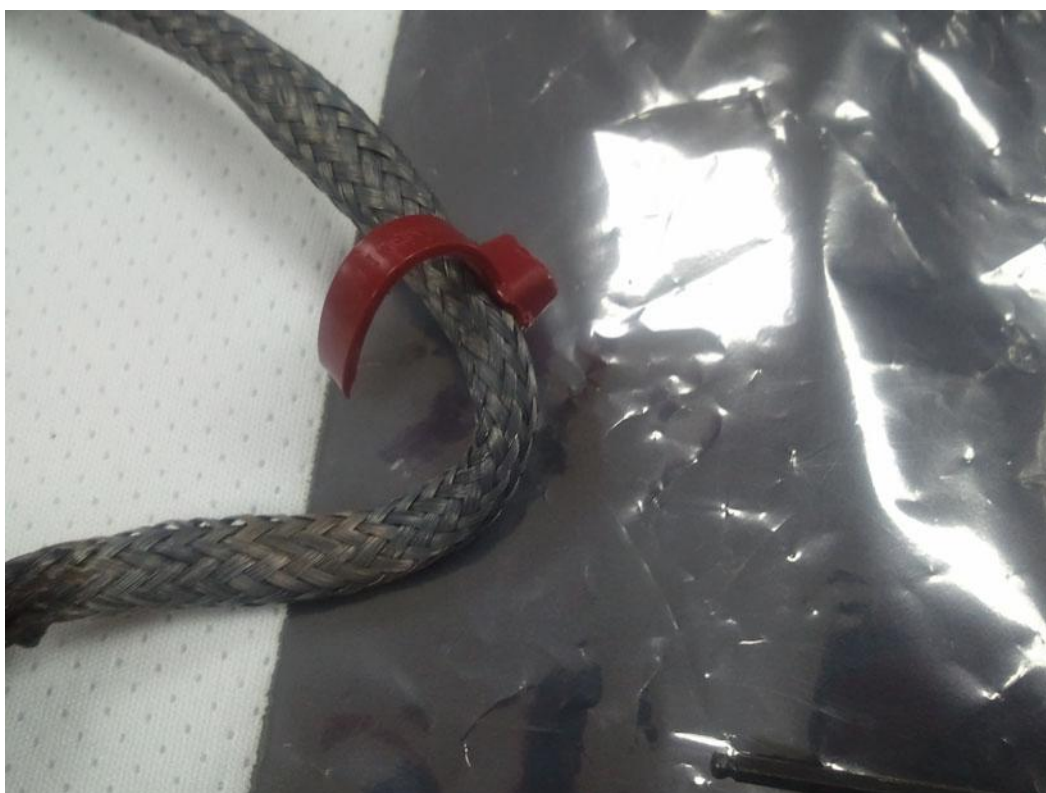
Figure D.50.—Wire harness for Heater 1: Note melted ty-rap.

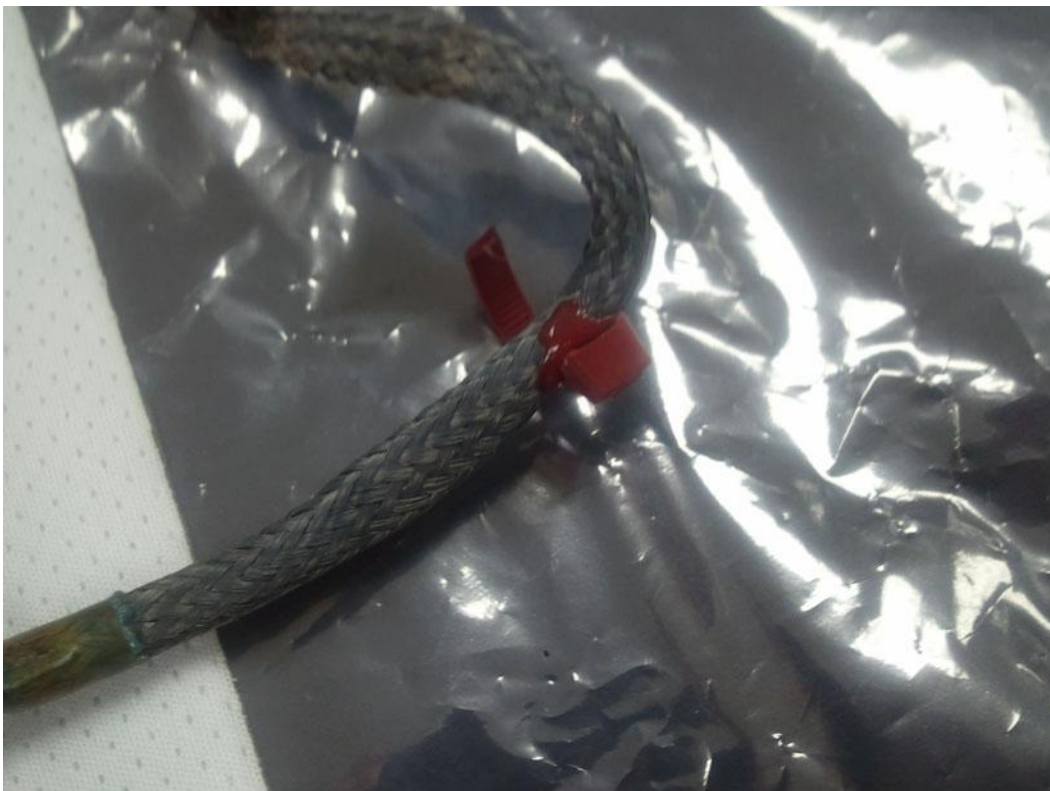
Figure D.52.—Wire harness for Heater 1: Note melted ty-rap.

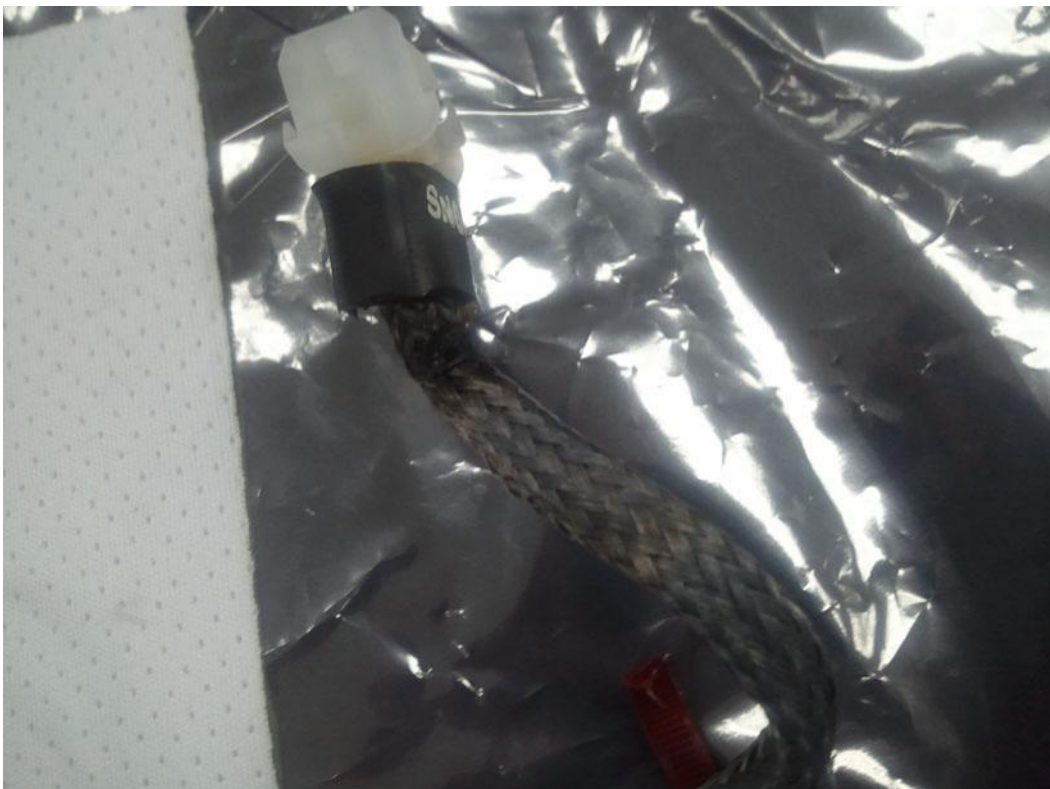
Figure D.54.—Wire harness for Heater 1: Note melted ty-rap and discoloration on wire braid.

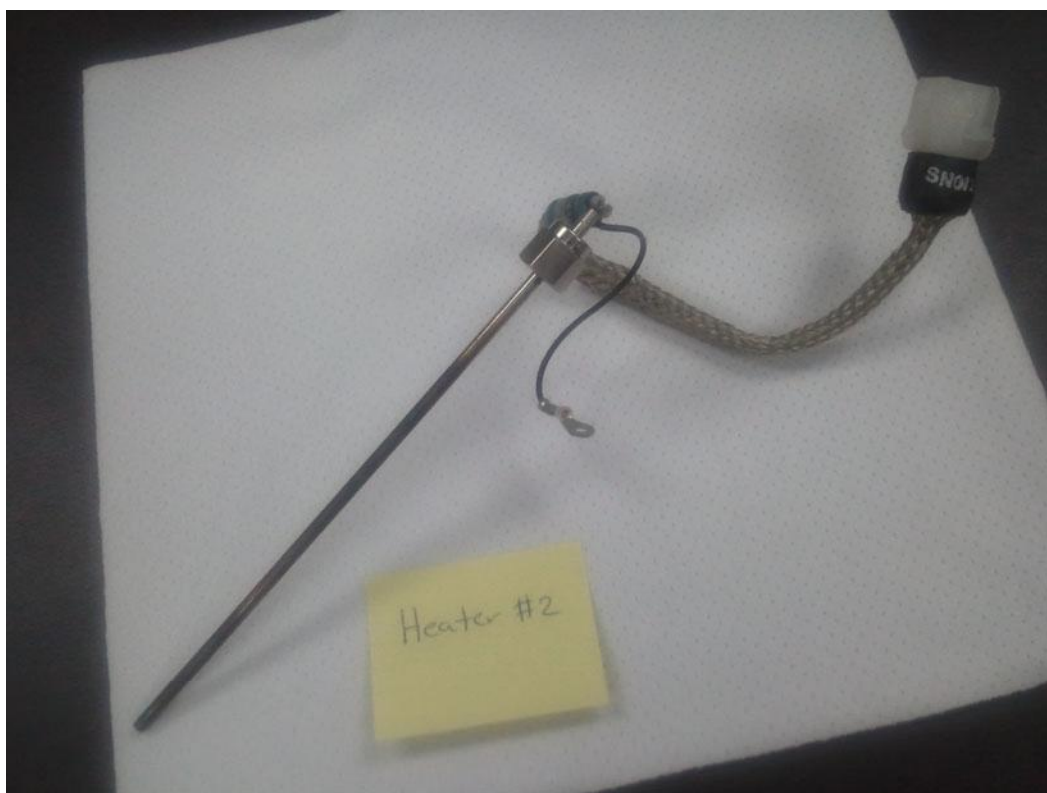
Figure D.70.—Heater 2 assembly: Note bluing and blackening on fluid immersed portion.

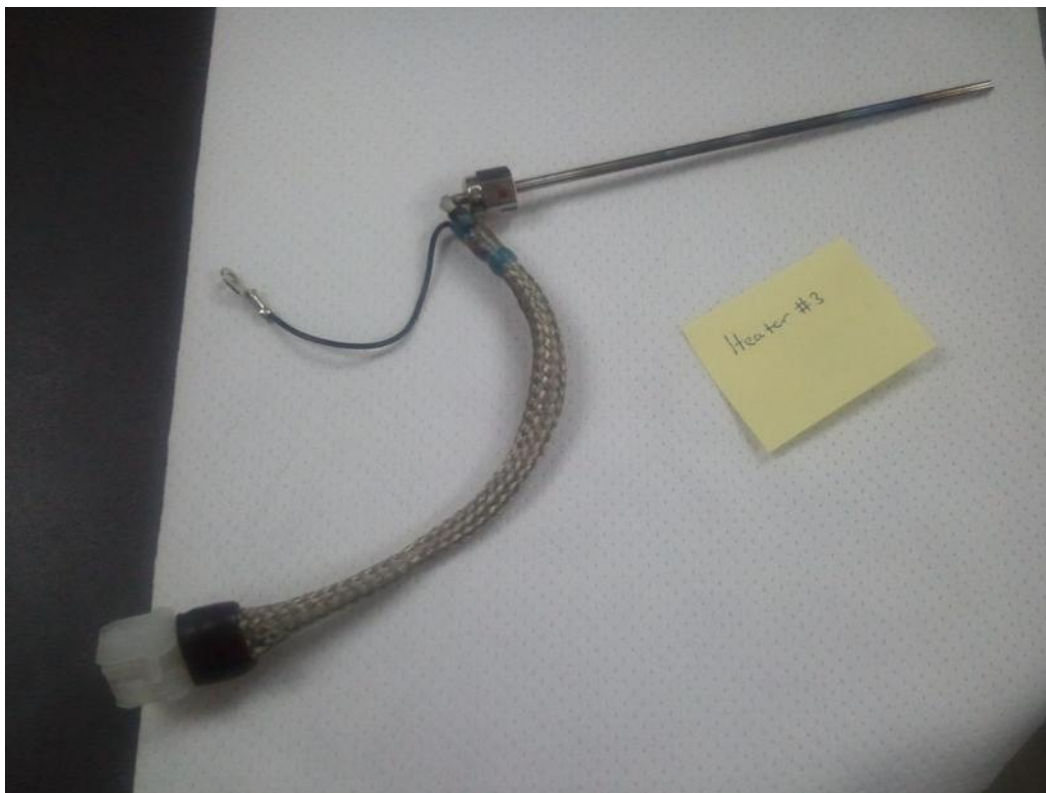
Figure D.91.—Heater 3 assembly: Note bluing and blackening on fluid immersed portion.

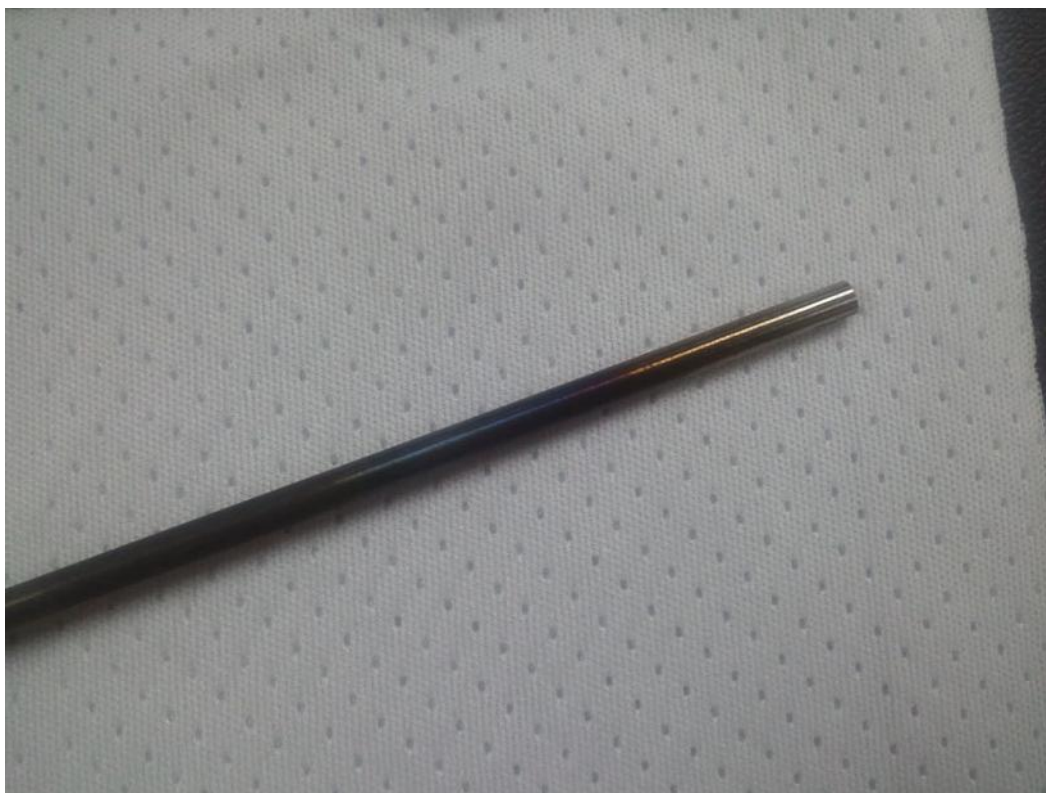
Figure D.92.—Heater 3 fluid immersed portion: Note bluing and blackening.

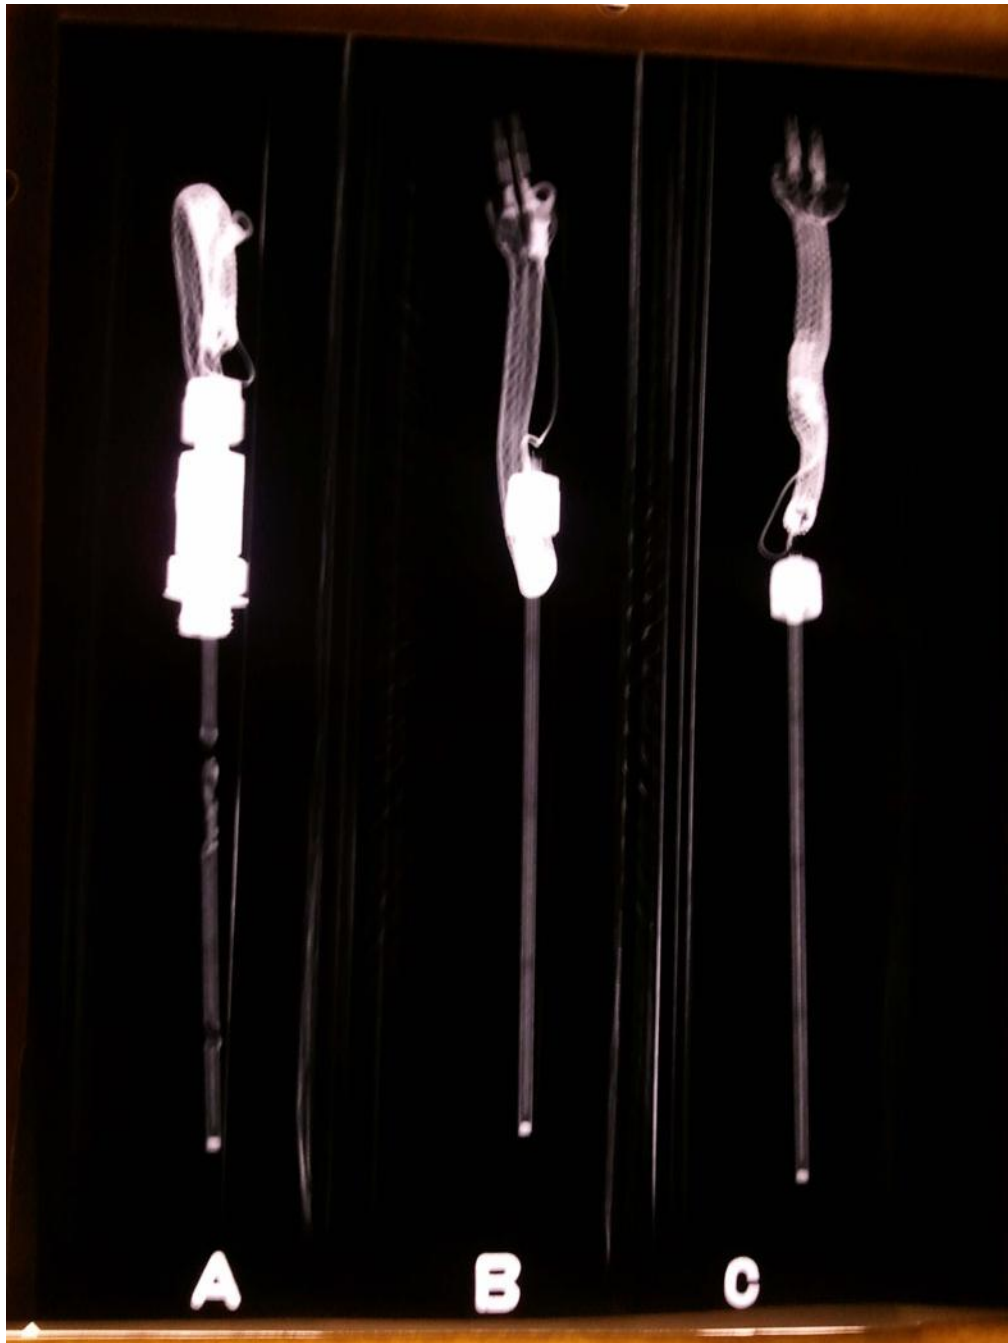
Figure E.1.—Planar view of heater assemblies bulk fluid heaters of 1, 2, and 3, respectively. Note damage in heater 1.

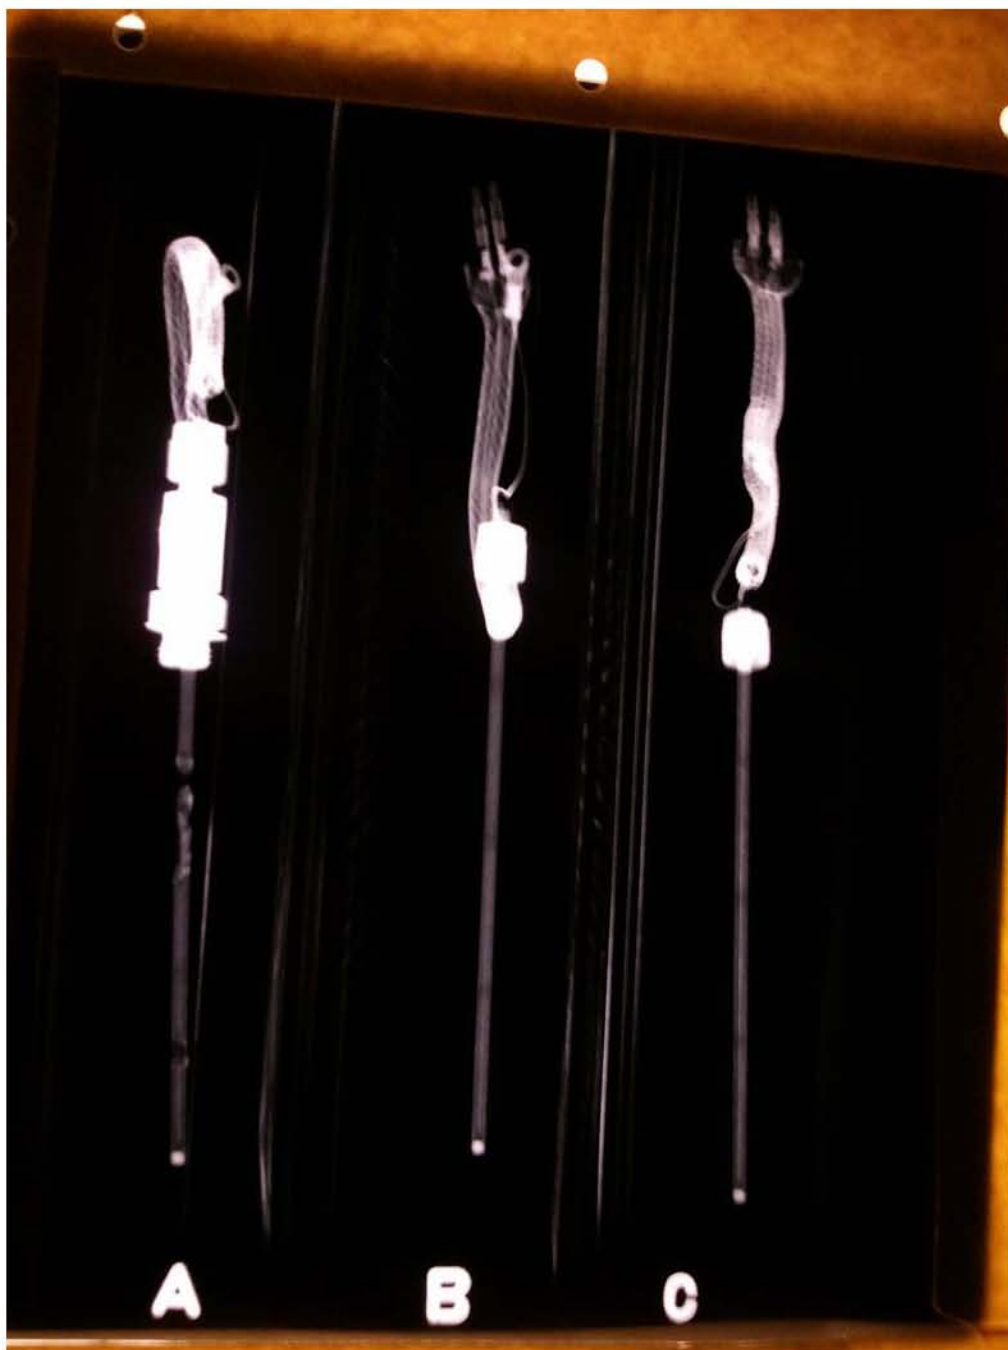
Figure E.2.—Planar view of heater assemblies bulk fluid heaters of 1, 2, and 3, respectively.
Note damage in heater 1.

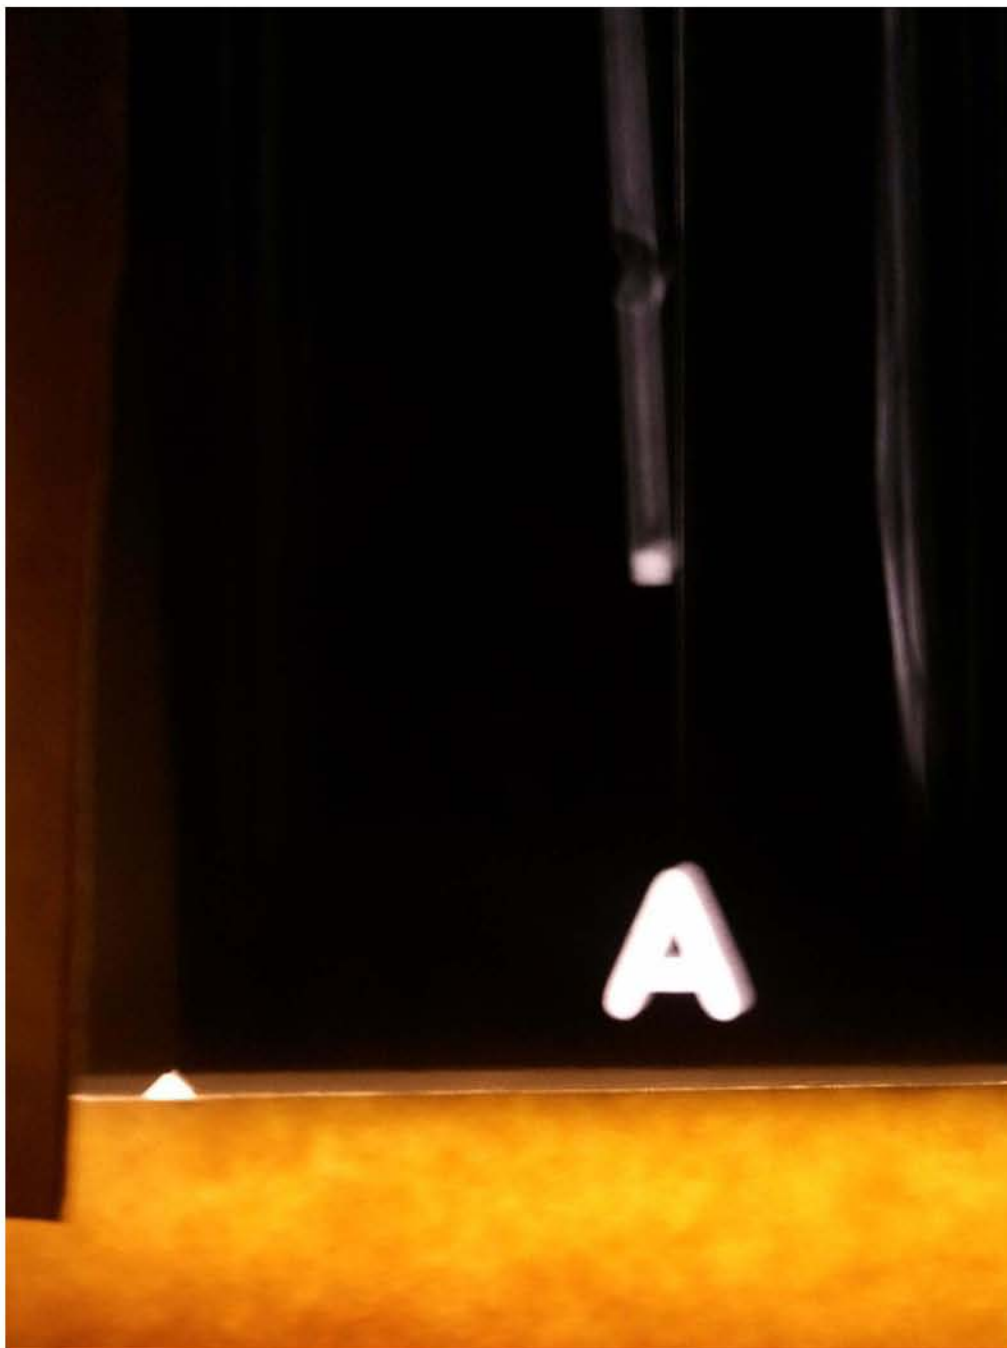
Figure E.4.—Close-up of Bulk Fluid Heater 1 damage at tip.

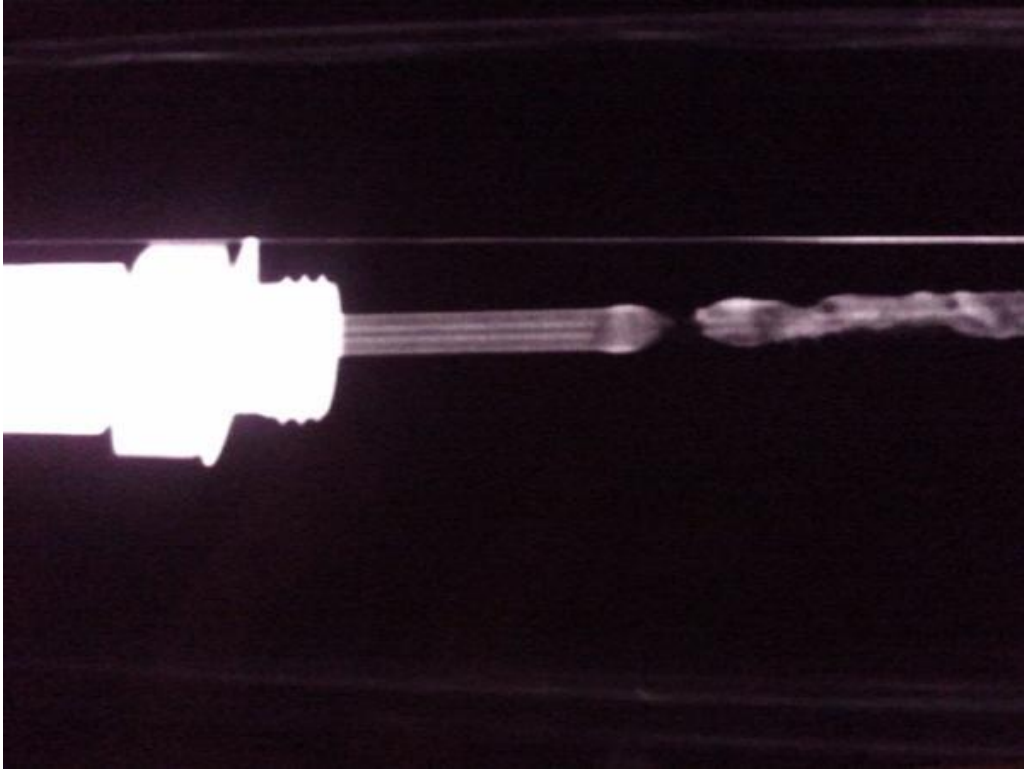
Figure E.6.—Close-up of Bulk Fluid Heater 1 damage along cartridge.
