Boiling Experiment Facility (BXF): Post Flight Assessment Anomaly Investigation Report

ZIN Technologies, Incorporated, Middleburg Heights, Ohio

Prepared under Contract NNC09BA02B

National Aeronautics and
Space Administration

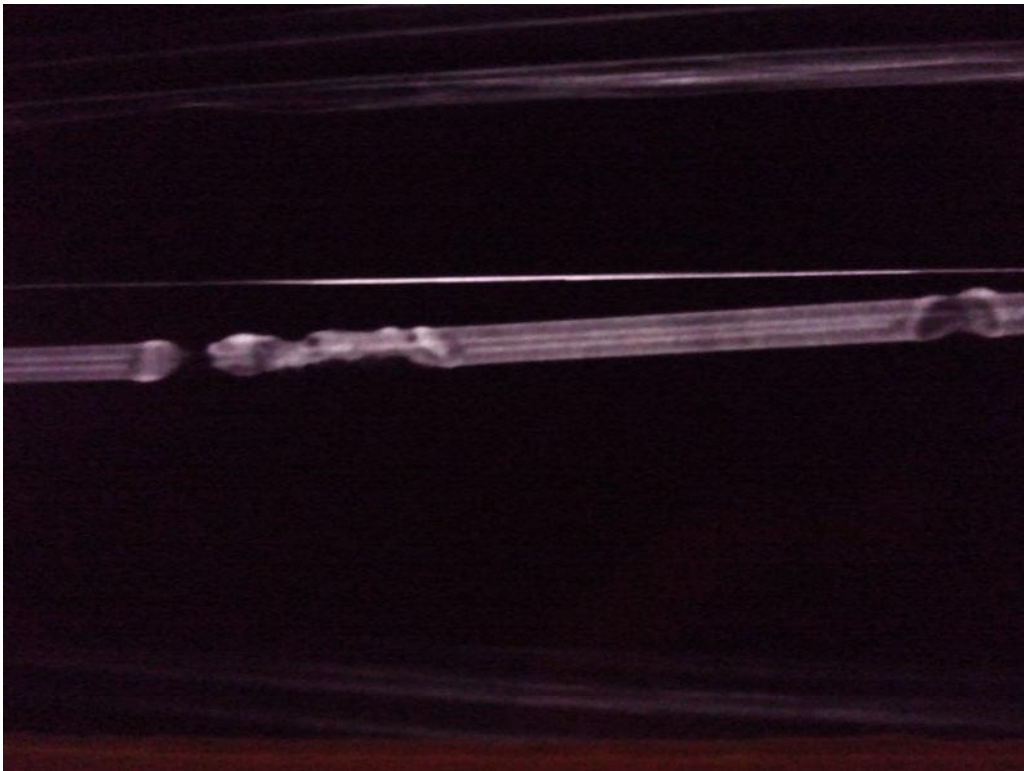
Figure E.7.—Close-up of Bulk Fluid Heater 1 damage along cartridge.

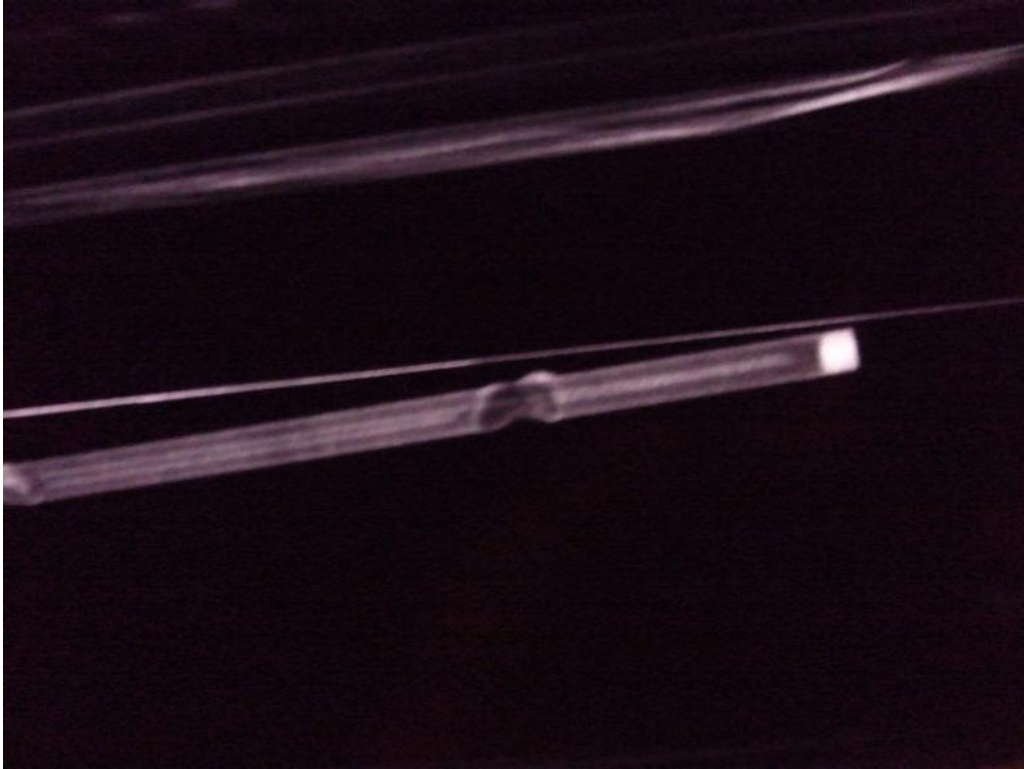
Figure E.8.—Close-up of Bulk Fluid Heater 1 damage at tip.

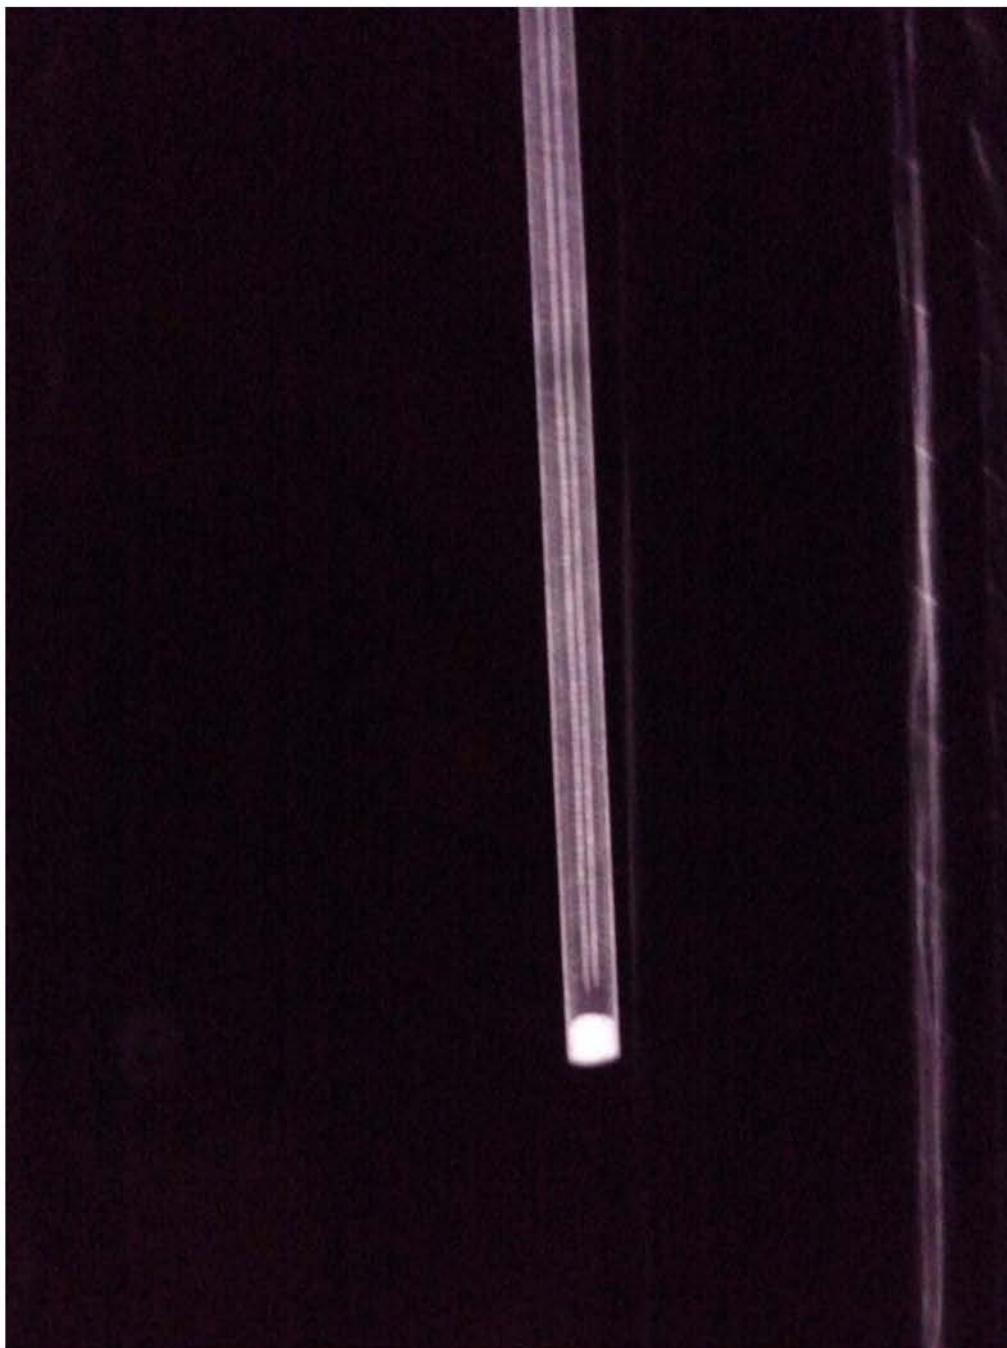
Figure E.13.—Close-up of Bulk Fluid Heater 2 along cartridge. Note irregularities in internal heater wire.

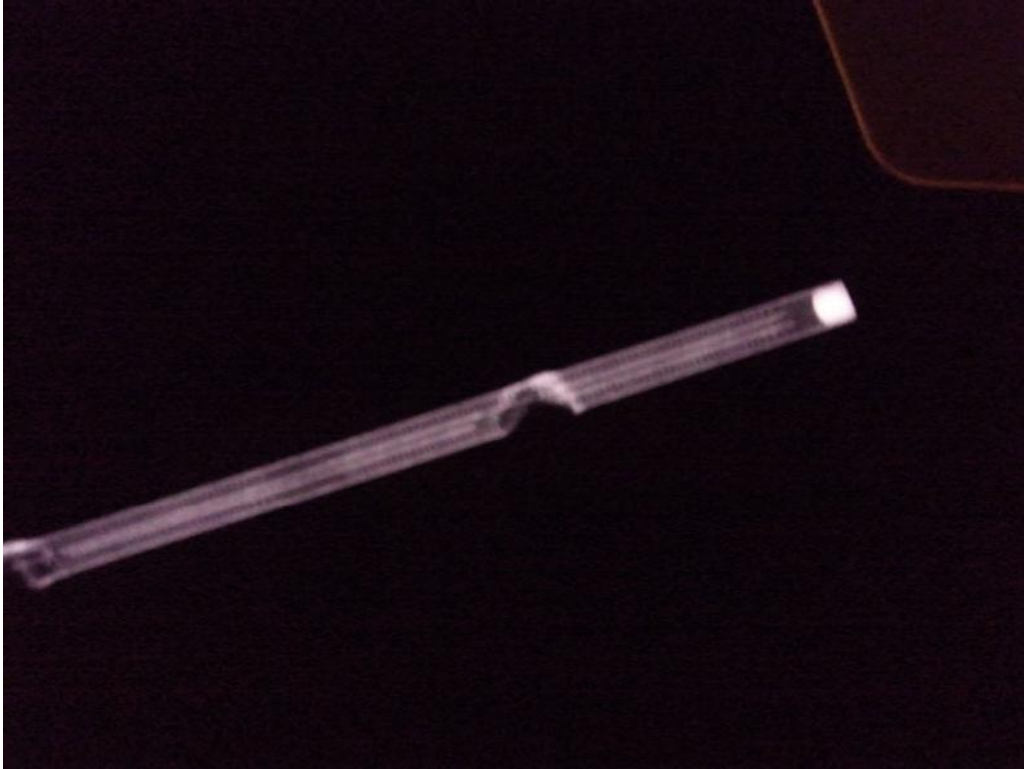
Figure E.36.—Close-up of Bulk Fluid Heater 1 damage along cartridge.

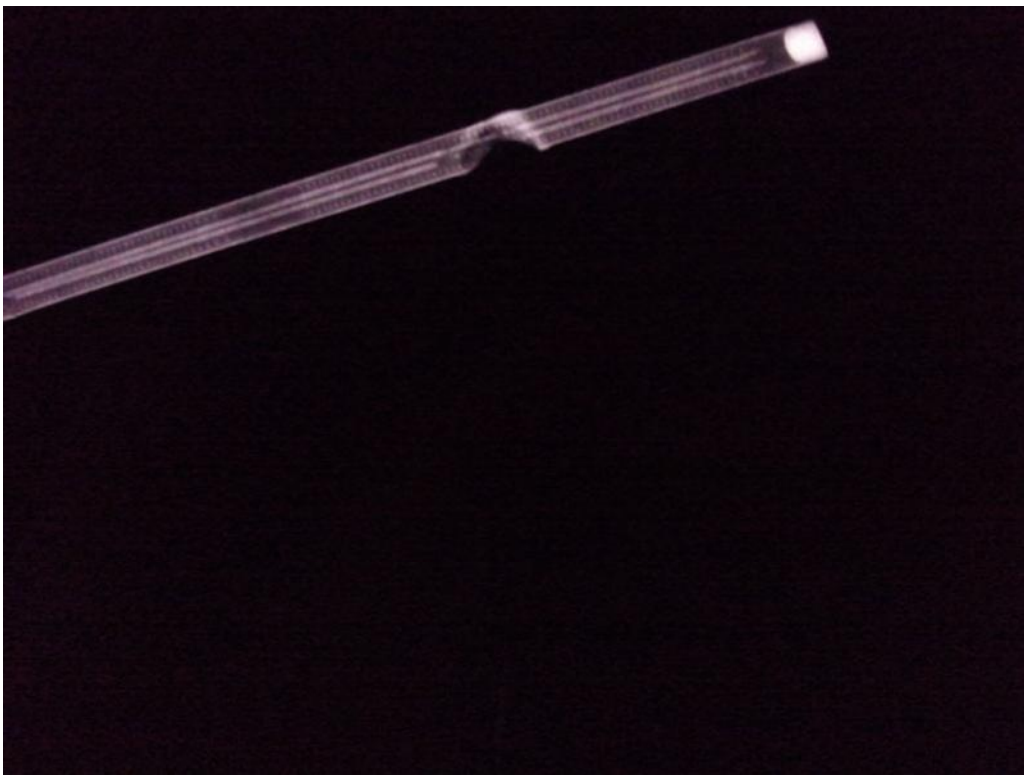
Figure E.37.—Close-up of Bulk Fluid Heater 1 damage near cartridge tip.

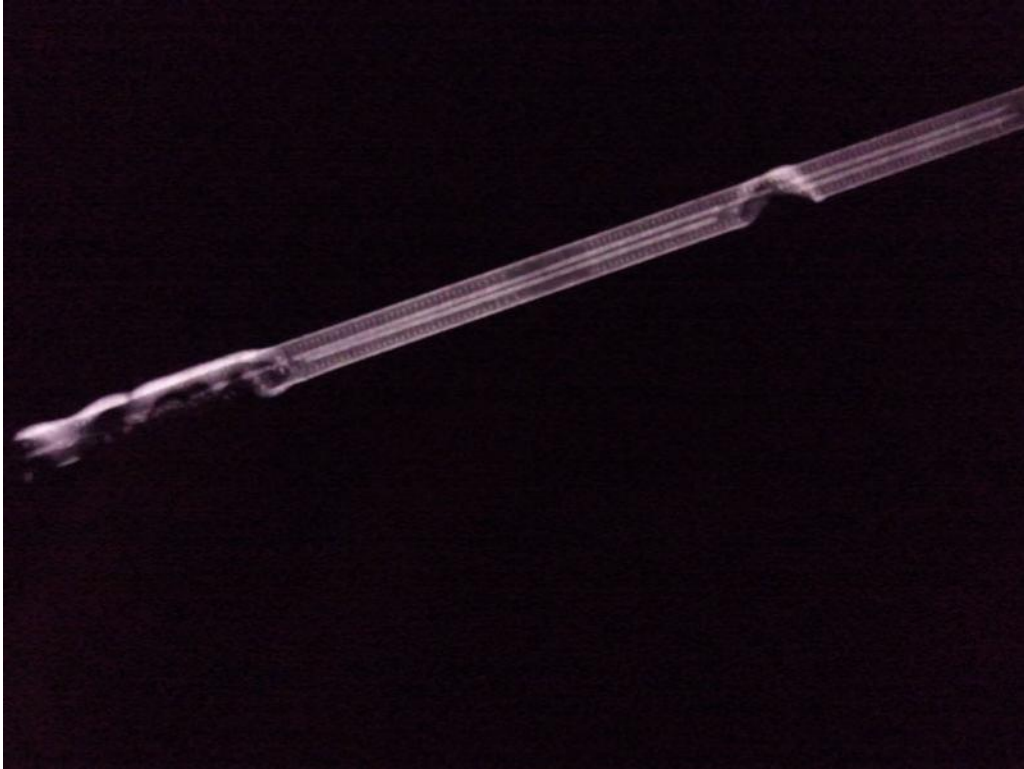
Figure E.38.—Close-up of Bulk Fluid Heater 1 damage along cartridge.

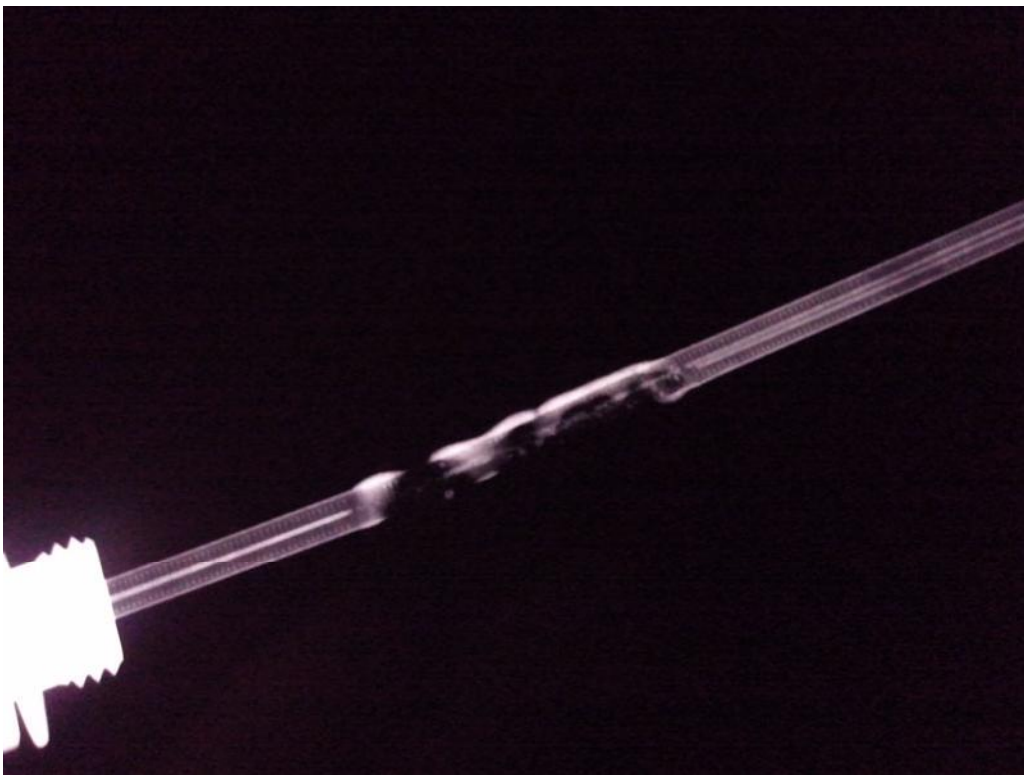
Figure E.39.—Close-up of Bulk Fluid Heater 1 damage along cartridge.

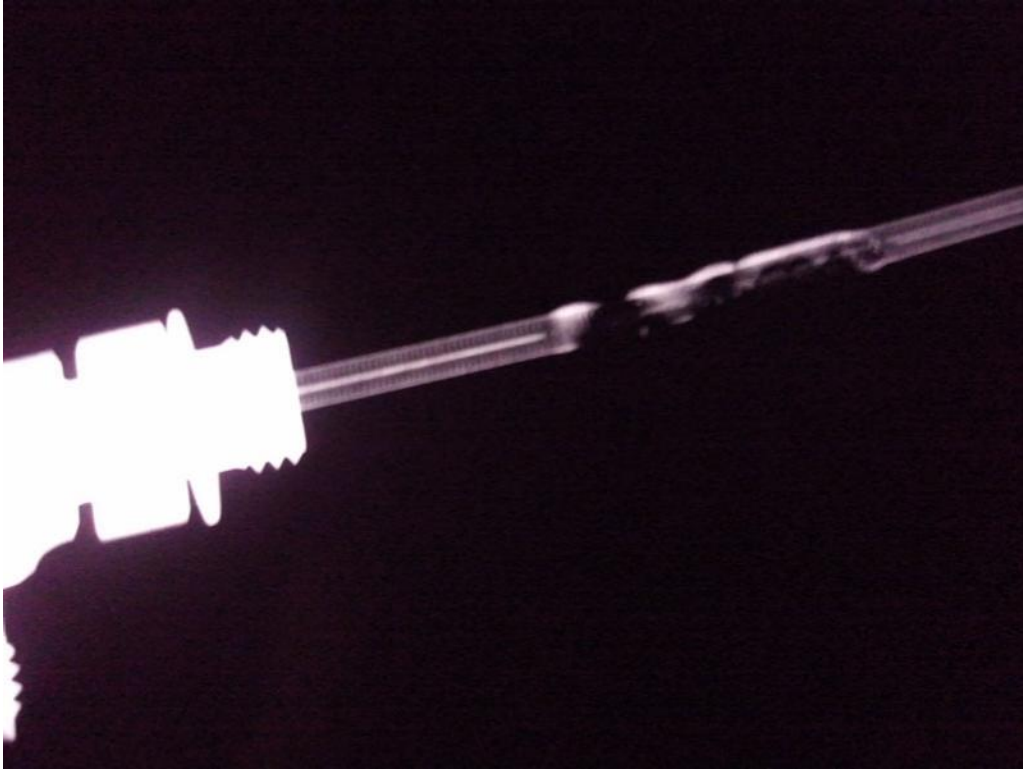
Figure E.40.—Close-up of Bulk Fluid Heater 1 damage along cartridge.

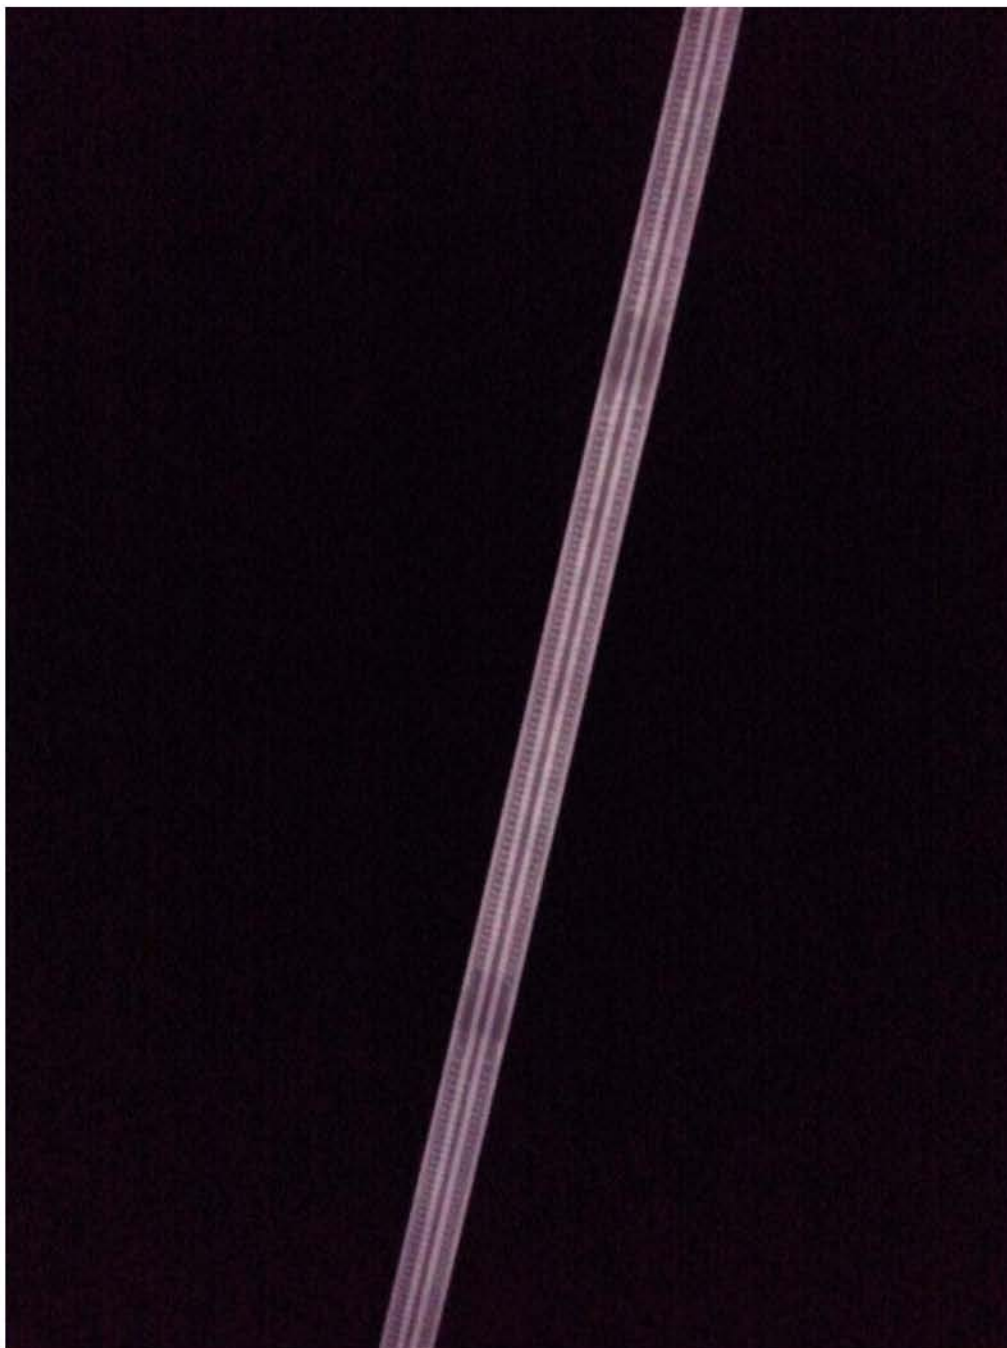
Figure E.78.—Close-up of heating element for Bulk Fluid Heater 3. Note irregularities.
