NASA/TM-2014-218538 (Corrected Copy)  
NESC-RP-14-00957

# A Comprehensive Analysis of the X-15 Flight 3-65 Accident

*Cornelius J. Dennehy/NESC  
Langley Research Center, Hampton, Virginia*

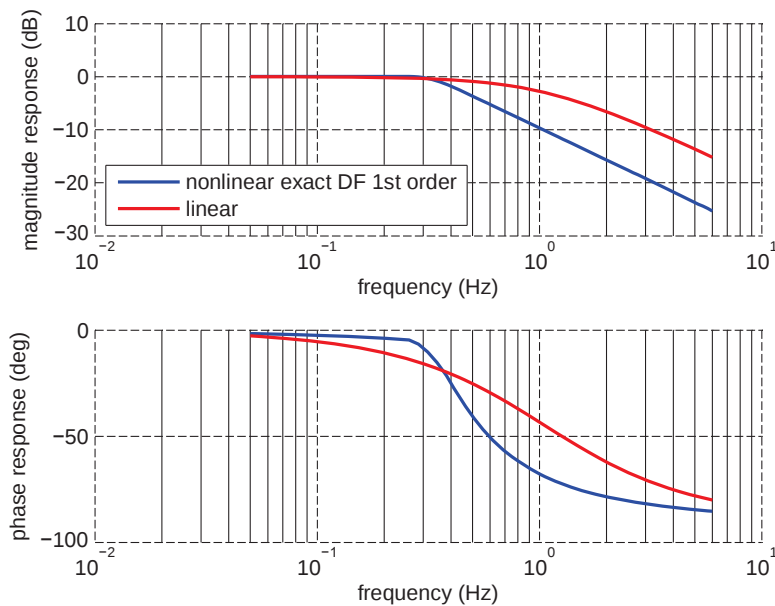
damping was particularly low, as it did during Flight 3-65, then the rigid-body oscillation was divergent, even with fixed adaptive gains.

**Figure 8.5-2. X-15 Power Actuator under Rate Saturation, 15-degree Amplitude**

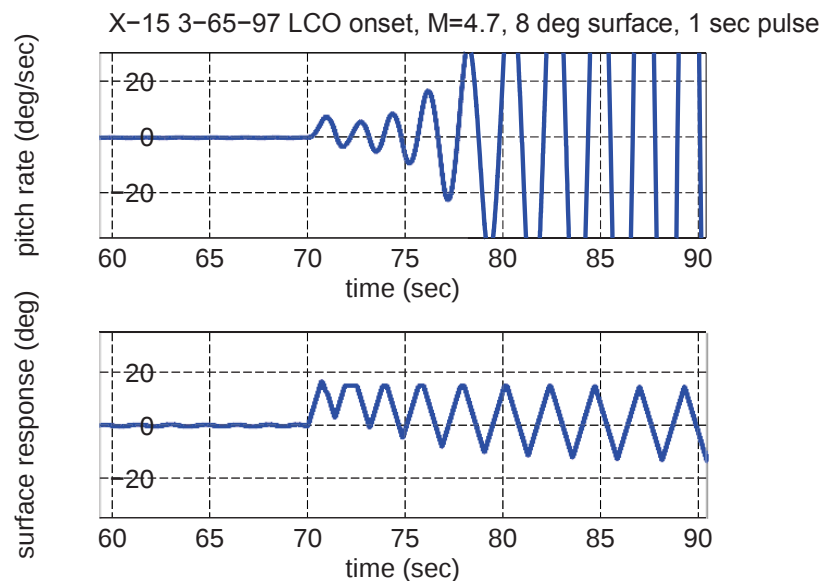
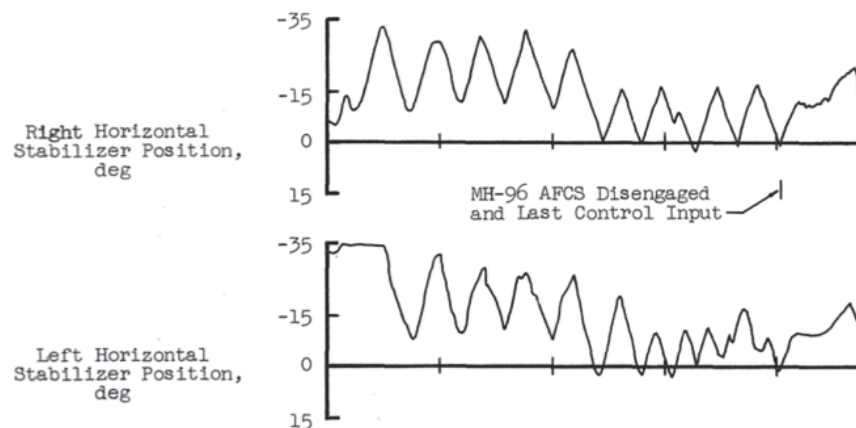
**Figure 8.5-3. X-15 3-65 MH-96 Servo Actuator LCO (simulated) versus Flight Data**

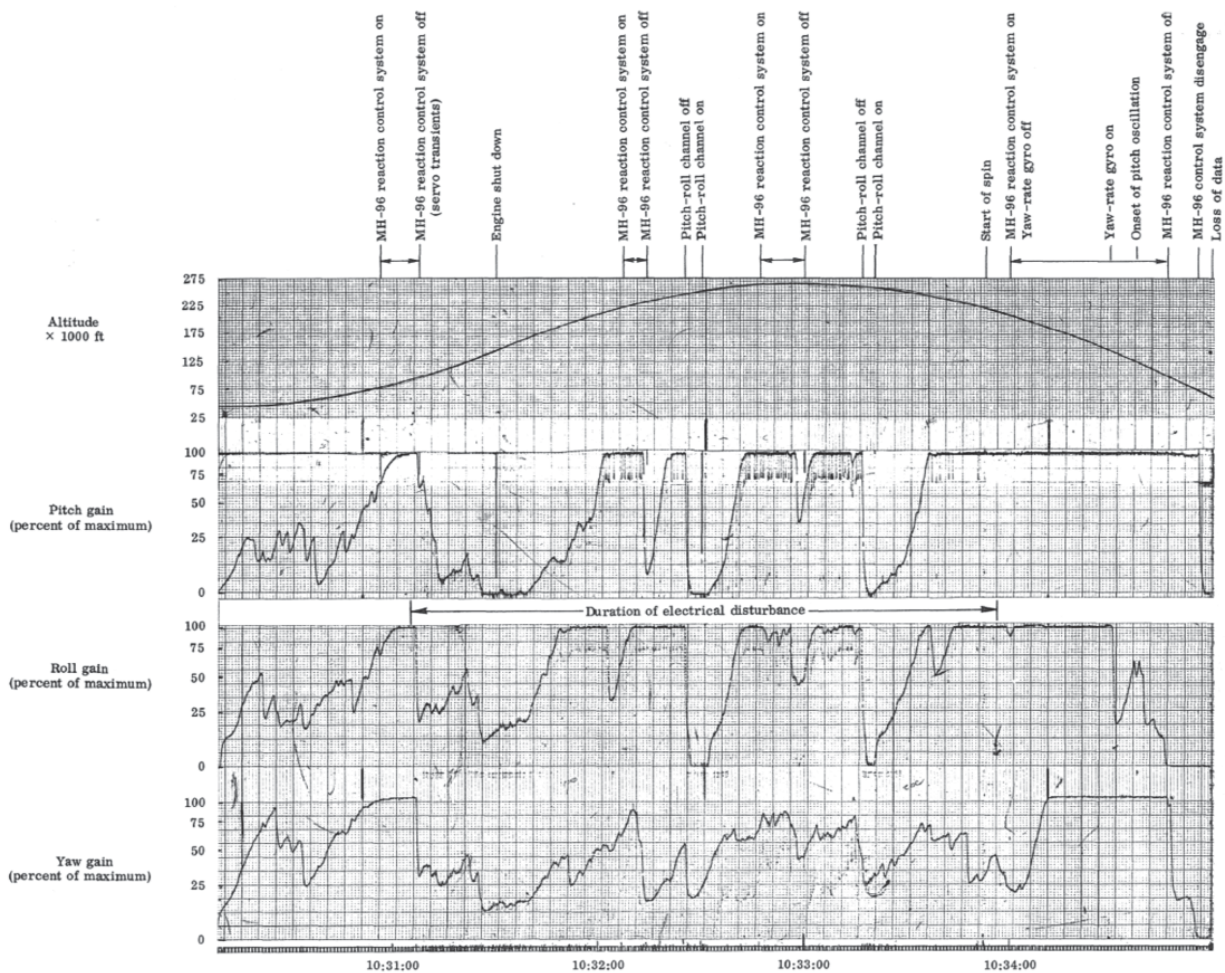
However, 14 seconds later, at 10:33:39 PST (MET + 211 seconds) and about 240,000 feet, the pilot reported that the aircraft control seemed “squirrely.” Twenty-two seconds later at 10:34:01 PST (MET + 233 seconds), the pilot said, “I’m in a spin.” Ground control did not acknowledge either of these transmissions. The pilot repeated, “I’m in a spin,” at 10:34:16 PST (MET + 248 seconds). At 10:34:17 PST (MET + 249 seconds), the flight controller said, “Say again.” At 10:34:17 PST (MET + 249 seconds), the aircraft was in descent at 184,000 feet with a velocity of 5,100 fps. The aircraft would begin to break apart 37 seconds later.

**Figure 9.1-2. AFCS Gain Variation during Flight 3-65**

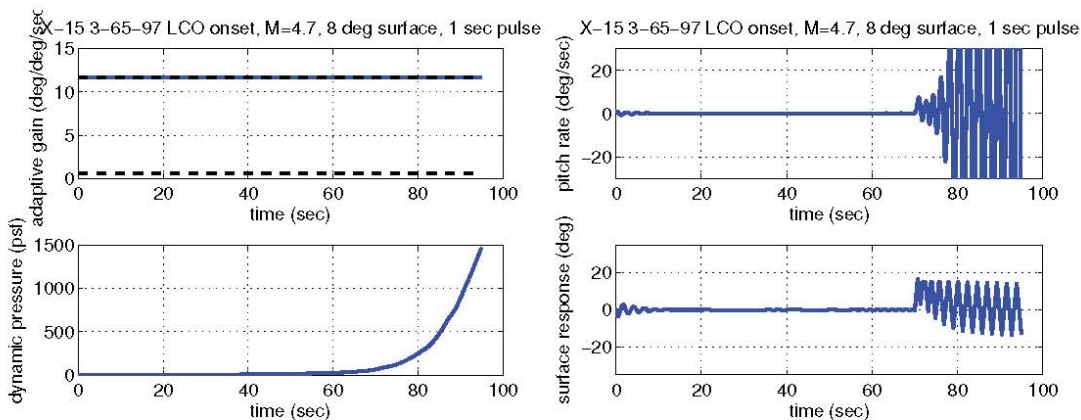
The adverse LCO appears in the anomalous entry due to saturation of the control surface actuators such that the short-period pitch mode of the aircraft is simultaneously excited during the period when the gain adaptation would otherwise be rapidly reducing system gain to compensate for the rapid increase in dynamic pressure (Figure A.15).

Figure A.15: MH-96 3-65 entry, pilot input

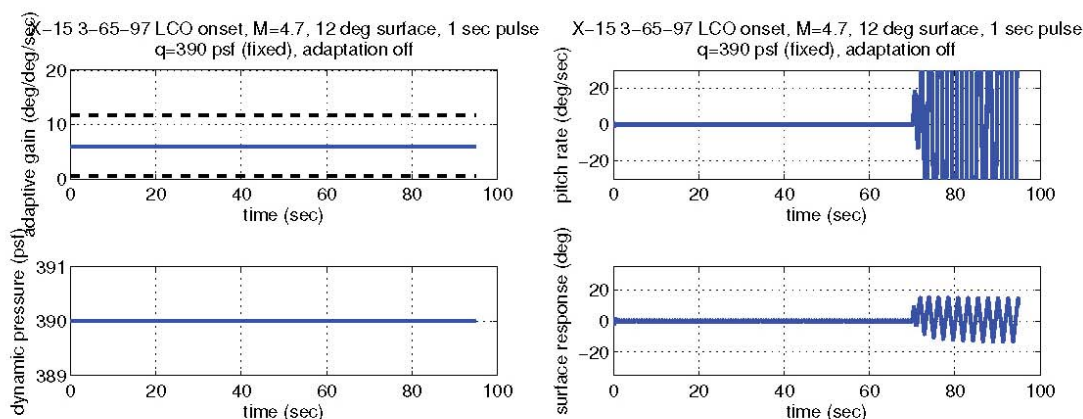
The same divergent LCO can be induced in the system even in a fixed gain condition with fixed dynamic pressure, if the pilot input magnitude is large enough to induce rate limiting in the actuator (Figure A.16). This occurs with moderate gain levels exceeding those of the fixed-gain SAS but much below the MH-96 maximum gain. This implies that a more serious mechanism involving the fundamental stability of the SAS inner loop is responsible for the limit cycle behavior, since in the fixed-gain case the behavior persists.

Figure A.16: Fixed dynamic pressure, large pilot input, fixed gain

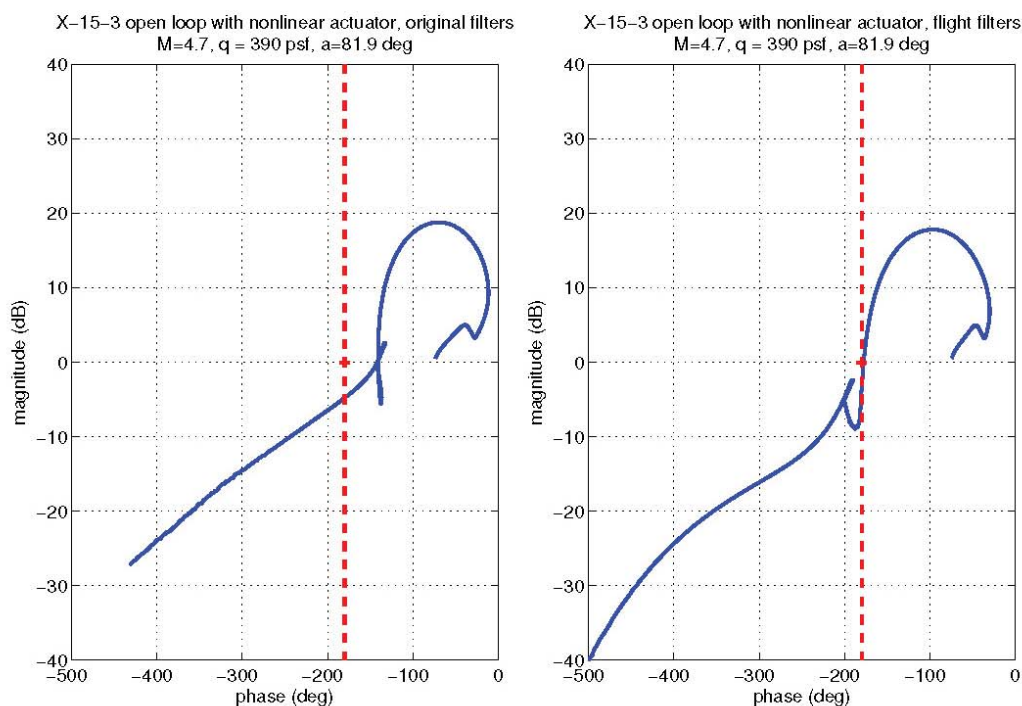
Based upon the time-domain analysis, it was observed that the large-amplitude LCO tended to be precipitated by large inputs causing actuator rate saturation coupled with an excitation of the short-period pitch mode. In order to determine the possible transition amplitude for the adverse LCO, the amplitude-frequency parameter space was searched for a DF such that the short-period mode would approach critical stability when at the 3-65 entry conditions (maximum forward gain, 390 psf). The transition amplitude for this condition consists of a large servo command of approximately 80 degrees peak equivalent, or a command-to-authority factor of about 6:1. Large servo commands exceeding the servocylinder limit of 1 inch (15 degrees equivalent) will cause saturation in the servo, the power actuator, or both. The effects of saturation on the actuator frequency response are shown in Figure A.22. Near the short-period frequency, the effective phase lag is increased by approximately 25 degrees.

Figure A.23: X-15 servoactuator large-amplitude LCO prediction

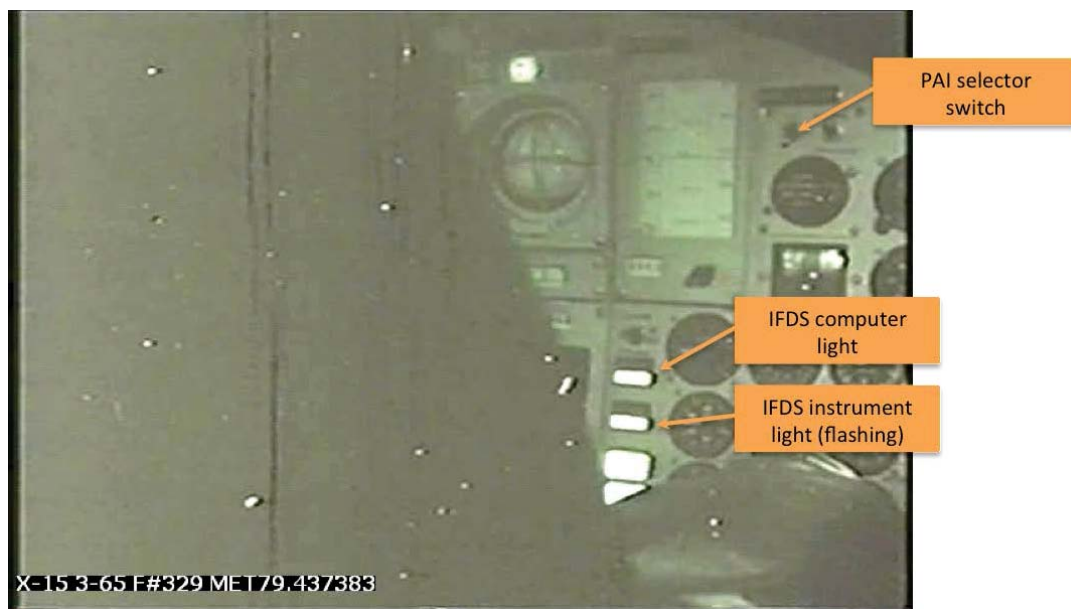
**Figure B-10. Cockpit Film – Begin IFDS Malfunction (MET = 79 seconds, 10:31:27 PST)**

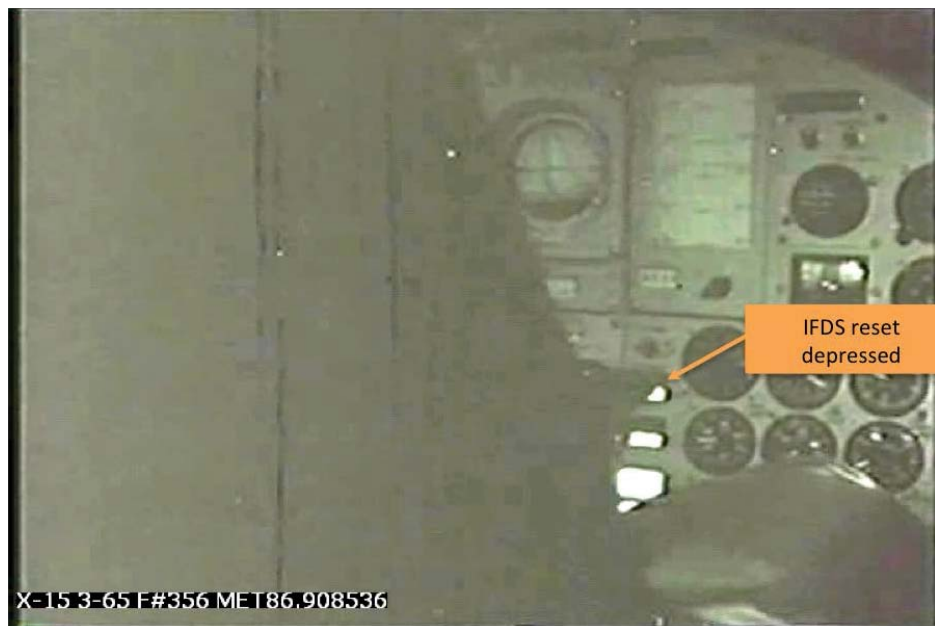
**Figure B-12. Cockpit Film – Pilot Attempts IFDS Reset (MET = 87 seconds, 10:31:35 PST)**

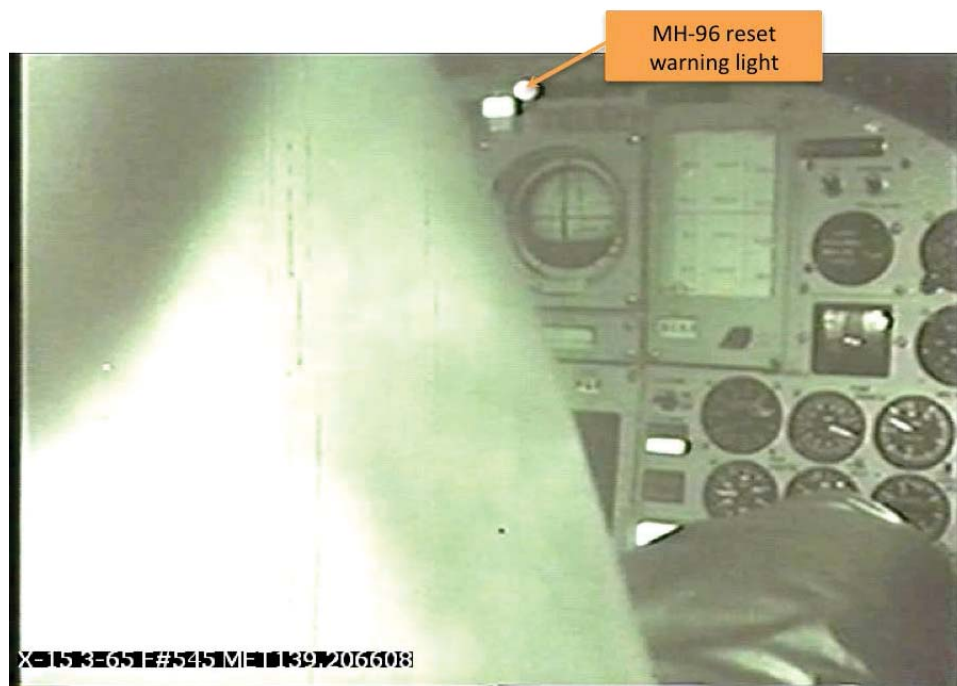
**Figure B-14. Cockpit Film – One of At Least Two MH-96 Disengages (MET = 139 seconds, 10:32:27 PST)**

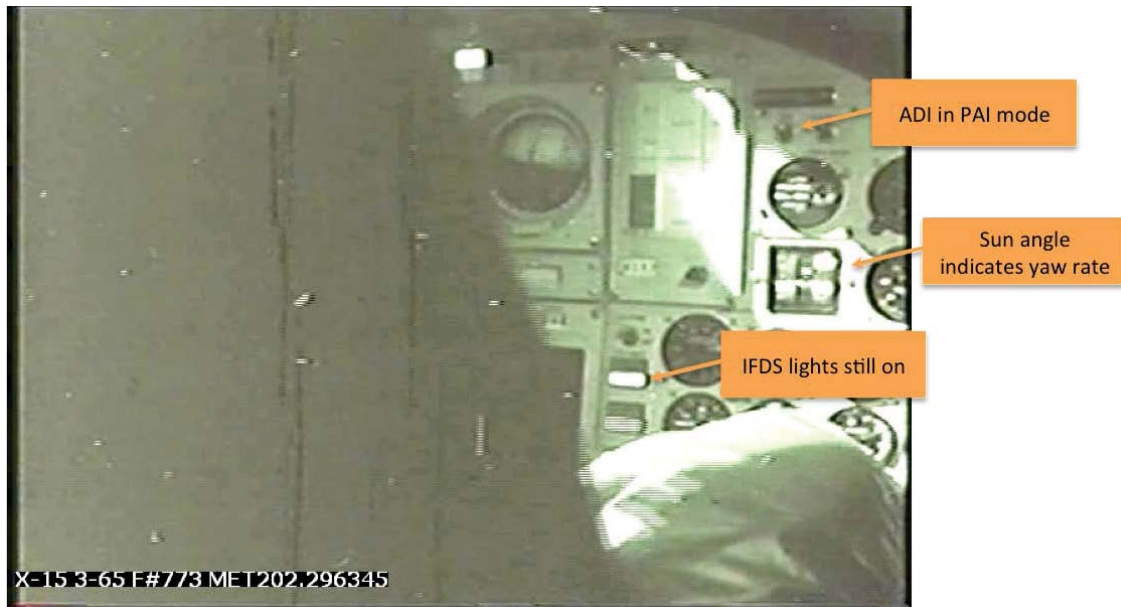
**Figure B-16. Cockpit Film – Spin Entry (MET = 202 seconds, 10:33:30 PST)**

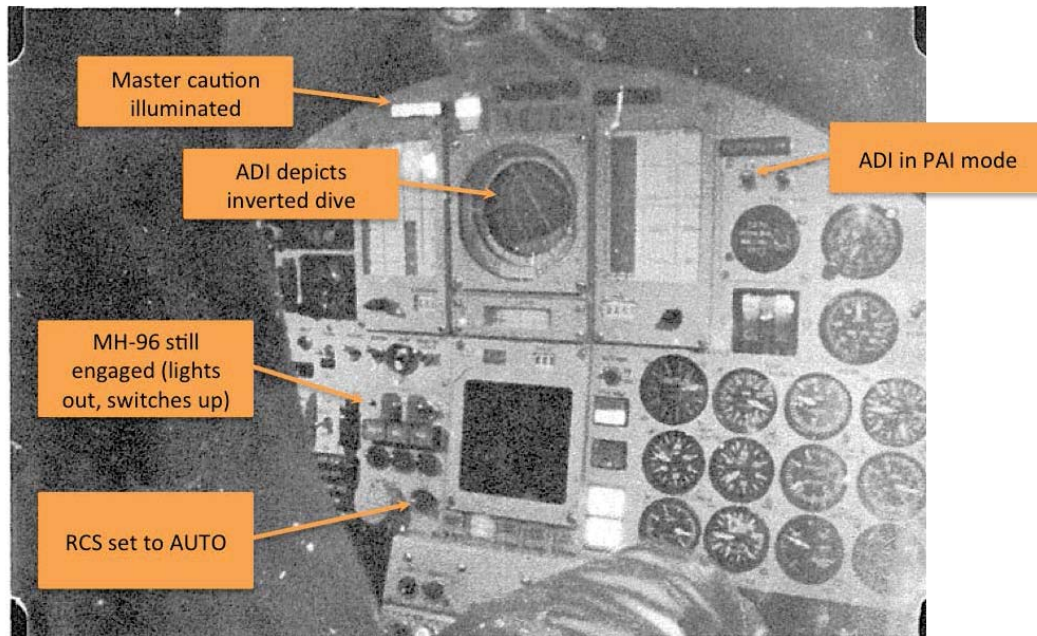
**Figure B-17. Cockpit Film – Last Camera Frame (MET = 286 seconds, 10:34:54 PST)**
