# Public Housing: A Tailored Approach to Energy Retrofits

Jordan Dentz, Francis Conlin, David Podorson,  
and Kunal Alaigh

*Advanced Residential Integrated Energy  
Solutions (ARIES) Collaborative*

June 2014

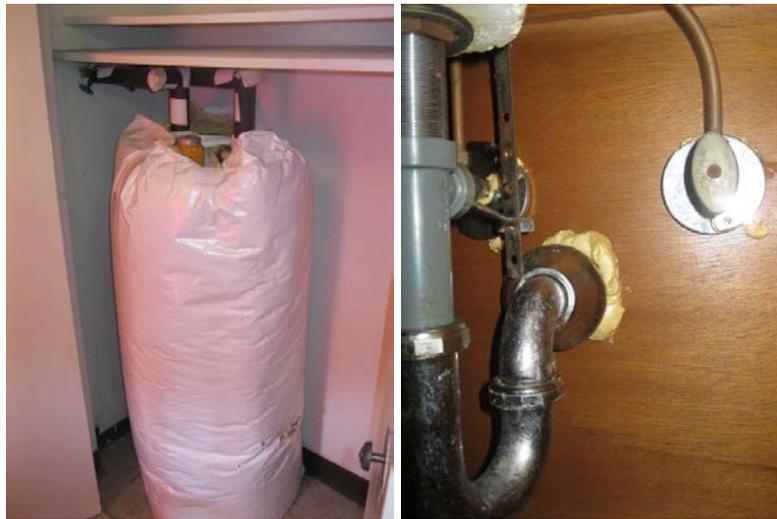
**Figure 3. Electric storage water tank with insulation wrap (left) and foamed plumbing penetrations (right) at IHA**

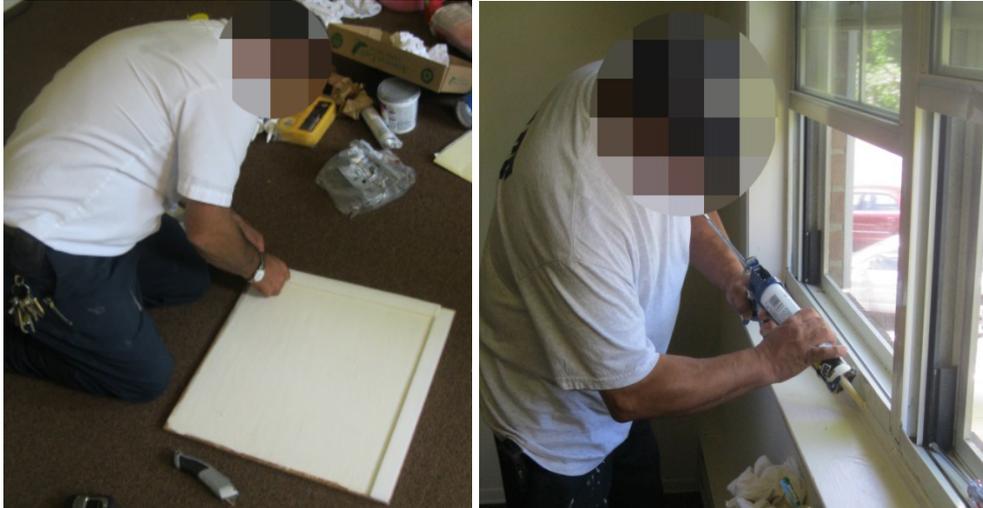
**Figure 4. Installing gasket on attic hatch (left) and caulking gap around window (right) at IHA**
