**Investigation of Fatality  
West Cameron Block 240  
OCS-G 27008  
December 1, 2006**

Gulf of Mexico  
Off the Louisiana Coast

U.S. Department of the Interior  
Minerals Management Service  
Gulf of Mexico OCS Regional Office

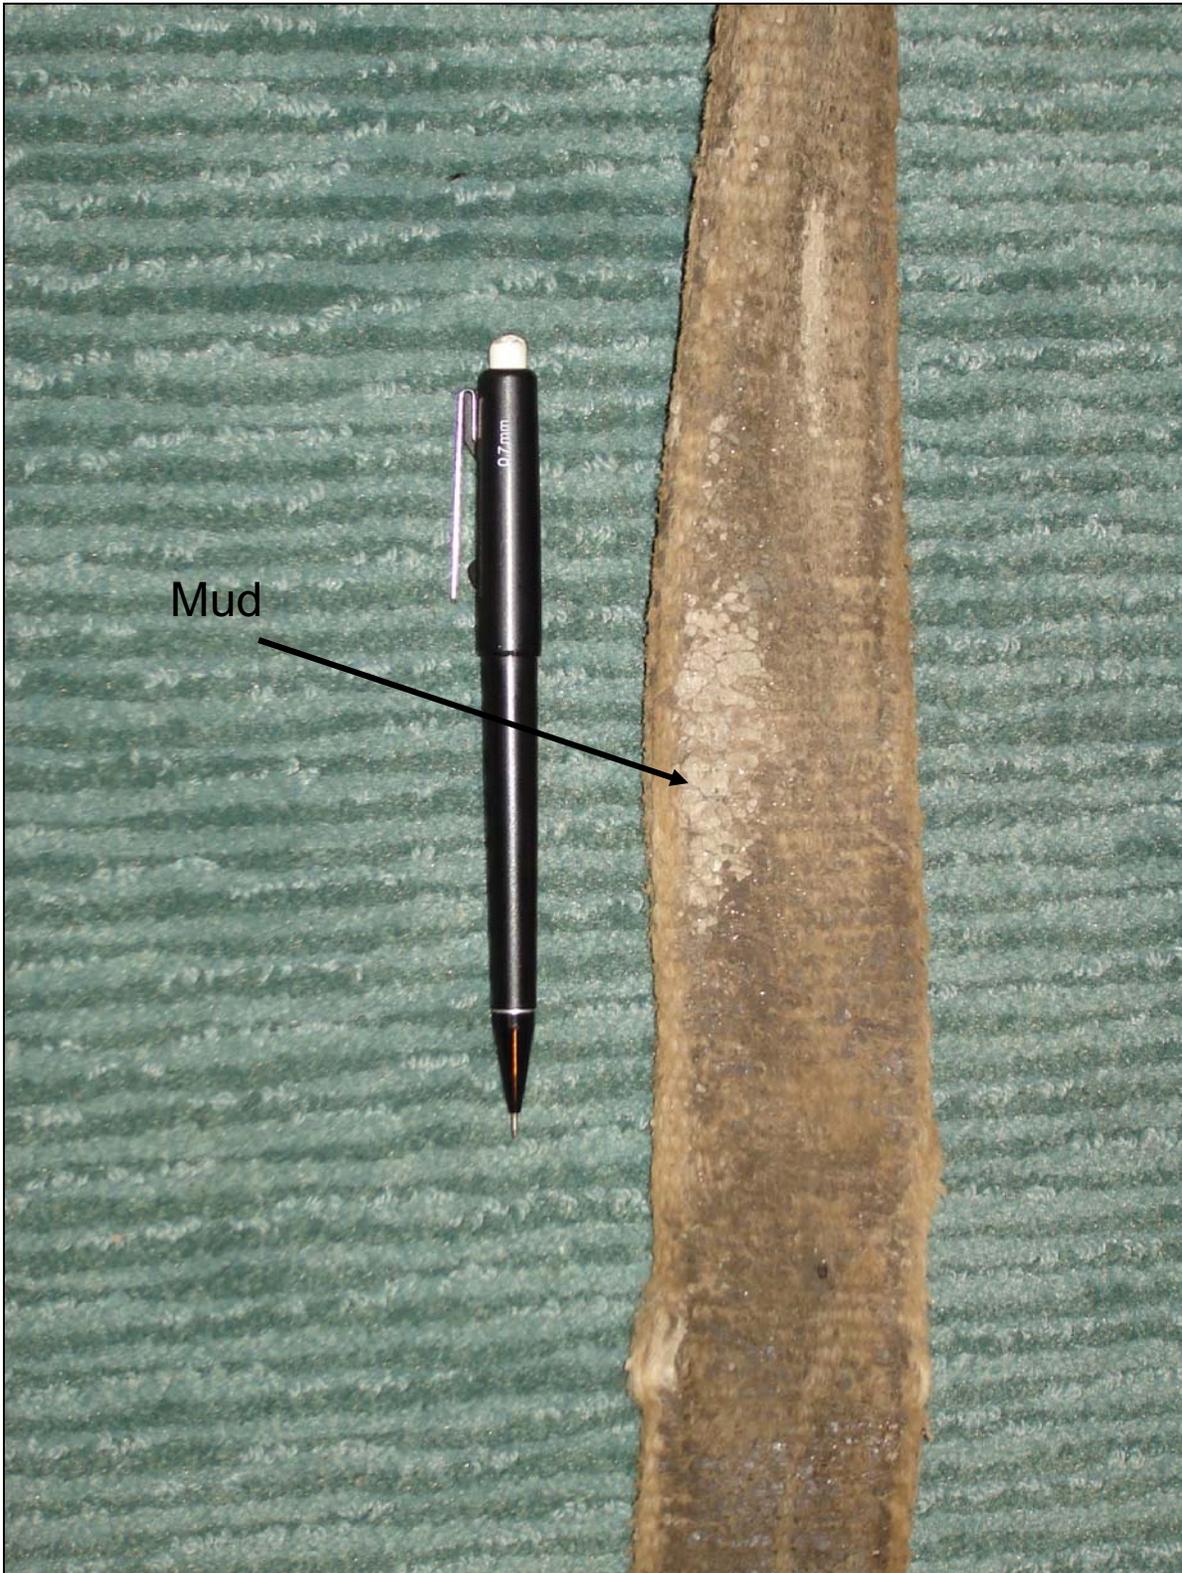
**Photo of Mid-Section of Nylon Strap used during the WC 240 Fatality**

While T-R3 was on the rig floor, he was solely responsible for attaching the nylon strap below the tool joint to allow T-D/HO to make the lift, and then walk the drill pipe to the V-door once it was lifted by T-D/HO. TR-3 acknowledged there was evident pipe dope on all of the drill pipe joints being lifted, with some having more pipe dope than others. *For an indication of the condition of the nylon strap, see Attachments 2-6.*

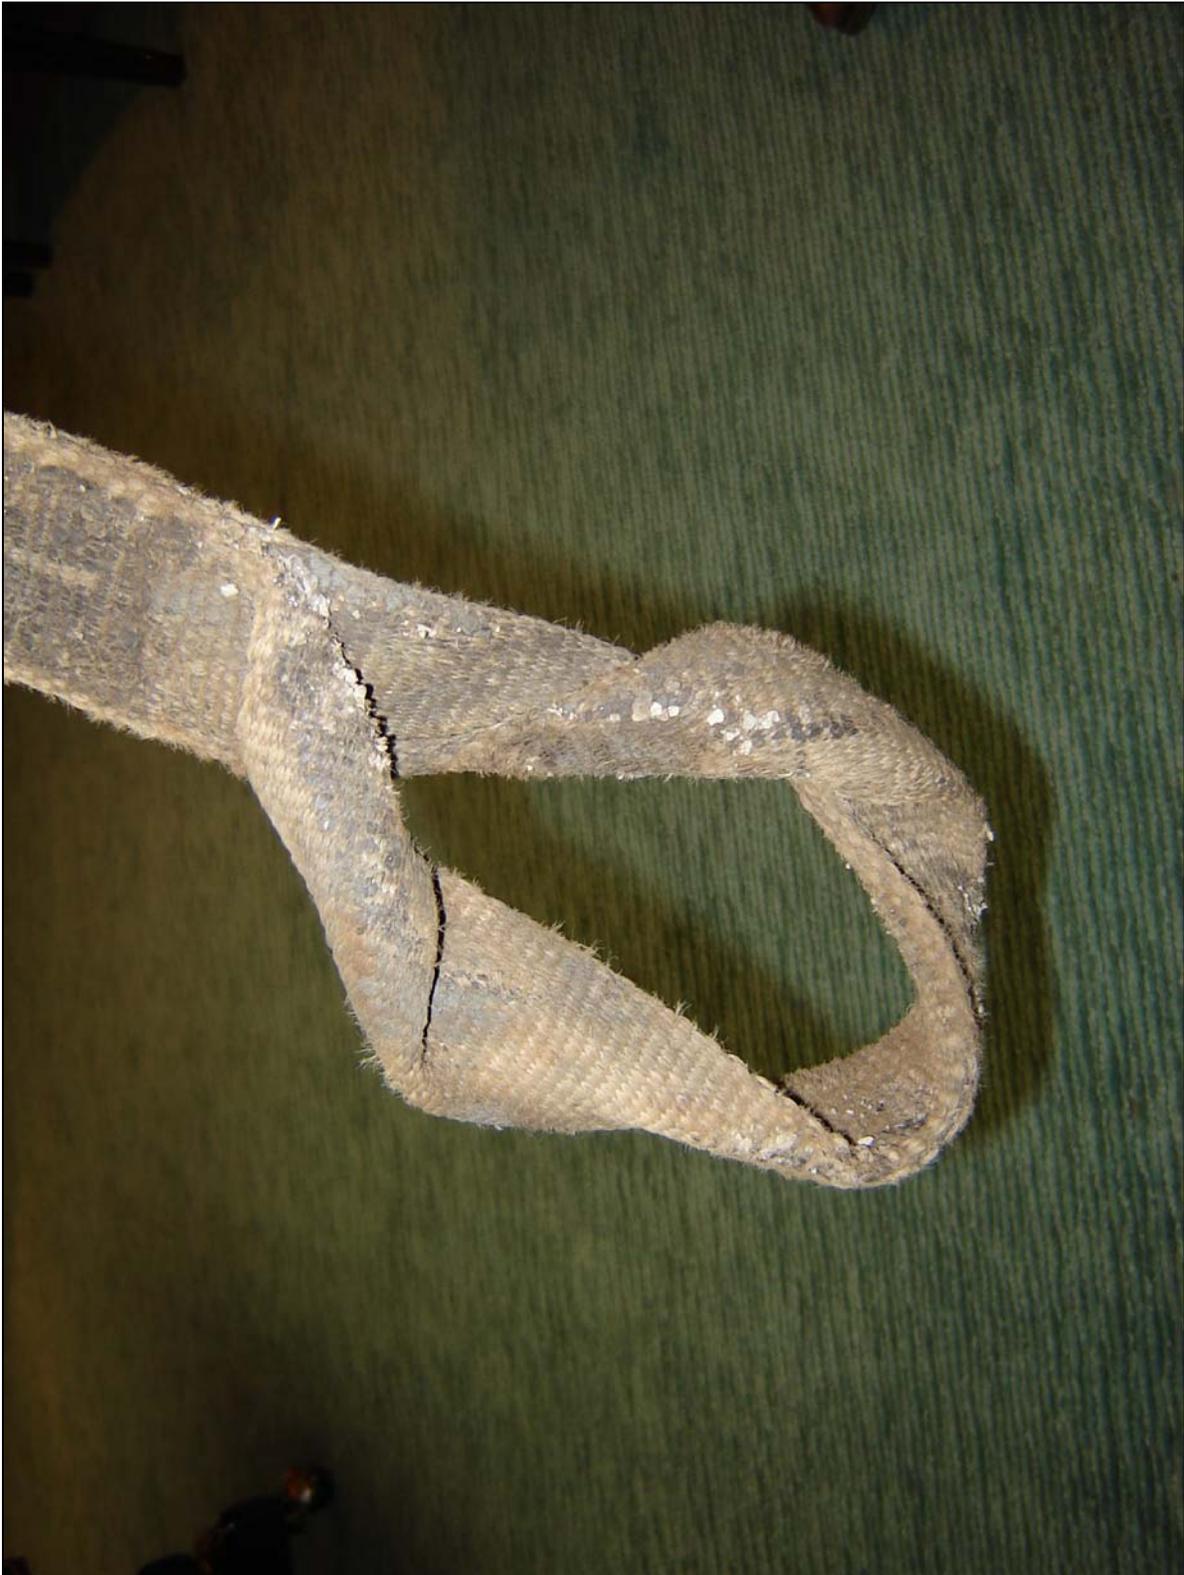
**Photo of Nylon Strap Eye**

1. It is the conclusion of the panel that, as the last joint of pipe was being pushed to the V-door, the necessary slackening of the hoist cable and an improperly cinched strap caused the eye of the cinched strap to ride up onto the pipe's tool joint and slip off the drill pipe.

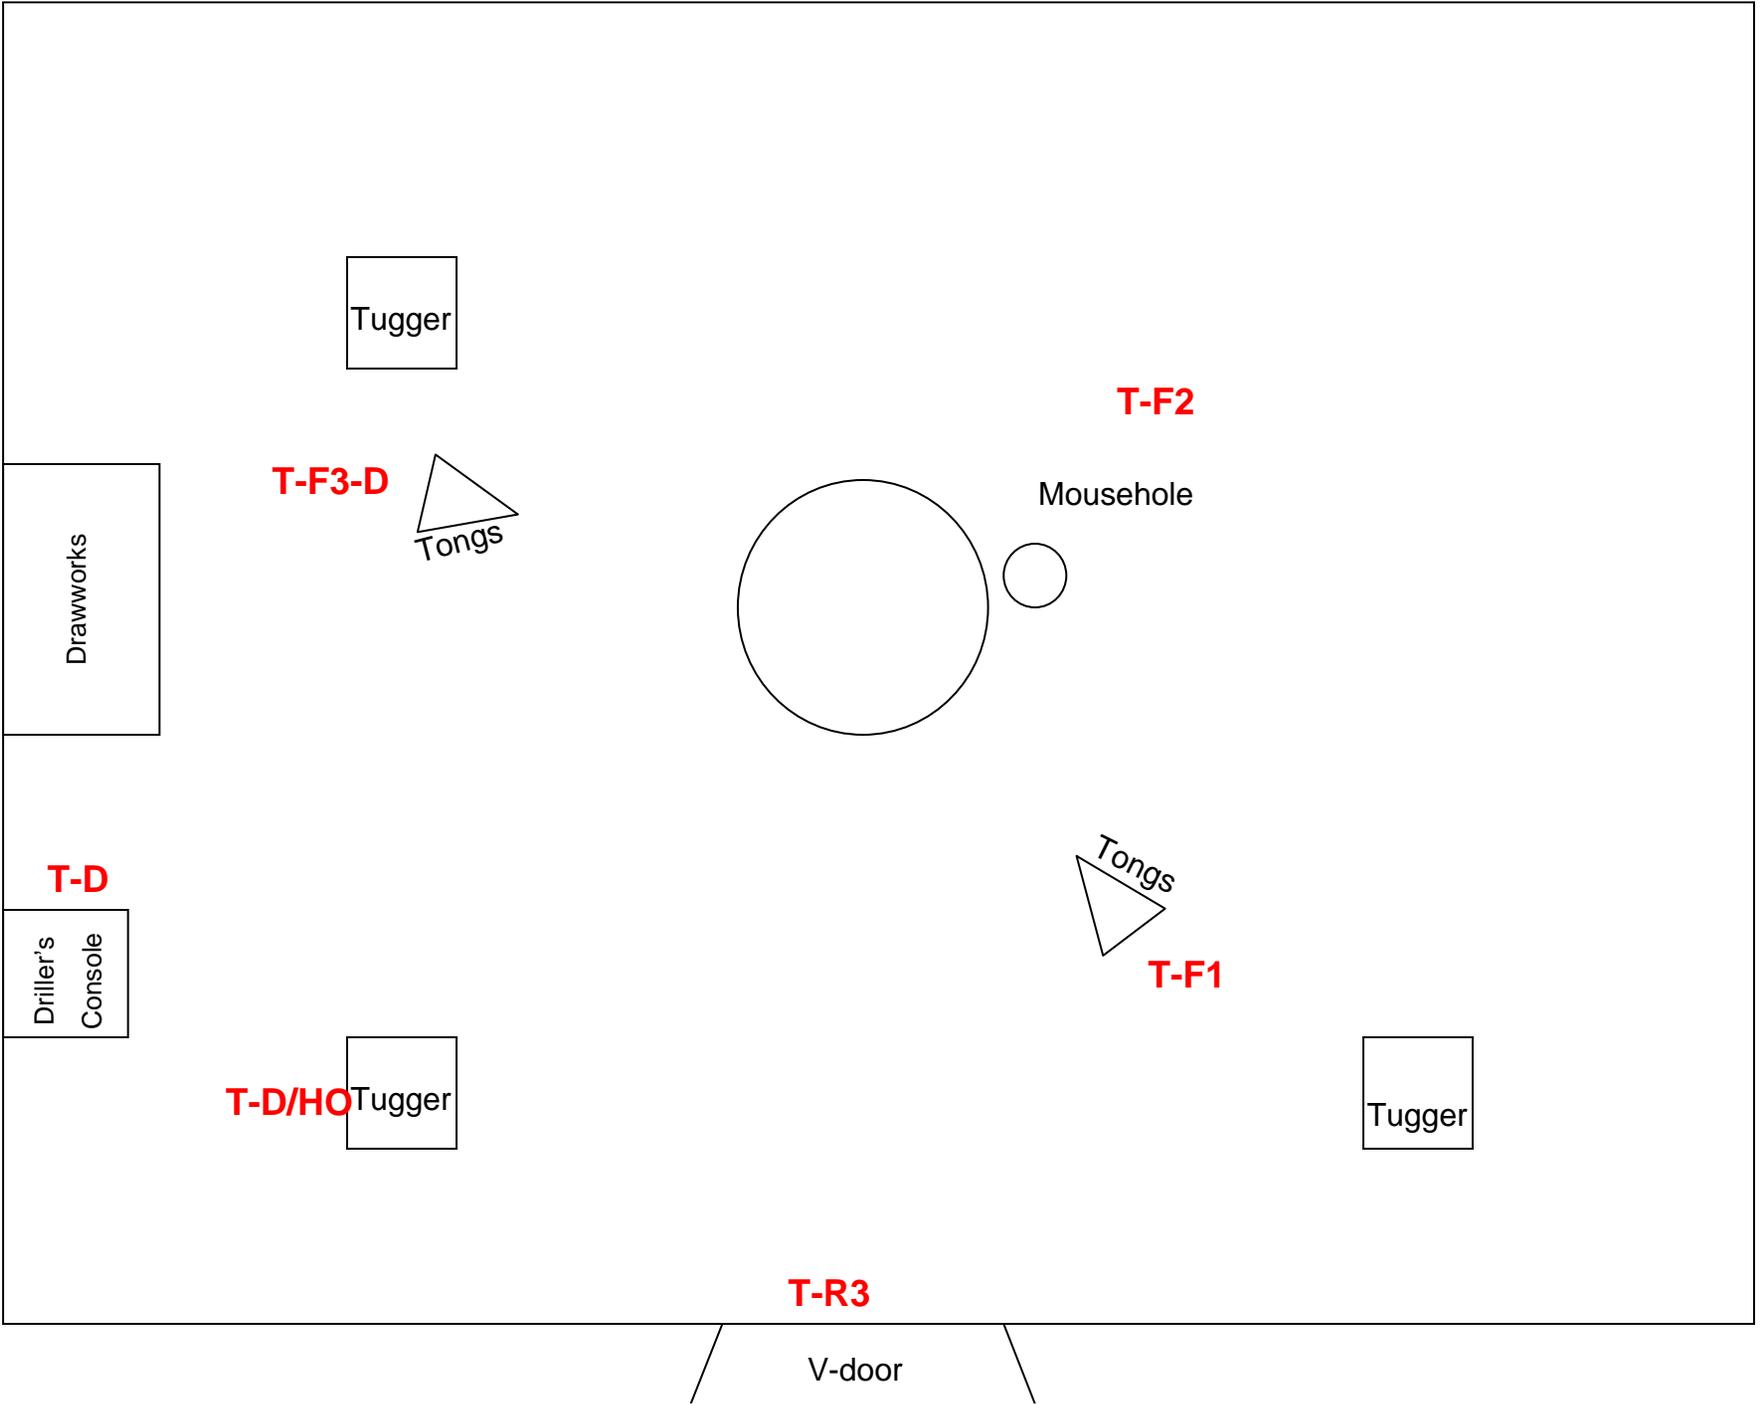
Layout of the TODCO 207 Rig at Time of Fatality

Prior to T-R3 making any connections to the drill pipe, T-F1 showed him the proper way to make the cinch three to four times according to T-F1. T-F1 said that he watched T-R3 make a few connections and then resume pulling the drill pipe. According to T-F1, T-F1 corrected T-R3 for attaching the nylon strap too high on the drill pipe tool joint. T-F1 said that he “had to set the joint down and explain to T-R3, because if it [the nylon strap] got on the tool joint the pipe would slip out.” T-F2 said that on one occasion the drill pipe was set higher than previous tool joints in the mousehole, which required T-F1 to cinch the strap below the tool, because T-R3 was having difficulties because of the tool joint’s height. Besides monitoring T-R3 make every strap connection, T-F1 was also responsible for operating the tongs, breaking drill pipe connections, and signaling to T-D/HO to lift the drill pipe. *For a depiction of the location of pertinent personnel at the time of the accident, see Attachment 7.*

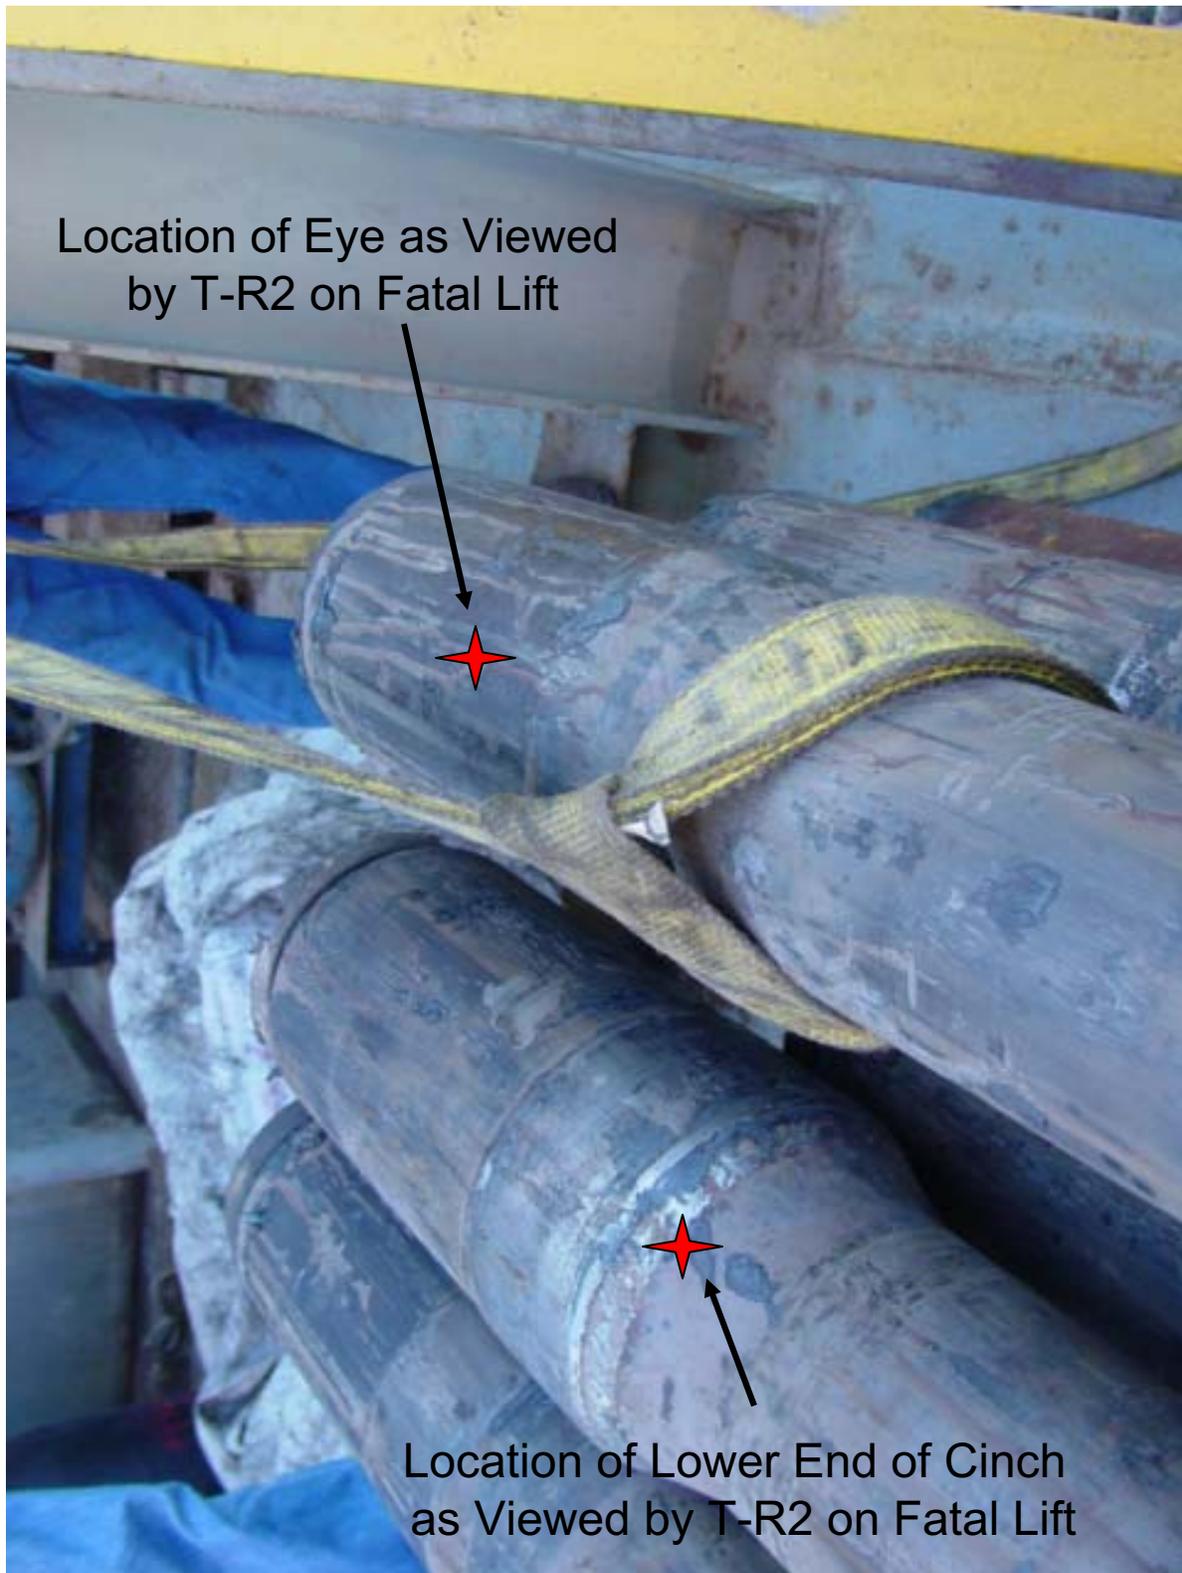
**Photo of Depiction of Single Choker Hitch**

Prior to the drill pipe striking T-F3(D), T-R2 witnessed a loose strap connection on the drill pipe while it was suspended above the rig floor, prior to its falling, and he thought the strap might come off. After T-R2 saw this, he hollered at T-R1 to get off of the catwalk, because “it looked like it wasn’t on there real good.” *For a depiction of the single choker hitch used during the laying down operation and the location of the strap on the pipe as viewed by T-R2 on the fatal lift, see Attachment 8.*

The exact manner in which the strap was improperly cinched is not known. It is concluded that the strap was placed either 1) too high on the joint with the eye of the strap either on the bevel of the tool joint or on the joint itself or 2) too low on the joint, thereby allowing the momentum of the strap, as the pipe was being lifted, eventually to slip over the bevel and eventually off the drill pipe's tool joint. **Therefore, the improper cinching of the strap onto the pipe is concluded to be a cause of the incident.**
