# The Alaska Earthquake

March 27, 1964

# Effects of the Earthquake Of March 27, 1964 In the Copper River Basin Area, Alaska

GEOLOGICAL SURVEY PROFESSIONAL PAPER 543-E

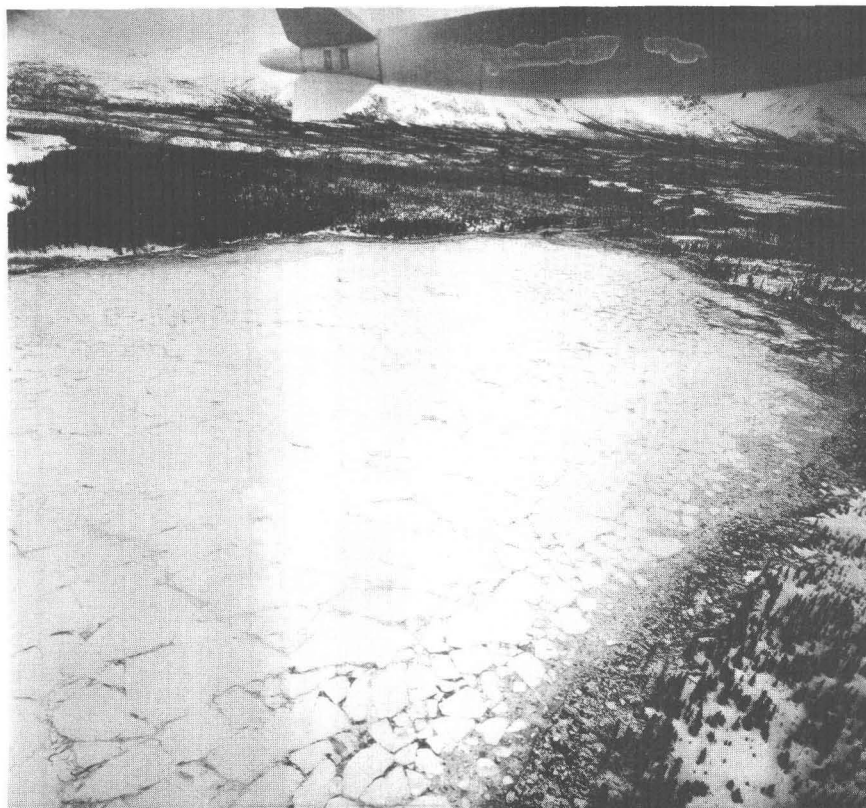
5.—View, to the northeast, of the northern end of Tonsina Lake showing intensely fractured ice and large blocks of ice stranded above water level along the shore. The lake is about half a mile wide at this point. Photograph by U.S. Army, April 8, 1964.

this general pattern. Ice on Klutina Lake and Tonsina Lake was highly fractured throughout (fig. 5). On Tazlina Lake the ice on the northern half of the lake was highly fractured (fig. 6), but ice on the southern half was fractured only around the margin, and a few linear cracks were formed across the lake. The greater intensity of the cracking of ice on these lakes was caused by water waves generated by sublacustrine landsliding off the fronts of large deltas built out into the lakes.

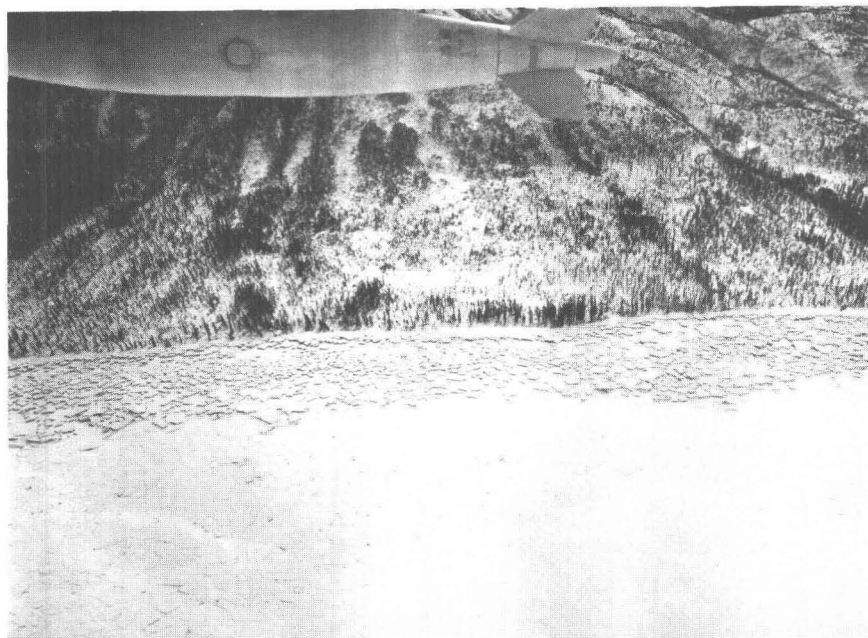
6.—View, to the east, showing intensely fractured ice along the eastern shore of Tazlina Lake, across from the large Nelchina River delta. Large blocks of ice stranded above water level along the shore are easily discernible, but the intense fracturing of ice away from the shore is obscured by the refreezing of the lake water and by a postearthquake snowfall. The segment of shoreline shown in this photograph is about half a mile long. Photograph by U.S. Army, April 8, 1964.

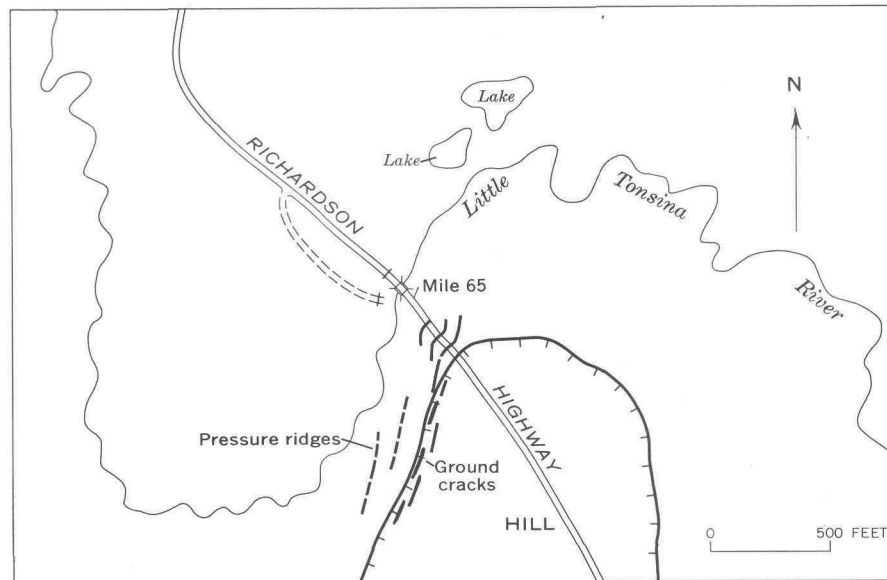
The Little Tonsina River landslide site (fig. 8, next page) is in the southern part of the area, on the southwestern side of the Richardson Highway at mile 65. Landsliding occurred along the northwestern side of a small hill underlain by unconsolidated silt, sand, and gravel deposits. Lateral movement of segments of the hill toward the northwest caused several large ground cracks to form on and parallel to the face of the hill and pressure ridges to develop on the floor of the Little Tonsina River valley (fig. 9). One of the large ground cracks formed by the lateral extension of materials toward an unconfined face (hillside) is shown in figure 10, and a pressure ridge developed in front of the slide area is shown in figure 11. The horizontal forces that formed the ridge were transmitted through a layer of seasonally frozen peat and silty sand, approximately 2 feet thick, overlying water-saturated silty sand. Locally, water-saturated silty sand was ejected to the surface through cracks in the seasonally frozen layer.

8. Sketch map of the Little Tonsina River landslide site.

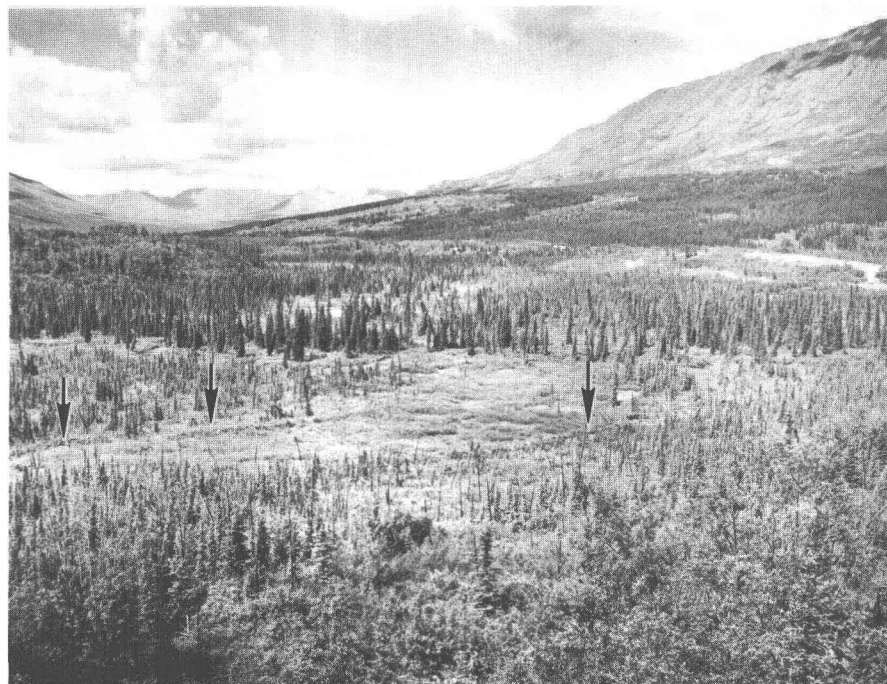
9.—View, to the northwest, showing pressure ridges on floor of Little Tonsina River valley near mile 65, Richardson Highway; pressure ridges (indicated by arrows) caused by landsliding on face of hill.

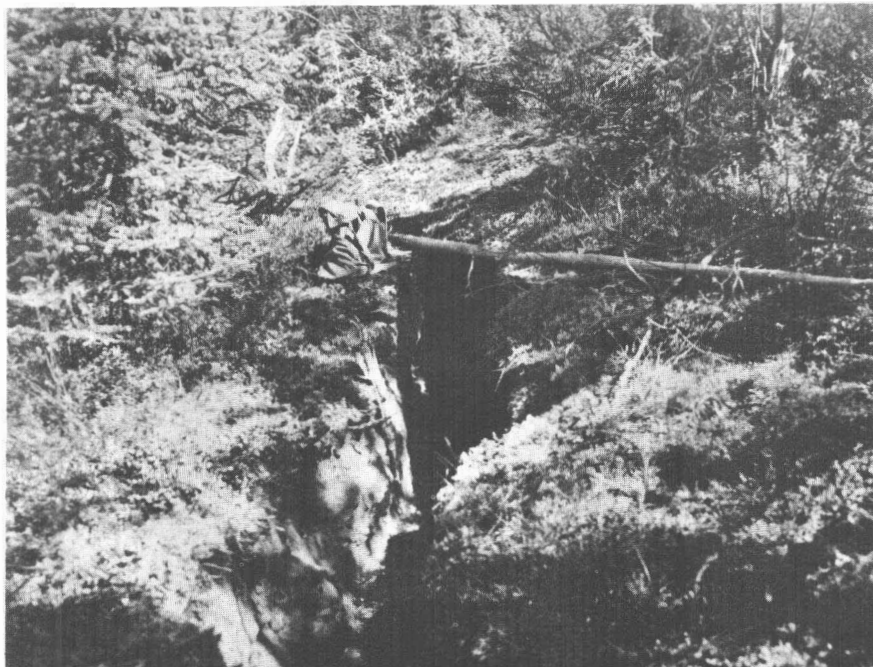
10.—One of several large ground cracks paralleling northwest side of small hill near mile 65, Richardson Highway. Crack, formed in fine- to medium-grained sand, has maximum width of 3 feet and depth of about 5 feet. The lateral extension of materials down the side of the hill caused the ground cracks and also caused pressure ridges to form on level ground several hundred feet in front of the base of hill.

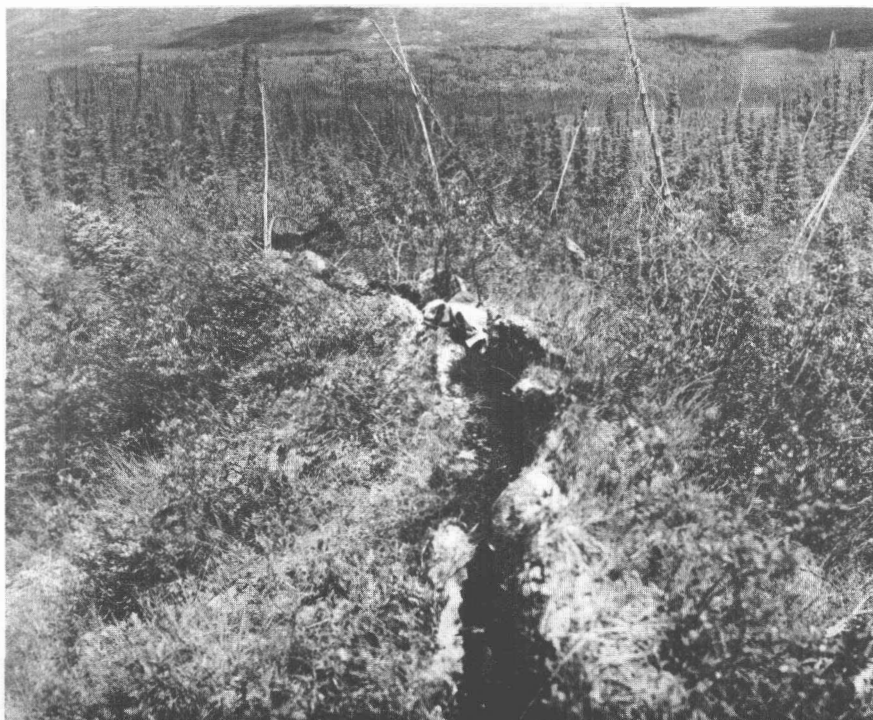
11.—Pressure ridge, 6 feet high, on flat surface bordering Little Tonsina River near mile 65, Richardson Highway. Crest of ridge broken irregularly by upward flexing of frozen peat caused by landsliding on a nearby hillside.

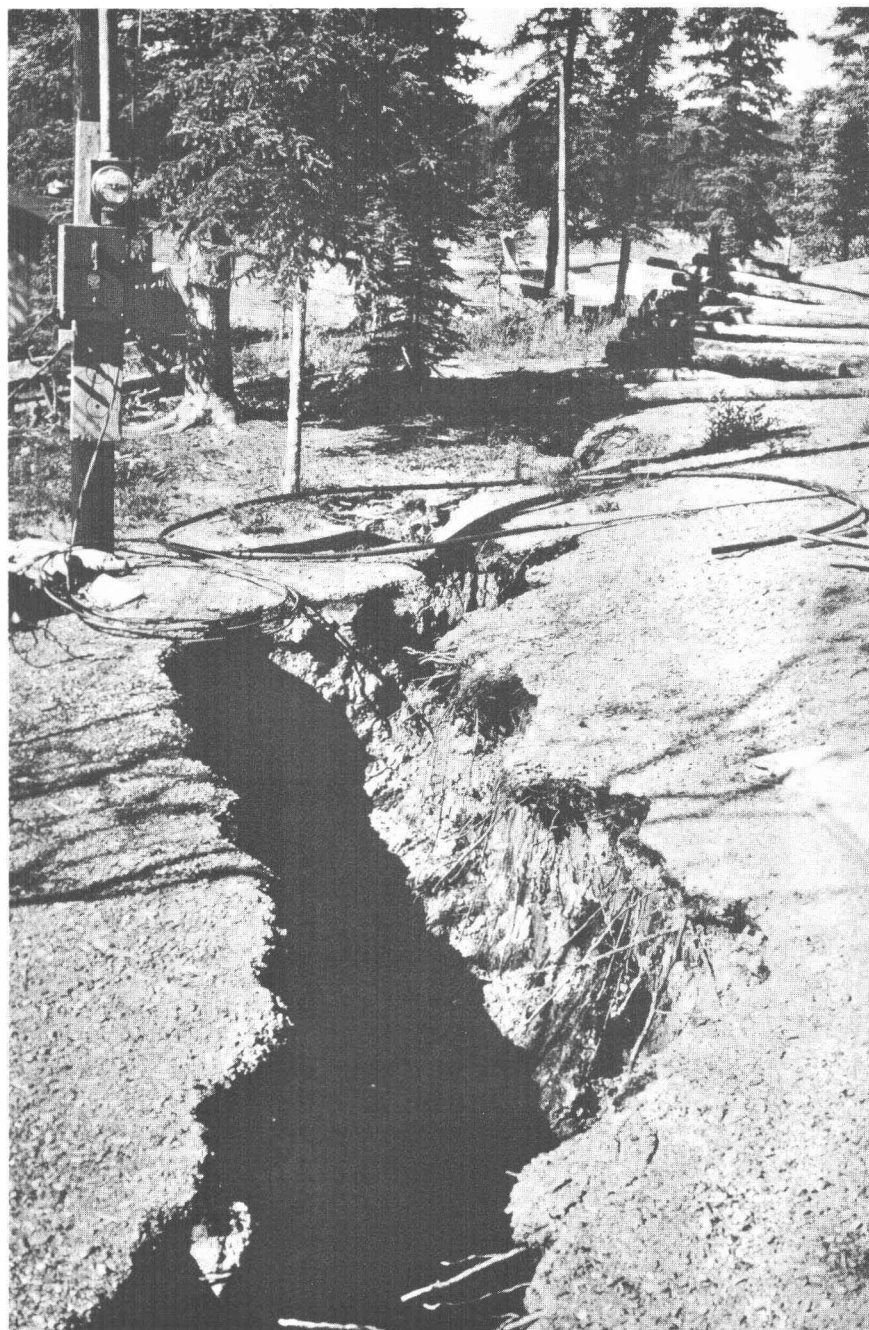
Other landslides include a large one at the mouth of Klutina Lake which caused the Klutina River to be diverted, several small ones along bluffs of the major rivers of the area, and numerous small slides marginal to lakes (see fig. 7). Ground cracks formed along margins of lakes by lateral movement of materials. An example is shown in figure 12 (p. 16).

12.—Large ground crack formed in clearing along south shore of lake about two-tenths of a mile north of mile 158, Glenn Highway. Maximum width of crack is 4 feet and depth is 6 feet. This ground crack is one of several that generally parallel the lakeshore.

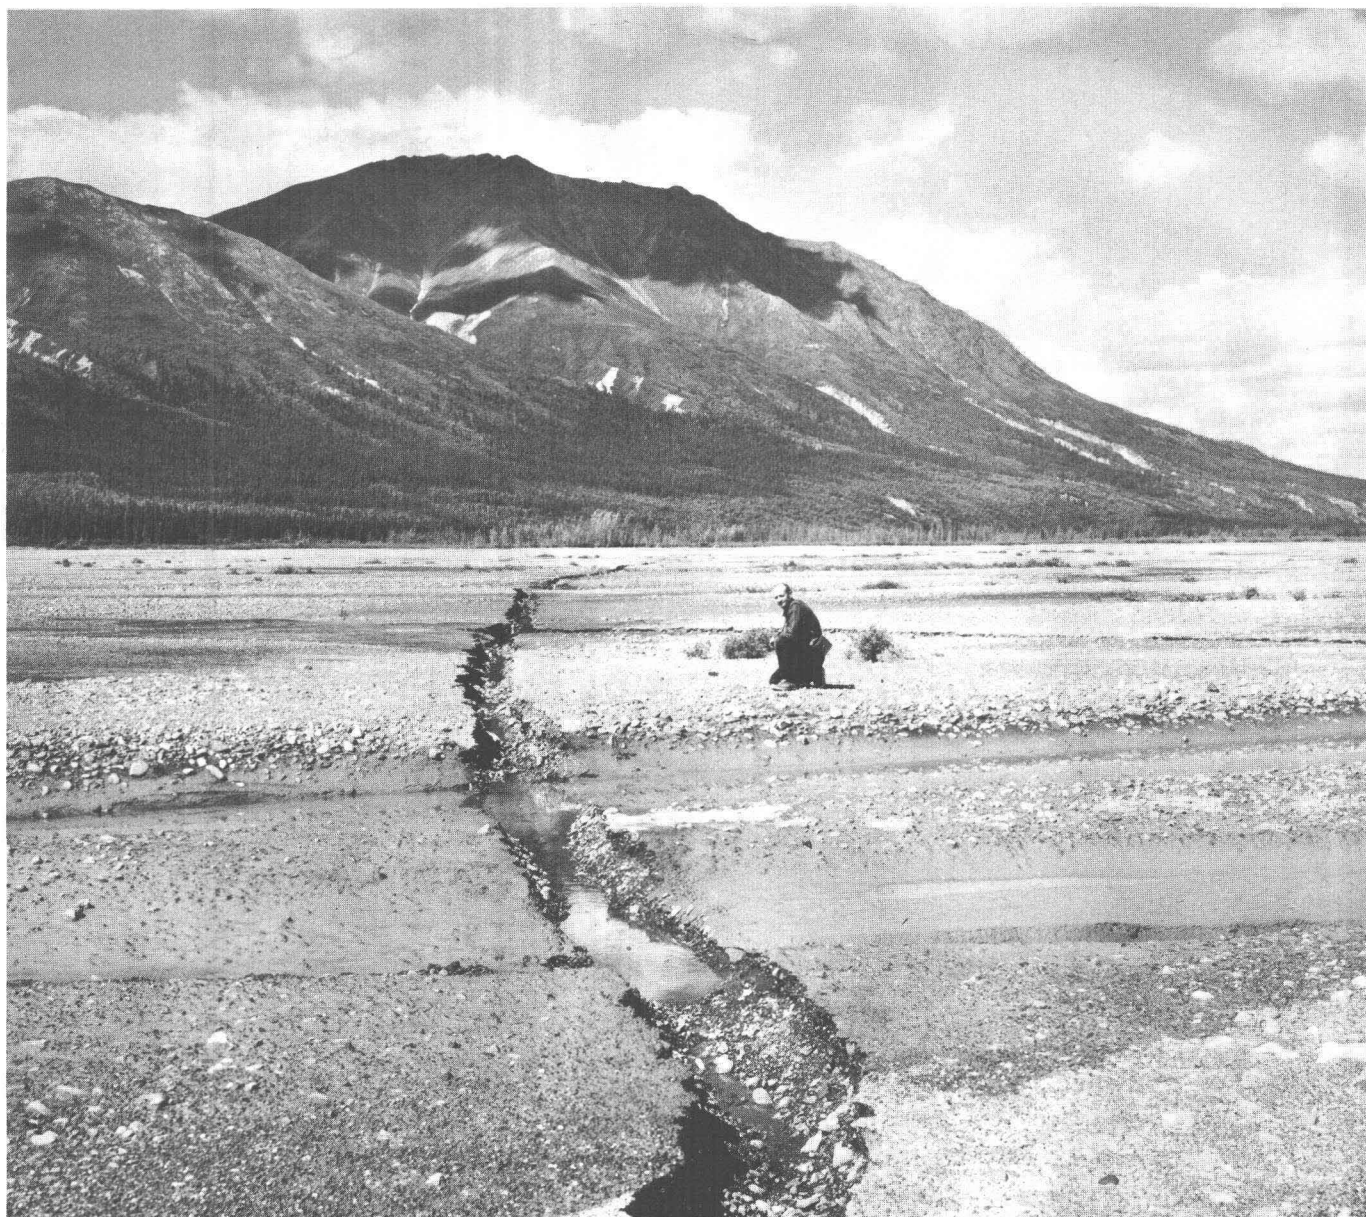
14.—Typical ground crack in outwash apron of Nelchina River 2 miles north of terminus of Nelchina Glacier; crack about 2 feet wide at widest point. Note how crack was deflected slightly in crossing swale in foreground. Standing water in swale marks the shallow ground-water table. Dark line behind man is trace of intersecting crack.

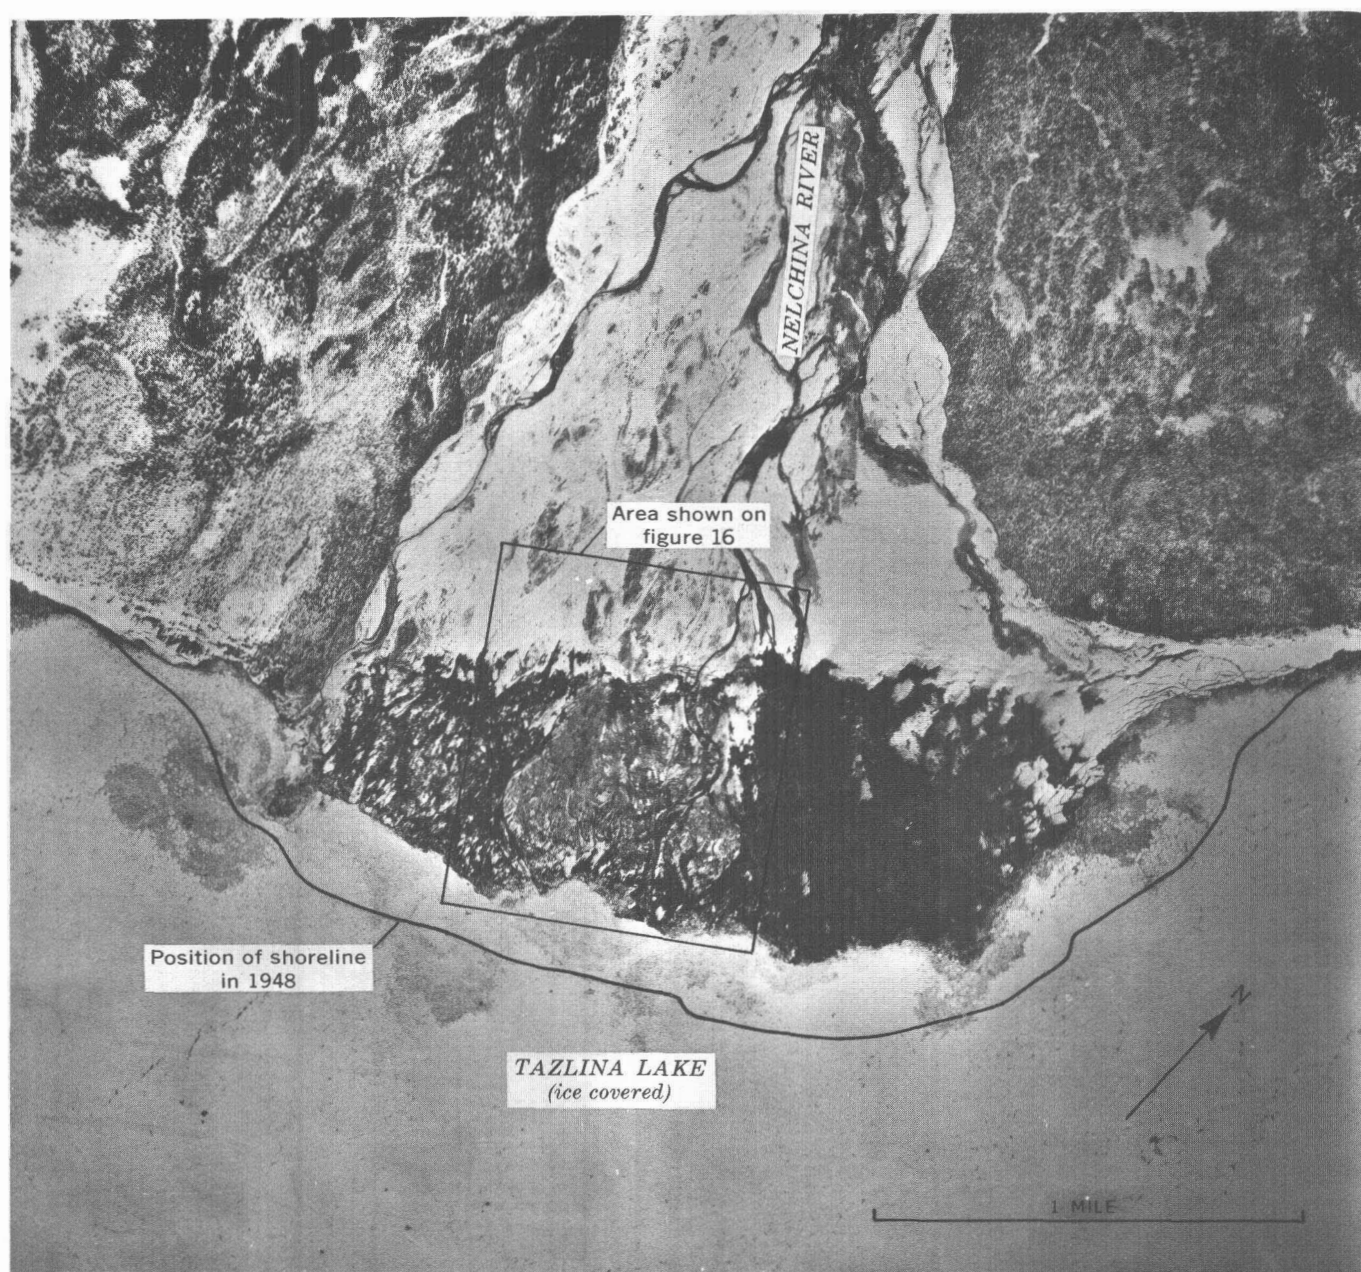
15.—The Nelchina River delta. Hingeline across the delta is conspicuous because most of the snow has been removed from the downslope side by water and sediment ejected from ground cracks. The position and character of the water-delta interface or shoreline in 1948 compared with the postearthquake shoreline indicate that large segments of the delta front slid into the lake. Photograph by U.S. Coast and Geodetic Survey, April 10, 1964.

The position and character of the water-delta interface in 1948 as compared with the position and scalloped character of the post-earthquake interface (see fig. 15) indicate that not only was there subsidence but that large segments of the delta front slid into the lake. This sublacustrine landsliding generated large waves that severely fractured the ice on the northern part of the lake and stranded large blocks of ice above water level along the shore. Large quantities of sediment and ice were discharged through the outlet of the lake into the channel of Tazlina River. Similar sublacustrine landsliding occurred off the fronts of deltas in Klutina Lake and in Tonsina Lake.

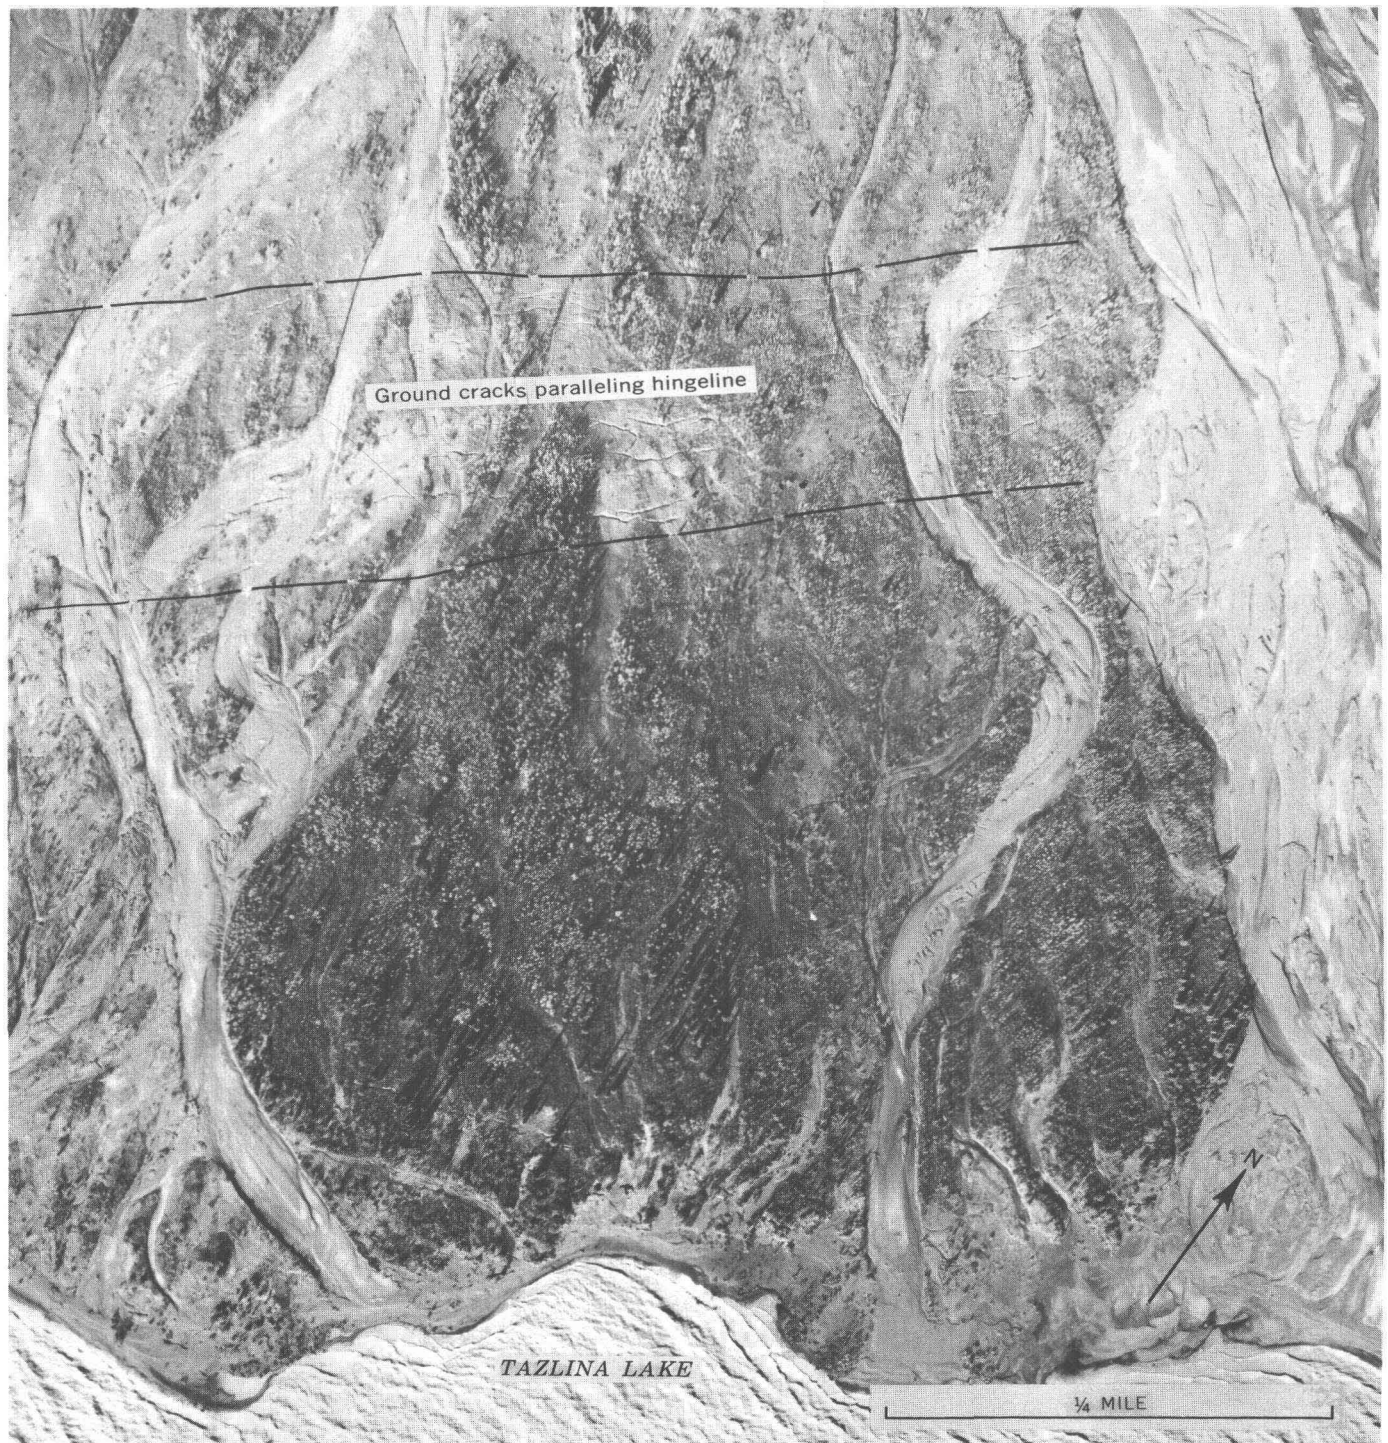
16.—Ground cracks along and paralleling hingeline on Nelchina River delta. Photograph by U.S. Geological Survey, October 1964.

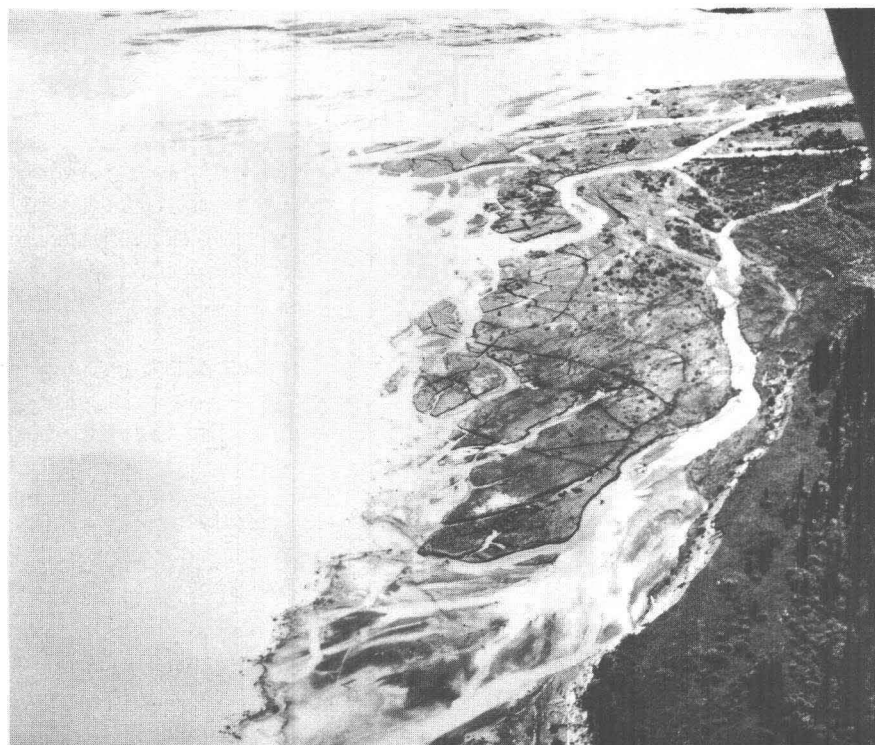
17.—North end of the large Nelchina River delta along the western shore of Tazlina Lake. Note the reticulate pattern of ground cracks which are as much as 6 feet wide.

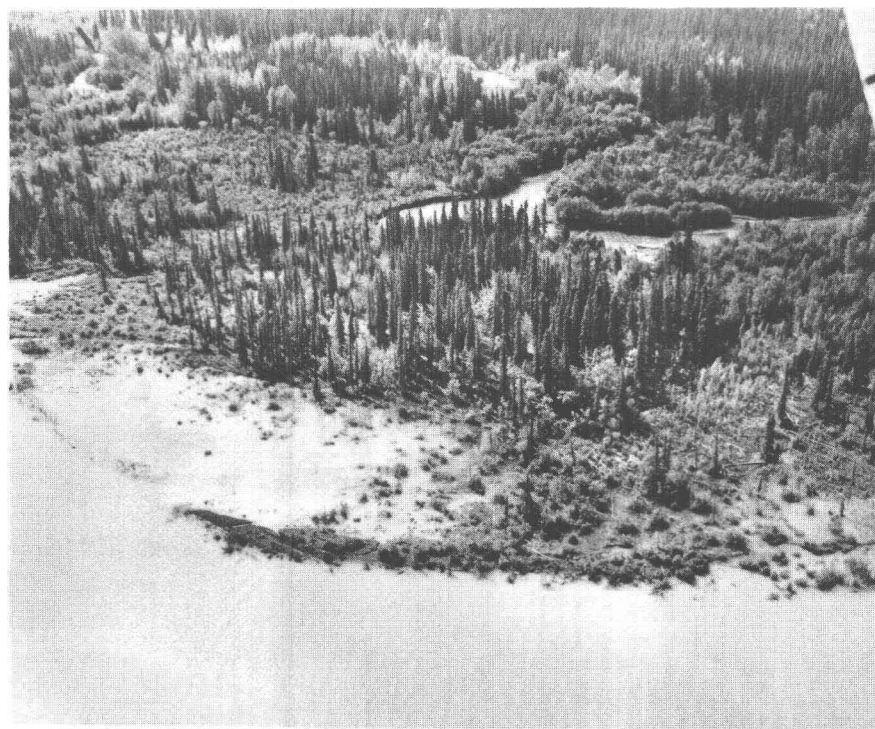
18.—View showing flooding of Kiana Creek delta along eastern shore of Tazlina Lake.

The flooded delta of Kiana Creek along the eastern shore of Tazlina Lake is shown in figure 18. Subsidence, probably caused by compaction of unconsolidated sediments, and lateral movement of materials toward the lakeshore caused flooding of the delta and the formation of numerous ground cracks. A large area along the eastern shore of Tazlina Lake just south of the Kiana Creek delta was inundated (fig. 19). This area, which is part of an old alluvial-fan delta of Kiana Creek formed when the creek was a much larger stream, was subjected to changes similar to those that occurred at the Kiana Creek delta.

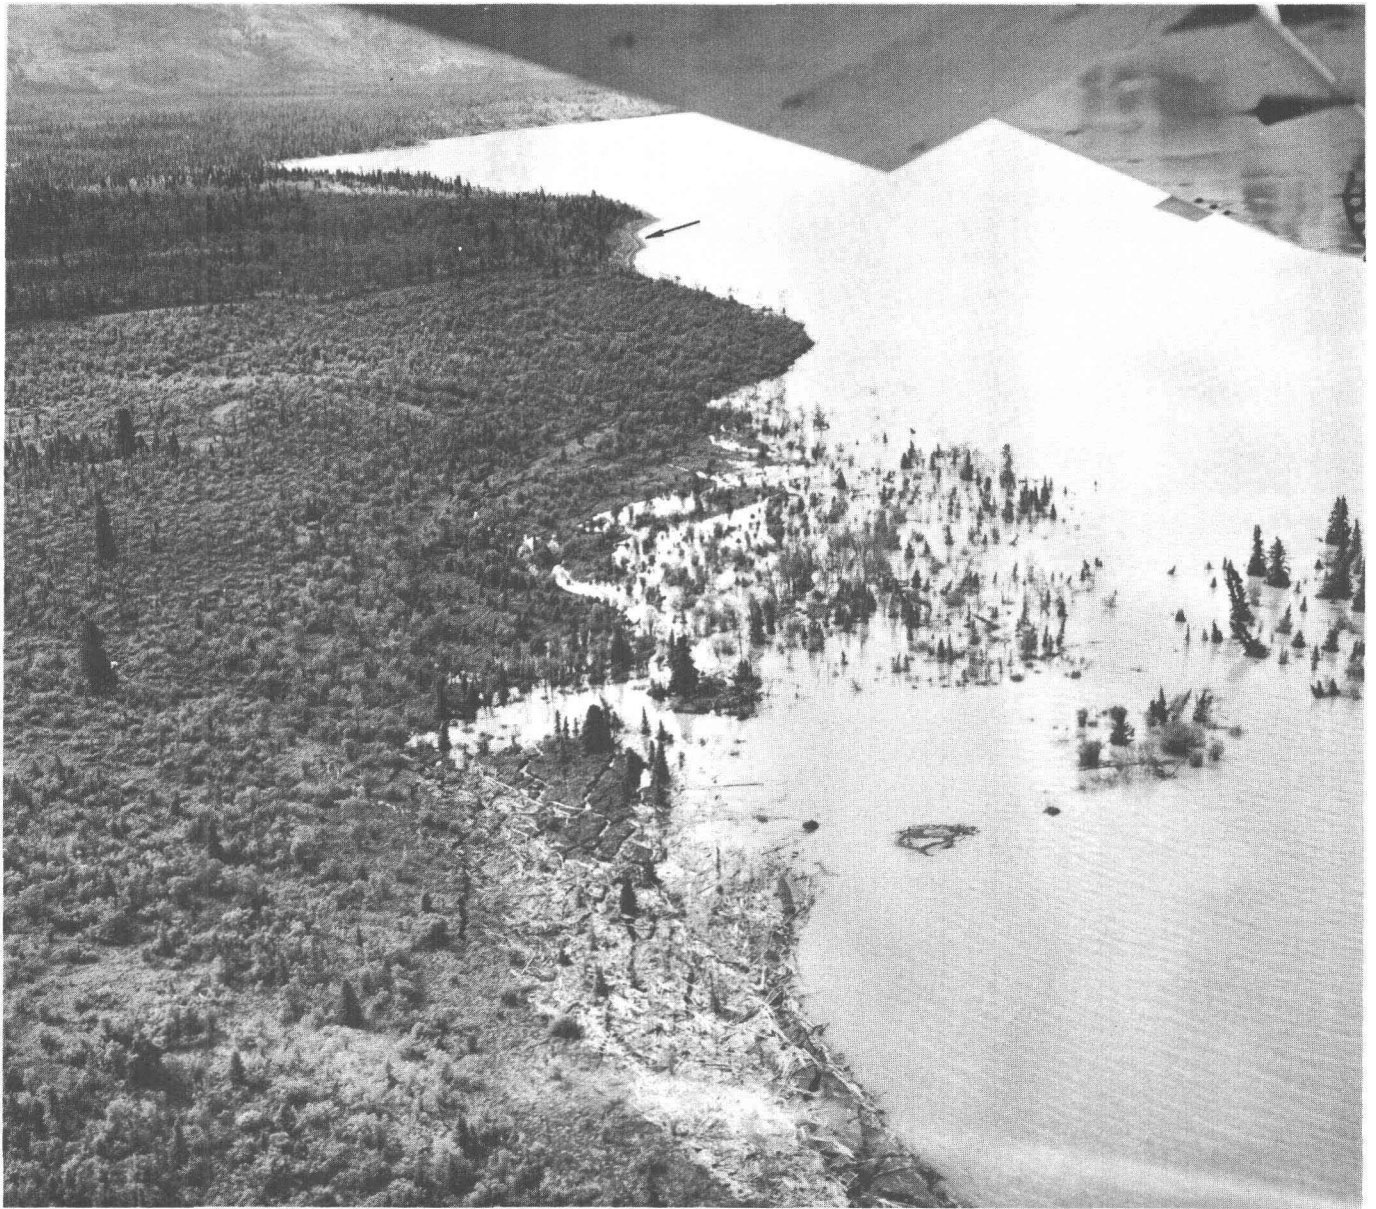
19.—Large inundated area along eastern shore of Tazlina Lake just south of the Kiana Creek delta. Lateral movement and vertical compaction of materials along lakeshore caused numerous ground cracks to form and the area to subside. Note normal beach (indicated by arrow) in the distance.

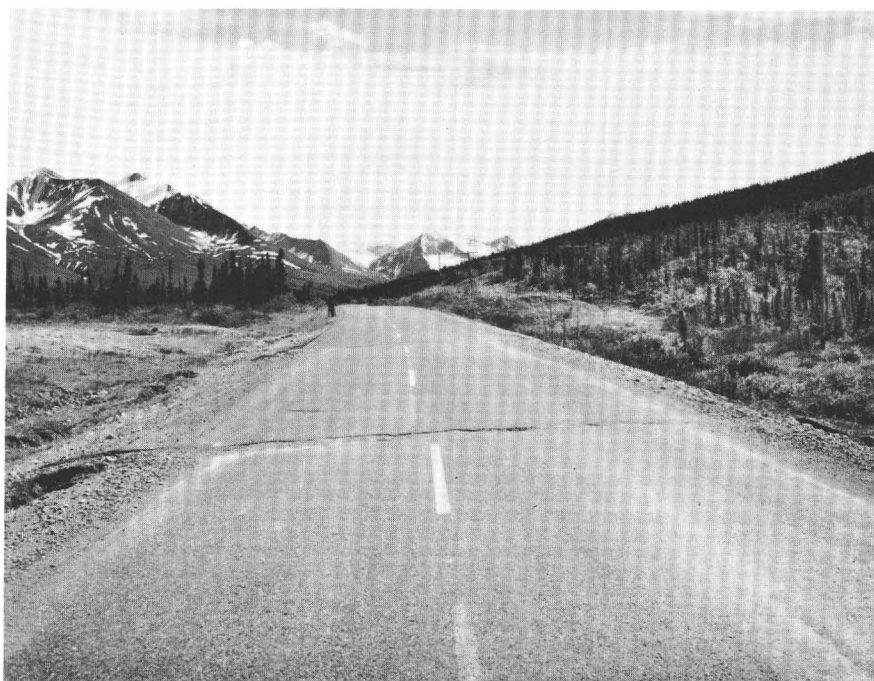
21.—View, to the southeast, showing the pavement surface of the Richardson Highway just south of the Little Tonsina River bridge at mile 65. Note the 8-inch horizontal offset of the centerline; vertical displacement is as much as 3 inches.

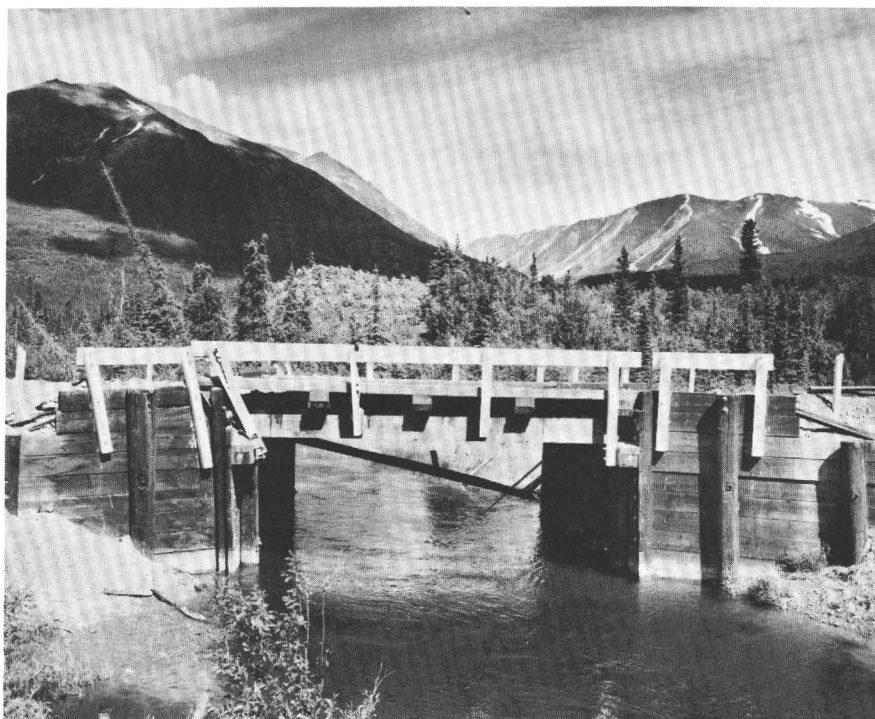
22.—Landslide movement on a hillside approximately two-tenths of a mile away caused the Little Tonsina River bridge to be shoved from the right to the left. Minor slumping occurred in road fill to the left of the bridge. Immediately after the earthquake the pavement was buckled more than 3 feet high at the left end of the bridge.

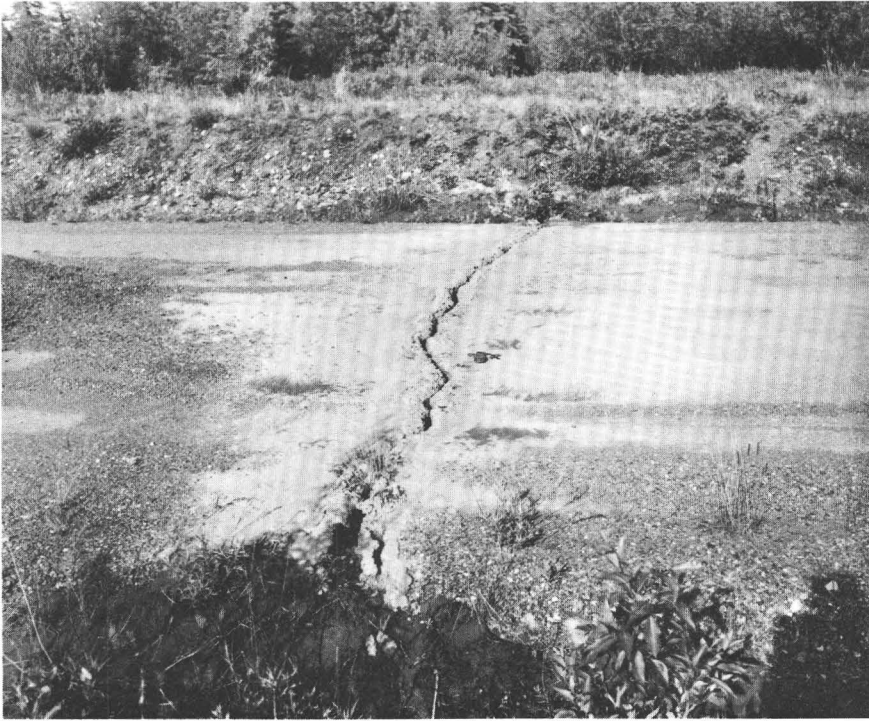
23.—Small crack across abandoned section of road on a low gravel terrace adjacent to Rock Creek at mile 86.1, Richardson Highway. Note the fine sand and silt along both sides of the crack.
