Evaluation of Acoustic Emission NDE of Composite Crew Module Service Module / Alternate Launch Abort System (CCM SM/ALAS) Test Article Failure Tests

NASA/TM-2010-216859

Failure tests of CCM SM/ALAS (Composite Crew Module Service Module / Alternate Launch Abort System) composite panels were conducted during 7/10/2008 and 7/24/2008 at LaRC. This is a report of the analysis of the Acoustic Emission (AE) data collected during those tests.

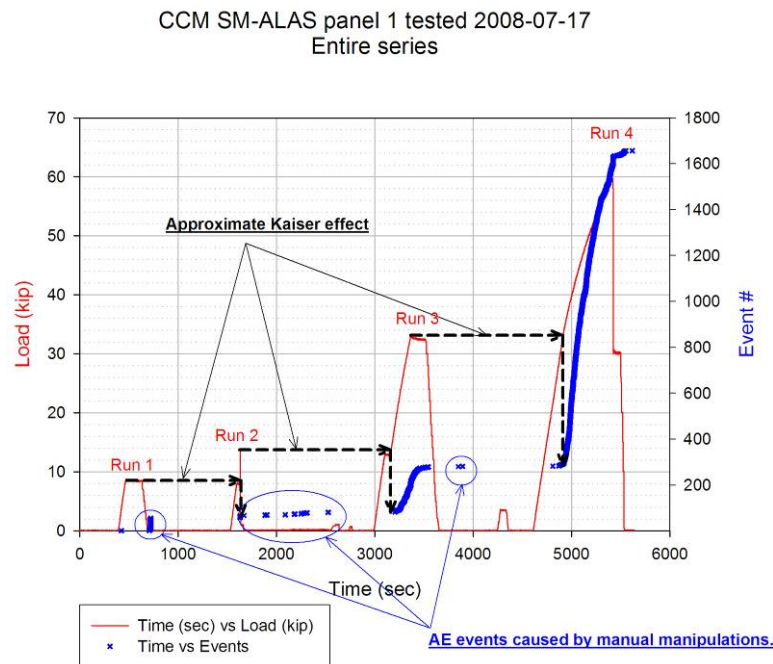
Figure 7 – Acoustic emission rate vs. load profile and Kaiser effect

The plot in figure 7 of AE events, plotted against the load profiles that panel 1 was subjected to, shows how the Kaiser effect applies to this test. The Kaiser effect is related to “conditioning” of

a material during loading. [2] It states that if no damage has occurred since a previous load cycle, then acoustic emission should not occur during a subsequent load cycle until the peak load of the previous cycle has been reached. It is primarily valid for metallic materials in which dislocation acceleration and inclusion fractures are the primary AE sources. It is only approximate for composite materials due to their more complex internal structure, which leads to more internal friction and other interferences that can occur during post-damage loading and unloading and is known as the Felicity Effect. [2] Hence, some AE may occur upon reloading at loads lower than previous peak. For this test it does indeed look like the Kaiser effect is valid for the first three load cycles. However what we see in run 4 is that the AE rate increases when the load reaches the previous peak, even though some AE was occurring prior to that.

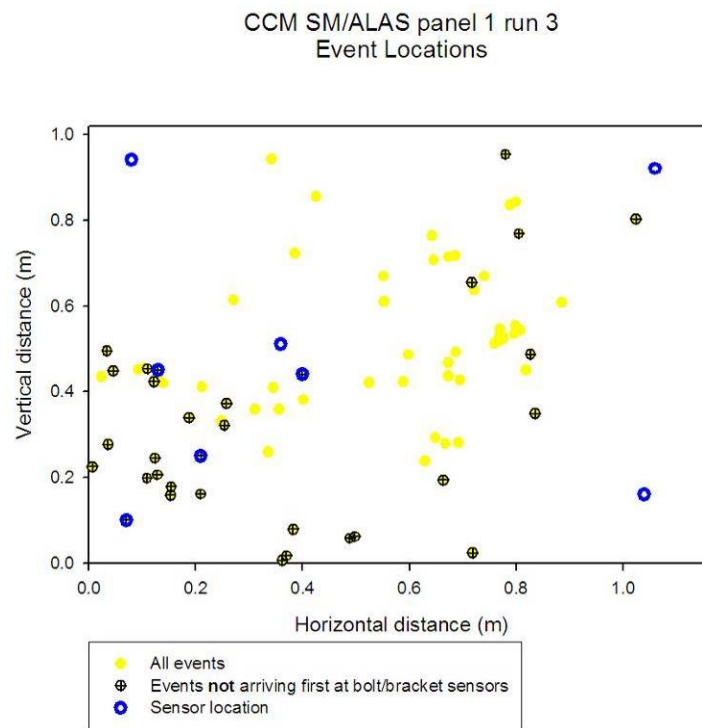
Figure 13 – Identification of bolt /bracket noise for Panel 1 Run 3

It is good to see that the central region of the panel, where the brackets attach, is relatively devoid of events that didn't arrive at the fittings first (black cross-hair). Also, the “bolt/bracket noise” events (yellow) do cluster around the fixture location especially near the end of the fitting where the panel tapers. However, it is noted that there are “bolt/bracket noise” events (yellow) that are located away from the bolt/bracket region and “non-bolt/bracket noise” ones (black) that are located in the bolt/bracket region. This is believed to be due to potential errors in the location calculations that result from difficulty in identifying the first arrival of small signals (i.e. poor signal to noise effects).

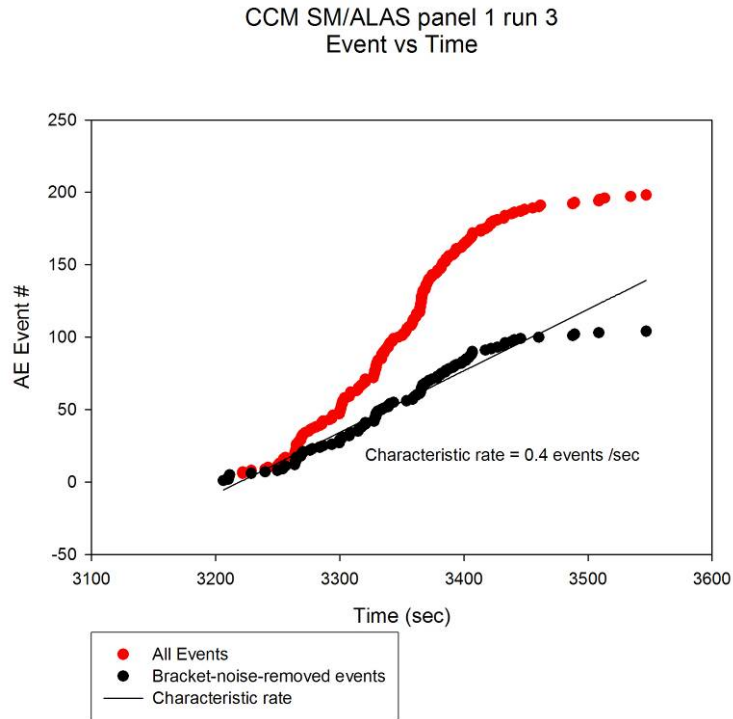
Figure 15 – Investigation of characteristic AE rate: panel 1 run 3

It is assumed that most of the loading of panel 1 went to deformation of the bracket and damage around the bracket bolts. If these events are removed by deleting those that have first arrivals at a bolt/bracket sensor, an AE rate characteristic of composite noise under load without bracket mounting damage can be estimated from the remaining plotted events. In figures 15 and 16, one can see that there is a difference in the “characteristic” rates from run 3 compared to run 4 with run 4 having a higher rate. Many of the events of run 4 occur at higher loads (see figure 7) than run 3, so, one could expect that the higher AE rate of run 4 events are more likely to include composite damage events. Conversely, the 0.4 events/second rate of run 3 is possibly related to internal friction. This rate will be compared to the rates from the panel 2 tests later.

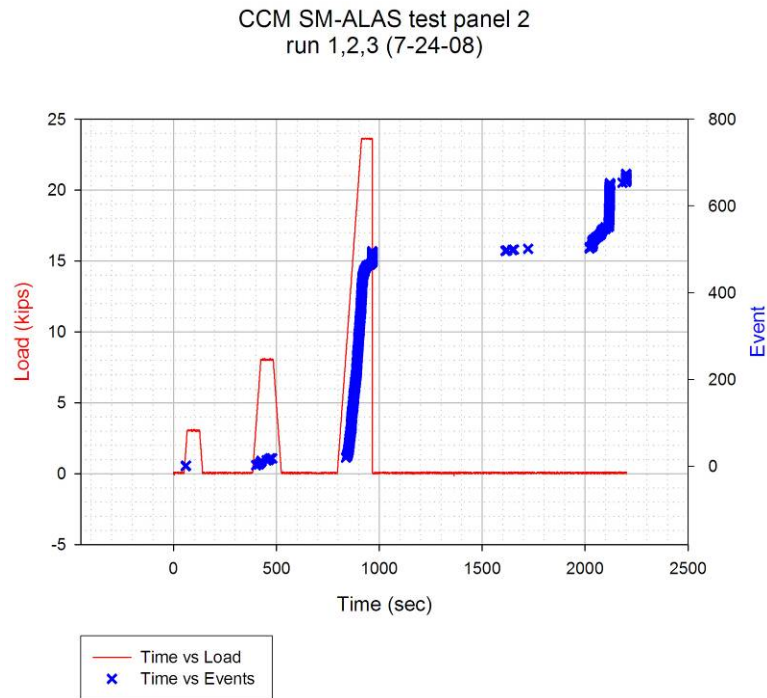
Figure 19 – Acoustic emission rate vs. load profile for panel 2 runs 1-3

In the following figures 19 and 20 are plots of AE events times plotted against the load profile. The data was not collected in one file as it had been for panel 1. Data acquisition was stopped after run 3 to relocate sensor 6, because there seemed to be substantial AE in the lower portion of the panel. Also, panel 2 did not have bracket failure as did panel 1. Runs 1 and 2 had 2 and 17 events respectively and are not analyzed in depth although the Kaiser effect is noted between runs 1, 2 and 3 as seen in figures 21 and 22. For this panel the “panel” sensors (1, 2, 3, 4, 6, 8) were amplified with a higher gain (54 dB gain) than the “non-panel” sensors (5, 7 @ 42 dB gain). Before relocation of sensor 6 the trigger gain was at 23 dB, but a runaway trigger occurred about halfway through the load hold of run 4 (due to the higher amplitude of the events arriving at sensor 6) so the trigger gain was dropped by 3 dB to 20 dB @ approx. 104 sec during run 4. Changes to trigger gain will affect the number of events that are recorded but not the amplitudes of those events. Due to the Kaiser effect, events in run 4 and 5 are less likely to be damage

events since run 3 had “preconditioned” this panel with a peak load of 24 kips, whereas 4 and 5 only went to 8 and 14 kips respectively.

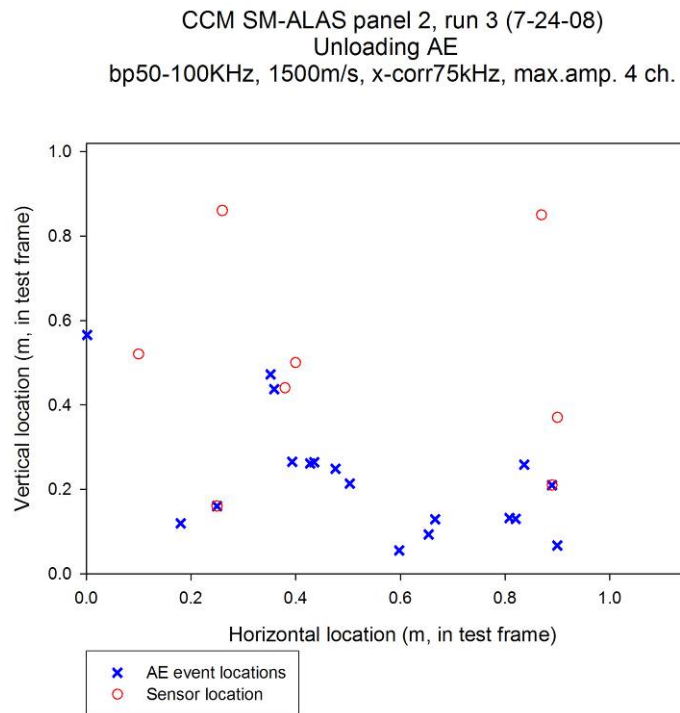
Figure 28 – Locations of unloading events for panel 2 run 3

The source locations of these unloading events were calculated and are plotted in figures 28 and 29. The figures are 2D side views of the test panel in the test fixture with the same perspective as seen in figures 5, 17, and 30.

Note that the locations definitely cluster in the lower half of the panel. Figure 30 shows a postmortem C-scan of panel 2 and as noted in the cut plan for destructively examining the panel “white areas in the scan are where the threshold was not exceeded, meaning essentially no sound is coupled through the panel.” [3] That means that either delamination in the composite or debonding of skin in the regions of honeycomb core had occurred. Most of the lower half of the panel has that damage. It is very likely that internal friction of the damage contributed to the unloading events. This indicates that the damage was present prior to the unloading of run 3. The large number of events during loading in run 3 could indicate the occurrence of the damage, although as seen in later plots locations of the events do not definitively highlight the damage regions. However, that could be due to the fact that the damage covers almost 75% of the panel.

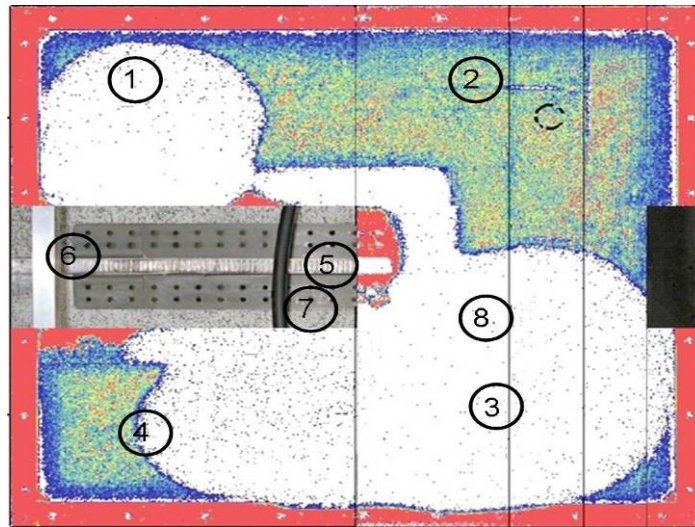
Figure 30 – Post-mortem c-scan of panel 2 showing large area of delamination (white region) of skin from core

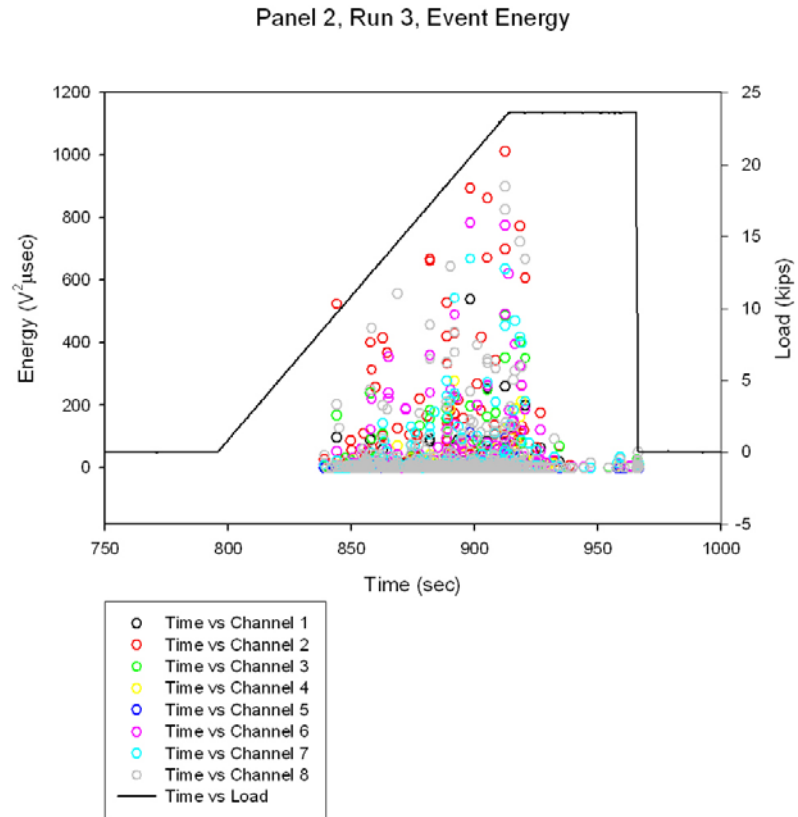
Figure 33 – Calculated energy of each AE event plotted by channel (sensor) and time for panel 2 run 3

One can see in figure 33 of the event energy for run 3 the peak energies are at least an order of magnitude larger than any of the other runs for panel 2. Also one sees energy increases with time during loading, until the load hold starts at approximately 920 seconds. This increase can be indicative of damage development because of increasing energy release during loading.

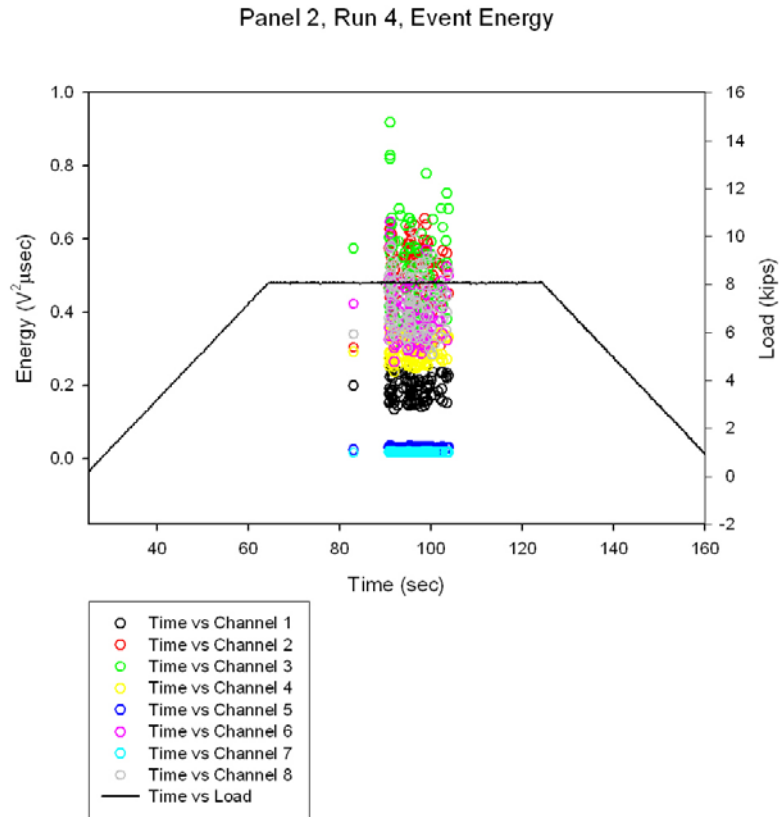
Figure 34 – Calculated energy of each AE event plotted by channel (sensor) and time for panel 2 run 4

It was previously noted that events during run 4 were unlikely to be damage events due to the Kaiser effect. The energy plot for those events as seen in figure 34 also supports this. During the run 4, as noted previously, runaway triggering was occurring and the trigger gain was reduced toward the end of the run to alleviate that. The very low values of energy, at least two orders of magnitude less than runs 5 and 3, support the concept of non-damaging sources. The results also show distinct segregation by channel into energy bands which would also imply a single repeating non-damaging source of constant amplitude, because the distance traveled from a single source to sensor and hence the attenuation would be the same for every event arriving at a particular sensor.

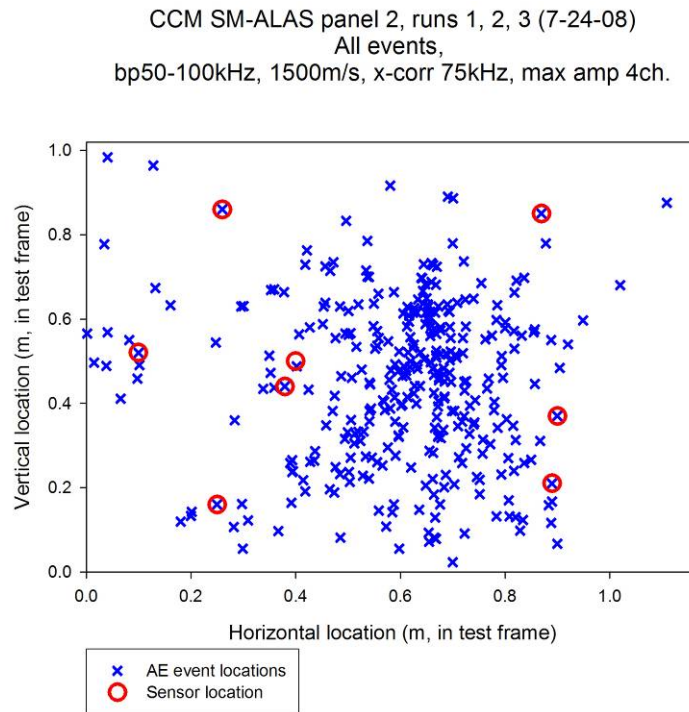
Figure 36 – Combined plot of event locations for runs 1-3

Because of the small number of low energy events for runs 1 and 2 the location of all the events for runs 1, 2, and 3 are plotted together in Figure 36. The figure is a 2D side view of the test panel in the test fixture with the same perspective as seen in figures 5, 17, and 30.

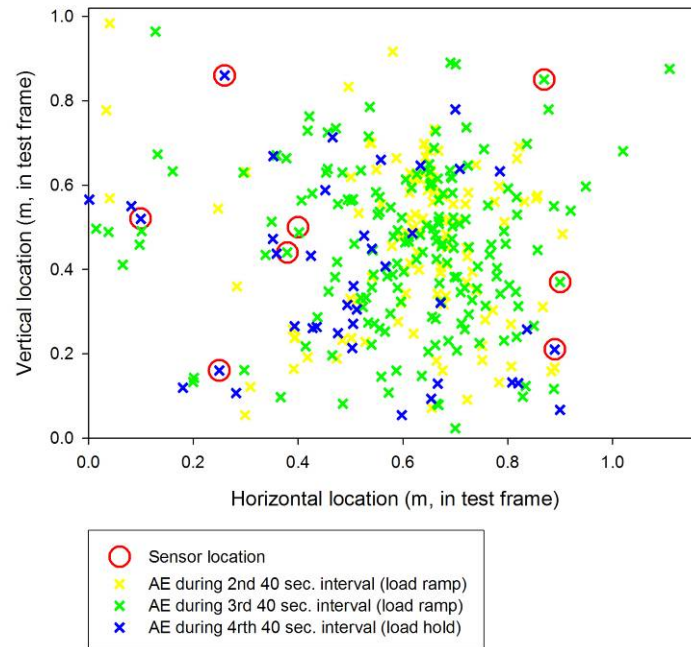
Figure 37 – Time and location plot of events for run 3

Run 3 had the largest number of events of all the runs and they were spread over most of the load profile. It was felt that indicating the time and location of the event may provide some information concerning the damage development. Figure 37 shows the location plot that has the events colored to indicate what portion of the load profile it occurred in. The profile was divided approximately into quarters, as seen in Figure 38, with the first quarter containing essentially no events and the last quarter containing the load hold and unloading events. The scattering is broad but it does look like the events tended to occur near the right half of the panel schematic earlier in the test and moved toward the left and down with time.

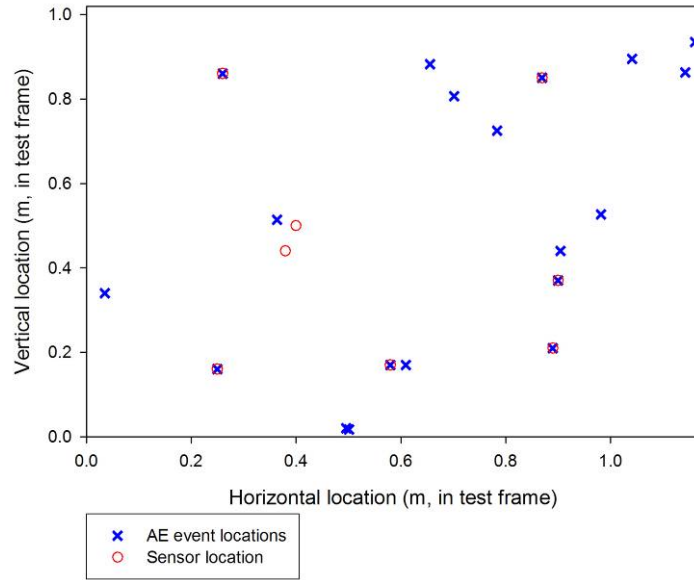
Figure 39 – Event location plot for run 4

It was suggested previously that the events from run 4 are likely to be from a single non-damaging source. However, the location calculations as seen in figure 39 are scattered with approximately 40% of all the event locations either not calculable or located well outside the frame. This is most likely due to the low energy levels making it difficult to calculate the signal time arrival at each sensor.

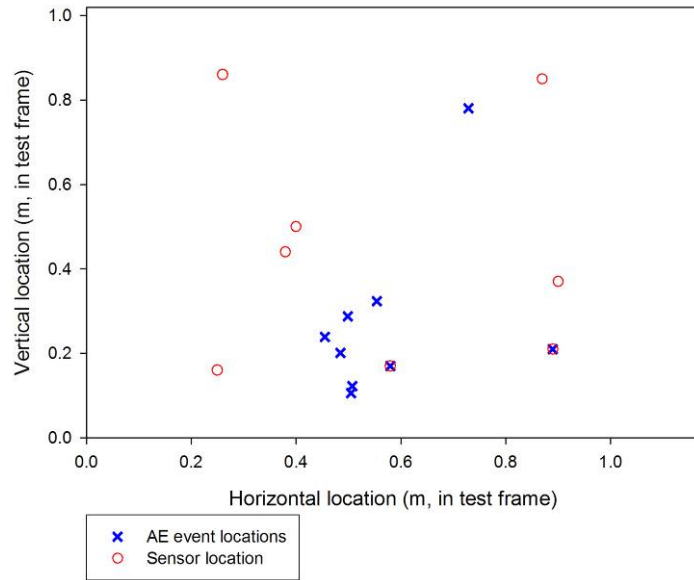
Figure 40 –Event location plot for run 5

The events of run 5 cluster in the bottom half of the panel toward the center as seen in figure 40. This correlates reasonably well with the location of the later events in runs 1-3.

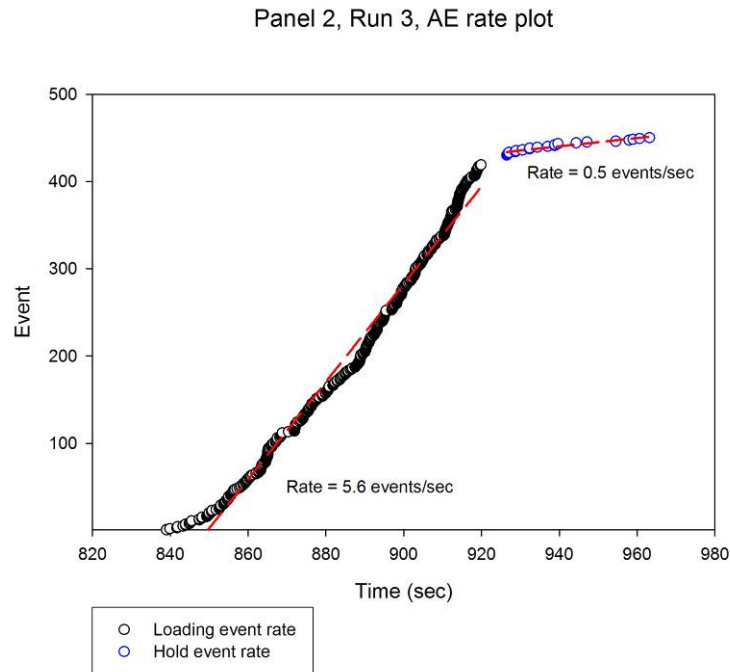
Figure 41 –Event rates for run3

In figures 41 and 42 are plotted the event rates for panel 2 runs 3 and 4. Comparing these to the rate from panel 1 (0.4 events/second), only the AE occurring during the load hold of run 3 is comparable. The AE rates during loading for both runs 3 and 4 are an order of magnitude higher. It might be suggested that run 3 was damage and the slightly higher rate of run 4 was also damage, but, as noted previously, the energy and location results suggest otherwise for run 4.
