Railroad Accident Report

**Collision of Two Canadian National/Illinois
Central Railway Trains
Near Clarkston, Michigan
November 15, 2001**

**NTSB/RAR-02/04
PB2002-916304
Notation 7508
Adopted November 19, 2002**

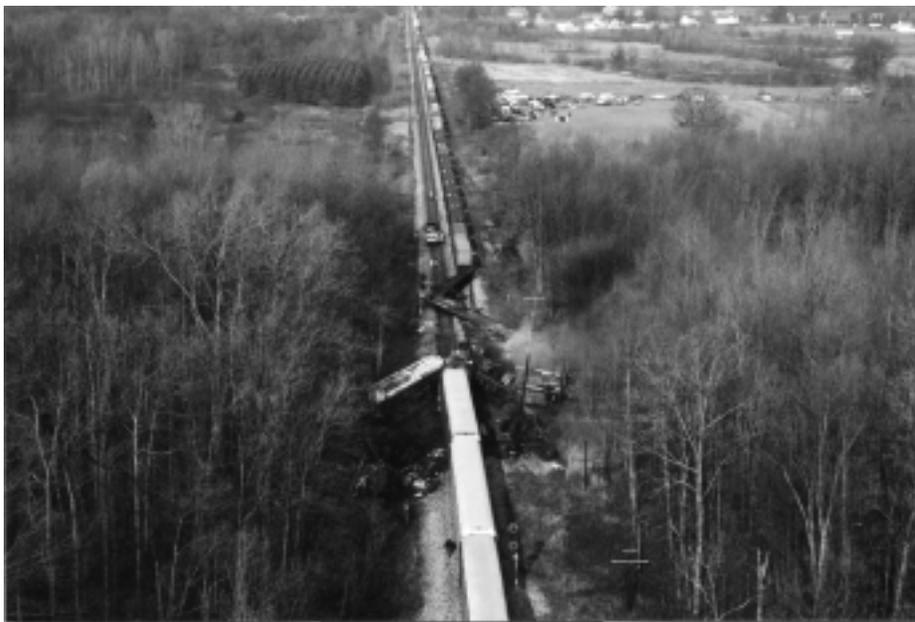
Figure 1. Accident aftermath. (Train 243 is at the bottom of the picture and train 533 is at the top of the picture.)

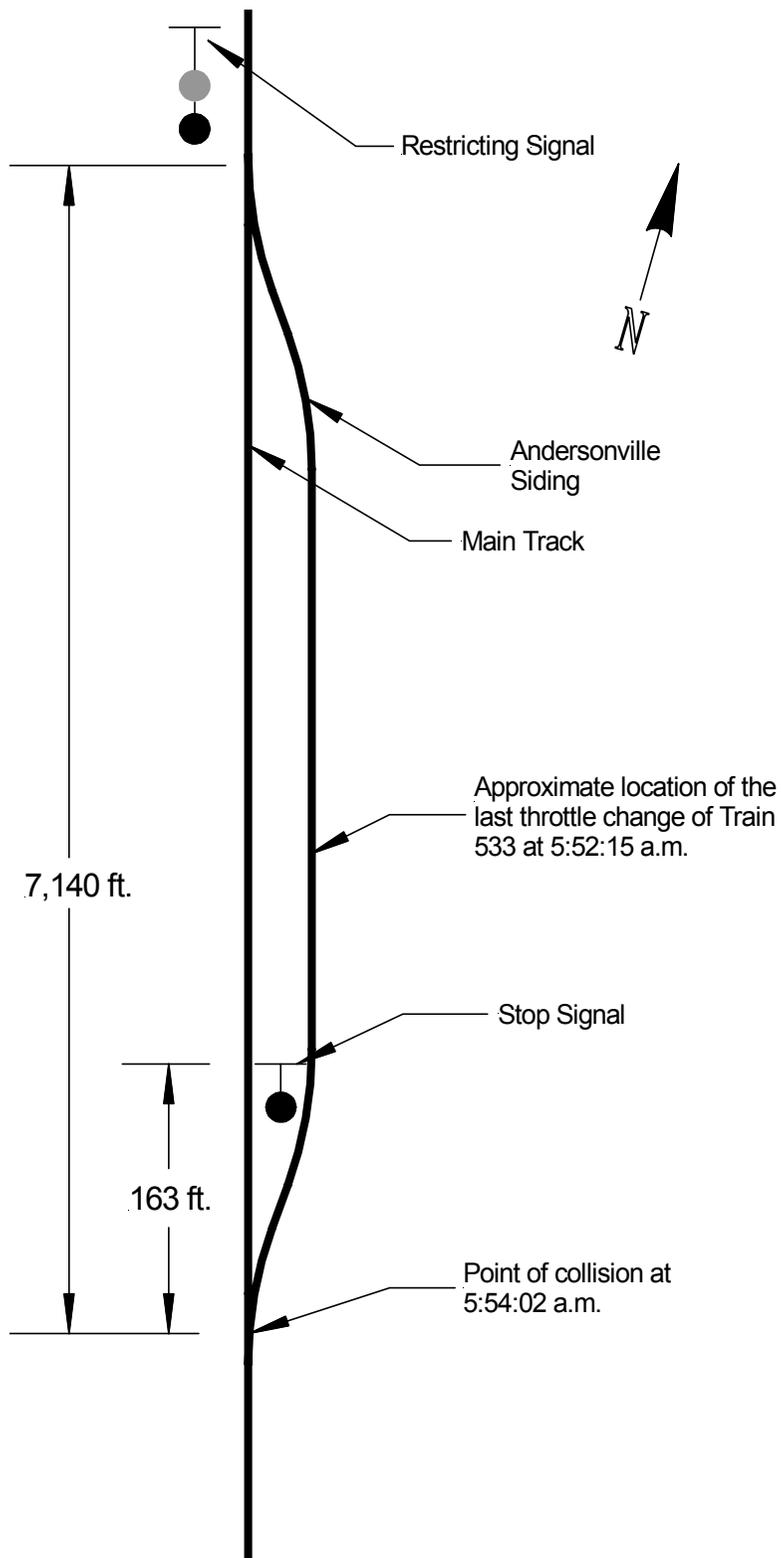
No evidence was found that the train 533 engineer made any control maneuvers in response to the stop indication, such as applying the brakes, during the last 2 minutes before the accident.⁴ The engineer told investigators that he had had no conversations with the conductor during their trip up to and through the Andersonville siding; and there is no evidence that the conductor attempted to activate the emergency brakes to stop the train.⁵

Figure 2. Diagram of the main track and Andersonville siding, showing the approximate locations of the last throttle change for train 533 and the point of collision, based on the estimated times provided by event recorder data.
