# Special Investigation Report on the Safety of Parachute Jump Operations

NTSB/SIR-08/01  
PB2009-917001

## Special Investigation Report on the Safety of Parachute Jump Operations

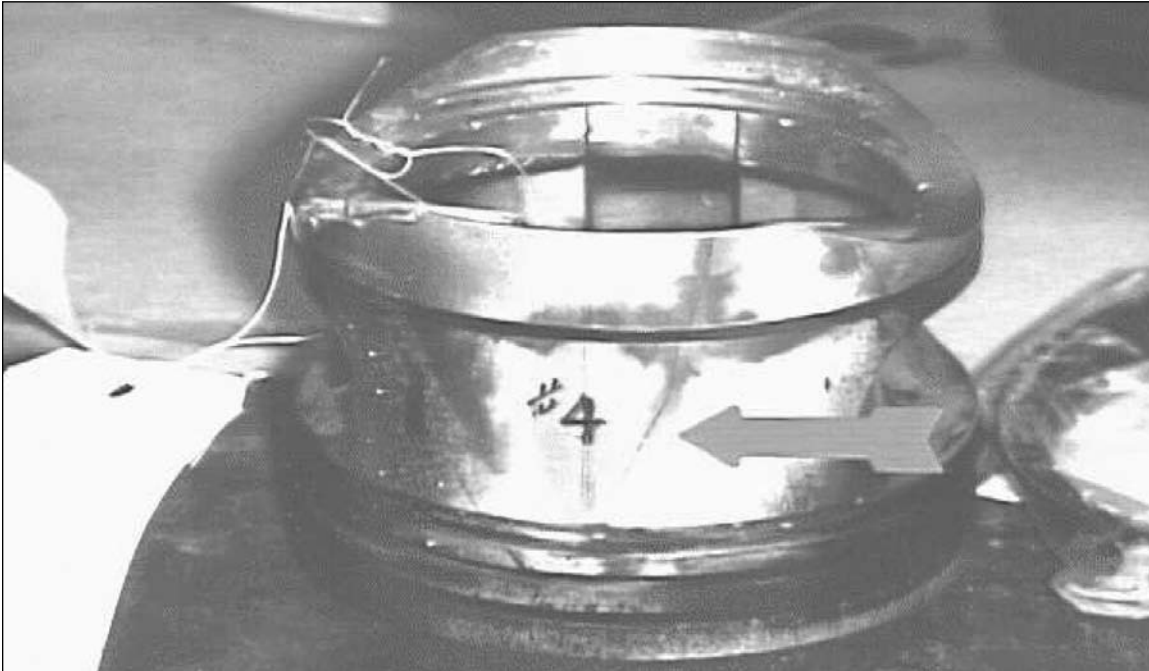
Two of these airplanes crashed following a loss of engine power. On August 14, 1993, a Cessna 182A lost engine power during takeoff and crashed in East Moriches, New York. The investigation found that inadequate piston manufacturing (all were of the same design and part number and were not manufactured by the original engine manufacturer<sup>5</sup>) resulted in fatigue cracking in the skirts of all six pistons. (See figure 1 on page 8.)

**Figure 1.** Cracking (visibility enhanced during examination with a liquid penetrant) on the No. 4 piston skirt from the East Moriches, New York, accident airplane.

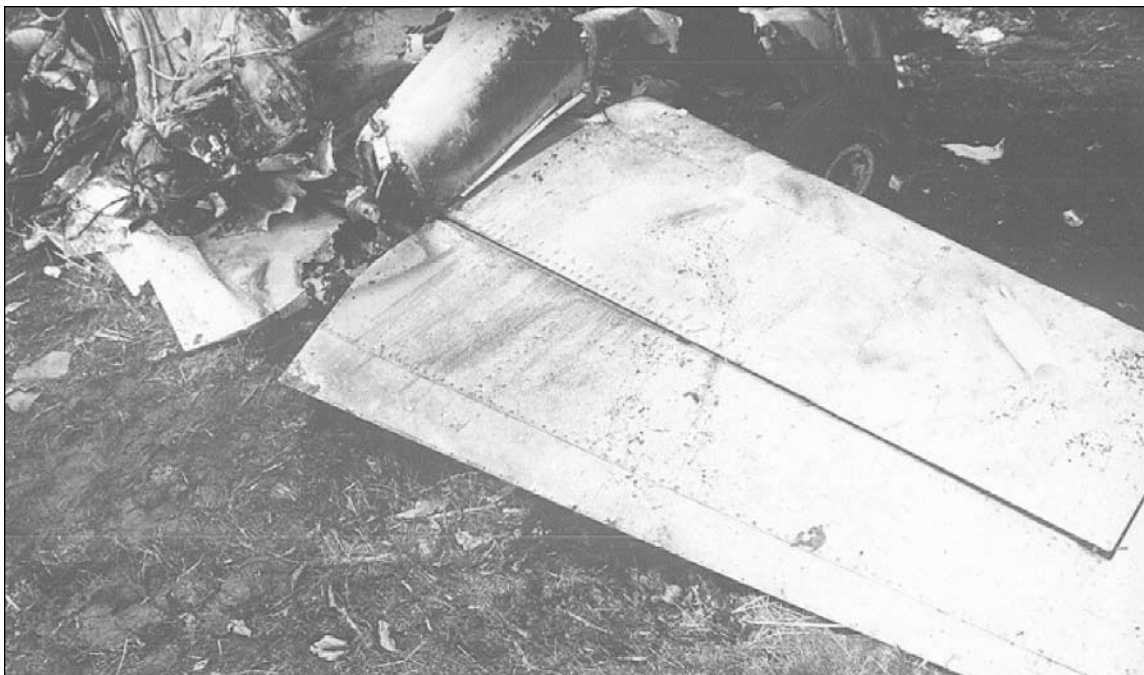
**Figure 2.** Engine oil coating the underside of the horizontal stabilizer on the Grain Valley, Missouri, accident airplane.

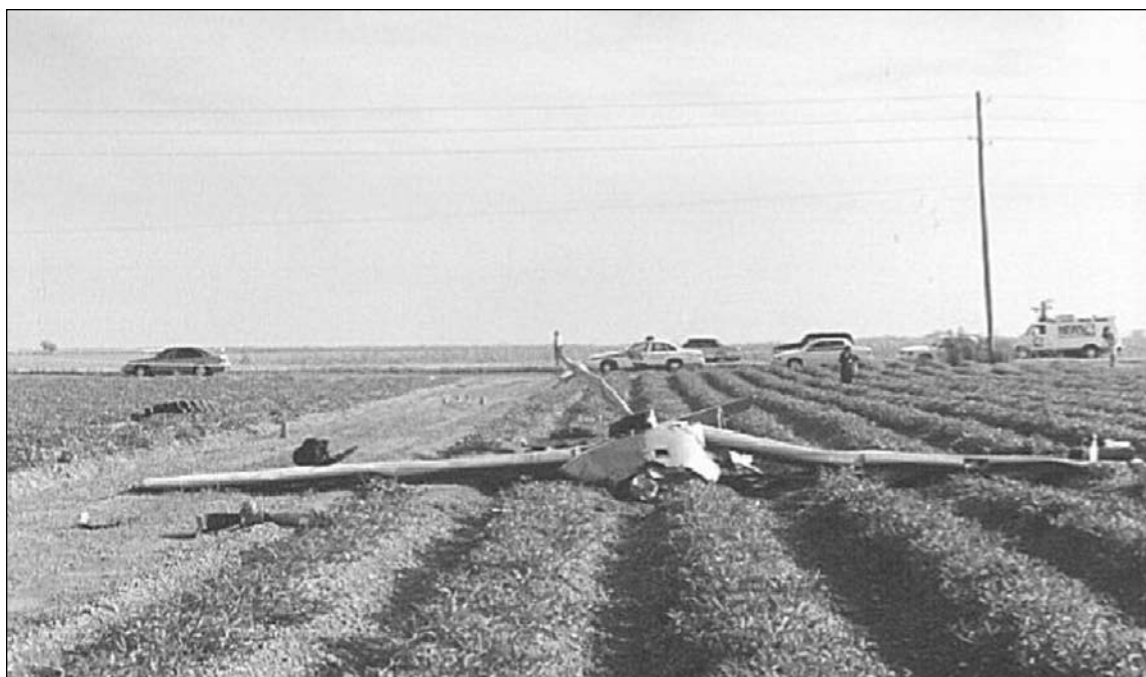
The pilot of the Cessna 205 that crashed May 25, 1997, in Homestead, Florida, had leveled the airplane at 3,500 feet and slowed it with the intent of allowing one parachutist to jump from the airplane before transporting the other parachutists on board to higher altitudes. As the first parachutist prepared to jump from the airplane, the airplane's left wing and nose dropped, and it entered a spin to the left. The airplane descended to the ground, and the pilot and five parachutists were killed; the parachutist who egressed at 3,500 feet survived. The investigation found that the commercial pilot failed to maintain airspeed as he slowed the airplane for the first parachutist's jump and that he failed to apply spin recovery emergency procedures. (See figure 3 below.)

**Figure 3.** Wreckage of the Homestead, Florida, accident airplane.

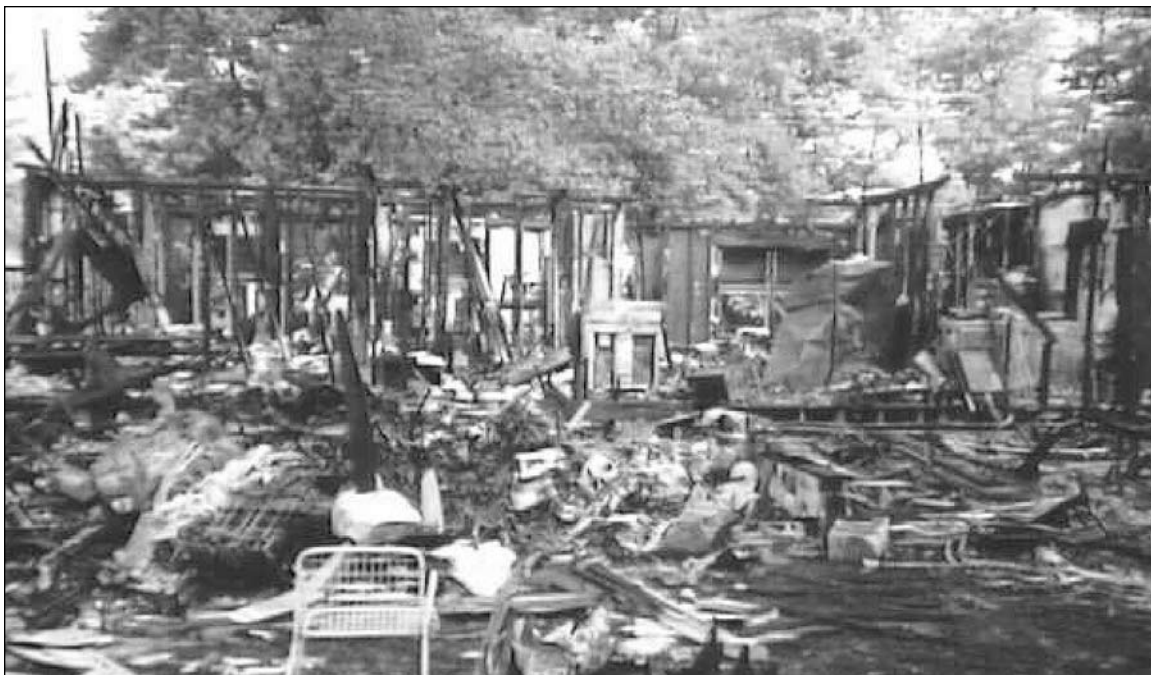
The investigation of the September 10, 1995, accident in West Point, Virginia, involving a Beech 65 that crashed following a loss of power in one engine on takeoff for undetermined reasons,<sup>15</sup> killing the pilot, 10 parachutists, and 1 person in a house (see figure 4 below), revealed that the airplane's cabin seats had been removed, but maintenance records did not indicate when. Further, the maintenance records did not contain recalculated weight and balance information to correspond with other modifications (the accident airplane was loaded over its maximum gross weight and beyond its aft cg limit at the time that it crashed).

**Figure 4.** Remains of the house impacted by the West Point, Virginia, accident airplane.
