NATIONAL TRANSPORTATION SAFETY BOARD

RAILROAD ACCIDENT REPORT

**COLLISION OF WASHINGTON METROPOLITAN
AREA TRANSIT AUTHORITY TRAIN T-111 WITH
STANDING TRAIN AT SHADY GROVE PASSENGER
STATION, GAITHERSBURG, MARYLAND
JANUARY 6, 1996**

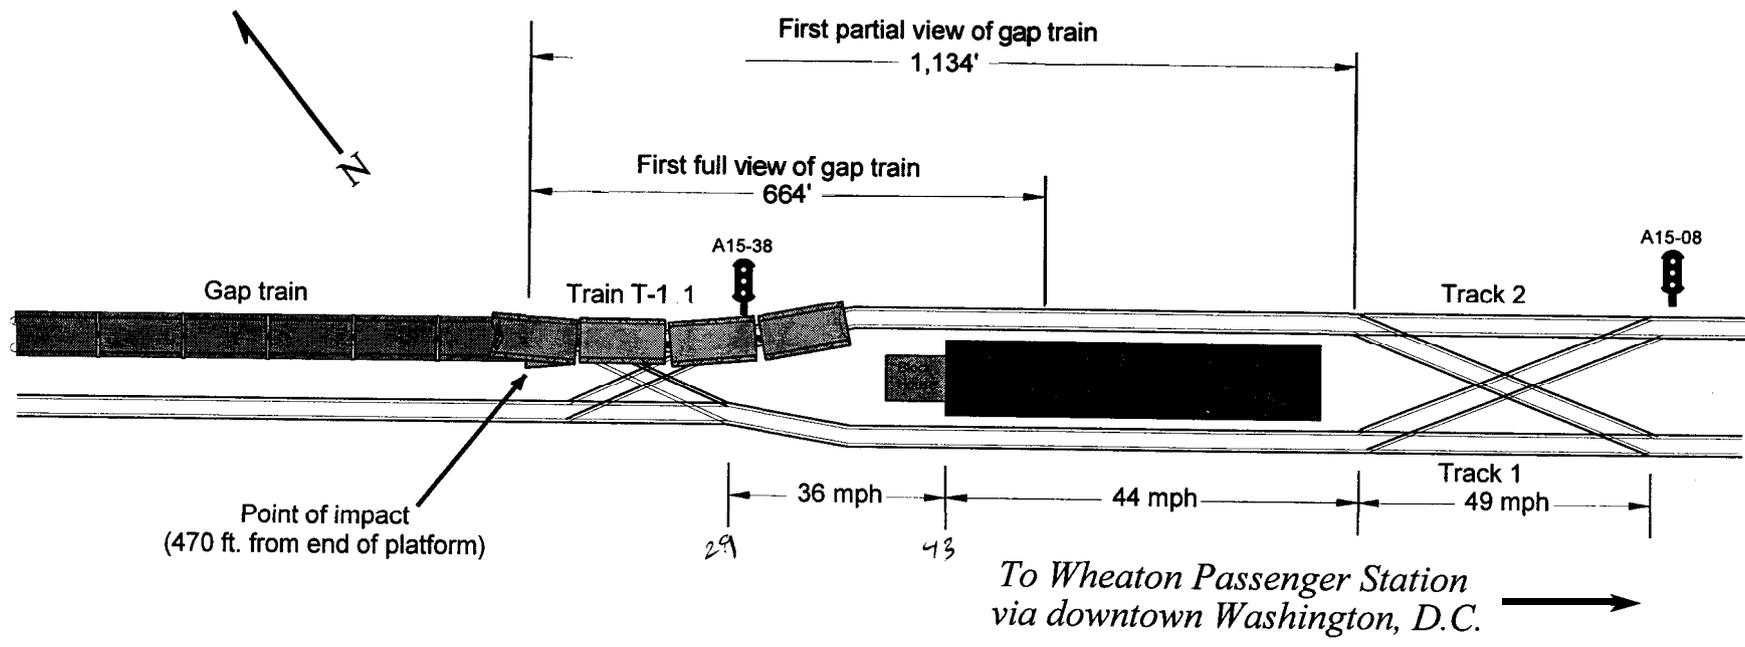
Figure 4 – Accident site (not to scale). Speeds shown are calculated average speeds of train T-111 between the points indicated.

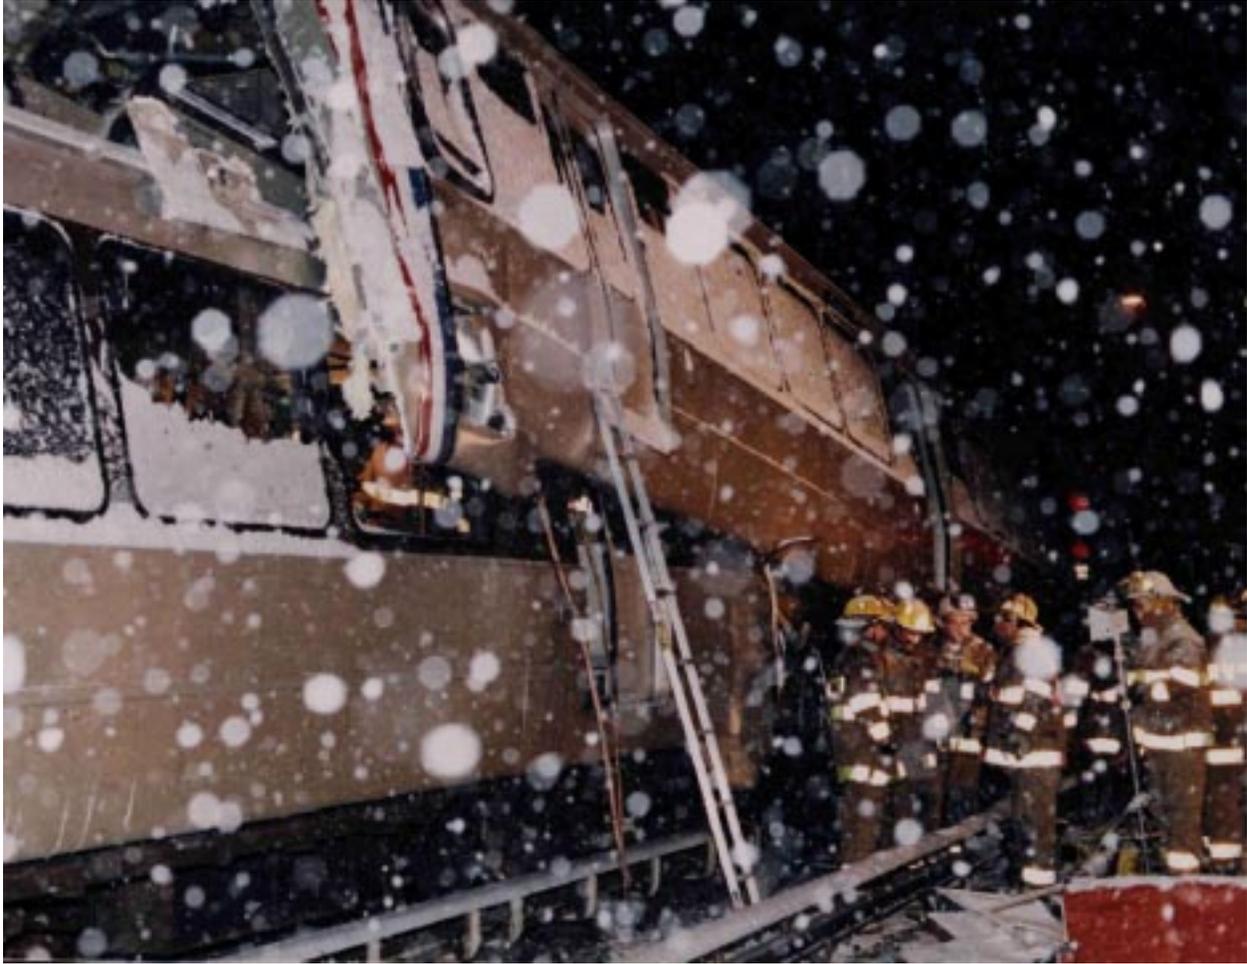
Car 3252, the lead car of train T-111, sustained the most extensive damage. The shell of the car became partially disengaged from the frame and came to rest partially on top of the lead car of the gap train. (See figure 5.) The fiberglass end cowl of the car was pushed inside the carbody, and the end underframe assembly moved rearward¹⁰ as a unit, collapsing several of the transverse beams aft of the unit, buckling the floor, and upsetting passenger seats. The

Figure 5 – Final position of accident trains. Gap train (left) has telescoped 21 feet into the shell of train T-111

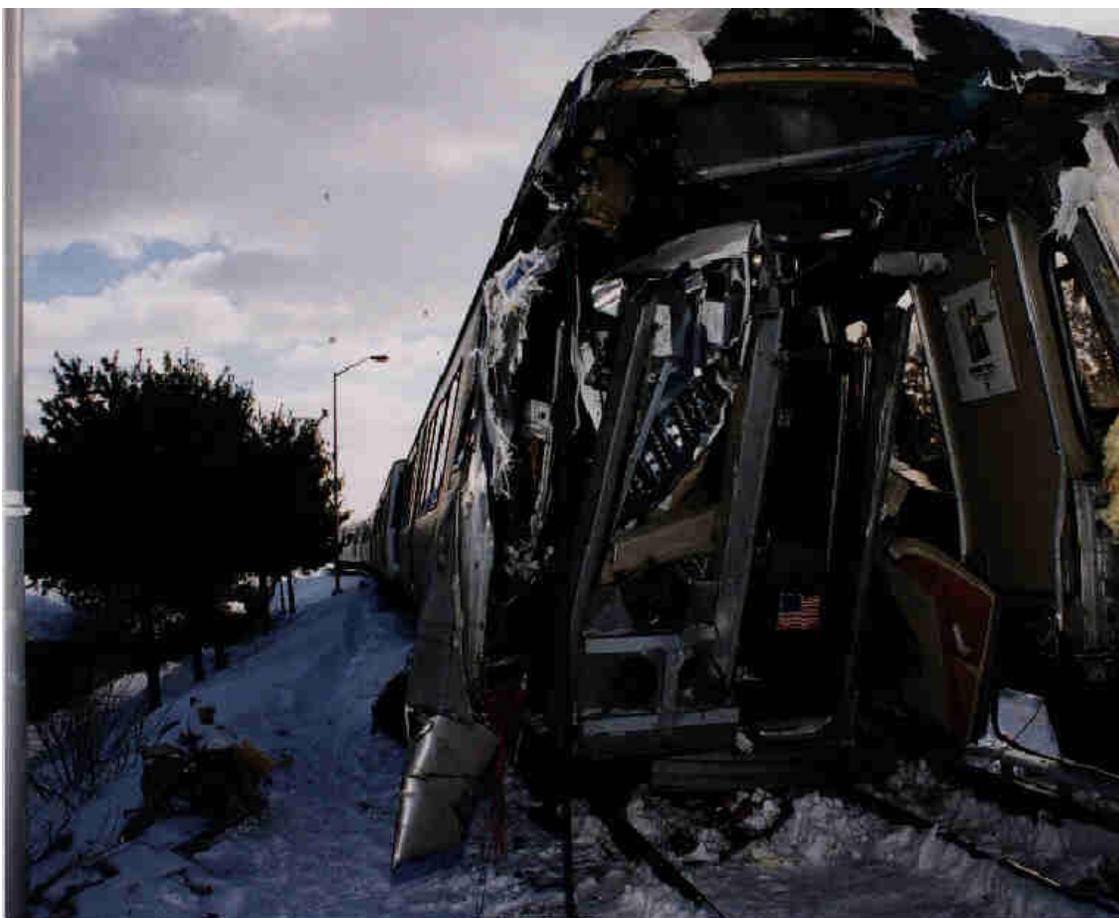
Figure 6 – Head end of train T-111

operator's compartment was completely crushed. (See figure 6.)

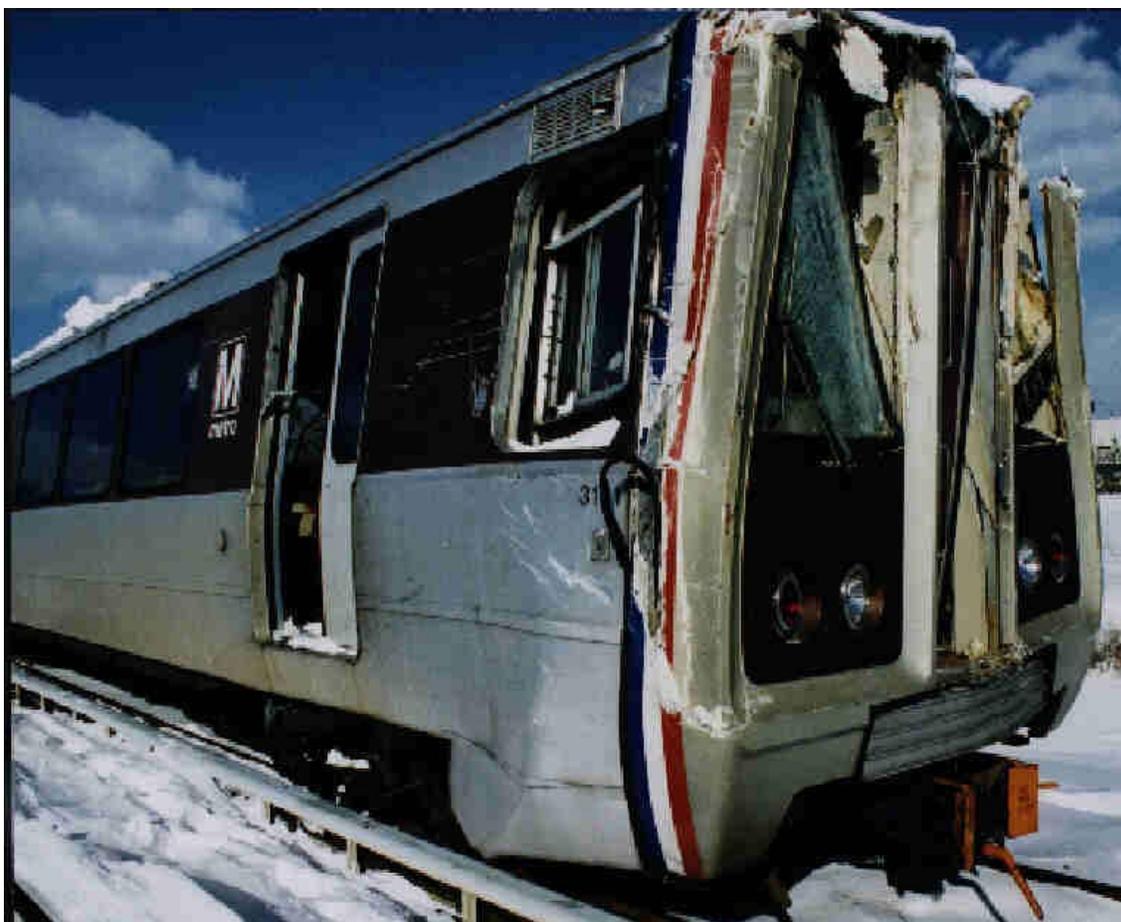
Car 3191, the lead car of the gap train, sustained a uniform crush of approximately 10 inches across the front of the car at frame level (figure 7) and telescoped approximately 21 feet into the lead car of train T-111. The fiberglass cowl sustained cracking and other damage but remained relatively intact and attached to the shell of the body. The operator's compartment and interior of the car received relatively minor damage.

Figure 7 -- Head end (struck end) of gap train

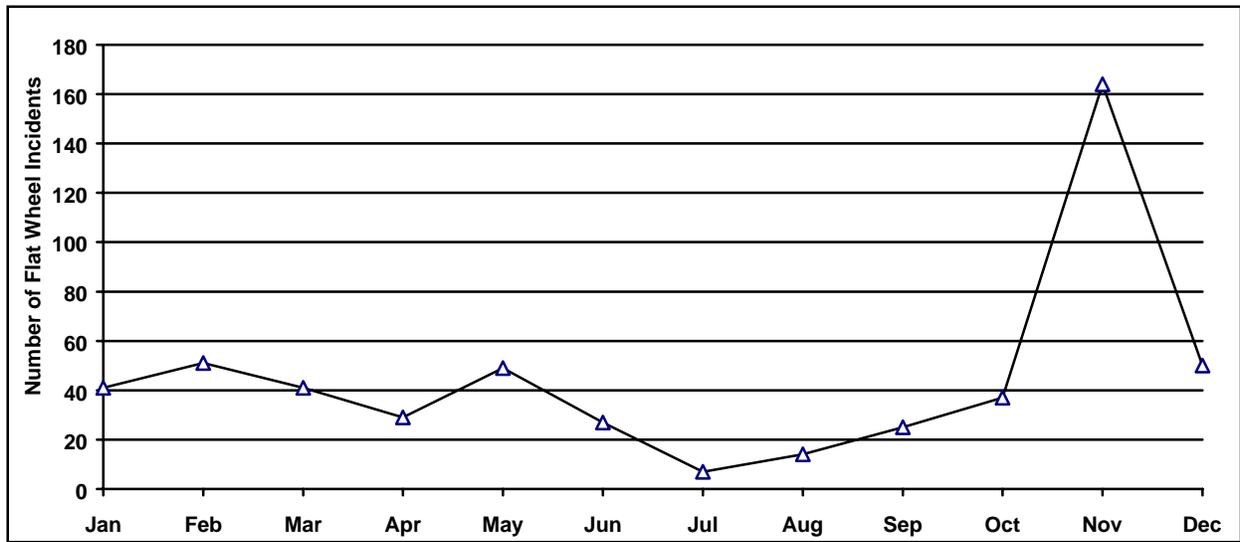
Figure 10 – Flat wheel incidents occurring in 1995 and resulting in multiple wheel flats. Source: Metrorail maintenance and reliability system (MARS) significant incident report provided at Safety Board request.

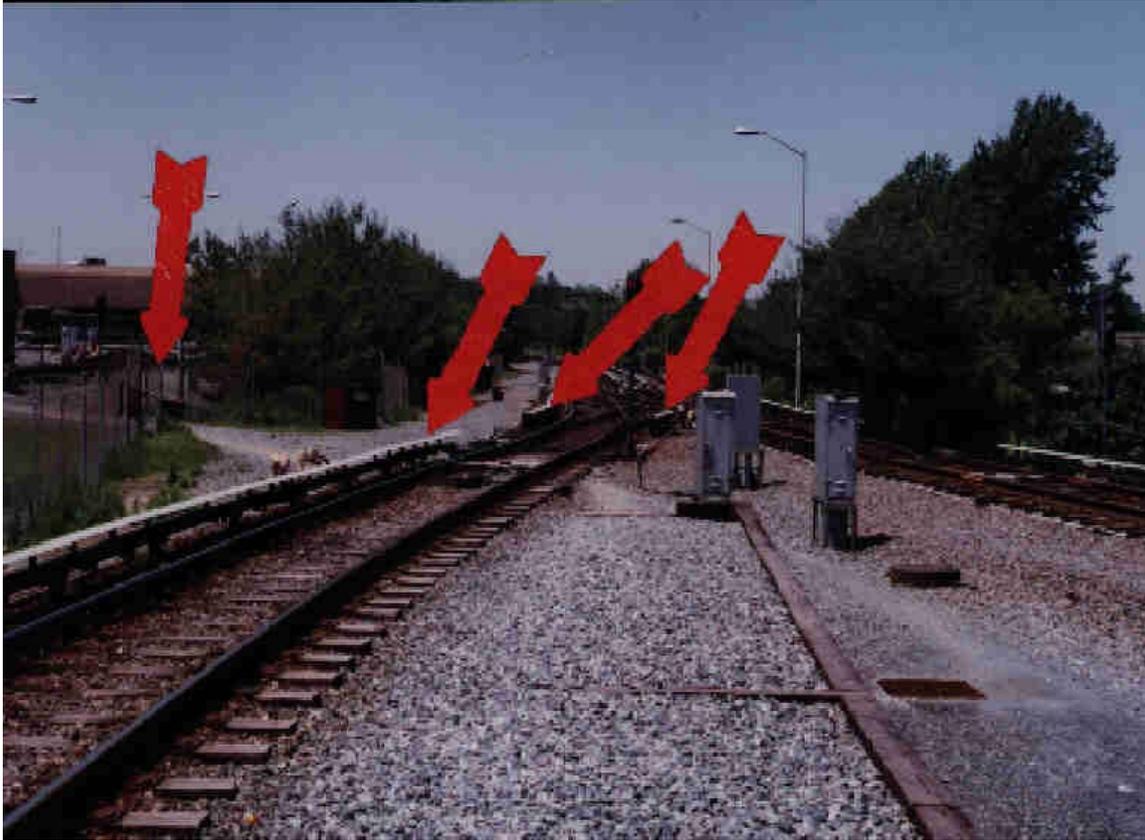
Figure 11 -- Looking north toward the interlocking just north of the Shady Grove passenger station. Arrows at center indicate portions of third rail that remained energized for approximately 40 minutes after the accident. Arrow at left indicates property security gate through which rescue workers entered the track bed.

According to interviews with firefighters, rescue operations were curtailed when it was found that a portion of the third rail in the accident area remained energized. (See figure 11.) Since this section of rail lay in an area where it could pose a potential hazard to firefighters, the officer in charge of rescue operations ordered all rescue workers out of the track bed except those working inside the train. The officer stated that at that time he was aware that two passengers were aboard train T-111. After determining that they were not injured, he purposely delayed their egress until the third rail could be confirmed to be deenergized. He added

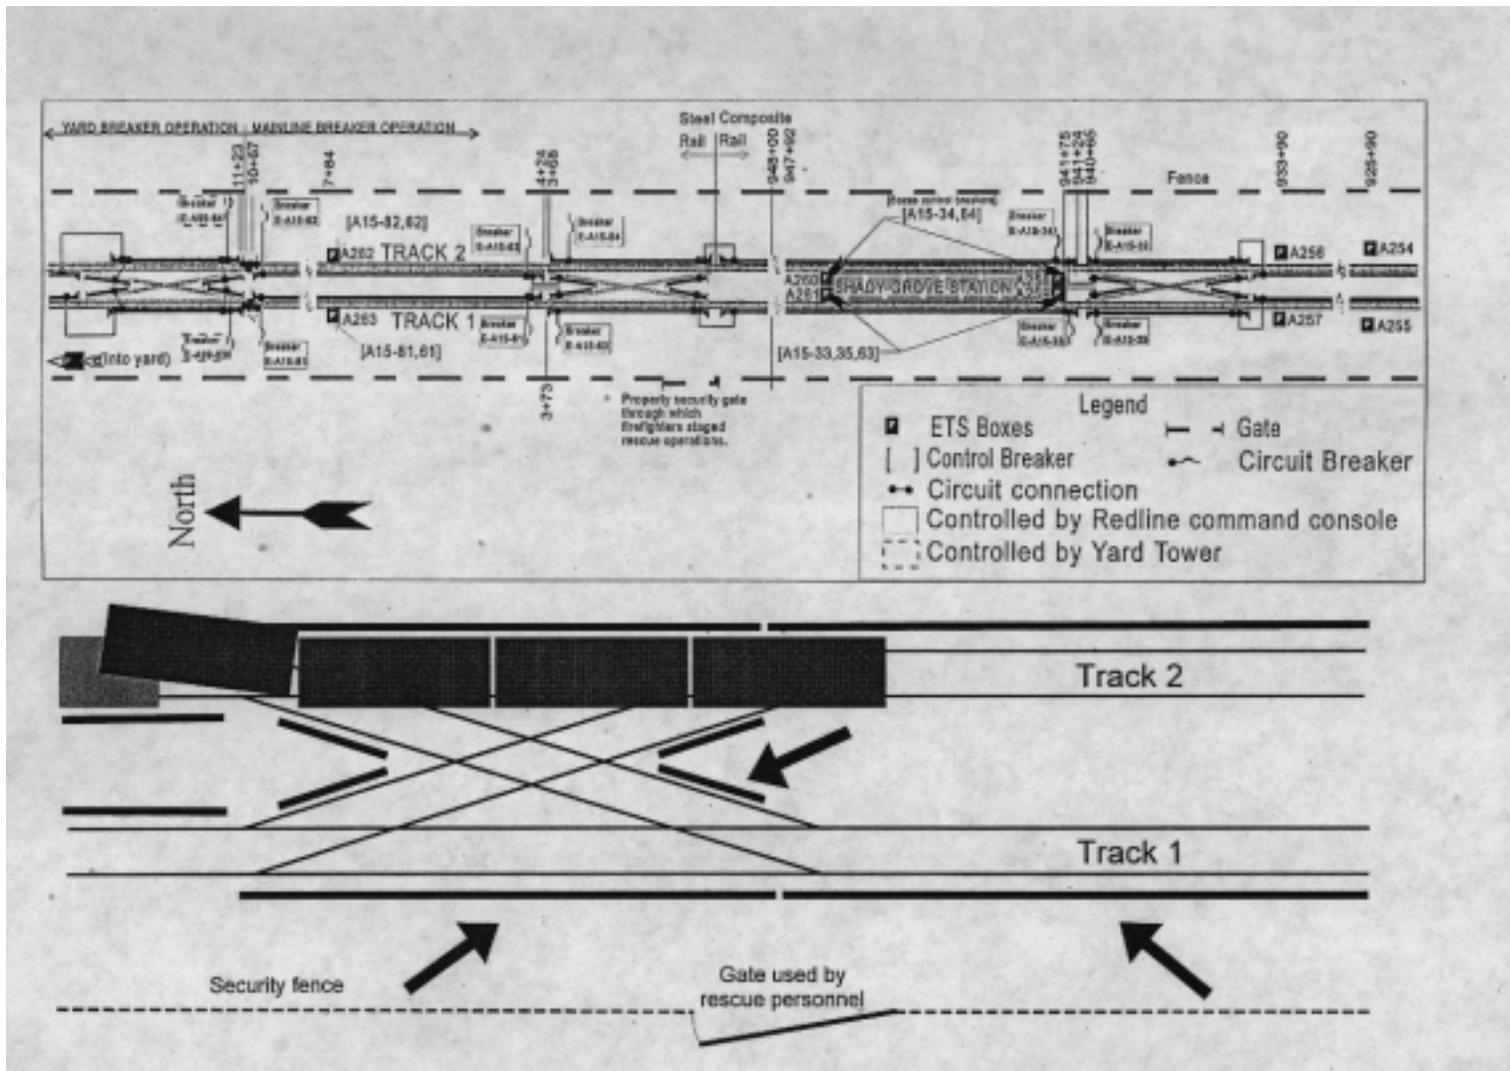
Figure 12 – Schematic representations (not to scale) of Metrorail third rail power control in the accident area. Arrows in the lower illustration indicate third rail sections that remained energized for 43 minutes after the accident.

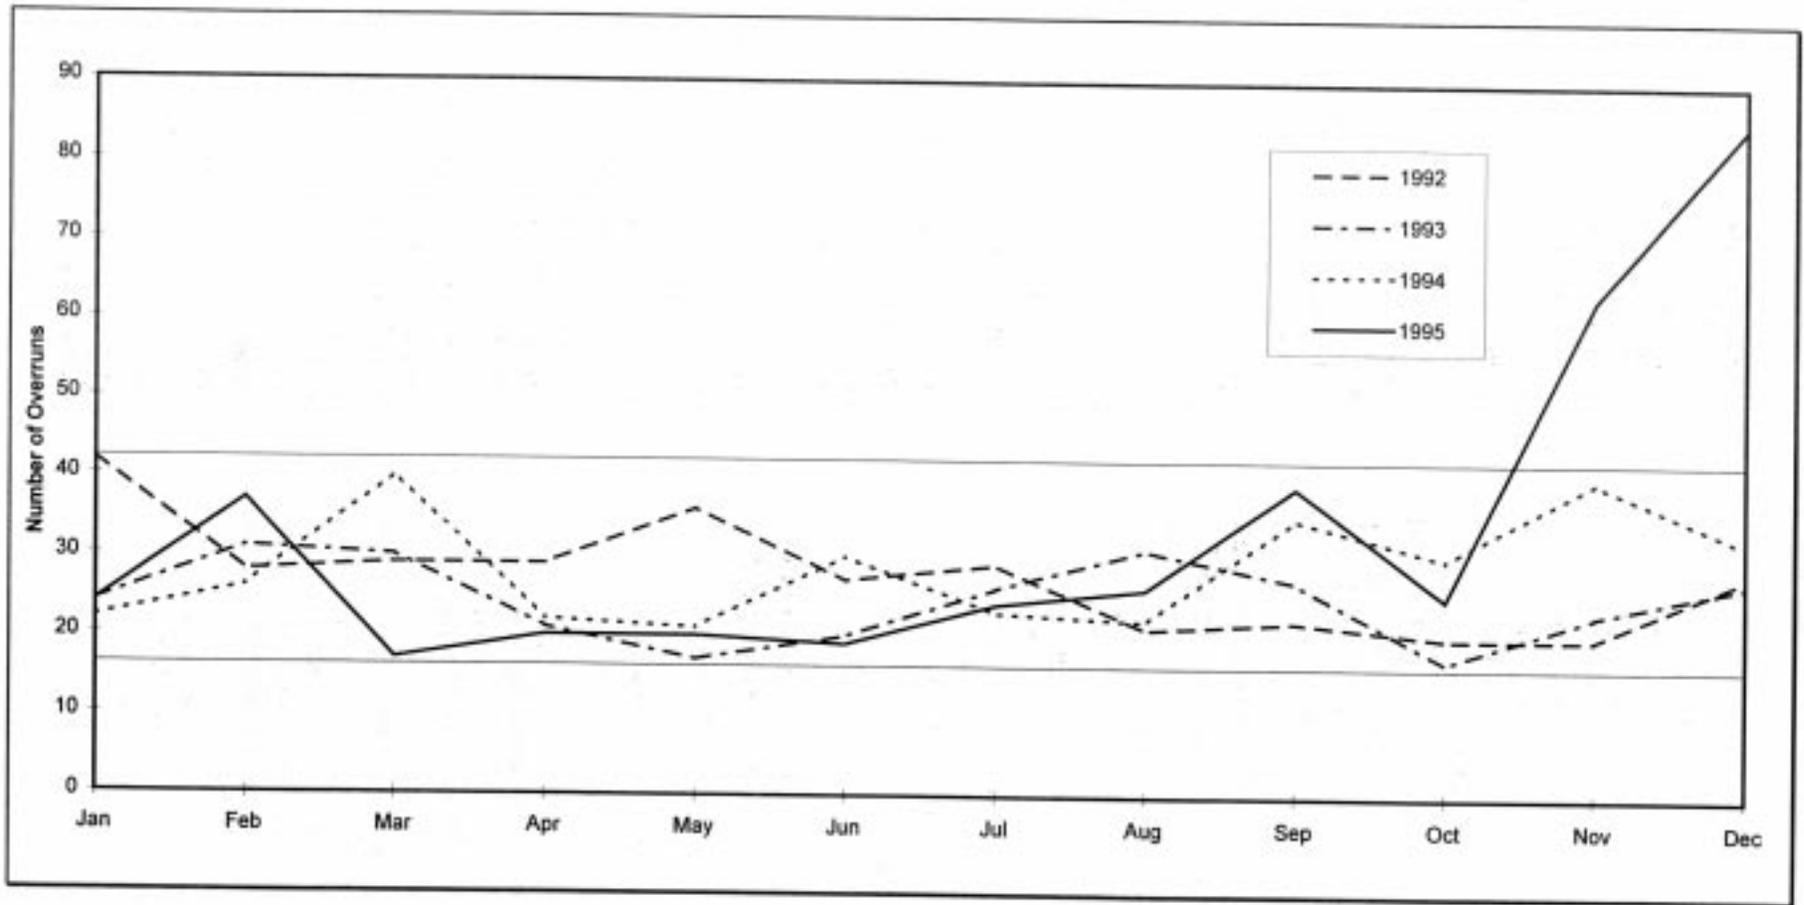
Figure 15 -- Station/platform overruns (by at least one set of doors) on the Metrorail system 1992 through 1995
