U.S. Fire Administration/Technical Report Series

Aerial Ladder Collapse Incidents

USFA-TR-081/April 1996

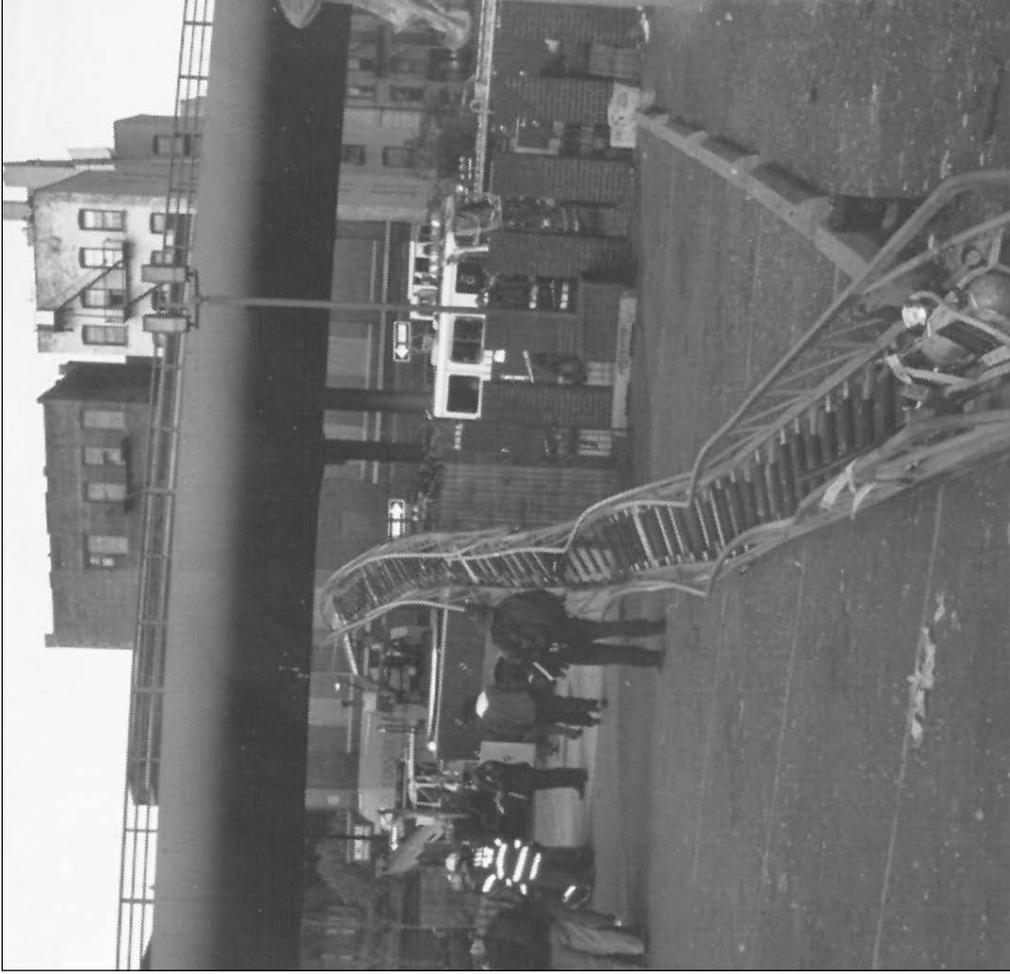
Prior to the collapse, the tip of the left rail rested on the window sill. The weight of the occupants caused a twisting force to the unsupported right side.

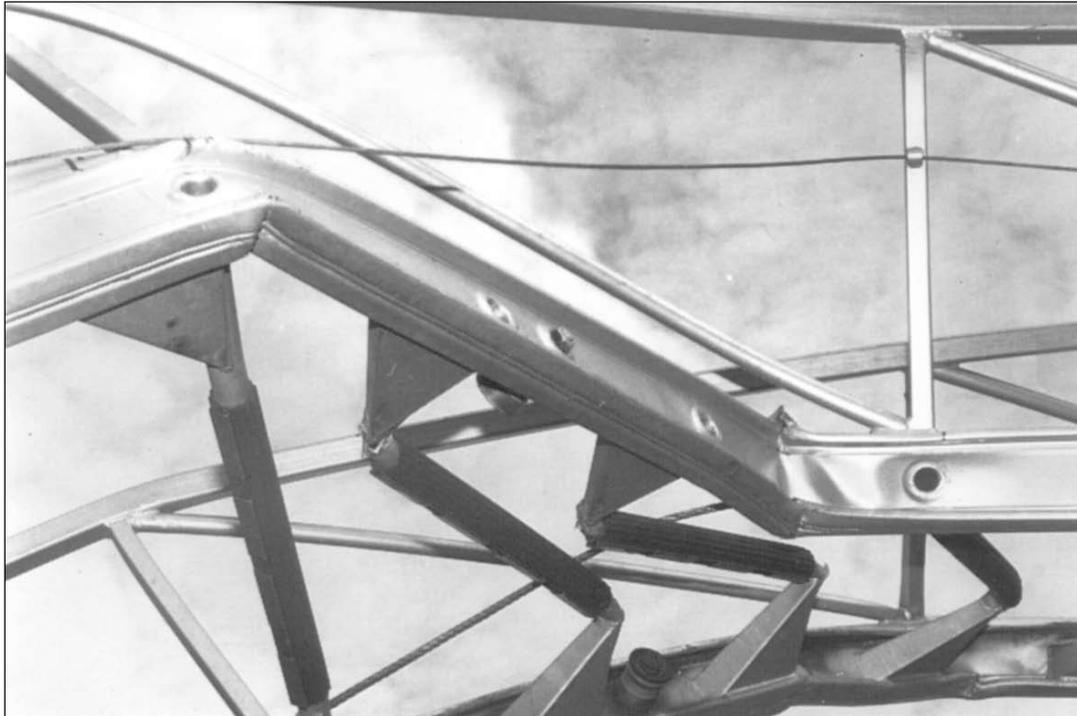
The twisting failure occurred in the lower right bed section, collapsing the ladder to the right side.

The primary structural failure occurred when the main beam on the lower right side of the bed section, buckled inward, slightly above the point where it is supported by the ladder raising mechanism. This part of the ladder would be subjected to the maximum bending stress when the ladder is in a cantilever (unsupported) position. The buckling of the lower beam also crushed two of the rungs and caused a secondary buckling of the left main beam in the same area. The buckling indicates that the failure resulted from compression forces in the beam, which are caused by the bending stress in the ladder.

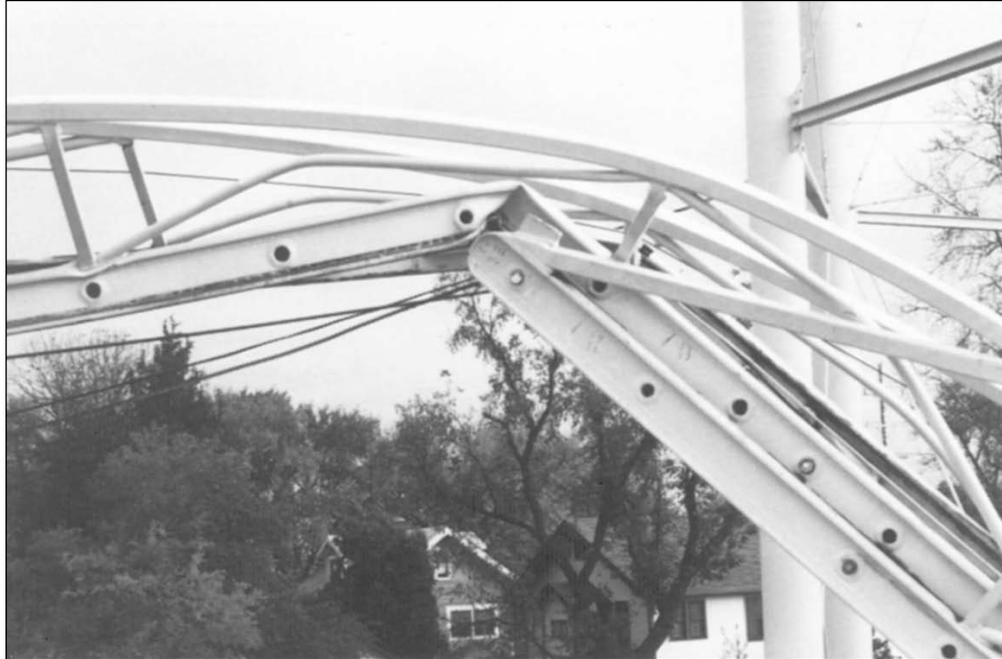
Firefighters in Mundelein, Illinois were practicing a stokes basket evolution when their aerial ladder failed just above the bed section. The firefighters had run a rope through pulleys attached to the tip and the front tow hook (seen below), and were attempting to raise the basket when the collapse occurred.

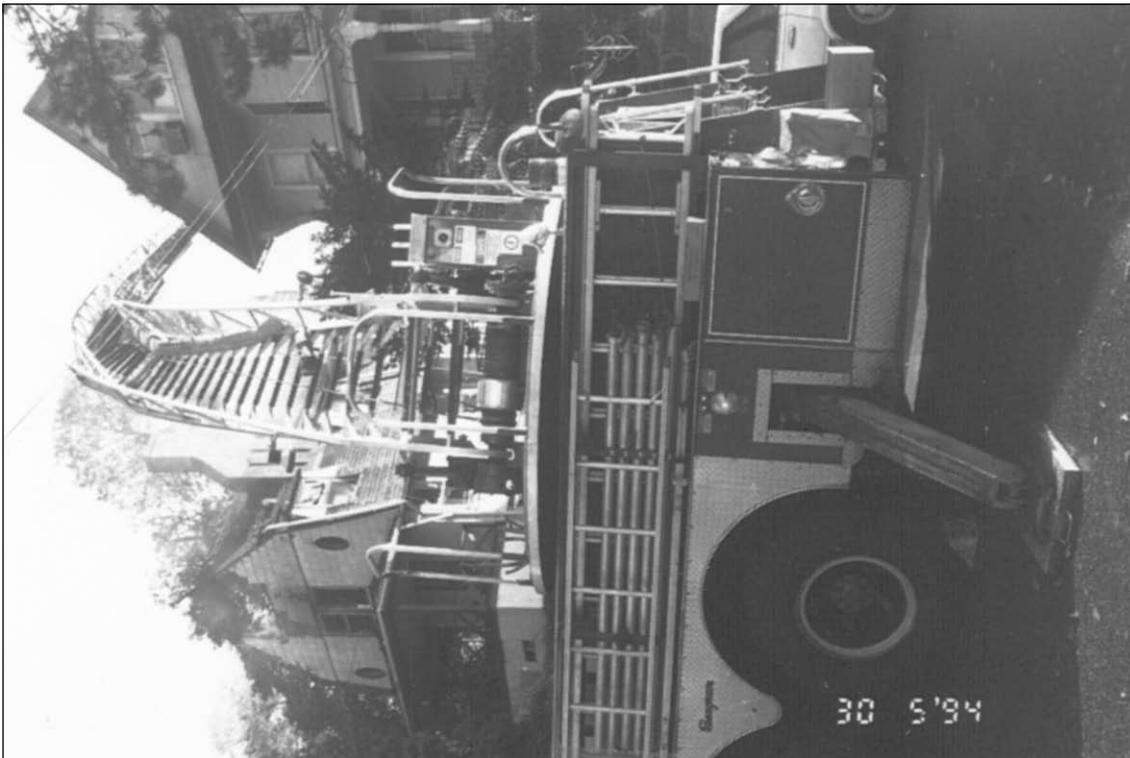
The ladder failed in the first fly section just above the bed section

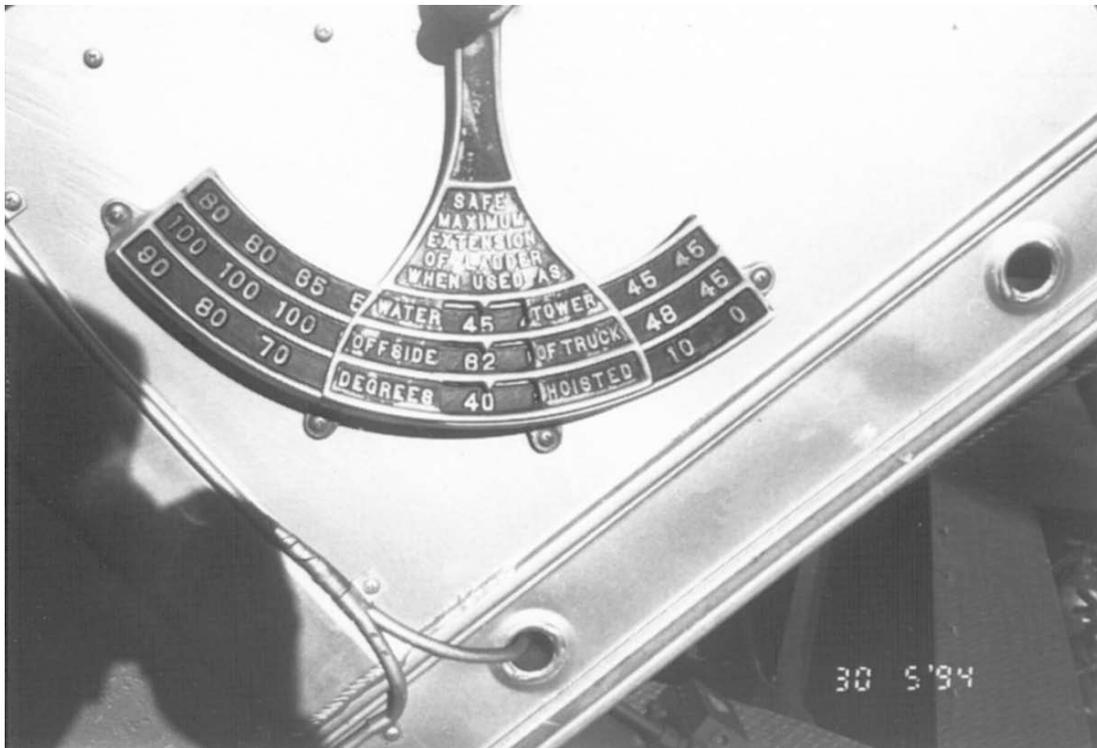
A Yonkers, New York aerial ladder failed during ladder pipe operations.

Although the exact angle of elevation at the time of the Yonkers collapse is unknown, the ladder was fully extended at an angle estimated at less than 50 degrees. The inclinometer shows that the maximum safe extension at 40 degrees elevation for a water tower operation is 45 feet.

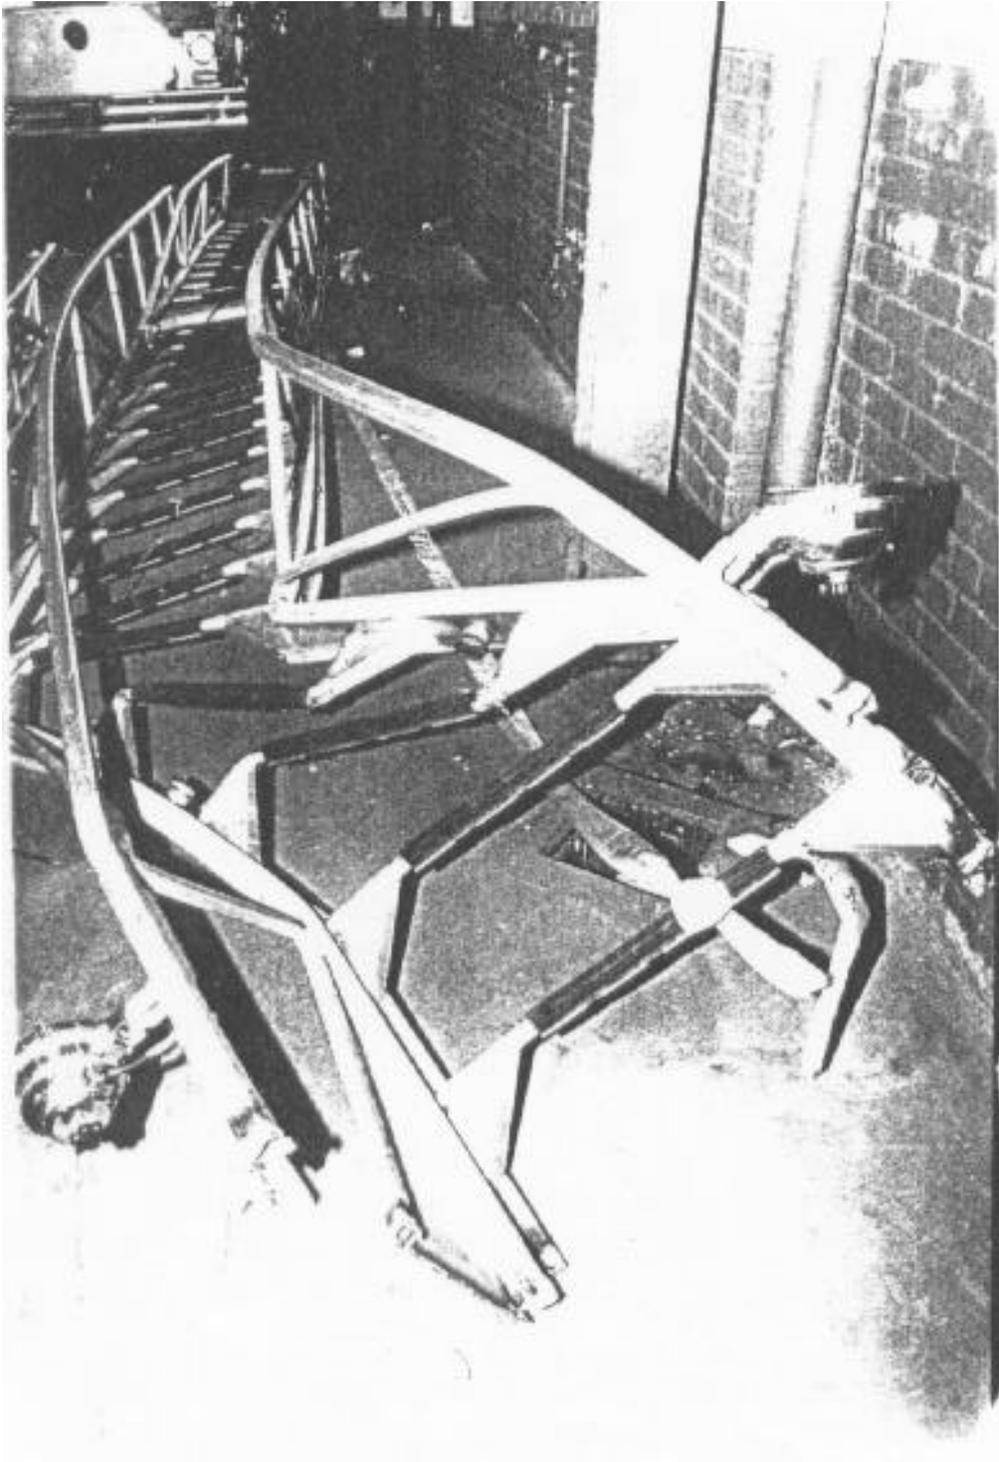
Figure 4. Photograph of the Bed Section of the Failed Ladder Showing the Buckled "Hinges" in the Right Bottom Chord.
