U.S. Fire Administration/Technical Report Series

# Highrise Office Building Fire One Meridian Plaza

Philadelphia, Pennsylvania

USFA-TR-049/February 1991

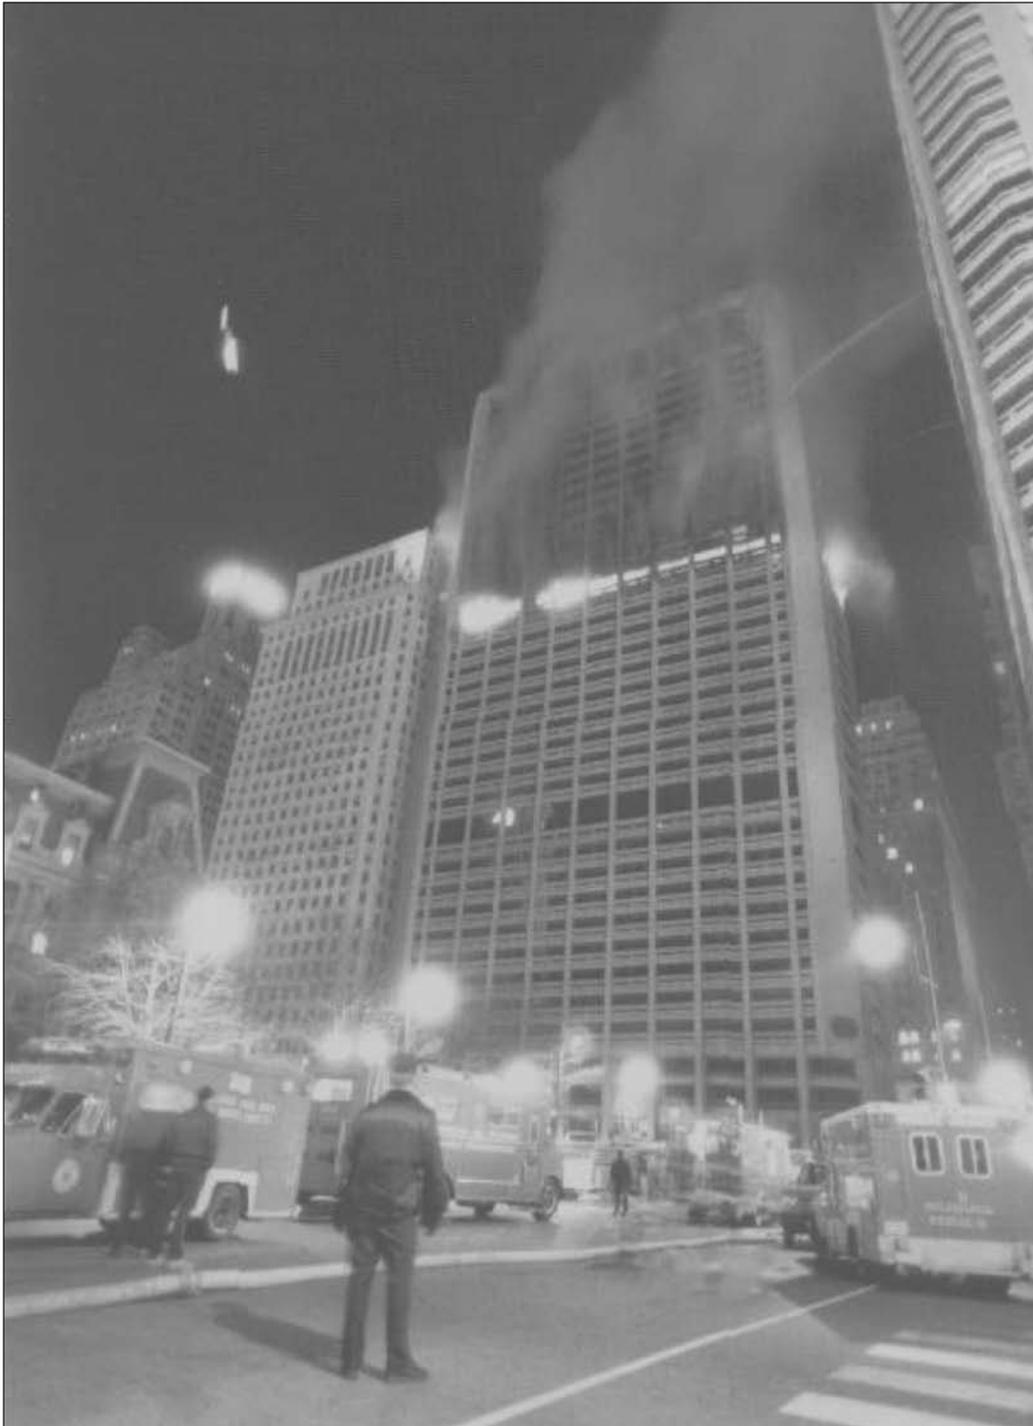
**Exterior view of One Meridian Plaza and fireground operations in the early morning hours of February 24, 1991. Fire involves the 22nd, 23rd, 24th, and part of the 25th floors. Note the heavy stream played on the exterior from an adjacent building.**

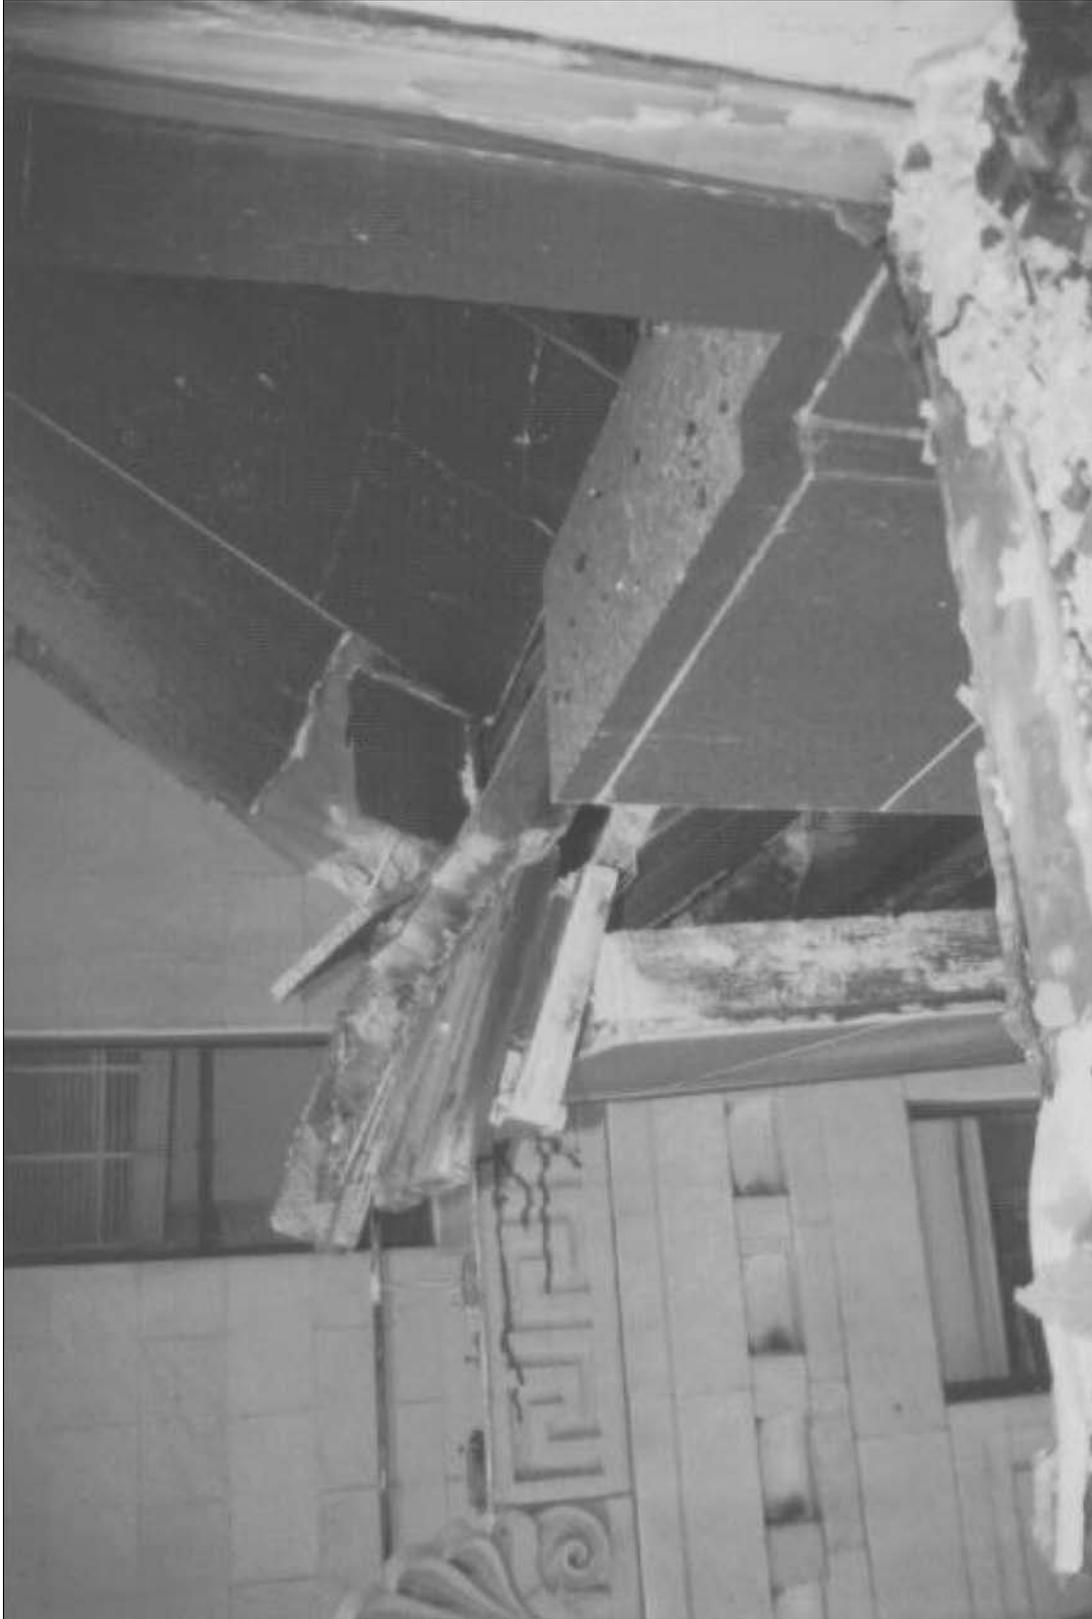
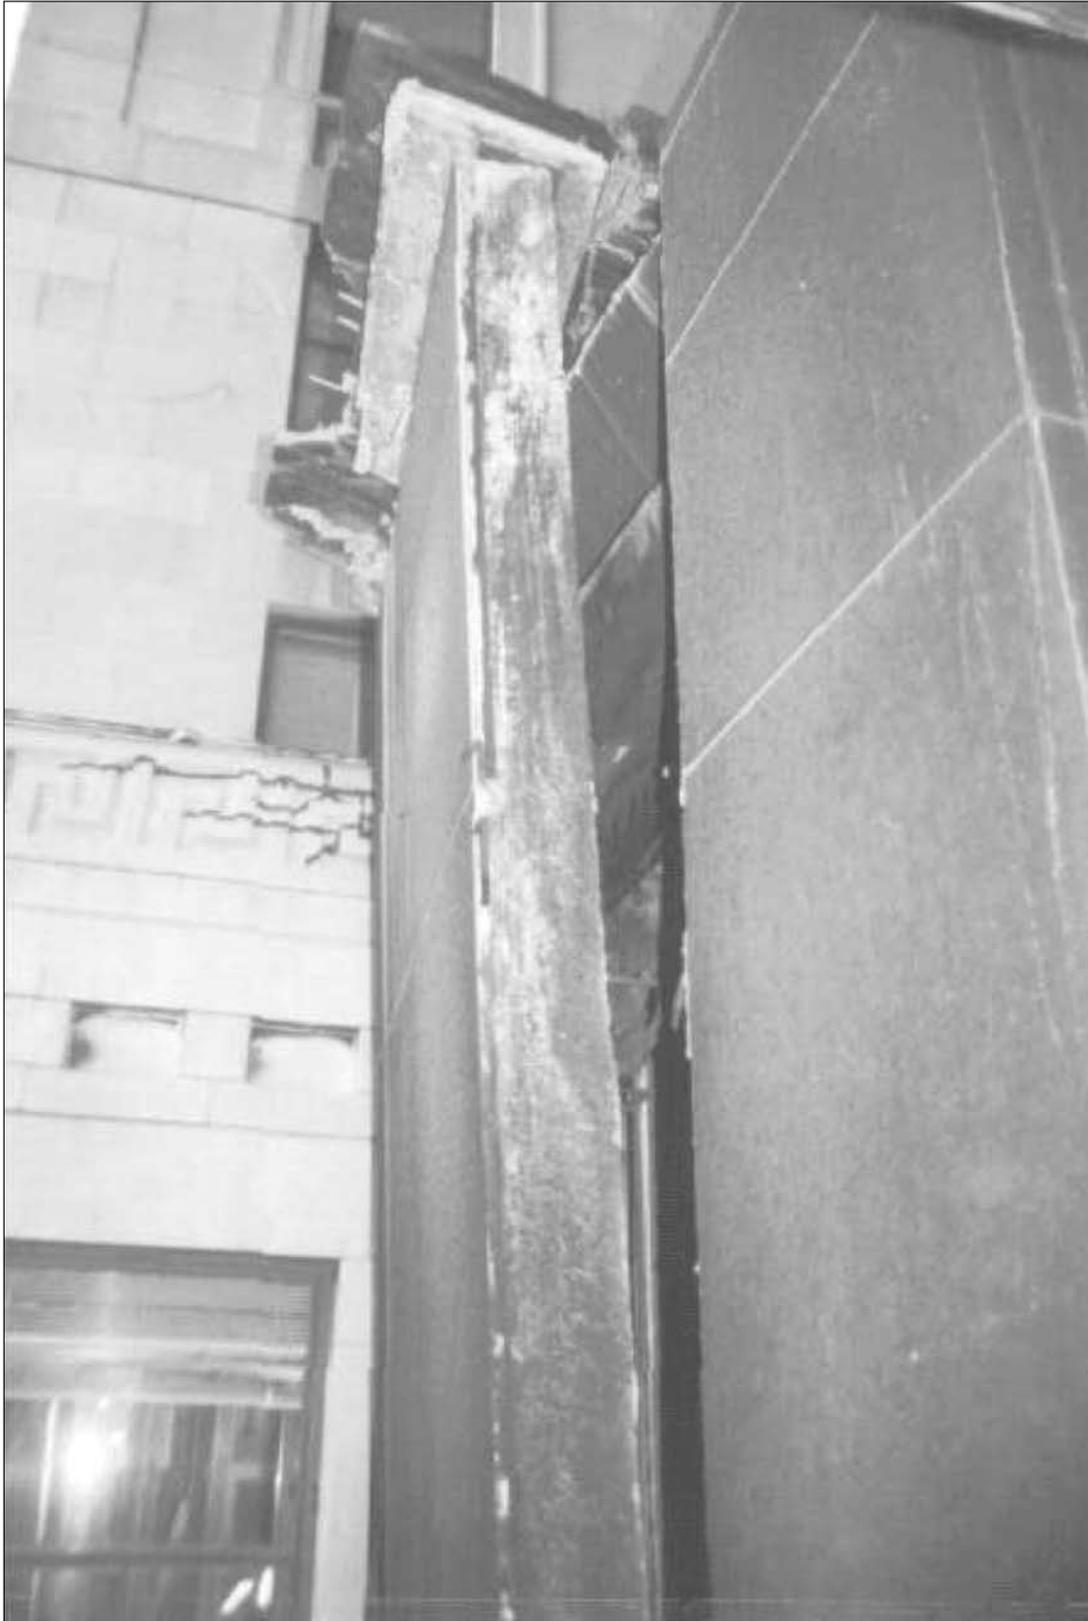
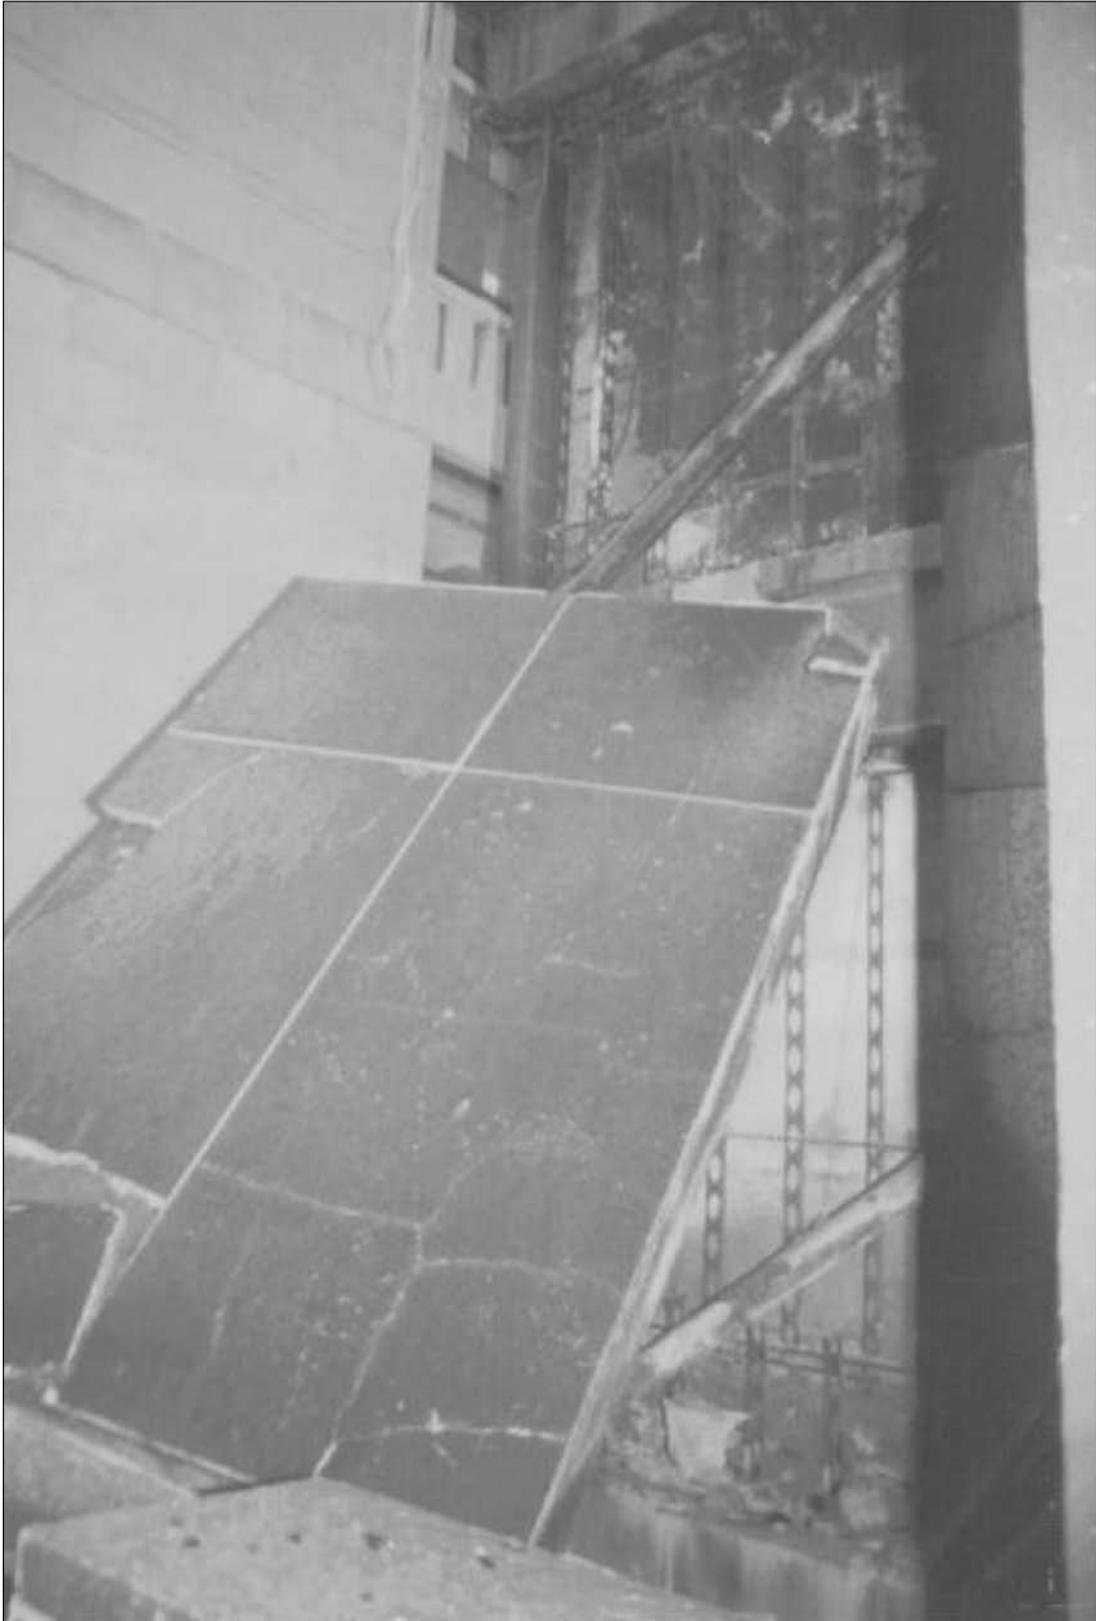
Here and in the next two photos exterior granite panels from the east stair tower were dislodged due to the thermal expansion of the steel frame of the building.

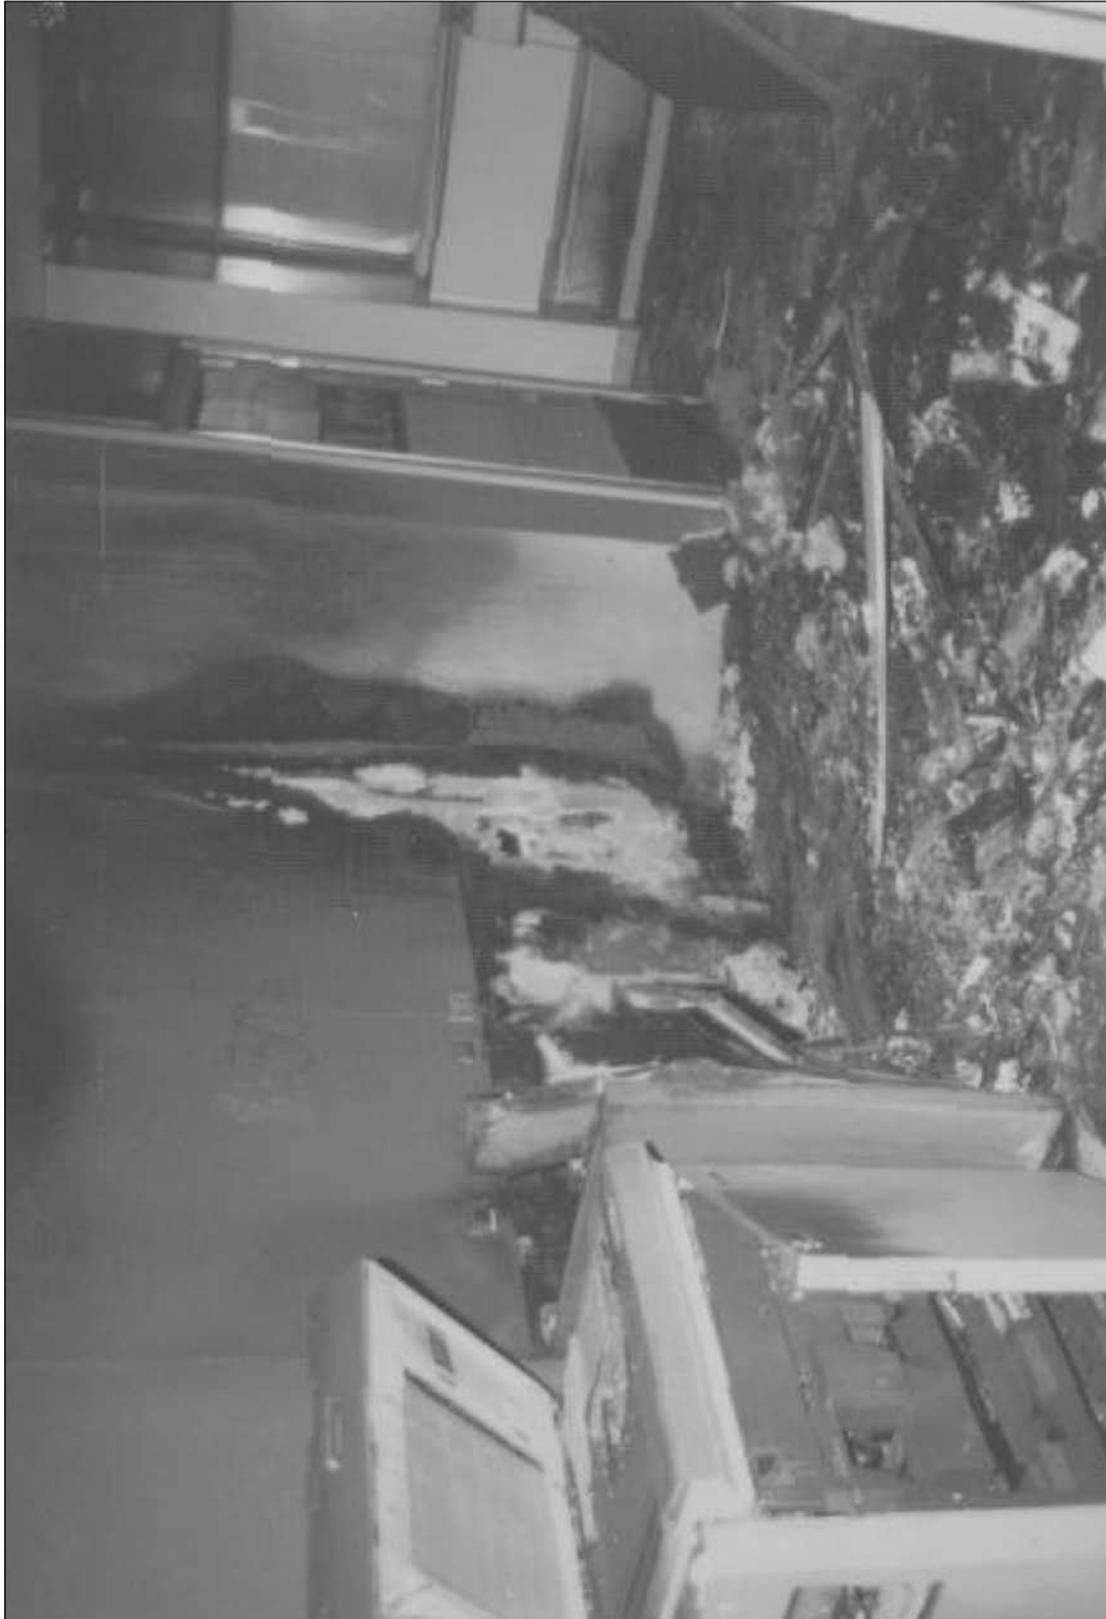
The fire was stopped when it reached the 30th floor, which was protected by automatic sprinklers. As the fire ignited in different points this floor level through the floor assembly and by autoexposure through the windows, 10 sprinkler heads activated and the fires were extinguished at each point of penetration. The vertical spread of the fire was stopped solely by the action of the automatic sprinkler system, which was being supplied by fire department pumpers. The 30th floor was not heavily damaged by fire, and most contents were salvageable. The fire was declared under control at 3:01 p.m., February 24, 1991.

**One of the areas of fire penetration on the 30th floor where a single sprinkler head activated to stop the upward extension of the fire.**

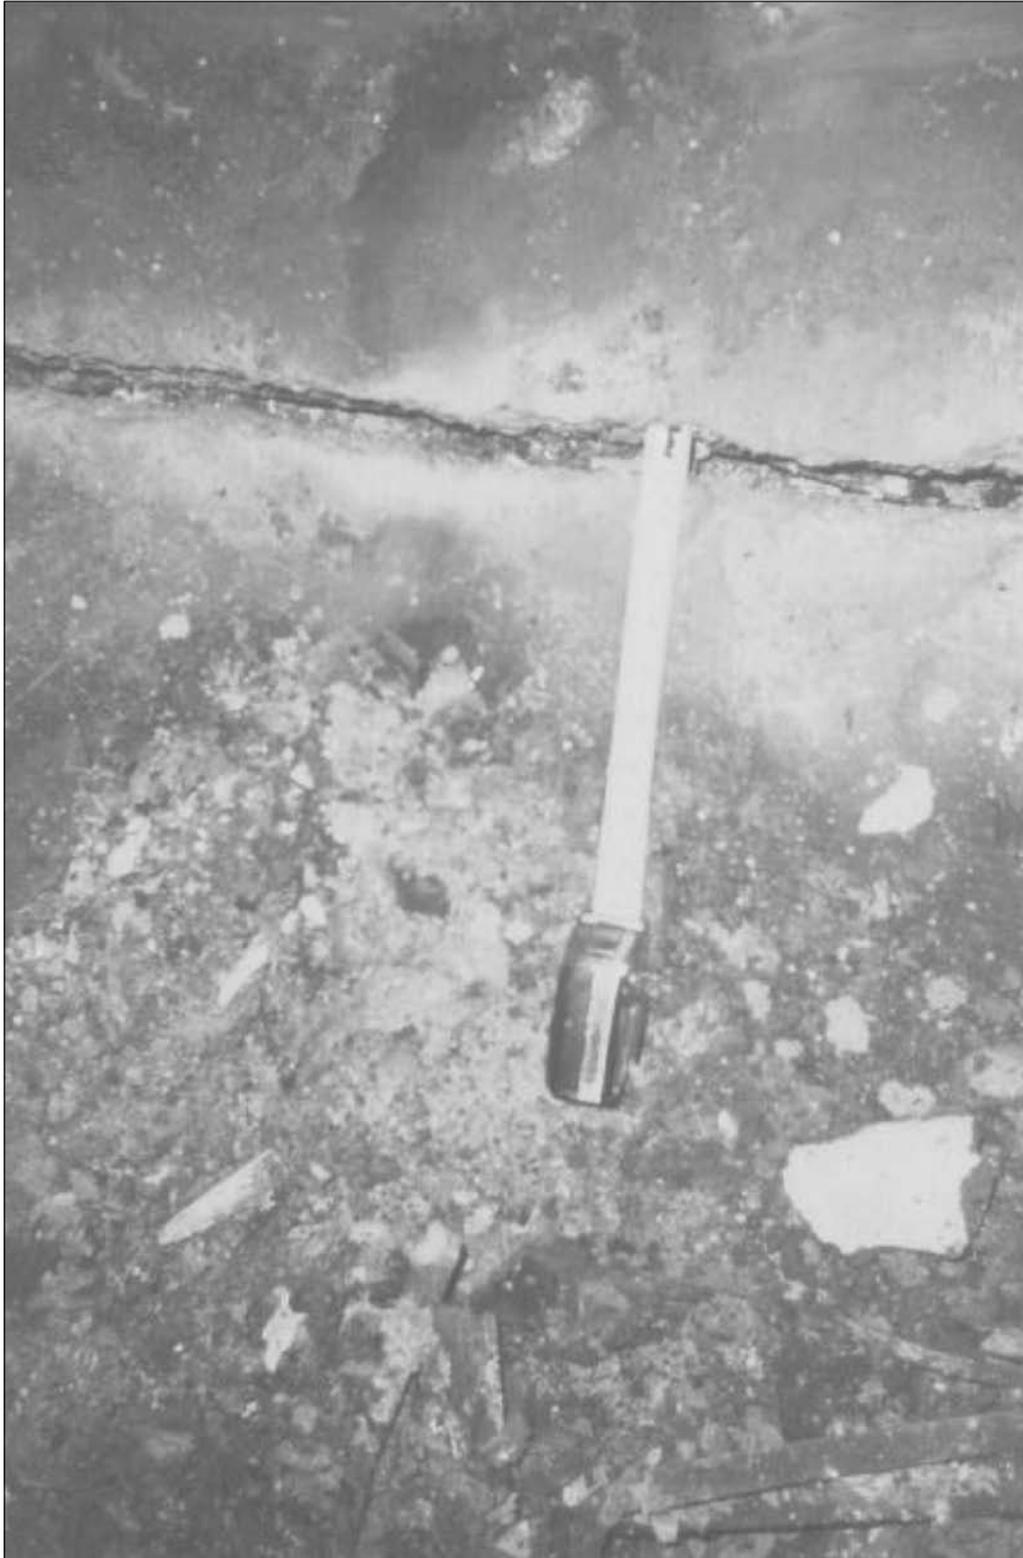
Prior to deciding to evacuate the building, firefighters noticed significant structural displacement occurring in the stair enclosures. A command officer indicated that cracks large enough to place a man's fist through developed at one point. One of the granite exterior wall panels on the east stair enclosure was dislodged by the thermal expansion of the steel framing behind it. After the fire, there was evident significant structural damage to horizontal steel members and floor sections on most of the fire damaged floors. Beams and girders sagged and twisted--some as much as three feet--under severe fire exposures, and fissures developed in the reinforced concrete floor assemblies in many places. Despite this extraordinary exposure, the columns continued to support their loads without obvious damage.

Close-up of crack in concrete floor, 28th floor.

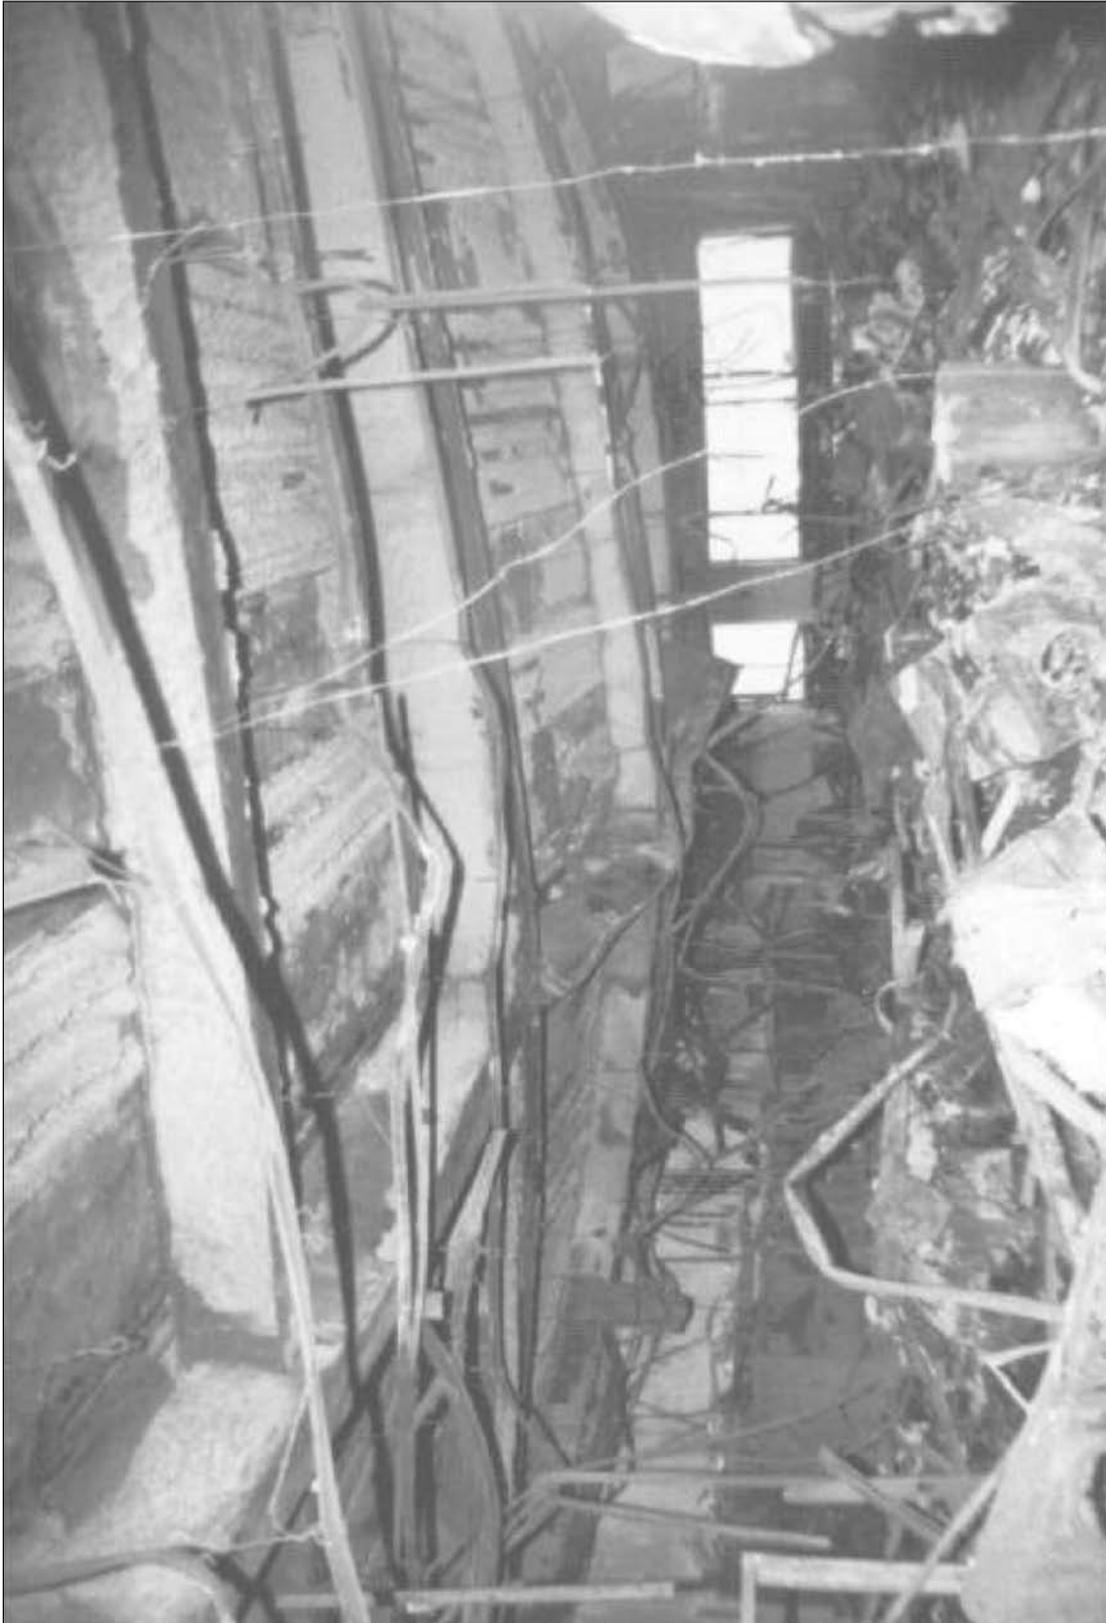
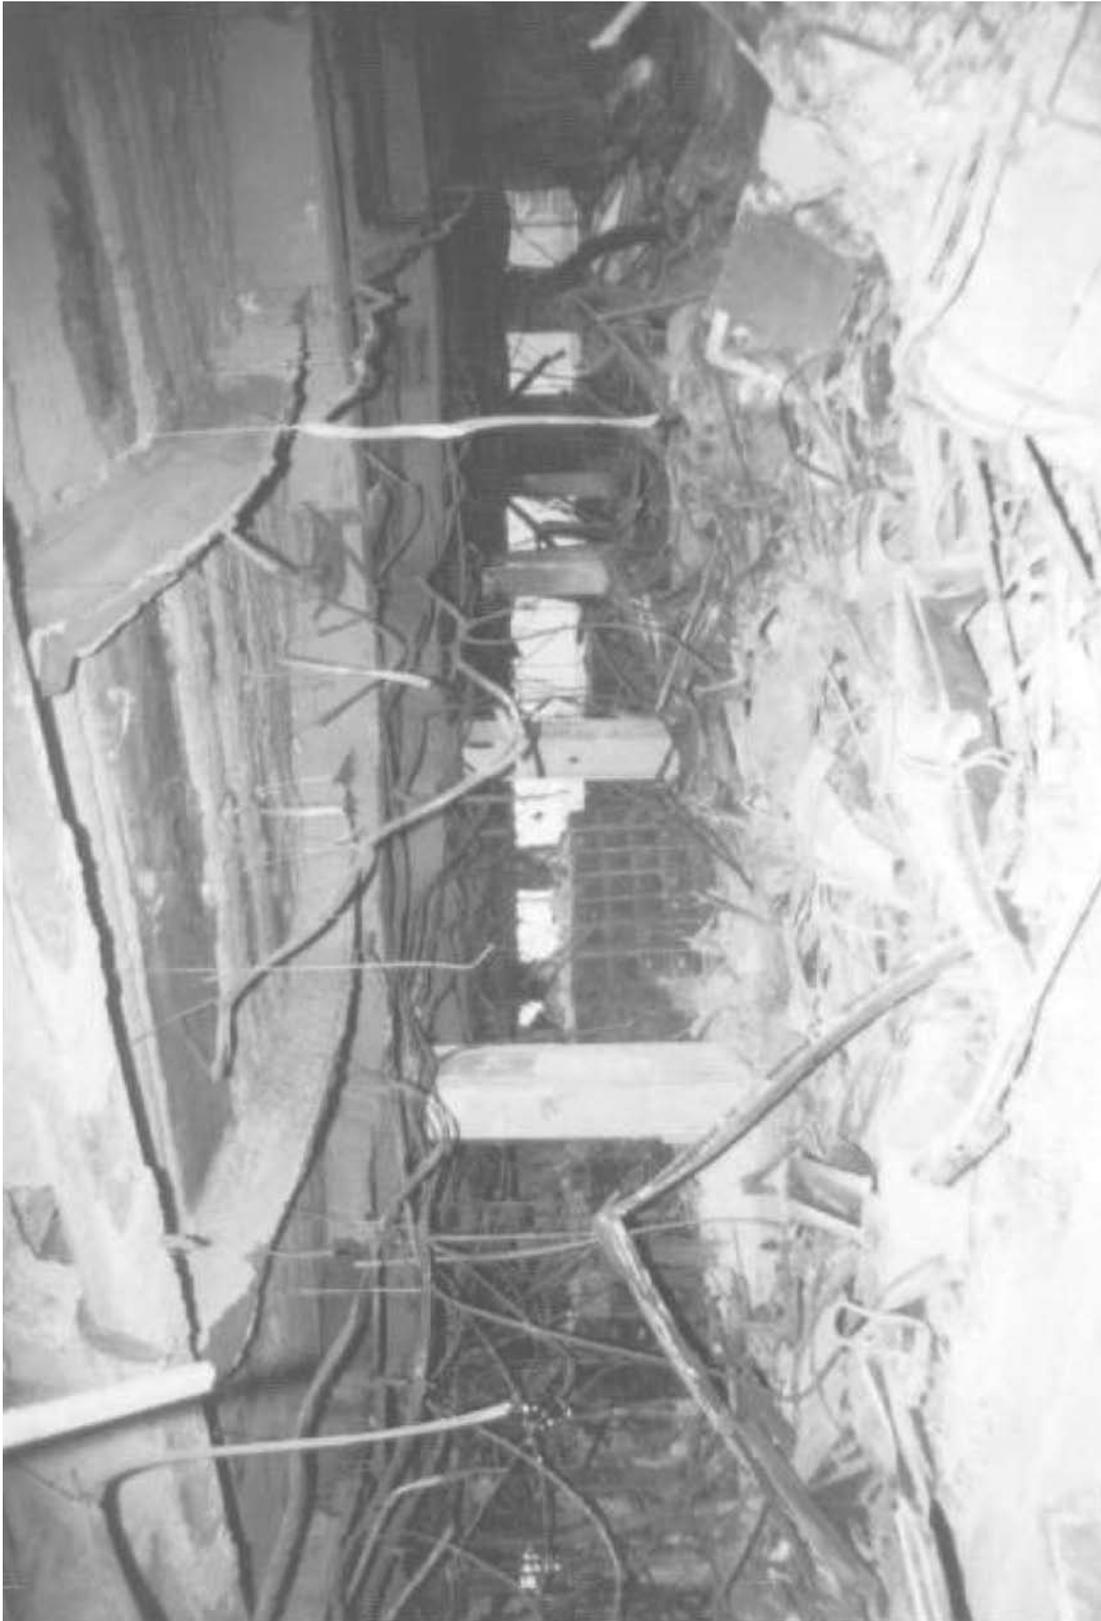
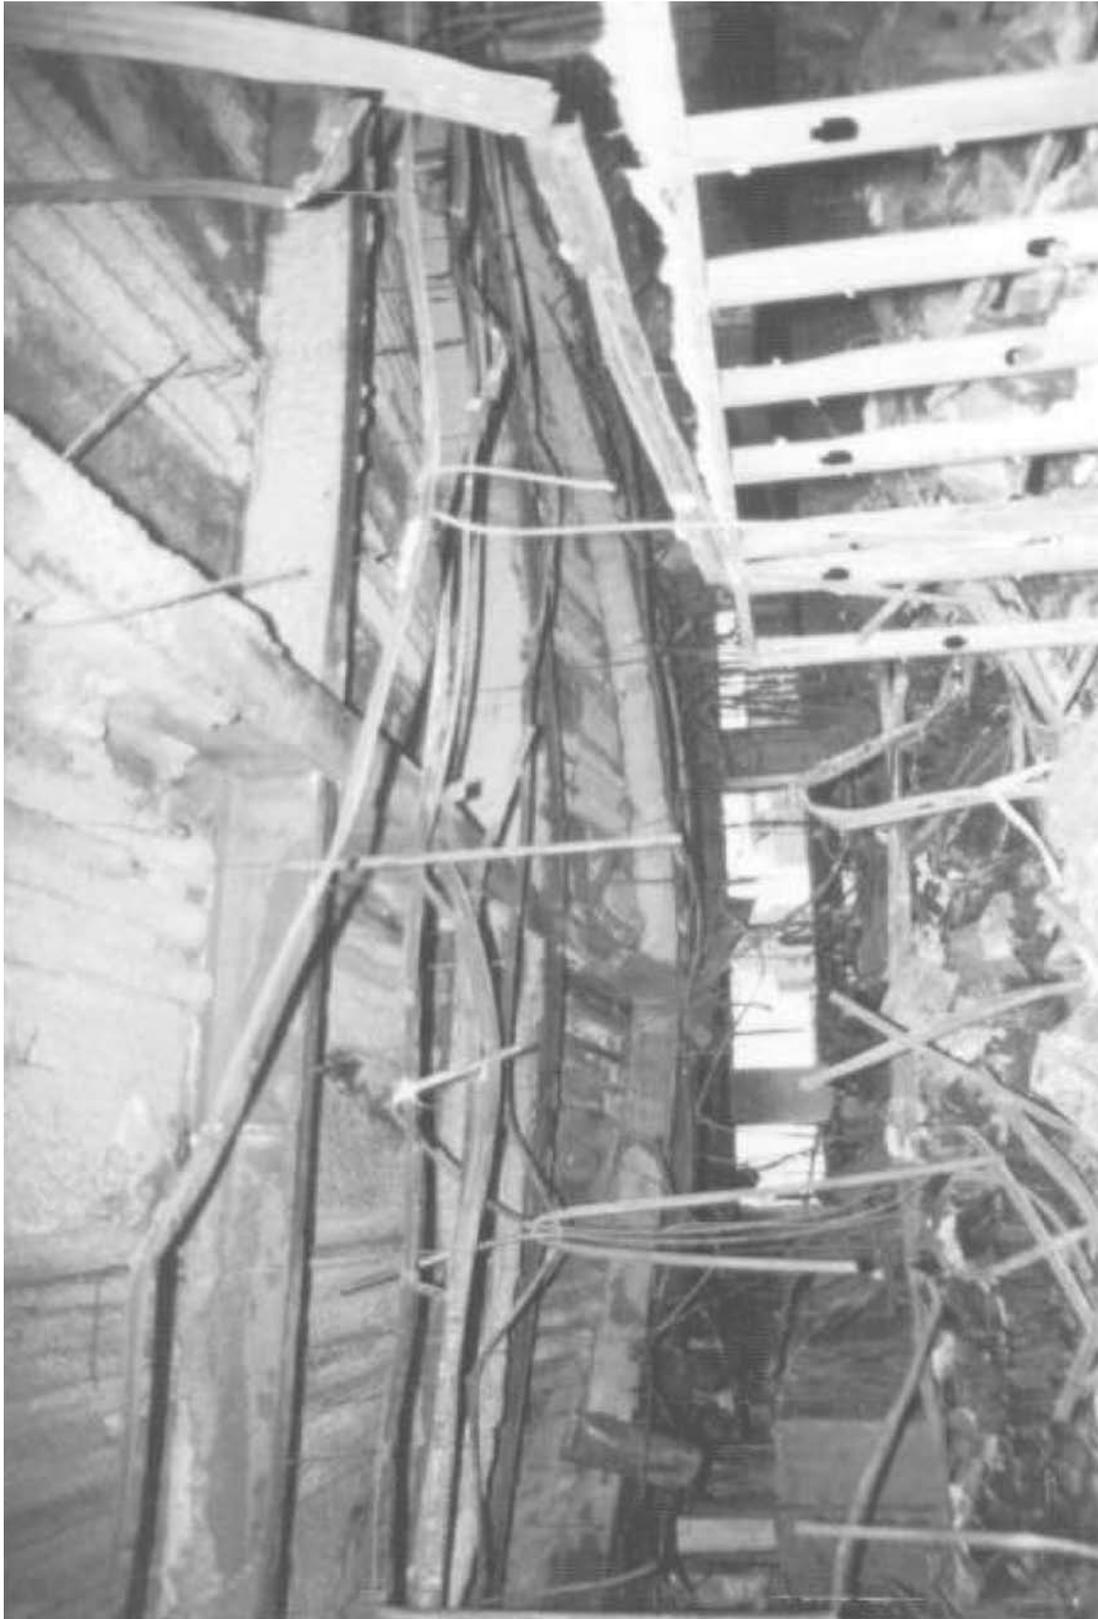
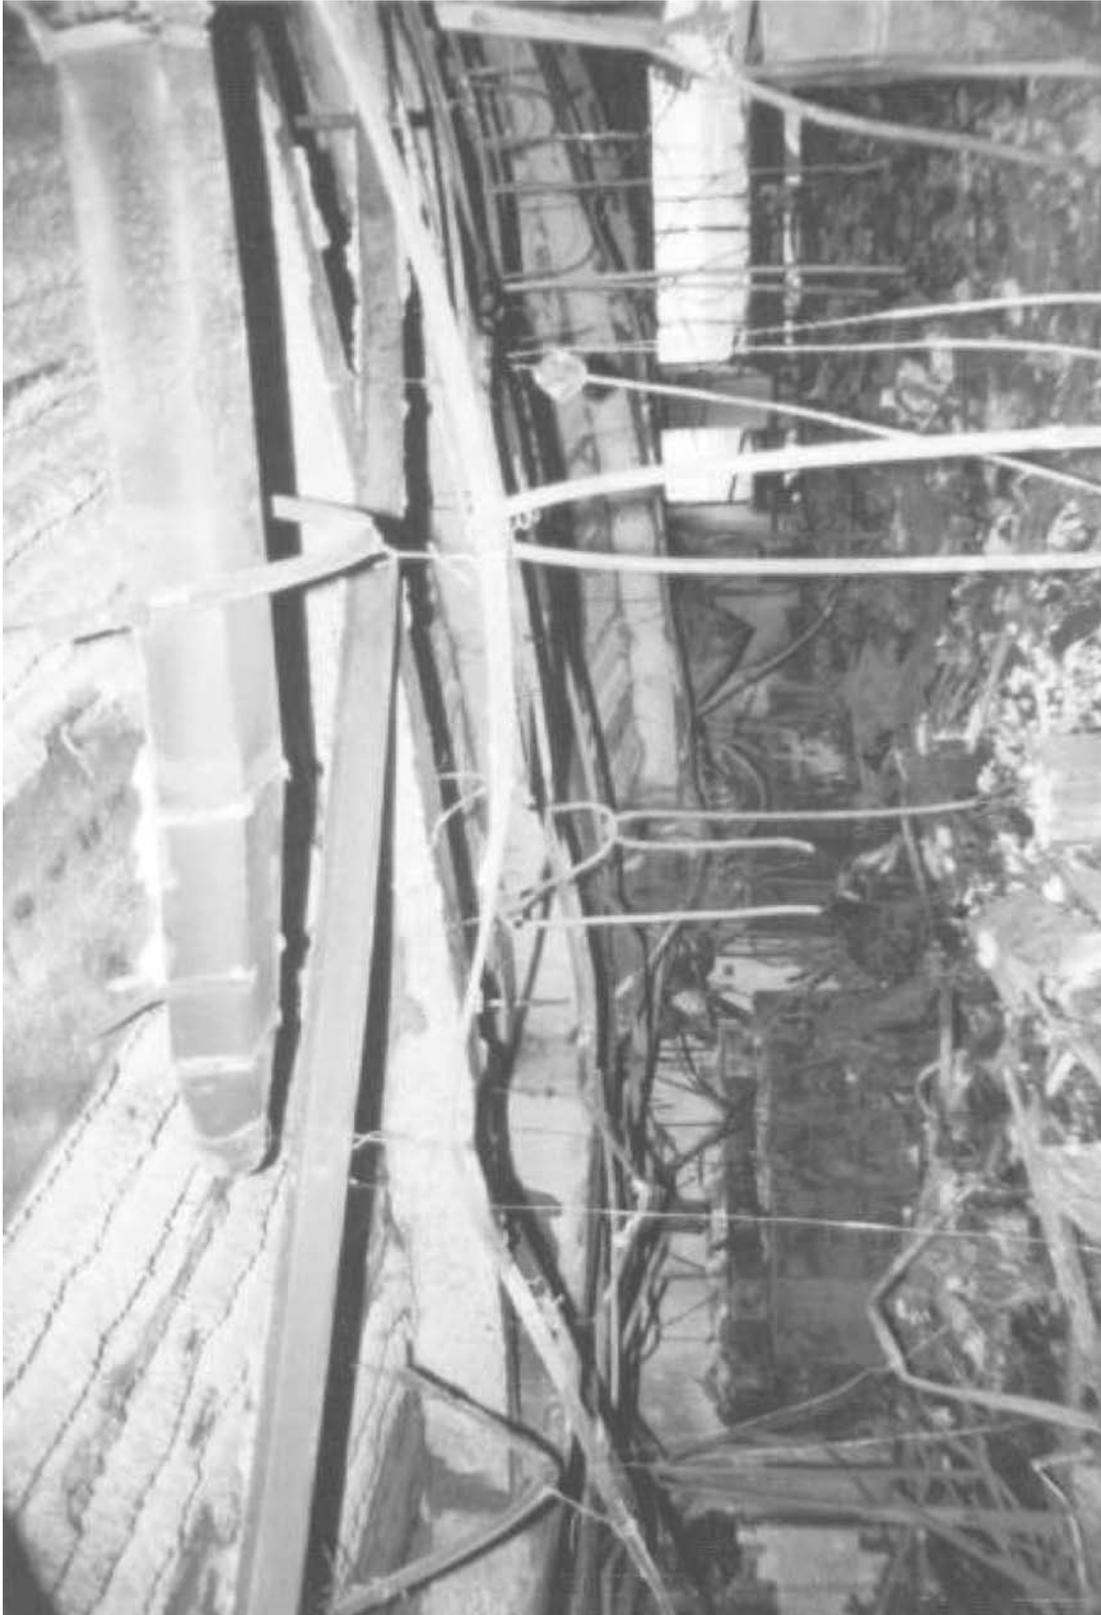
Here and in the next three photos are interior views of floor areas after the fire. Note the total consumption of the available fuel and sagging of the floor deck of up to three feet between columns.

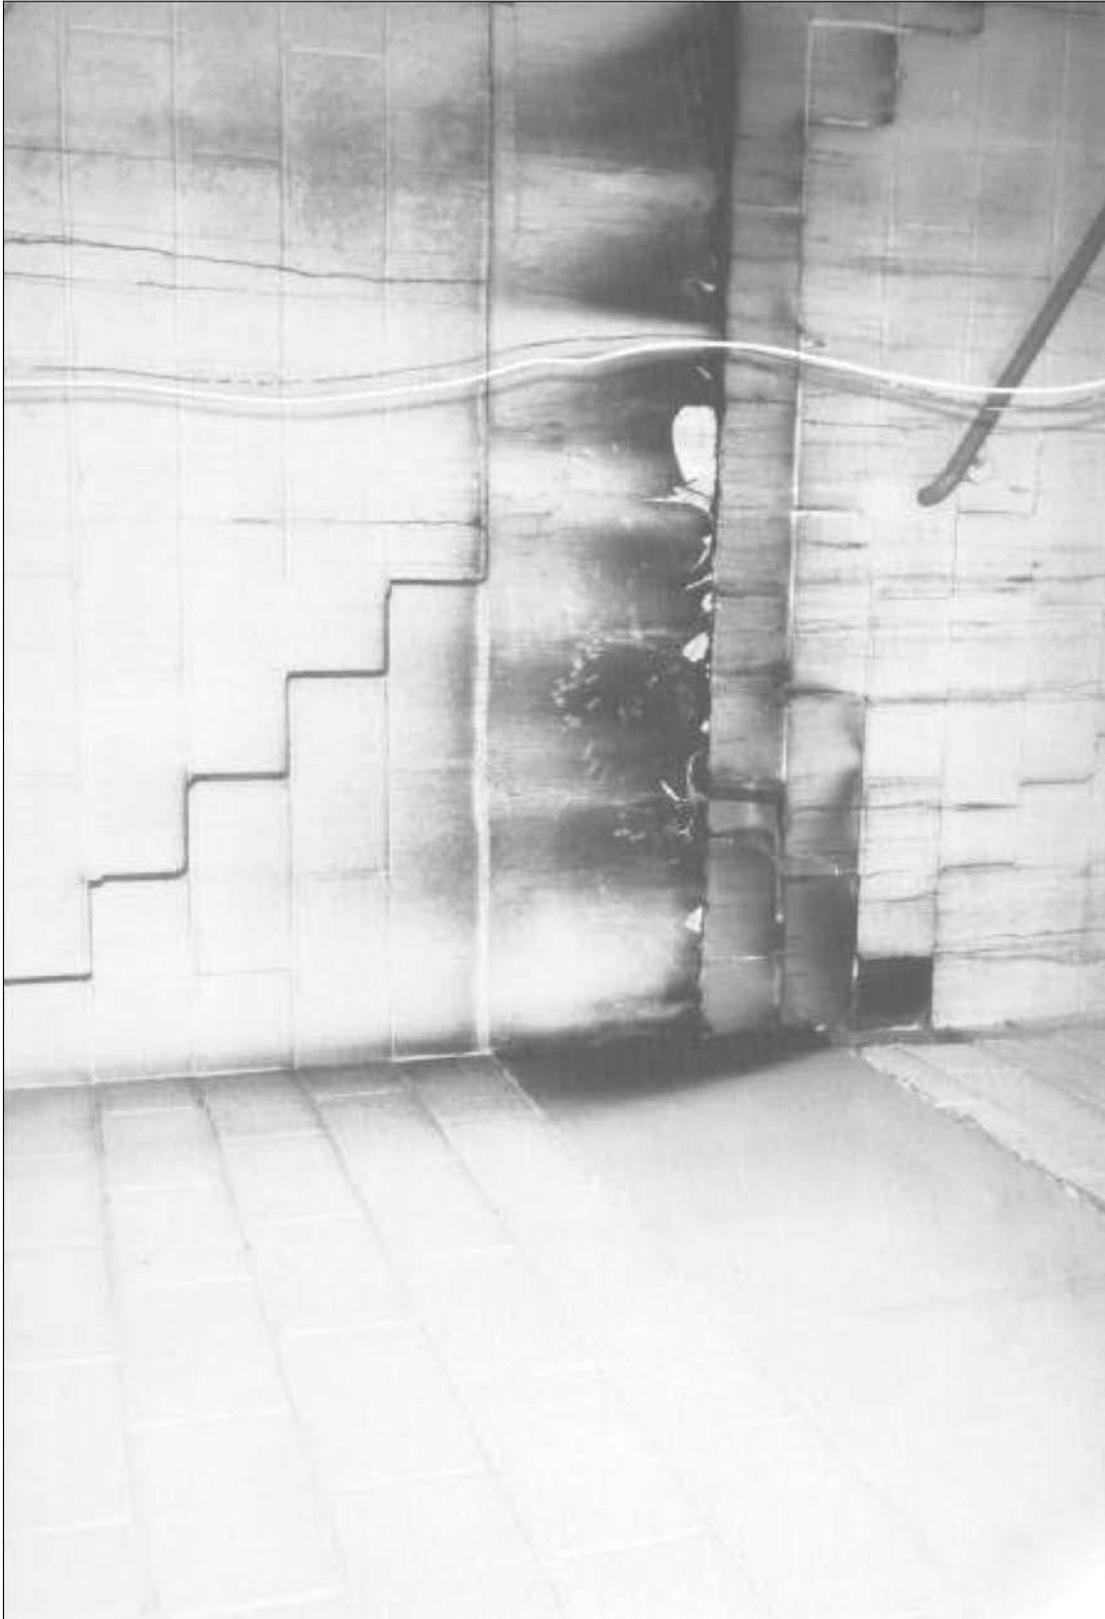
Fire tower between 25th and 26th floors. Note heavy fire and smoke damage.

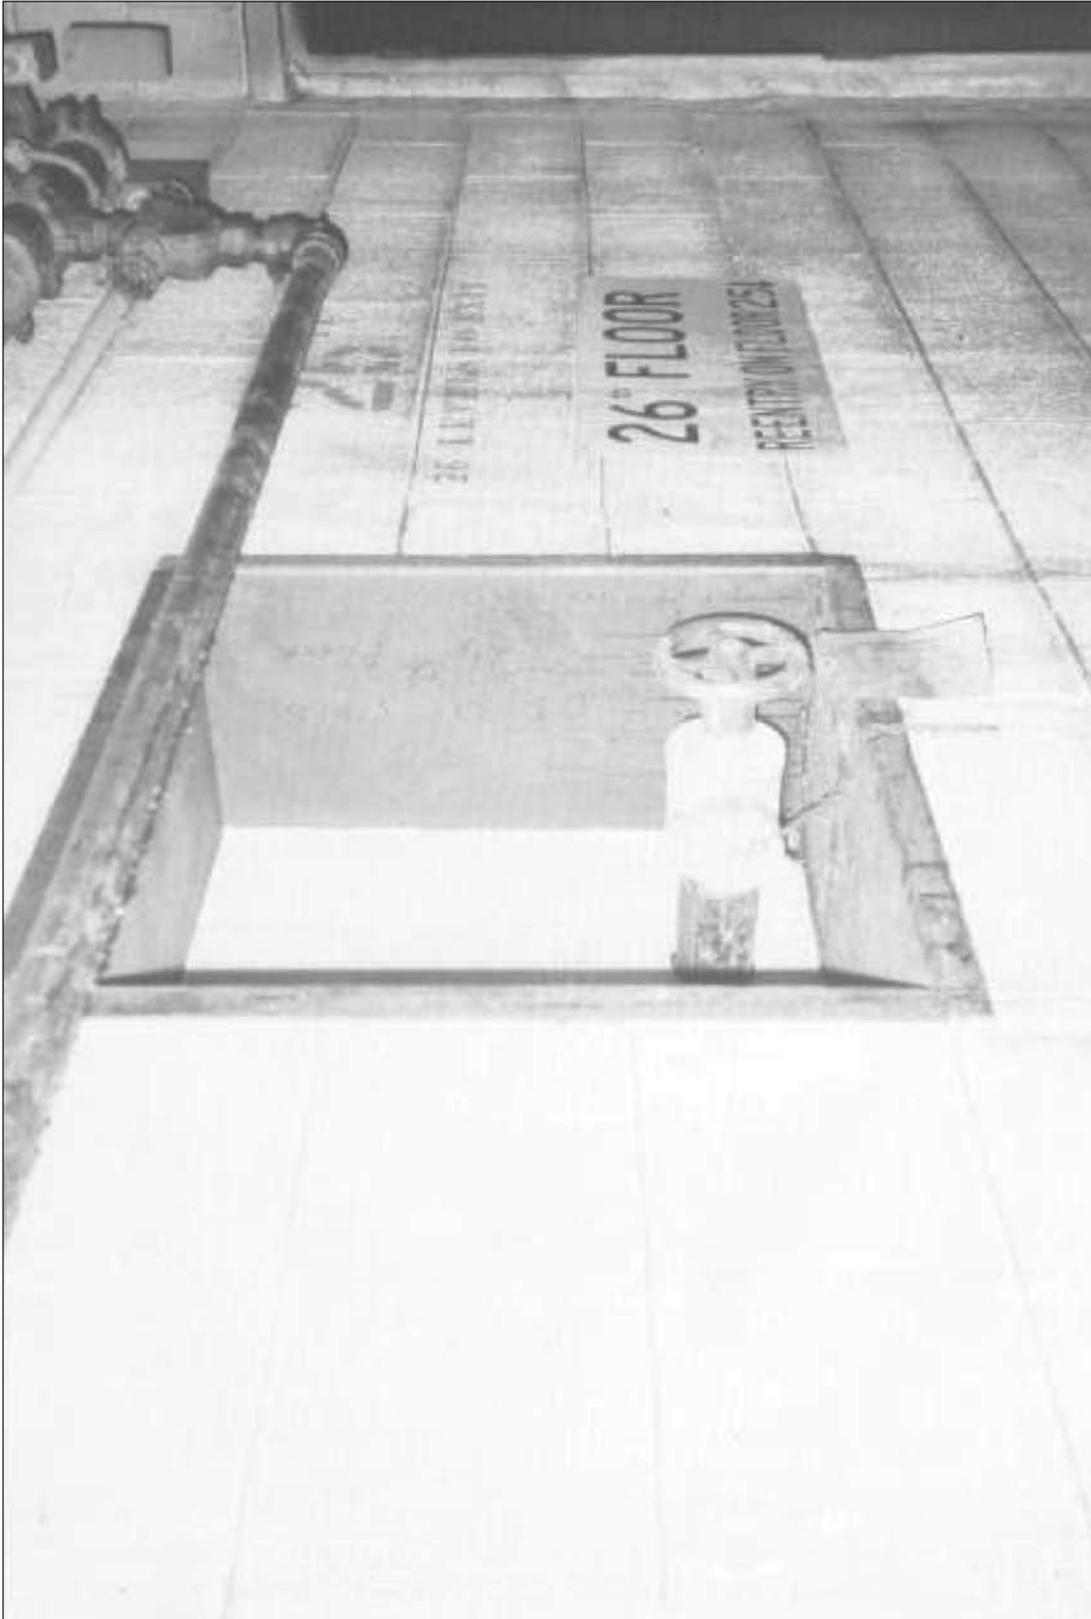
When the PRVs were originally installed, the pressure settings were improperly adjusted. Index values marked on the valves did not correspond directly to discharge pressures. To perform adjustments the factory and field personnel had to refer to tables in printed installation instructions to determine the proper setting for each floor level.<sup>4</sup> For more detailed information about PRVs see Appendices D and E.

The PRV equipped hose outlets on the 22nd floor of One Meridian Plaza, adjusted as reported at the time of the fire, would have produced nozzle pressures of approximately 40 psi. This is insufficient for a straight stream device and dangerously inadequate for a fog nozzle.

Standpipe hose outlet with pressure reducing valve (PRV), 26th floor.
