U.S. Fire Administration/Technical Report Series

# Highrise Office Building Fire One Meridian Plaza

Philadelphia, Pennsylvania

USFA-TR-049/February 1991

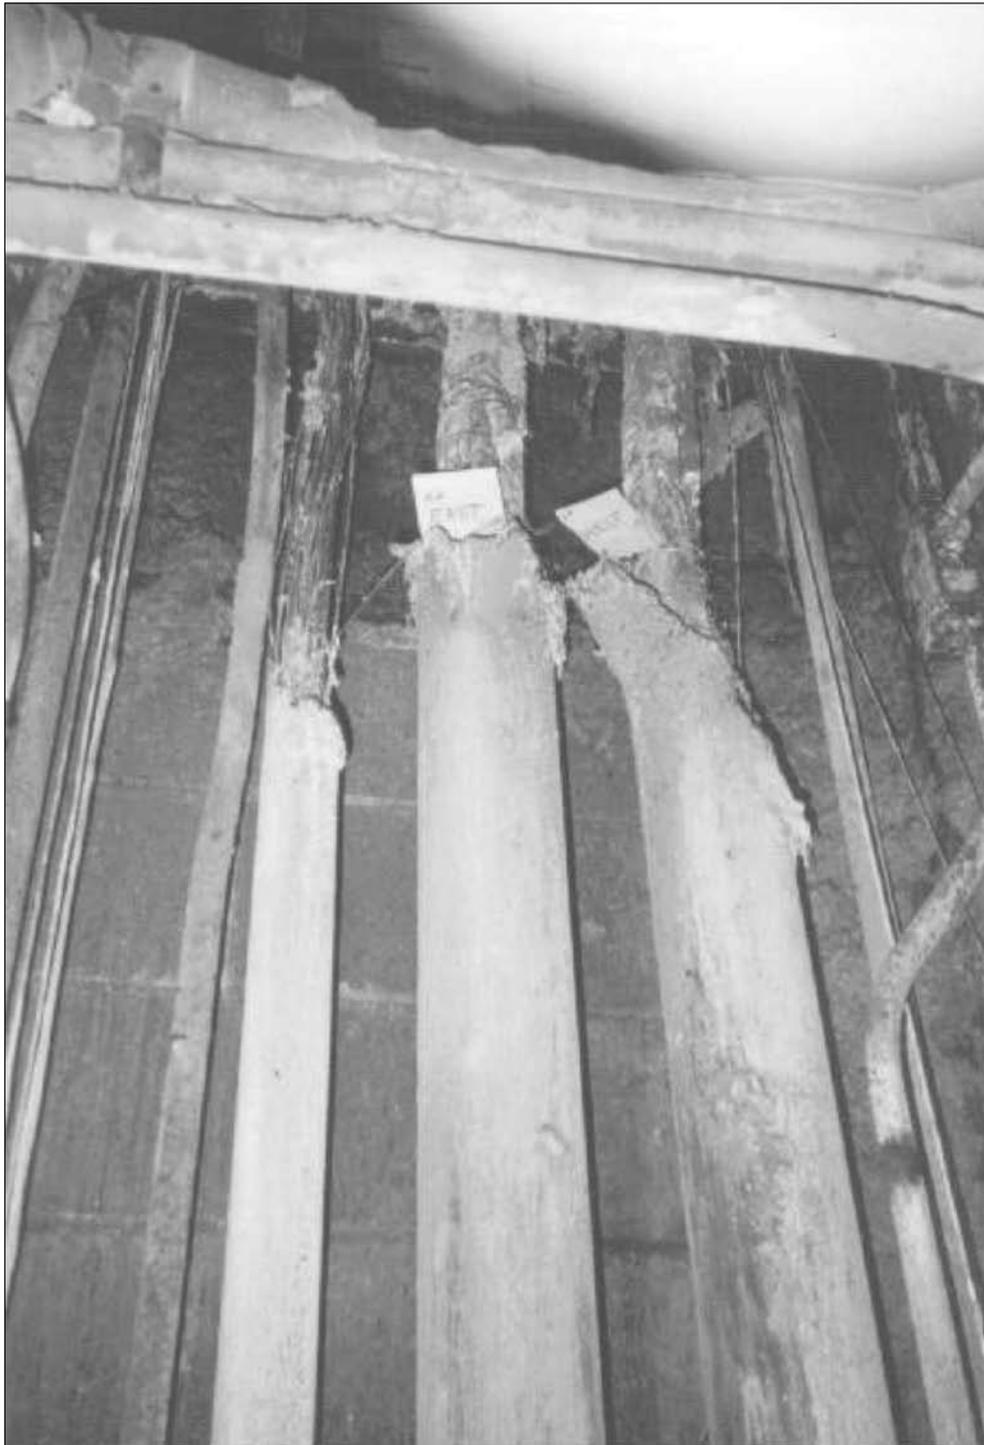
Electrical Systems	Installation of the primary and secondary electrical power risers in a common unprotected enclosure resulted in a complete power failure when the fire damaged conductors shorted to ground. The natural gas powered emergency generator also failed.
Fire Barriers	<p>Unprotected penetrations in fire-resistance rated assemblies and the absence of fire dampers in ventilation shafts permitted fire and smoke to spread vertically and horizontally.</p> <p>Ventilation openings in the stairway enclosures permitted smoke to migrate into the stairways, complicating firefighting.</p> <p>Unprotected openings in the enclosure walls of 22nd floor electrical closet permitted the fire to impinge on the primary and secondary electrical power risers.</p>
Standpipe System and Pressure Reducing Valves (PRVs)	Improperly installed standpipe valves provided inadequate pressure for fire department hose streams using 1-3/4-inch hose and automatic fog nozzles. Pressure reducing valves were installed to limit standpipe outlet discharge pressures to safe levels. The PRVs were set too low to produce effective hose streams; tools and expertise to adjust the valve settings did not become available until too late.

Shortly after the battalion chief and the attack team reached the 11th floor there was a total loss of electrical power in the building. This resulted when intense heat from the fire floor penetrated the electrical room enclosure. The heat caused the cable insulation to melt resulting in a dead short between the conductor and the conduit in both the primary and secondary power feeds, and the loss of both commercial power sources. The emergency generator should have activated automatically, but it failed to produce electric power. These events left the entire building without electricity for the duration of the incident in spite of several efforts to restore commercial power and to obtain power from the generator.

**Electrical shaft enclosure on the 30th floor, showing side-by-side risers for the two power supplies, both damaged by fire penetration at the plenum level of the adjoining office space.**

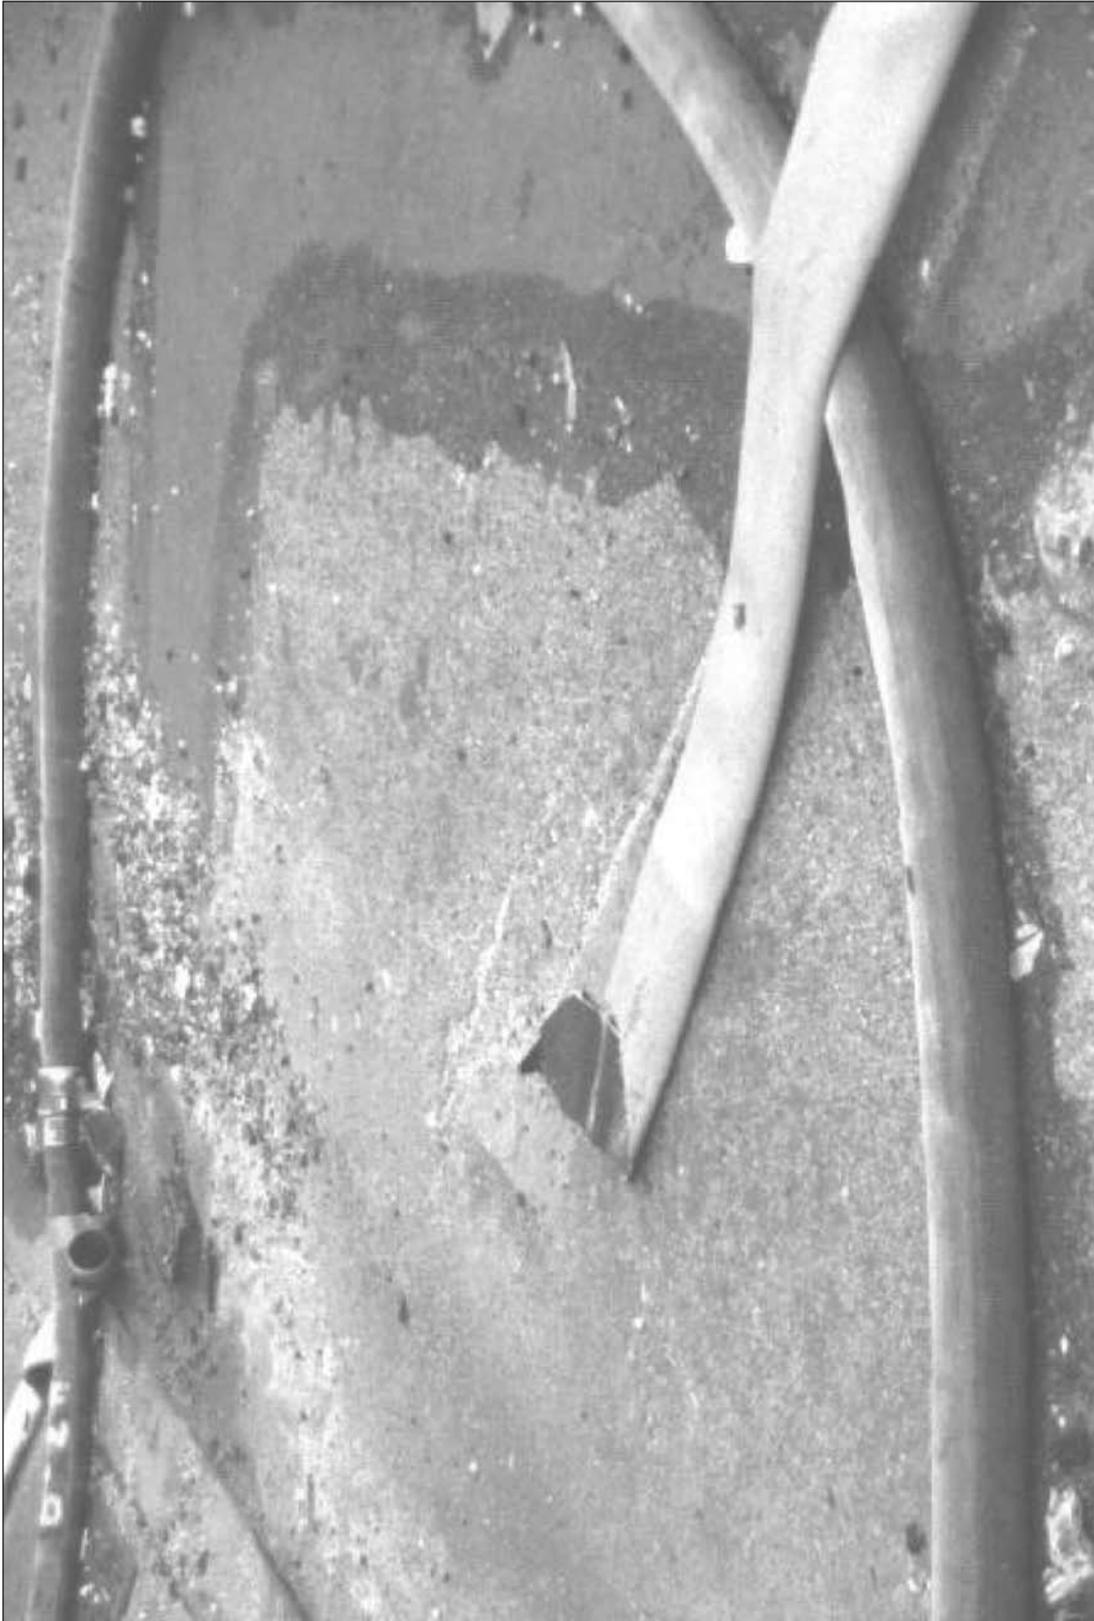
Section of 5-inch hose that was ruptured by falling debris outside the building. Hose lines feeding the standpipes and entering the stairways were damaged several times and had to be replaced at great risk to firefighters. (Shoring boards were later used to protect the hose lines.)

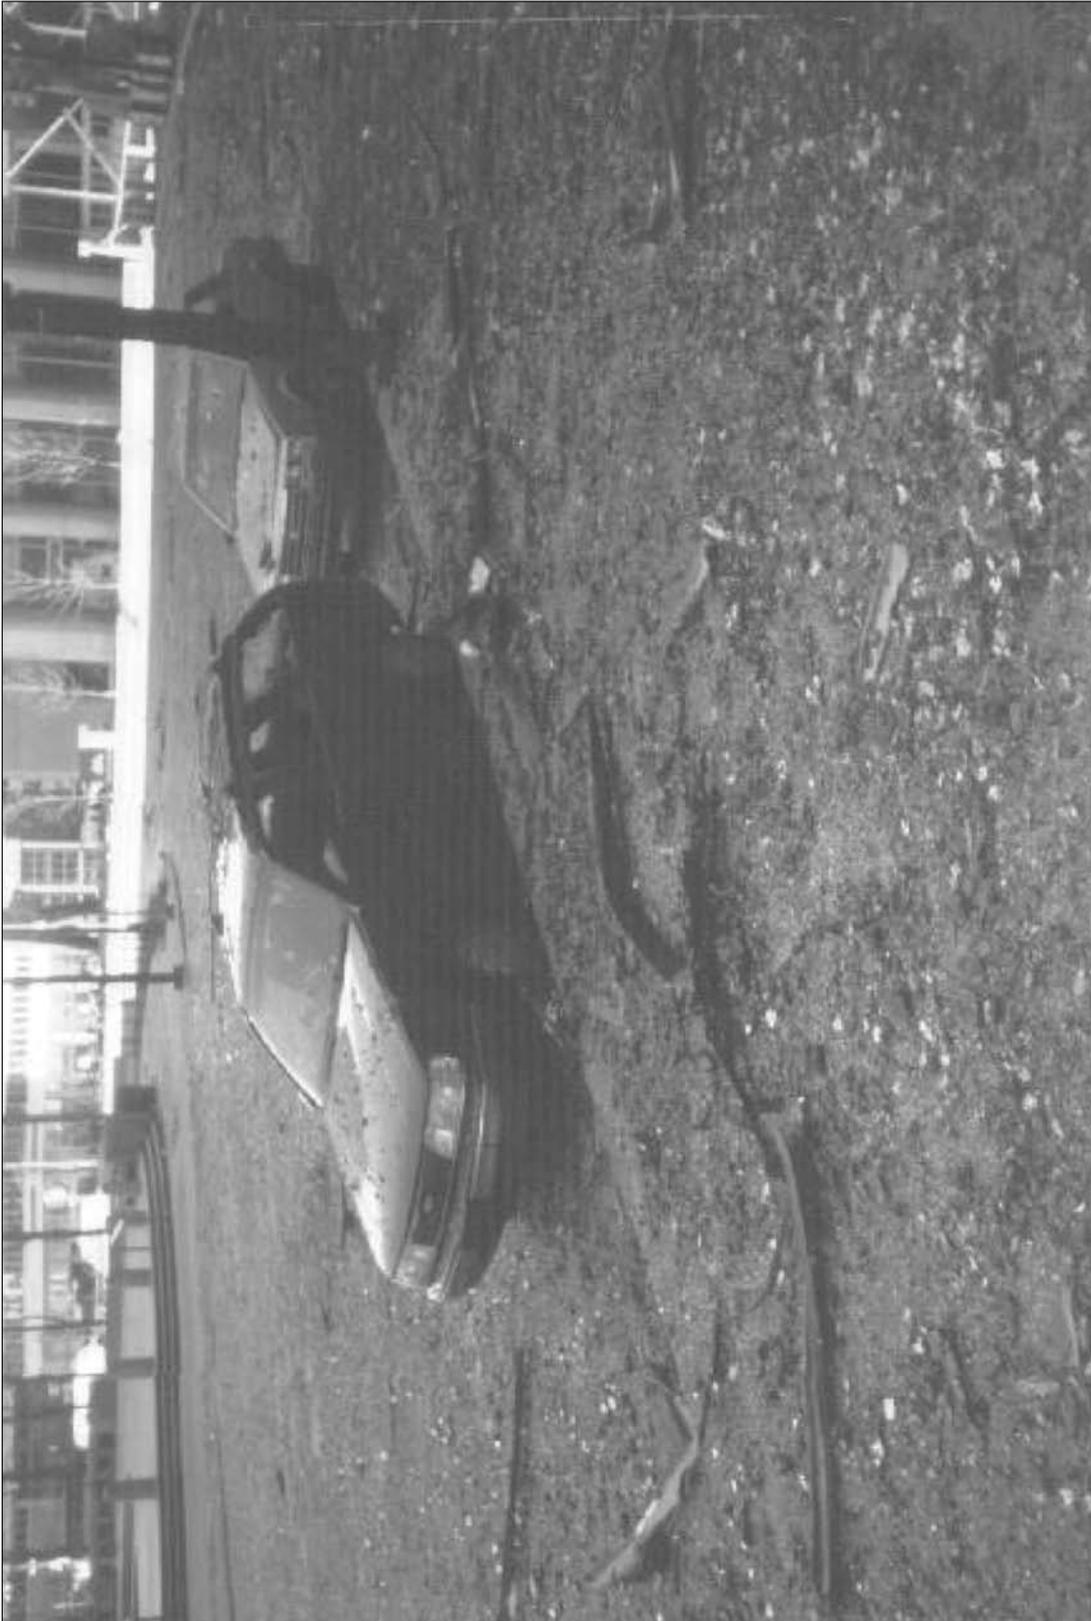
Street in front of the building from front steps showing stranded autos and debris in street.
