# Kona Village Apartments Fire

Bremerton, Washington

USFA-TR-121/November 1997

Investigated by: John Kimball

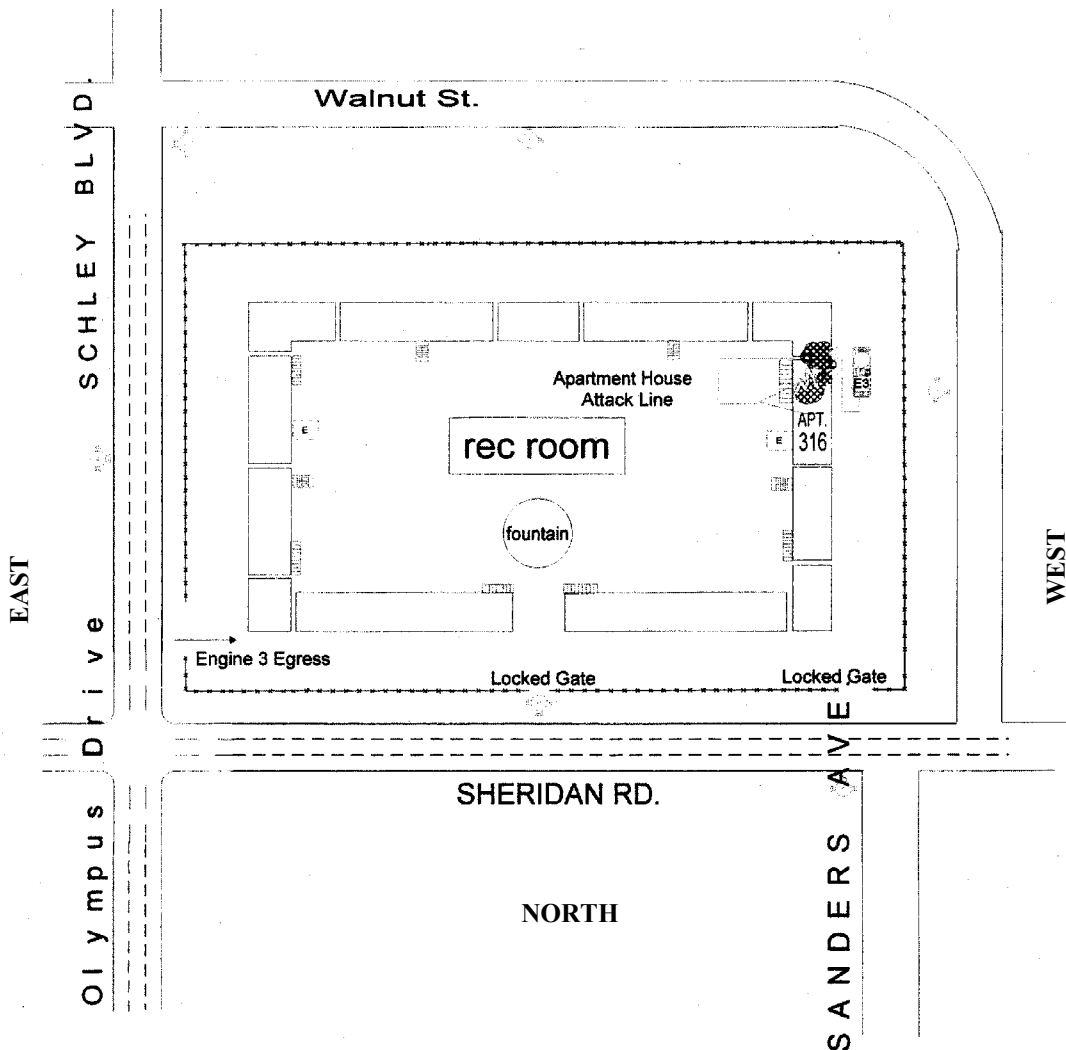
Diagram 2. Fire origin and first-in engine location

Diagram 2 indicates origin of fire and position of first arriving engine. Heavy smoke was evident on the west side and coming from the courtyard.

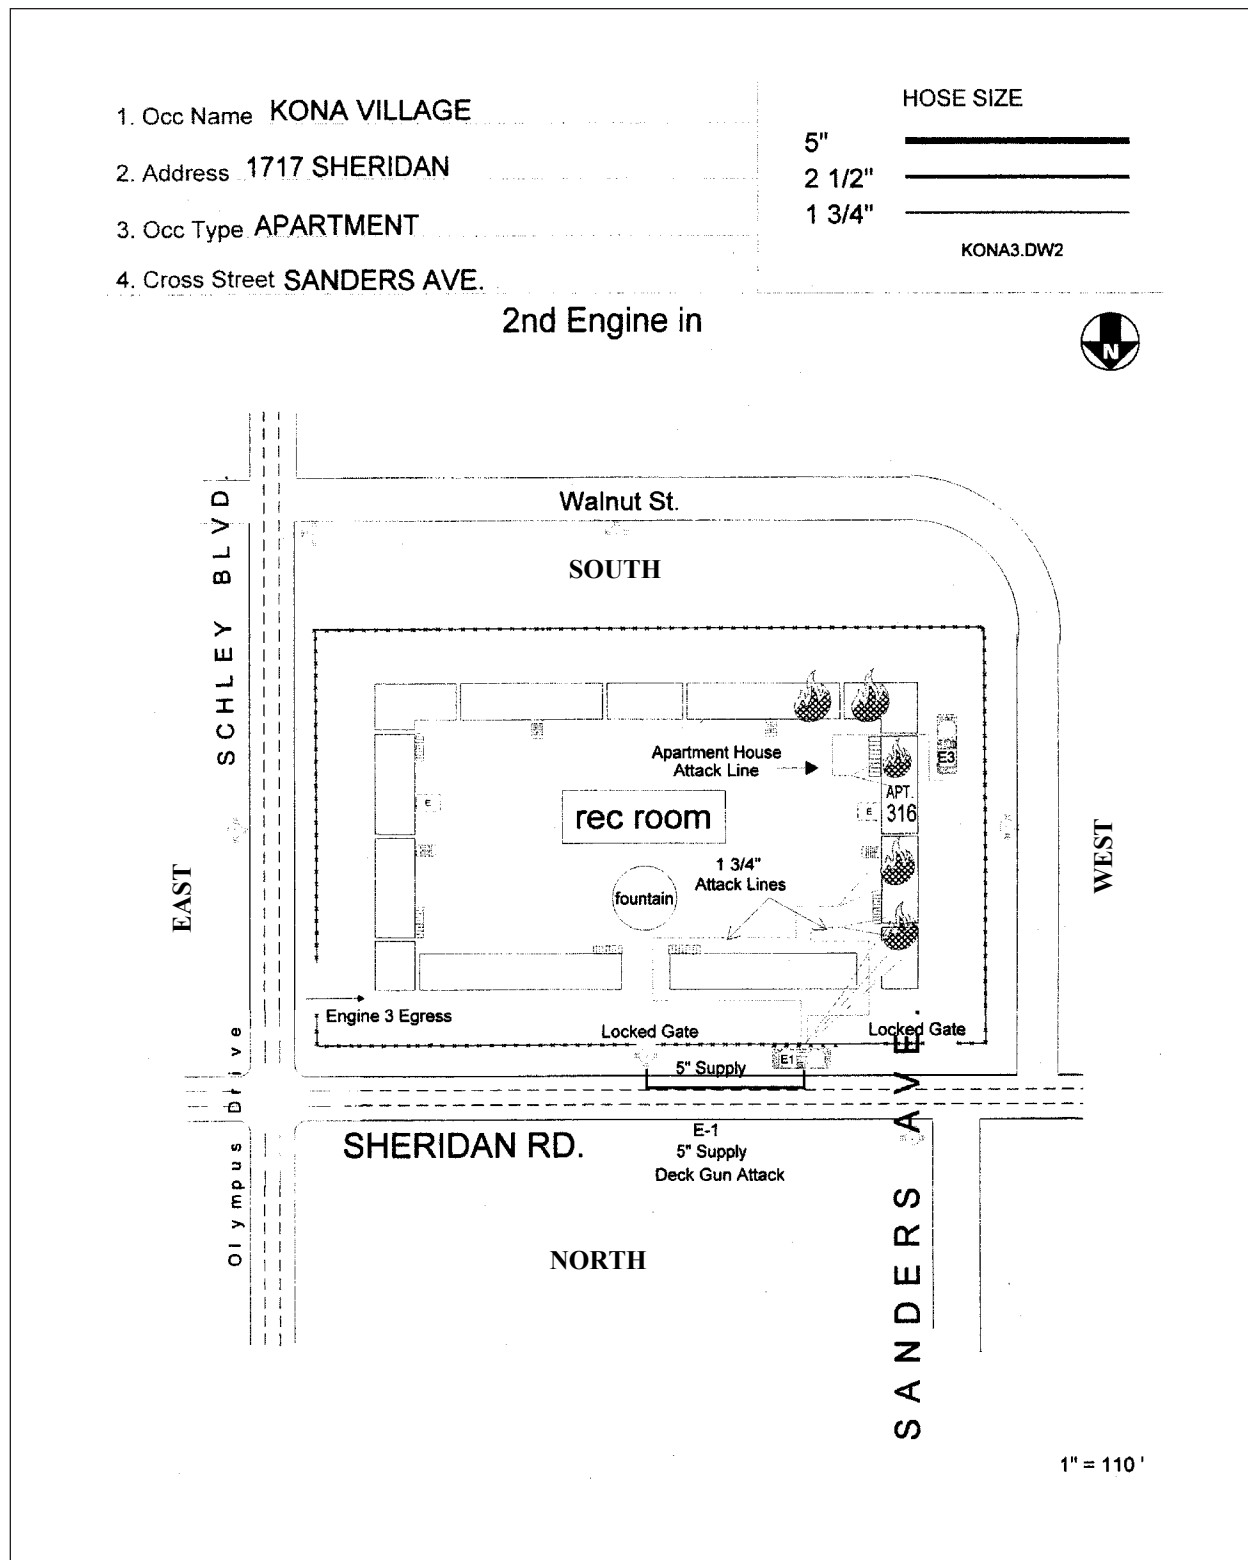
Diagram 3. Position of second engine and early fire travel

Diagram 3 indicates the position of second arriving engine (E-1) and extent of rapid fire travel. Conditions deteriorated from heavy smoke to heavy fire in a matter of seconds. E-1 hooked directly to hydrant and directed a large-caliber deck gun stream over the roof in an attempt to cut the radiant heat and protect firefighters and residents in the courtyard.

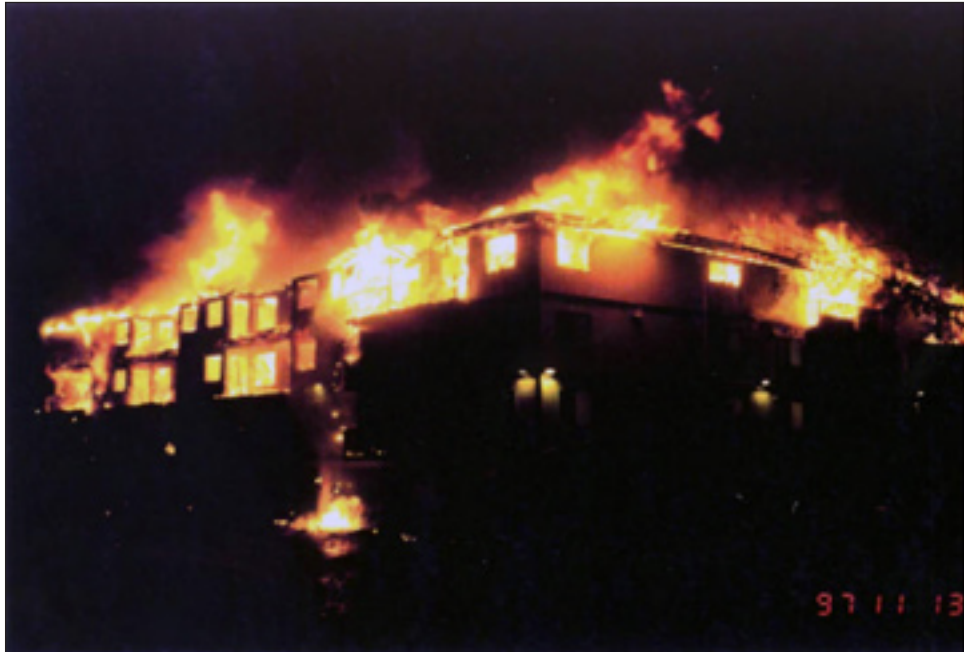
Photo 1 was taken at the southeast corner of building, shows fire conditions twenty minutes after dispatch.

The area of origin and location of the fatalities is at the left in the photo. The fire has extended horizontally through the attic area and dropped down via pipe chases and utility shafts.

Photo 1. Extreme fire conditions at the southeast corner

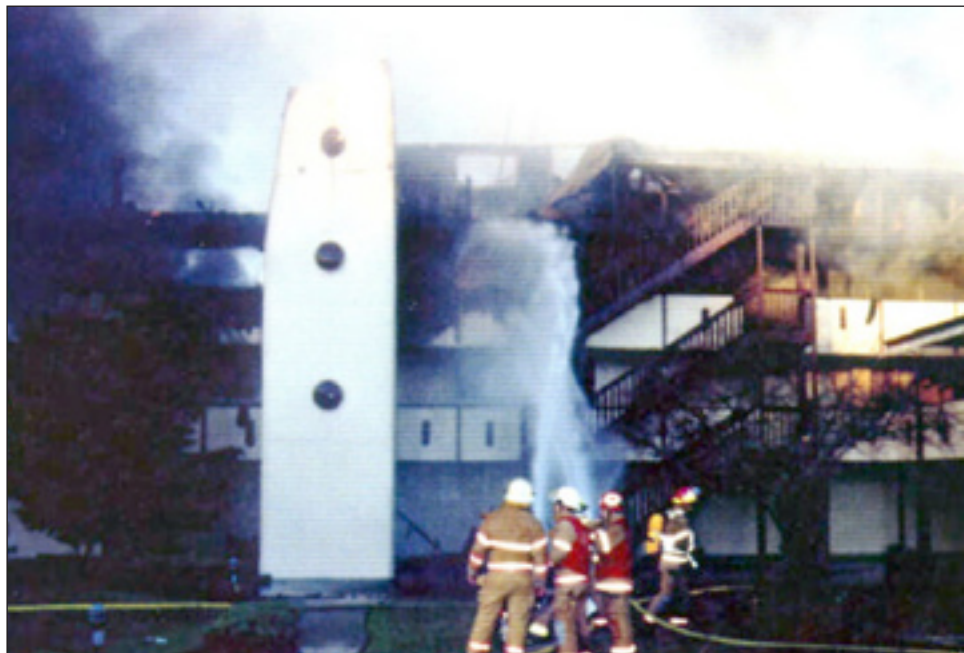
Photo 2 shows interior courtyard operations. Crews are deploying a portable monitor and multiple handlines to cutoff exterior fire extension. The two-story portion (north) is visible at the right. The enclosure to the left is the elevator. The apartment of origin is to the upper left.

Photo 2. Interior operations in courtyard, west wing

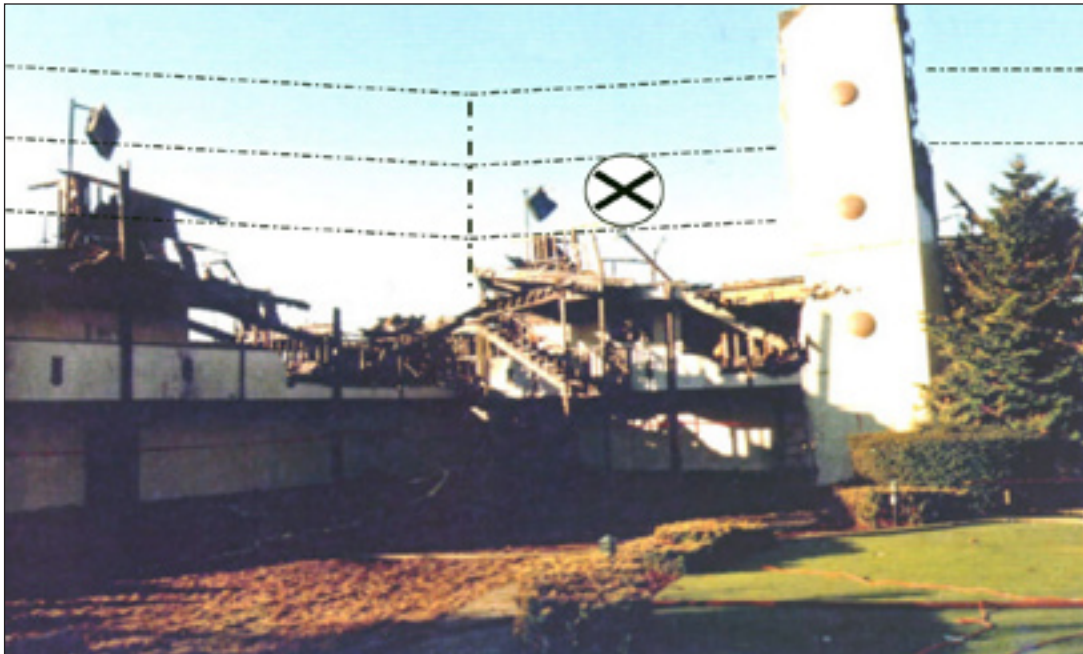
Photo 3. The view from the interior courtyard toward the SW corner.  
The X approximates the apartment of origin. Note the  
hose cabinets and piping still standing

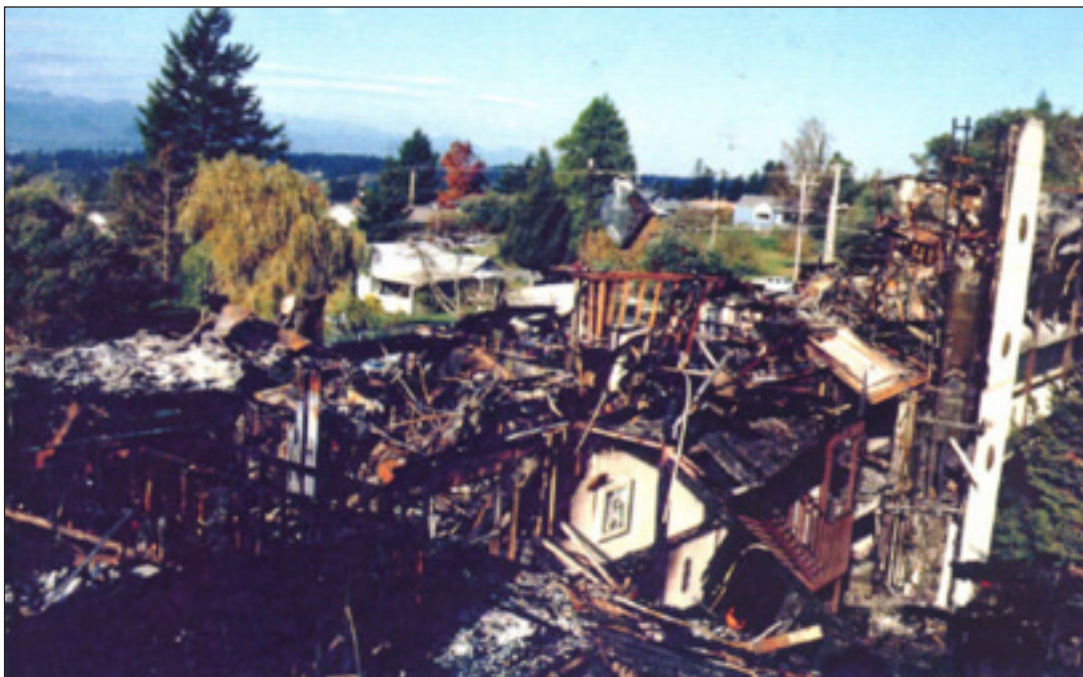
Photo 4. An elevated view of the west wing looking in a NW direction.  
The apartment of origin is at the center left

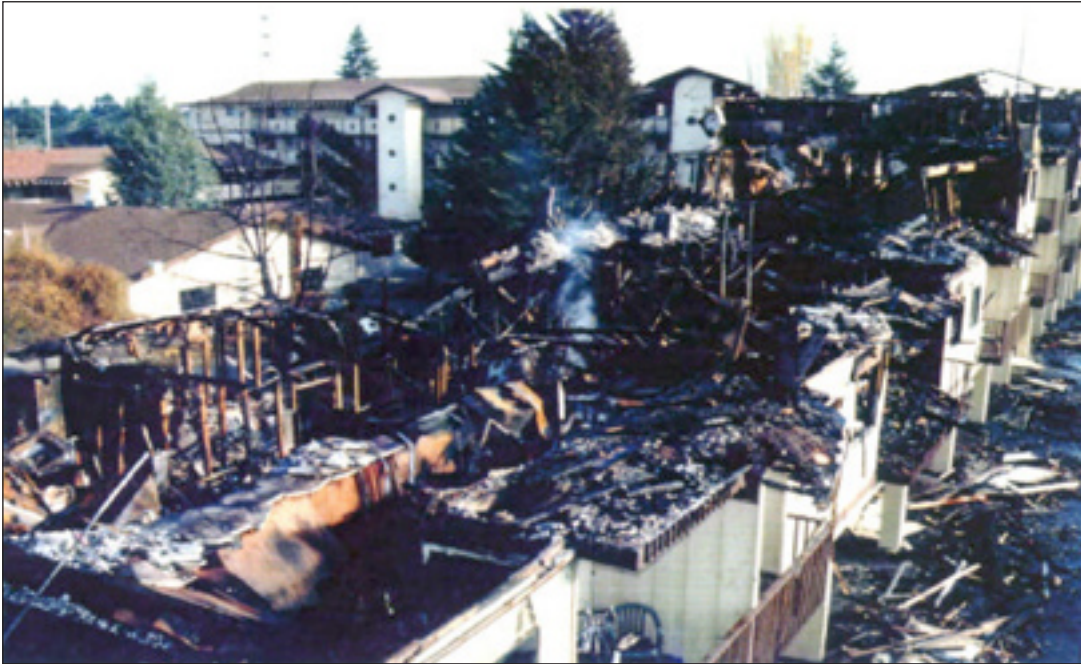
Photo 5. An elevated view of the south wing toward the east wing.  
The fire was stopped at the SE corner
