10 961

## FIELD INVESTIGATION OF THE NATURAL GAS PIPELINE ACCIDENT AT CANTERBURY WOODS, ANNANDALE, VIRGINIA

National Transportation Safety Board  
Department of Transportation  
Washington, D. C. 20591

Robert W. Beausoliel, Clinton W. Phillips, and Jack E. Snell

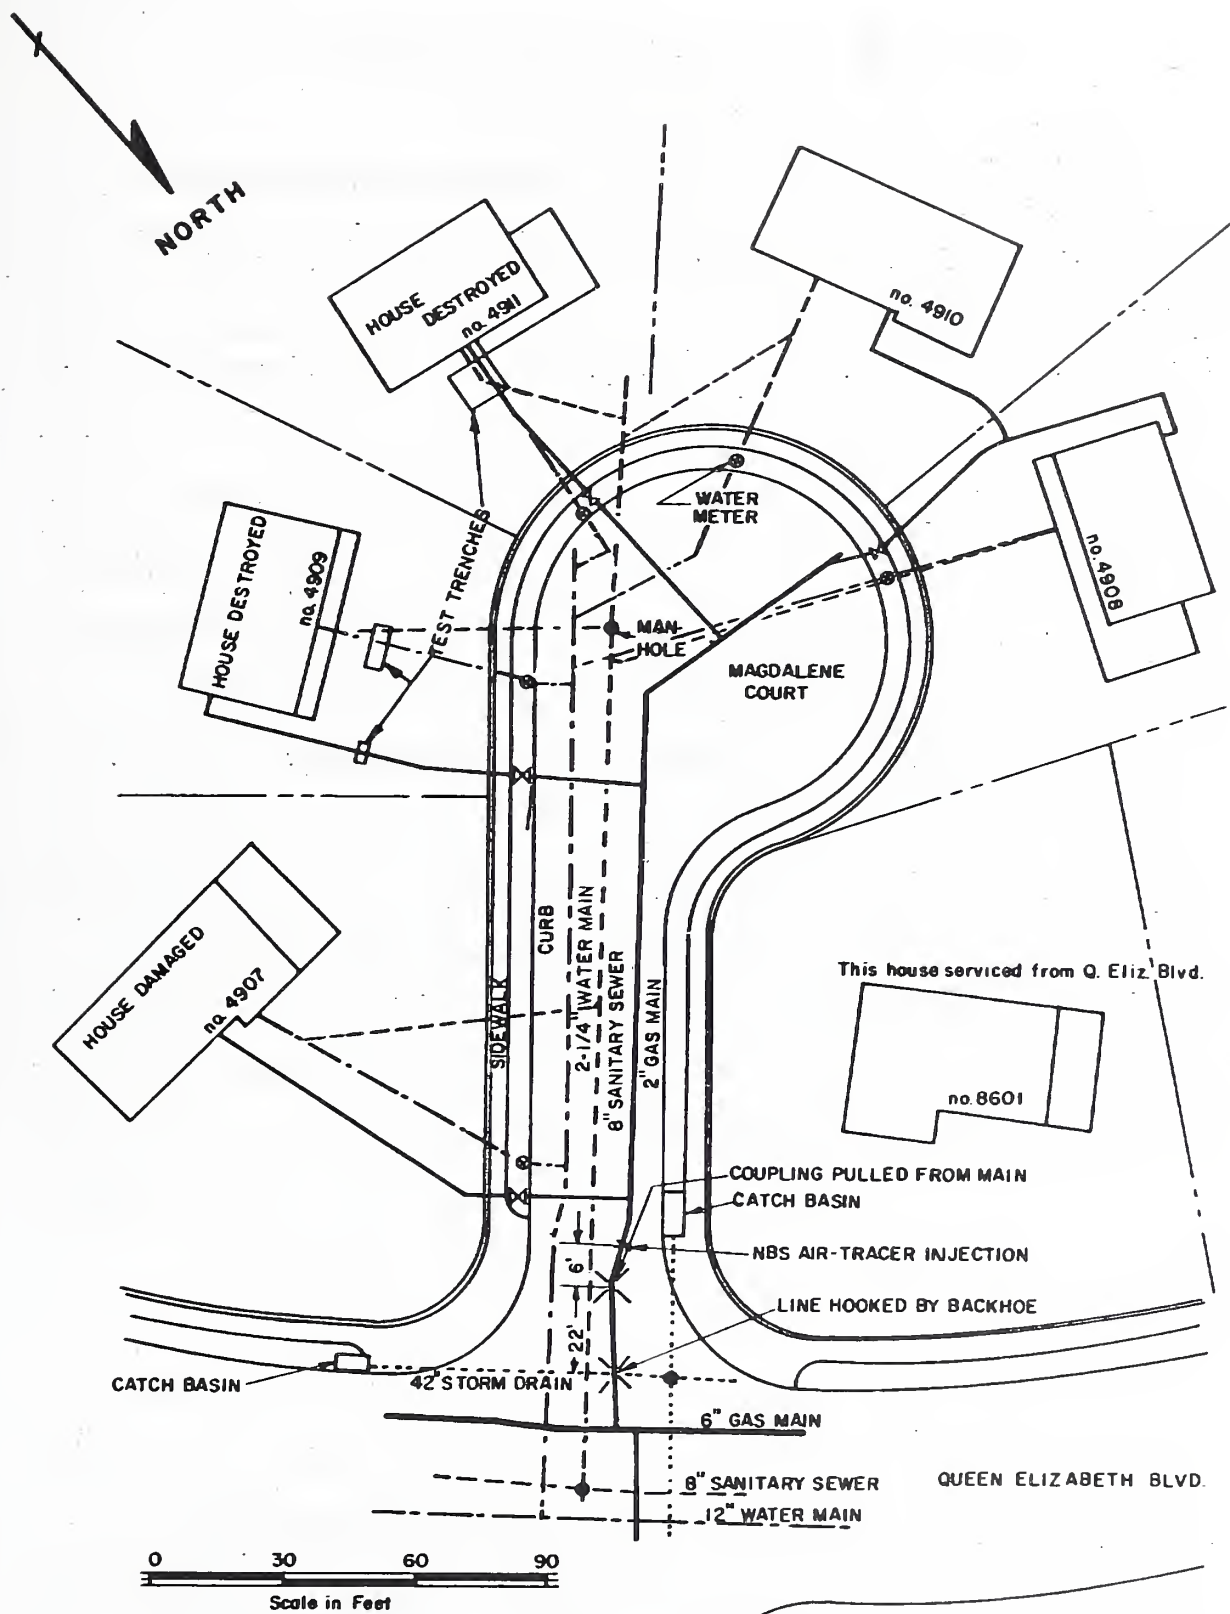
Figure 1. Accident Site.

- a. At 7:55 a.m., during the process of excavating for storm sewer pipe replacement for Queen Elizabeth Boulevard, a contractor's back hoe hooked a 2-inch, schedule 40, steel gas main serving five houses on South Magdalene Court, as indicated in Figure 1.

- a. Expansion joint between driveway and carport concrete slabs at 4907.
- b. Crack in the concrete gutter in front of the water meter box at 4909.
- c. Blacktop and concrete gutter interface located about three feet north of the catch basin adjacent to 8601 at the corner of South Magdalene Court and Queen Elizabeth Boulevard.

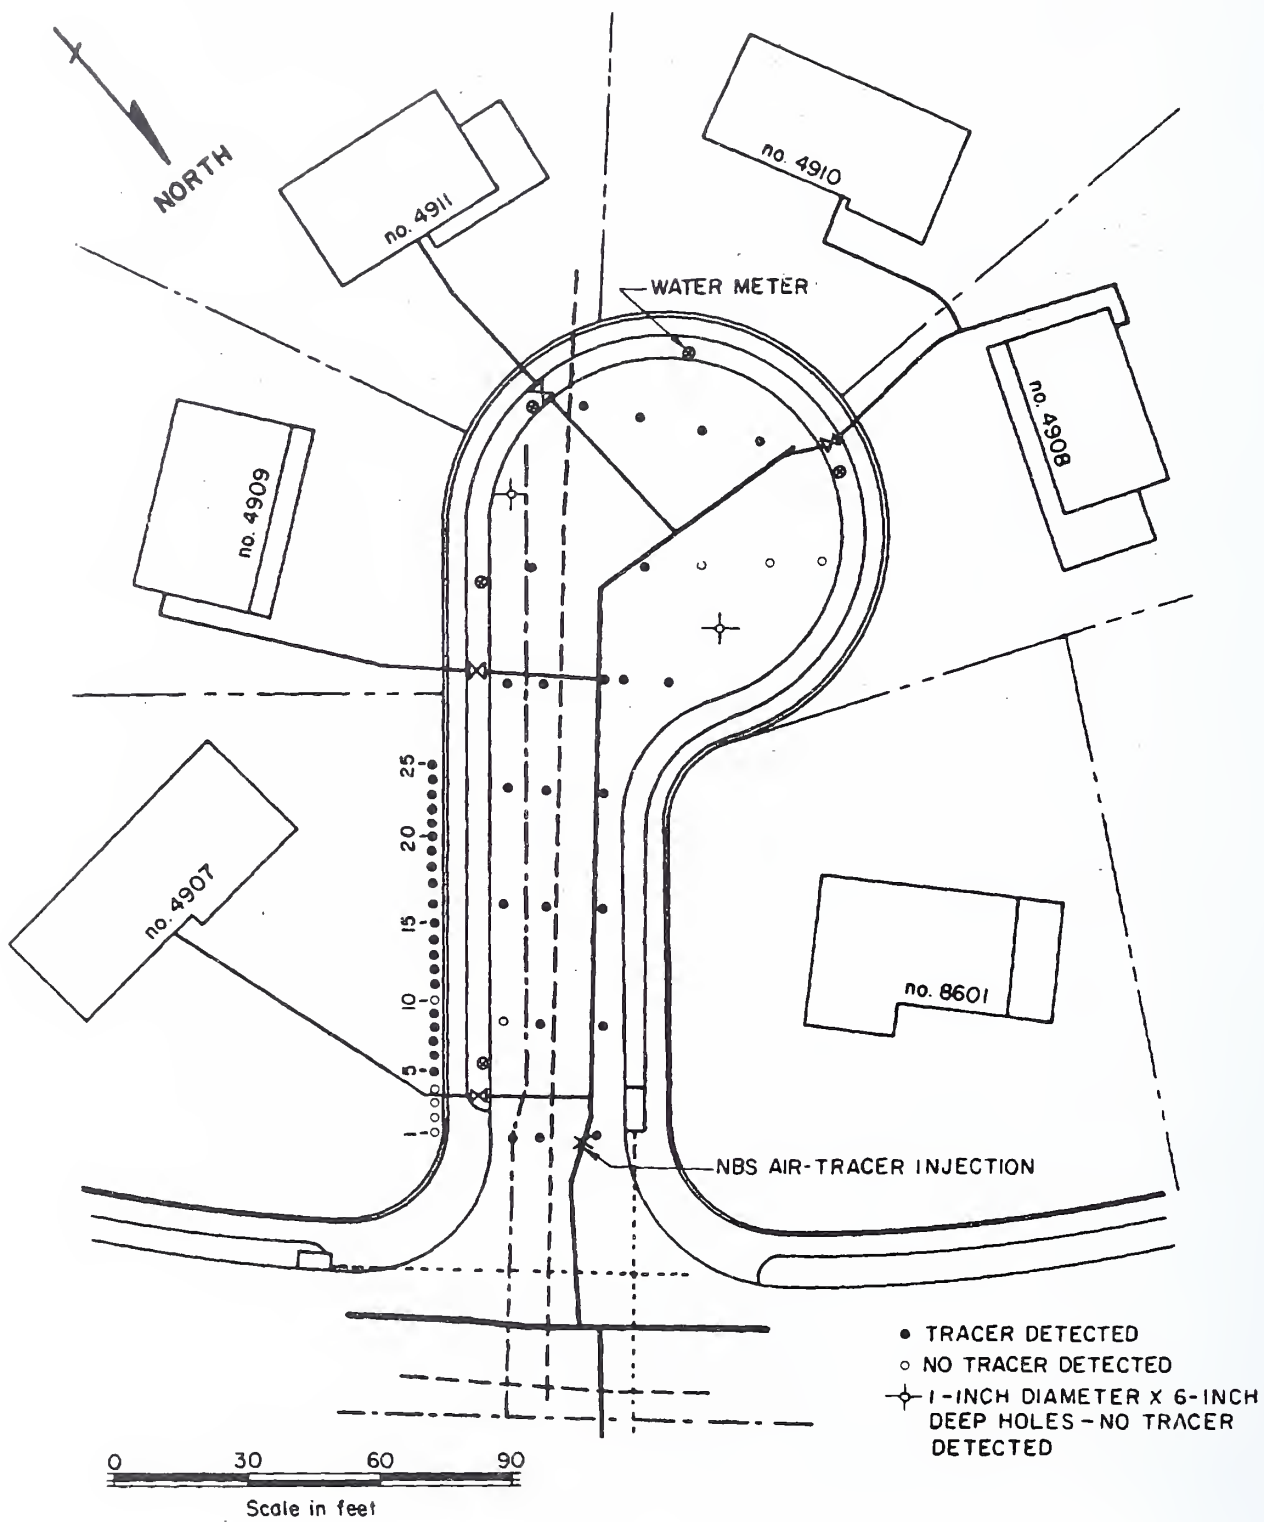
Figure 6. Network of drilled test holes.

The Fairfax County soil analysis sheets for Magdalene Court show only sub-base soil condition (approximate depth 10 inches) and do not show soil or fill condition beneath the sub-base. The drill hole pattern showed that tracer existed generally under the entire right-of-way surface at or above a depth of 2 feet. If a record of type of fill materials used in each utility trench and the depth below the right-of-way that these materials are located had been available, a better judgment could be made concerning the probable distribution paths of tracer in light of the tracer pattern recorded over the plan view of the right-of-way.

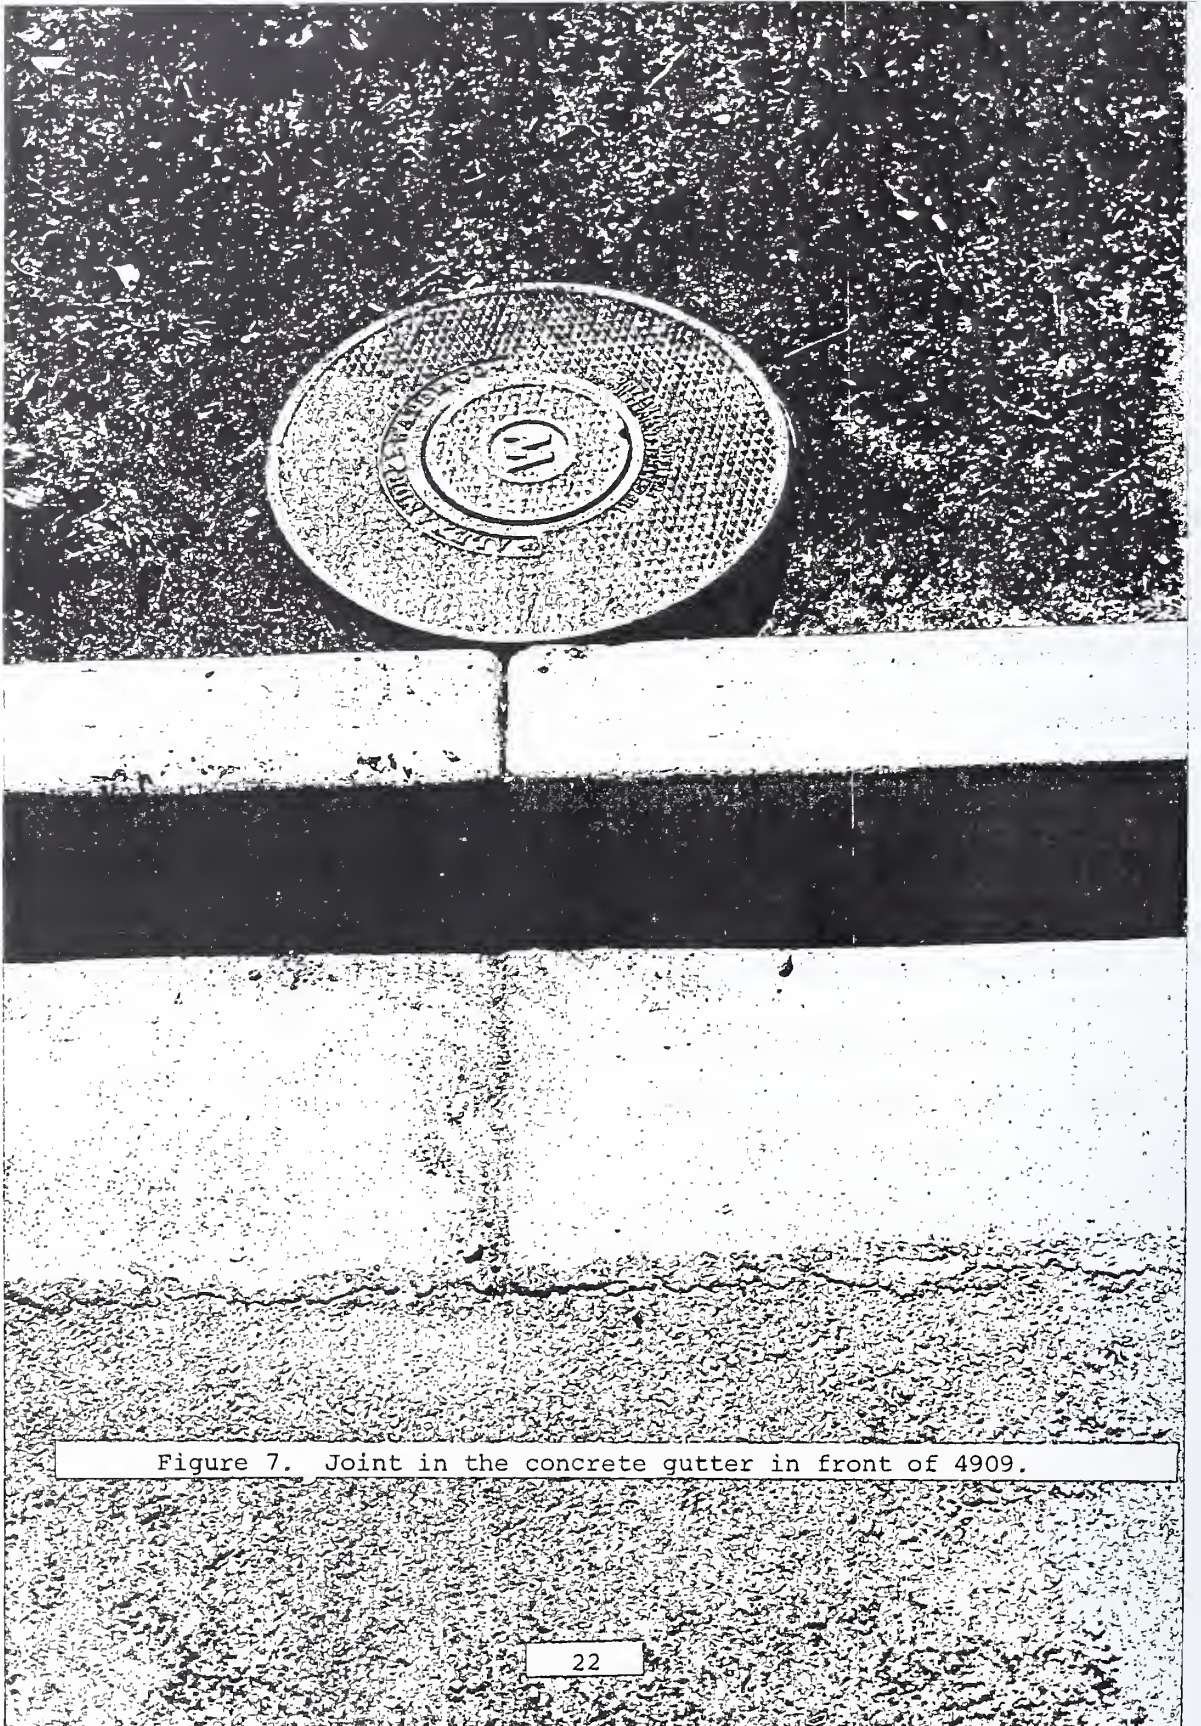
be established so that soil could be seen blowing up from the ground as had been observed during the accident and at the locations noted from the aforementioned videotape. These positions are (1) the blacktop and concrete gutter interface near the catch basin, (2) the driveway and carport concrete slab expansion joint at 4907, and (3) the joint in the concrete curb in front of the water meter box at 4909. See Figure 1.

Figure 7. Joint in the concrete gutter in front of 4909.

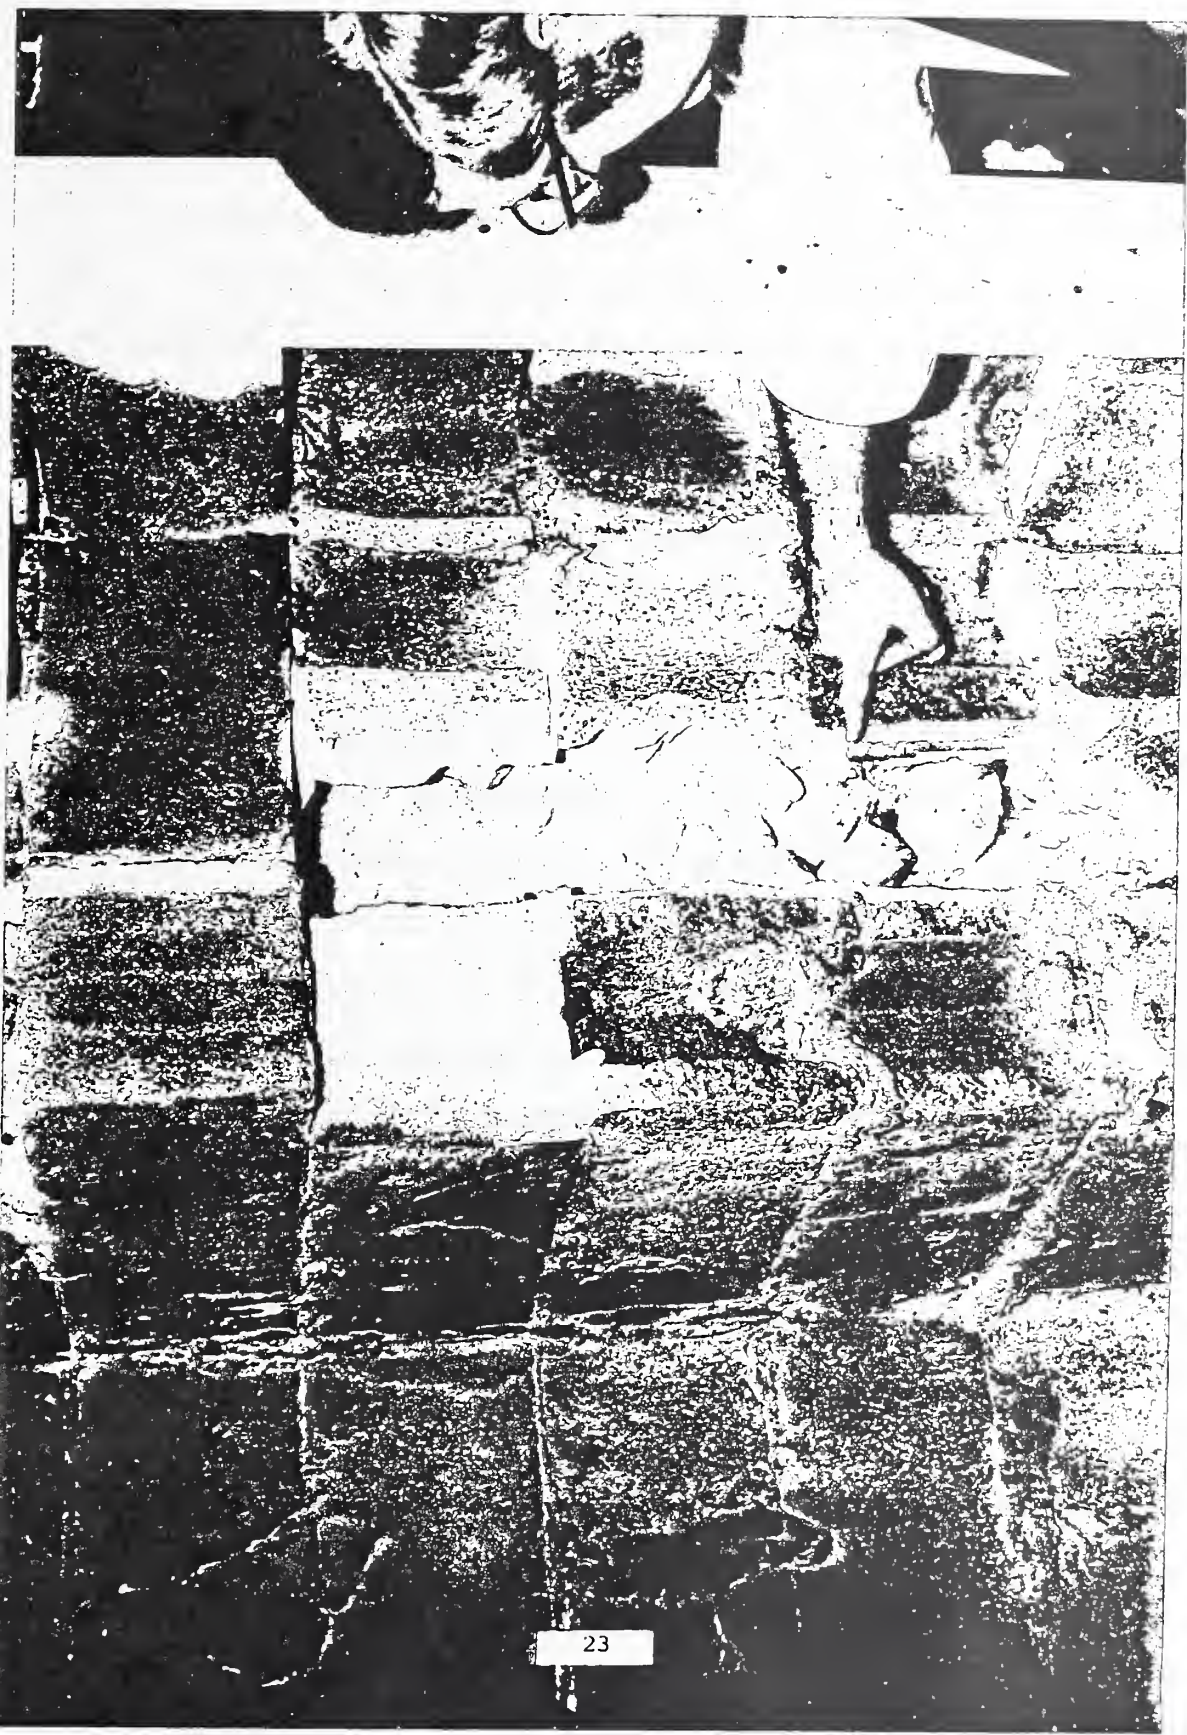
Figure 8. Rock rubble against the foundation wall at 4907.

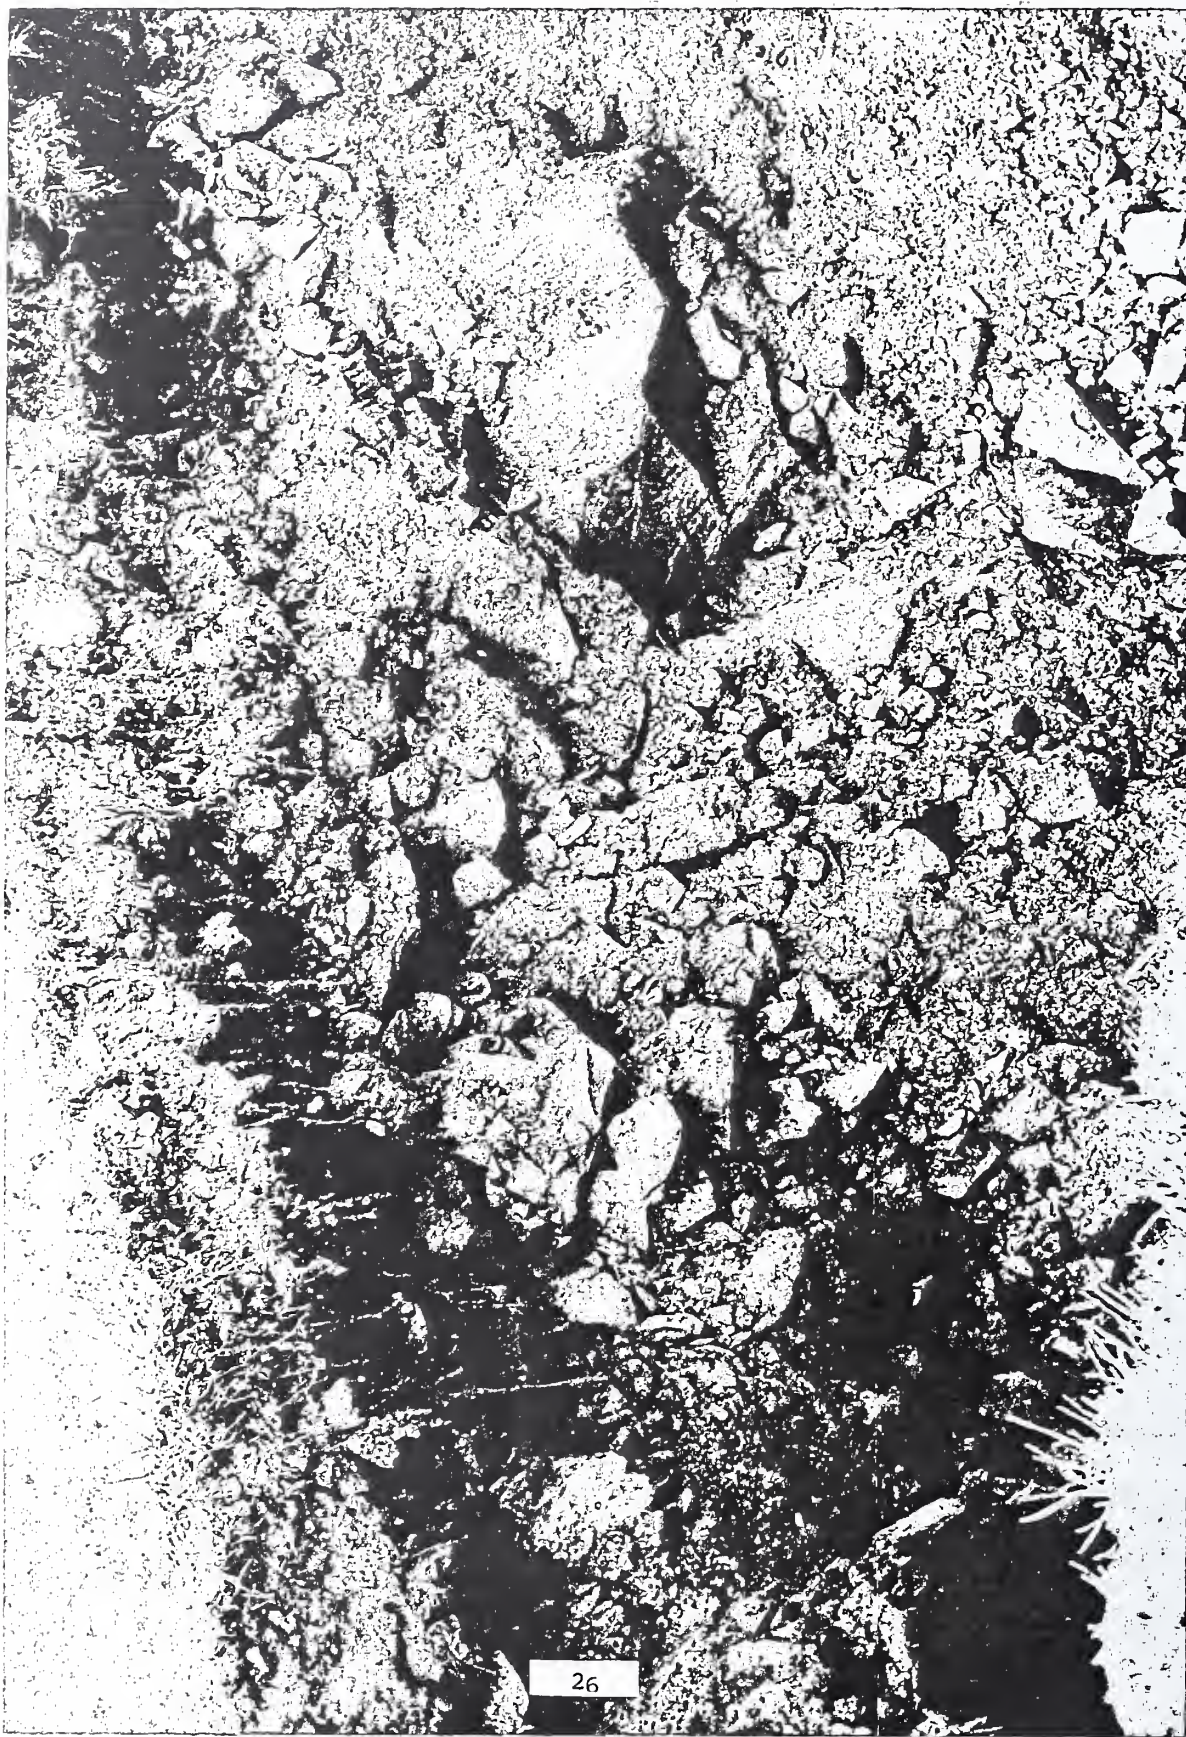
The test trenches in front of 4909 and 4911 contained much rock rubble. See Figures 9 and 10. This rock rubble consisted of loosely-placed rock backfill. The Federal Highway Administration's report containing results of rock-soil samples is attached as Appendix 7.3. This report shows that the trench at 4909 containing the water and sewer lines had fine soil to a depth of 0.4 of a foot, coarse angular rock

Figure 9. Rock rubble in the water and sewer service trench at 4909.

fragments loosely placed as backfill between 0.4 and 5.8 foot depths, and at 6.8 foot depth a fine soil existed. In other words, the rock fill of five inches or greater sieve-size was sandwiched between layers of fine soil material in the 4909 water and sewer line trench. The water/sewer lines were covered by about six inches of rock-free fill in this trench but rested directly on rock fill. No tracer was detected in the immediate vicinity of the water/sewer lines. The water line was beside and below the sewer line.<sup>1</sup> (See Fig. 10.) Water line depth was 69 inches below grade and sewer line depth was 63 inches. No tracer was detected in the gas line trench at 4909. Appendix 7.3 shows that this trench contained a mixture of fine soil and angular rock fragments. The gas line was bedded in rock-free fill and covered with rock-free fill about eight inches deep. The gas line depth was about 24 inches.

- d. Natural gas could flow again into or to the same homes if another natural gas leak were to occur in the vicinity of the leak of March 24 unless the rock rubble paths are eliminated.

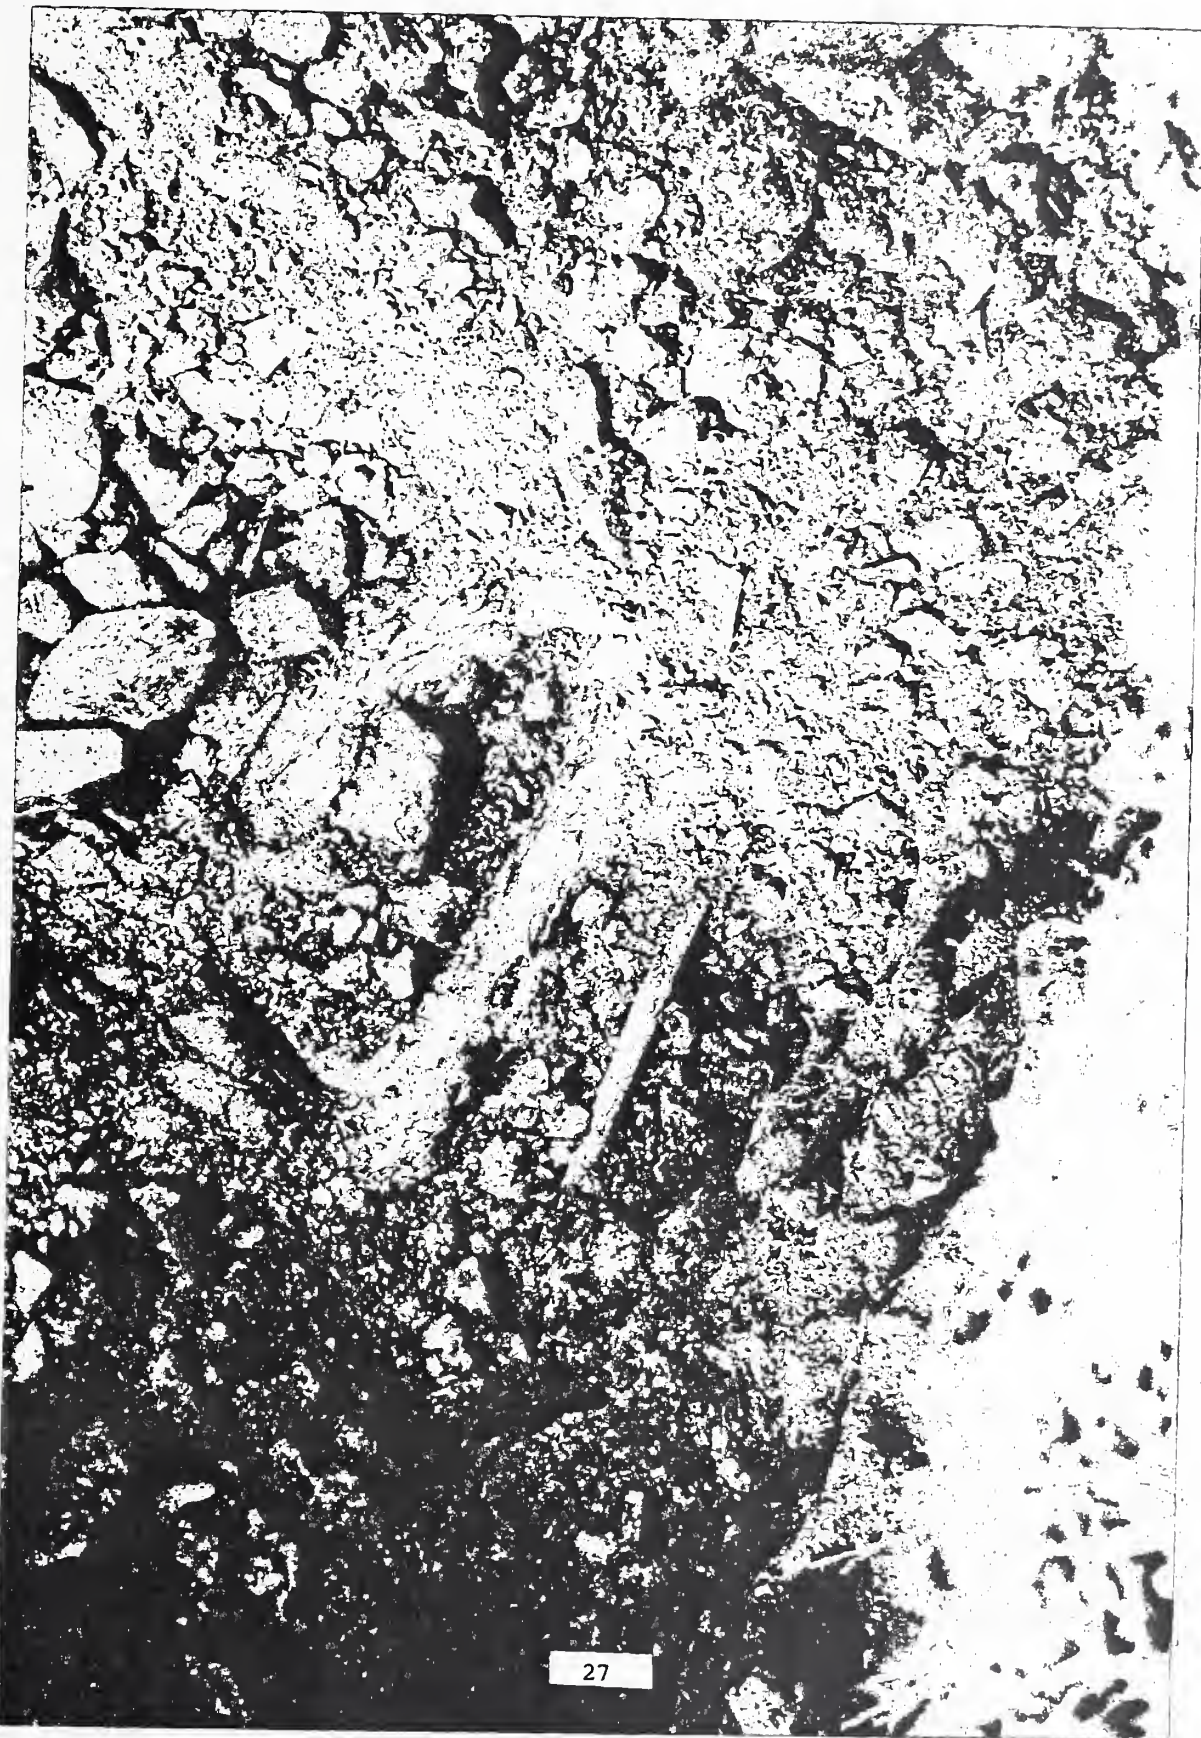
Figure 10. Rock rubble bed for water and sewer services at 4909.

Throughout the digging process on May 18, tracer was detected in the trench at 4911. Rocky fill was found in direct contact with water, sewer, and gas lines.<sup>2</sup> Appendix 7.3 shows that coarse angular rock fragments, five inches or greater sieve size, were loosely placed around the water line.

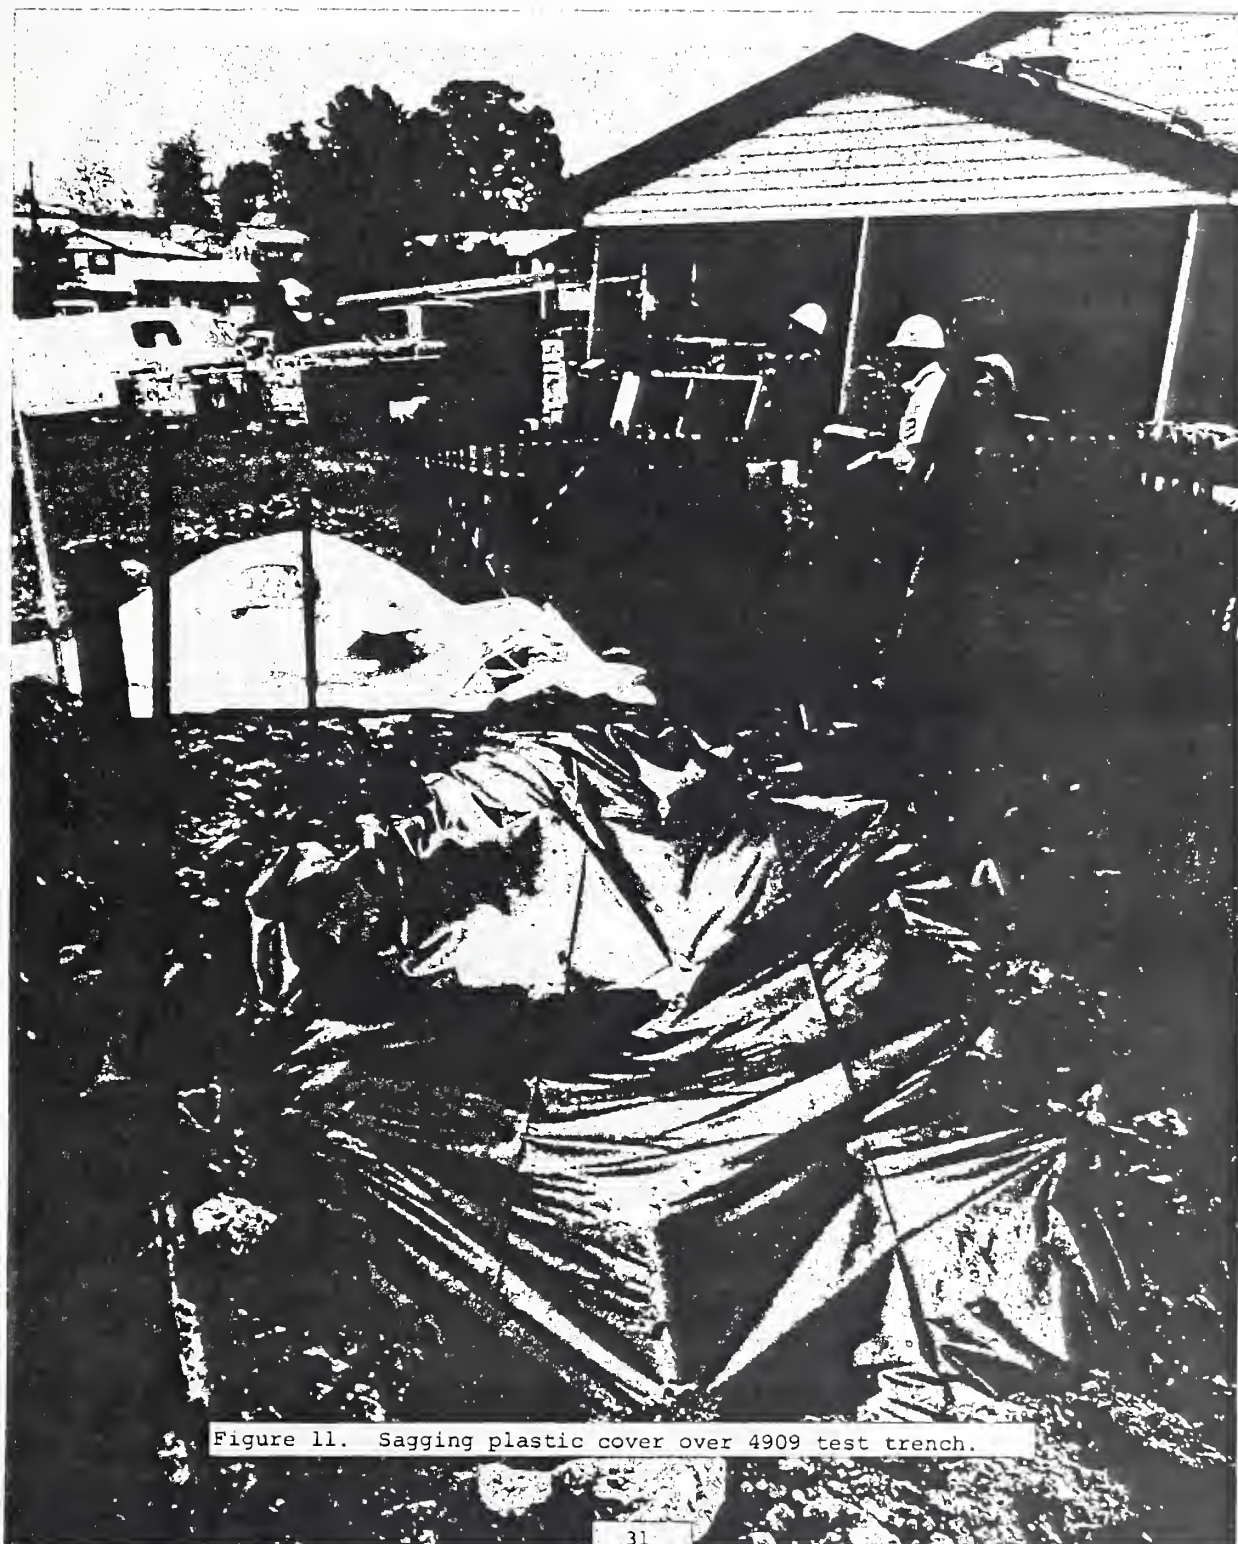
In the quantitative air flow test at 4909, with the vacuum pump off, air tracer entered the trench through the rock fill and caused the plastic cover sheet to be forced up. With the vacuum pump operating at a measured maximum capacity of 15.0 cfm, this capacity was not sufficient to cause the plastic cover to collapse. A micromanometer indicated a varying positive pressure of up to 0.02 inches W.G. (water gage) in the trench with the pump running. To determine if a slight wind was affecting this observation, the vacuum pump and the air supply to the street cavity were turned off. The plastic cover sagged into the trench within one

This test indicates that the air-tracer flow into the trench was in excess of 15 cfm. Also, this air flow test showed that the air-tracer readily passed through voids in the rock rubble from the injection point 150 feet away to the front of the foundation wall at 4909. Air flow at the injection point was 41 cfm and cavity pressure was 3.5 psig at the time of this test.

Figure 11. Sagging plastic cover over 4909 test trench.

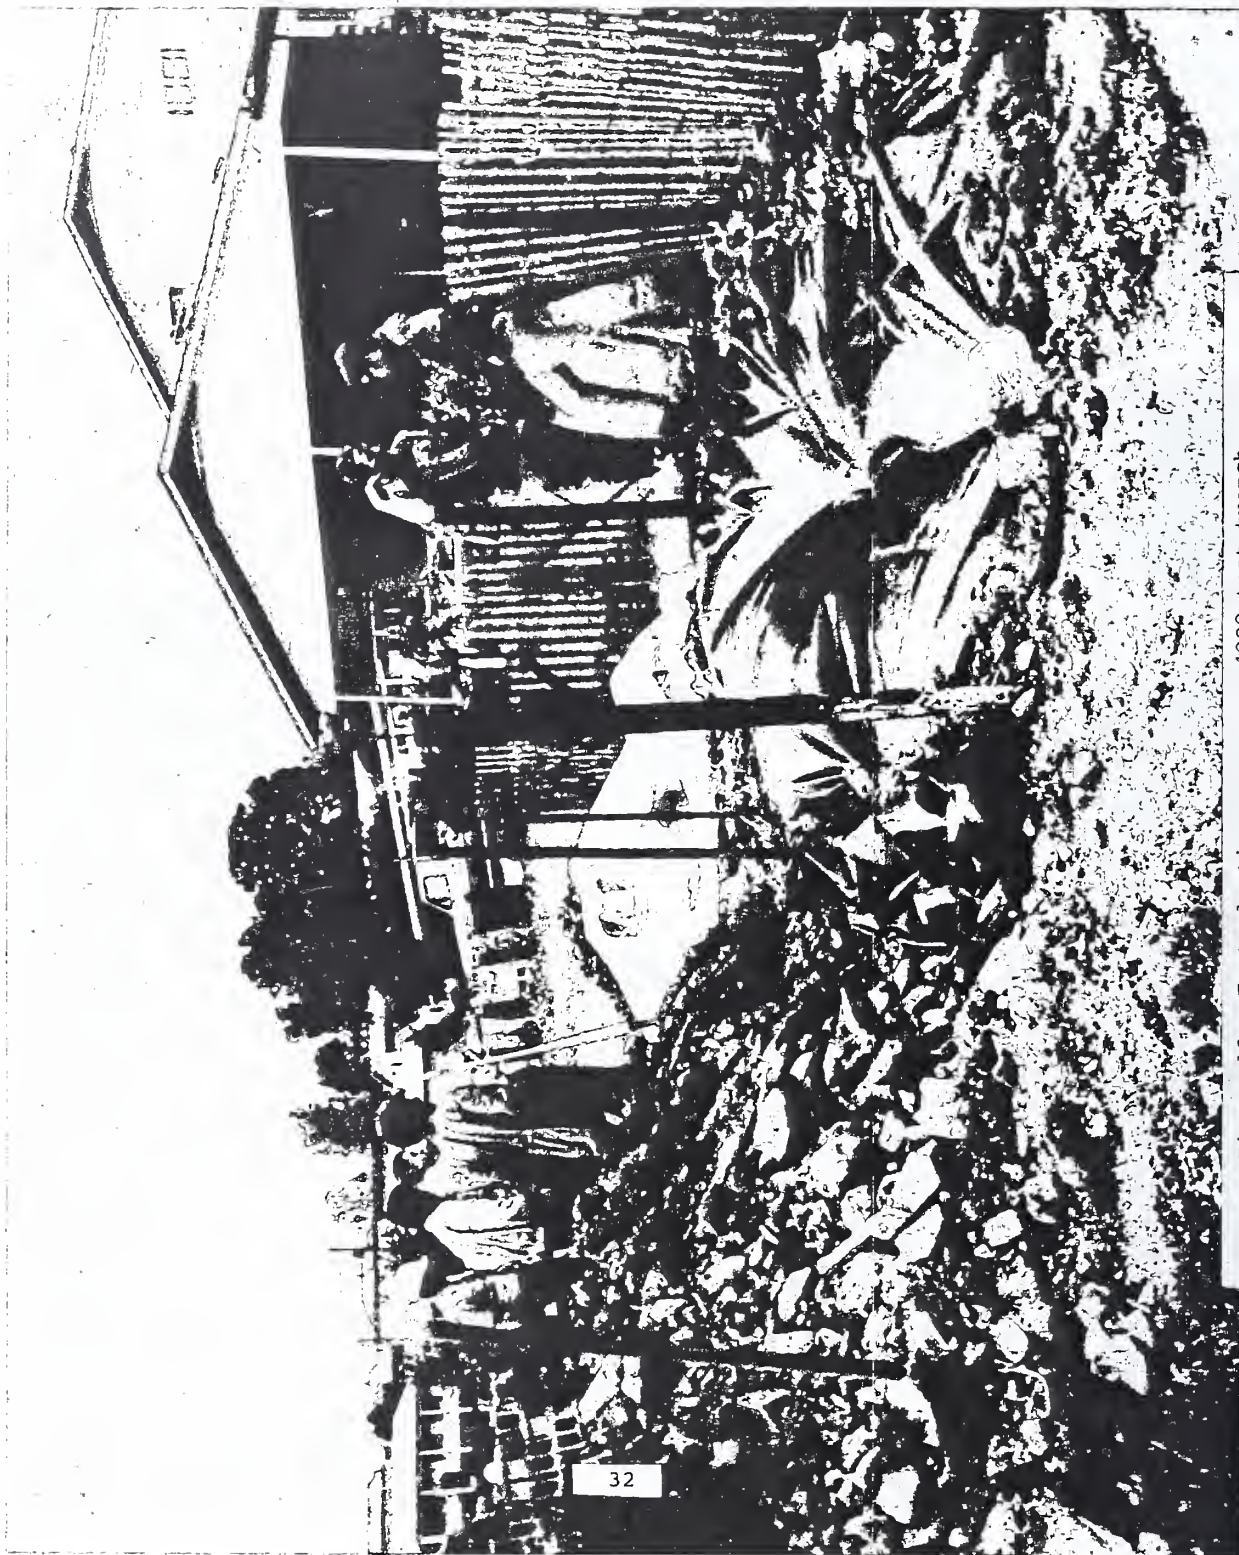
Figure 12. Taut plastic cover over 4909 test trench.
