# NBS SPECIAL PUBLICATION 592

## An Investigation of the Miyagi-ken-oki, Japan, Earthquake of June 12, 1978

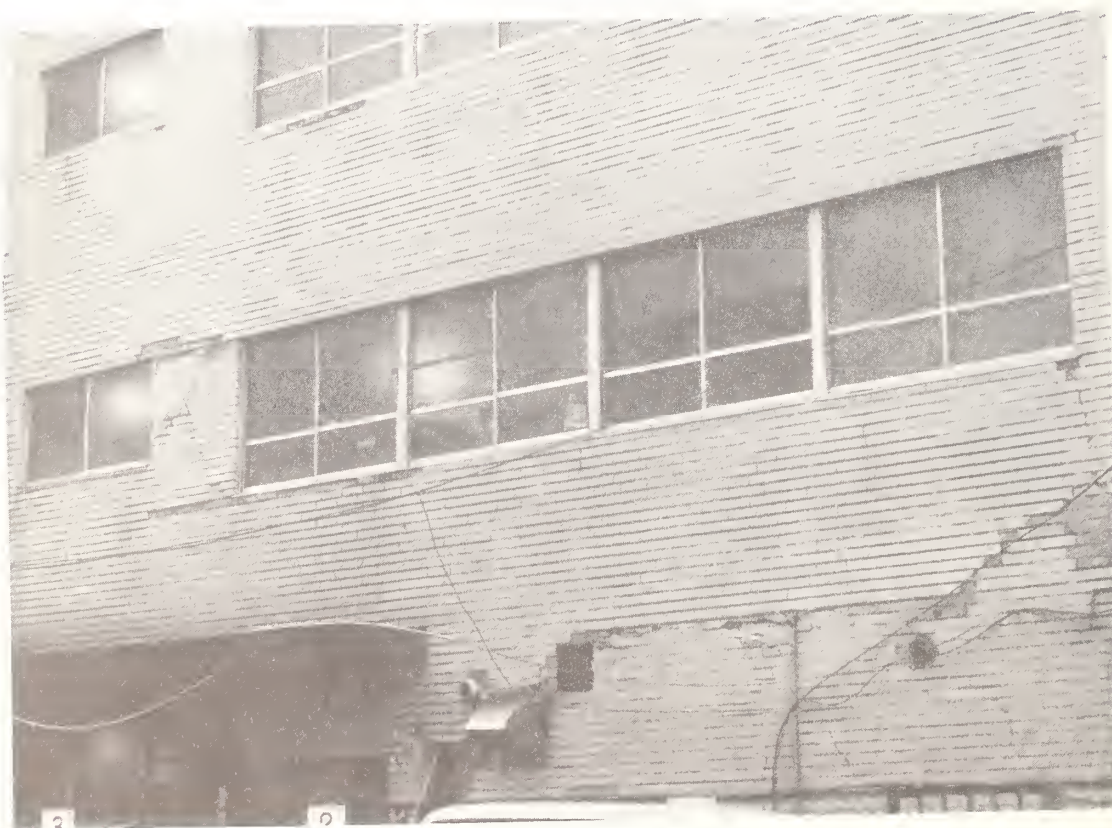
Figure 5.6 Second Eastern Building Company Building, Sendai. A typical modern building in Sendai; the only apparent damage to the glazed tile veneer on the exterior was cracking on spandrels and shear walls.

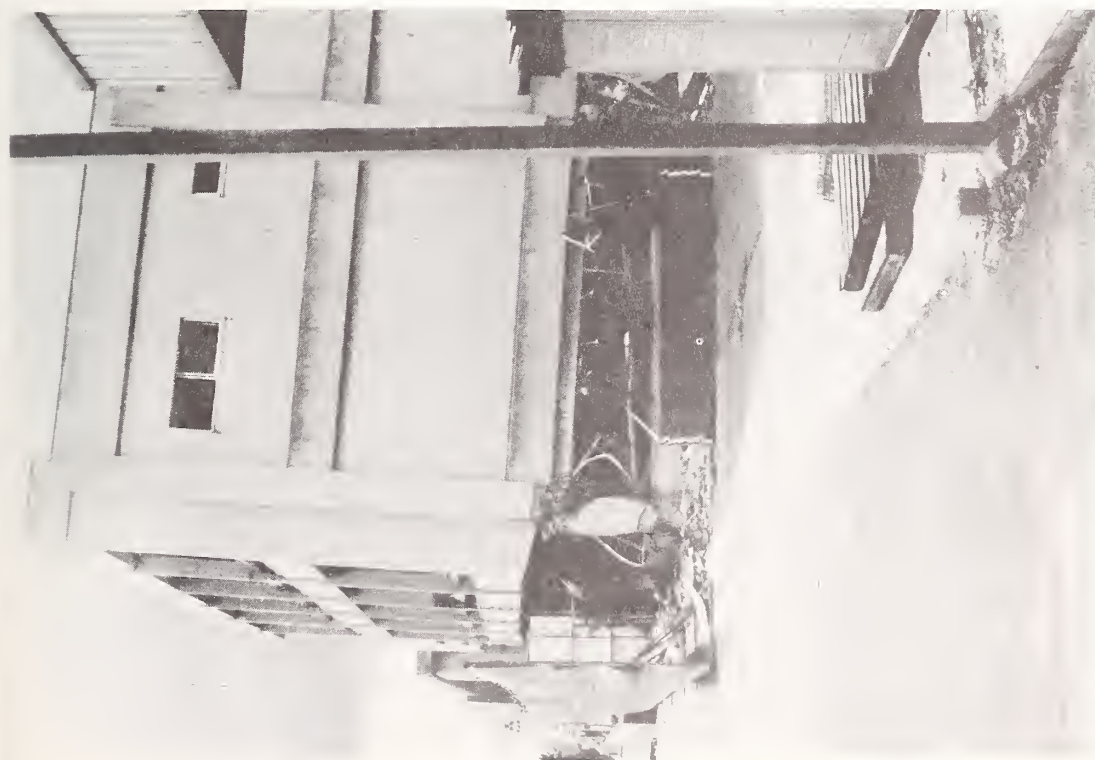
Figure 5.24 Maruyoshi Building, view from the east.  
Failure of first story columns occurred  
in shear.

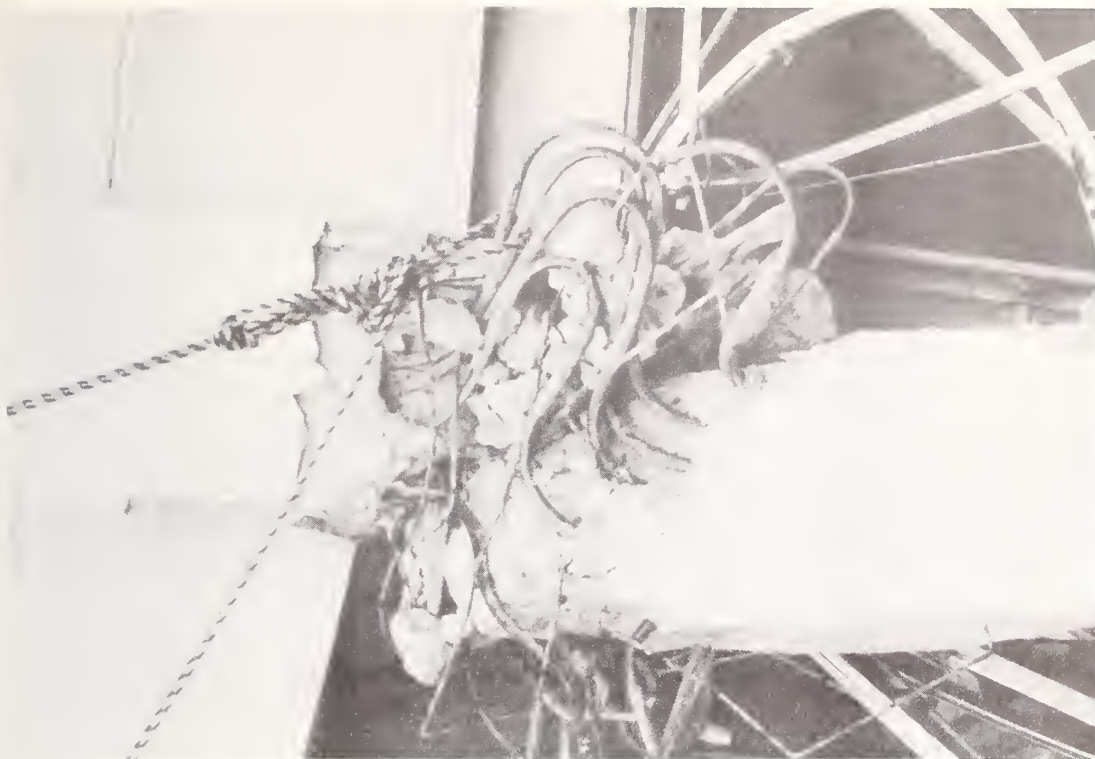
Figure 5.25 Maruyoshi Building. Detail of a joint  
at the top of a first story column.

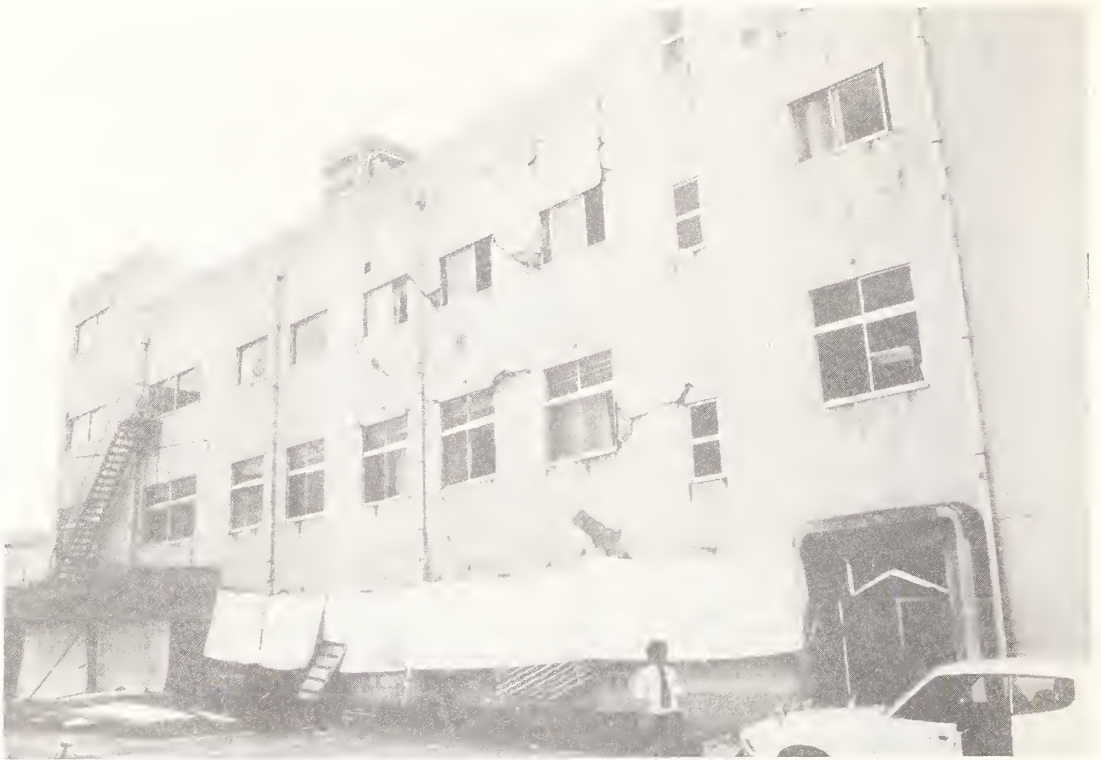
Figure 5.32 Kinoshita Building, Oroshicho area, of Sendai. Extensive diagonal cracking was observed on the east face (rear) of the building.

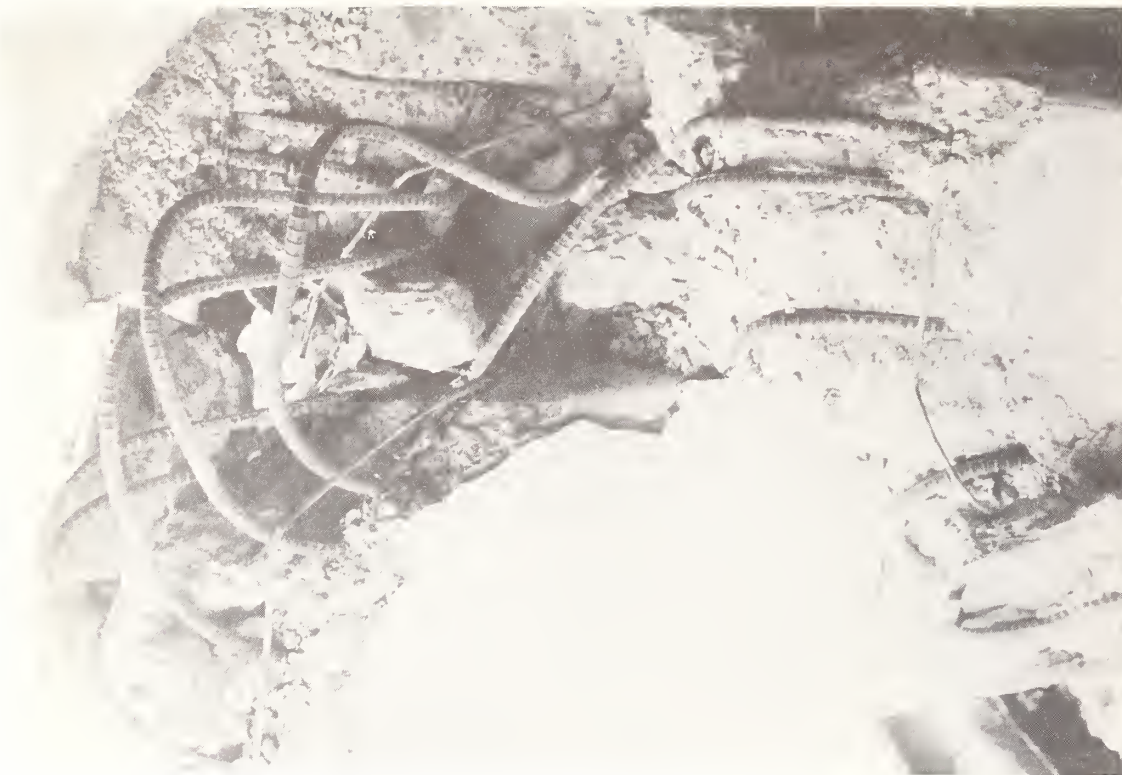
Figure 5.43 Yazaki Industries Buildings. Detail of column shear failure, east side. Note use of deformed bars.

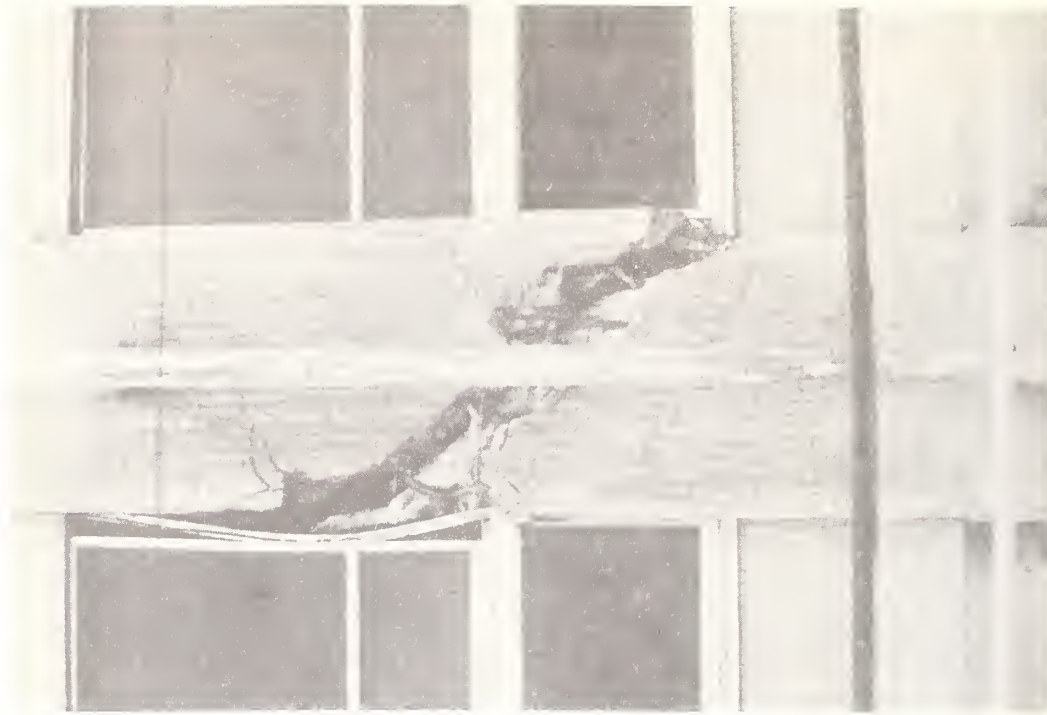
Figure 5.56 Tonan High School. Detail of column damage, exposing reinforcement.

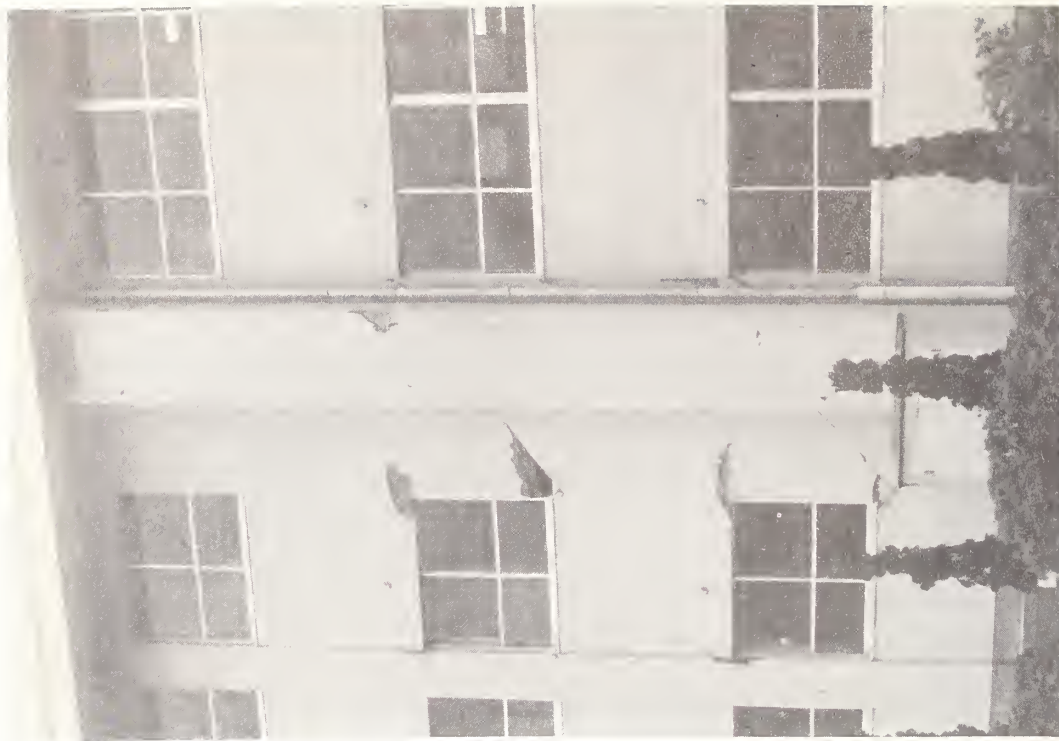
Figure 5.63 Izumi High School, typical classroom building, north face. All faces with the larger infill panels were similarly damaged.

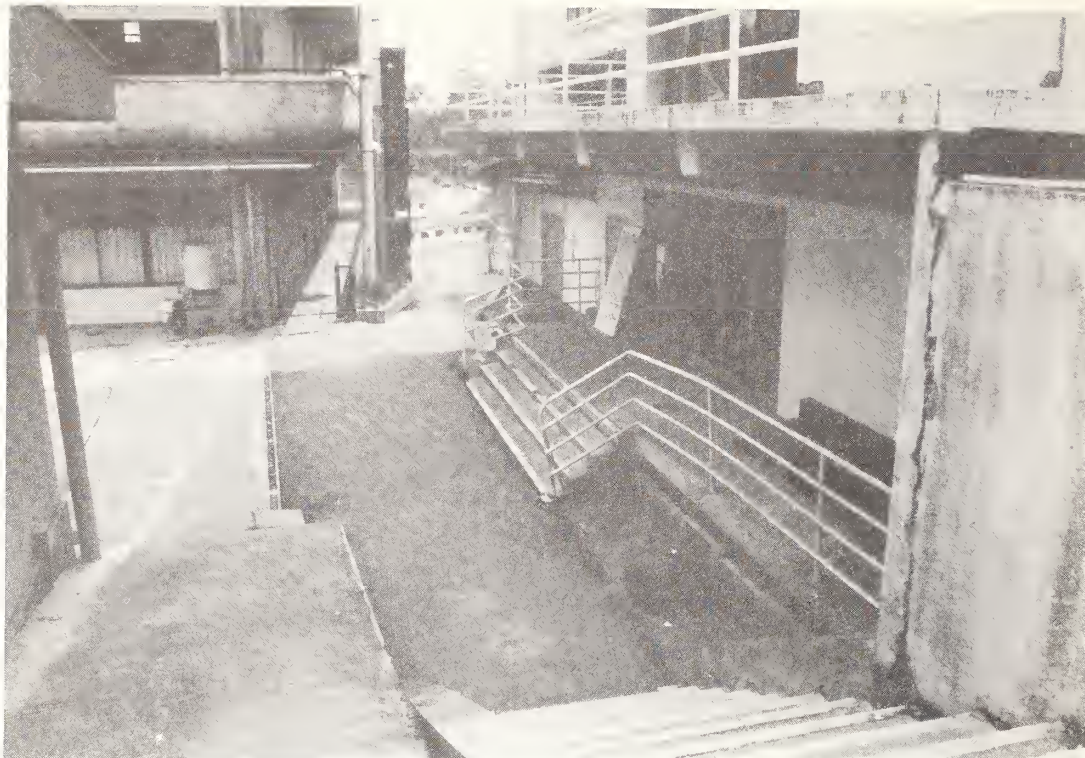
Figure 5.79 Tohoku Institute of Technology, walkway and north entrance of building 5 shows settlement of backfill along length of building.

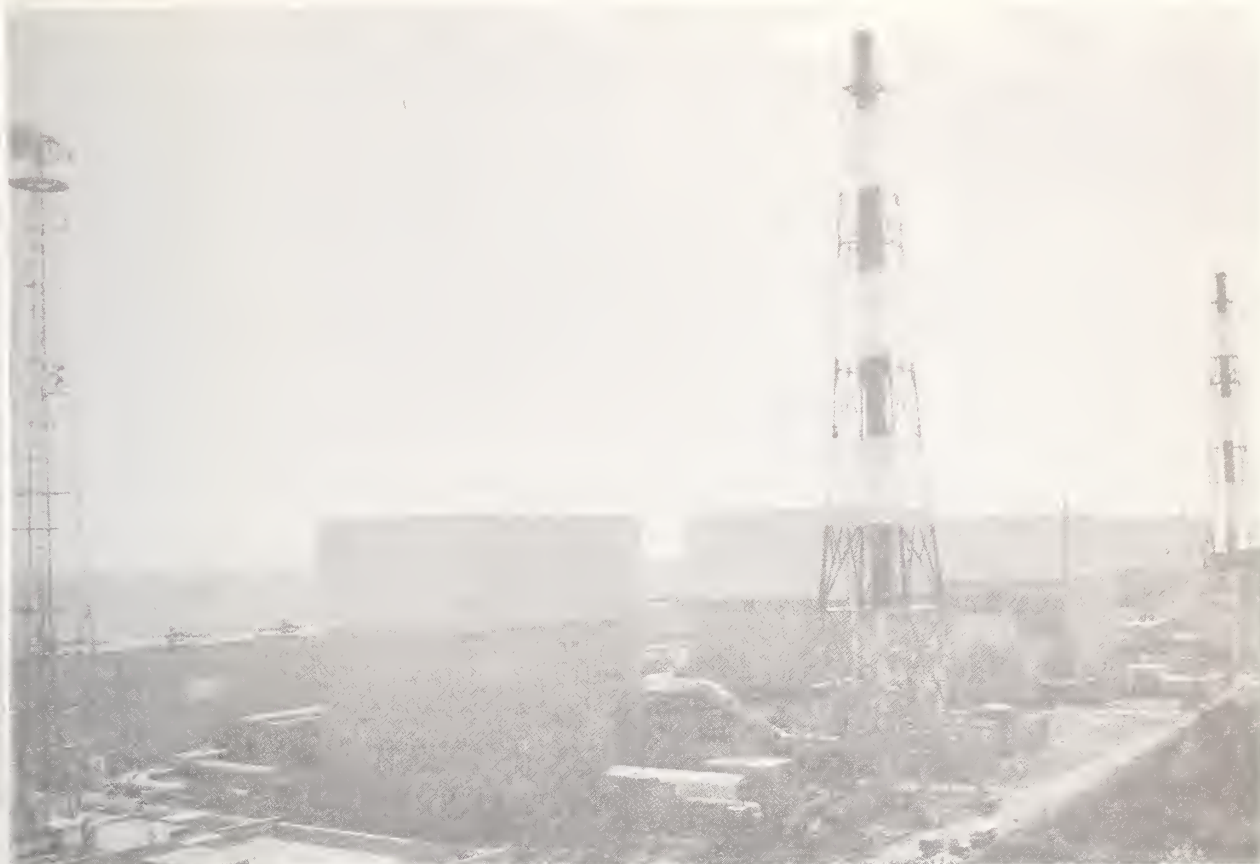
Figure 6.3 Fukushima Nuclear Power Plant: the containment structures of Units 1 through 4. None of these structures showed damage.  
(Tokyo Electric Co. photograph)

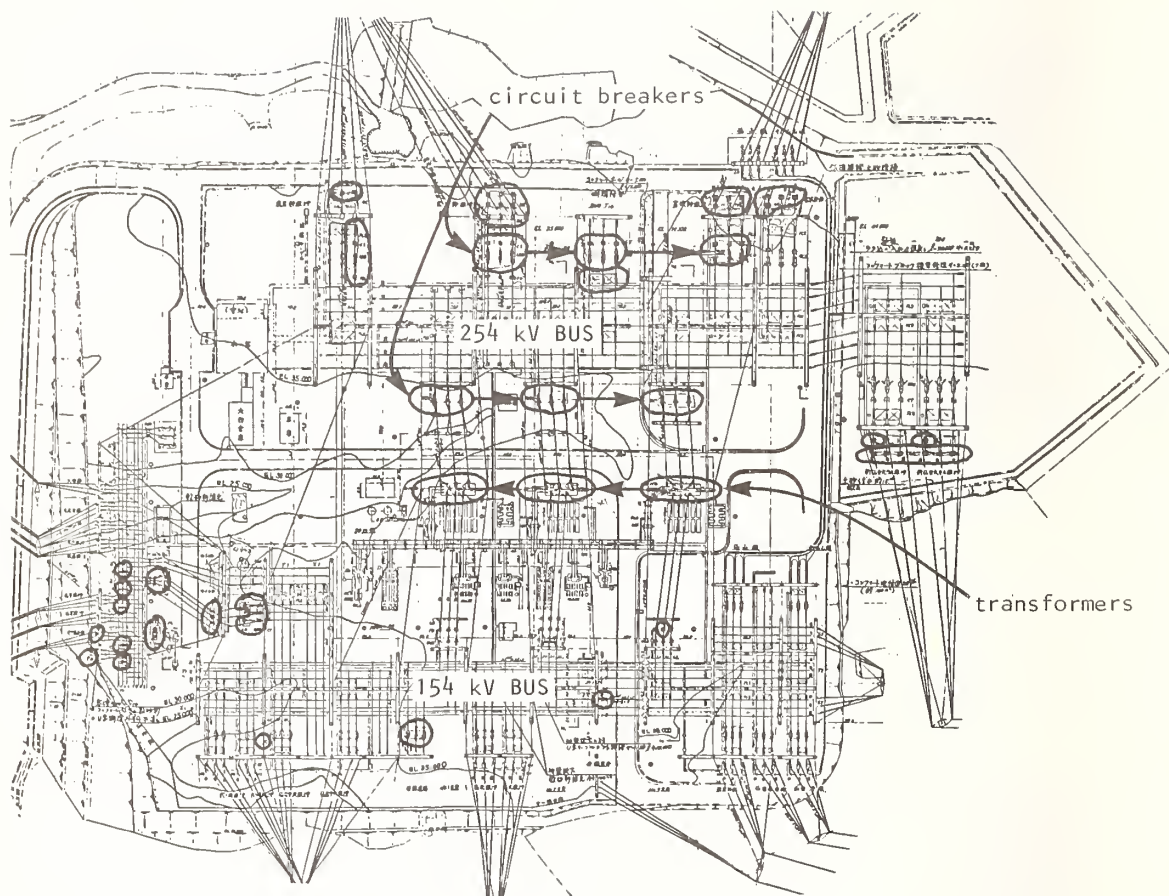
Figure 6.20 Sendai Substation, Izumi: plan of the facility showing the location of damaged equipment (circled). The solid contour lines indicate areas that were filled.

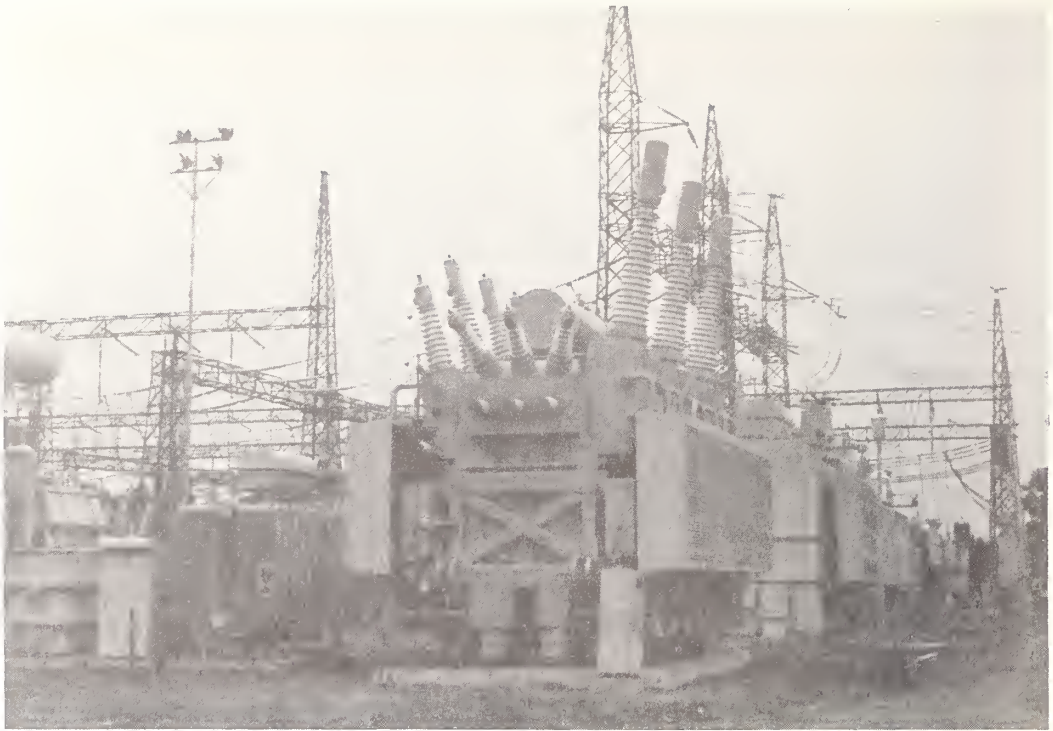
Figure 6.29 Sendai Substation, Izumi; a repaired but still disconnected transformer. All of the transformers at the substation lost some bushings or lightning arrestors. Some damaged parts were being replaced at the time of the investigation.
