# **The Repair and Return to Flight of Solid Rocket Booster Forward Skirt Serial Number 20022**

*T.W. Malone and C.S. Jones  
Marshall Space Flight Center, Marshall Space Flight Center, Alabama*

***June 2008***

## TECHNICAL MEMORANDUM

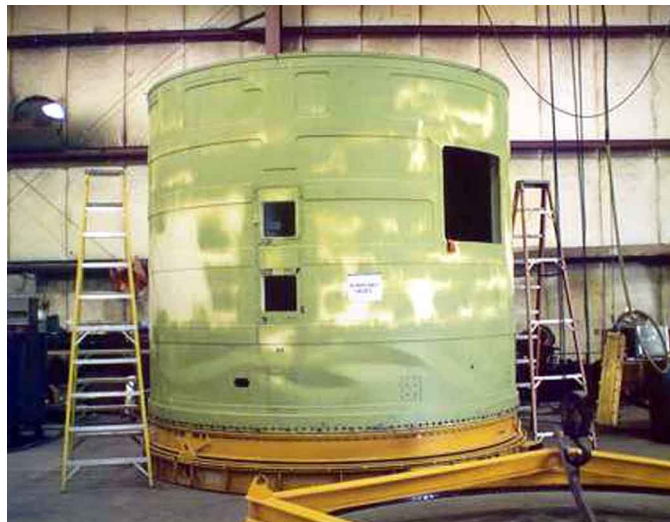
After the STS–37 launch, S/N 20022 suffered water impact loads in excess of its design strength. The structural alloy (Al 2219) sustained damage that included skin buckling in the aft skin bay area as shown in figure 1. Depressions were observed to a depth of 1.6 cm (0.64 in) in the lower bay.

Figure 1. S/N 20022 buckled forward skirt.

Using a hydraulic press, located at General Products in Huntsville, AL (fig. 2), buckling was removed within 0.5 cm (0.2 in). This operation restored the area contour within the experience base.

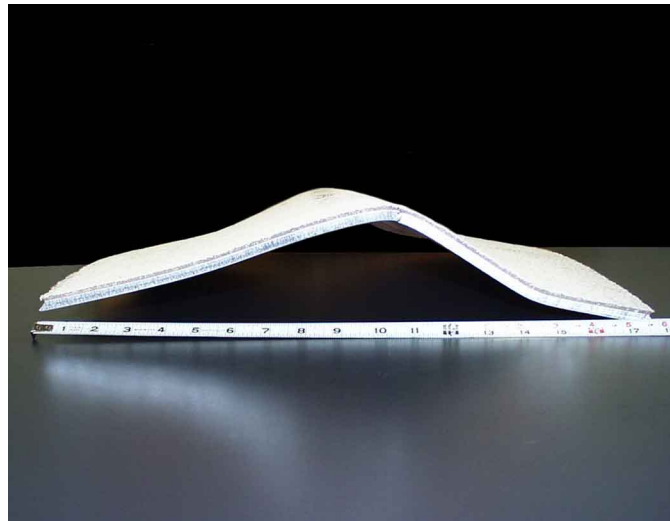
Figure 11. As-received, S/N 007 test section, side view.

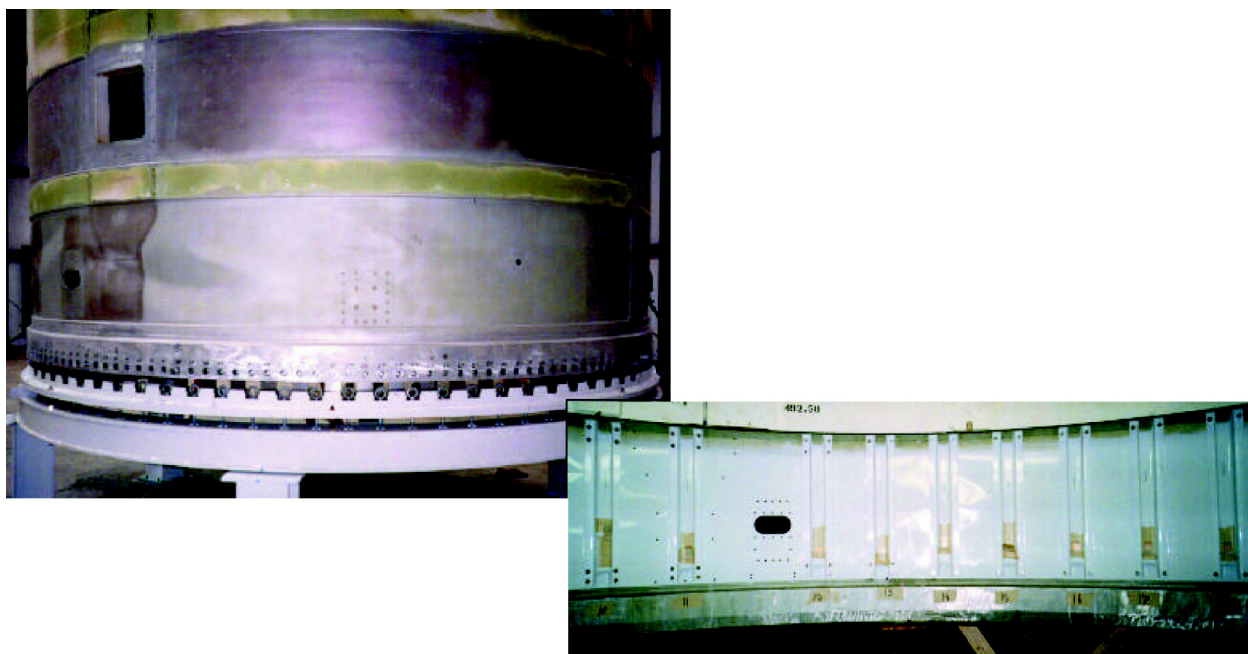
Figure 16. Exterior of S/N 20022 with callout of installed stringers.

As a result of these evaluations, stringers were fabricated and installed on S/N 20022 (fig. 16) in preparation for its return to flight.
