Bathymetric and Velocimetric Surveys at Highway Bridges Crossing the Missouri River between Kansas City and St. Louis, Missouri, May 22–31, 2017

Scientific Investigations Report 2020–5018

By Richard J. Huizinga

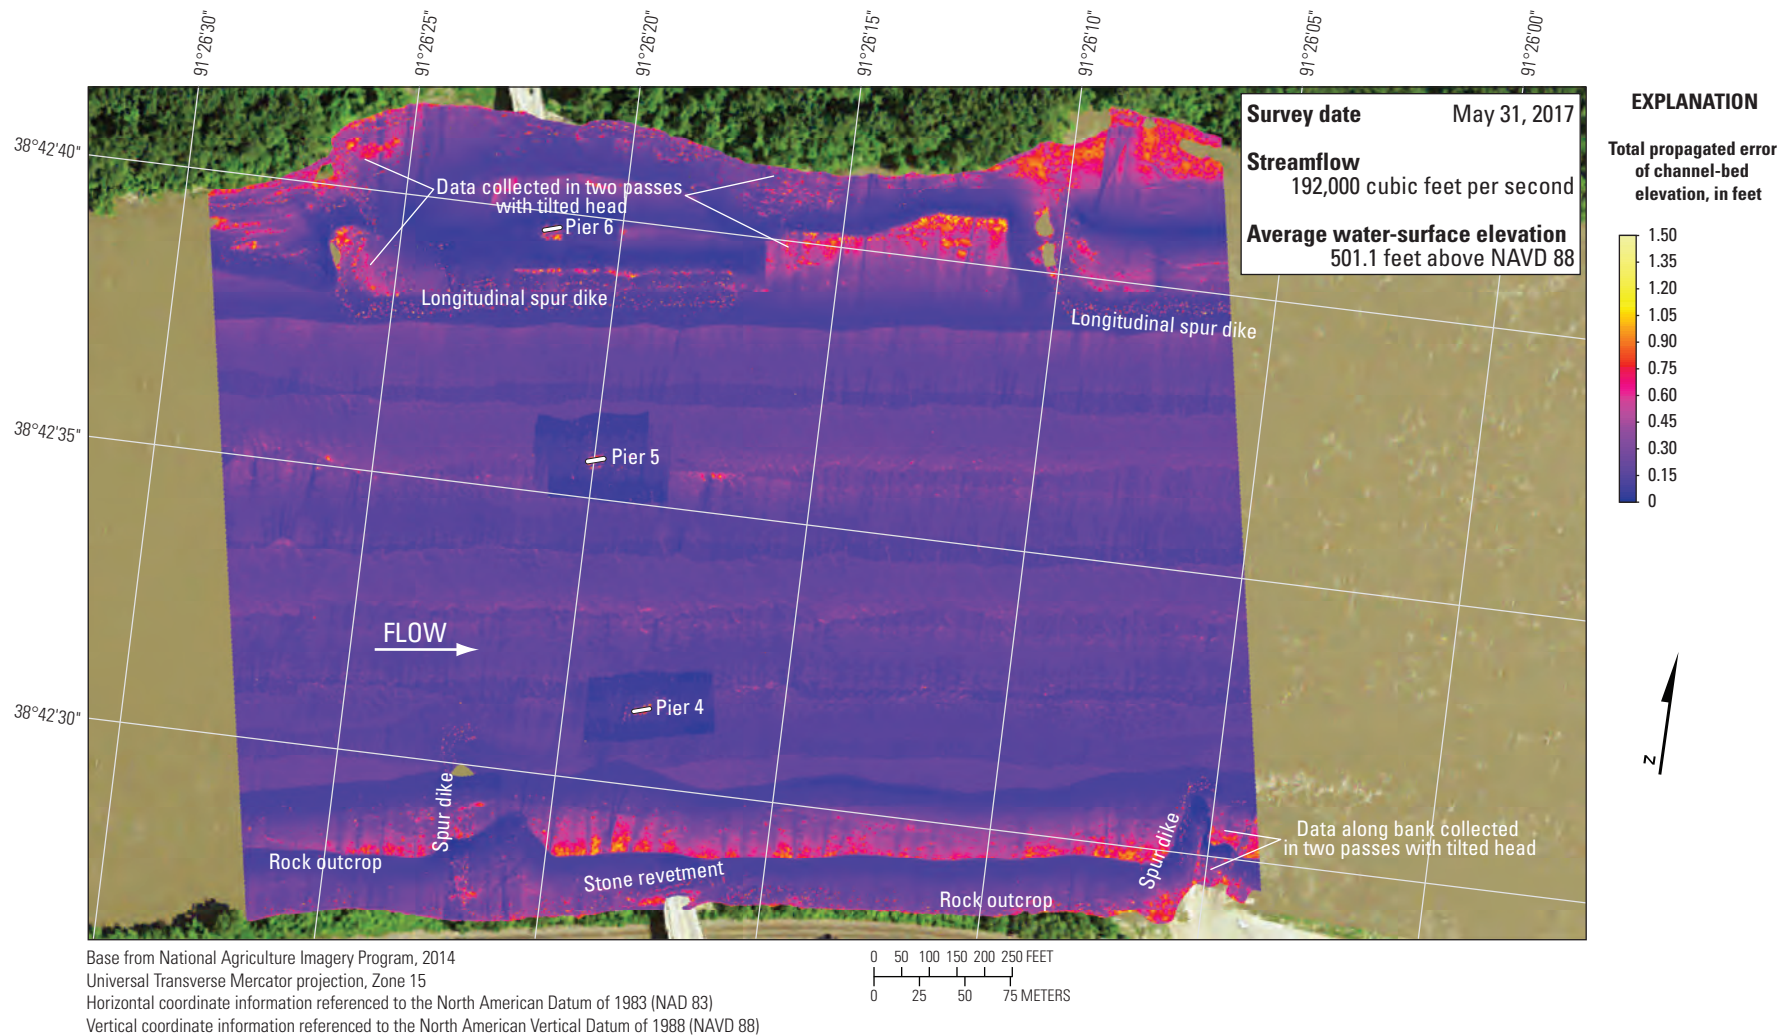
The largest TPU in this group of surveys was 1.74 ft (table 4); however, as noted in previous studies, TPU values of this magnitude typically happened near high-relief features, such as the front or side of a pier footing (fig. 5). More than 97 percent of the TPU values were less than 0.50 ft (table 4), which is within the specifications for a “Special Order” survey, the most stringent survey standard of the International Hydrographic Organization (IHO; International Hydrographic Organization, 2008). As has been noted in previous surveys with this equipment, the TPU values were larger near moderate-relief features (banks, spur dikes, rock riprap and outcrops, and scour holes near piers; fig. 5). Occasionally, the TPU values also were larger (1.00 ft or greater) in the outermost beam extents of the multibeam swath in the overlap with an adjacent swath, particularly when the MBES head was tilted for the survey lines along the banks or near the piers (fig. 5). Overlapping adjacent swaths in the channel thalweg (the line of maximum depth in the channel) also can indicate larger TPU values because substantial bed movement can happen between survey passes (fig. 5). More than 80 percent of the TPU values were 0.25 ft or less (table 4). The tops of bridge substructural elements (pier footings and seal courses) typically had TPU values of 0.25 ft or less.

Figure 5. Total propagated uncertainty of bathymetric data from the Missouri River channel near structure A6288 on Missouri State Highway 19 at Hermann, Missouri.

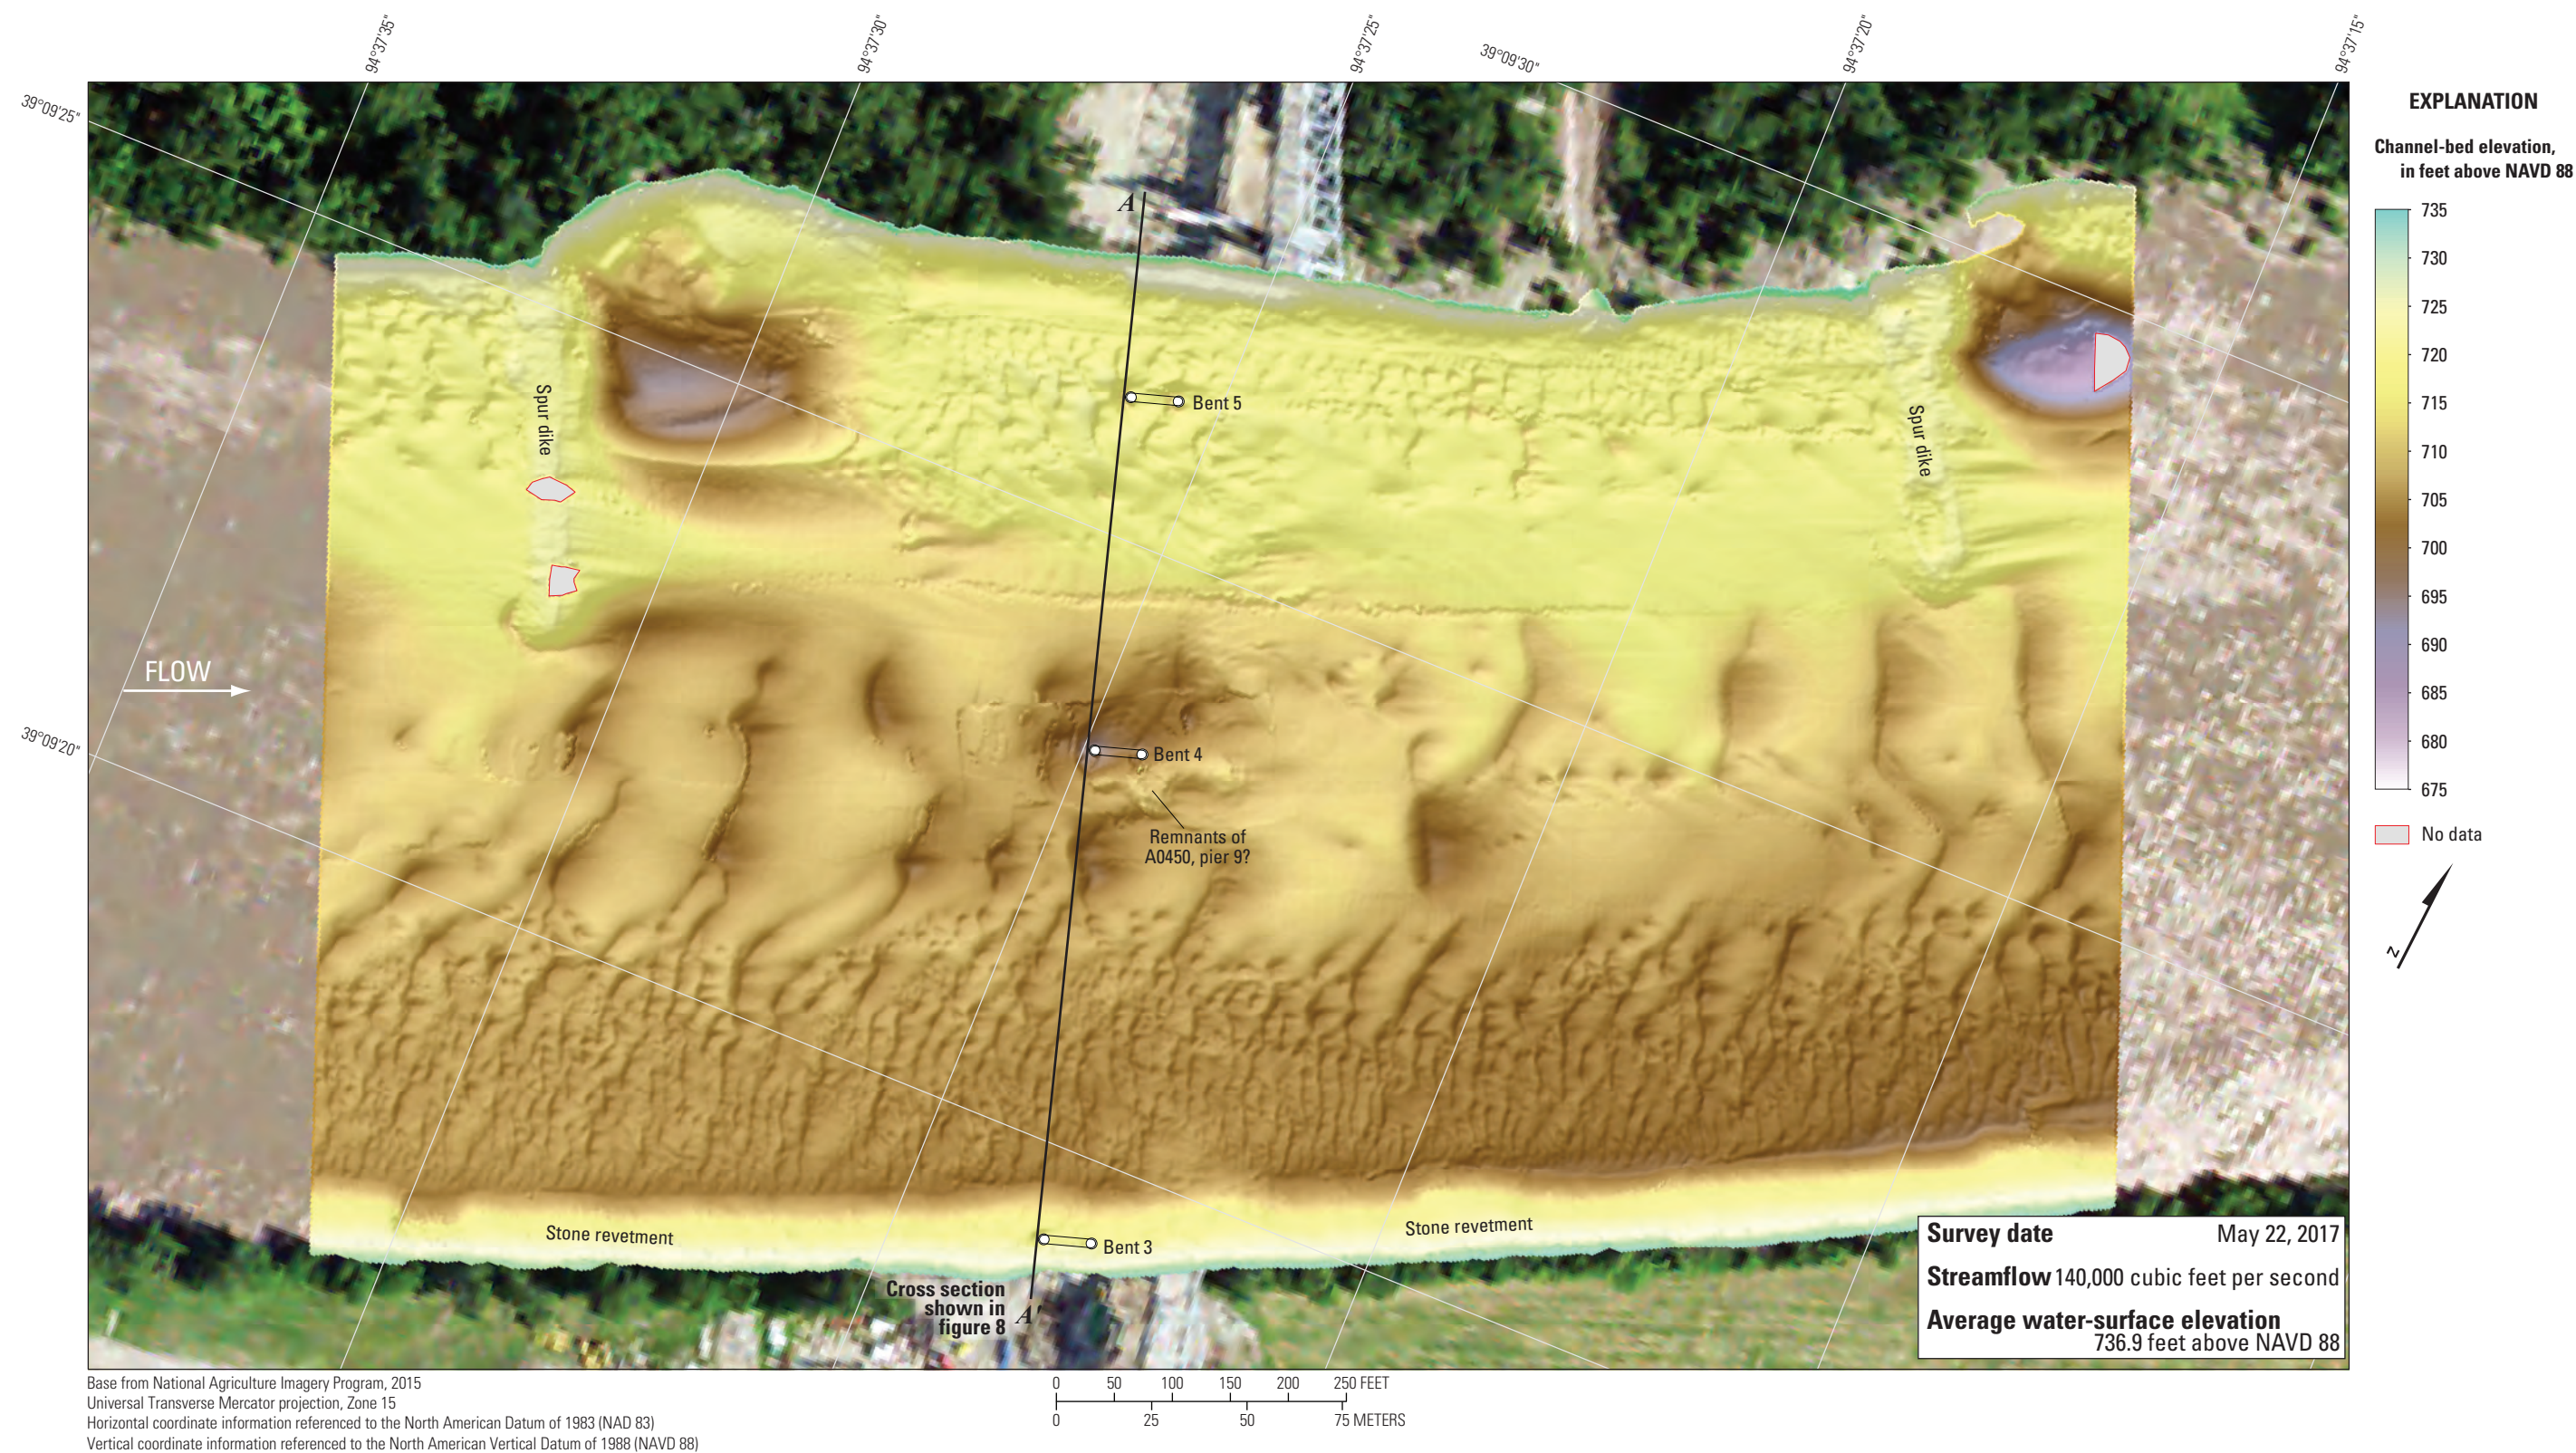
Figure 6. Bathymetric survey of the Missouri River channel near structure A8340 on U.S. Highway 69 in Kansas City, Missouri.

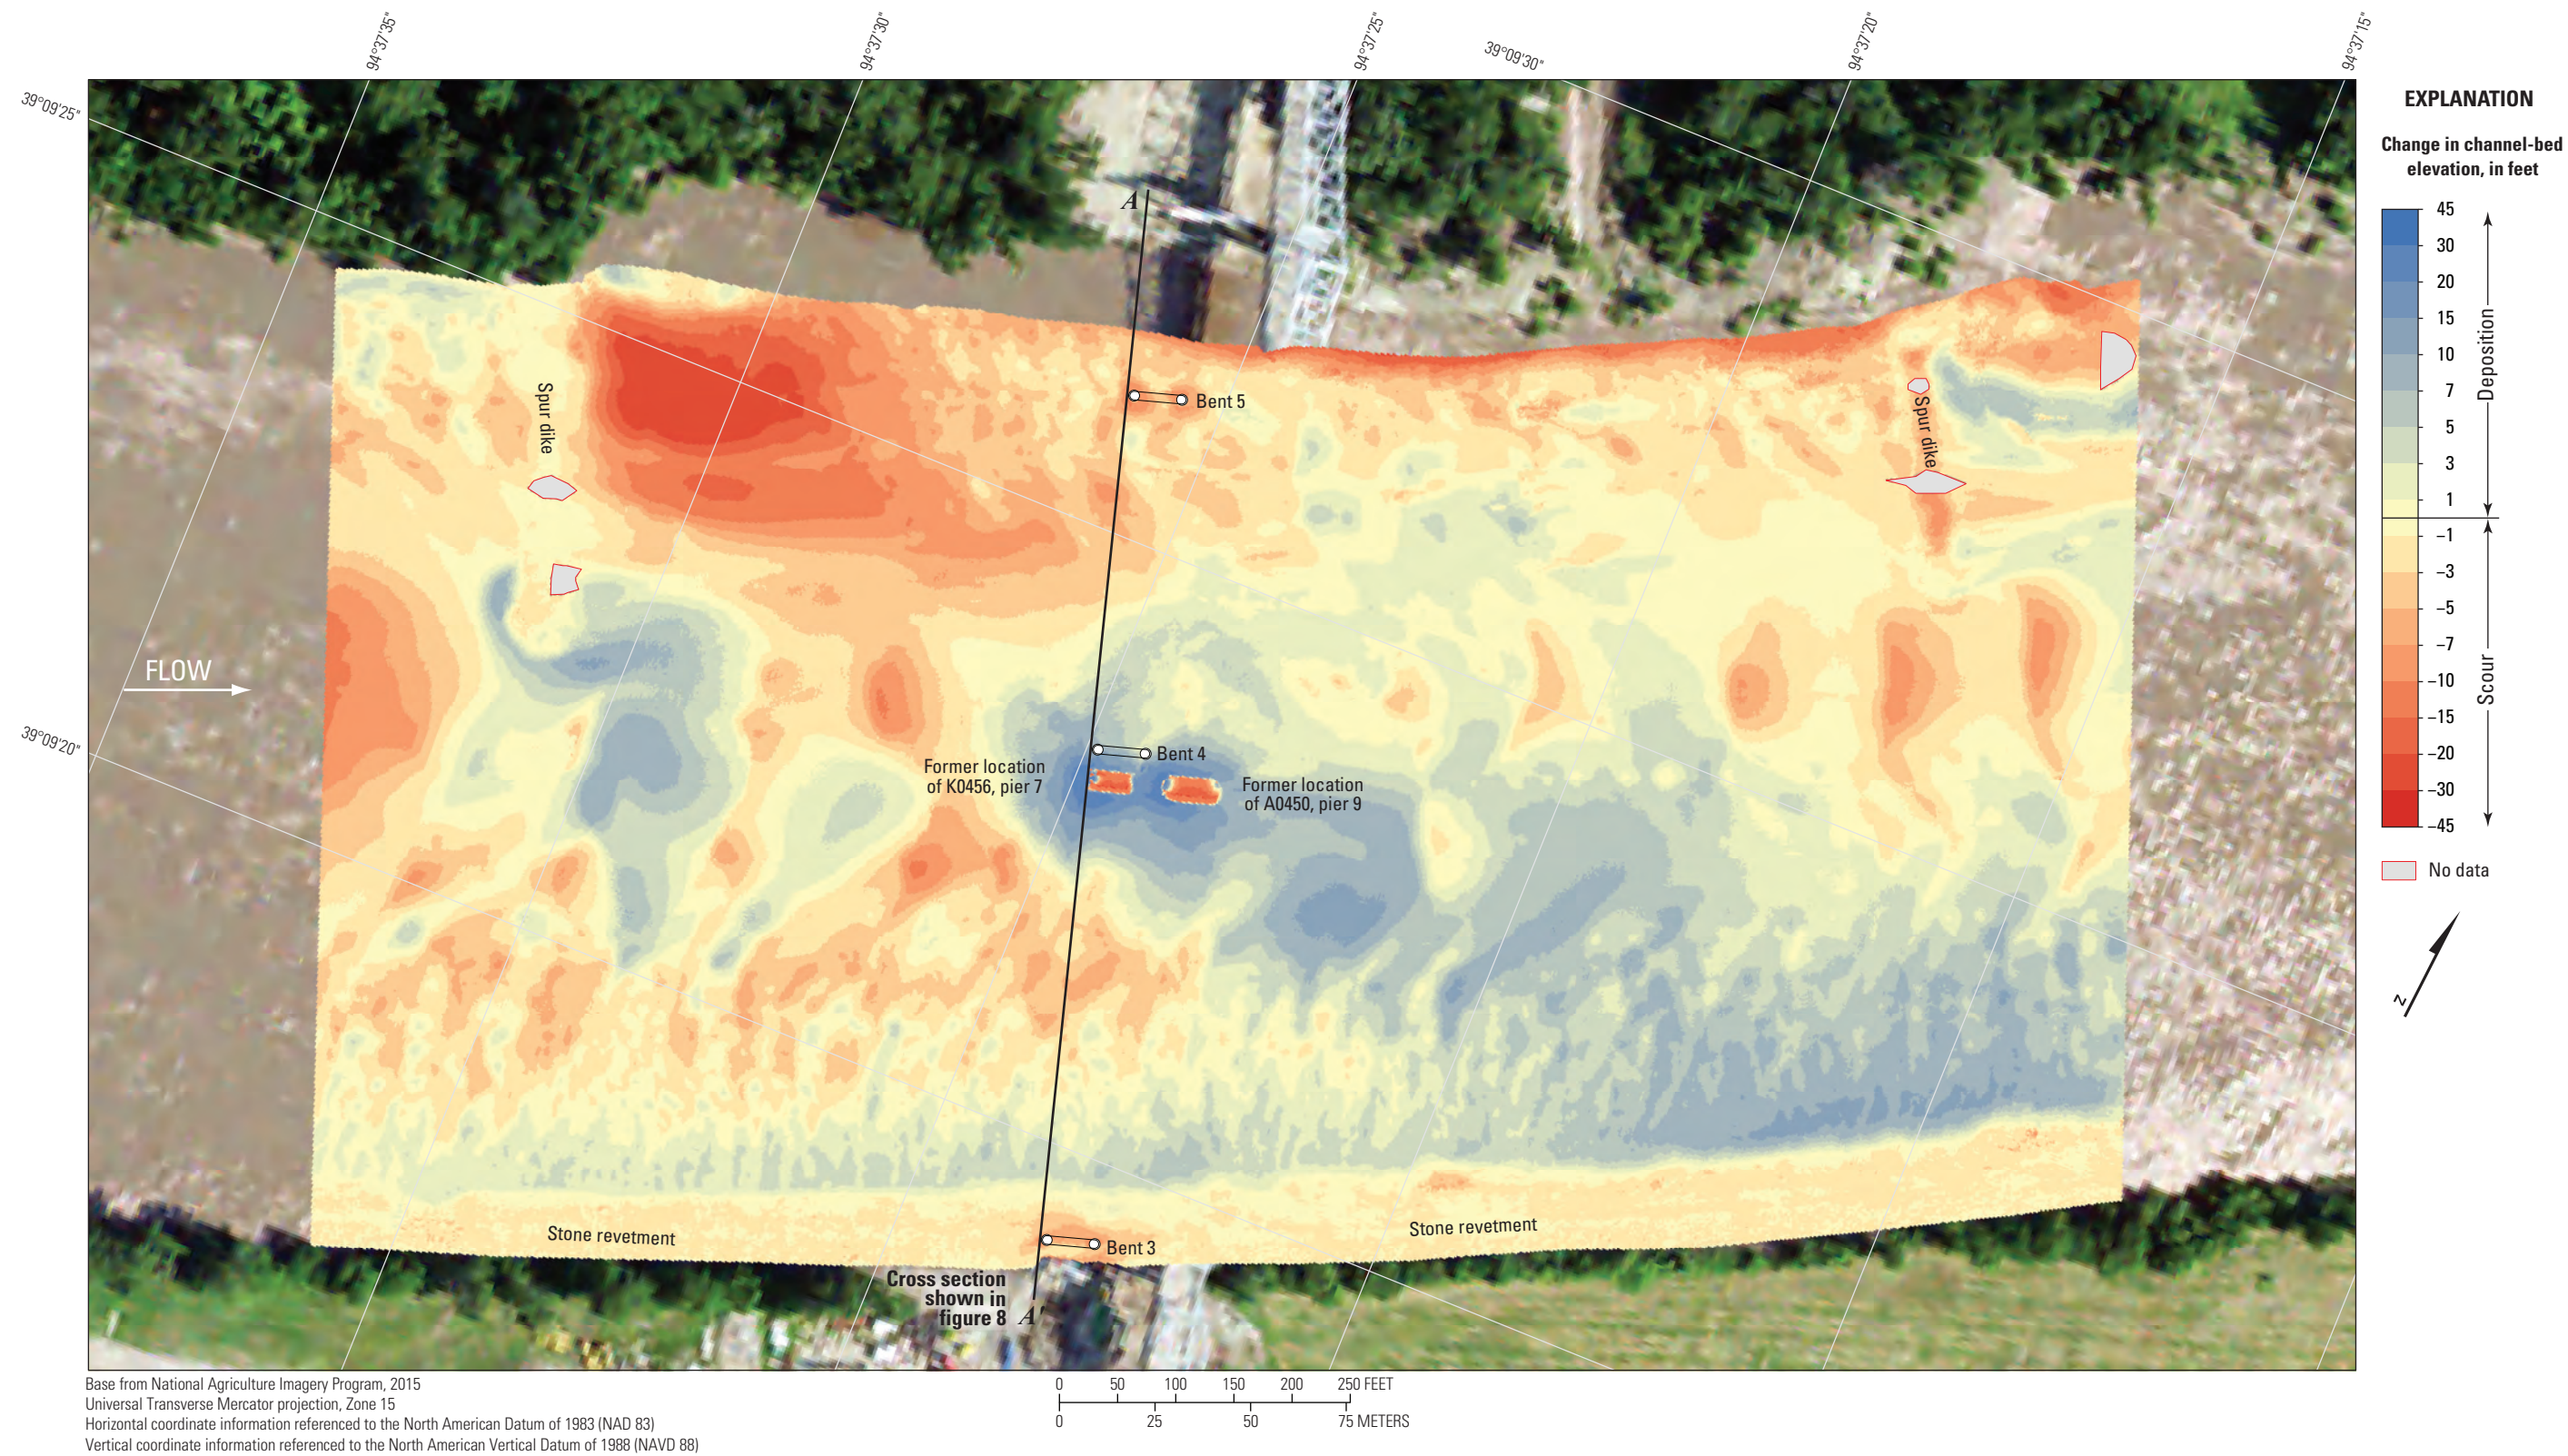
The difference between the survey on May 22, 2017, and the previous flood survey on July 16, 2011, indicates several areas of substantial bed variation between 2011 and 2016 (fig. 9). There was an area of substantial deposition of more than 20 ft near the former location of the main channel bridge piers for structures K0456 and A0450, where a scour hole present in the 2011 survey (Huizinga, 2012) has subsequently been filled (fig. 9). Additional deposition was observed in the thalweg along the toe of the right (south) bank and in the troughs of several large dunes present in the middle of the channel in the 2011 survey (fig. 9). However, there was an area of substantial scour of more than 30 ft downstream from the spur dike on the left (north) bank upstream from the bridge (fig. 9) and an apparent widening of the channel to the north (figs. 8, 9). Minor scour indicated along the stone revetment on the right (south) bank may be the result of minor positional variations between the surveys. The average difference between the bathymetric surfaces (the statistical average value of the gridded raster surface [fig. 9] created from the difference between the 2017 and 2011 [previous] survey gridded

raster bathymetric surfaces) was −0.33 ft (table 7), indicating minor overall channel degradation between the 2011 and 2017 surveys. The net volume of cut in the reach from 2011 to 2017 was about 91,800 cubic yards (yd³), and the net volume of fill was about 76,300 yd³, resulting in a net loss of about 15,500 yd³ of sediment between 2011 and 2017.

Figure 9. Difference between surfaces created from bathymetric surveys of the Missouri River channel near structure A8340 on U.S. Highway 69 in Kansas City, Missouri, on May 22, 2017, and July 16, 2011.

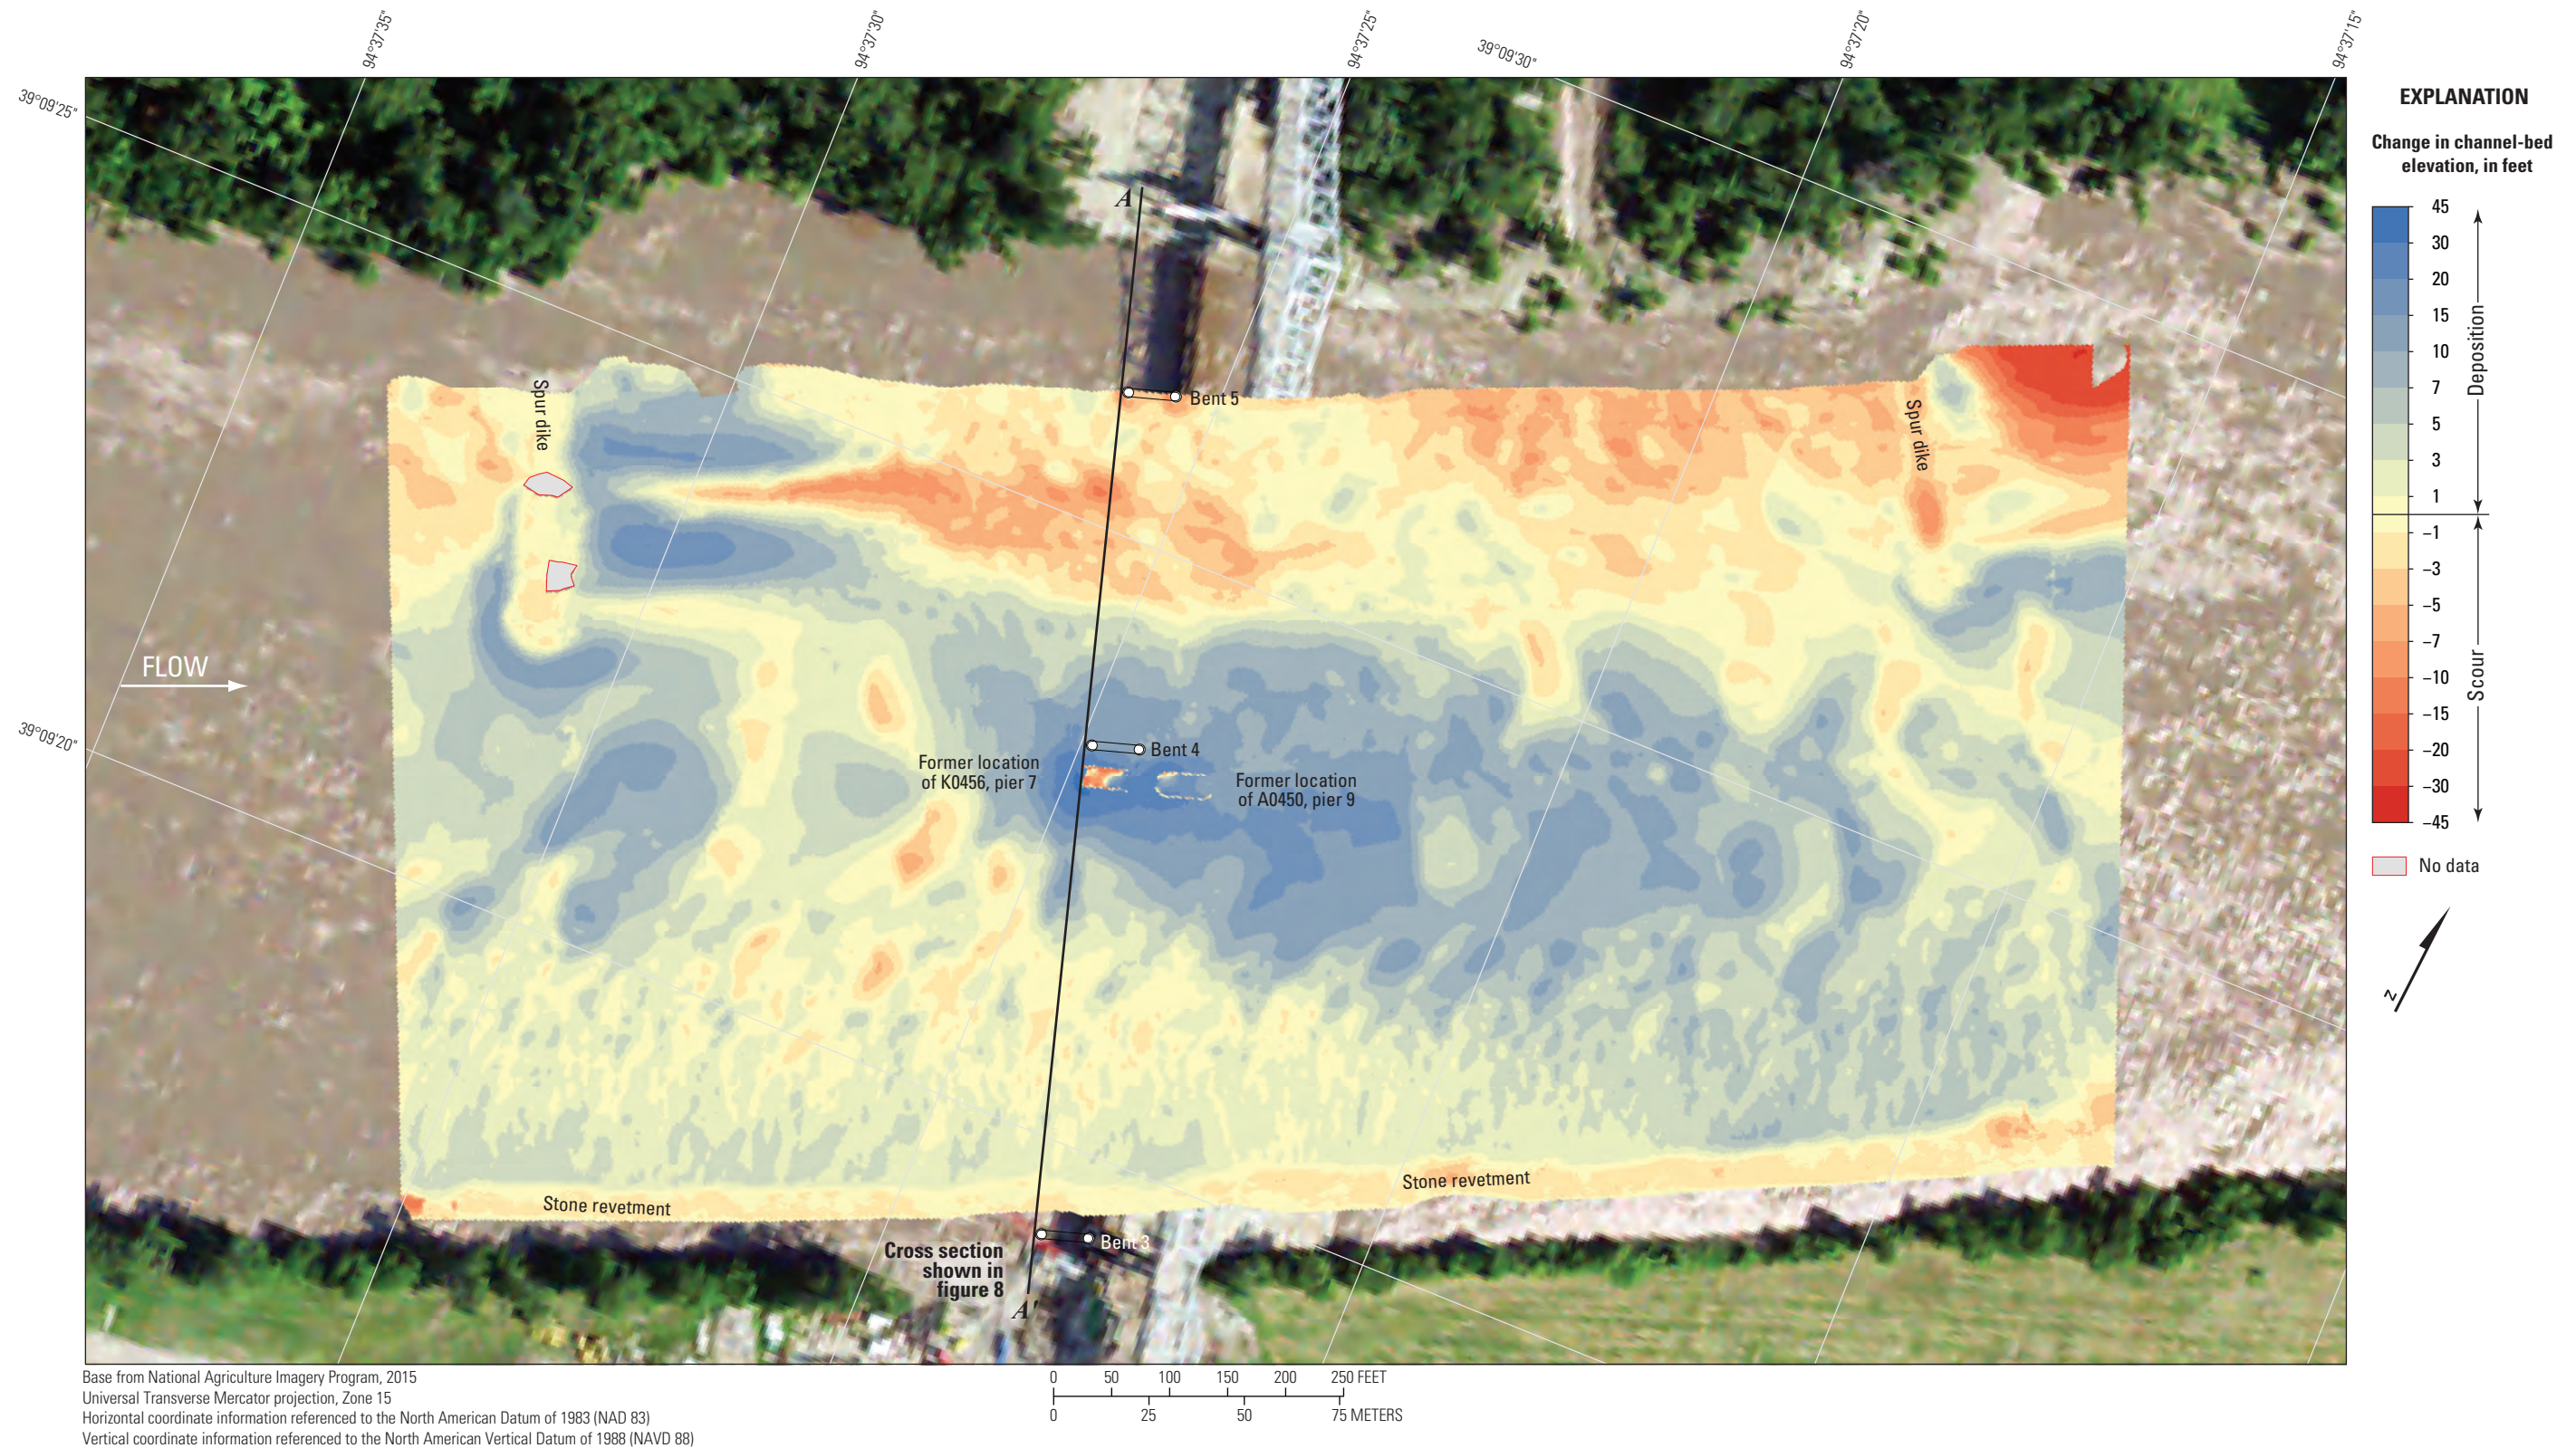
The difference between the survey on May 22, 2017, and the previous nonflood survey on March 15, 2010, indicates more widespread deposition between 2010 and 2017, with substantial deposition of more than 20 ft again near the former location of the main channel bridge piers for structures K0456 and A0450, where a scour hole present in the 2010 survey (Huizinga, 2010) has subsequently been filled (fig. 10). Additional deposition was observed throughout the middle of the channel and downstream from the spur dike on the left (north) bank upstream from the bridge (fig. 10). However, there was an area of substantial scour of more than 30 ft downstream from the spur dike on the left (north) bank downstream from the bridge and scour generally along the left (north) side of the channel near the bridge and downstream (fig. 10). Minor scour

Figure 10. Difference between surfaces created from bathymetric surveys of the Missouri River channel near structure A8340 on U.S. Highway 69 in Kansas City, Missouri, on May 22, 2017, and March 15, 2010.

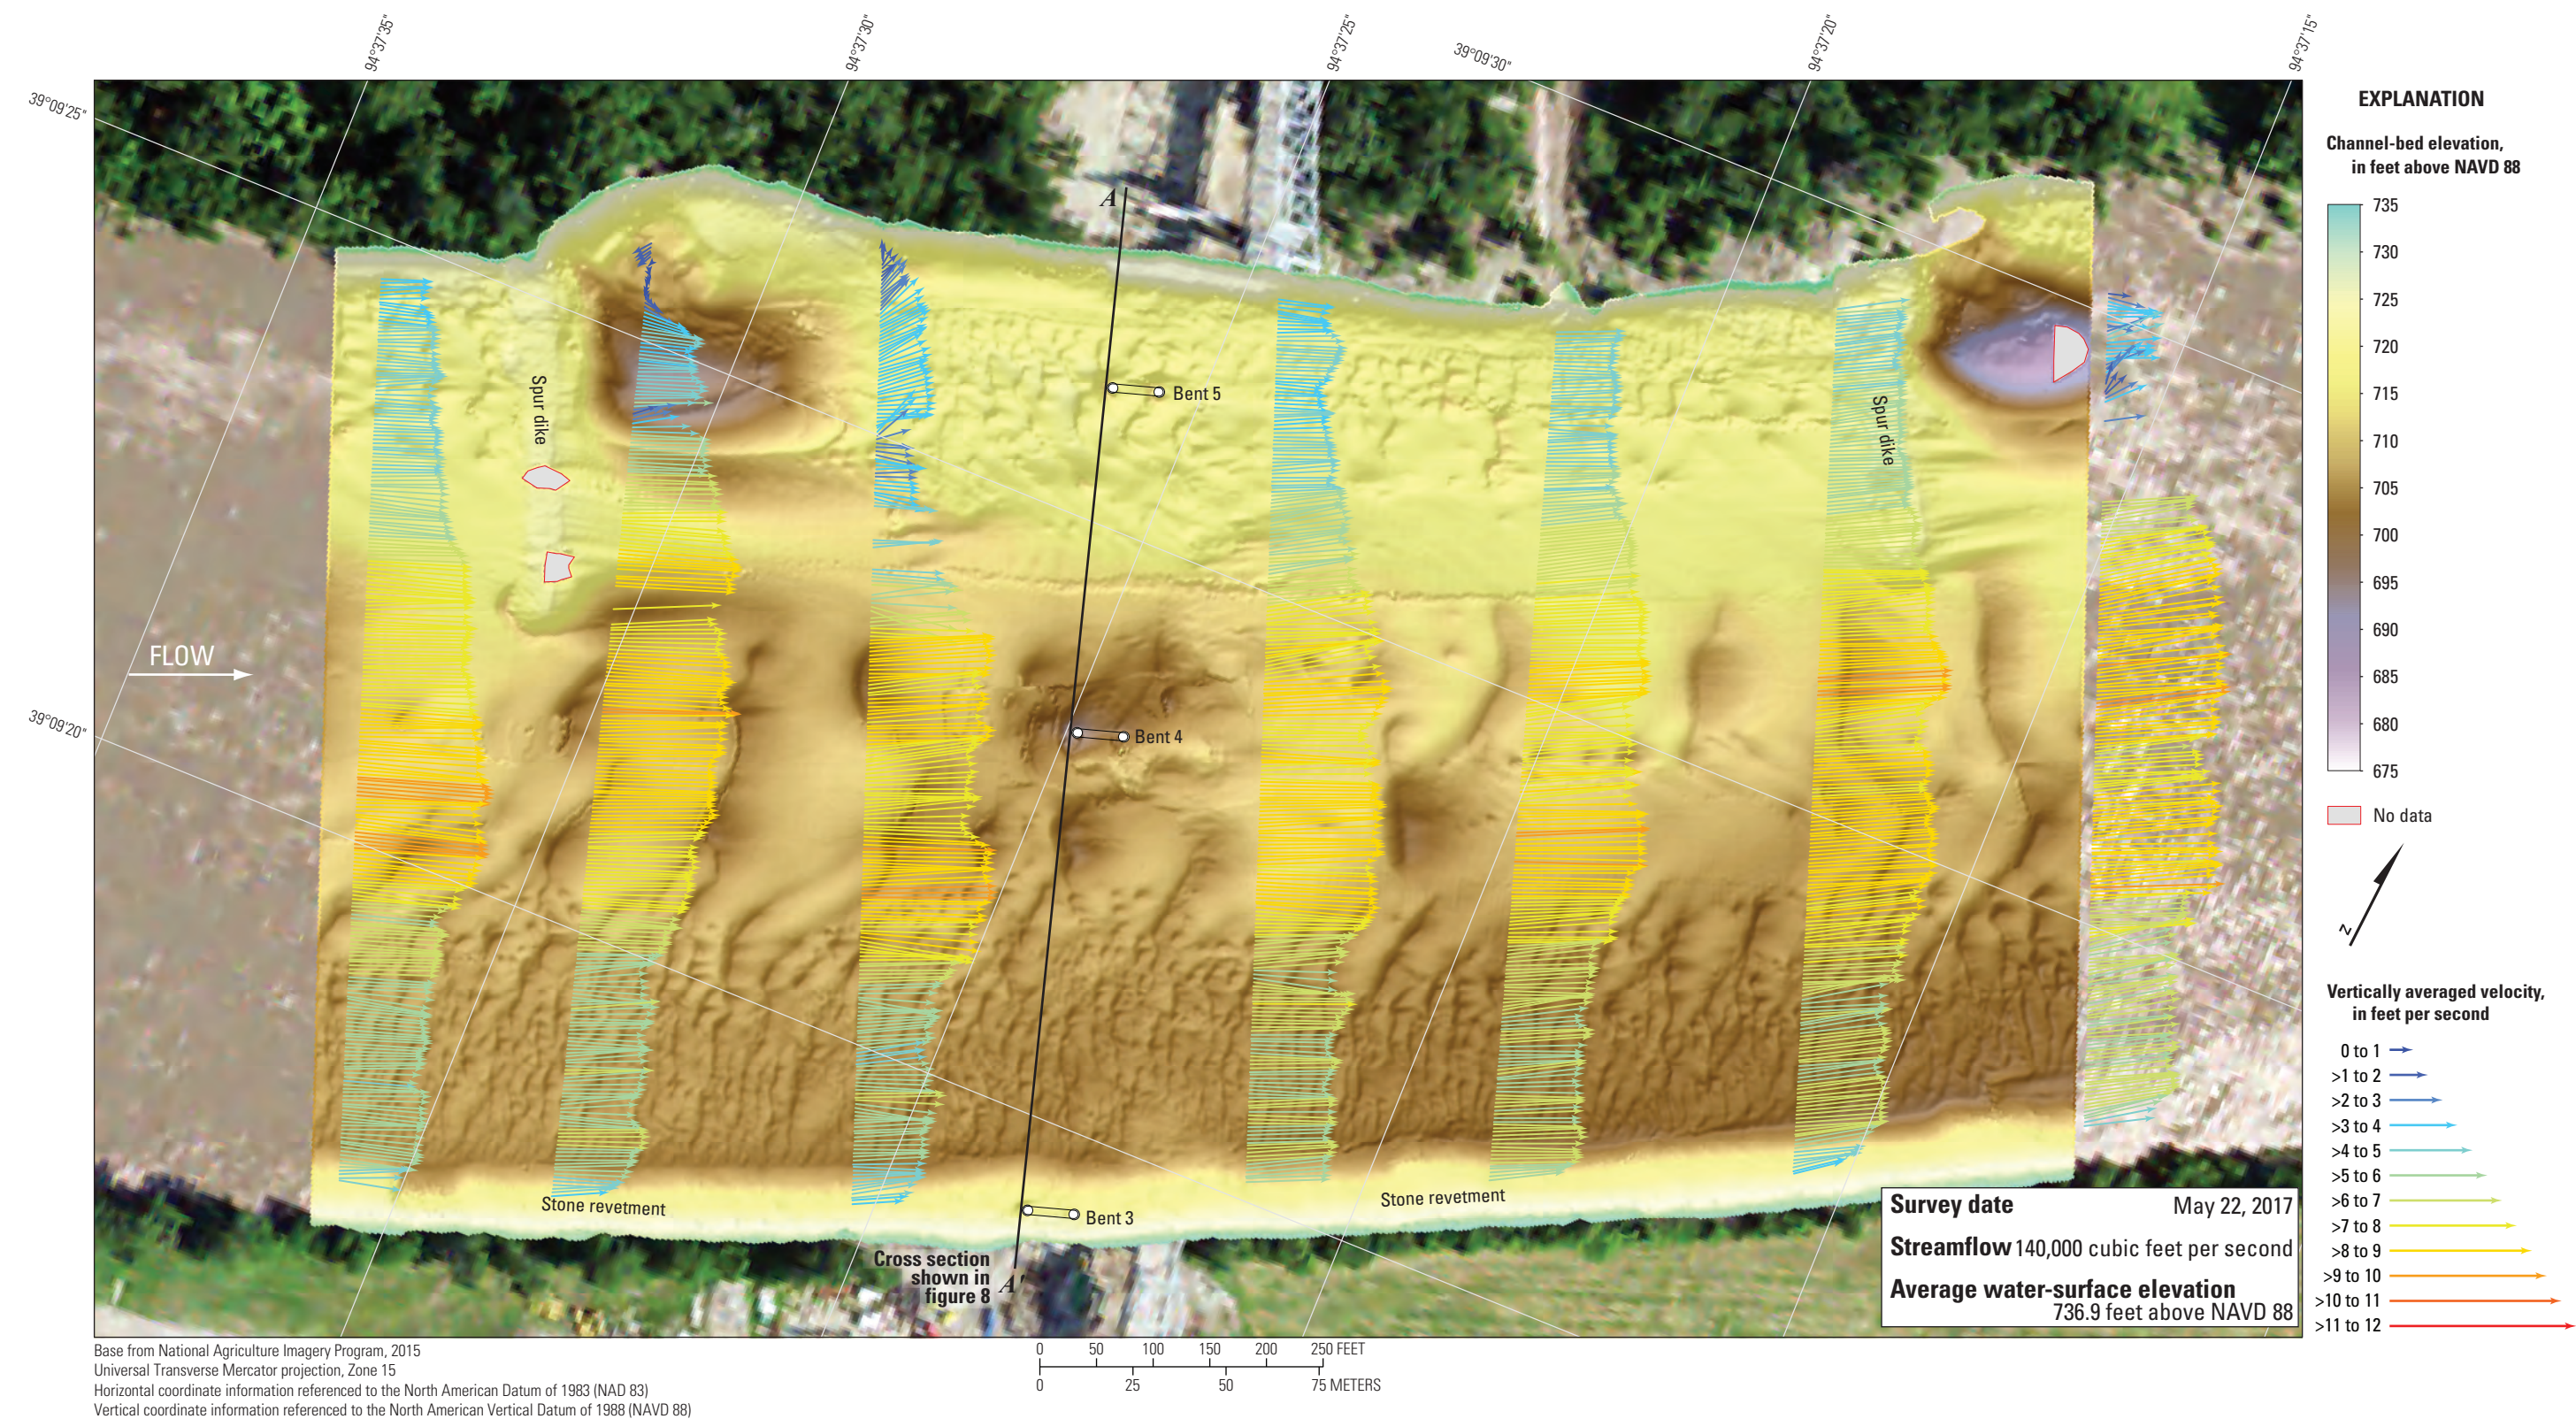
The vertically averaged velocity vectors indicate mostly uniform flow throughout the reach (fig. 11). A maximum velocity of about 10 feet per second (ft/s) was present in the upstream middle of the channel, and a minimum velocity of about 1 ft/s was present with flow reversal downstream from the various spur dikes in the reach (fig. 11). Minimal effect on the velocity was observed downstream from bent 4 (fig. 11), indicating the new pier design is appropriately hydrodynamic. Minor turbulence was present in all the sections (fig. 11).

Figure 11. Bathymetry and vertically averaged velocities of the Missouri River channel near structure A8340 on U.S. Highway 69 in Kansas City, Missouri.

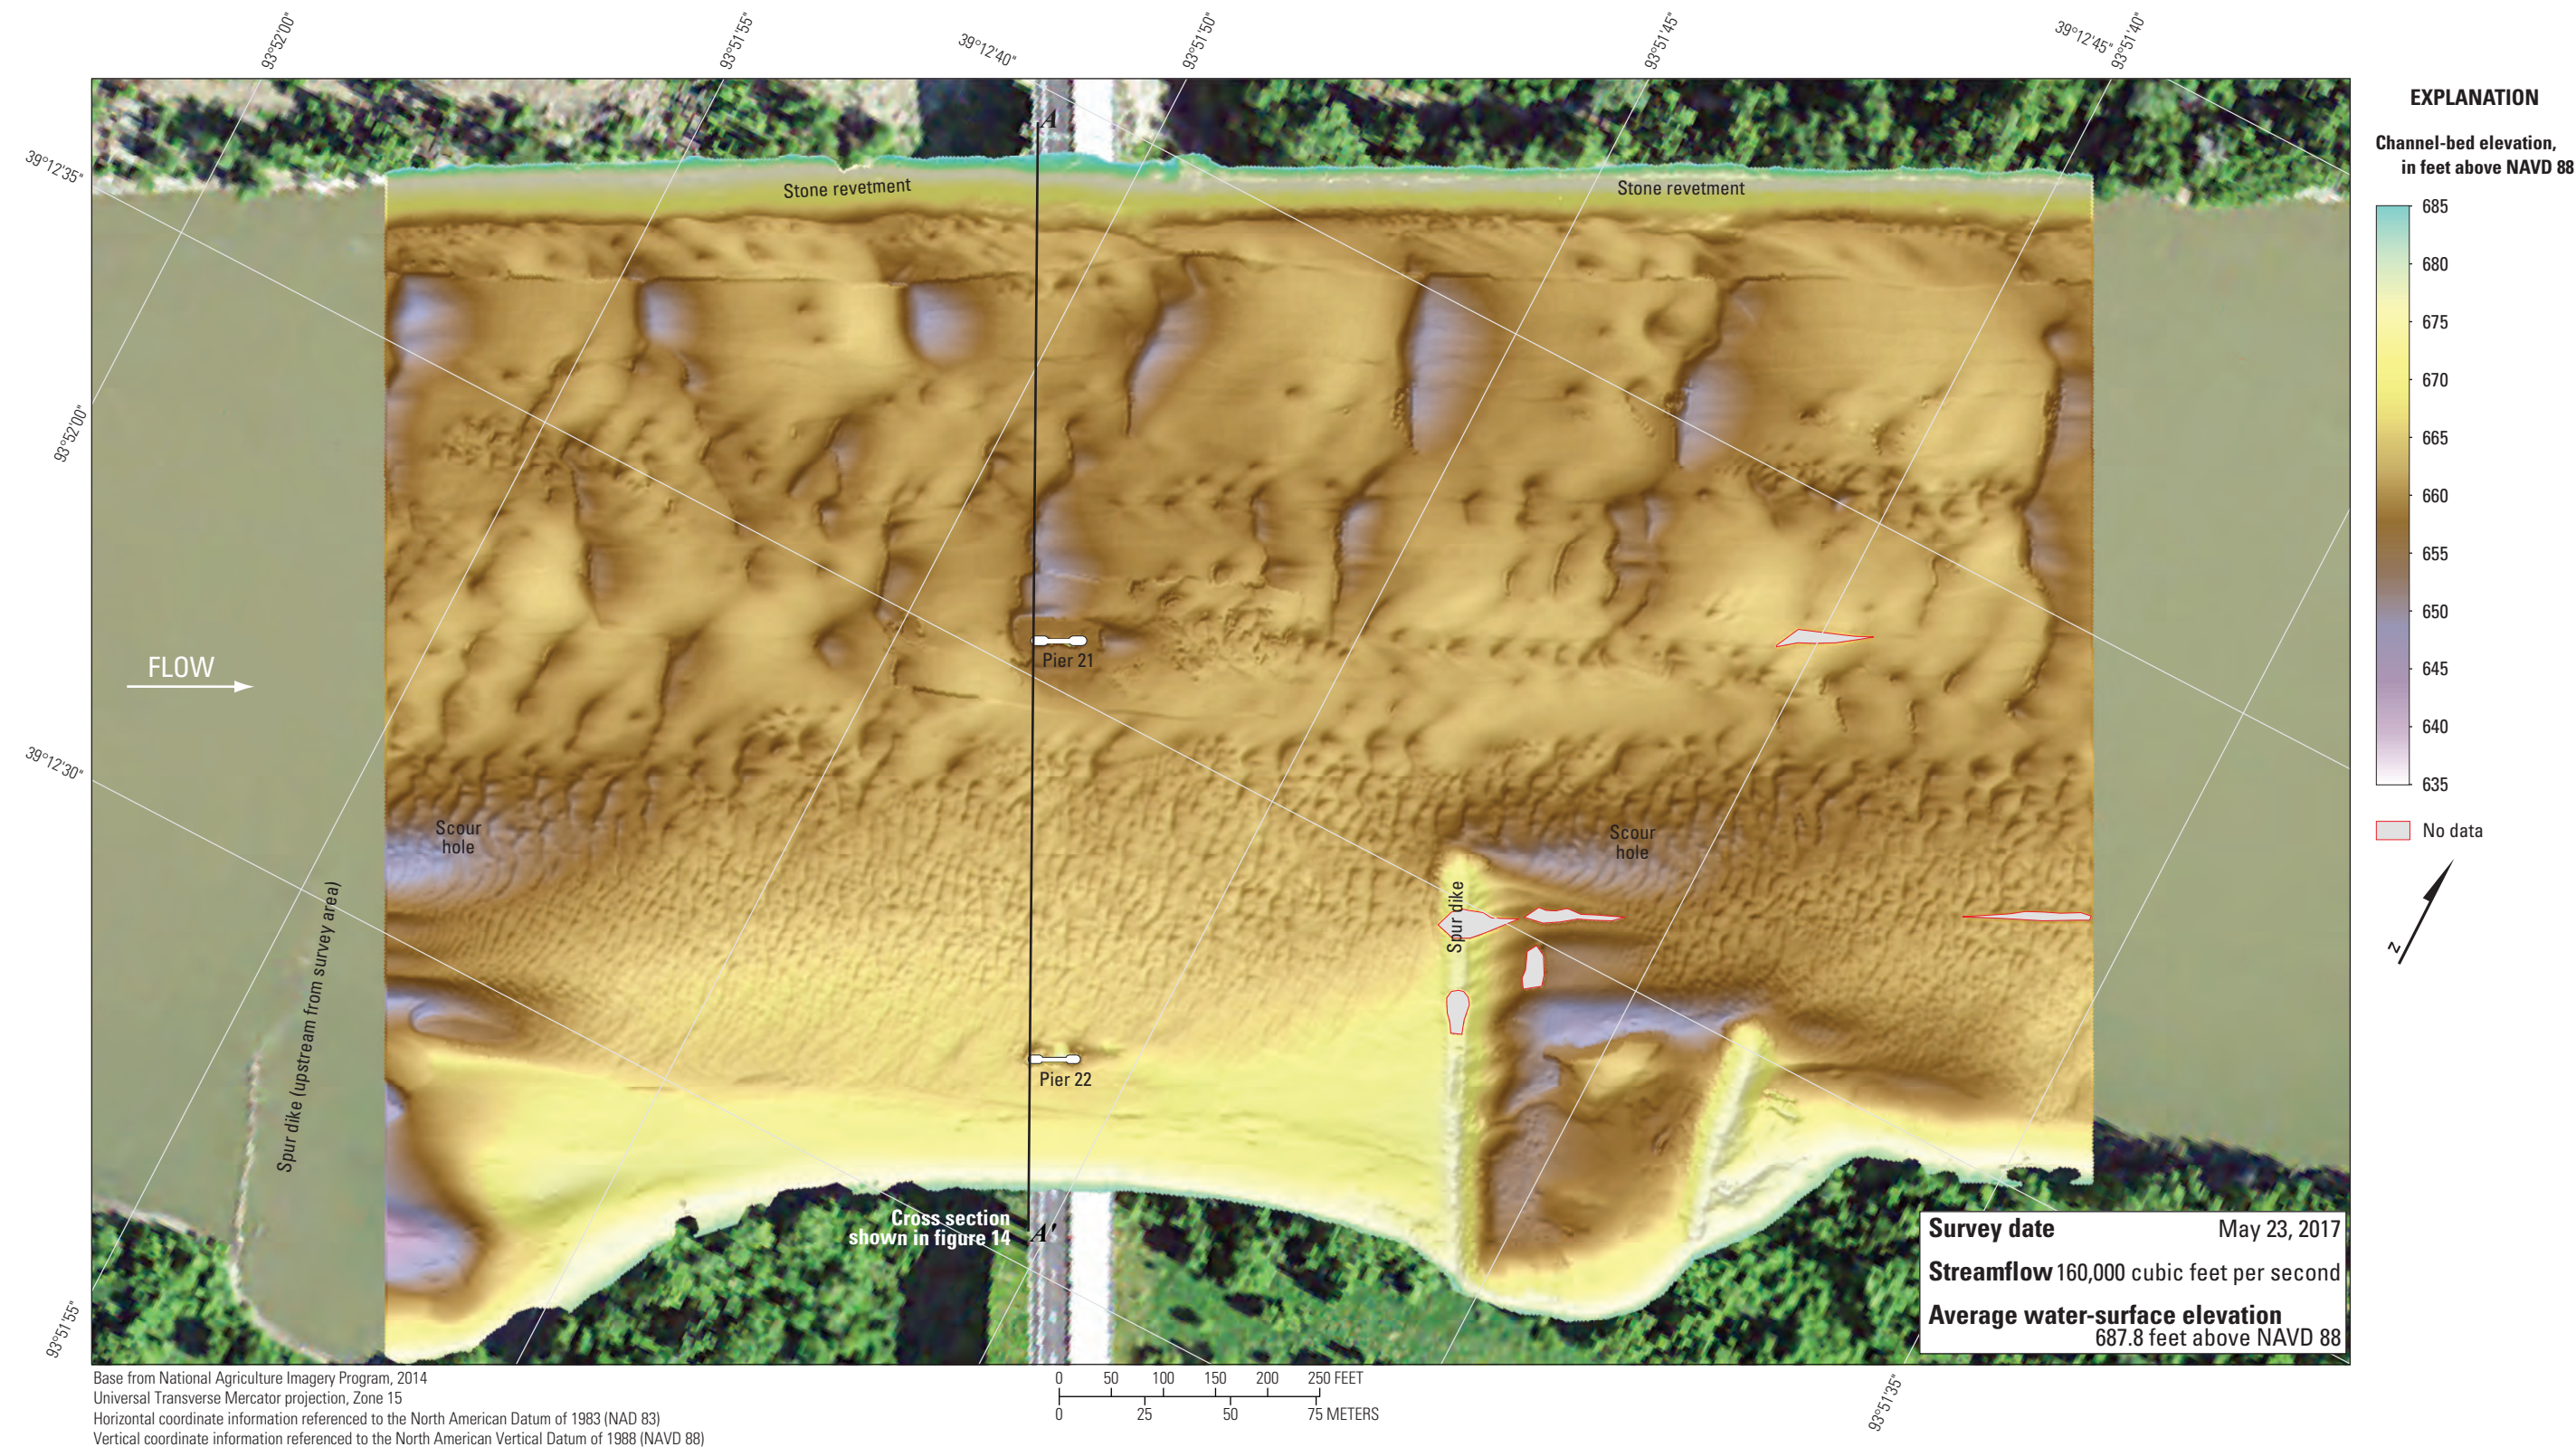
near pier 22 near the right (south) bank (fig. 12). Information from bridge plans indicates that piers 21 and 22 are founded on shafts drilled 28 to 50 ft into bedrock, having about 47 ft of bed material between the channel bottom and bedrock at pier 21 and about 28 ft of material at pier 22 (fig. 14; table 6). The surveyed bed generally was similar to the previous multibeam survey on April 24, 2013, except on the left side of pier 21 (fig. 14).

Figure 12. Bathymetric survey of the Missouri River channel near structure A5664 on Missouri State Highway 13 at Lexington, Missouri.
