Bathymetric and Velocimetric Surveys at Highway Bridges Crossing the Missouri River between Kansas City and St. Louis, Missouri, May 22–31, 2017

Scientific Investigations Report 2020–5018

By Richard J. Huizinga

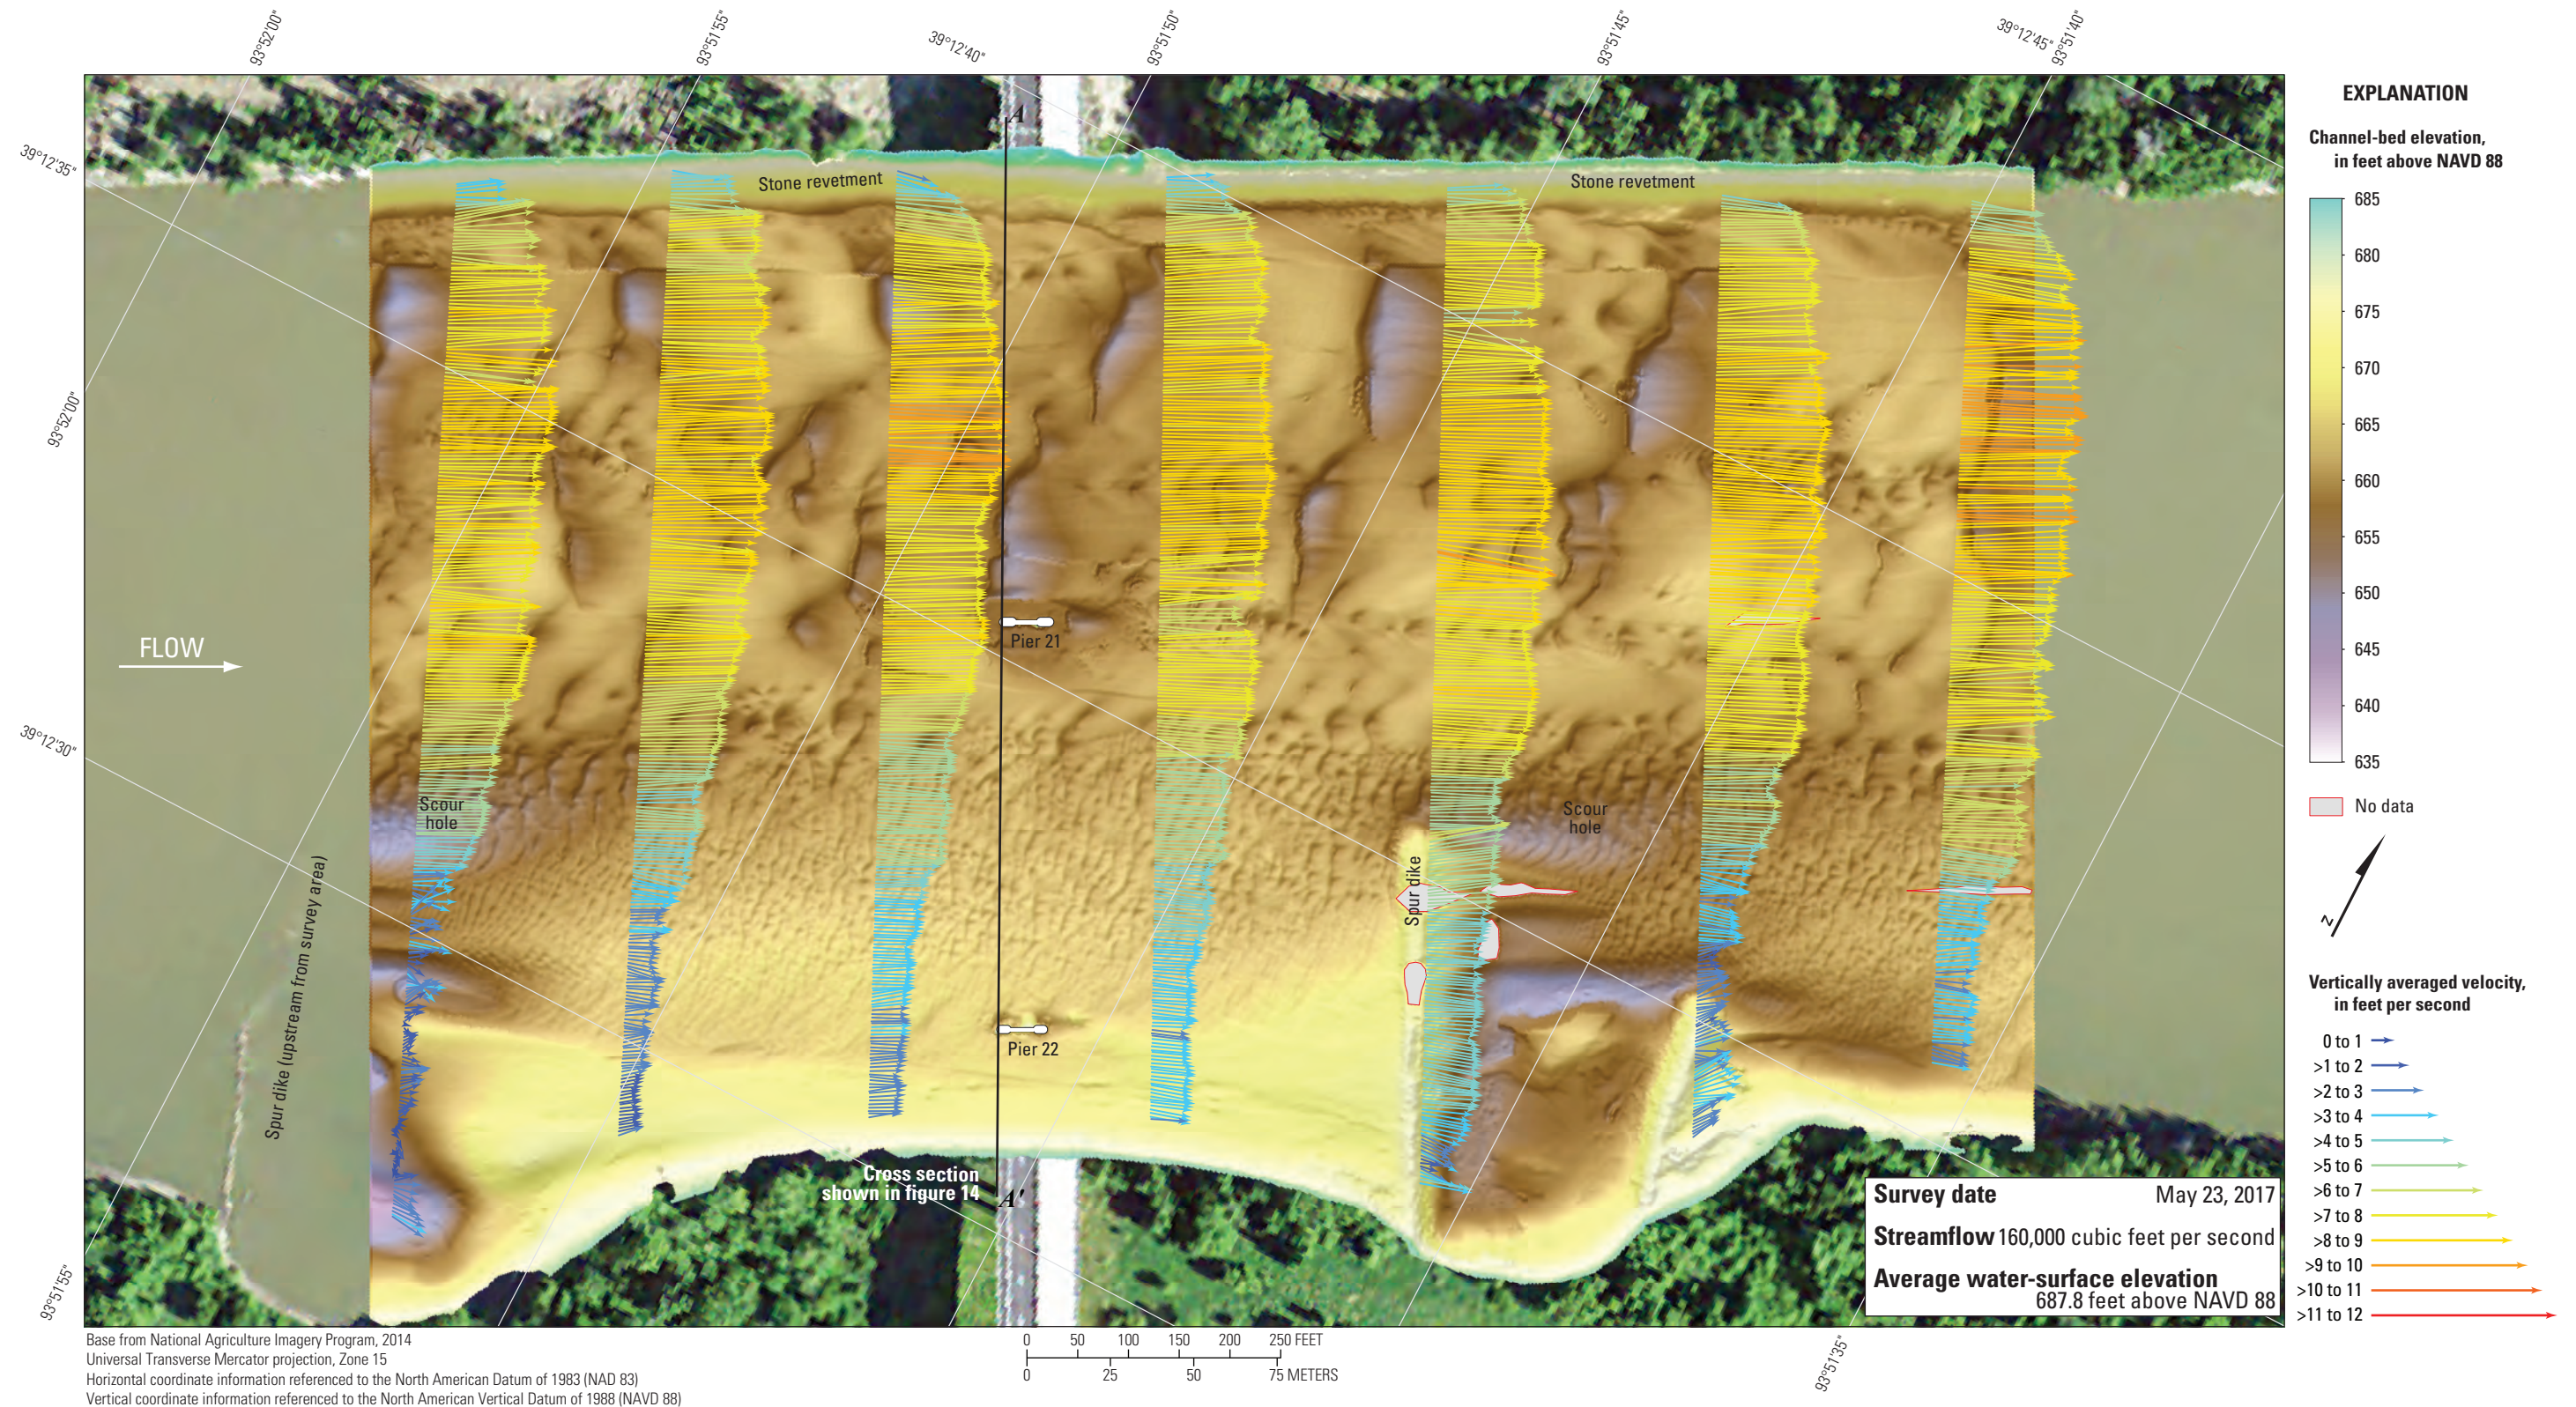
The vertically averaged velocity vectors indicate mostly uniform flow throughout the reach (fig. 17). A maximum velocity of about 10 ft/s was present in the downstream middle of the channel, and a minimum velocity of about 1 ft/s was present with flow reversal downstream from the various spur dikes in the reach (fig. 17). Minimal to moderate turbulence was observed at several transects (fig. 17), likely as a result of localized flow disturbances caused by the spur dikes and bedforms. The bridge piers were aligned with flow, with only moderate effects on the velocity and no evident turbulence downstream from either pier (fig. 17).

Figure 17. Bathymetry and vertically averaged velocities of the Missouri River channel near structure A5664 on Missouri State Highway 13 at Lexington, Missouri.

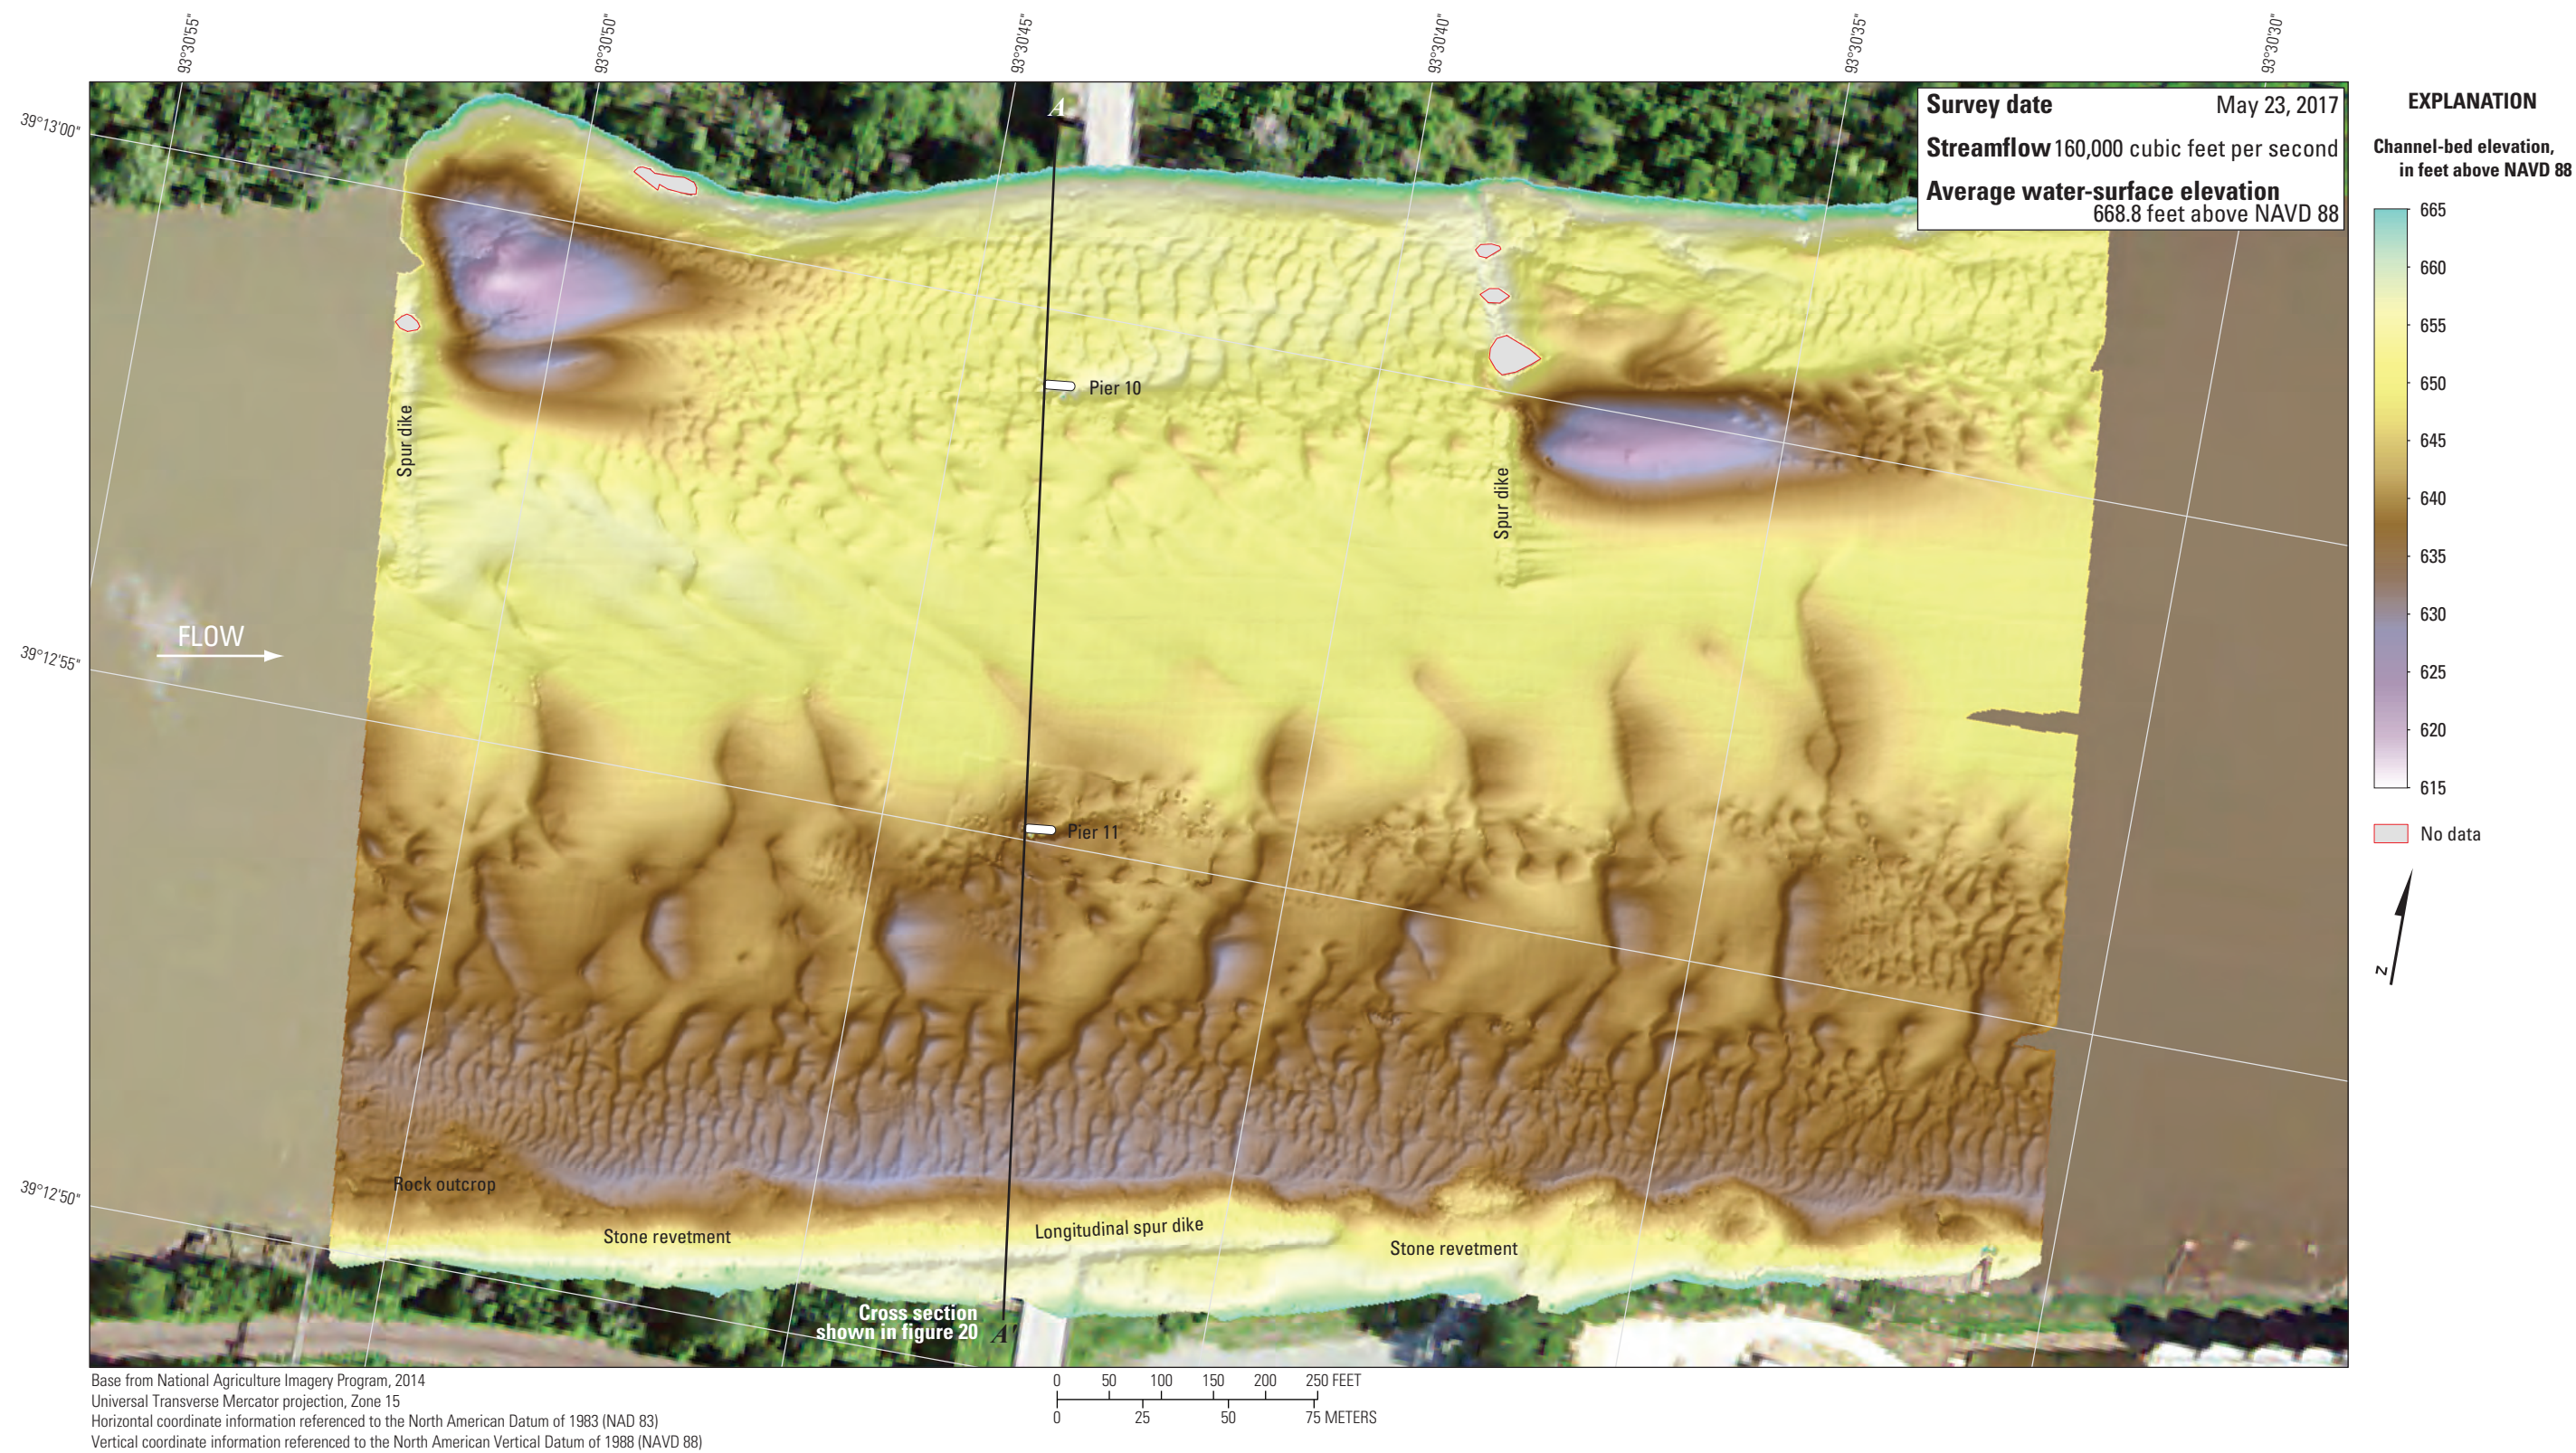
The minor scour holes near piers 10 and 11 were difficult to discern from nearby dunes and ripples (figs. 18, 20). Information from bridge plans indicates that piers 10 and 11 are founded on shafts drilled 30 to 42 ft into bedrock, having about 34 ft of bed material between the bottom of the scour hole and bedrock at pier 11 (fig. 20; table 6). The surveyed bed generally was similar to a previous multibeam survey on July 21, 2011, but with 5 to 10 ft of deposition between piers 10 and 11 (fig. 20).

Figure 18. Bathymetric survey of the Missouri River channel near structure A5910 on U.S. Highway 24 at Waverly, Missouri.

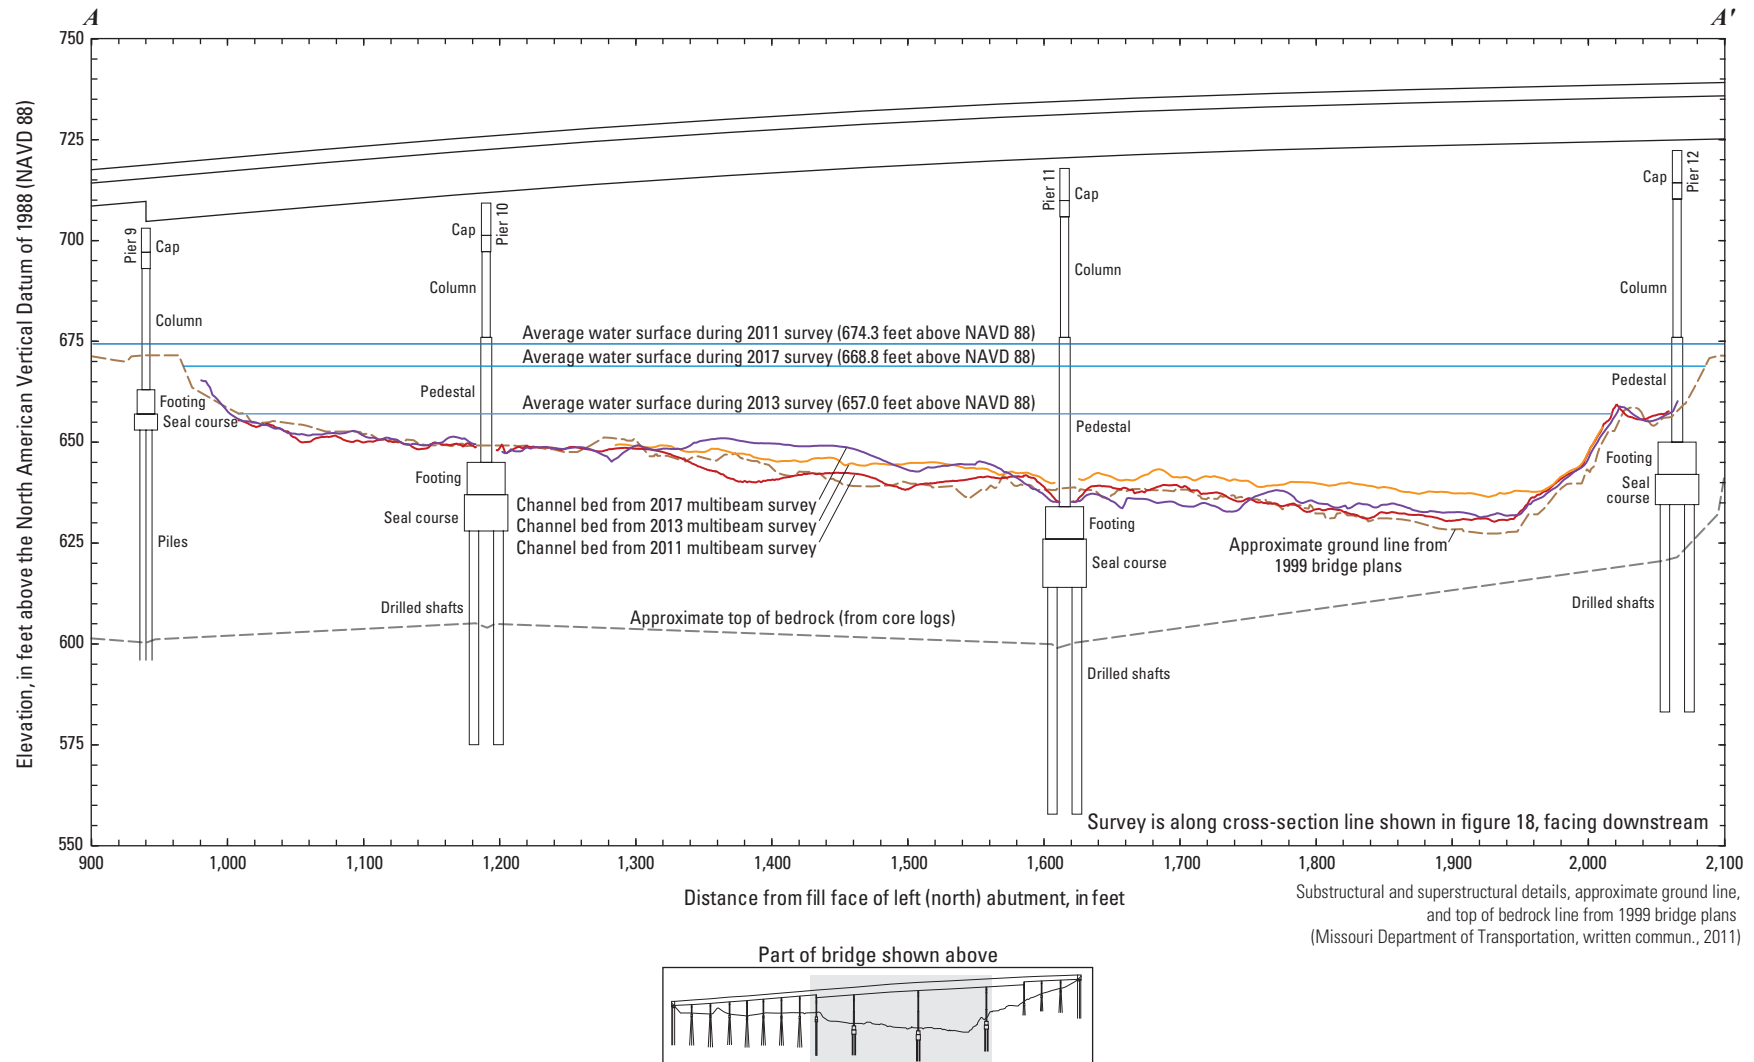
Figure 20. Key features, substructural and superstructural details, and surveyed channel bed of structure A5910 on U.S. Highway 24 crossing the Missouri River at Waverly, Missouri.

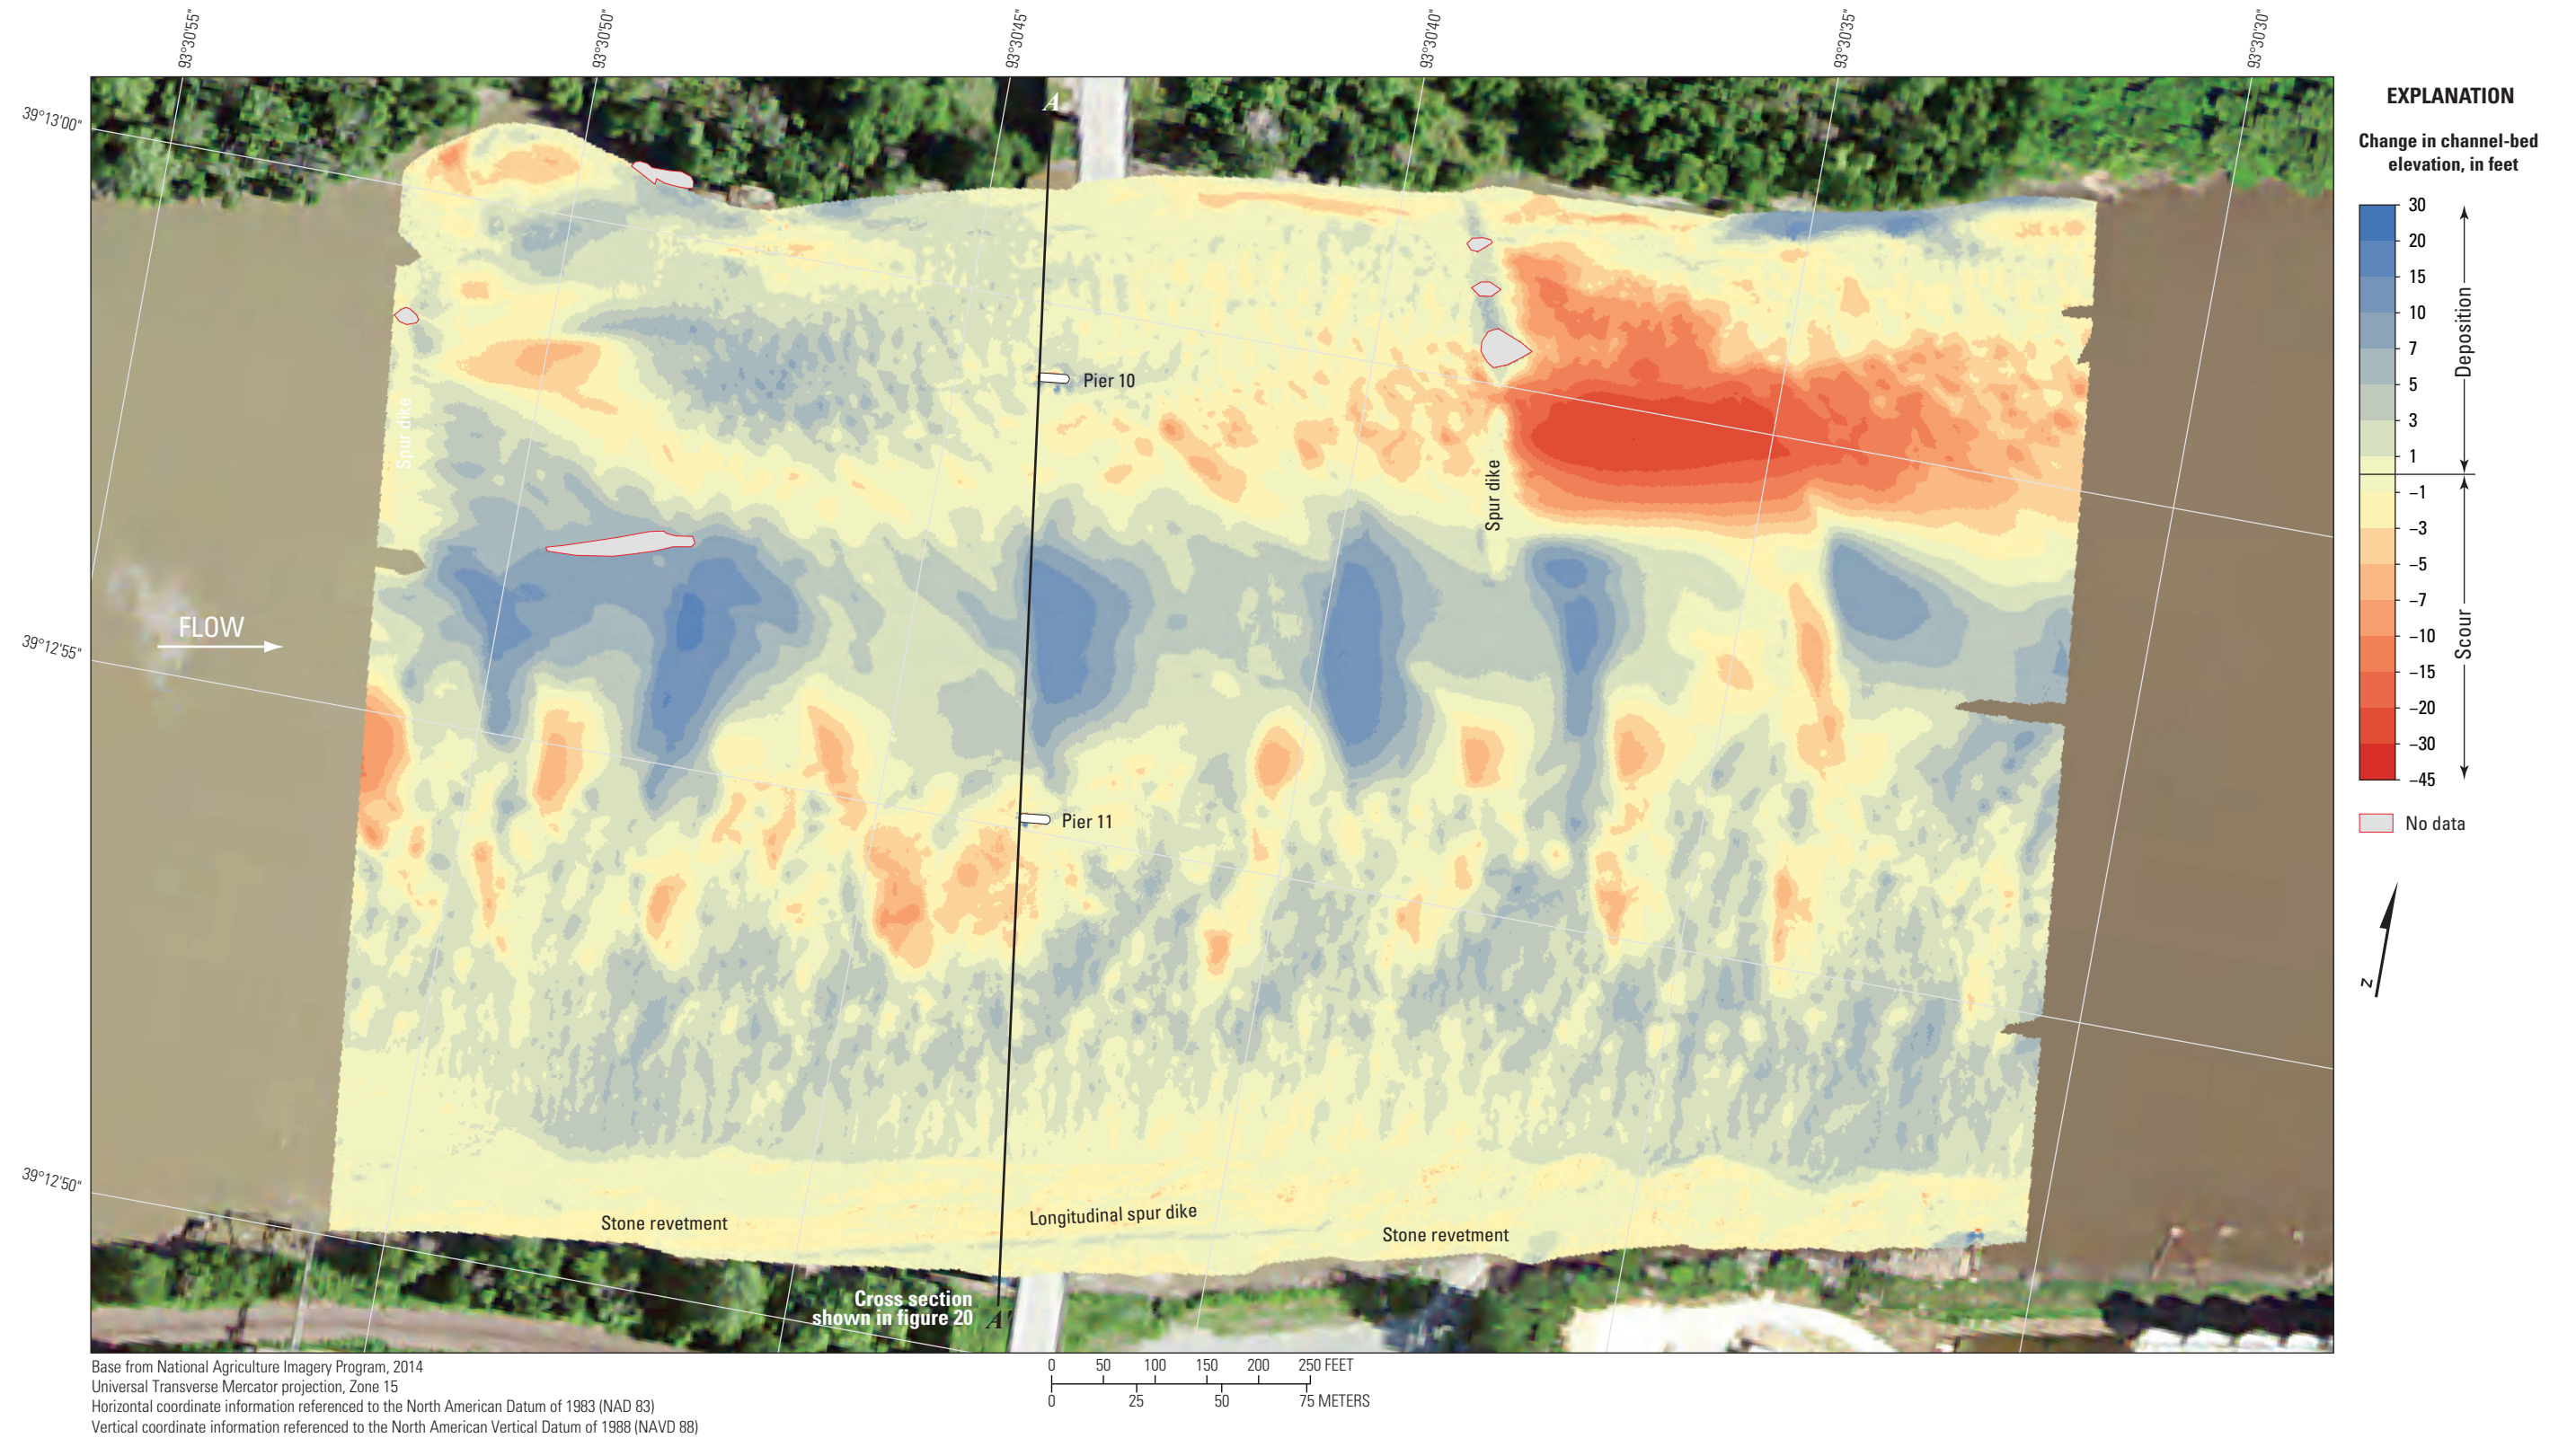
The difference between the survey on May 23, 2017, and the previous flood survey on July 21, 2011 (fig. 22), indicates a relative balance of deposition and scour throughout the reach between 2011 and 2017, resulting in an average difference of +0.64 ft between the bathymetric surfaces (table 7). The net volume of cut in the reach from 2011 to 2017 was about 77,800 yd³, and the net volume of fill was about 118,000 yd³, resulting in a net gain of about 40,200 yd³ of sediment. There was substantial deposition of more than 15 ft in the troughs of the large dunes observed in the middle of the channel in the 2011 survey, but a substantial scour hole was present downstream from the downstream spur dike in the 2017 survey that was not present in the 2011 survey (fig. 22; Huizinga, 2012). The cross-section data from the 2017 survey demonstrate the pattern of deposition in the middle of the channel between piers 10 and 11 compared to the 2011 survey (figs. 20, 22). The frequency distribution of bed elevations was similar in 2017 and 2011; however, more survey-grid cells were present

Figure 22. Difference between surfaces created from bathymetric surveys of the Missouri River channel near structure A5910 on U.S. Highway 24 at Waverly, Missouri, on May 23, 2017, and July 21, 2011.
