UNITED STATES
NUCLEAR REGULATORY COMMISSION
OFFICE OF NUCLEAR REACTOR REGULATION
OFFICE OF NEW REACTORS
WASHINGTON, DC 20555

June 13, 2018

NRC INFORMATION NOTICE 2018-07: PUMP/TURBINE BEARING OIL SIGHT GLASS
PROBLEMS

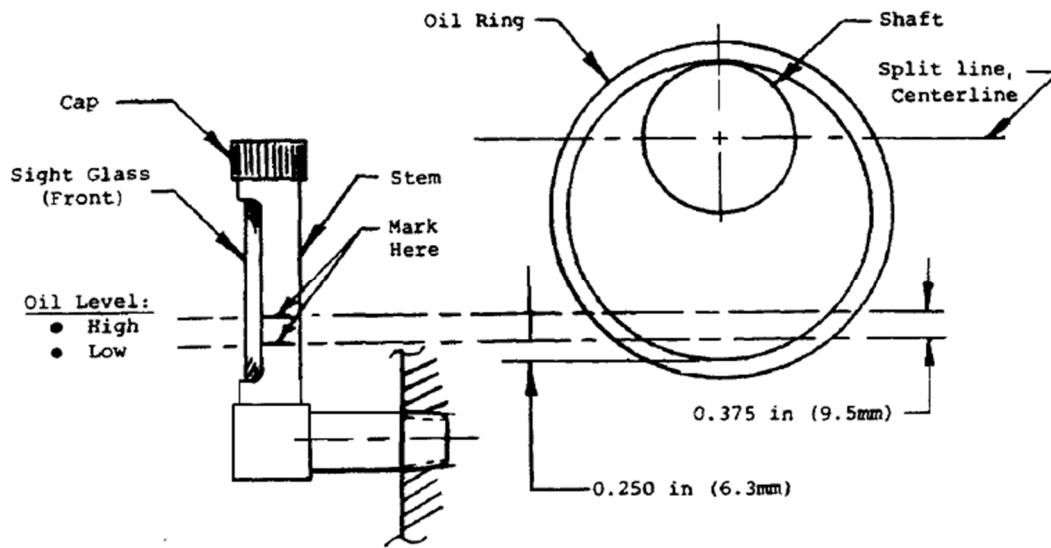
The licensee performed an investigation and identified the apparent cause for the bearing damage was a failure to replenish the oil reservoir after removal of a 10- to 11-ounce oil sample following the last quarterly surveillance test on June 21, 2017. The technician did not replenish the oil reservoir because the vertical (columnar) sight glass indicated that the oil level was within the marked bands. The vendor manual states that the minimum proper oil level (in the reservoir) in slinger ring lubricated bearings is 0.250 (1/4) inch above the bottom dead center of

the inside diameter of the oil slinger rings (see Figure 1). The vendor manual also states that the sight glass should have two marks that indicate the minimum and maximum oil levels. Although these marks should be approximately 0.375 (3/8) inch apart, the as-found marks were significantly wider than 3/8 inch. The licensee determined the as-found oil level after the September 13, 2017, event was below the minimum recommended level on the vendor drawing even though the oil level was observed to be within the normal range of the as-found scribe marks on the sight glass.

Figure 1 Recommended oil level for ring oil lubricated bearings
(Source: Davis-Besse Vendor Manual Guidance, Terry Corporation)
