NASA TECHNICAL MEMORANDUM

NASA TM-82424

LOX/GOX RELATED FAILURES DURING
SPACE SHUTTLE MAIN ENGINE DEVELOPMENT

By C. E. Cataldo
Materials & Processes Laboratory

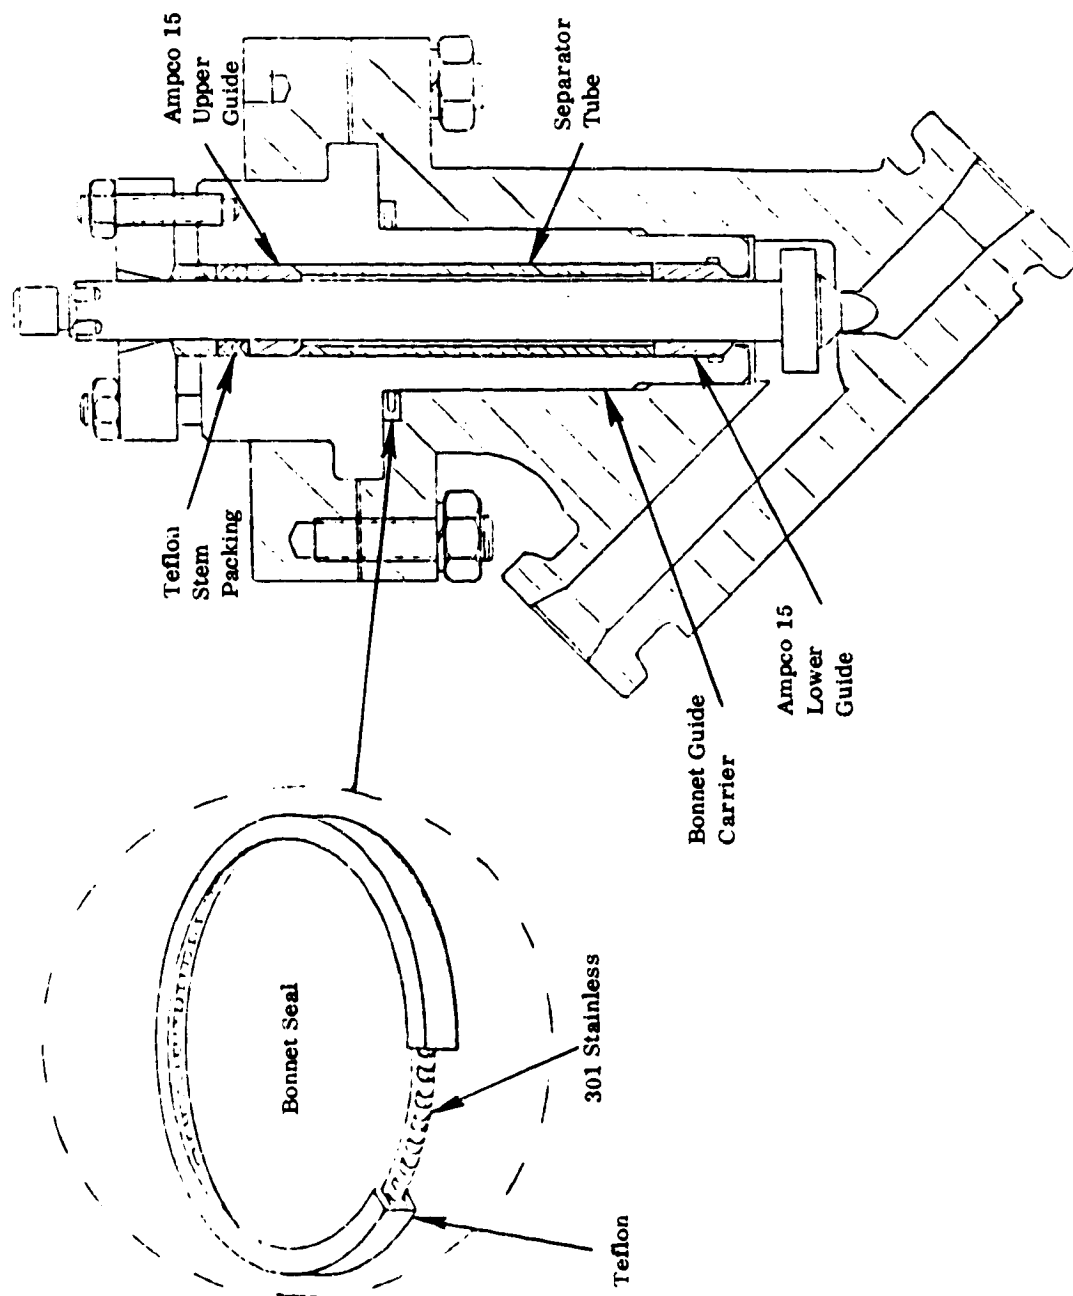
Figure 3. Coca 4B oxidizer P/B F/M lox bleed.

located on a stub line to the main flow line. A schematic of this valve and associated components and materials is shown in Figure 3. This particular valve was found to have a burned bonnet seal (Teflon). There was no evidence of significant prior contamination. Note that the valve was installed such that lox/gox pressure was over the ball. The downstream valves were reversed, with the low pressure under the ball; thus, protecting the stem packing and seals from exposure to lox while in the closed position.

It was concluded that primary velocities and surges in the unprimed stub bleed line, caused by main line surges, could have resulted in pressures of 20,000 psi and velocities of 400 ft/sec. This would have resulted in high temperatures, generated by adiabatic gox compression in the stub line. Temperatures on the order of 1220°F were calculated because of this effect. The ignition temperature of Teflon at 3060 psi is approximately 850°F. The Teflon seal was a static bonnet seal (Rayco) of TFE Teflon with an internal spring, used between the cap and body of the valve. The spring and seal were burned; no other damage occurred to the valve. No other cause, other than adiabatic compression, was found to explain the Teflon ignition.

The explosion and major assembly damage were not attributed to the Teflon ignition in the valve but to surges and overpressure in the system. The Teflon ignition was caused by the pressure surge because of erratic main lox valve opening, and the installation of the valve such that the Teflon was exposed to the surge pressure.

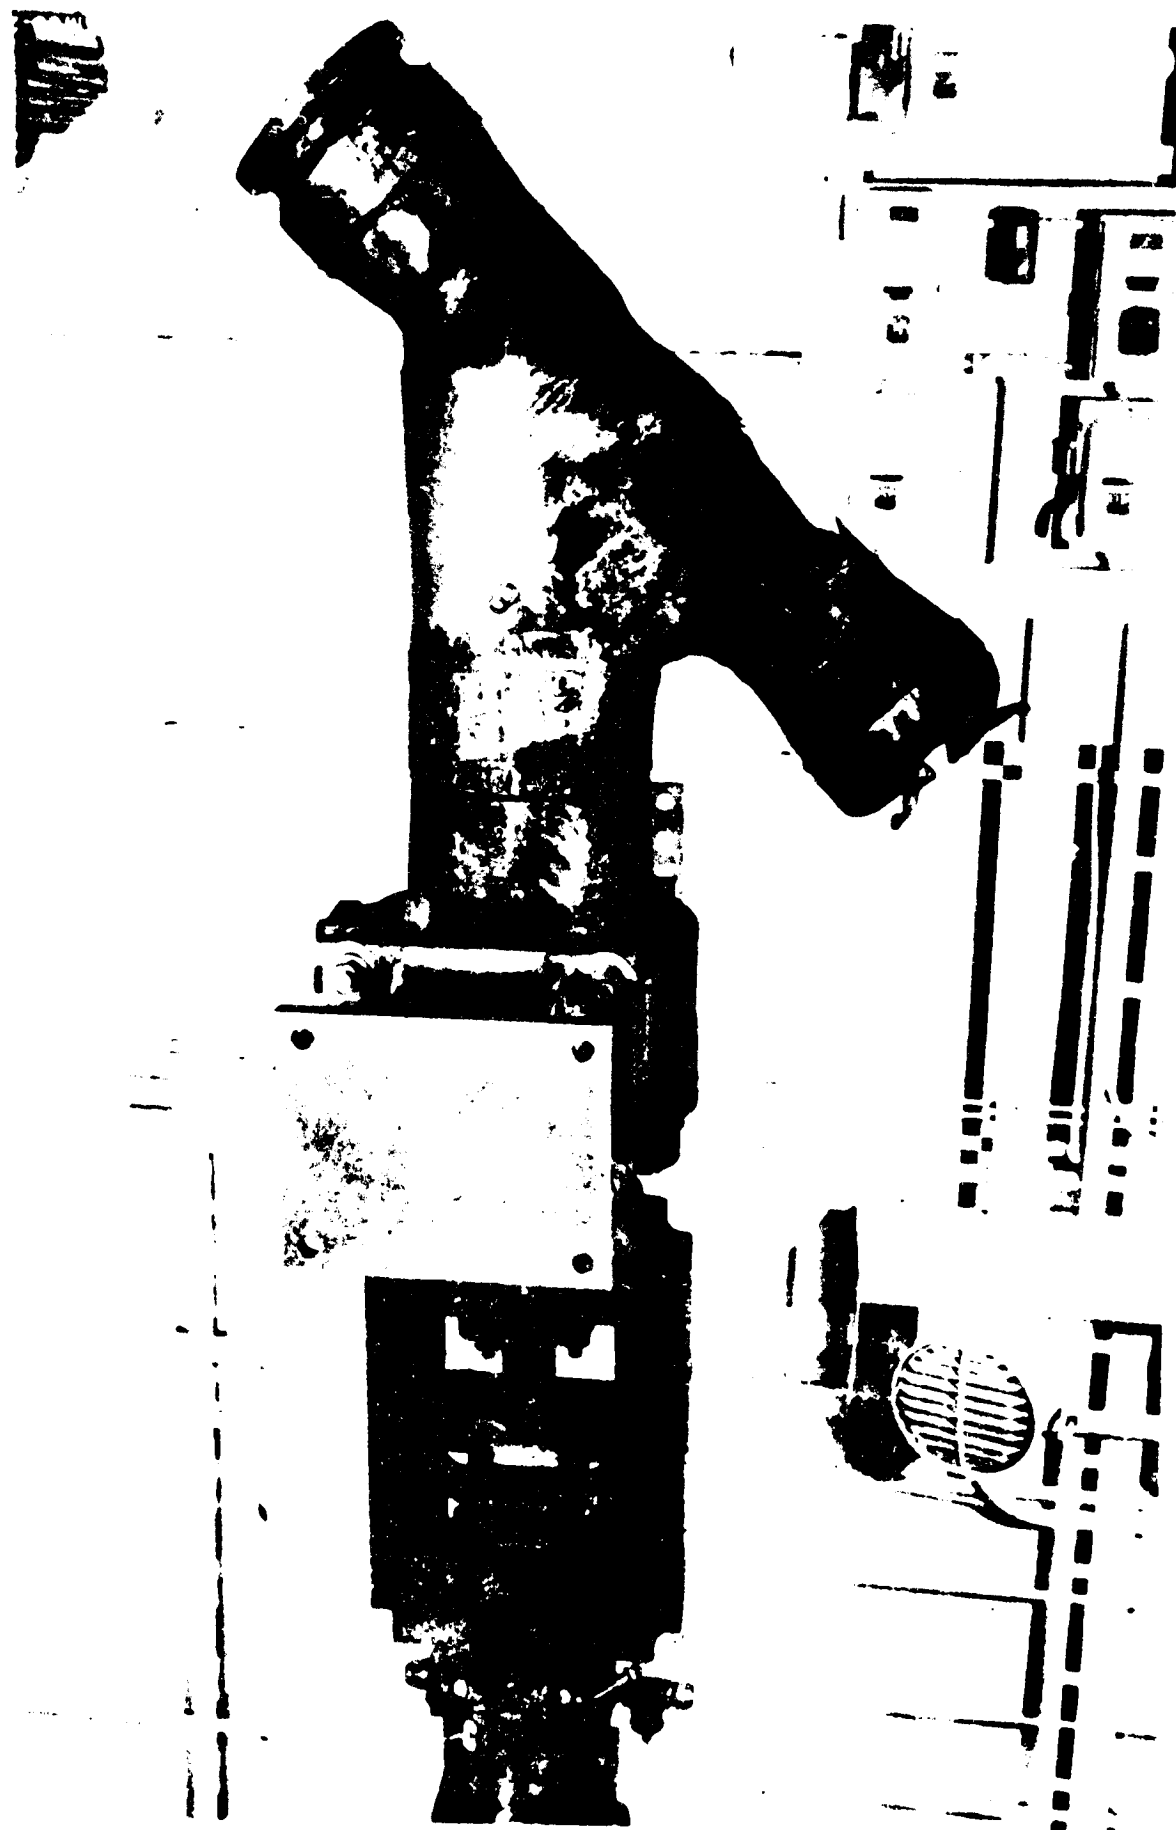
A simplified schematic of the test hardware is shown in Figure 4. The test set up and annotations as to post test observations are shown in Figure 5. Extensive burning occurred in the SA-5 Annin Throttling valve, as illustrated in Figures 6 and 7. Also, damage was observed in a flowmeter (LA-71). The meter lost two adjacent rotor blades; a retaining ring was dislodged; and two anti-rotation pins were missing (Fig. 8 and 9).

The 6-in. Annin valve was of typical construction and was used as a throttling valve with a fail open mode. The poppet shaft seals were on the low pressure side of the valve. The valve body material was 316 CRES and the lip seal of the valve was an integral part of the body. The poppet material was also 316 CRES, containing an AMPCO aluminum bronze seal ring which mated against the 316 body for sealing. The poppet shaft rode in an aluminum bronze bushing and was sealed by a battery of Teflon chevron seals in the shank.

Figure 7. Annin valve SA5 - post test.

- 1) The flowmeter was redesigned to minimize the risk of blade breakage and loss of pins and retainer rings due to mechanical vibrations.
- 2) Revised procedures were implemented in the operation of throttling valves. The procedures were developed to minimize valve position changes during high lox flow conditions; cavitation conditions were avoided; and additional screens were employed to intercept foreign particles.

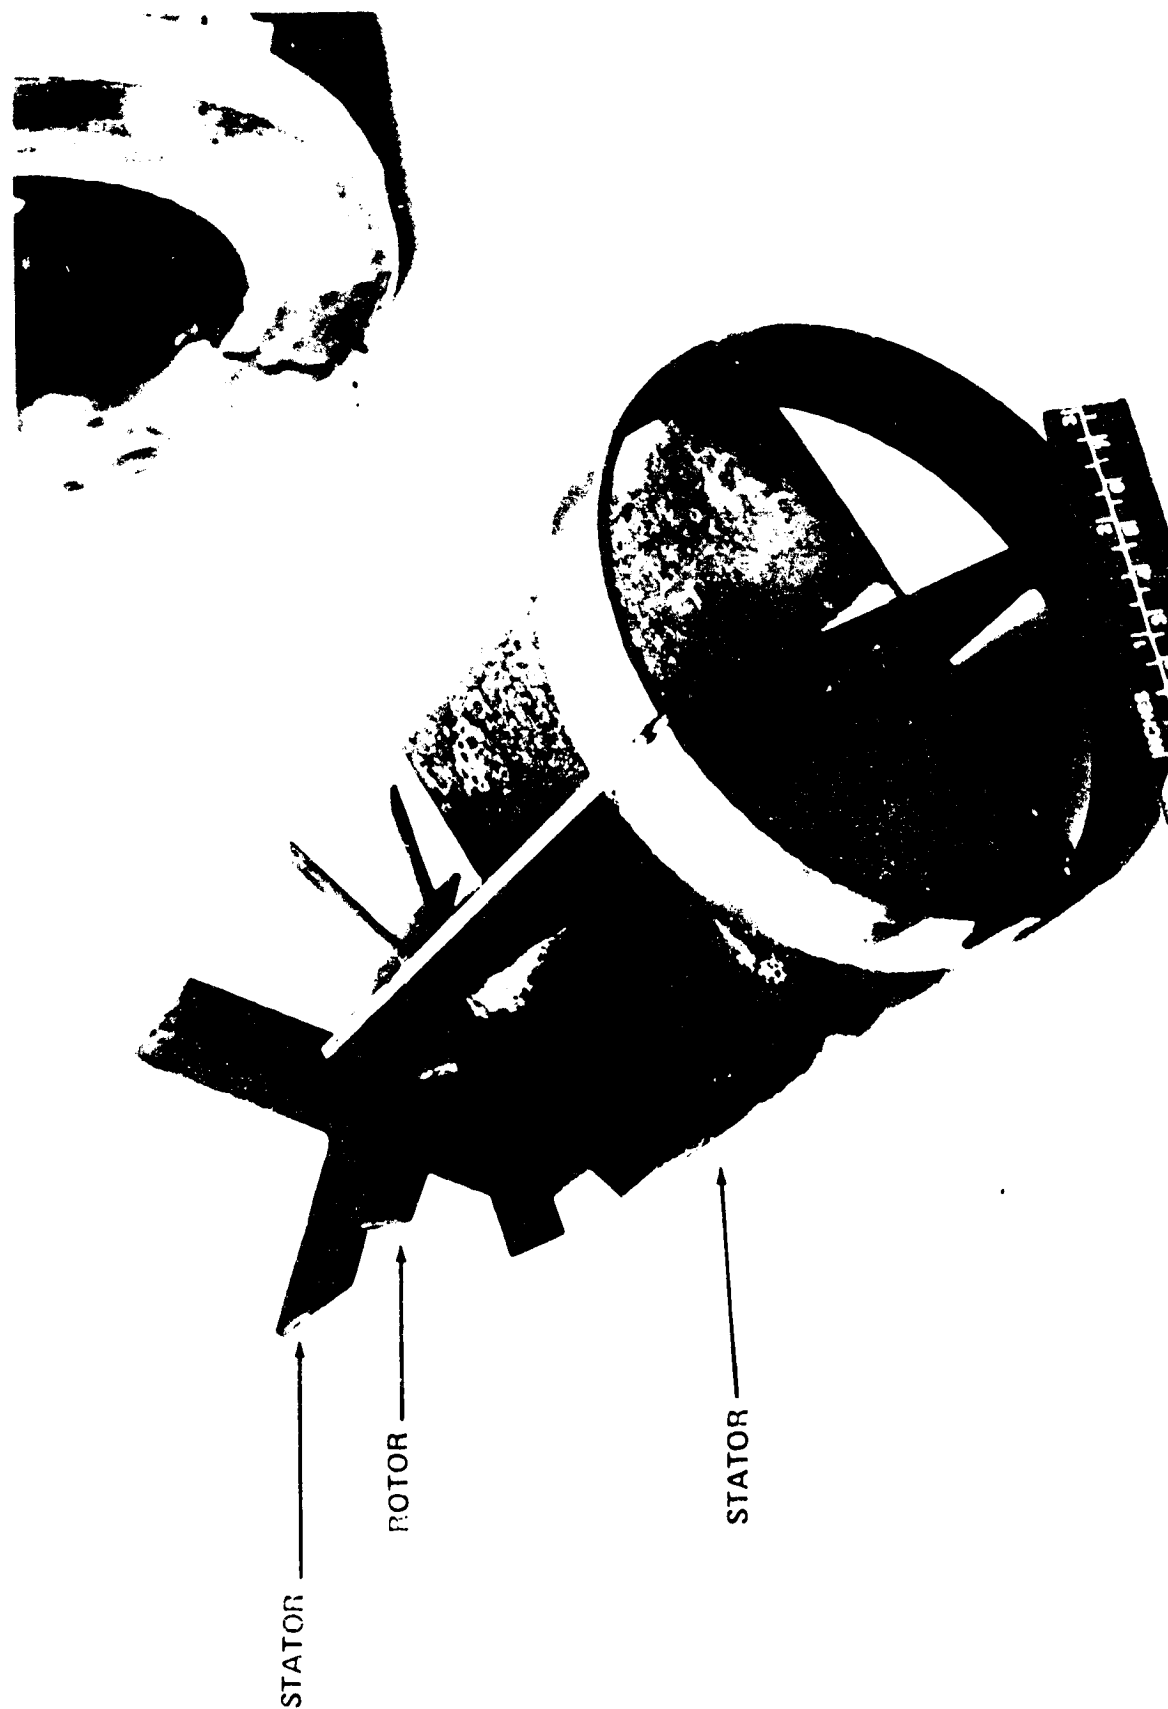
The 6-in. diameter flowmeter, made by Flow Technology, Inc., Tempe, Arizona, was of 1970 vintage and had been previously used in development testing (16 tests and 413 sec test time). The ten blade rotor was SAE 9310 steel, nickel plated. Most other parts were 302 and 304 CRES. Following the failure, two adjacent blades were missing; the 308 CRES anti-rotation pins were missing; the 440C CRES rotor bearing was free, but rough running; and the Sprialoc ring, which held the flow straighteners in place, was out of its groove and bent over the downstream vanes. Analysis of the rotor blades showed them to be AMS 6260 aircraft quality 9310 steel, with a hardness of RB 93-96. Some globular oxides and sulfides were evident in the microstructure, and the material showed a typical air melted structure. Failure in both blades initiated at the leading face. The leading failed blade had numerous scratches from sanding and a portion of the fractured edge followed a large scratch. The fractures were primarily cleavage type, and were found to be identical to samples broken in the laboratory by bending LN₂ soaked specimens. Some other blades on the rotor were slightly undercut at the root; the second fractured blade was 0.0001 out of spec; and part of the fracture ran through this area (Fig. 10). Stress calculations on the blade showed that the combined torque load on the blade and a load calculated from the impact of a loose anti-rotation pin would approach the yield strength of the alloy.

The accident investigation board concluded that the probable cause of the accident was the loss of blades from the LA 71 facility flowmeter and subsequent ignition from the impact of the blades with downstream components, probably the SA-5 valve. It was also concluded that this valve operated with a cavitation condition just downstream of the throat. This condition would tend to propagate burning once ignition occurred. The resulting internal fire would restrict flow from the HPOTP causing excessive pressures in the ducting, loss of flow in the preburner pump, subsequent

Figure 8. Coca 1A facility flowmeter LA71 - post test.

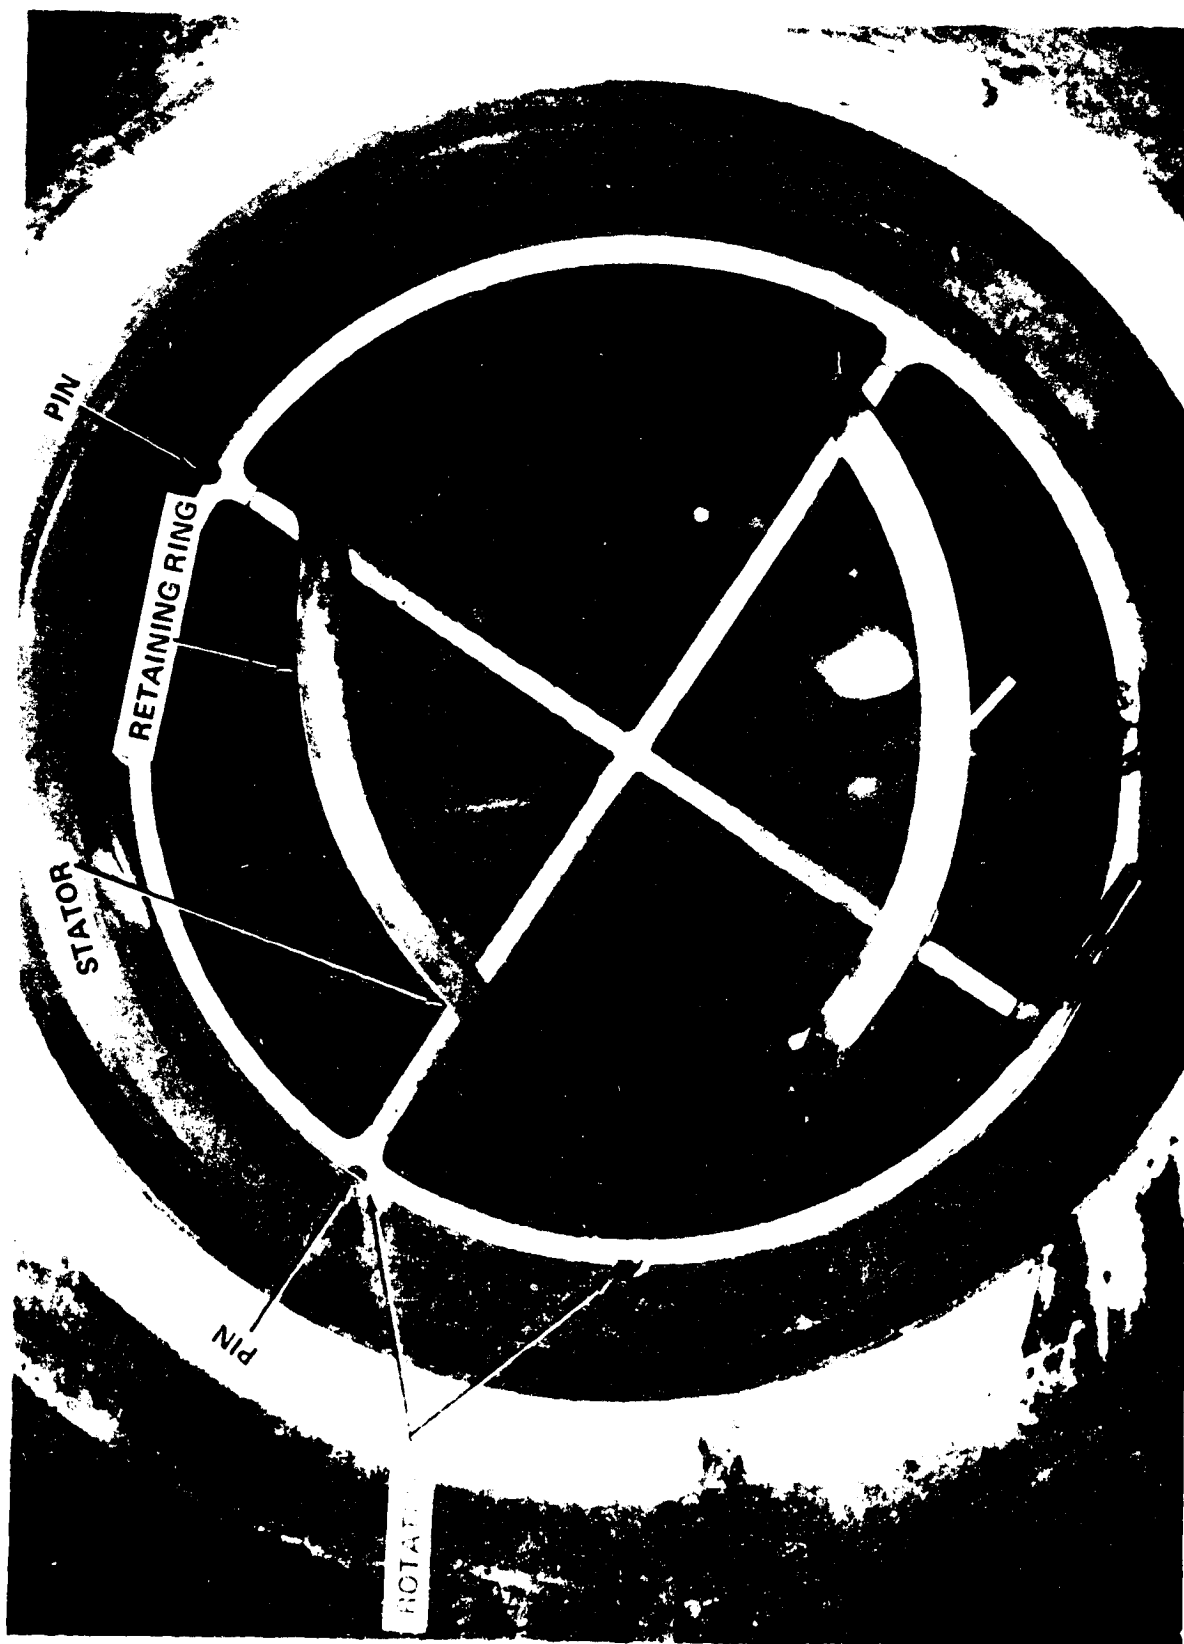
Figure 9. Coca 1A facility flowmeter SA71 retaining ring - post test.

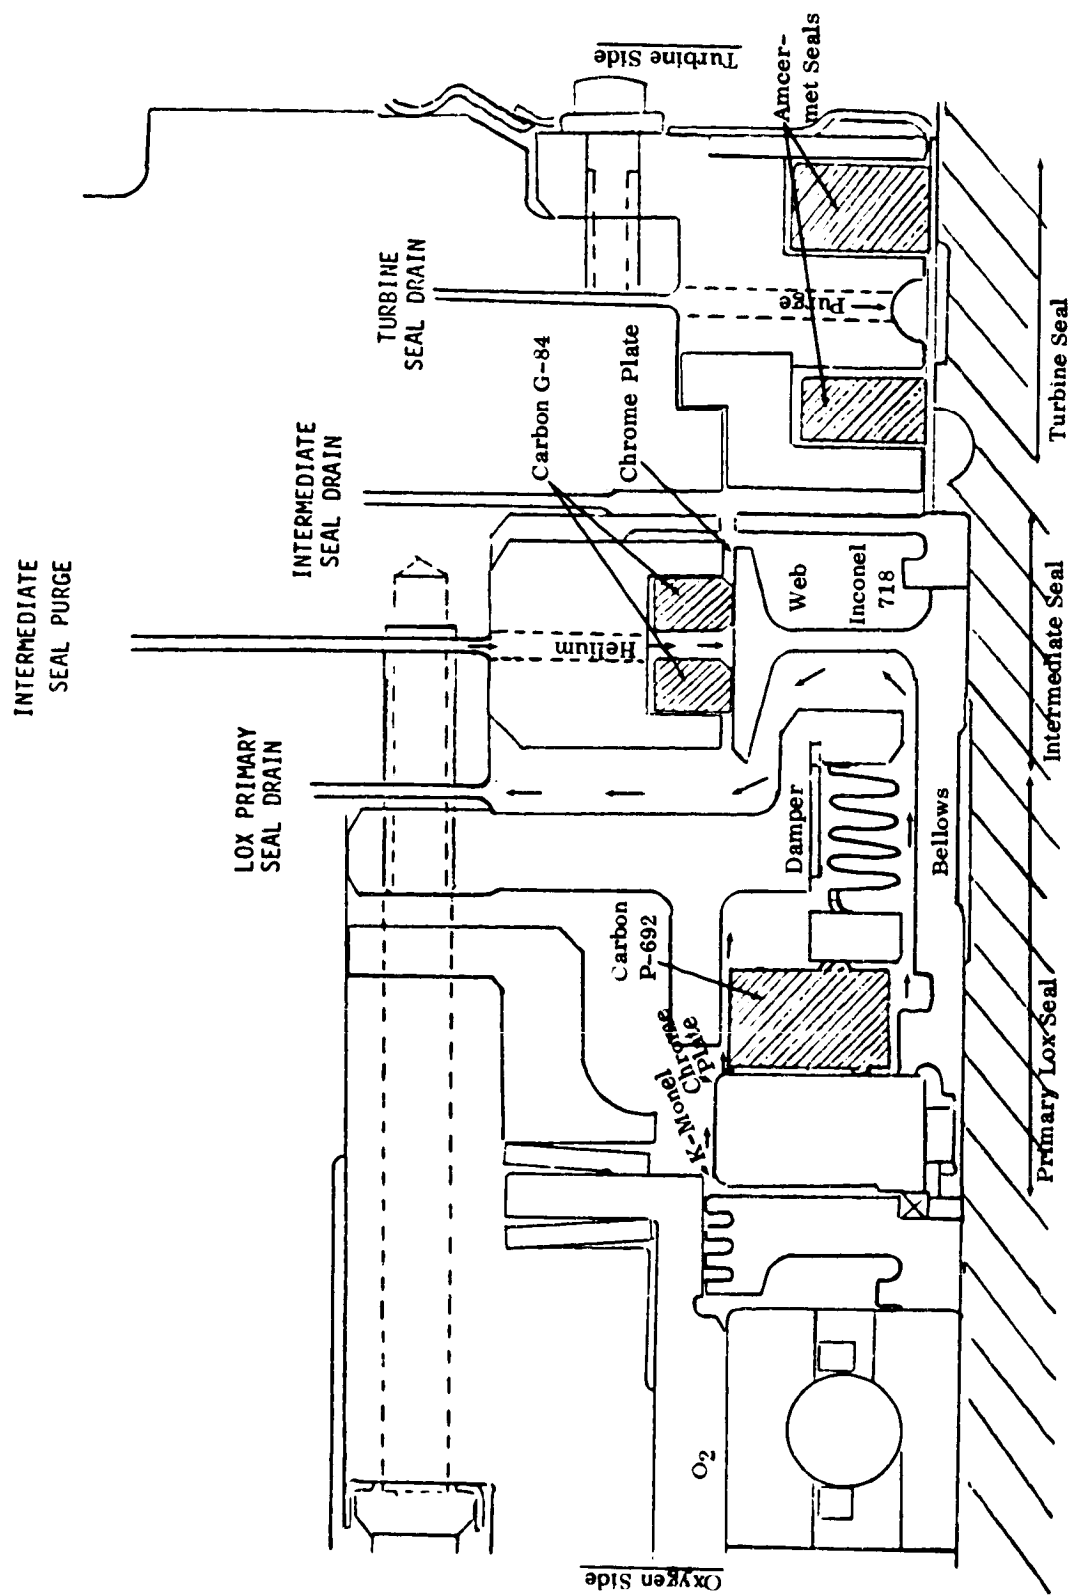
Figure 15. Configuration of the primary seal area of the HPOTP and the associated materials of construction.

- 1) Loss of hydrodynamic lift in the primary lox seal, causing rubbing of a carbon seal against a stainless steel mating ring, creating frictional heat and ignition of the carbon composite. Figure 15 illustrates the configuration of the primary seal area of the HPOTP, and the associated materials of construction.
- 2) Primary oxidizer seal bellows (Inco 718) weld failure, allowing oxygen leakage.
- 3) Ignition of the interface of the bellows and its vibration damper as a result of friction.
- 4) Contamination in the seal cavity.
- 5) Hot gas leakage past the intermediate seal into the primary seal area.
- 6) Vibration of the carbon seal against the mating ring.

The major materials used in the HPOTP seal package are listed in Table 1. Oxygen compatibility for each material was confirmed by laboratory tests under the environmental conditions experienced. Three extensive studies were made: (1) ignition studies of the primary lox seal carbon (P-692) ring by rubbing and overheating; (2) ignition of the thin metal bellows (Inco 718) by fretting against the damper ring, fatigue failure, or adiabatic compression of trapped oxygen gas; and (3) particulate contamination of either carbon seal or bellows, producing fresh surfaces and local hot spots under the dynamic use conditions. Post accident examination showed that the metal bellows and damper spring had burned completely, but the carbon seal was only partially burned.

Since no direct cause could be identified, design changes of major importance were implemented to correct all deficiencies defined. A new primary seal concept was employed using a labyrinth concept, and the carbon seal concept was eliminated.

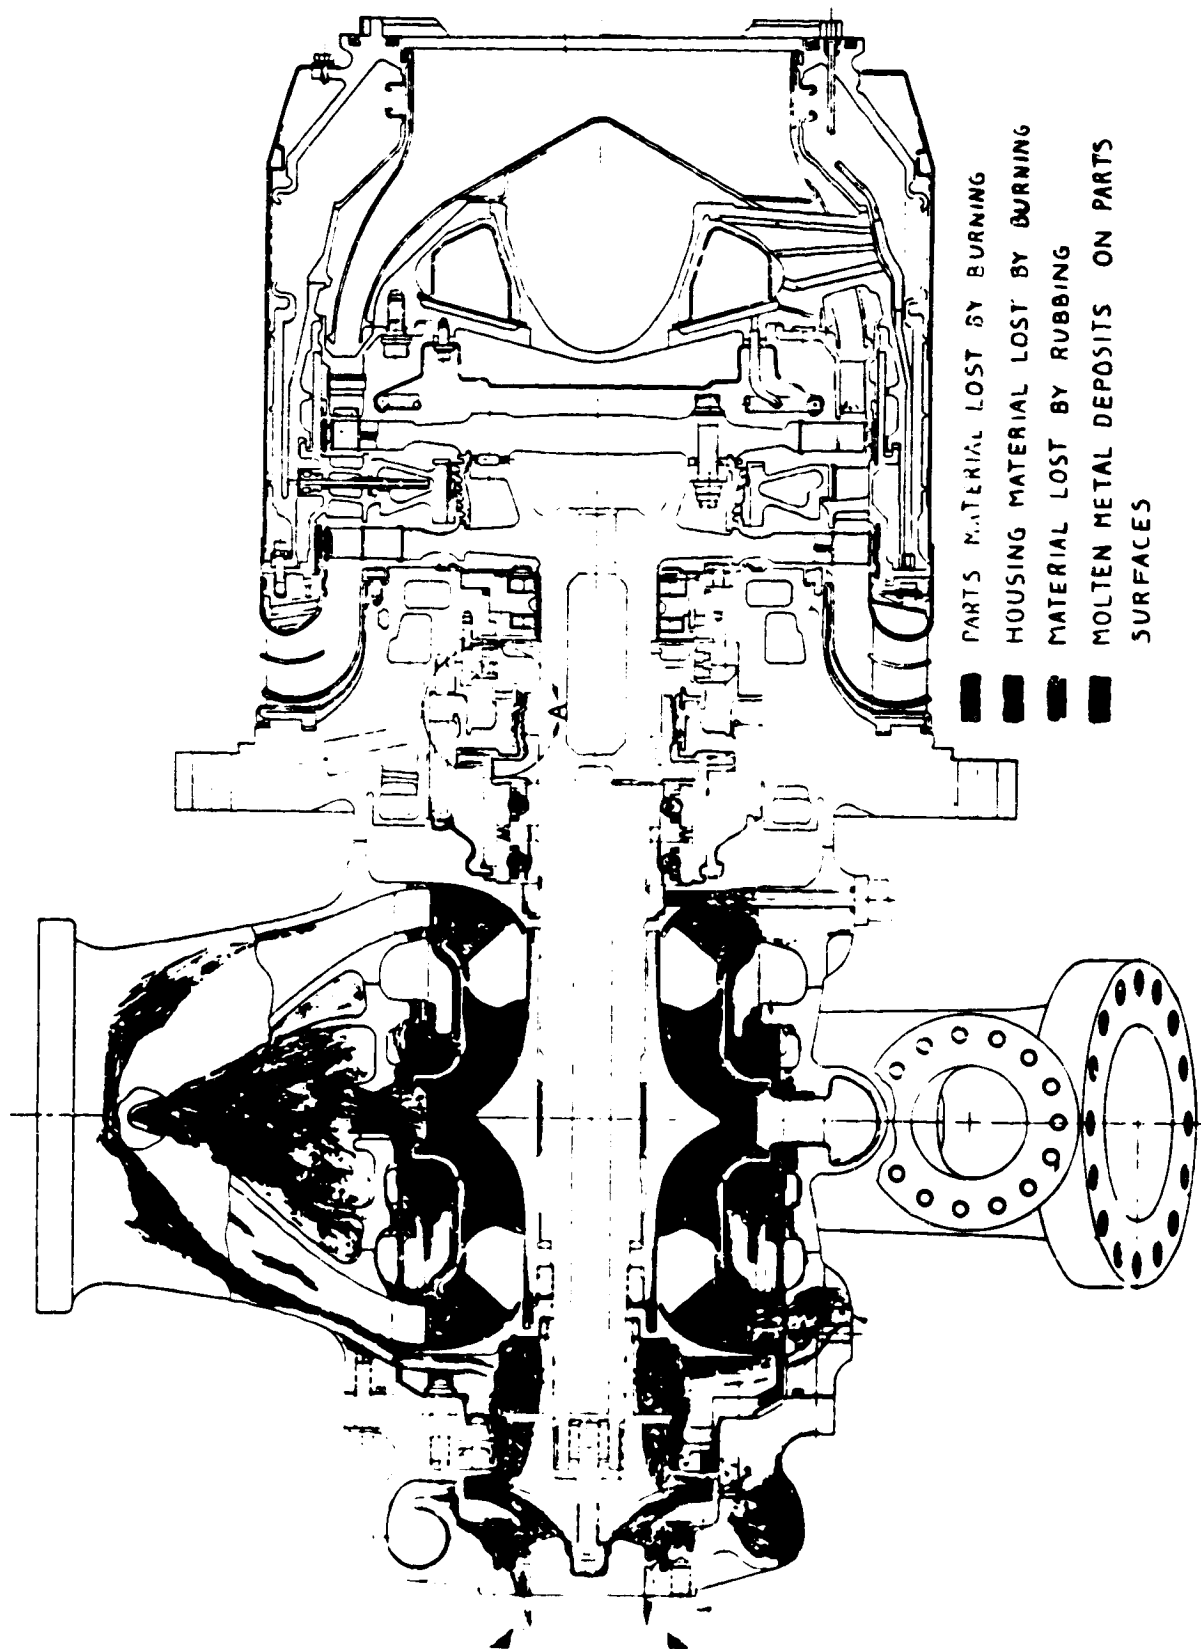
The investigating board concluded that the failure was caused by a bearing failure in the HPOTP. A load imbalance of the four bearings apparently occurred because of liquid oxygen coolant flow characteristics. The flow was such that the axial and radial loads on the pump end pair of bearings were not shared, but were concentrated on the inboard bearing. Also, the inboard turbine end bearing was not cooled adequately to provide satisfactory bearing life. The board also found inadequacies in the pump rotor balancing that needed more improvement. A cross-sectional view of the HPOTP is shown in Figure 20. A sketch of the HPOTP is shown in Figure 21 showing the principal areas of damage.

Figure 21. Cross-sectional drawing of high-pressure oxidizer turbopump after fire showing area of damage.

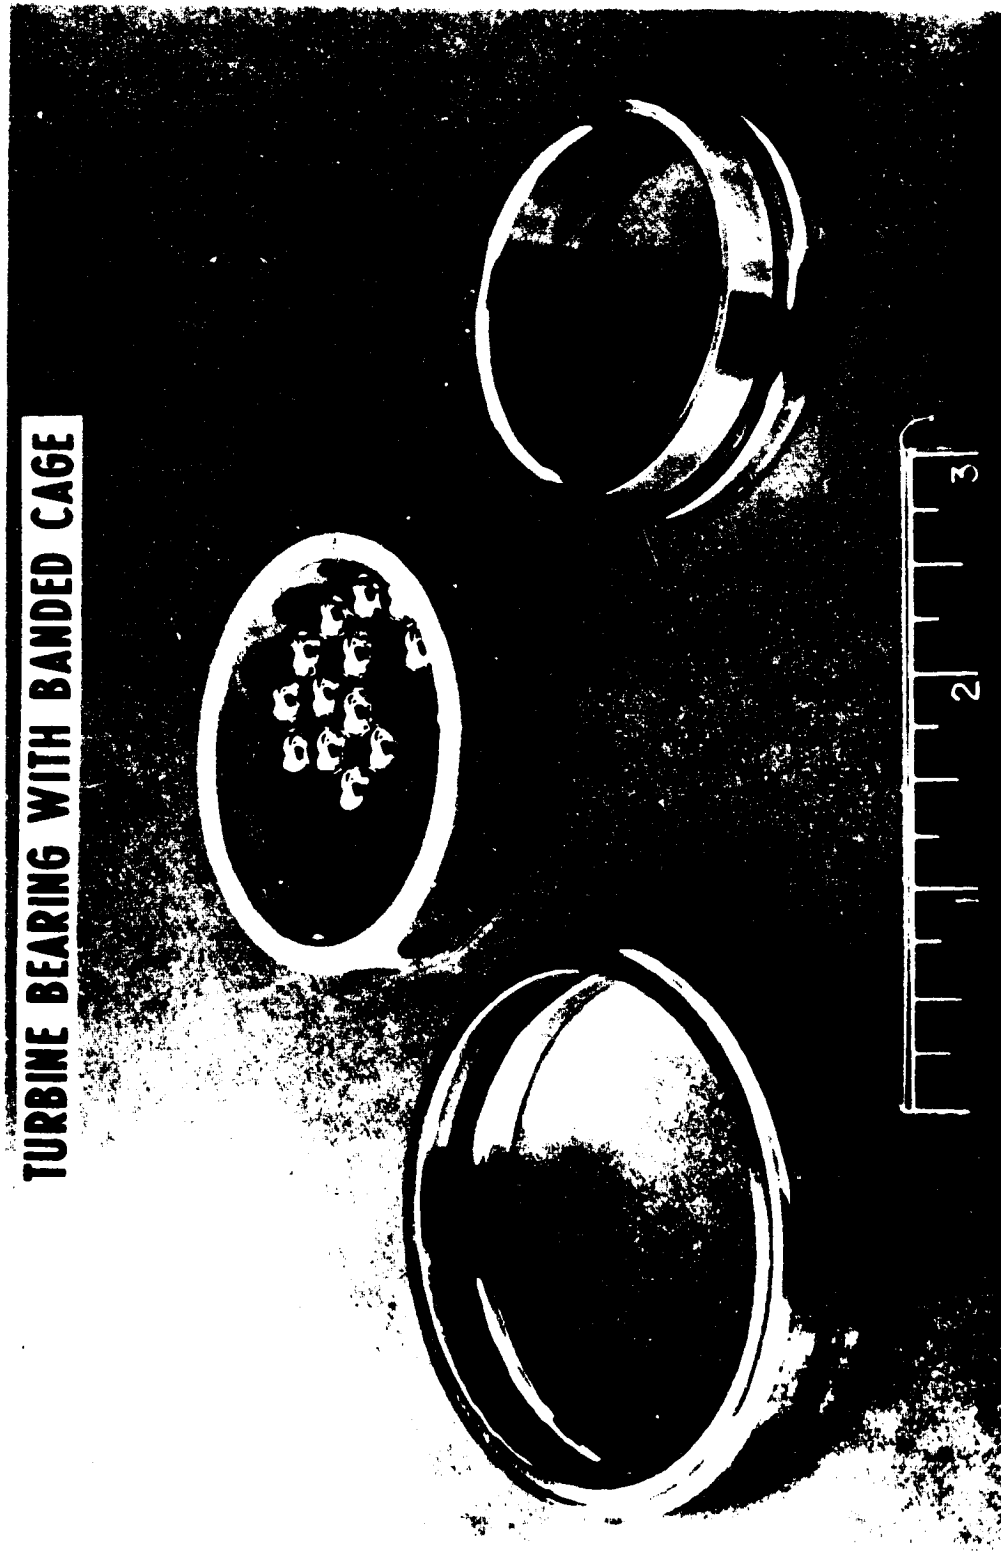
6. HPOTP Bearings - (Material 440C Balls and Races, Figure 22). All bearings (Nos. 1 and 2 on the pump end and Nos. 3 and 4 on the turbine end) were burned and essentially destroyed except for parts of the inner and outer races. All balls were missing and assumed destroyed.

by fire. Examination of the remaining races indicated moderate to heavy synchronous radial loads and non-uniform wear, indicating an unbalanced condition. It appeared that the worst fire damage occurred between the two sets of bearings, in the inducer area, and was more severe on the No.2 bearing side.

Figure 22. HPOTP bearings.

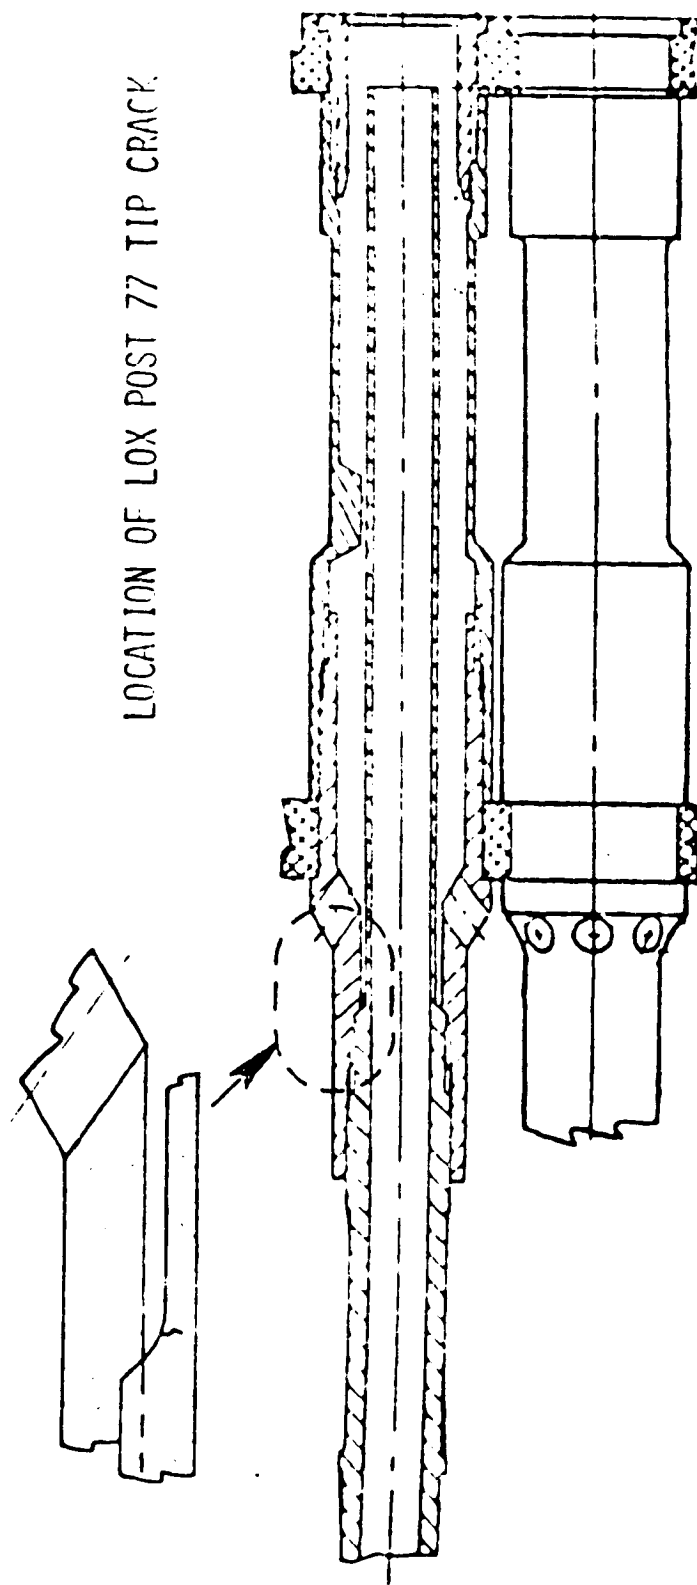
Post-test examination revealed a crack in the radius of a lox post, and several lox posts were bent, up to 1/4-in. in line with the outside hot gas transfer ducts. Some damage was observed on 18 lox posts and retainers. Cracks were found in the interpropellant plate.

The investigation of this failure concluded that the crack in the tip of lox post No. 77 (in No. 13 outer row) was caused by high cycle fatigue. This particular crack was not a through crack; it had progressed 0.010 through a 0.020 in. wall. The bent posts were caused by high temperature, high velocity, hot gas impingement. The lox posts were made from 316L CRES and apparently lacked sufficient high temperature strength to be structurally adequate. The Inconel 718 interpropellant plates were cracked parallel to the post axis and the cracks were attributed to low cycle thermal fatigue. One other post (post 8, row 12) was found to have failed at the friction weld, on the 316L side, by hot tensile failure, primarily because of overheating after the burning began. Early in the development program, the lox posts were made from HS-188, and no bending or cracking was encountered during testing. The 316L posts were used after the first three injectors, since the structural and thermal analysis showed them to be adequate, and considerable difficulties had been experienced in manufacturing the HS-188 units. The high loads and temperature effects and subsequent bending of the 316L posts had not been anticipated.

Figure 24. Main injector 0002, lox post failure.

Laboratory studies made in support of the failure investigation further defined the lox post vibration frequencies and mode shapes. Dynamic and structural models were made to simulate the failure mode. Vortex flow models were made and studied. It was concluded that the lox posts in line with the outer gas ducts failed first because of higher dynamic forces and higher temperatures. Thermal bending of the post caused increased tip loading. Vibration was most severe in the outer row of the posts. Consequently, several modifications were made to the main injector, including the incorporation of larger propellant face plate ducts, and better GH₂ cooling of the lox posts by using larger GH₂ orifices.

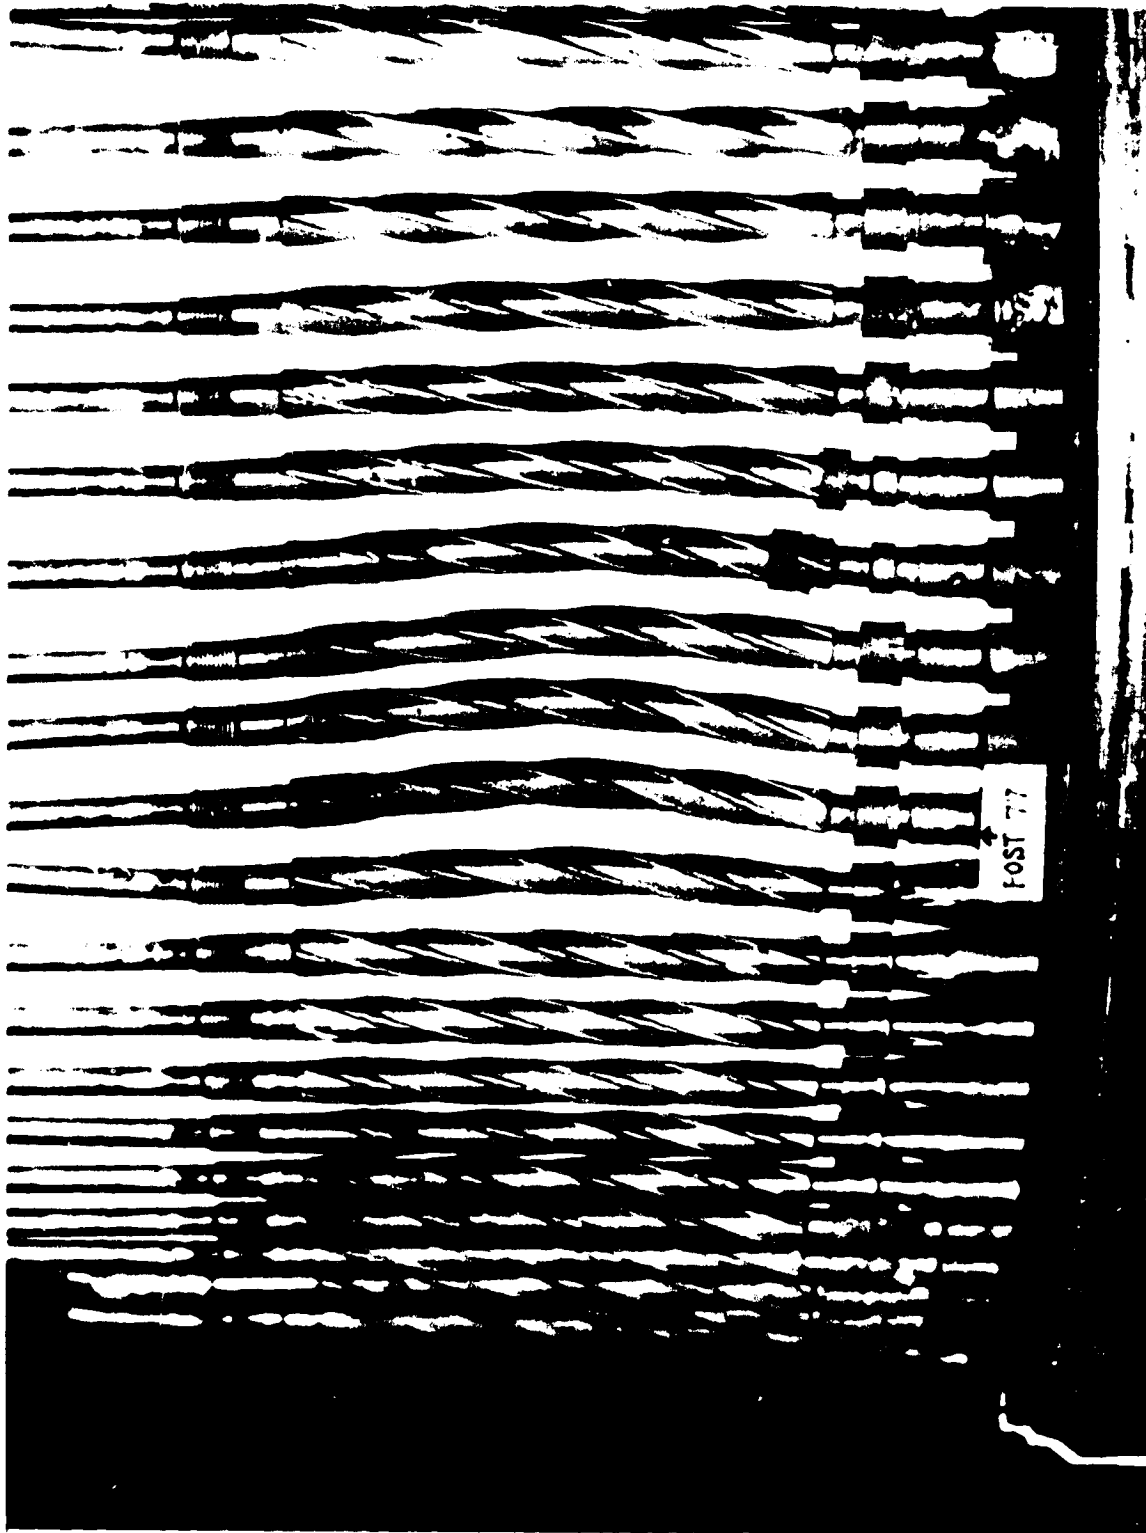
Figure 25. Deformation of lox posts.

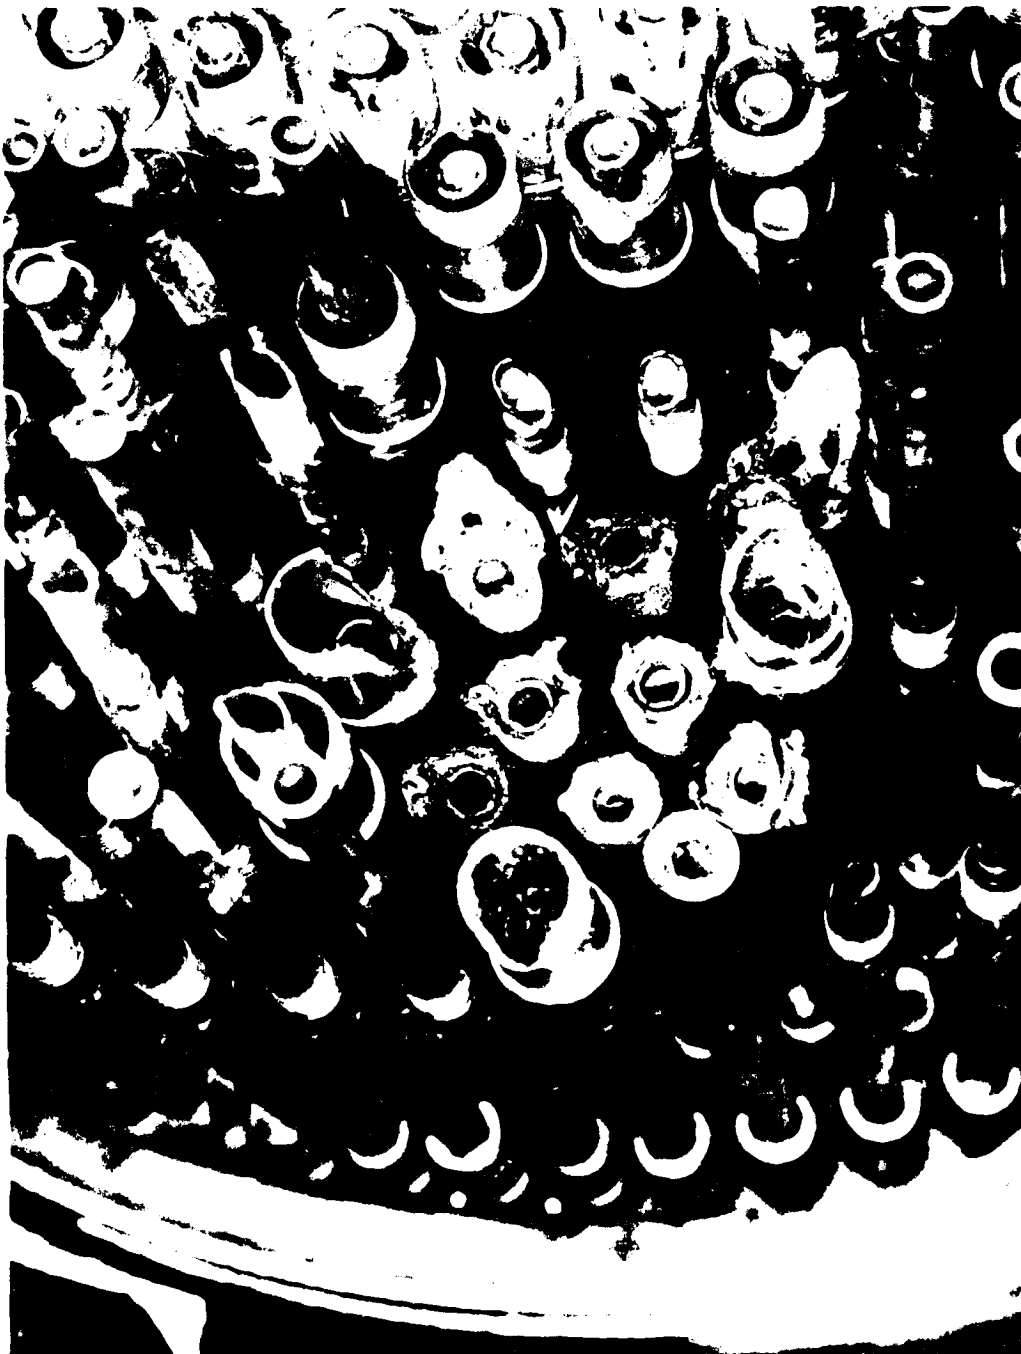
Damage was limited to a burnthrough of the injector secondary and primary face plates, burning of lox posts, and retainer and nozzle tube ruptures.

Figure 26. Post tips and injector face.

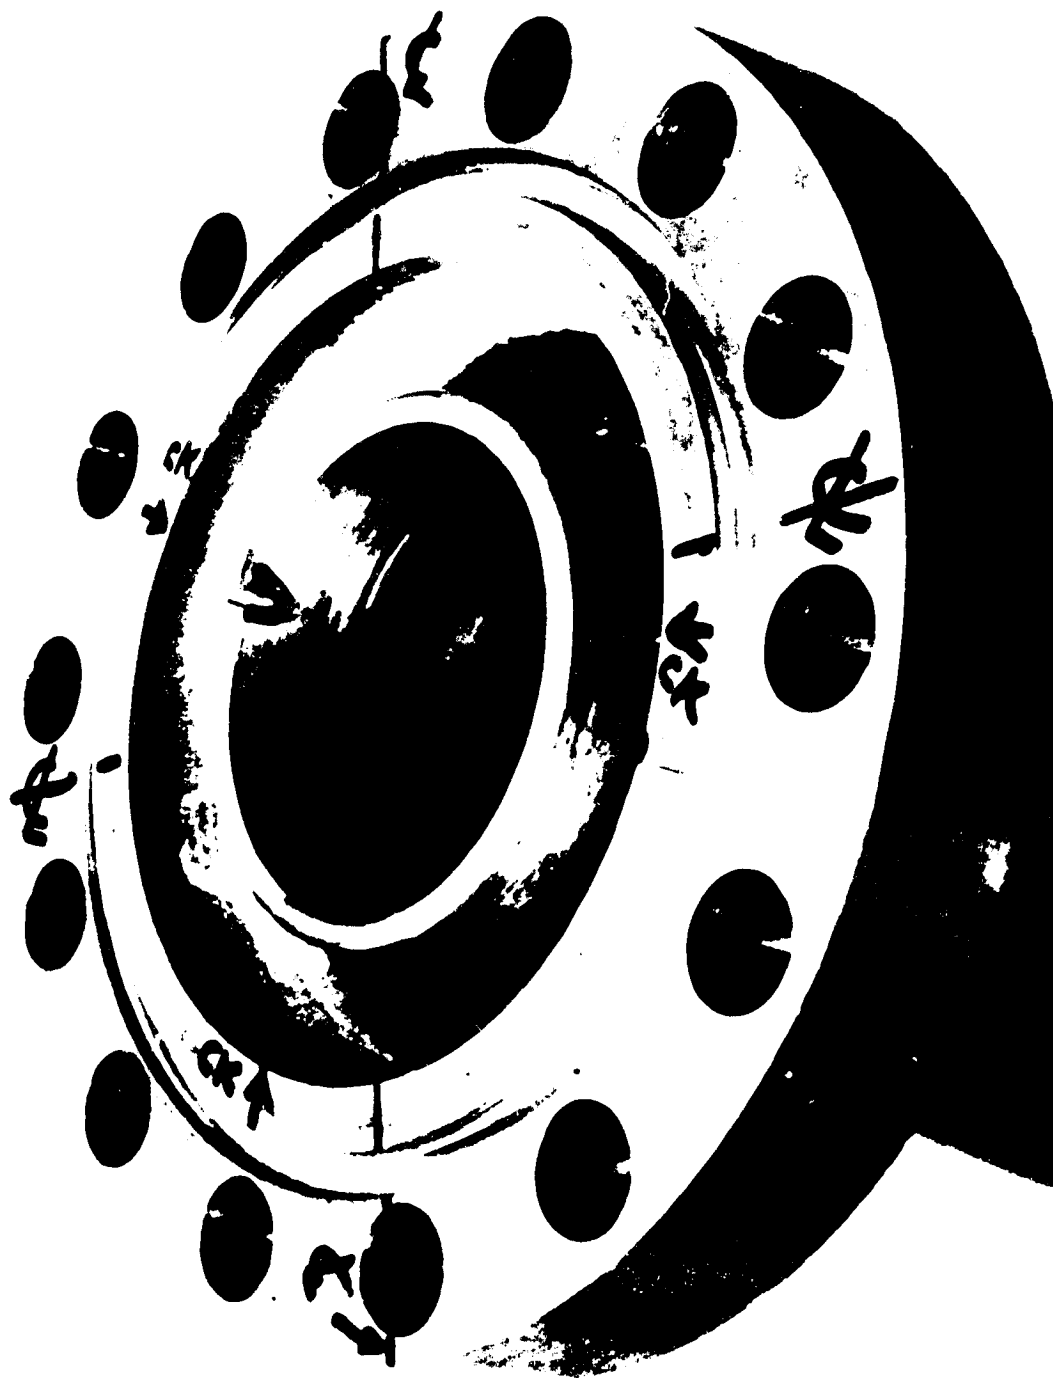
Figure 32. Burned region at inside of flow guide.

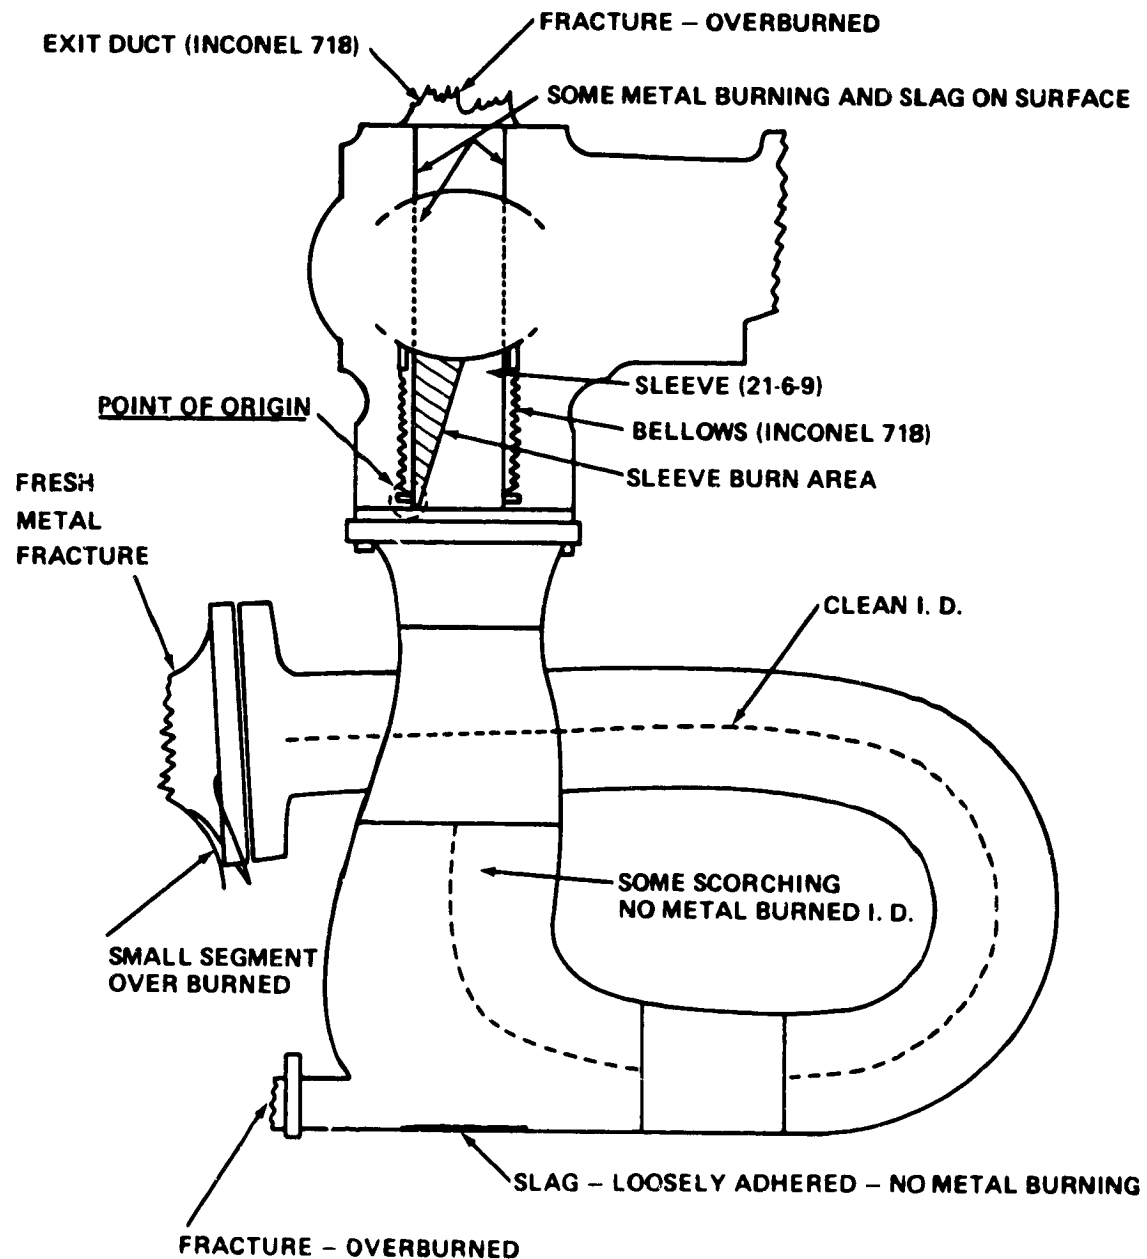
Figure 45. Origin of fire.
