NASA TECHNICAL MEMORANDUM

NASA TM-82424

LOX/GOX RELATED FAILURES DURING
SPACE SHUTTLE MAIN ENGINE DEVELOPMENT

By C. E. Cataldo
Materials & Processes Laboratory

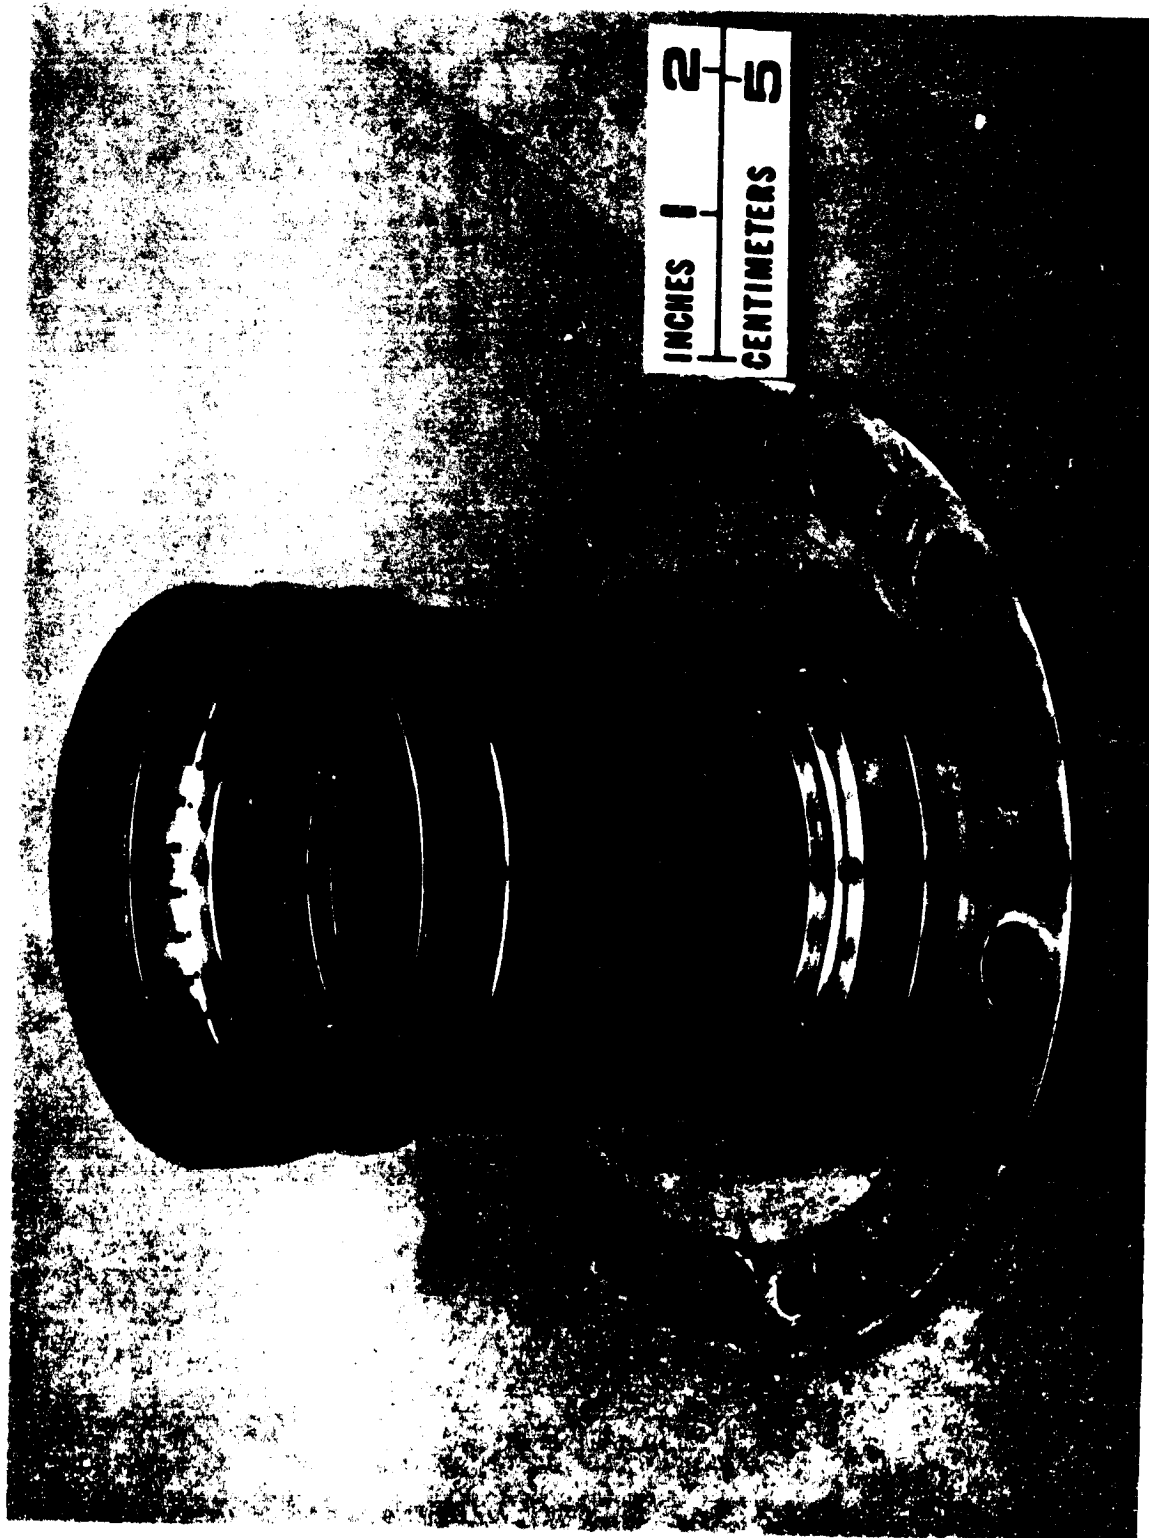
Figure 48. MOV inlet liner and bellows assembly removed from another valve and the evidence of severe fretting in the flange area.
