Bulletin 685

RELATION OF LANDSLIDES AND GLACIAL
DEPOSITS TO RESERVOIR SITES

SAN JUAN MOUNTAINS, COLORADO

WALLACE W. ATWOOD

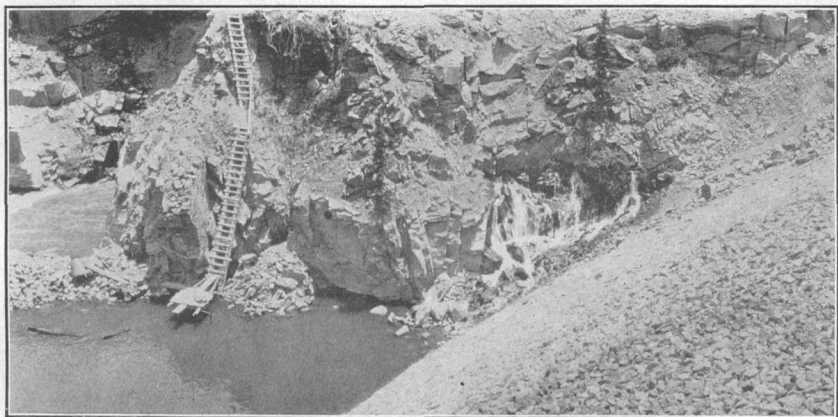
C. SOUTH MARGIN OF THE DAM ON THE DOWNSTREAM SIDE, SHOWING LEAKAGE AROUND THE SOUTH END OF THE DAM.

This leakage is through fractured rock. The tunnel opening is near the left margin of the view.

The possibility of checking this seepage by cribbing is under consideration, and every effort will be made by those in charge of the project to prevent this leakage from becoming serious or endangering the success of the project. The landslide mass through which the waters seep appears to consist of very coarse material mixed indiscriminately with finer detritus. If a body of landslide material contains sufficient clay to block up the interstitial spaces and thus form an impervious mass, it may be safely used to retain water. Here the waters have evidently passed through an eighth to a quarter of a mile of this material. It is conceivable that as the waters pass through they may carry and deposit clays in just such places as to block up the subterranean routes, but on the other hand there is evidently the danger of waters going through in such volume and with such velocity that the finer materials in the landslide mass may be washed out and the underground routes become larger and larger.

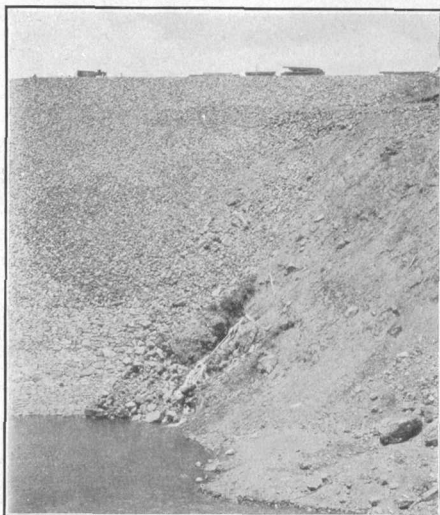
A. NORTH MARGIN OF THE FARMERS' UNION DAM FROM DOWNSTREAM SIDE.
The landslide mass appears at the right, and near the edge of the dam seepage is shown.

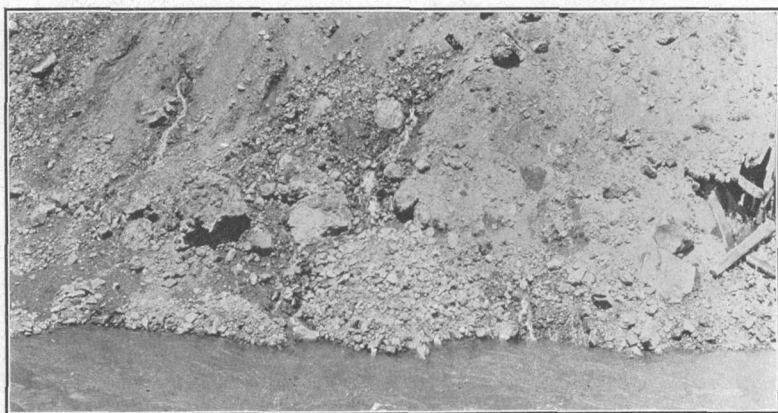
B. SEEPAGE THROUGH THE LANDSLIDE MASS JUST BELOW THE FARMERS' UNION DAM.

At the right is the opening of a prospect tunnel.

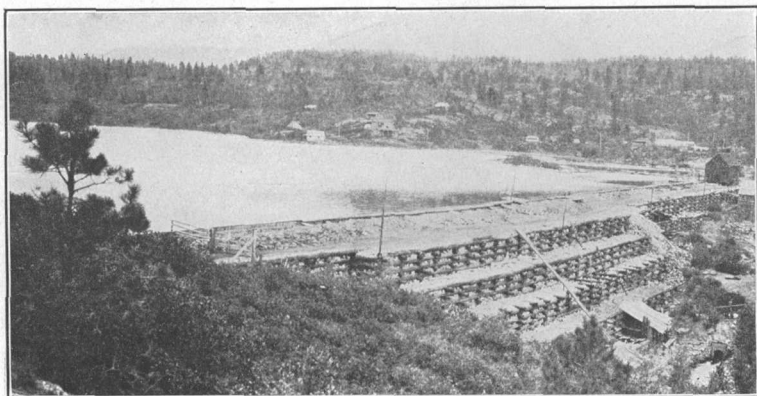
C. IGNACIO RESERVOIR AND DAM.

The floor of the valley where the waters have been stored was formerly a broad stretch of meadowland. Much of that land had been taken up by ranchmen, who had established their homes. The site of the dam was a narrow place in the stream course just below the broad flat-bottomed portion of the valley. The constriction where the dam has been placed is due to a large landslide area associated with the neighboring cliff at the north. (See fig. 4.) In this cliff there is a thick, heavy flow of lava over a volcanic tuff or breccia.

The dam was not constructed at so great expense or with so much care as many of the more modern structures, and there is always some leakage. It has been reported that twice in the history of the reservoir large leaks have developed. The timbers are now very badly rotted, and the remaining life of the dam would appear to be relatively short.

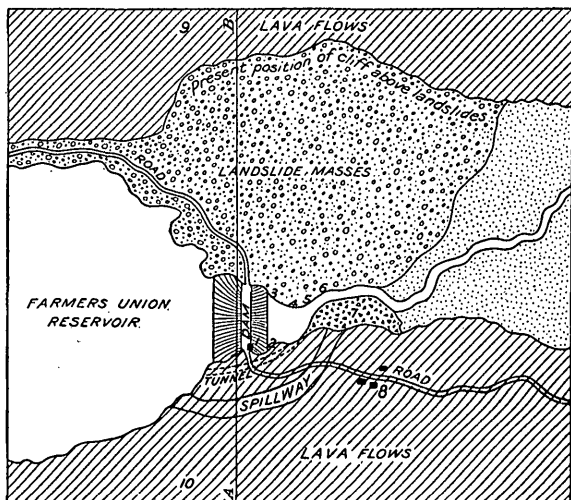
FIGURE 4.—Sketch map showing the geologic conditions immediately adjoining the dam of the Farmers' Union reservoir. 1, Control gates; 2, lower opening of tunnel; 3, 4, 5, 6, places where seepage flows have been noted; 7, angular debris opposite lower end of spillway; 8, construction camp; 9, 10, canyon walls; A-B, position of cross section shown in figure 5.

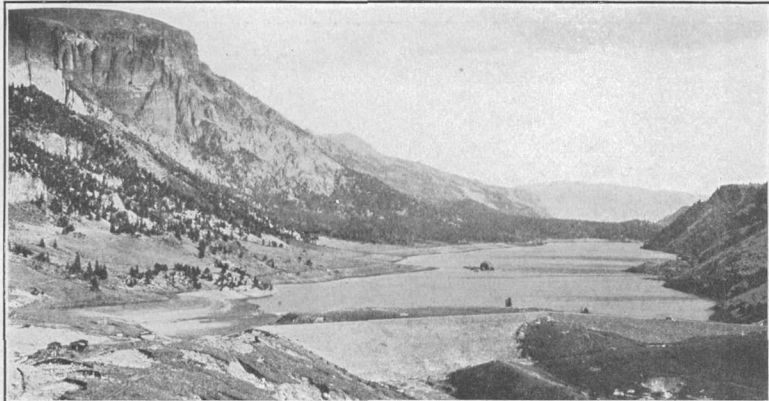
rim of the lake basin (fig. 9), large quantities of water have seeped through and issued fully a mile and a half to the south, forming a small pond from which, at times, a rushing torrent flows by Antelope Springs and into the Rio Grande. About the south end of the reservoir, however, no signs of leakage appear in the great landslide mass; the surface is apparently entirely unmodified. The water appears at the south margin of this landslide mass not from a single exit, like an underground stream, but probably from general seepage through this huge mass of material. About half a mile below the reservoir there is a small lake or pond in the midst of the landslide masses (fig. 9), and the waters in this small lake have risen and fallen with the waters in the reservoir. It is clear, therefore, that the seepage is quite free as far south as this lake, and the stream already referred to makes it also very apparent that the seepage is free still farther south and, indeed, throughout the mass.

A. SANTA MARIA RESERVOIR FROM THE NORTH.

Bristol Head is at the left. The landslide mass blocking the reservoir at the south appears just beyond the water. The dam appears in the foreground. At the left in the foreground glacial drift is exposed.

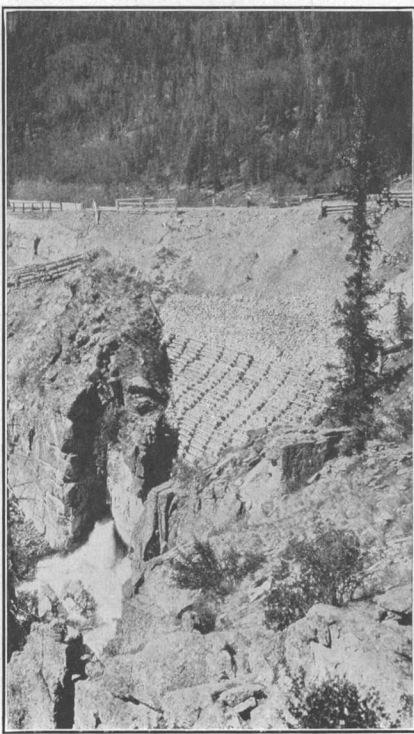
B. MOSCA RESERVOIR DAM AND SPILLWAY, SHOWING THE GORGE BELOW THE RESERVOIR SITE IN THE FOREGROUND. C. TUNNEL OUTLET AT MOSCA RESERVOIR. SHOWING THE CRIBBING PUT IN AFTER THE FIRST BREAK OCCURRED

The first of these developed around the southwest end of the dam (see Pl. IV, *C*), and later ones resulted in a large washout along the road 1,500 feet to the northwest. (See fig. 11.)

Before the reservoir was two-thirds full the fine till began to give way and to wash out so that it became necessary to construct cribbing filled with broken rock along the upstream limb of the V-shaped contact of the latite and gravel. (See Pl. IV, *C*.) A core wall about 120 feet in length has been built in a westerly direction from bedrock at the contact of the moraine with the latite. This contact is said to dip 45° along the line of the wall.

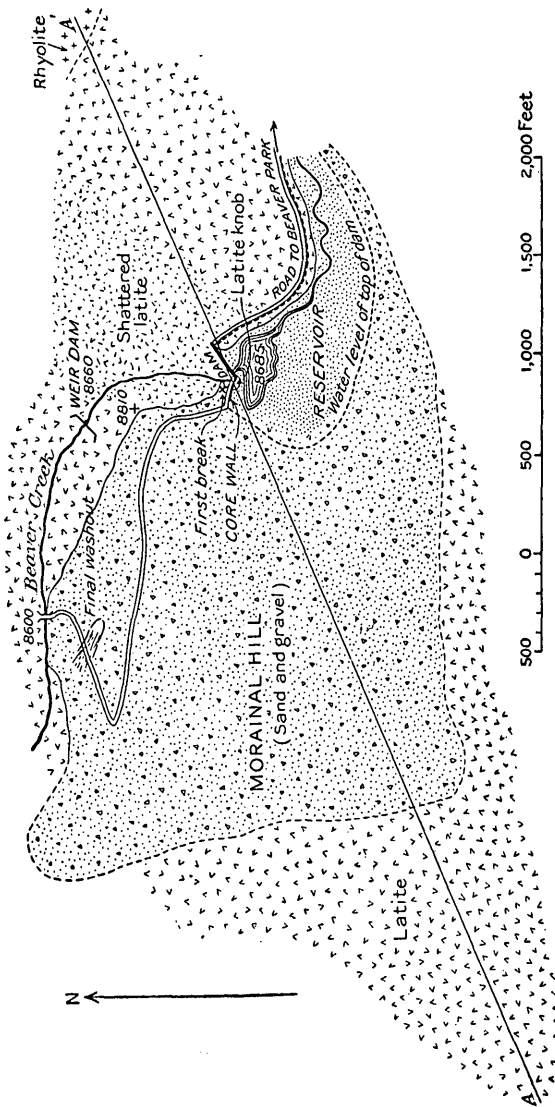
FIGURE 11.—Sketch map of Mosca reservoir project and environs, showing approximate boundaries of geologic formations. (The exact location of the core wall is not known.)

The conditions can be best understood from the sketch of the dam and its environs (fig. 11) and the profile section across Beaver Creek just below the reservoir (fig. 12). These drawings are intended to present the relations graphically rather than to afford accurate maps of the locality. It should be understood that the contact between the volcanic rock and the gravels in the profile of figure 12 is hypothetical except for the points where it meets the surface.

When the water was allowed to rise in the reservoir a second time a much larger leak developed at a point some 1,500 feet from the reservoir, on the slope 100 yards south of the road bridge. This leak proved to be even more serious than the first and quickly developed into a disastrous washout. The water escaped so rapidly and abundantly that the soft, unconsolidated sands and gravels are described as having been catapulted out of the hill, leaving a ravine as much as 20 feet deep and being washed down the slope to the valley bottom to form a large torrential fan. Although the beds at once became saturated and seepages appeared over nearly the entire slope, the bulk of the water is reported to have come out at about 20 feet below the bottom of the reservoir. This leakage proved so great and serious that it was necessary to reopen the head gate at once and relieve the pressure from the head of water in the reservoir. For several months during the winter of 1914–15 no effort was made to use the dam. In the spring of 1915 an attempt was made to puddle the reservoir west of the dam but without success.

The essential causes of the failure of the Mosca reservoir to retain water are clearly the presence of the buried channel and the unusually high porosity of the sands and gravels that fill it. This porosity is shown by the fact that at the time of the examination the

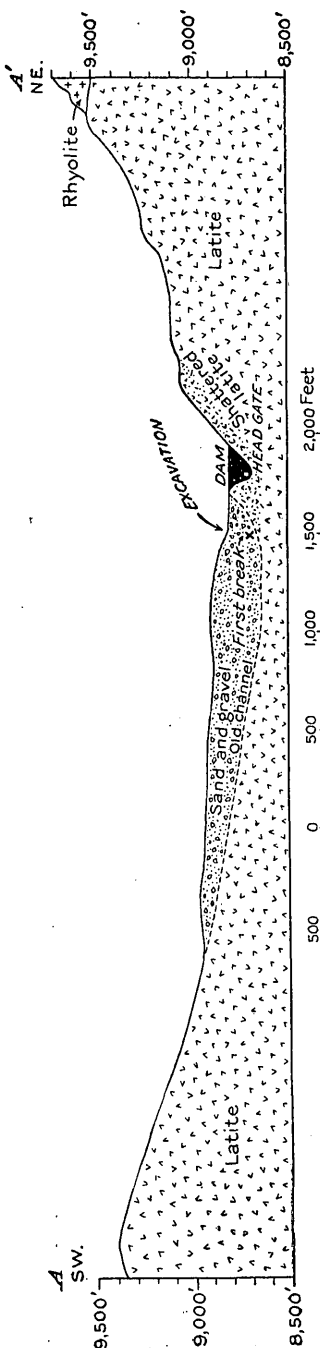
FIGURE 12.—Profile section across Beaver Creek at Mosca dam, along line A-A' of figure 11.

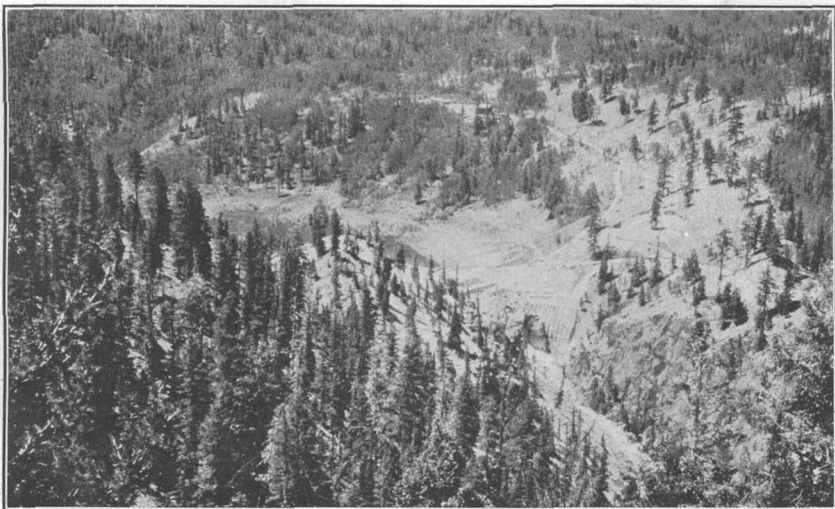
The rock knob at the southwest end of the dam and the immediate rock mass at the other end of the dam have been interpreted as of landslide origin. This would account for the hillside topography shown in Plate V, *B*, and for the shattered condition of the dock at both ends of the dam. A serious leakage has occurred around the northeast end of the dam.

B. MOSCA RESERVOIR SITE.

This view shows the location of the dam, the cribbing where the first break occurred, the landslide mass at the left end of the dam, the great moraine at the right end of the dam, and the narrow gorge below the reservoir site.
