# **ANP District Headquarters Facilities in Helmand and Kandahar Provinces Have Significant Construction Deficiencies Due to Lack of Oversight and Poor Contractor Performance**

SIGAR Audit-11-3

## ANP District Headquarters Facilities In Helmand and Kandahar Provinces Have Significant Deficiencies Due to Lack of Oversight and Poor Contractor Performance

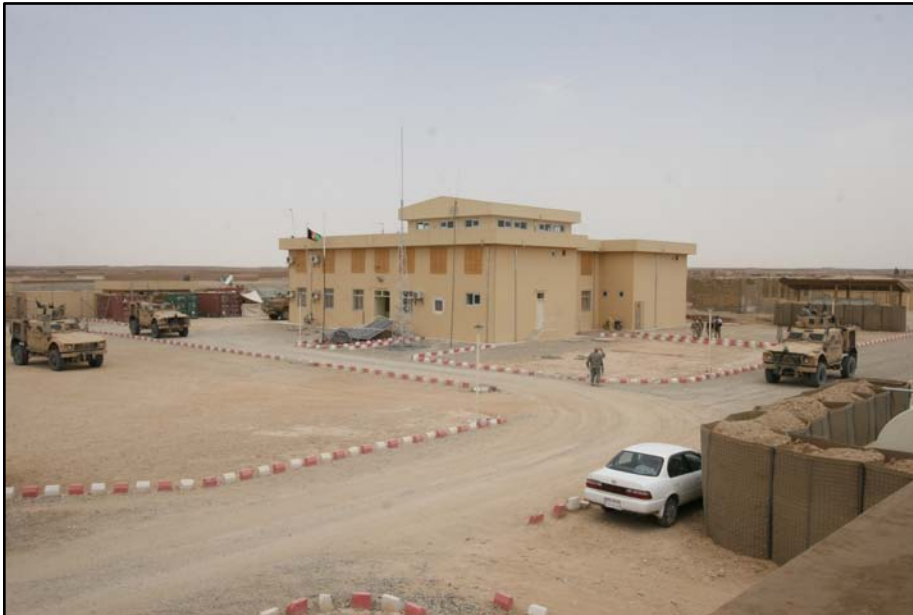
**Photo 1: Nahri Saraj ANP District Headquarters**

According to the contract documents, each completed compound should contain a central headquarters building that includes prisoner holding cells, administrative offices, billeting areas, food preparation and dining facilities, latrines with showers, and an armory. Each compound should also have a perimeter wall, four guard towers, a well house, water storage tank, and fuel storage for both diesel and propane. Photo 1 shows one completed facility at Nahri Saraj.

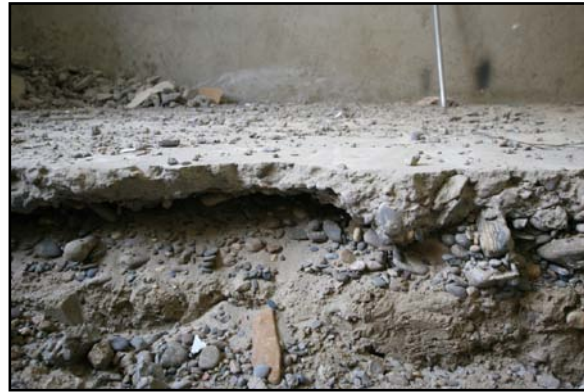
not appear to meet slump test standards, indicating weak concrete. Photo 2 shows a construction worker pouring a watery concrete mixture, not likely to meet concrete test standards, for a roof slab at one of the six sites. Photo 3 shows poor concrete at what appears to be a slab-on-grade at the Garm Ser site.

**Photo 3: Poor Concrete Slab-on-Grade with No Reinforcement at Garm Ser Site**

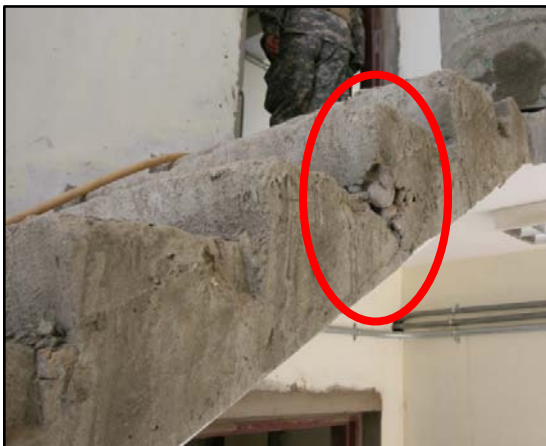
Our inspections found concrete stairs at facilities that were poorly formed, improperly constructed, and comprised of poor concrete with questionable strength. The cast-in-place concrete stairs at all six sites did not conform to the construction drawings either structurally or architecturally. The plans indicated that the stairs were intended to be monolithically cast-in-place reinforced concrete with a curved metal wearing strip embedded at the edge of each step and sealed with a chemical sealant. The treads and risers of the stairs we observed were of varying dimensions. We also observed that the steps were formed separately from the sloped base of the stairs, creating a weakened section that could fail under normal use. Photographs 5 and 6 shows poorly consolidated concrete and improperly formed stairs at Garm Ser.

**Photo 5: Poorly Formed and Consolidated Concrete Stairs at Garm Ser Site**

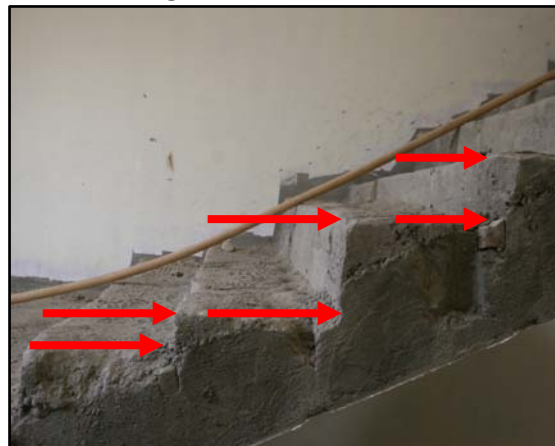
**Photo 6: Crumbling Concrete Stairs of Different Heights at Garm Ser Site**

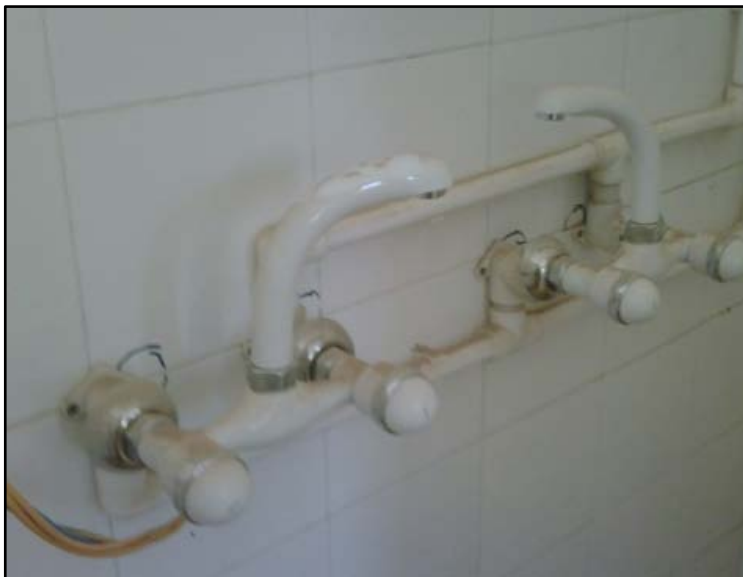
The contract required that all faucets be chrome-plated brass with a single mixing lever. We found that at the four sites where faucets were installed, none met the specification requirements. At two of the sites, dual-handle residential-grade plastic faucets were installed. Chrome-plated faucets were installed at the other two sites, but they appeared to be residential grade and also had two handles. At all four sites, the installed faucets did not appear to be able to withstand the heavy use expected at this type of facility. Photo 13 shows the plastic, "goose-neck" faucets that do not meet contract requirements, installed at Takha Pul.

**Photo 13: Residential Grade "Goose-Neck" Faucets at Takha Pul Site**
