# **NATIONAL BUREAU OF STANDARDS REPORT**

5223

## **SUMMARY REPORT - VAPOR BARRIER INVESTIGATION**

Thule and Sondrestrom Air Force Bases, Greenland

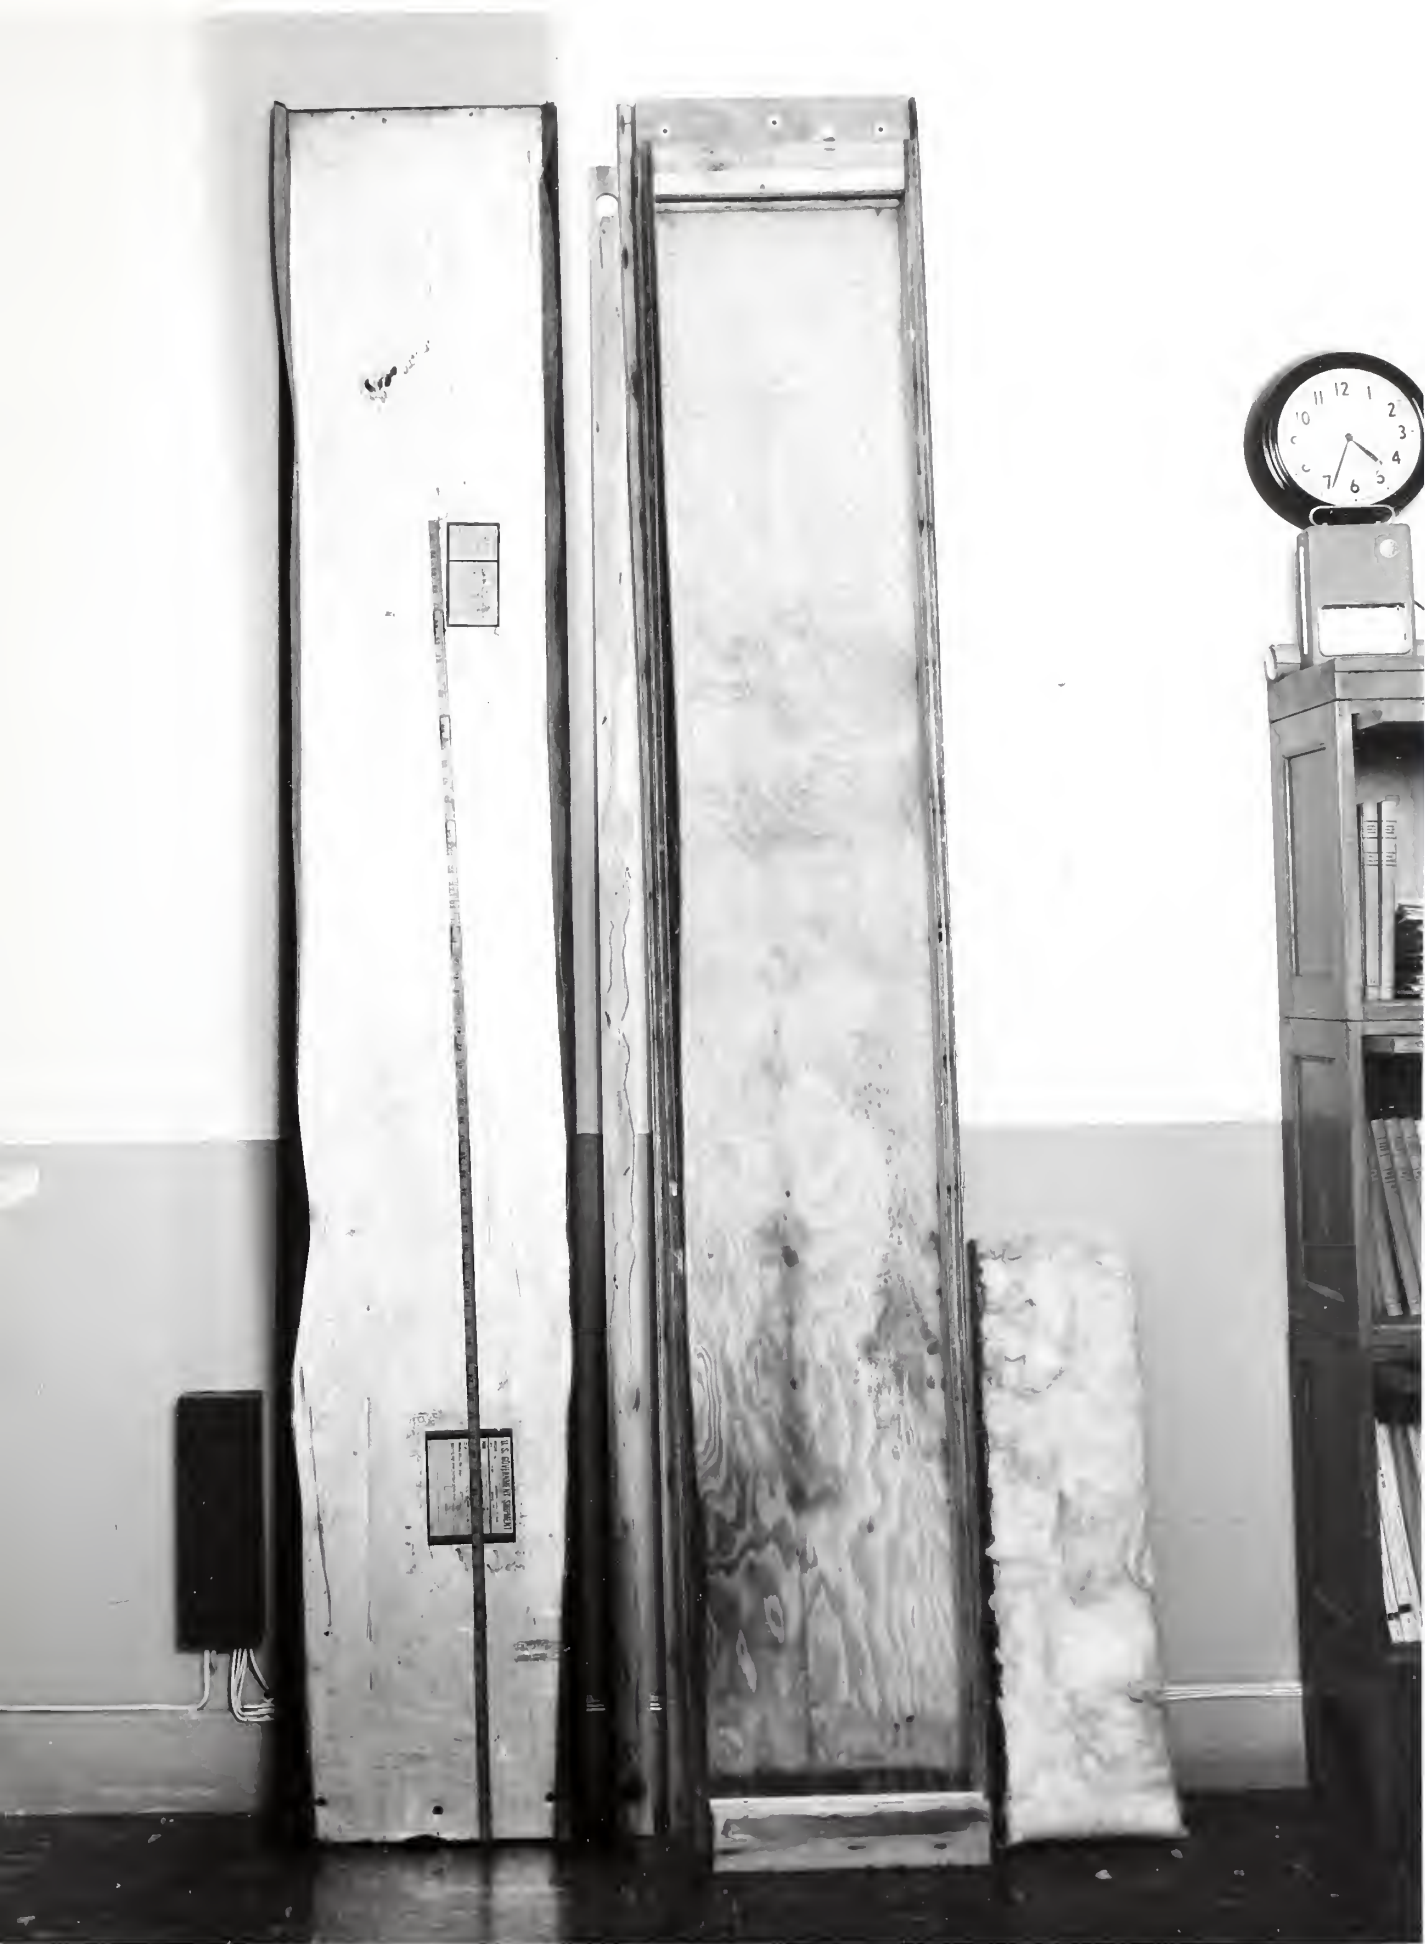
Figure 3

The smaller panel (Figures 3 and 4) was 16 inches wide and approximately eight feet high, and is probably of 1951 construction. This panel was generally in poor condition; most nailed joints were loose and the interior of the panels was wet and water-marked. The exterior skin was in good bond with the 1/4-inch plywood except near the edges (see Figure 3) where the aluminum is wrapped around the edge to form part of the joint. Nails holding this wrapped edge in place were loose and rusty and the thin strip of plywood down the eight-foot length was warped and delaminated to the extent that the three plies could be peeled with the fingers. The plywood immediately under the exterior skin (left side of Figure 4) was damp and wet to the touch; some delamination was visible on the inner ply next to the insulation, especially near knot holes. The 3/4-inch plywood overlay at the bottom of the panel was water-marked and contained surface cracks. This piece was probably exposed to exterior weather conditions. One 3/4-inch plywood stile was sound, but the other near the male portion of the tongue and groove joint was delaminated two plies deep in two places (center of Figures 3 and 4). The thickness of this stile ranged from its original value of 3/4 inch to a maximum swelled dimension of 1 1/2 inches, and the stile was wet completely through its thickness and 3 5/8-inch width. The sound stile showed moisture marking for 1 1/2 inches of its width as measured from the exterior side. The insulation was moist to the touch for depths of 1/2 inch to two inches in 3 1/2 inches, as measured from the exterior side. Several samples of the glass fiber insulation were weighed, oven-dried, and re-weighed, and the results showed overall moisture contents from 10 to 14.5 percent above dry weight at this time. The dry density was 3.1 pounds per cubic foot. Normally, insulation of this type could have one or two percent hygroscopic moisture above dry weight. The greatest concentration of moisture occurred near the bottom of the panel. The warm side plywood was not delaminated, and the bond between aluminum and plywood was tight and continuous. This plywood was damp near the stiles, presumably from moisture migrating from the stiles.

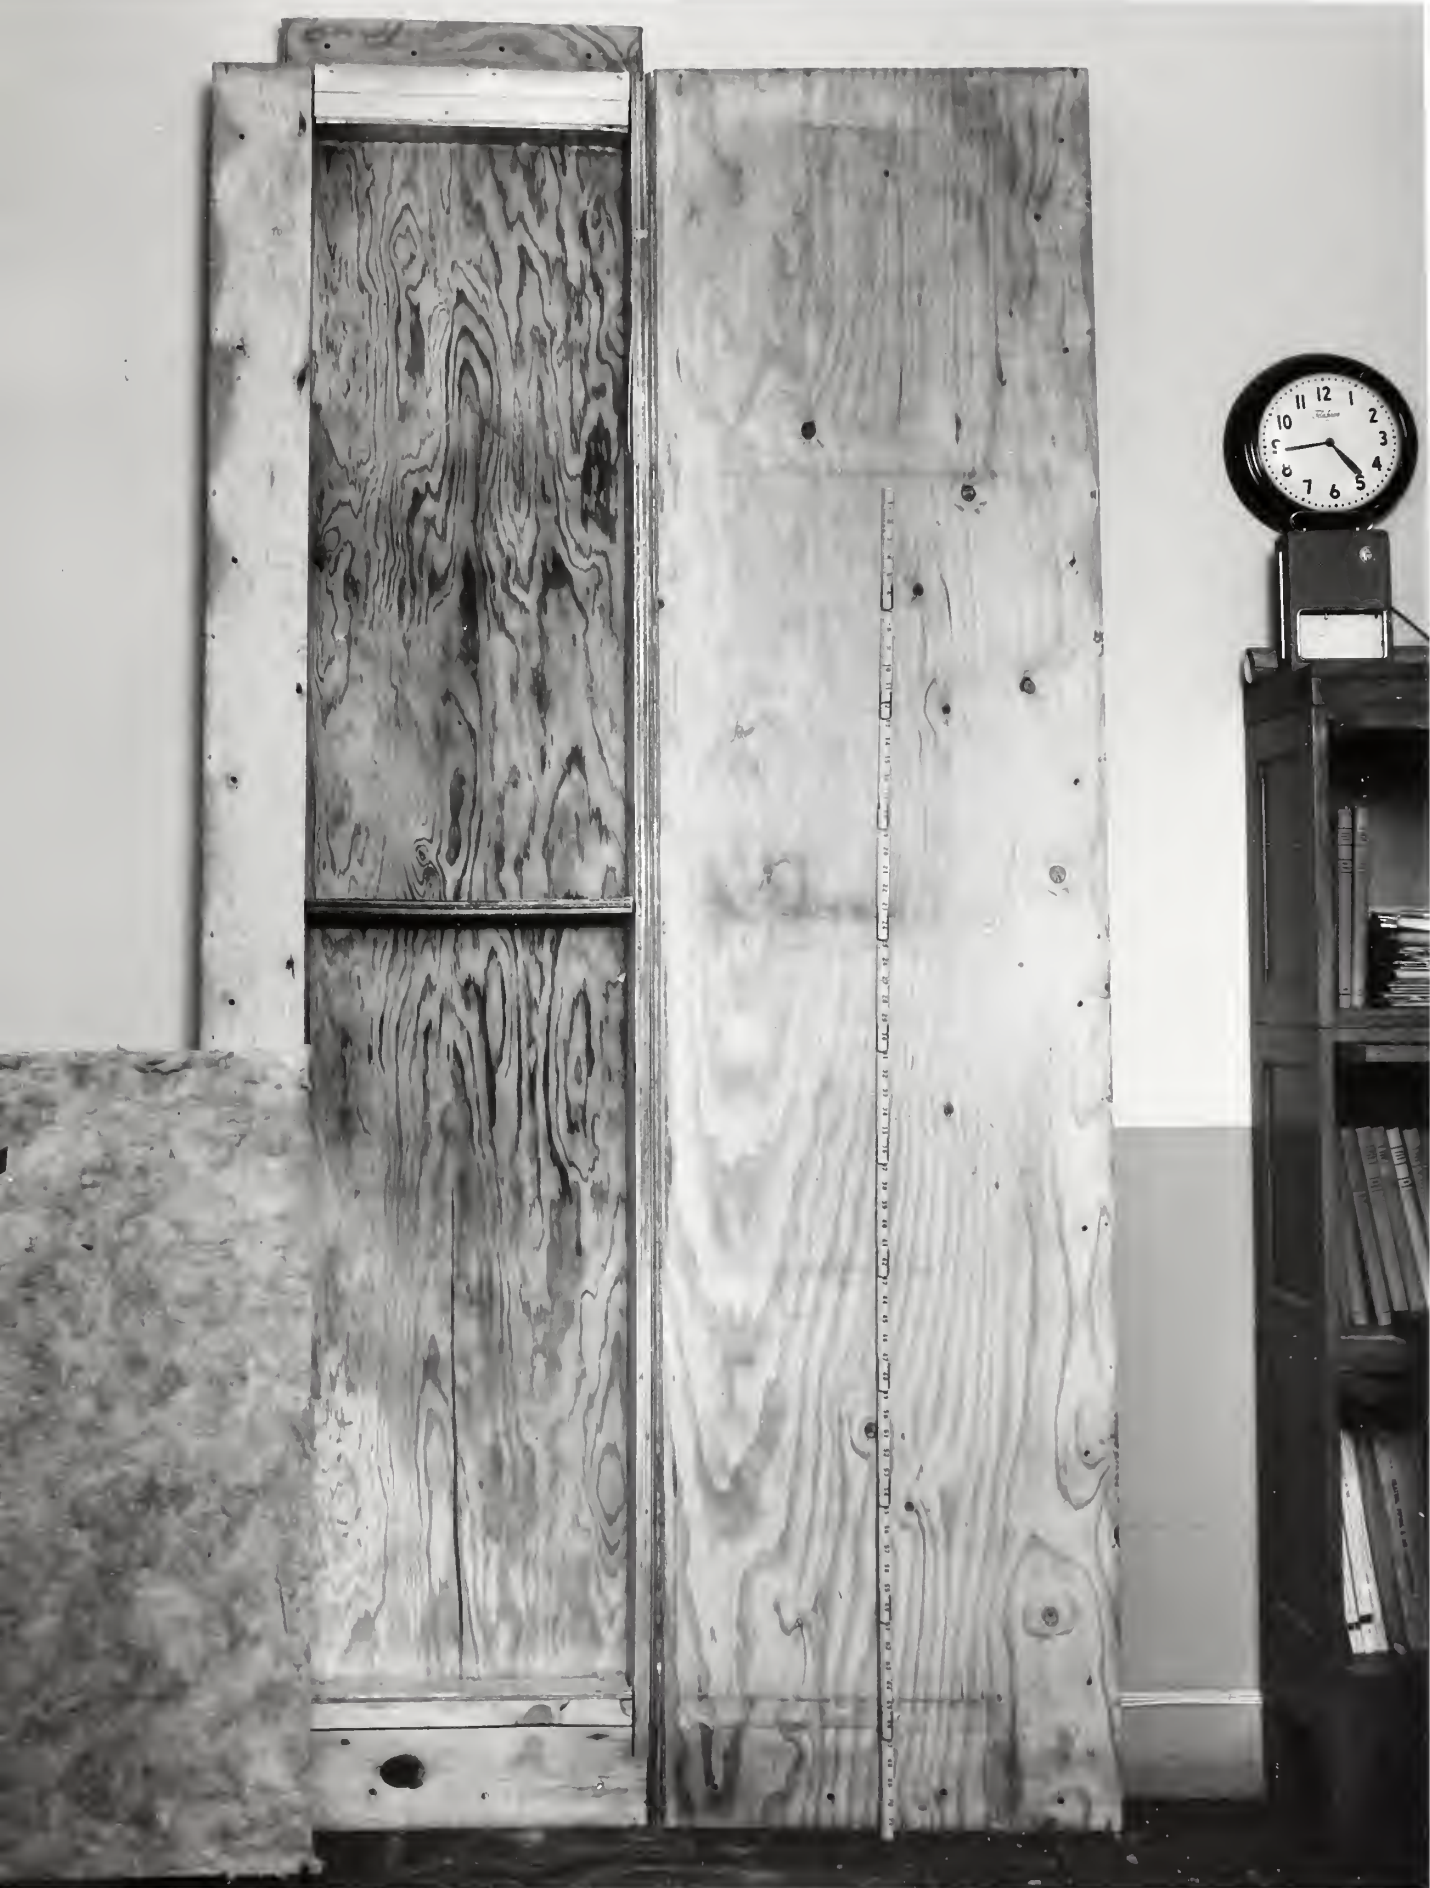
Figure 5

The larger panel (Figure 5) was 18 inches wide (insulated space), approximately eight feet high, and was probably of recent construction. This panel, generally, was in good condition. Considerable moisture-staining and wet areas were noted on the interior plywood. A small amount of delamination occurred on this sheet. Moisture concentrated near the central 3/4-inch plywood divider (Figure 5) and at the edges of the panel. The wood members of the remainder of the panel were sound. The insulation was damp on the indoor surface and did not appear so moist as in the smaller panel. Both interior and exterior aluminum skins were well bonded to their respective sheets of plywood except for the wet areas near the center of the interior sheet; at this point, the aluminum was separated from its backing sheet of plywood.
