# **Report of Roof Inspection: Partial Delamination of Adhesive-Bonded Seams at an Army Facility**

Walter J. Rossiter, Jr. and James F. Seiler, Jr.

November 1988

Prepared for:  
U.S. Army Engineer District, Baltimore  
P O Box 1715  
Baltimore, MD 21303-1715

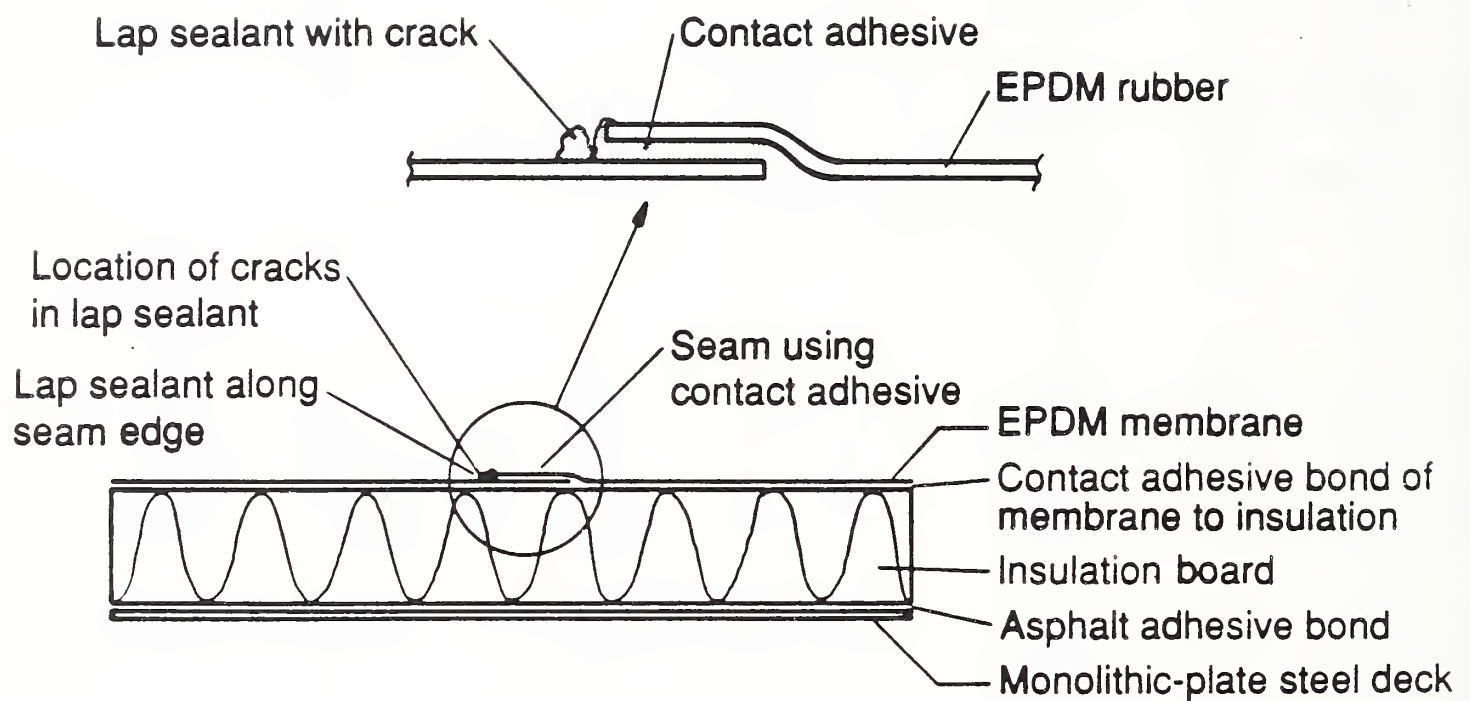
Figure 1. Cross Section of the Roof Construction Including a Seam and the Lap Sealant at the Seam Edge (Not to Scale).

- o In observing the in-place lap-sealant, many areas were seen where a hairline crack had formed parallel to the seam. The crack was along the edge of the upper sheet comprising the seam (Figure 1). (The hairline cracks were as described in the COE request for assistance, and were the reason for inspecting the roof.) In two small areas, a sample of sealant was removed from the seam using a knife. The removed sealant samples were judged to be pliable. Although the evidence from this observation was limited and subjective, it suggested that embrittlement of the lap-sealant had not occurred. Further testing of the lap-sealant was not performed.

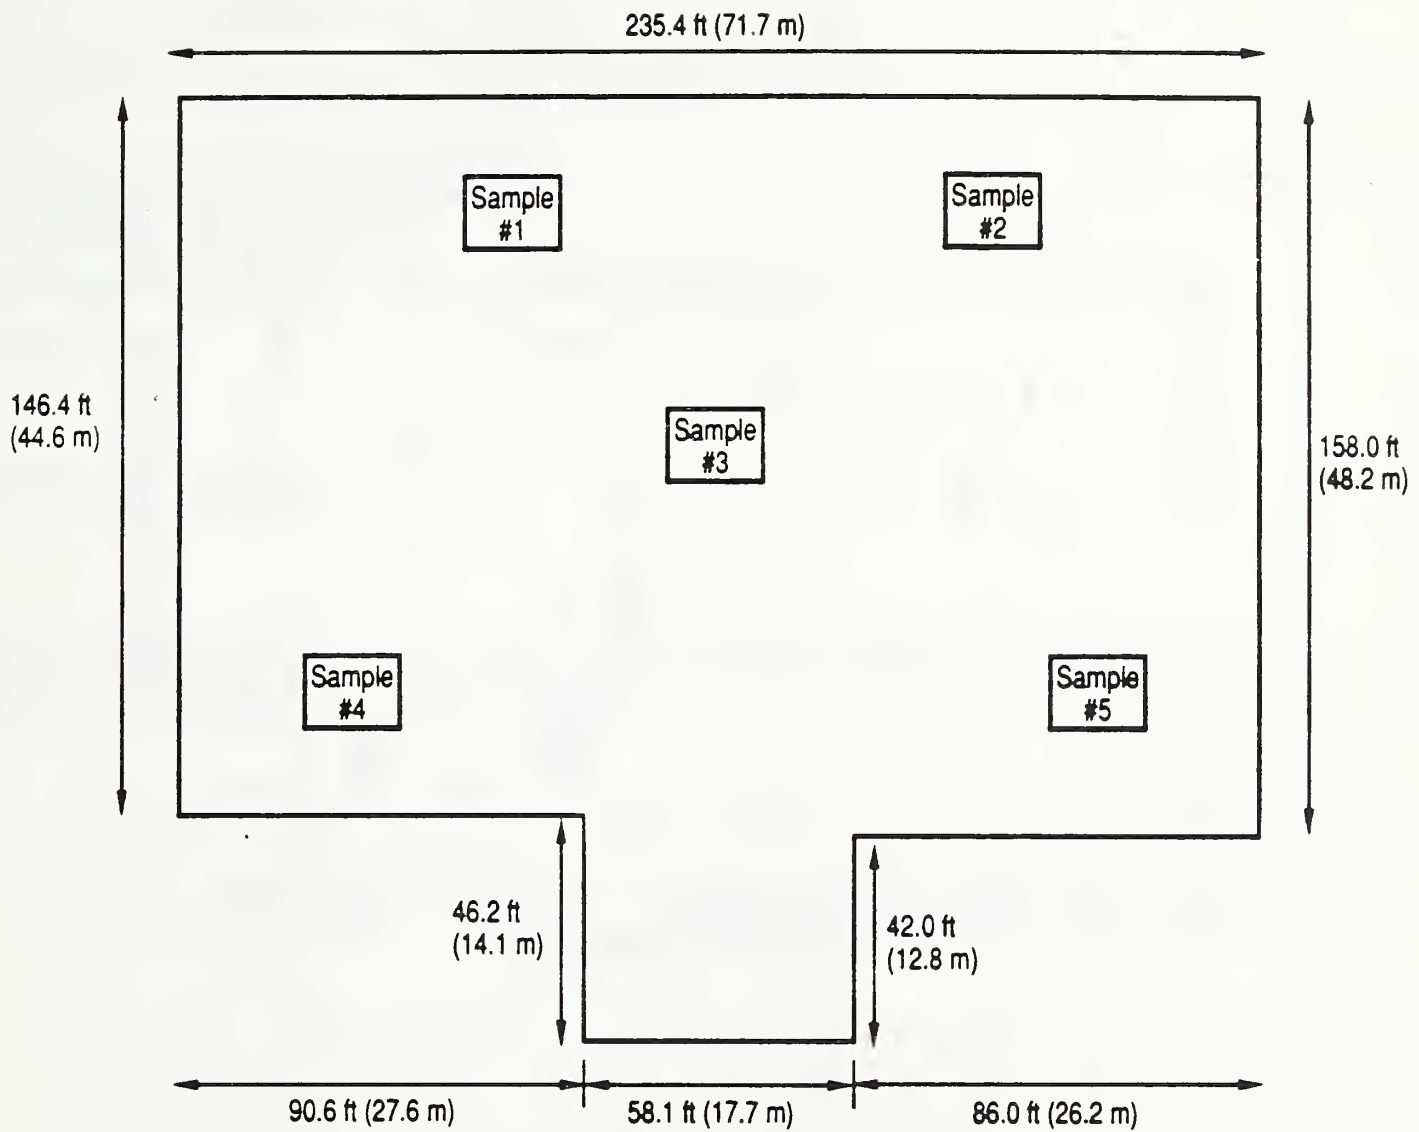
Figure 2. Plan Indicating Approximate Dimensions of the Roof and Locations of the Test Cuts.

Test samples of the lap seam were taken from five general sections of the roof: each corner and in the center of the building (Figure 1). Before cutting the membrane, it was decided to take both "good" and "bad" samples from each of the 5 sections. Good samples were those having no hairline cracks visible in the lap-sealant; whereas bad samples had a crack in the lap-sealant and some delamination of the bond along the seam edge, though not across the entire width of the seam.

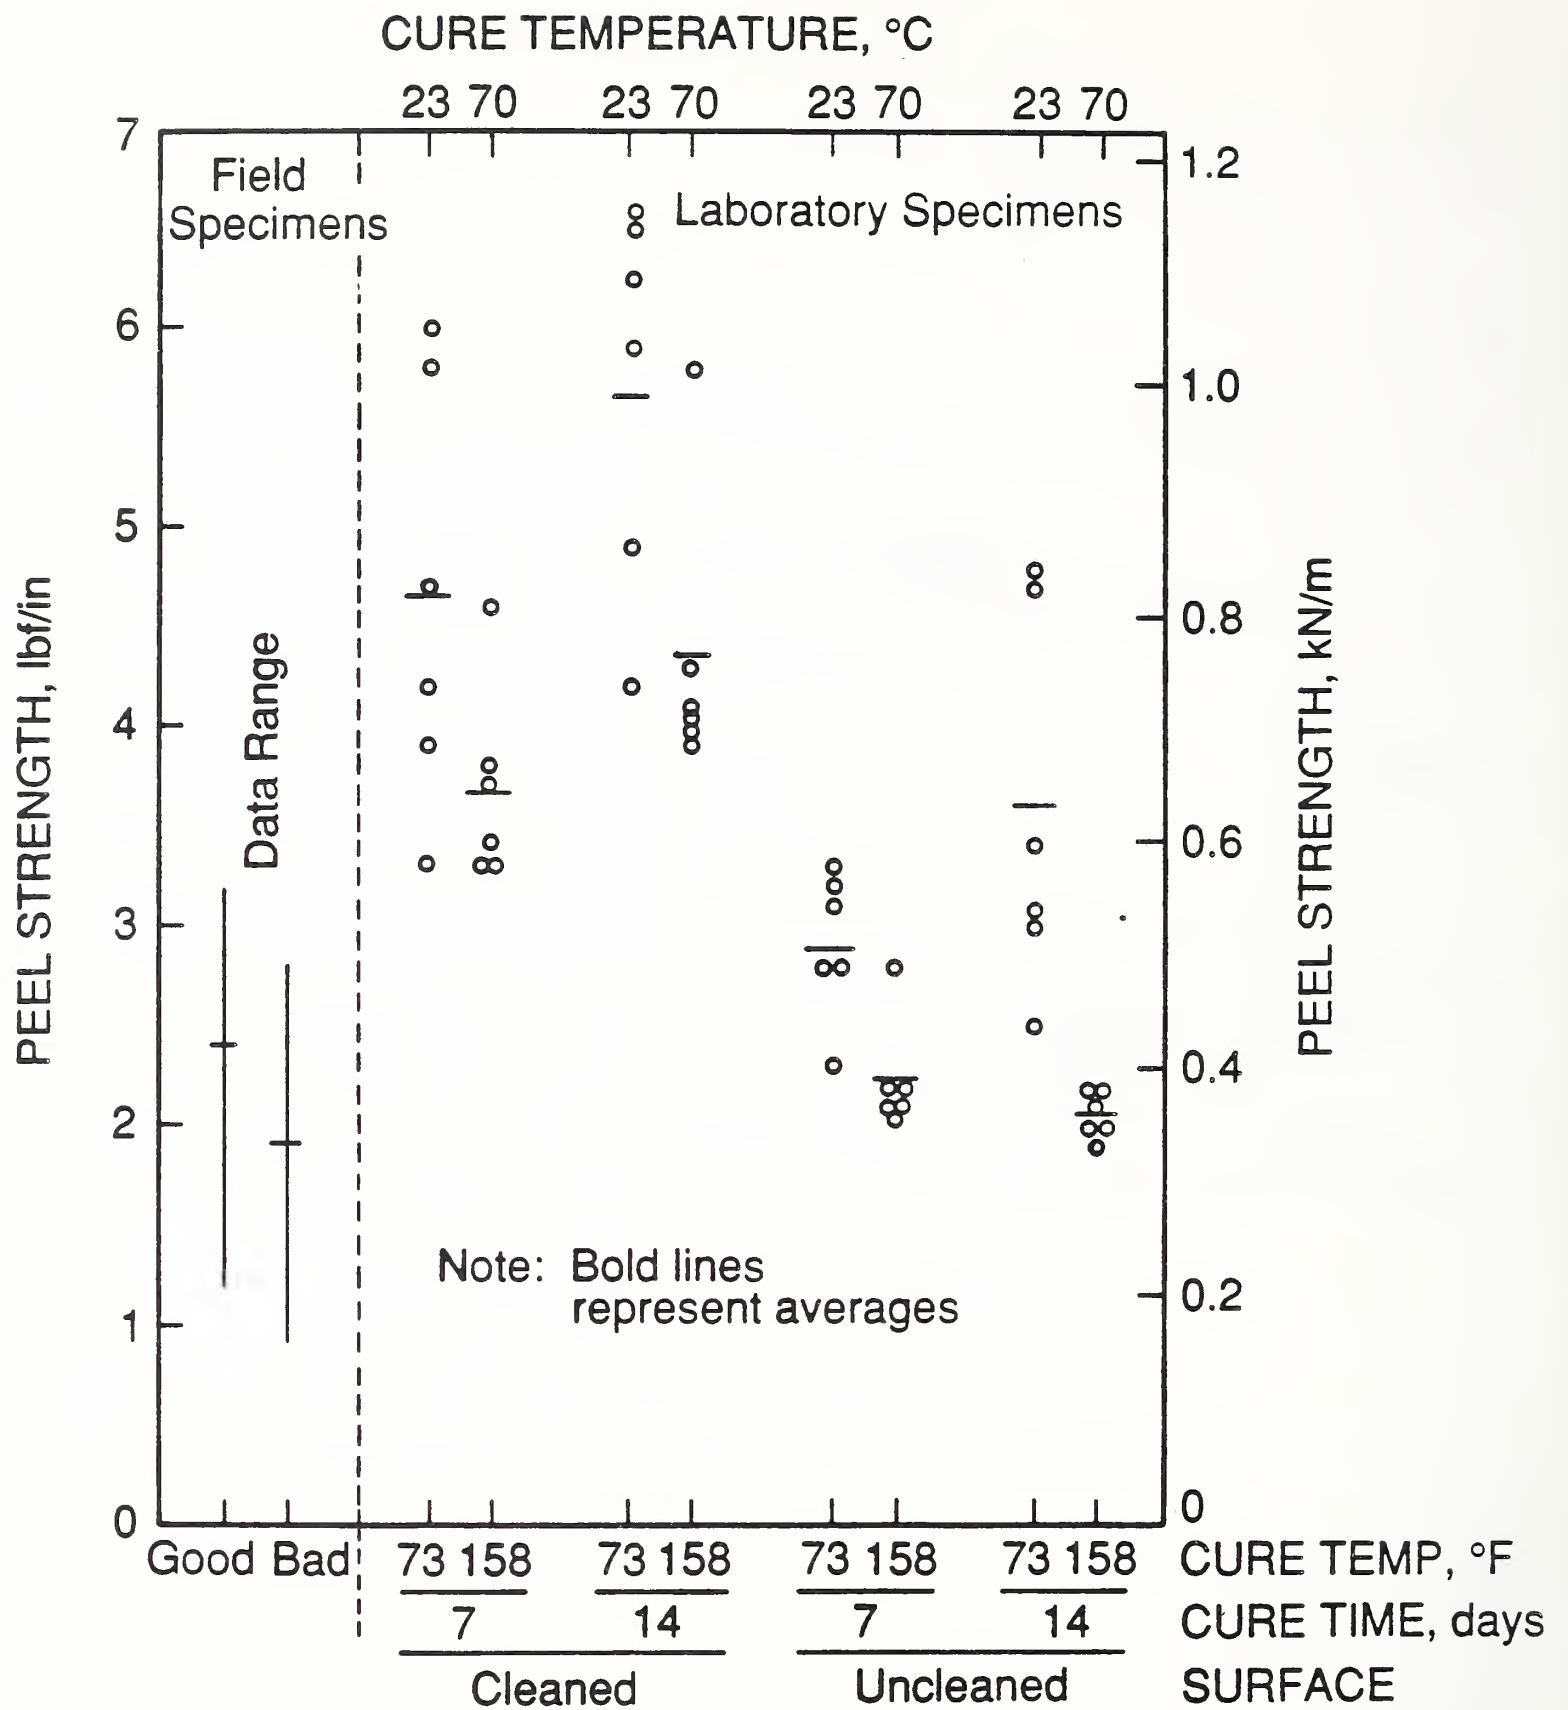
Figure 3. Results of the T-peel Tests for the Laboratory Samples in Comparison With Those of the Field Samples.

under close-to-optimum conditions of seam formation. (Longer cure times may produce stronger bonds, but this parameter was not further investigated in the present study.) The average maximum value of 5.7 lbf/in. (1.0 kN/m) was more than twice the average value of 2.8 lbf/in. (0.49 kN/m) found for all field specimens.

The importance of the three application conditions (Table 4) on seam strength is evident from Figure 2. For every comparable instance of cure time and temperature, the uncleaned specimens displayed lower bond strengths than the cleaned specimens. The reduction in strength was of the order of 40 percent. The finding was not unexpected, since previous studies using T-peel tests had indicated loss in T-peel strength due to uncleaned surfaces. Moreover, in the present study, the average bond strength of any set of uncleaned specimens had lower strength than all cleaned specimens. In fact, the averages for specimens representing three of the four uncleaned conditions (Figure 2) were between 2 and 3 lbf/in. (0.4 and 0.5 kN/m), which was the approximate range for the average values of all field samples

It is also evident from Figure 2 that, as the cure time lengthened from 7 to 14 days, the bond strength generally increased. This result was also consistent with previous NIST findings regarding a butyl-based contact adhesives which cures over time. An exception was for the uncleaned specimens cured at 158 °F (70 °C). In this case, a slight decrease in strength was observed in time. No reason for the observation was apparent.

From Figure 2, the effect of cure temperature was quite apparent. For every comparable instance of cure time and surface condition, the average bond strength of specimens cured at 158 °F (70 °C) was less than that for specimens cured at 73 °F (23 °C). The finding was not expected. Rather, it was expected that higher bond strengths would be found with increased cure temperatures due to an acceleration of the curing reaction. Although the data were limited for this observation, they did suggest that the adhesive/rubber system used to prepare the laboratory specimens tended to give lower strengths when cured at high temperatures.

Finally, in discussing the effect of the specimen preparation conditions, it is noted that the two lowest average bond strengths were found for specimens prepared using uncleaned rubber, and cured at 158 °F (70 °C). These strengths were about 2.1 to 2.3 lbf/in. (0.37 to 0.40 kN/m), which, perhaps coincidentally, were comparable to the average values found for the field specimens (Figure 2). Although the evidence was limited, it raised questions as to what extent the cleaning procedure in the field and the cure temperatures contributed to the observed values of strengths of the field specimens. The roof with a black EPDM sheet was installed in the summer in Washington, DC. which could have provided some periods of high temperature during curing. In addition, as discussed previously, a few of the field samples exhibited noticeable surface contamination. More importantly, as will be discussed in Section 3.6, SEM analysis indicated a talc-like substance on the surfaces of the rubber.
