TWR-18076

Field Joint Protection System Rain Qualification Final Test Report

11 May 1989

MORTON THIOKOL, INC.

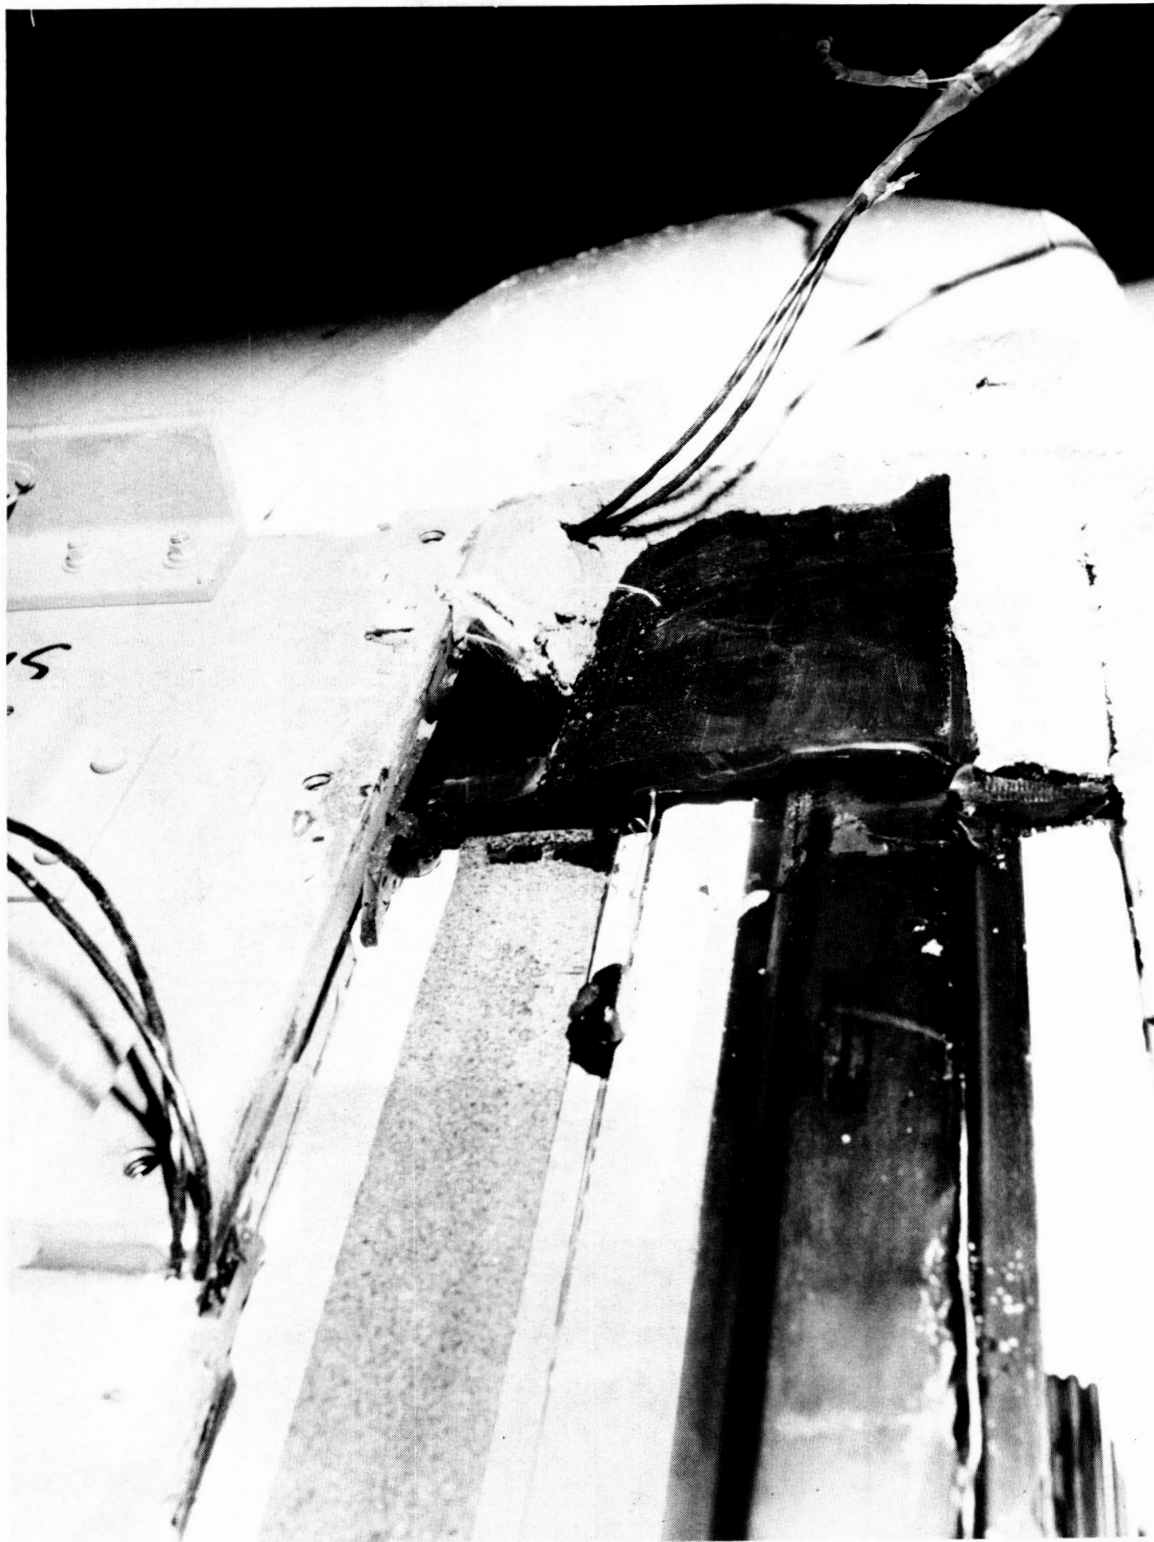
N109405-11

During the test, water entered through the open upper end of the systems tunnel and was funneled down between the tunnel and case. A sealant void at the moisture seal butt splice allowed this water to flow underneath the FJPS. The most likely cause of voids was improper bondline preparation, particularly on the moisture seal surface.

During disassembly, it became obvious that water had entered through the open upper end of the systems tunnel and was funneled down between the tunnel and case. A sealant void at the moisture seal butt splice allowed the water to flow into the FJPS (Figure 5). This void was located at approximately 90 deg, was 1 in. wide, and extended to the open space under the systems tunnel. The void was most likely due to improper bondline preparation and/or because the sealant may have been applied after its pot life had been exceeded. Sealant did not bond sufficiently to the moisture seal and the Kevlar retainer strap. A significant amount of water was found in this area. It was determined that this area was the major entrance for water into the FJPS. Once water entered this portion of the FJPS, it spread by capillary action around the case.

Figure 5. FJPS Rain Test — Moisture Seal Butt Splice, Sealant Unbond

Due to the omission of systems tunnel covers and systems tunnel floor plate closeout, the test assembly was not representative of flight hardware and resulted in a gross overtest. It is therefore recommended that the test be declared void. It is also recommended that the test be repeated. To improve the probability of moisture exclusion from the field joint, the retest should include a complete closeout of the systems tunnel, sealed systems tunnel ends, and improved adhesive bondline preparation.

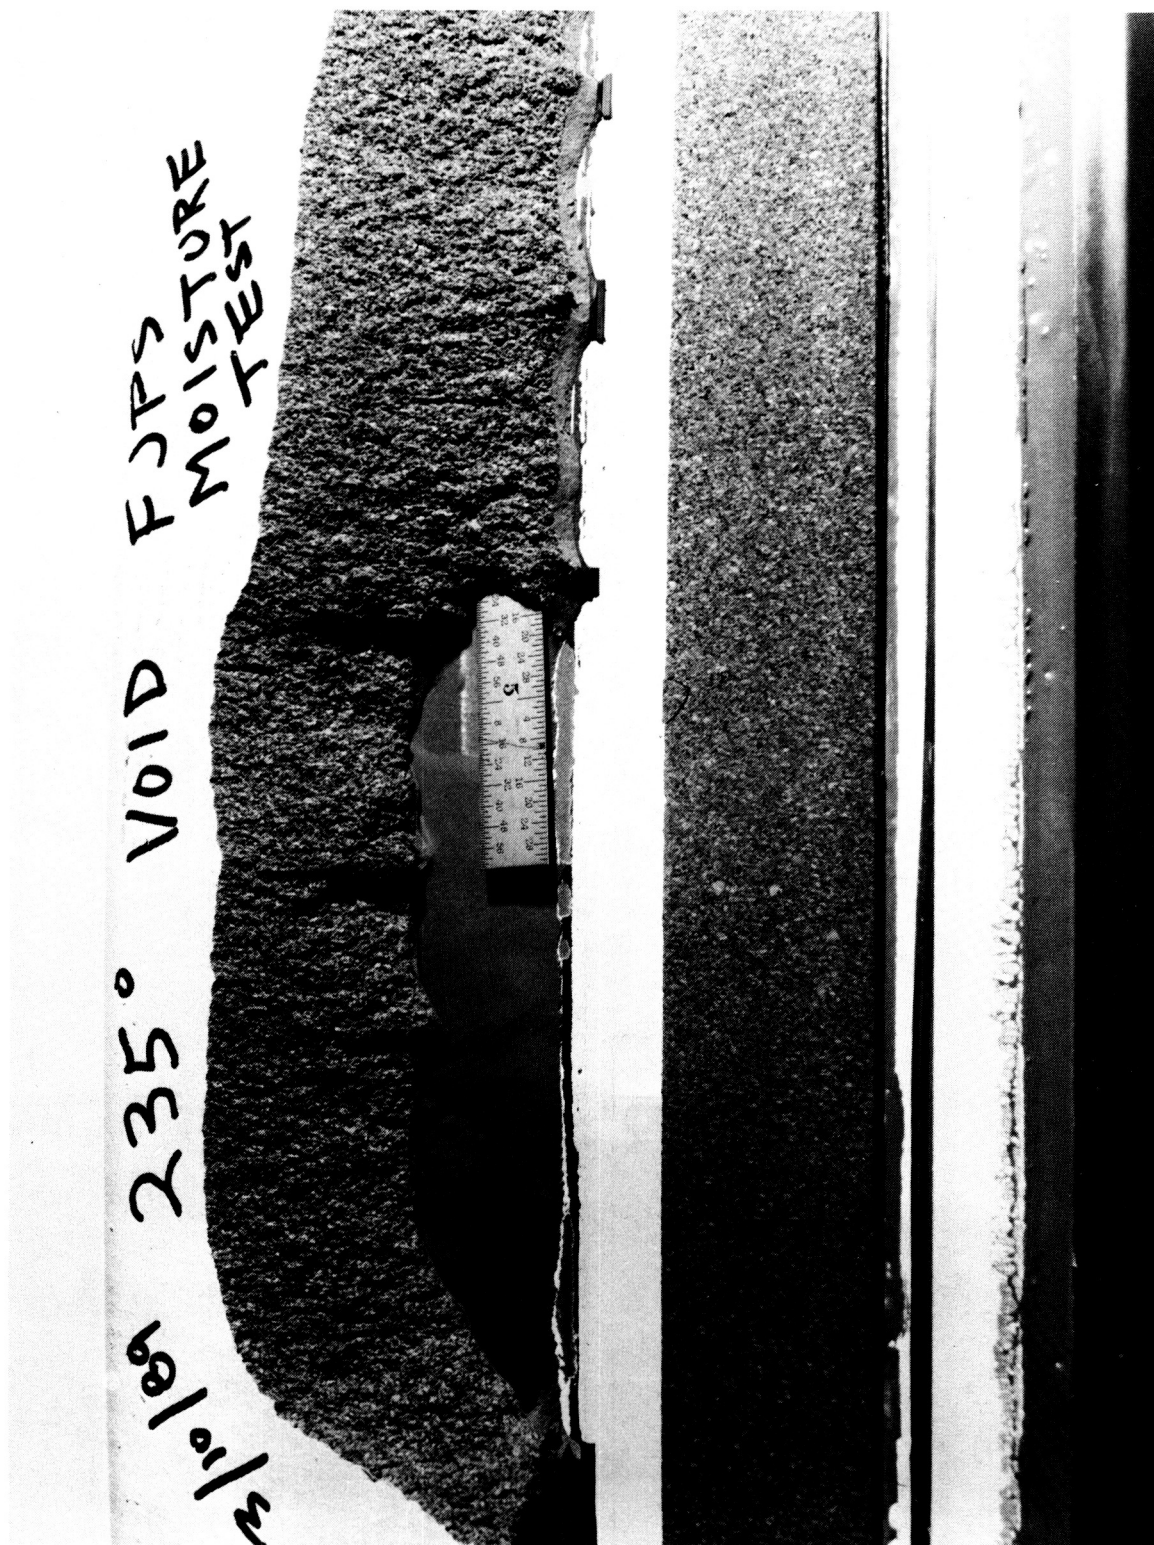
N109405-20

An adhesive void was located over the heater sensor at 235 deg (Figure 6). This void was approximately 10 in. long by 2 in. wide axially.

Figure 6. FJPS Rain Test — Cork-to-Heater Sensor Unbond at 235 degrees

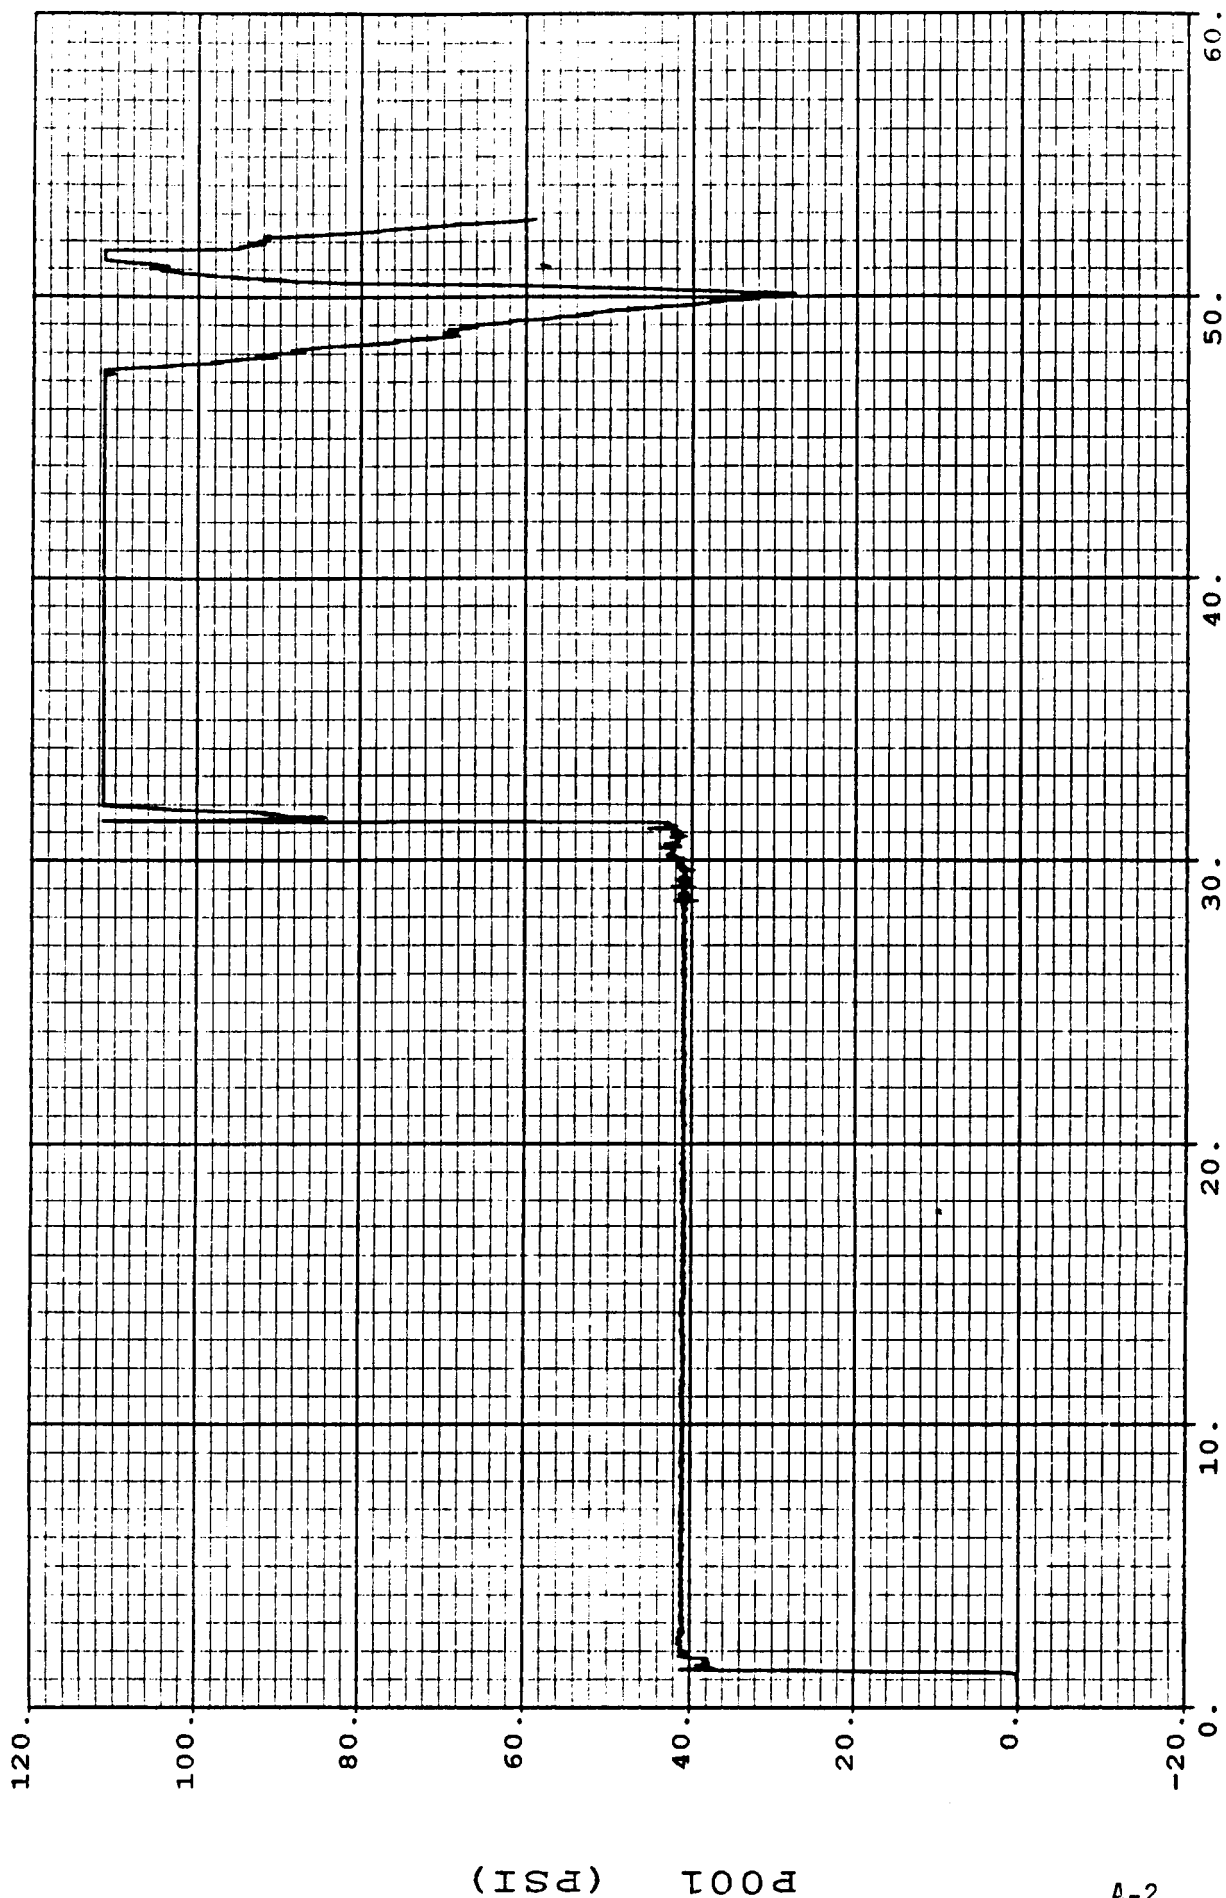
P001 Water Pressure

Three pressure gages (P001, P002, P003, locations shown in Figure 4) were used to monitor test fixture water pressure, and the results are included in the appendix. P001 was damaged at approximately 30 minutes into the test due to water in the gage connector. However, results of the other two gages show that constant water pressure (approximately 41 psi) was maintained throughout the test.

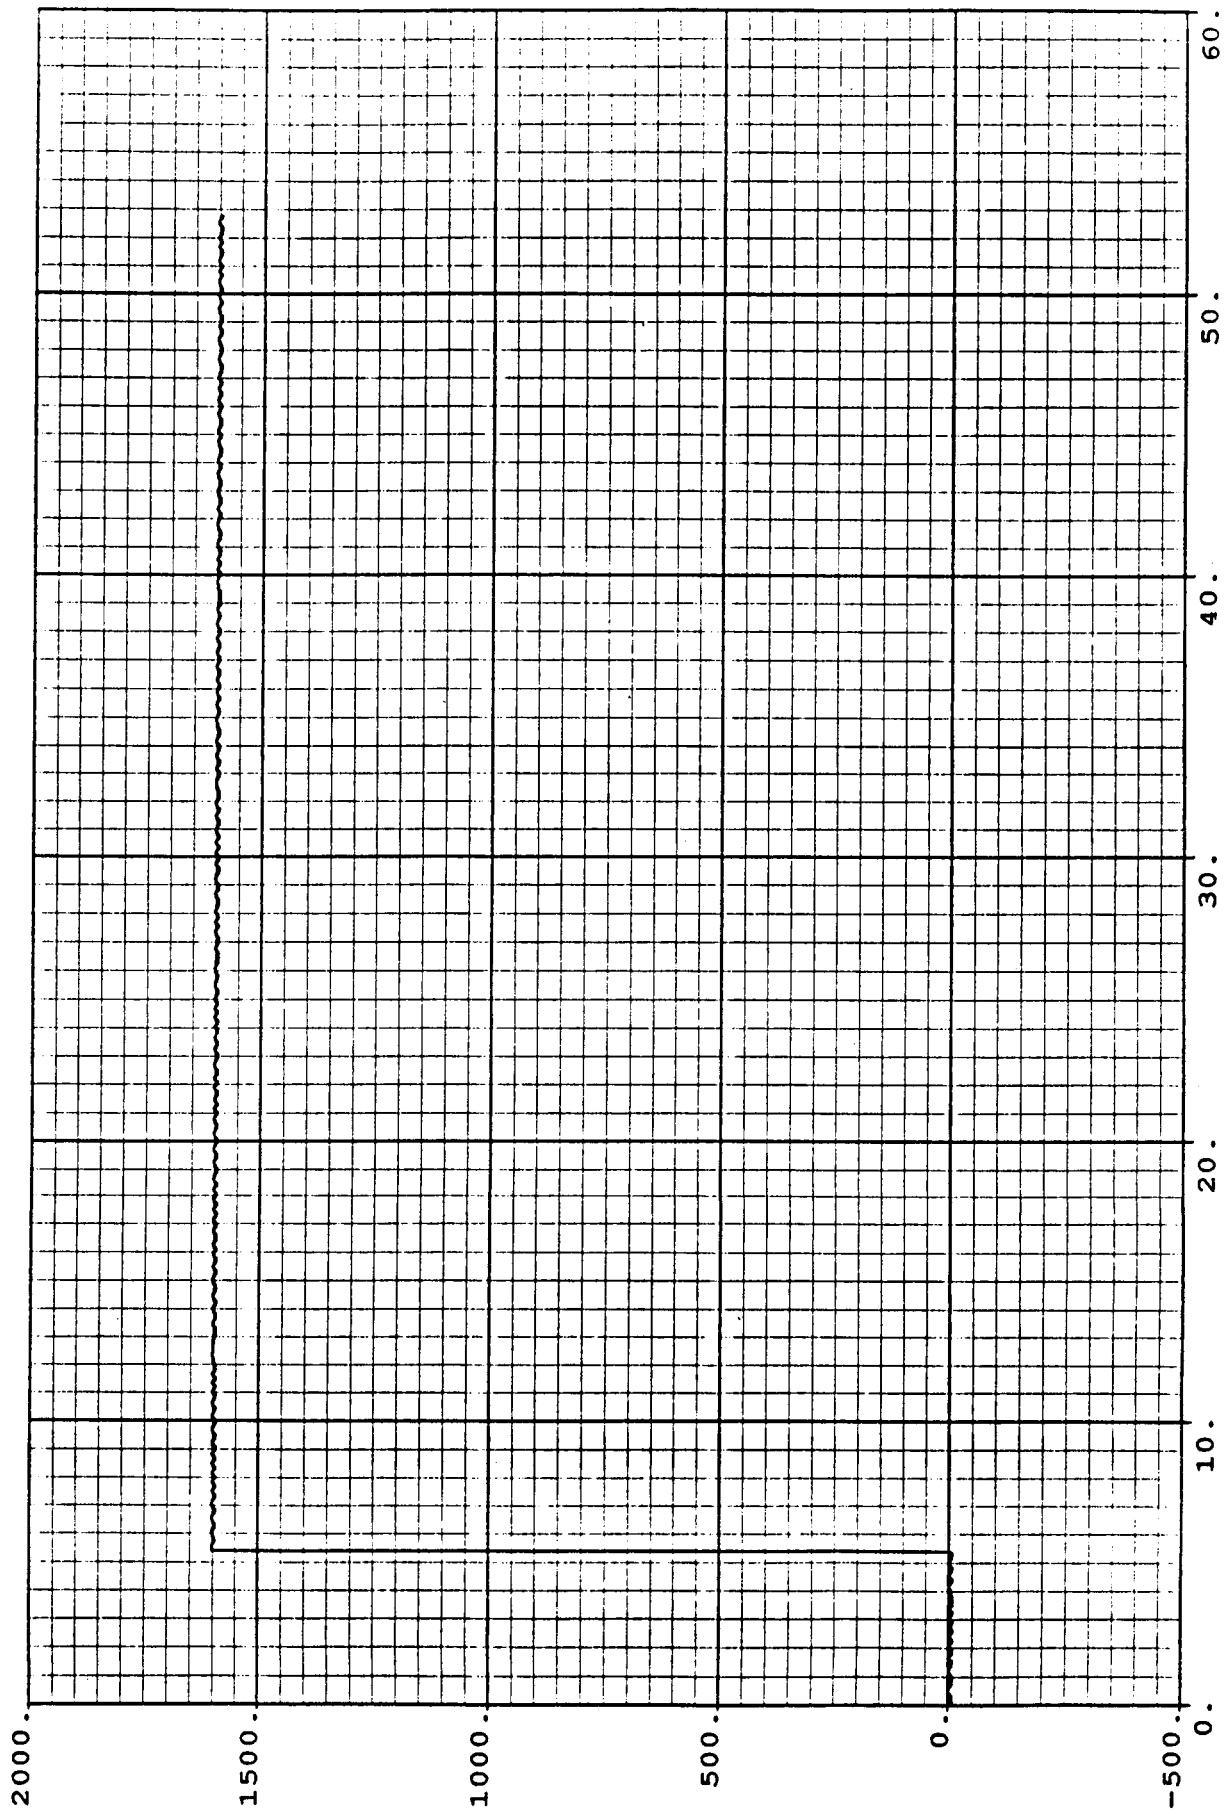
M002 Moisture Detector Gage

Two moisture detection gages (MOO2, from 65 to 110 deg; and M003, from 110 to 155 deg) registered moisture at approximately five minutes into the test. M006, located from 245 to 290 deg, registered moisture at approximately 28 minutes into the test. All other gages showed no indication of moisture. Plots of the moisture detection gage results are included in the appendix. These plots show water indication, as an "on" or "off" function, versus time.
