# School Bus Run-off-Bridge Accident Omaha, Nebraska, October 13, 2001

## Highway Accident Report NTSB/HAR-04/01

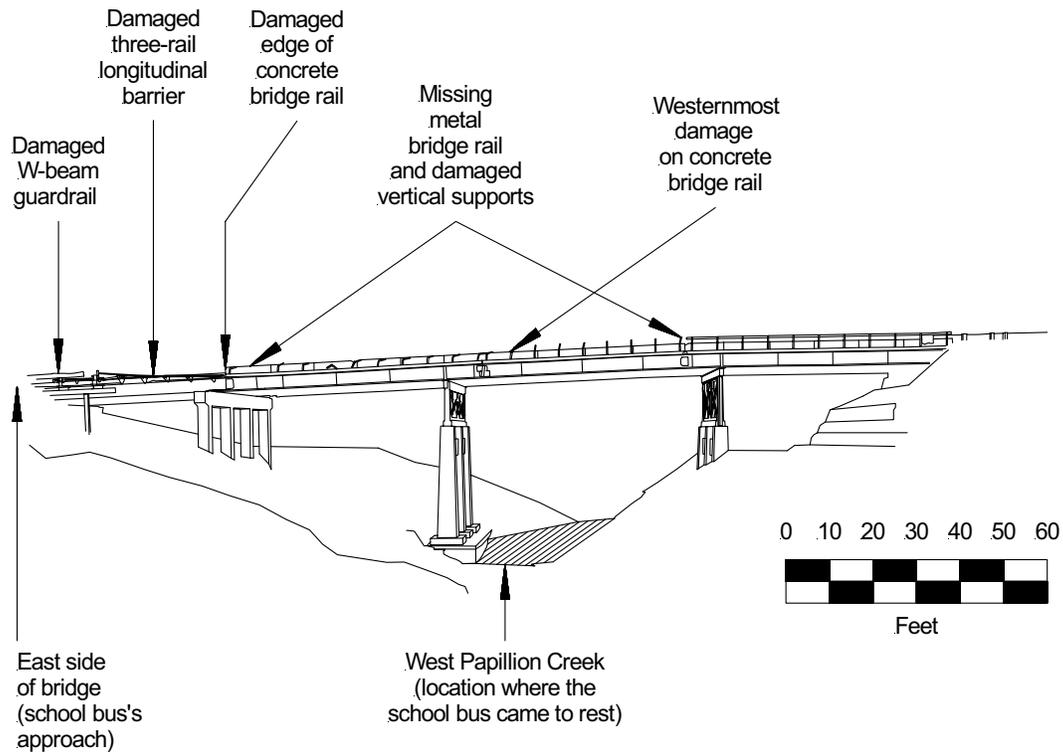
**Figure 6.** Side view of accident site and damage to West Papillion Creek Bridge. (Note: The diagram does not show the accident bus's initial impact with the guardrail on the east side of the bridge because the area's topography prevented the mapping tool from recording that portion of the bridge.)

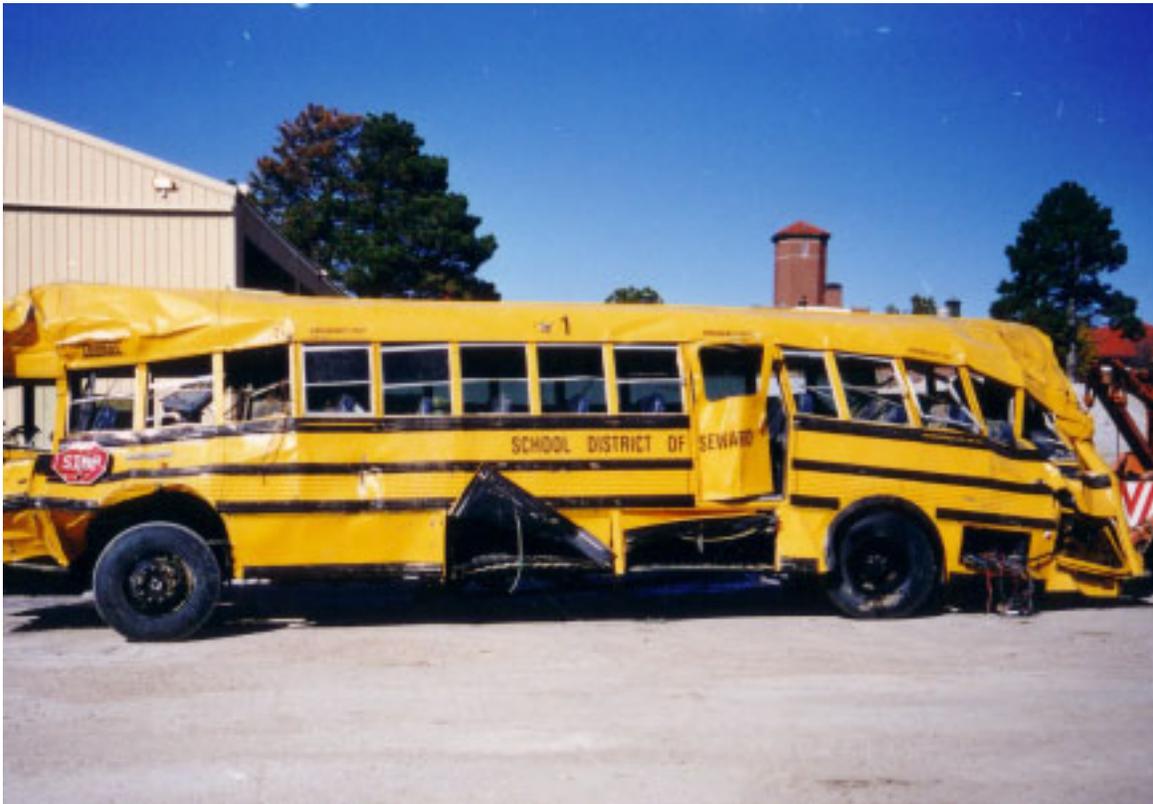
**Figure 12.** Left side of accident bus.

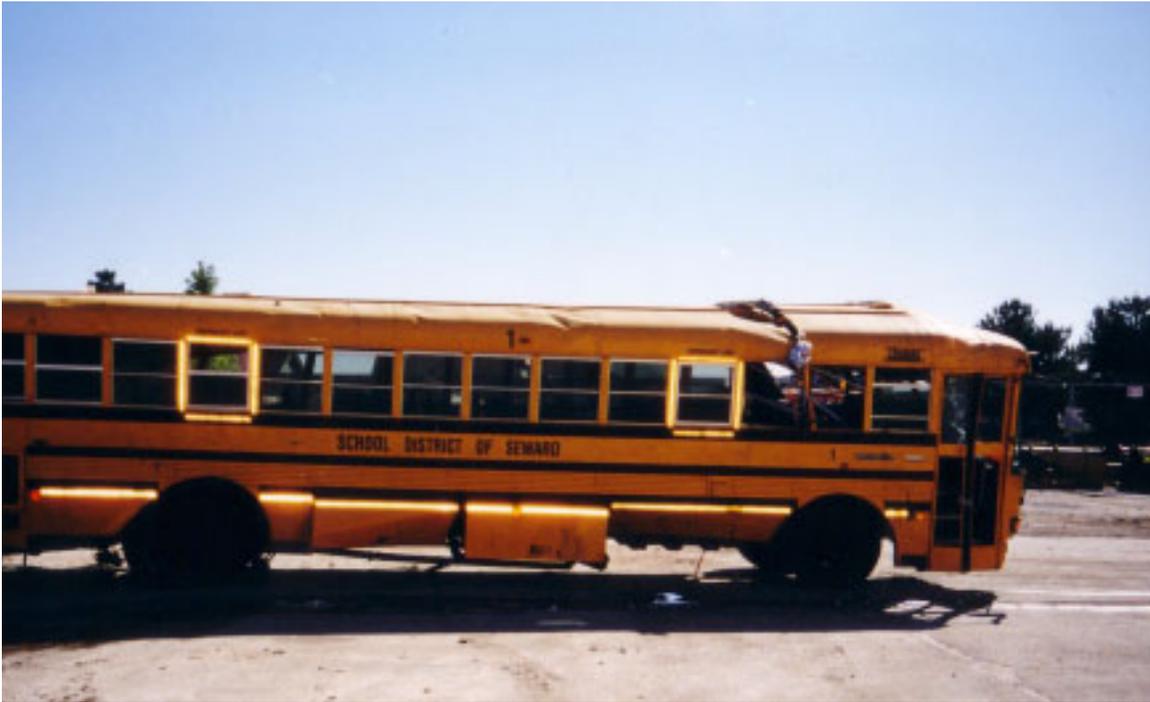
**Figure 15.** Right side of accident bus.

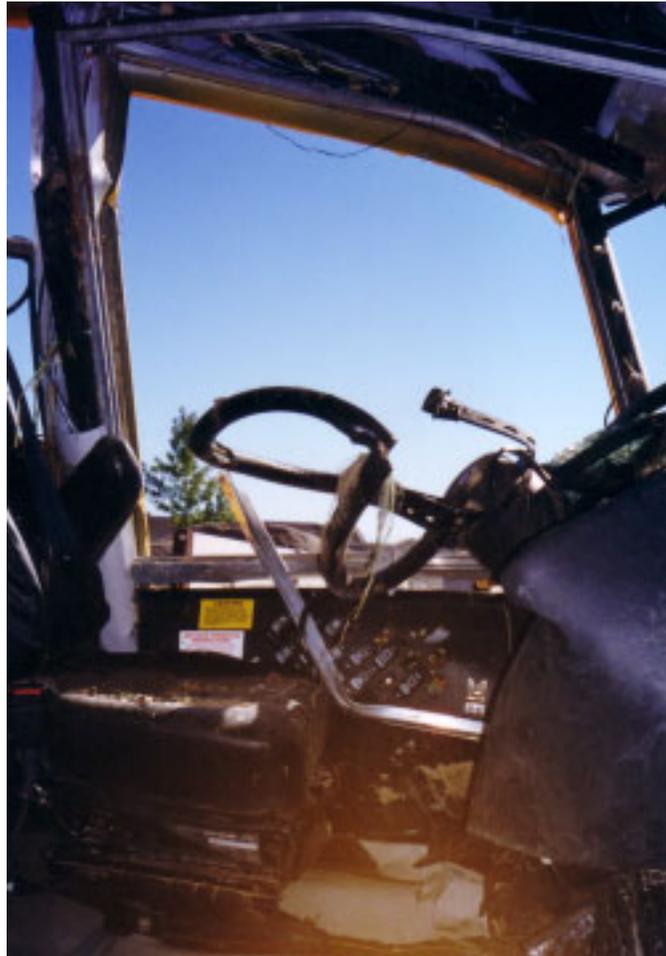
**Figure 16.** Damage to driver's seat.

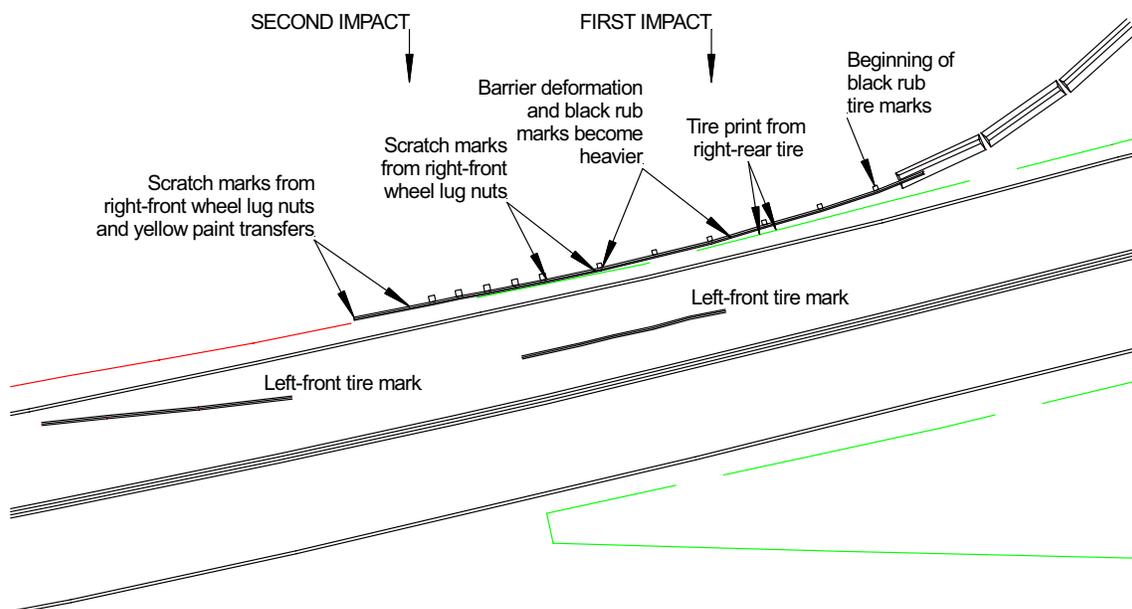
**Figure 17.** Physical evidence left by school bus impacts to guardrail.

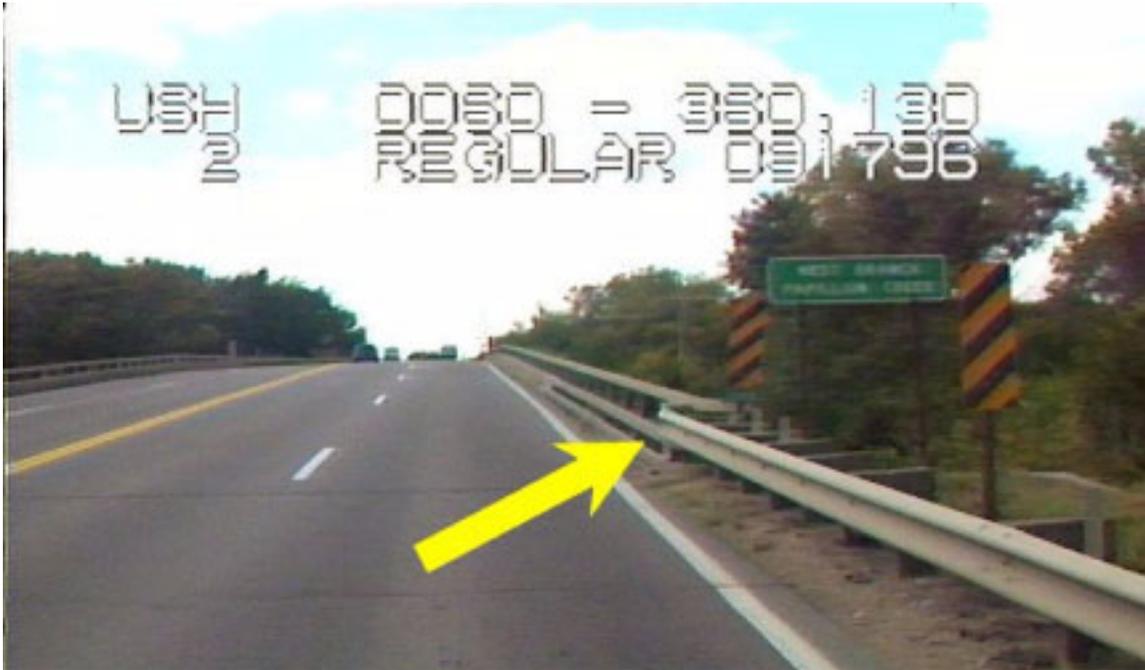
**Figure 20a.** Summer 1996 NDOR photo-logging image of the barrier system installed in 1985 (westbound view). Arrow indicates transition from W-beam to three-rail barrier.

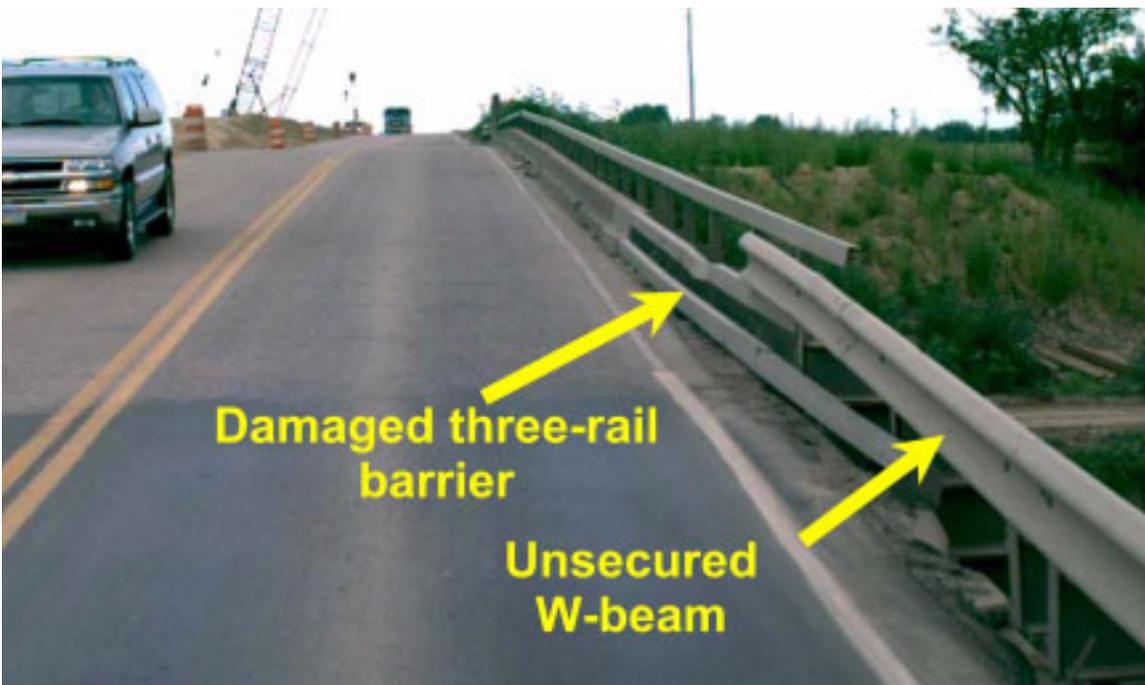
**Figure 20b.** Summer 2001 NDOR photo-logging image of the repair to the barrier system after the May 2001 truck incident (westbound view). Shown is the east end of the remaining three-rail barrier and the west end of the repair to the three-rail barrier.

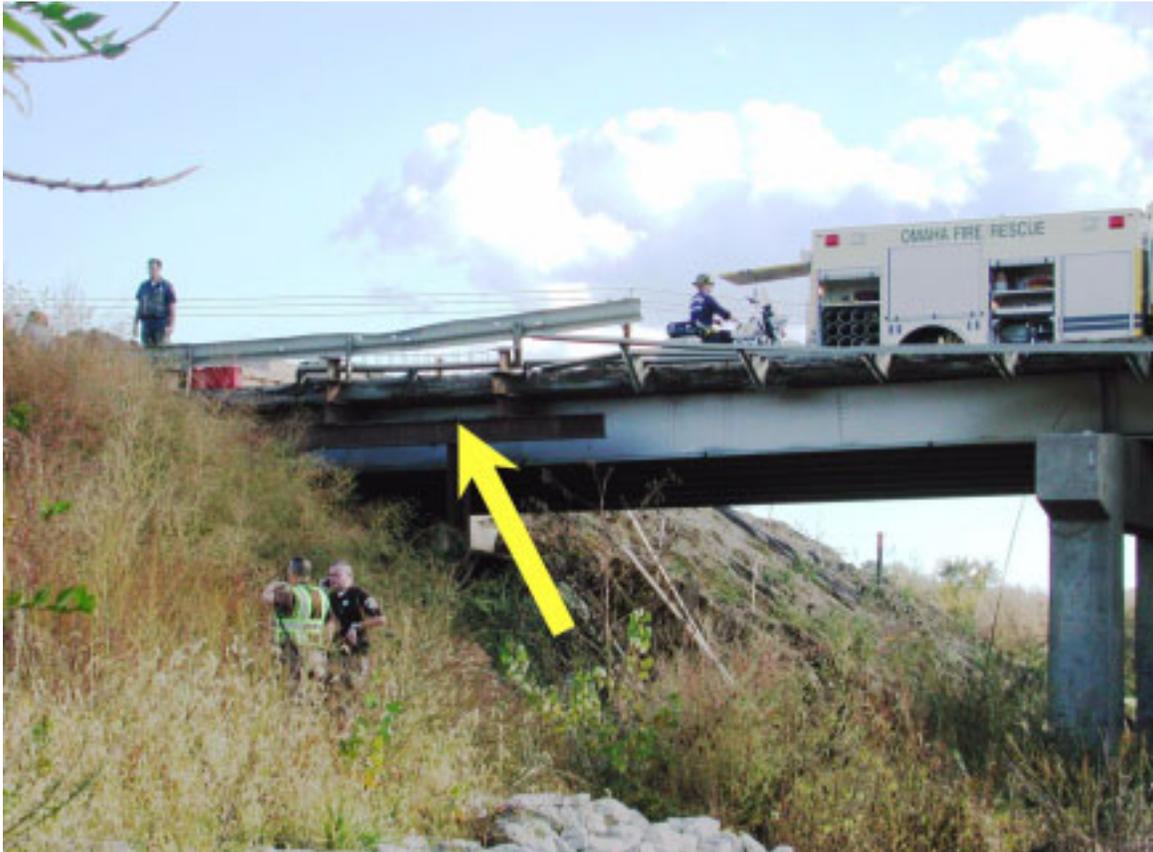
**Figure 21.** Bridge repair by contractor shown immediately after October 13, 2001, accident. (Source: DCSO)
