NASA/TM-2009-215955

# Experimental Behavior of Fatigued Single Stiffener PRSEUS Specimens

*Dawn C. Jegley*  
*Langley Research Center, Hampton, Virginia*

December 2009

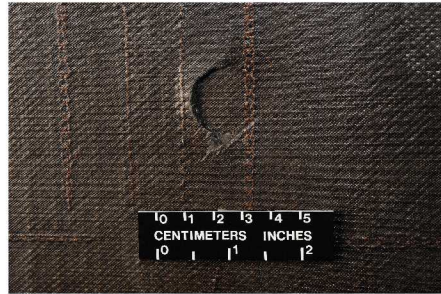
Figure 7. Machining damage to specimen F4.

Prior to delivery to NASA the OML of specimen F4 was damaged during the machining process. A photograph of this damage is shown in figure 7. The dent is approximately circular with a 1-inch diameter and the maximum depth is approximately 0.1 inches. No damage at this location is visible on the stiffened or Inner Mold Line (IML) side of the specimen.

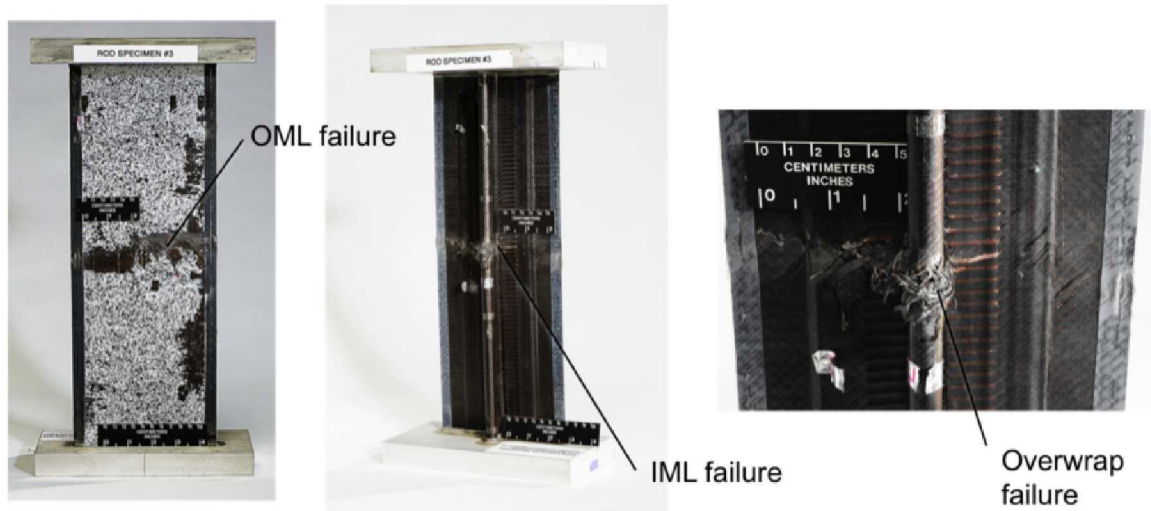
Figure 24. Rod specimen failure.

Rod-stiffened specimens failed midlength across the full width of the specimen. Minimal delamination can be seen between the flange and skin. Overwrap damage can be seen around the rod. Specimens R3 and R4 failed in the same manner. Frame specimen F4 was damaged prior to fatigue cycling but still withstood the cycling with no indication of damage progression and failed at a load equal to 78 percent of the failure load of specimen F3. Failure at the specimen corners and at the top of the location where the rod overwrap intersects the frame is evident in both specimens F3 and F4.

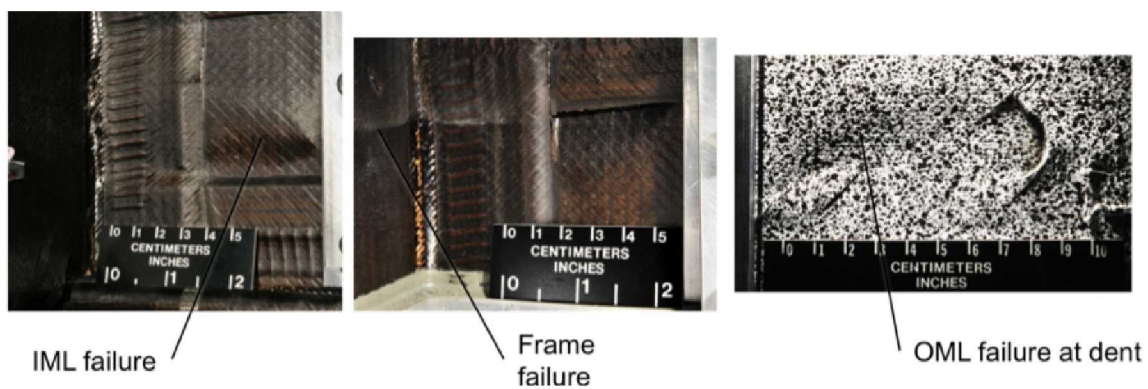
b) Specimen F4

Based on experimental evaluation of nominally identical single-stiffener compression-loaded specimens subjected one or 55,000 cycles of loading, fatigue cycling has no influence on failure load or mode. Visible damage to the skin of a specimen where the frame was loaded in compression reduced the failure load to 78 % of the failure load of the undamaged specimen.
