Occurrence and Attempted Mitigation of Carbon Dioxide in a Home Constructed on Reclaimed Coal-Mine Spoil, Pike County, Indiana

Scientific Investigations Report 2010–5157

By Bret A. Robinson

U.S. Department of the Interior
U.S. Geological Survey

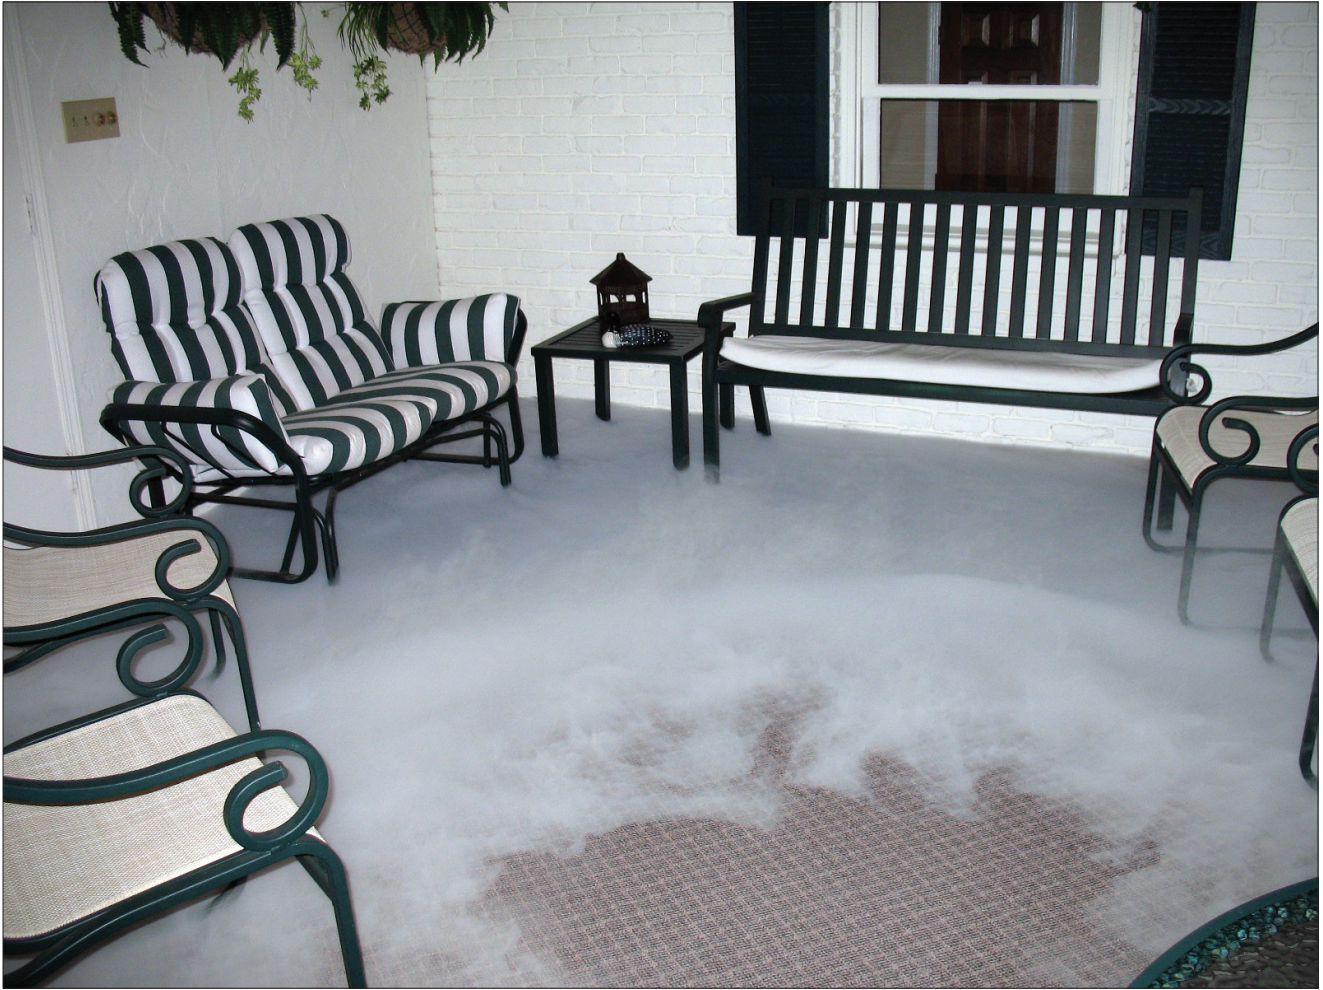
Figure 1. A carbon dioxide cloud that has settled to floor level. (In this photograph, condensation allows the dry-ice-generated carbon dioxide cloud to be visible; however, in most settings, carbon dioxide generated from natural soil processes will not be visible.)

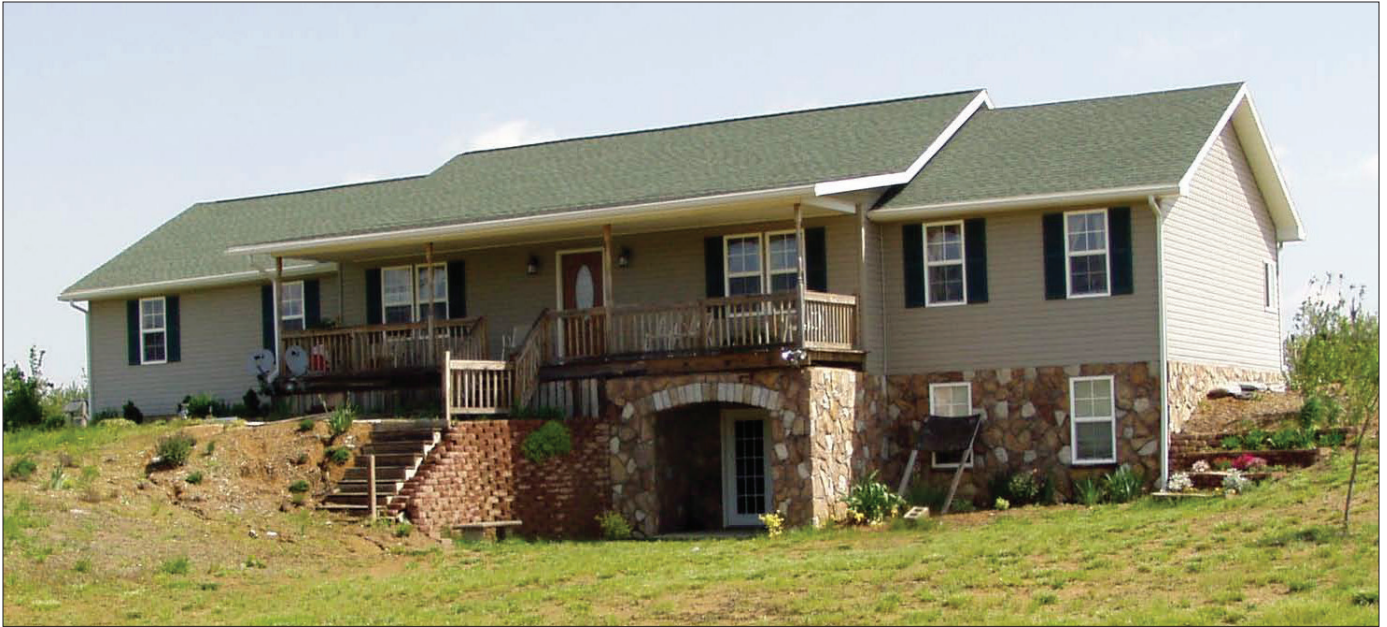
Figure 2. The study-site home in east-central Pike County, Ind., where the intrusion of carbon dioxide as a soil gas has posed a health risk.

In 2006, the Indiana Department of Natural Resources (IDNR), Division of Reclamation became aware of at least three homes in southern Indiana that were experiencing elevated levels of CO_2 and depressed levels of O_2 . All three homes were constructed on or near recently reclaimed surface coal mines. At two of the homes, mitigation efforts were able to reduce CO_2 concentrations to acceptable levels. Unfortunately, at one site (fig. 2) in east-central Pike County, Ind., herein referred to as the “study site,” building-foundation characteristics did not appear to be compatible with commonly applied mitigation approaches: sub-slab depressurization systems. Therefore, this site continued to represent a health hazard for the homeowners; in fact, when environmental conditions were unfavorable, the home was from time to time uninhabitable.

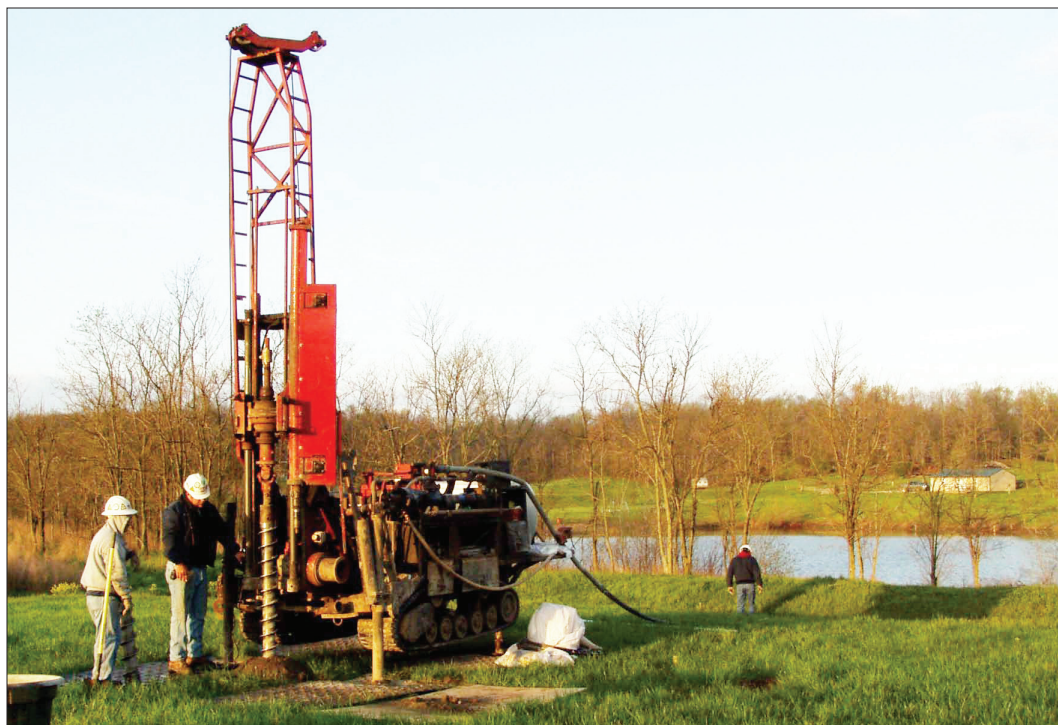
The boreholes were drilled with 4.25-in. inside-diameter hollow-stem augers and a drill rig mounted on an all-terrain vehicle (fig. 4). Each well (table 1) was constructed with a 5-ft-long polyvinylchloride (PVC) well screen and enough PVC well riser to extend the top of the well approximately 2 ft above the land surface. A well-screen sand filter was established in each well and extended approximately 2 ft above the top of the screen. A pump and tremie pipe were used to fill the well annulus with bentonite grout from the top of the sand filter to a level approximately 2 ft below the land surface. At each well, the remaining 2 ft of well annulus was filled with drill cuttings.

Figure 4. Drilling activities for installation of a temporary network of monitoring wells at the study site in east-central Pike County, Ind.

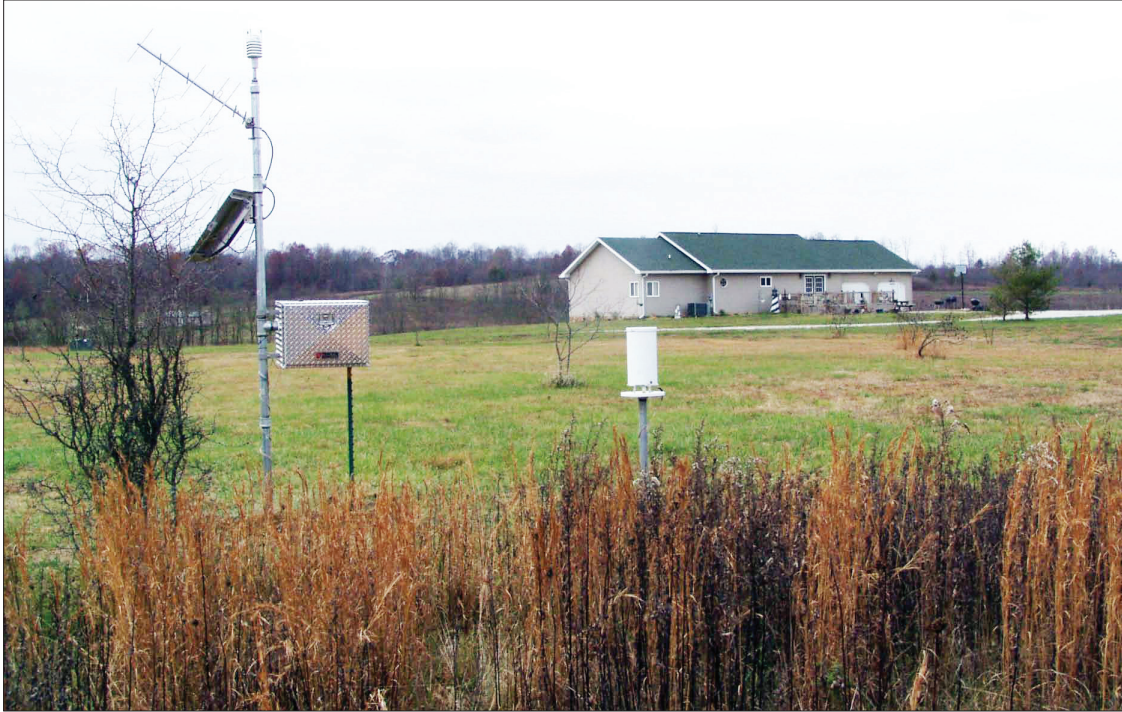
At the study site, a meteorological observation platform (figs. 3 and 5) was constructed and relevant data were collected from November 2008 to March 2010. These data included wind direction, wind speed, air temperature, barometric pressure, relative humidity, and precipitation. The first five of the listed parameters were measured by using a Vaisala Weather Transmitter WXT520 (Vaisala Inc., Woburn, Mass.). Precipitation was measured by using a tipping-bucket rain gage. Each data parameter was collected hourly and transmitted via satellite to USGS computers for processing and long-term storage.

Figure 5. Meteorological observation platform designed for hourly transmission of local meteorological data measured at the Pike County, Ind. study site.

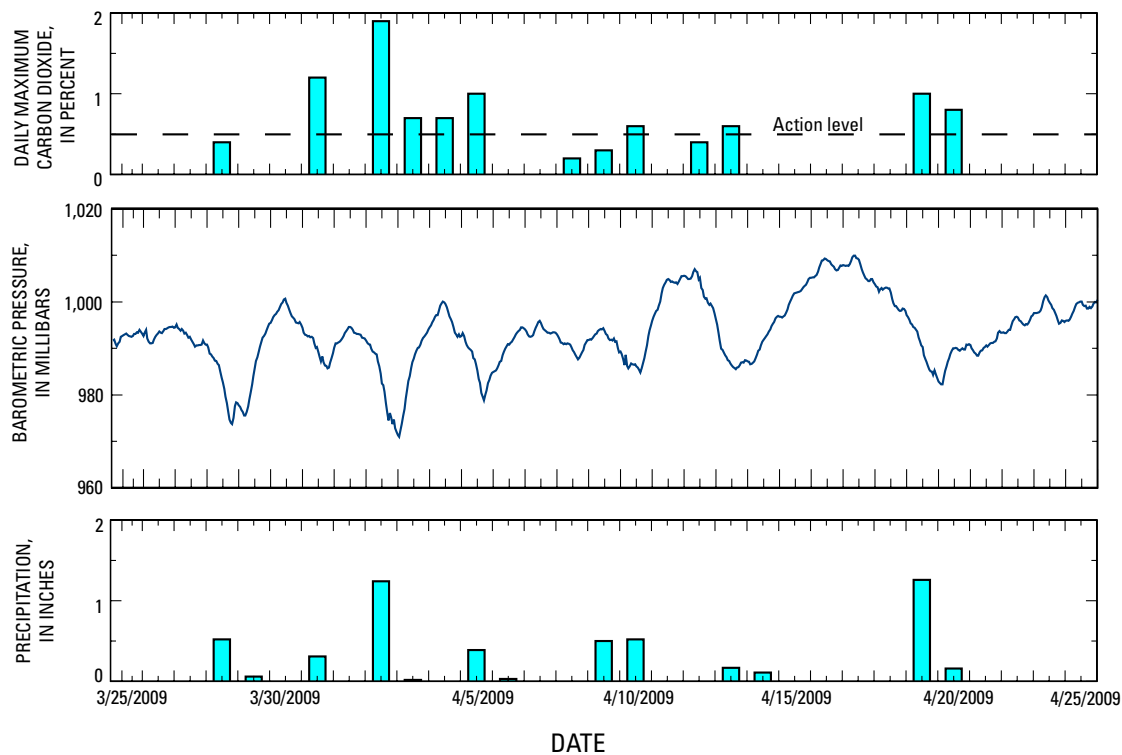
Meteorological and within-residence CO₂-concentration data for March 25 to April 25, 2009, are plotted in figure 6. At the top of the figure are vertical bars showing daily maximum CO₂ concentrations in the basement of the study-site home. (The “action level” line corresponds to a CO₂ concentration of 5,000 ppm, the broadly accepted health standard for CO₂.) Barometric-pressure data are presented as a continuous trace through the middle of the figure. Daily precipitation totals are presented as vertical bars at the bottom of the figure. Examination of this plot reveals that, within this 1-month period, substantial and rapid drops in barometric pressure were accompanied by rainfall and spikes in the CO₂ concentration on numerous occasions. This general pattern was consistently seen in the study-site home.

Figure 6. CO₂-concentration, barometric-pressure, and precipitation data collected from March 25 to April 25, 2009, at the study site in east-central Pike County, Ind. (Carbon dioxide values that were near background levels and trace amounts of precipitation are not plotted so that meaningful values can be shown at an appropriate scale.)

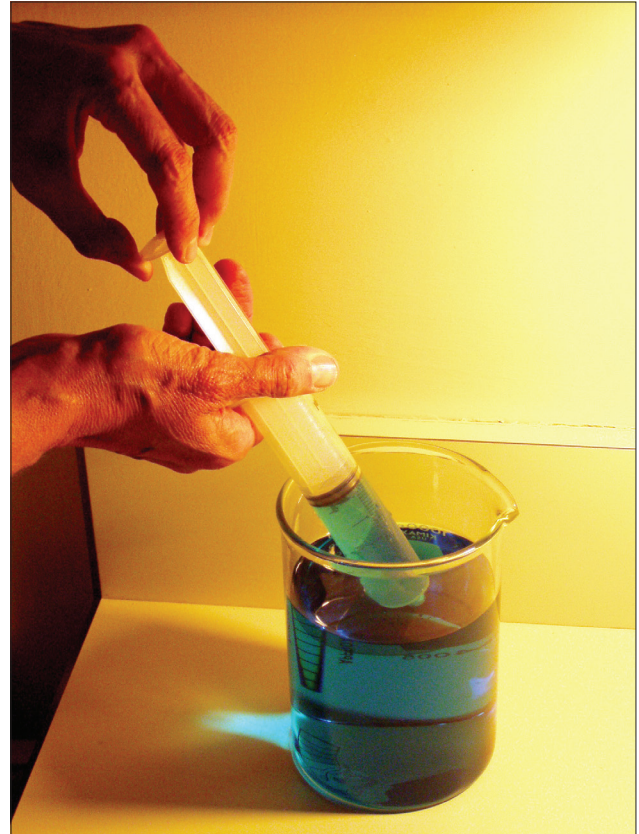
A syringe in a beaker of water (fig. 8) can be used as a physical model to illustrate this process. When a force is applied to withdraw the plunger from the syringe, a low pressure is generated within the syringe, and water from the beaker is drawn in to fill the potential void. In this physical model, the syringe represents the structure that is influenced by an approaching low-pressure front, and water in the beaker represents the surrounding soil gases that are drawn into the structure as a result of the established pressure gradient.

Figure 8. Syringe in a beaker of water, used to illustrate the effect of how a drop in barometric pressure draws soil gases into a structure.

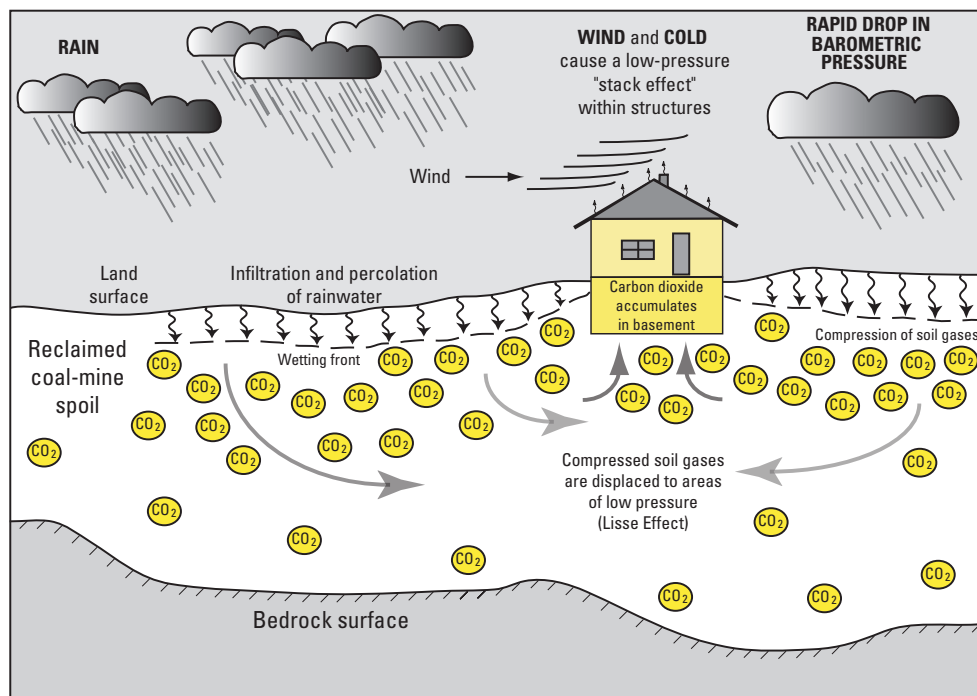
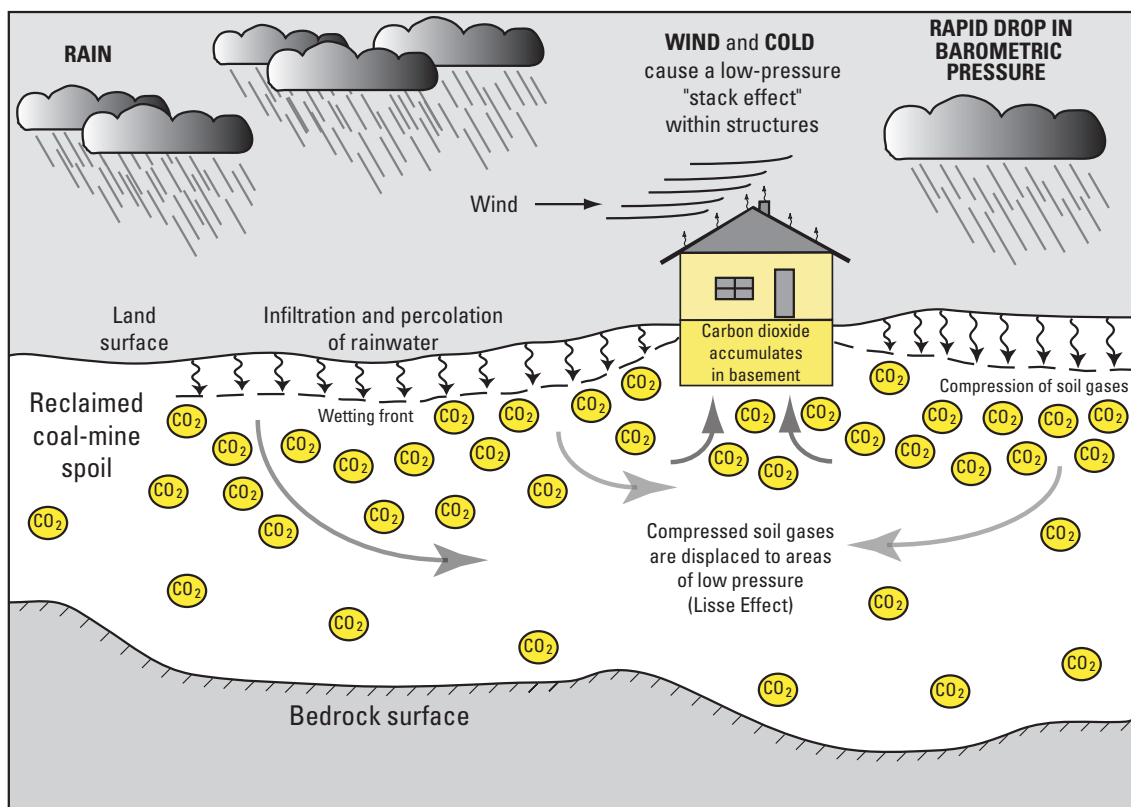
Data collected at the study site and a review of the relevant literature led to the development of a conceptual model which, as depicted in figure 7, shows those conditions that drive the CO₂-intrusion process. The significance of the controlling components (rapid drops in barometric pressure, rainstorms, windy conditions, and cold weather) shown in this model are briefly described below.

Soil gases naturally move from areas of relative high pressure to areas of relative low pressure. When a weather front causes a rapid drop in barometric pressure to an area, all atmospheric and near-surface gases respond to its effect. The gases inside a structure tend to rise under reduced barometric pressure and, as they rise, soil gases surrounding the structure's foundation are drawn in by the resultant pressure gradient. Soil gases will enter the home via any pathway that allows their transmission: cracks in the house's floor or walls, expansion joints between footers and slabs, locations where plumbing components pass through the outer shell of the structure, and places where porous construction materials allow gas passage.

Figure 7. Conceptual model depicting four of the environmental conditions that may lead to carbon dioxide intrusion to structures: rapid drops in barometric pressure, rain, wind, and cold.

During rainstorms, a phenomenon known as the Lisse effect (Guo and others, 2008) may act to drive soil gases, including CO_2 , toward a structure or dwelling. With intense rainfall, infiltrating rainwater traps and compresses soil gases which migrate toward areas of low pressure. Because precipitation falling on a house is diverted by manmade drainage systems (the roof, gutters, downspouts, and perimeter drains), the materials directly beneath the footprint of a house do not receive as much infiltrating precipitation as surrounding soils. Therefore, the drier soils beneath a house represent an area of relative low pressure where soil gases tend to migrate and collect (fig. 7).

Soil-gas intrusion is also expected during windy and cold weather (Walker, 2010). During windy conditions a phenomenon, described by the Bernoulli Principle, causes low pressure to form inside a structure as wind blows across the structure's large and small openings. During cold-weather conditions, heating the air inside a structure causes the air to rise and a low-pressure condition to be generated inside the structure (U.S. Environmental Protection Agency, 2010). Therefore, similar to the effect created by an approaching low-pressure front, windy and cold-weather conditions can cause soil gases to be drawn into a structure in response to an established pressure gradient.

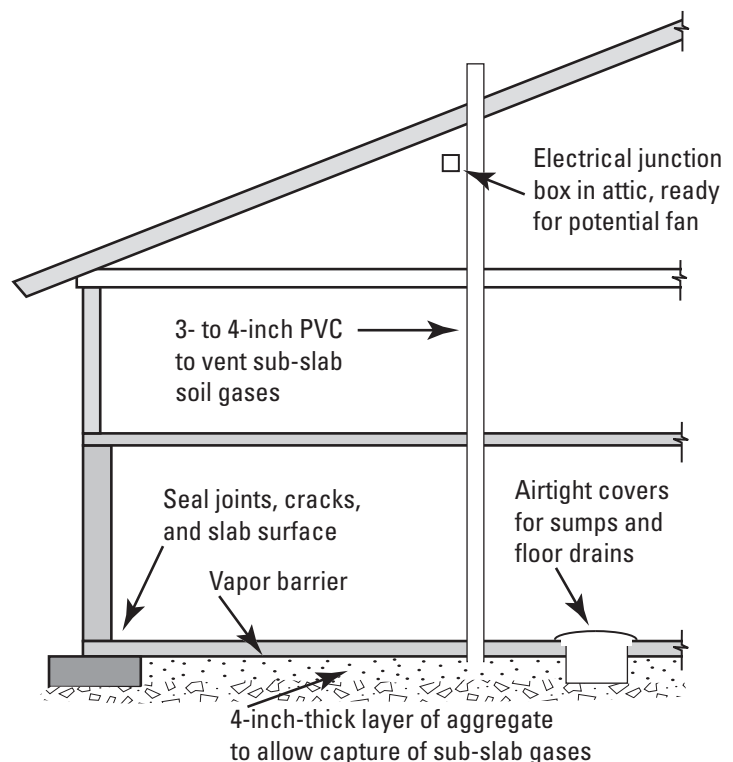
Figure 9. New-construction steps that can be taken to reduce soil-gas intrusion or facilitate mitigation.

Where construction of a basement is planned, several steps can be taken to lessen the problem or facilitate mitigation if soil-gas intrusion is found to occur. These steps are described in a variety of building-guideline publications (Nebraska Department of Health and Human Services, 2007; US Environmental Protection Agency, 2009a, b) and include the following (fig. 9):

- Pouring the basement slab on a layer of aggregate. This aggregate can serve as a soil-gas collection layer if an active mitigation system is to be installed.
- Placing a vapor barrier between the basement slab and the sub-slab aggregate.
- Placing plumbing lines and an electrical junction box at strategic locations to accommodate a future mitigation system if one becomes necessary.
- Sealing all joints, cracks, and surfaces where soil gases may enter the basement.
- Installing gas-proof floor drains and sump-pit covers to inhibit gas intrusion.

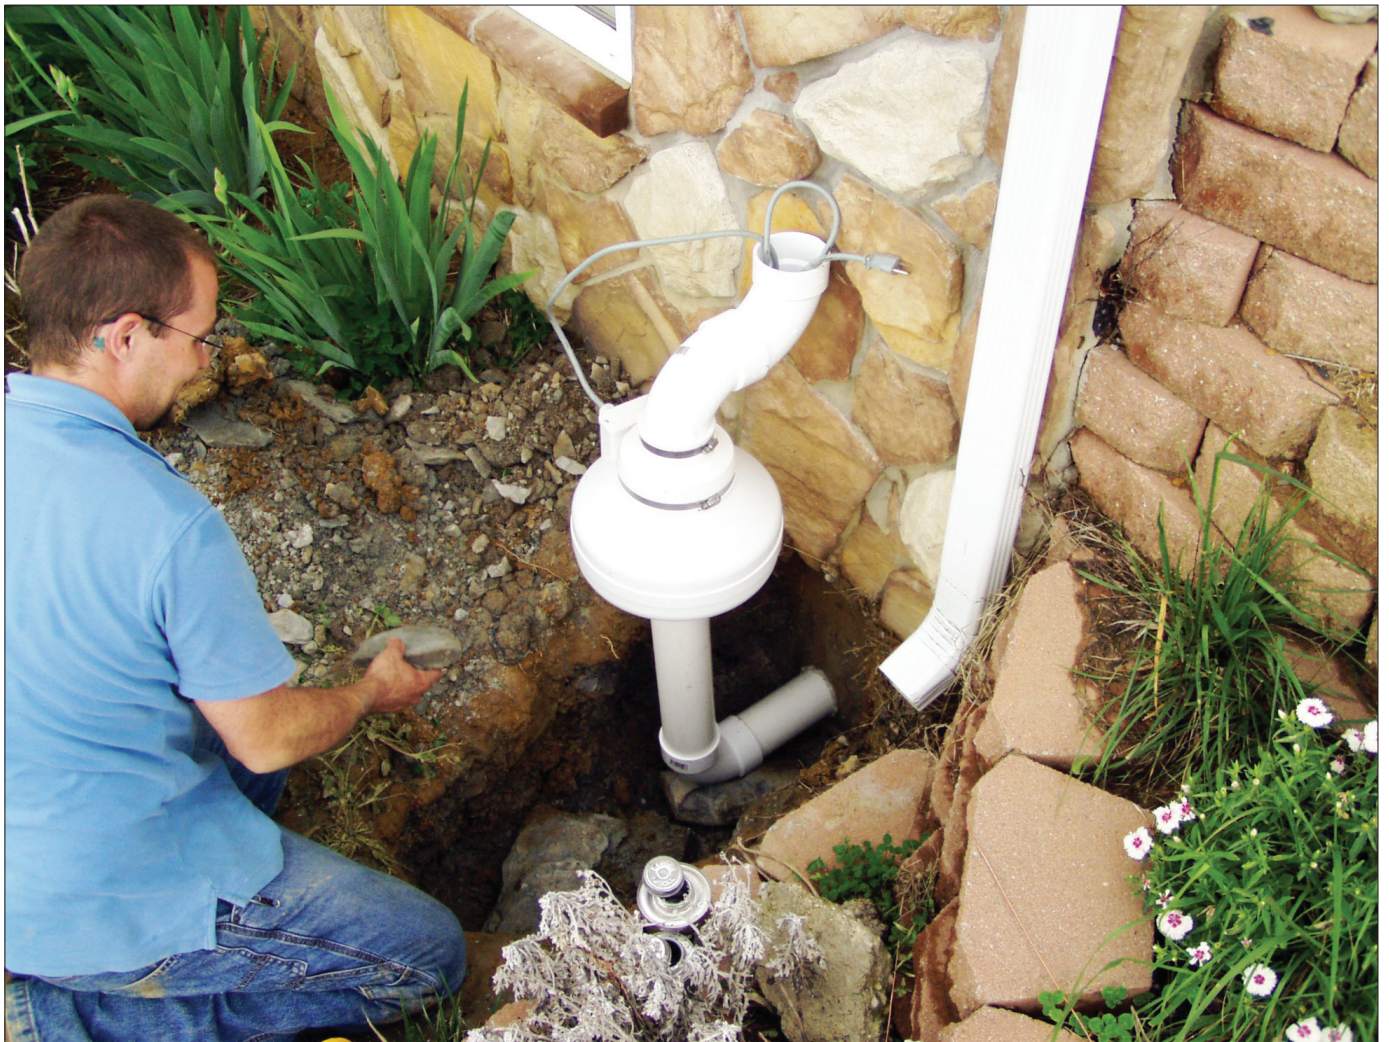
Figure 10. Mitigation system established to depressurize the block walls of the study-site home, Pike County, Ind.

On April 28, 2009, a mitigation system was established to depressurize the block walls of the study-site basement. A small pit was excavated adjacent to the study-site home and an electric drill was used to remove a 4-in.-diameter core from one of the wall blocks. A length of 4-in. PVC pipe was inserted in the cavity of that block and a RadonAway RP 265 fan (RadonAway Inc., Ward Hill, Mass.) was connected to depressurize the basement's block walls (fig. 10) and exhaust the evacuated air to a point just below the home's roofline. The RP 265 fan is a high-volume fan rated to move air at up to 327 cubic feet per minute (ft³/min). To demonstrate that this device was effective at depressurizing the entire perimeter of the basement, a small hole was drilled in the basement wall at the opposite corner of the house and non-thermal smoke was puffed near that hole. The smoke was directly observed being drawn into the drilled hole, thereby confirming that the mitigation system was depressurizing the basement's block walls.

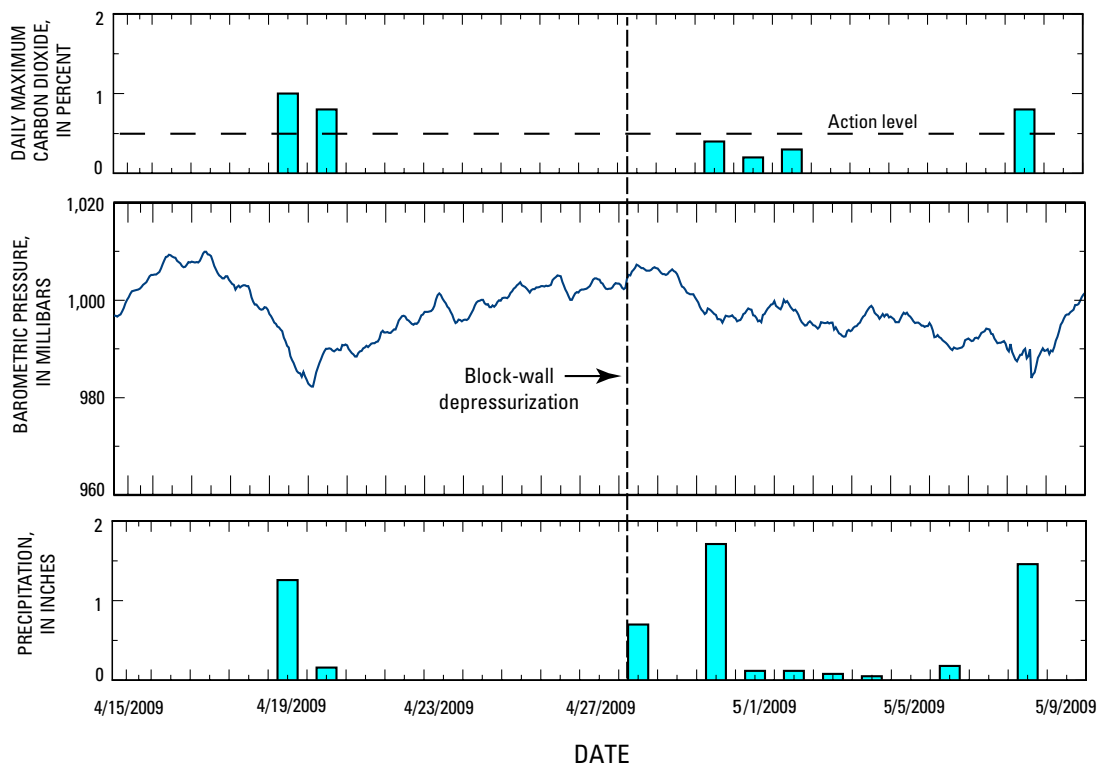
To determine whether this depressurization effort was sufficient to protect the home from CO₂ intrusion, in-home CO₂-concentration data were collected for a period of 2 weeks. During this period, the RP265 fan was run continuously. Data collected on May 8, 2009, revealed that a rapid drop in barometric pressure and accompanying rain were still capable of producing a threatening intrusion of CO₂ (fig. 11). On this date, CO₂ levels in the study-site basement reached a maximum of 0.8 percent, well above the targeted maximum of 0.5 percent. It was therefore concluded that, for the study-site home, block-wall depressurization alone did not provide sufficient protection.

Figure 11. CO₂-concentration, barometric-pressure, and precipitation data collected from April 15 to May 10, 2009, at the study site in Pike County, Ind. Block-wall depressurization was established on April 28, 2009. Data collected on May 8, 2009, revealed that this depressurization did not eliminate the CO₂-intrusion threat. (Carbon dioxide values that were near background levels and trace amounts of precipitation are not plotted so that meaningful values can be shown at an appropriate scale.)

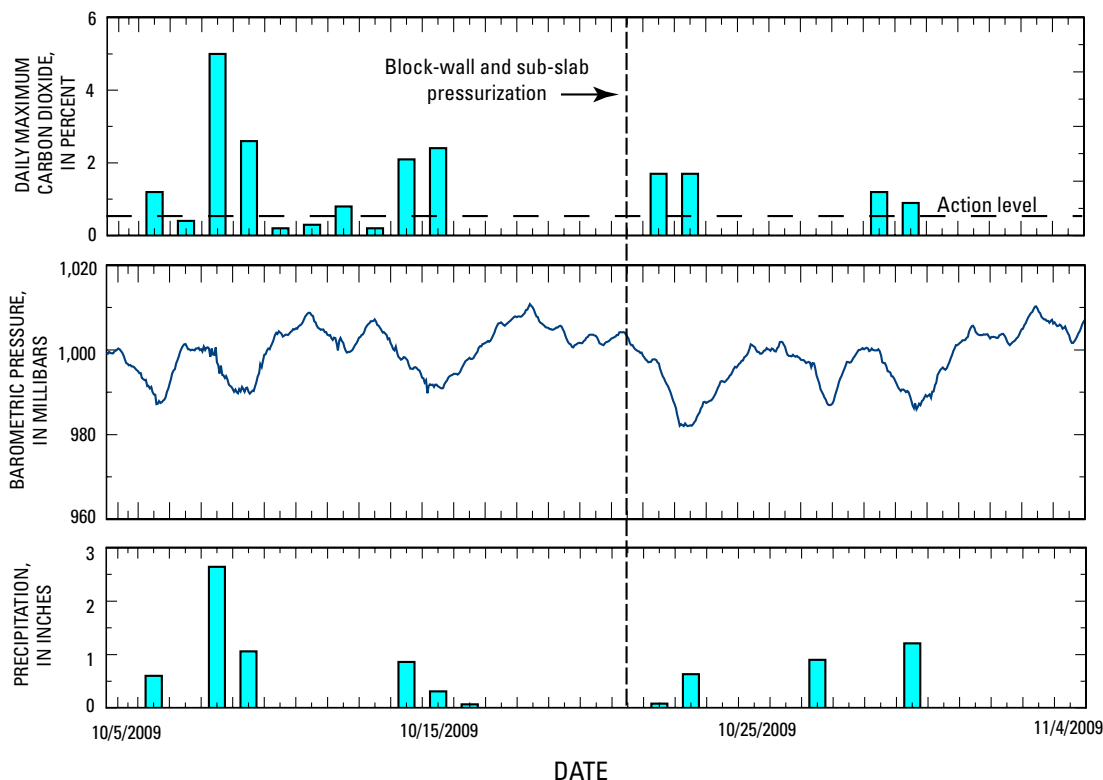
To determine whether block-wall and sub-slab pressurization was producing the desired mitigation effect, in-home CO₂-concentration data were plotted with barometric pressure and precipitation data for October 5 to November 5, 2009 (fig. 13). Data collected between October 22 and 30, 2009, revealed that this pressurization system was not able to prevent CO₂ intrusion to the study-site home when atmospheric conditions were conducive to intrusion.

Figure 13. CO₂-concentration, barometric-pressure, and precipitation data collected from October 5 to November 5, 2009, at the study site in Pike County, Ind. A combination of block-wall and sub-slab pressurization was established on October 21, 2009. Data collected between October 22 and 30, 2009, revealed that this pressurization effort did not eliminate the CO₂-intrusion threat. (Carbon dioxide values that were near background levels and trace amounts of precipitation are not plotted so that meaningful values can be shown at an appropriate scale.)

On October 21, 2009 the two fans that had been used to draw gases from within the block walls and beneath the slabs of the study-site home were reversed. This reversal of air-flow direction was an attempt to pressurize the block walls and the void spaces immediately below the slabs, thereby preventing soil gases from entering the study-site home.
