## **ADVANCED GAS TURBINE (AGT) TECHNOLOGY DEVELOPMENT**

**EIGHTH SEMIANNUAL PROGRESS REPORT  
(JULY 1983 — DECEMBER 1983)**

Engineering Staff of  
Garrett Turbine Engine Company  
A Division of The Garrett Corporation

JUNE 1984

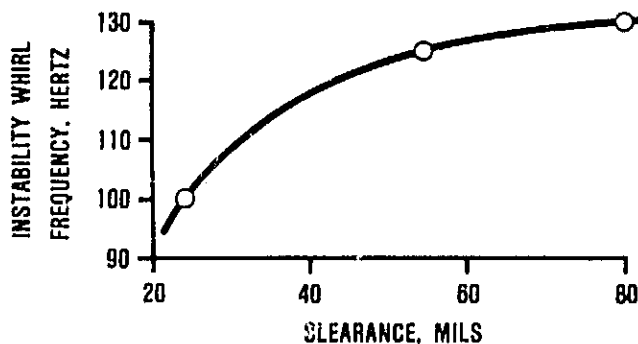
Figure 5. Compressor Backshroud Clearance Effect.

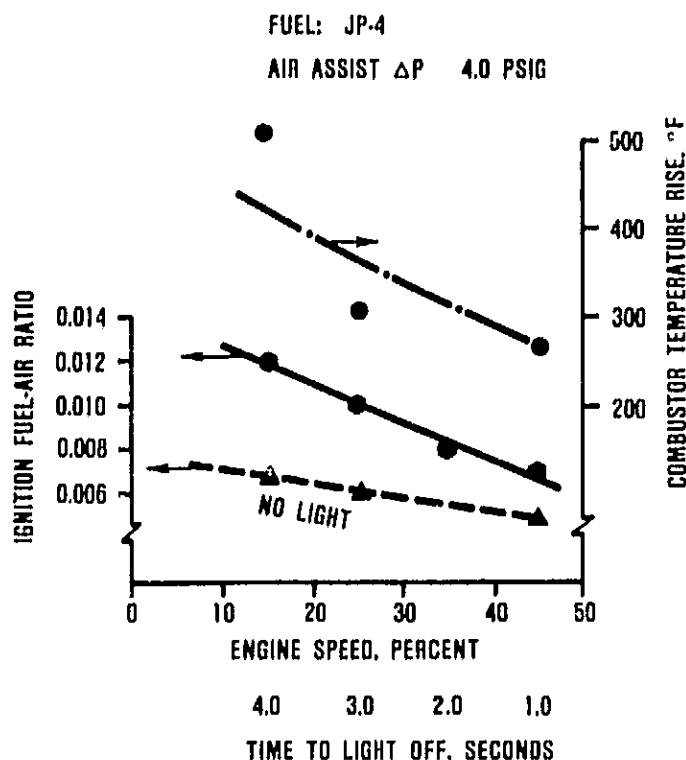
**Figure 13. Diffusion Flame Combustor Ignition Performance.**

Testing was conducted at idle and full load conditions. At the full load condition, the combustor maximum wall temperature was approximately 1800°F and uniform, while combustor discharge temperature pattern factor was within acceptable limits, 0.11. At idle, wall temperatures also were uniform with a maximum of 1800°F.

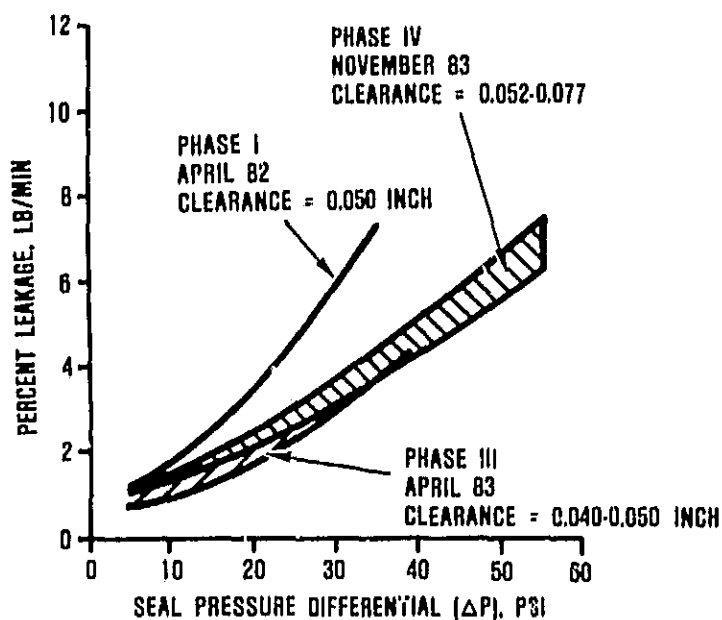
Figure 18. AGT Regenerator Seal Leakage.

These seals were evaluated for a total diaphragm clearance variance of 0.052 to 0.077 inch. The leakage level for the Phase IV seals (Figure 18) was equivalent to the Phase III seals, Reference 7, even though the diaphragm clearance was 0.012 to 0.037 inch higher. In addition, the Phase IV seal had the cooling air funnel beneath the crossarm support diaphragm, which permits additional leakage.

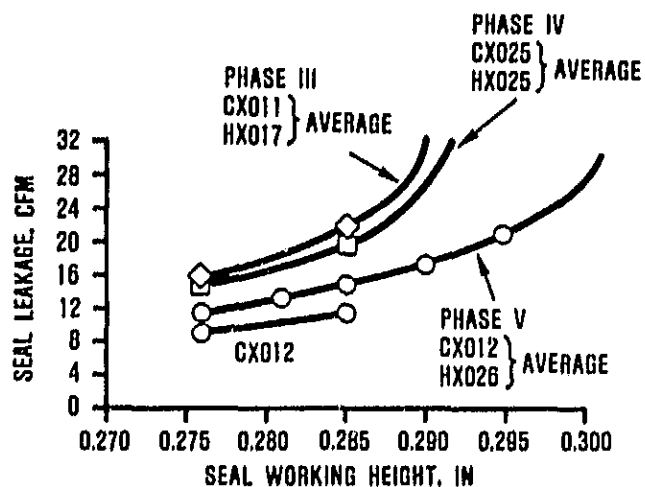
Figure 20. Leakage and Sensitivity Improvements of Phase V Seals.

The initial set of Phase V seals were fabricated for evaluation in the static seal rig. This seal design demonstrated a significant reduction in leakage level and sensitivity to diaphragm clearance (Figure 20) when compared to the Phase III and IV.

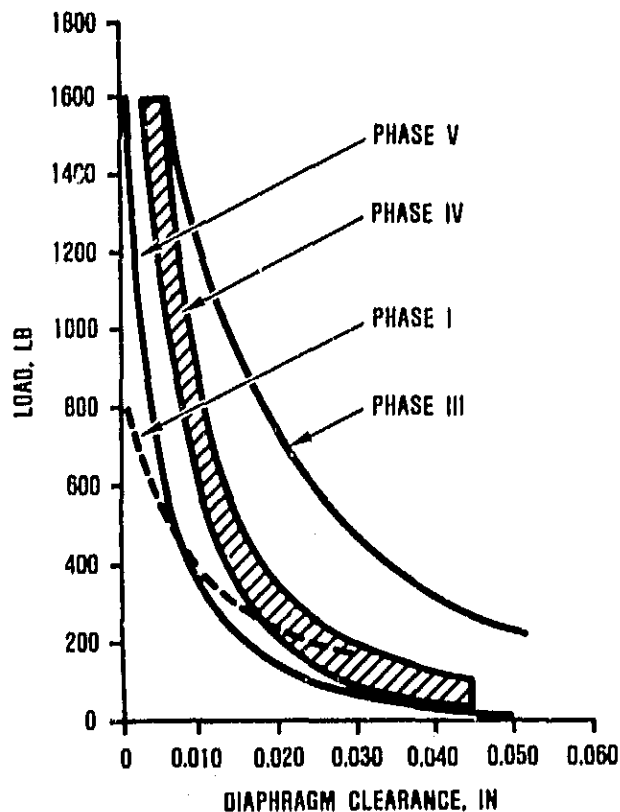
Figure 21. Regenerator Seal Mechanical Load.

The mechanical load characteristics for the Phase V seal also indicate a significant reduction when compared to the Phase III and IV configuration as shown on Figure 21. Thus, the Phase V configuration exhibits potential for reduced leakage and drive torque characteristics. This set of seals will be evaluated in the hot regenerator rig during the next reporting period.

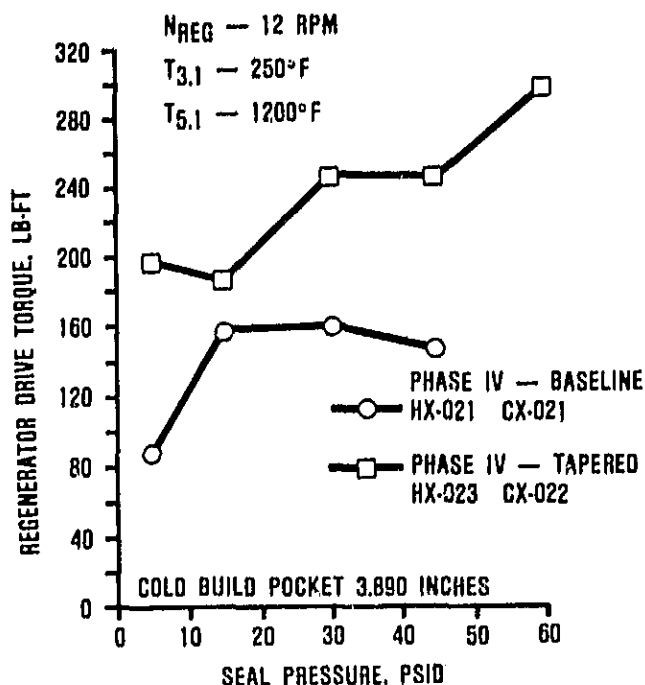
Figure 23. Regenerator Drive Torque.

Successful tests were completed on the baseline and tapered seal sets. The drive torque and leakage characteristic for these seals are shown on Figures 22 and 23, respectively.

The baseline seal set exhibited lower drive torque requirements and substantially higher leakage than the tapered seal set. The disparity in seal performance is probably a result of the higher seal stiffness of the tapered seal set.

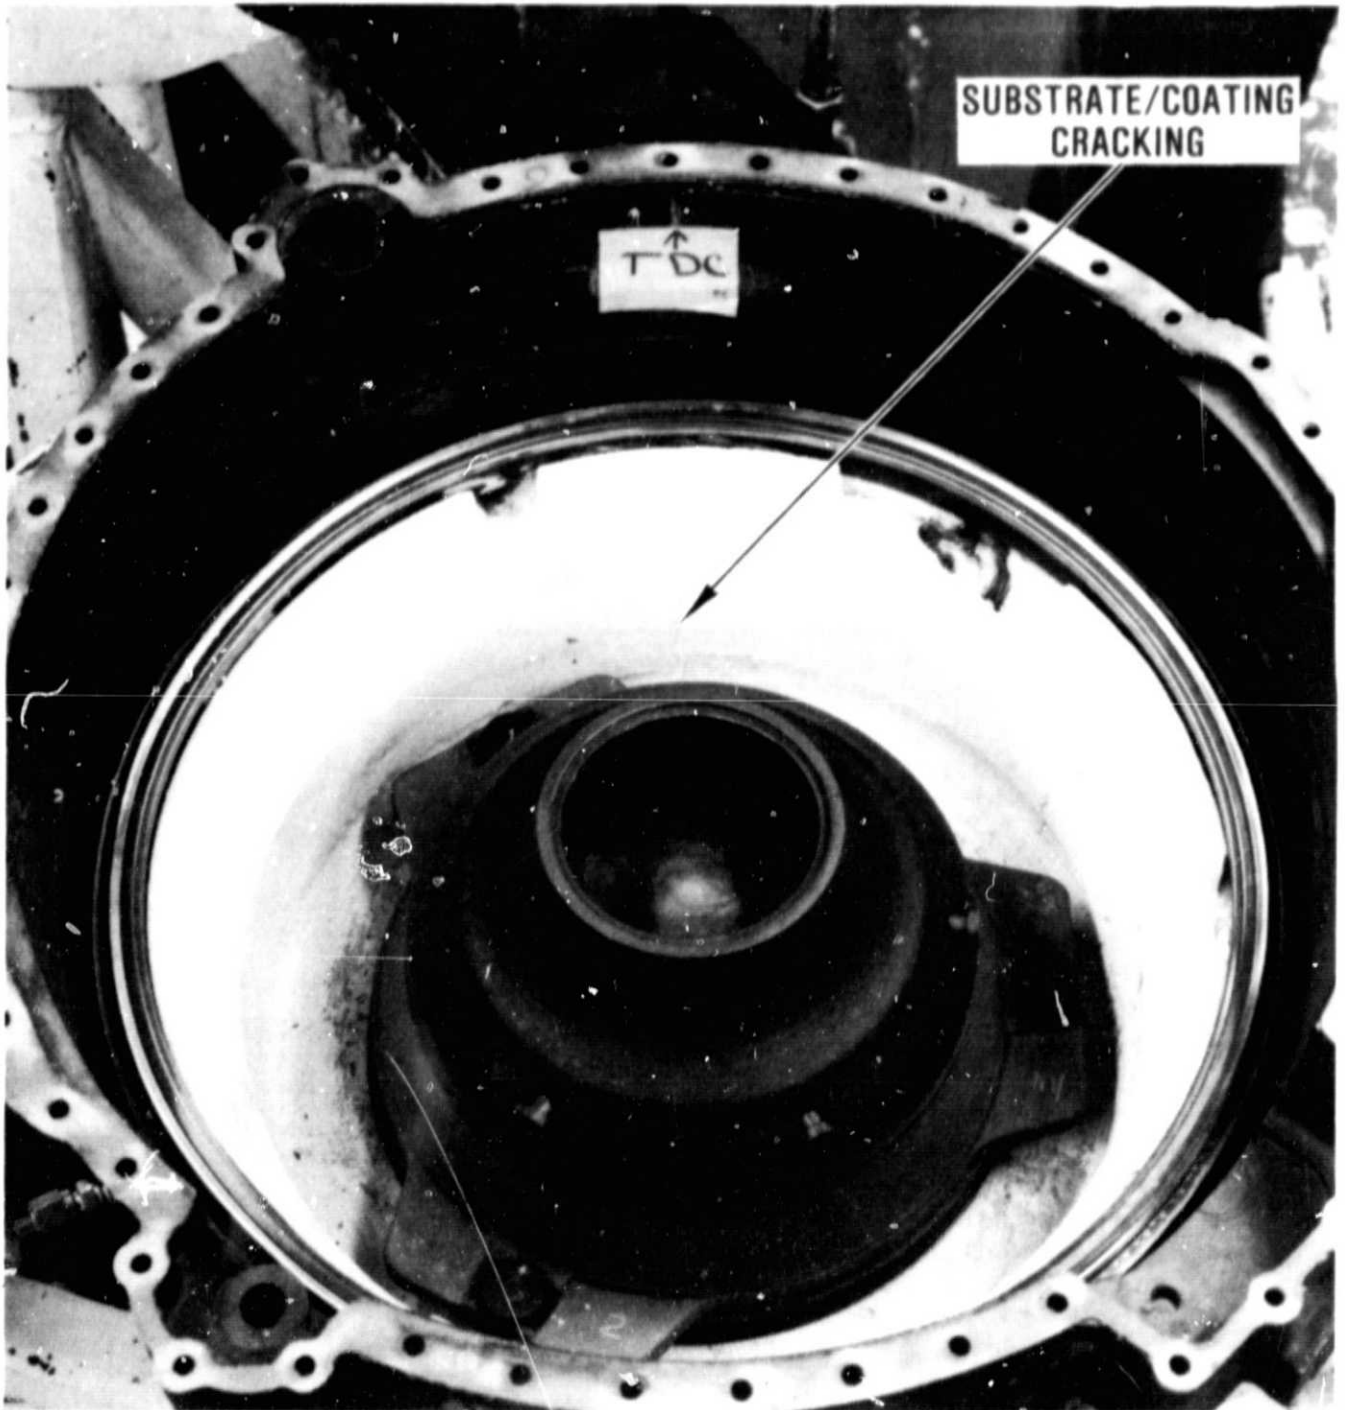
Figure 33. Vacuum Formed Insulation Coating Degradation.

The vacuum formed ceramic fiber insulation used to form the diffuser discharge flow path survived the test with minor radial cracks (Figure 33) through the flowpath coating layer and substrate. The surface coating appears to have cracked and spalled off the substrate in the highest velocity region immediately downstream of the diffuser discharge. Radial

cracking in the substrate was evident in the high velocity region immediately downstream of the diffuser discharge, and appears to be related to the vacuum forming fabrication process. Large voids are evident between the "plate-like" layers of material which weaken the insulation mechanical properties. Improved fabrication techniques by the supplier are expected to alleviate the poor quality of the insulation preforms.

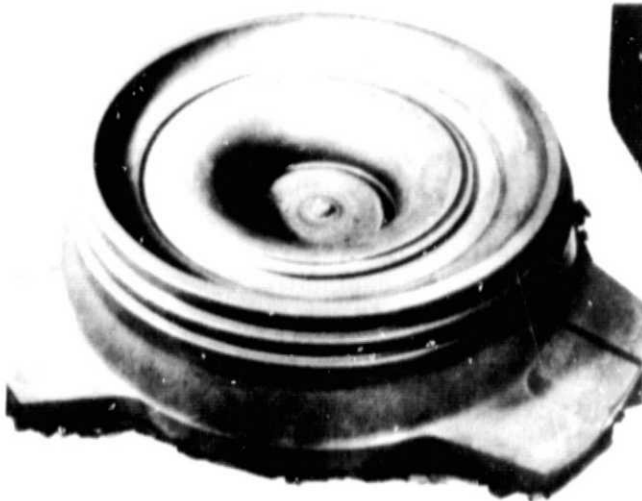
Figure 49. As-Molded Turbine Shroud.

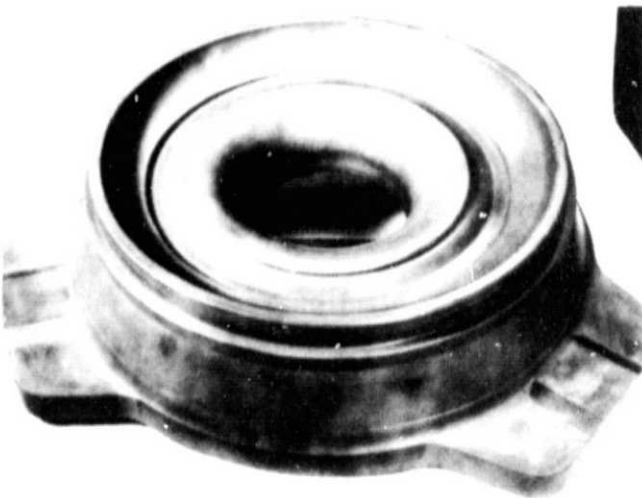
Figure 50. Green Machined Turbine Shroud.
