# Evaluation of Long Composite Struts

NASA/TM-2011-217049

**Carbon-epoxy tapered struts are structurally efficient and offer opportunities for weight savings on aircraft and spacecraft structures. Seven composite struts were designed, fabricated and experimentally evaluated through uniaxial loading. The design requirements, analytical predictions and experimental results are presented. Struts with a tapered composite body and corrugated titanium end fittings successfully supported their design ultimate loads with no evidence of failure.**

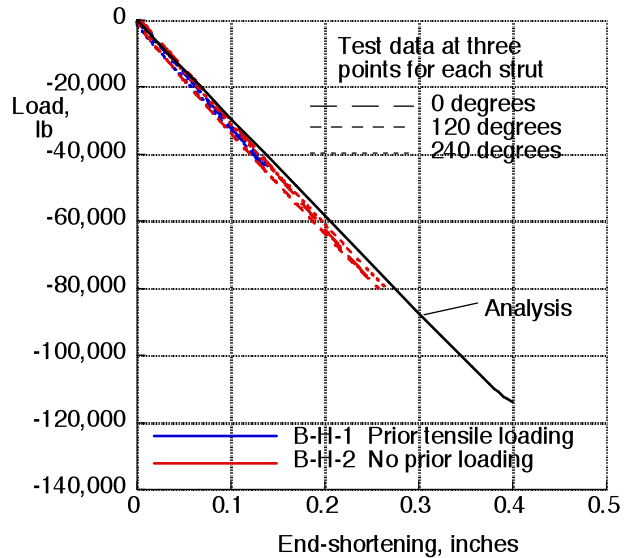
Figure 12. Axial displacement for struts of type B-H.

The heavily loaded bonded-fitting struts did not support the required loads. The first bonded-fitting strut tested, B-H-1, sustained damage in the initial tensile loading to DLL so it only sustained approximately 43,000 lb in the subsequent compressive loading. In order to start with a pristine strut for compression loading, the second bonded-fitting strut, B-H-2, was not initially loaded in tension. Even without the preload, strut B-H-2 failed in compression at approximately 80,000 lb, or approximately DLL. Little warning of impending failure was evident in the global measure of displacement. The end-shortening versus load for the compressive loadings are shown in Fig. 12. Strut B-H-1 measurements are shown as blue dashed lines for the three measurement locations around the circumference. Strut B-H-2 measurements are shown as dashed red lines while the analytical prediction is shown as the solid black line.

The three measurements for each strut agree well with each other and with analysis, indicating no buckling behavior is occurring in either strut and the struts have similar global stiffnesses.

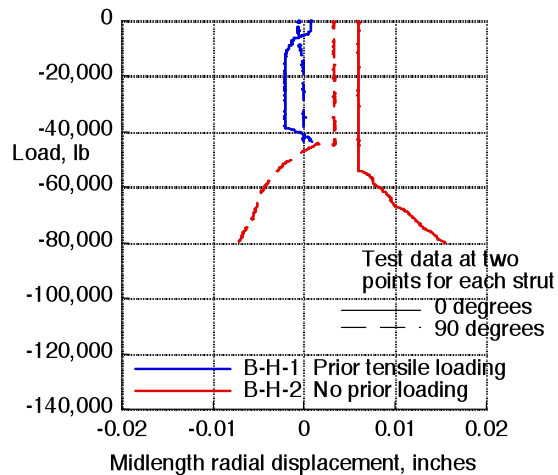
Figure 13. Radial displacement for struts of type B-H.

The radial deflections measured at two points at the midlength of each strut can be used to evaluate out-of-plane motion. These measurements for struts B-H-1 and B-H-2 are shown in Fig. 13 as blue and red lines, respectively. Since both of these measurements remain less than 0.02 inches, there was probably no buckle prior to failure.

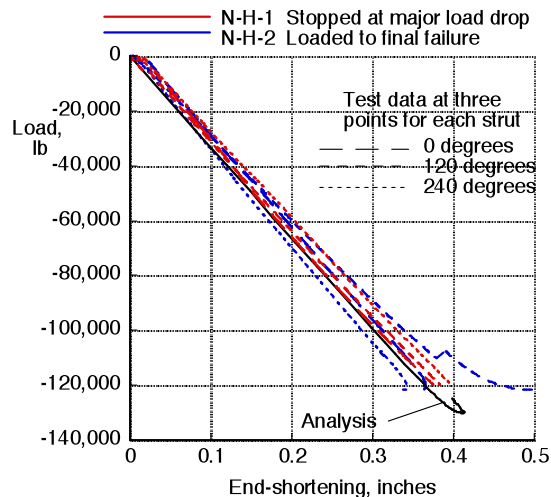
Figure 14. Axial displacement for pristine struts of type N-H.

Both heavily loaded pristine struts with corrugated fittings withstood their tensile DLL prior to compressive loading. Under compressive loading, one heavily loaded pristine corrugated-fitting strut withstood 110% of DUL while the other withstood 112% of DUL. All evidence of failure was in the fitting region. The end-shortening versus load for the compressive loadings are shown in Fig. 14. Strut N-H-1 measurements are shown as blue dashed lines for the three measurement locations around the circumference. Strut N-H-2 measurements are shown as dashed red lines while the analytical prediction is shown as the solid black line. The three measurements for each strut agree well with each other and with analysis for load less than 108,000 lb indicating no buckling behavior is occurring in either strut prior to DUL and the struts have similar global stiffnesses.

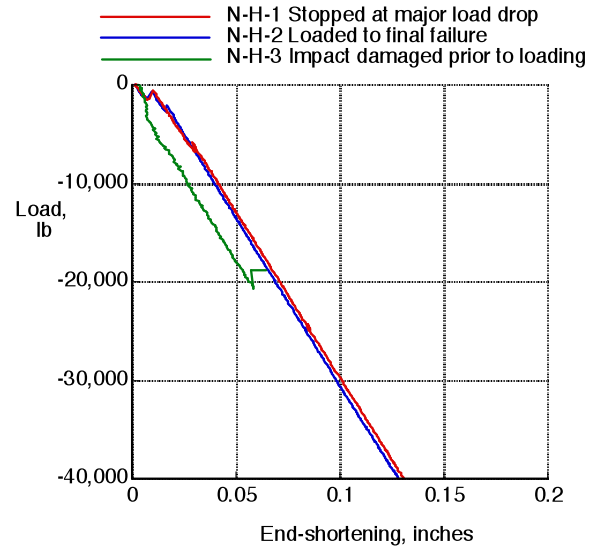
**Figure 15. Average axial displacement for struts of type N-H.**

The average of the three axial displacement measurements for all three N-H struts are presented in Fig. 15. The impact-damaged strut, N-H-3, failed through the impact site at a load of 21,100 lb. The initial stiffness of this strut was the same as N-H-1 and N-H-2 but this damage, though not readily visible without the right lighting, caused severe enough damage to reduce the failure load by 80 percent.

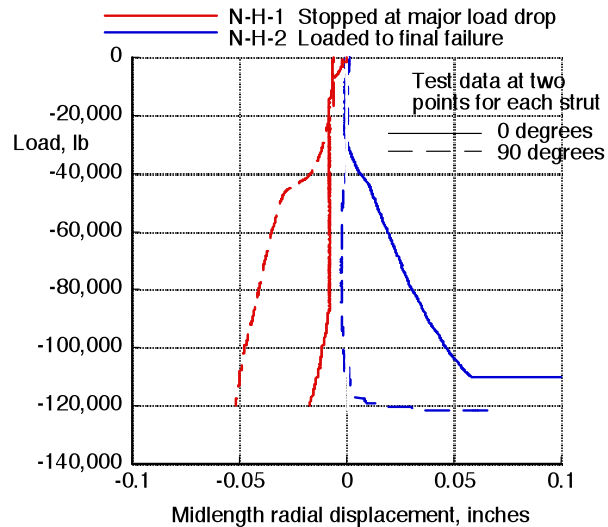
**Figure 16. Radial displacement for struts of type N-H.**

The radial deflection measured on two points at the midlength of each strut can be used to evaluate the out-of-plane motion of each strut. These measurements for struts N-H-1 and N-H-2 are shown in Fig. 16 as blue and red lines, respectively. Since both of these measurements are very small until immediately prior to failure, these struts did not buckle prior to failure.

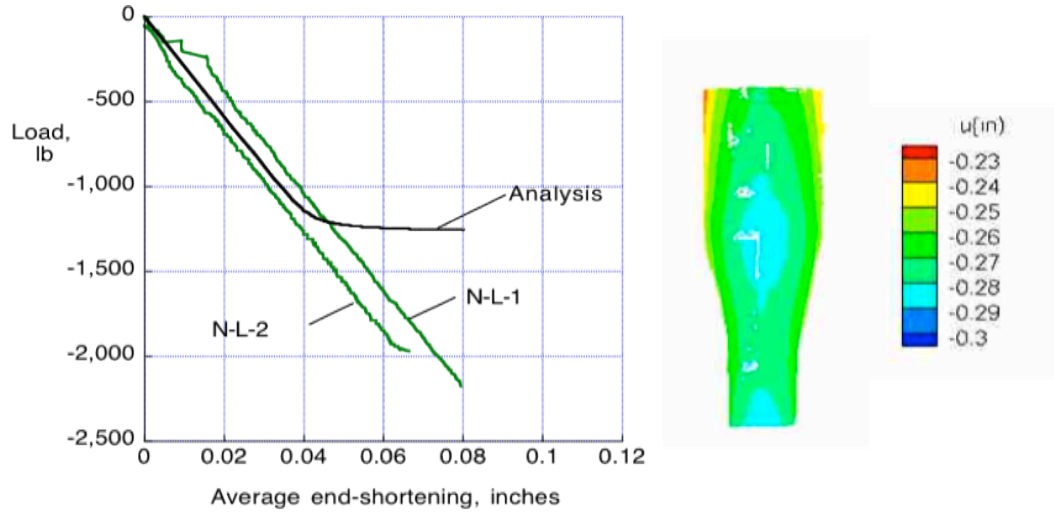
**Figure 17. Axial displacement for struts of type N-L with full field displacement at a load of 2,187 lb.**

The average of the axial displacement measurements for specimens N-L-1 and N-L-2 are shown as the green lines in Fig. 17. Analytical predictions are shown as back lines. The strut motion is not uniform around the circumference, however, the measurements are repeatable from one strut to the next. In both cases, good agreement between an average of the three test measurements (shown as the solid green lines) and the analysis can be seen for the initial loading of the struts. The struts buckled at a greater load than predicted by the analysis, possibly indicating that the influence of the initial geometric imperfection may not have been as significant as anticipated or that there may have been friction or other behavior at the ends in the fixtures to invalidate the “pinned” assumption at the ends. The full-field axial motion obtained from the vision image correlation system for a load level just prior to failure of 2,187 lb for strut N-L-1 is also shown in Fig. 17 for the bottom 10 inches of the strut. A relatively uniform axial deformation is seen. Note that the white regions in the figure represent areas for which the strain could not be calculated, typically because of surface obstructions or shadow.

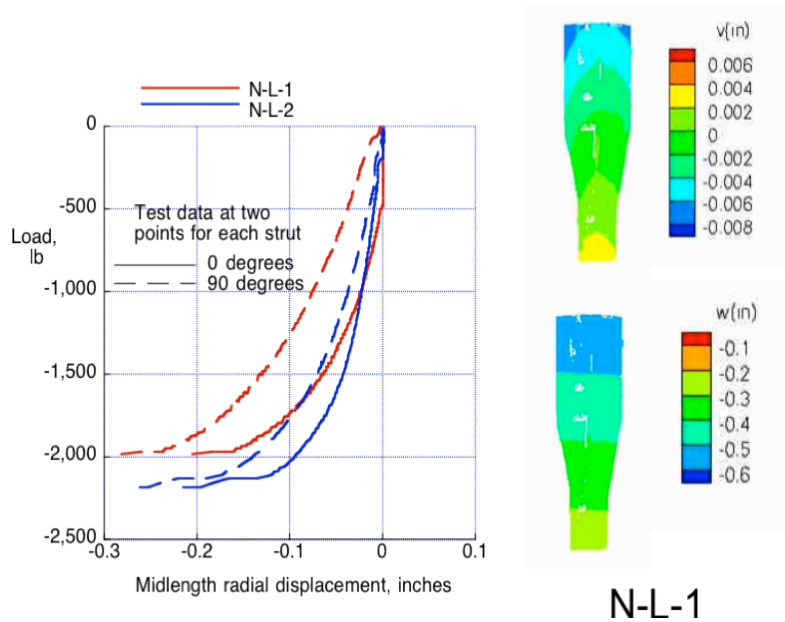
**Figure 18. Radial displacement for struts of type N-L with full field displacement at a load of 2,187 lb.**

The radial deflection measured on two points at the midlength of each strut can be used to evaluate the out-of-plane motion of each strut. These measurements for struts N-L-1 and N-L-2 are shown in Fig. 18 as blue and red lines, respectively. Radial motion indicates buckling occurred for both struts at a similar load of approximately 2000 lb and in a similar direction. Applied axial displacement was continued beyond the initial buckling point so the radial deflection curves can be seen to flatten out where the increased axial displacement supported no additional load. The full field measurements at a load just prior to failure for strut N-L-1 in the directions parallel to and perpendicular to the backstop are also shown in Fig. 18. As the strut buckles, this lower 10-inch region of the strut moves less than 0.1 inches parallel to the test wall (top fringe plot) and up to 0.5 inches toward the test wall (bottom fringe plot) as it buckles.

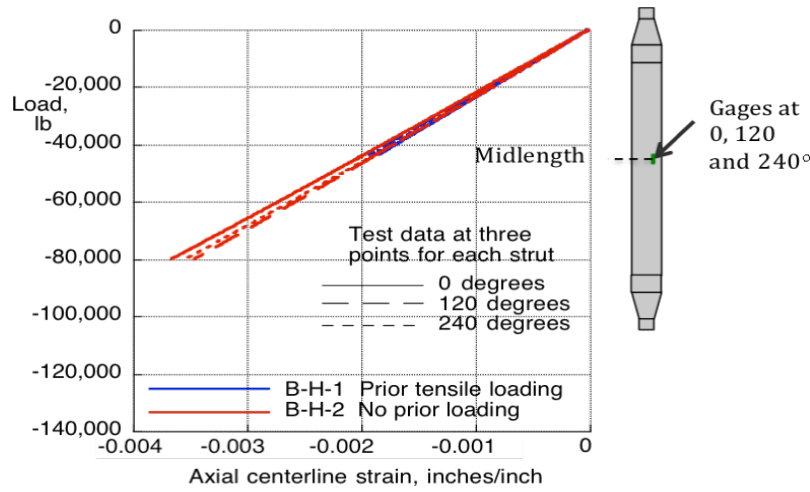
**Figure 19. Axial strain midlength for struts of type B-H.**

Midlength axial strains for specimens B-H-1 and B-H-2 are shown in red and blue, respectively, in Fig. 19. Midlength axial strains for specimens N-H-1 and N-H-2 are shown in red and blue, respectively, in Fig. 20. Measured axial strains at three locations around the circumference are shown as three dashed lines of different dash lengths in Figs. 19 and 20. Midlength strains for struts B-H are linear to failure and consistent between the two struts and around the circumference. Midlength strains for struts N-H are linear until immediately prior to failure and are also consistent between the two struts and around the circumference.

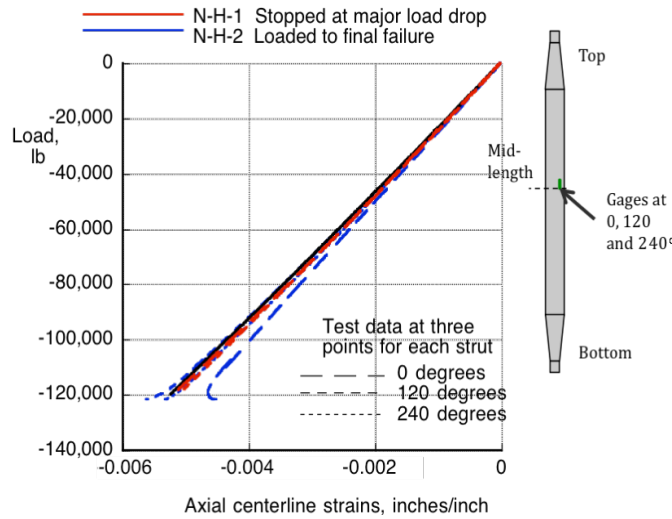
**Figure 20. Axial strain midlength for struts of type N-H.**

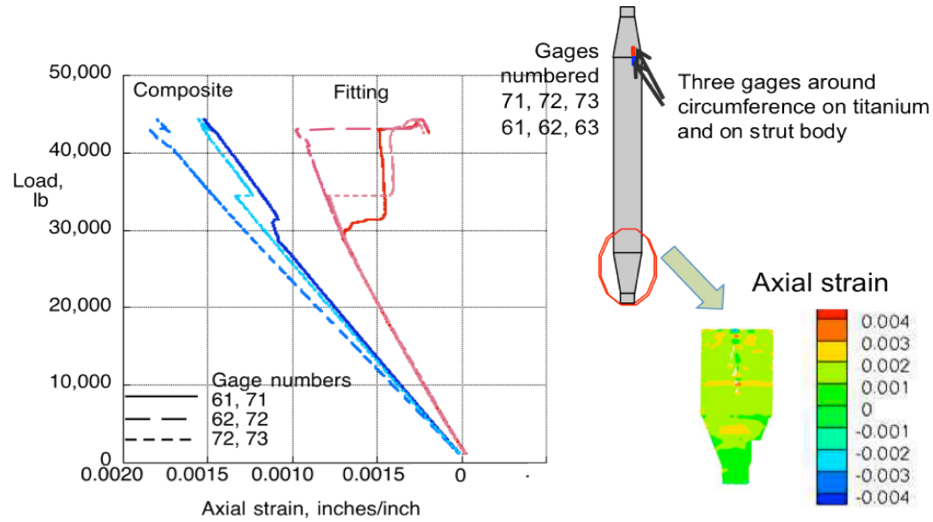
**Figure 21. Axial strain for interface location for strut B-H-1 loaded in tension with full field strain at a load of 43,835 lb.**

Measured axial strains at the fitting-to-composite interface region for specimens B-H-1 are shown in Fig. 21 for the tensile loading and Fig. 22 for the subsequent compressive loading. The full-field axial strain for the lower end of strut B-H-1 at approximately 43,835 lb tensile load and 43,615 lb compressive load are shown in Figs. 21 and 22, respectively. Axial gages were located on the exterior surface of the composite body and on the exterior surface of the titanium fitting at three locations around the circumference. Strains on the composite are shown in red and strains on the titanium surface are shown in blue. The discontinuities in the measured strain under tensile loading are believed to indicate damage to the bond between the composite steps and the titanium fitting. Damage to the bond began to initiate at a load significantly less than DLL in the tensile loading.

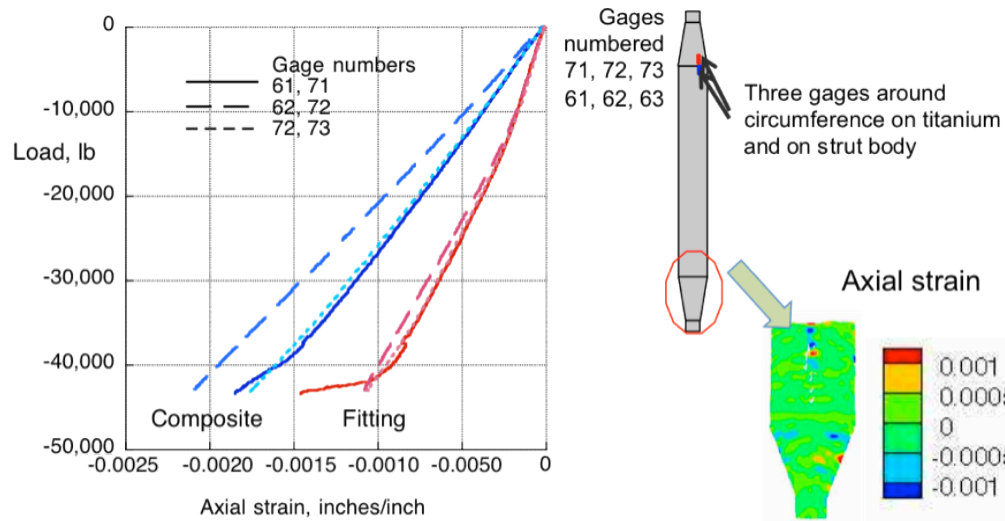
**Figure 22. Axial strain at interface location for strut B-H-1 loaded in compression with full field strain at a load of 43,615 lb.**

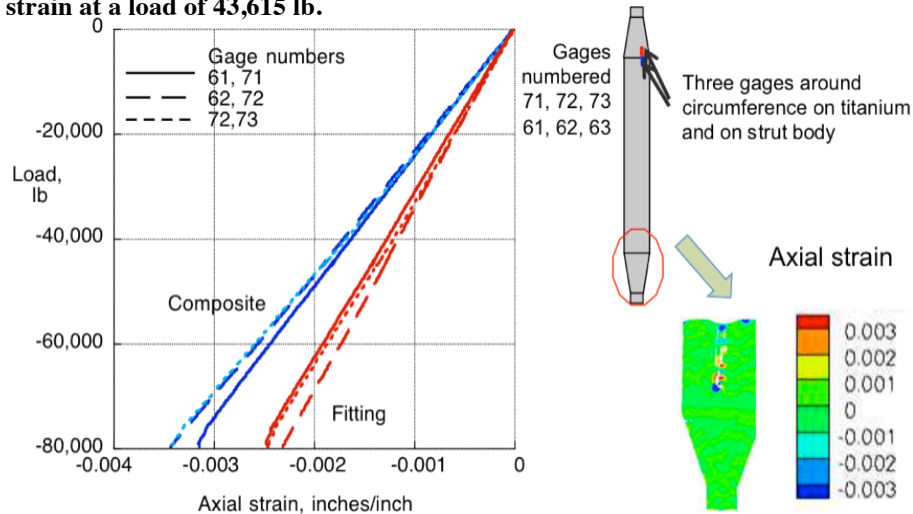
**Figure 23. Axial strain at interface location for strut B-H-2 loaded in compression with a full field strain of 79,980 lb.**

The strains at the interface between the composite and the titanium fitting are shown in Fig. 23 for strut B-H-2 loaded in compression. The full field strain for strut B-H-II-2 at approximately 79,800 lb compressive load is shown in figure 23. The strains in the titanium are not the same as in the composite body, however, both are linear and consistent around the circumference.

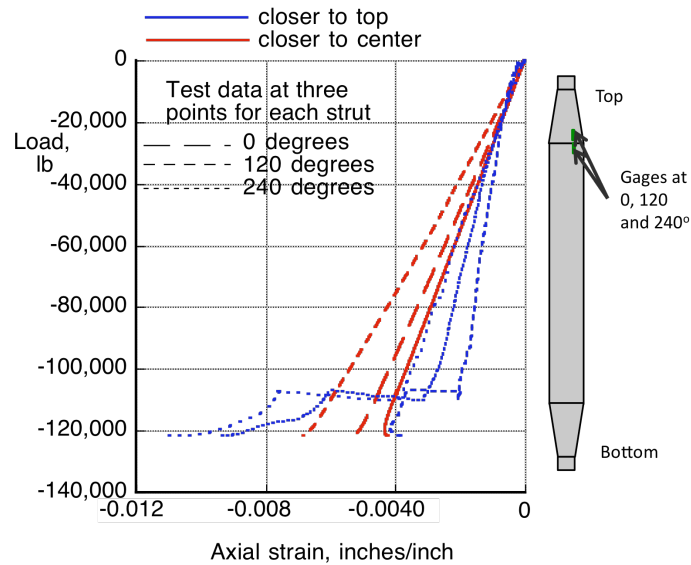
**Figure 24. Axial strain at taper for struts of type N-H-2.**

The strains on the composite surface in the taper region of strut N-H-2 are shown in Fig. 24. The red lines represent strains in the uniform diameter region adjacent to the taper and the blue lines represent strains in the taper itself. The strains are not uniform around the circumference, but all remain linear for load less than DUL. Nonlinearities can be seen in the strains in the taper region for load greater than DUL which could represent a failure in the adhesive bond between the carbon-epoxy and the titanium fitting.

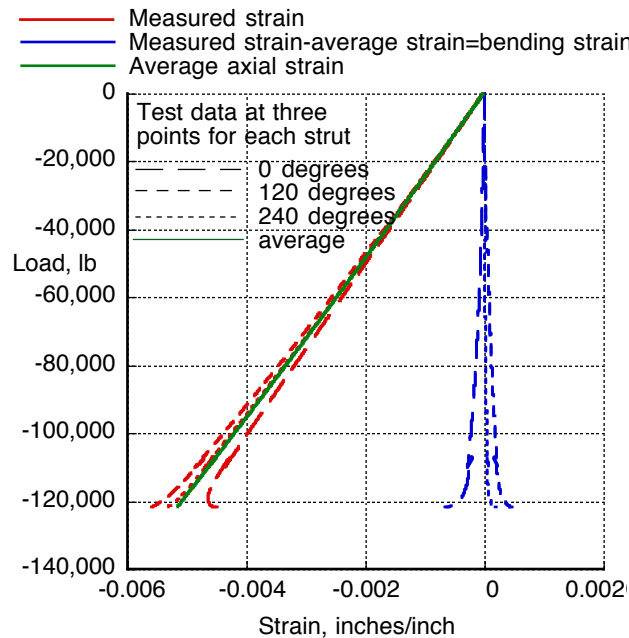
**Figure 25. Bending strain for strut N-H-2.**

The bending strain can be determined by averaging the strains measured at the midlength location and then subtracting this value from each measured value. This calculation removes the axial component of the strain, leaving only the bending component. The bending component at the three circumferential locations for strut N-H-2 is shown in Fig. 25. The bending strain is less than 10 percent of the total strain, also shown in the figure. Struts B-H did not display bending behavior.

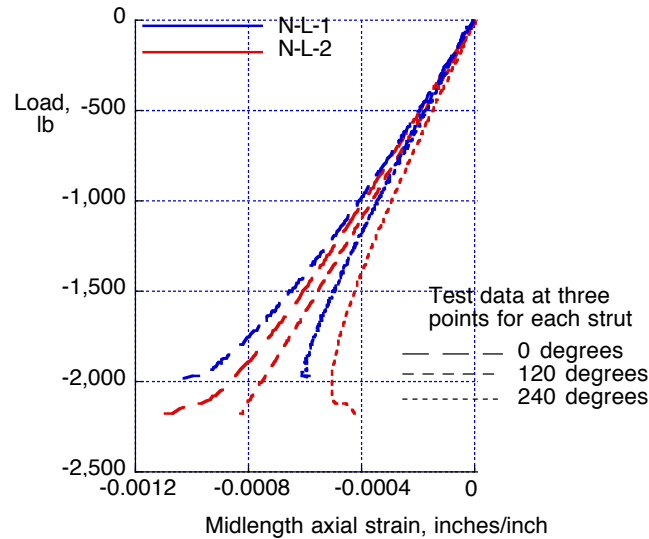
**Figure 26. Midlength strain for lightly loaded struts.**

Midlength axial strains for specimens N-L-1 and N-L-2 are shown in blue and red, respectively, in Fig. 26. Measured axial strains at three locations around the circumference are shown as three dashed lines of different dash lengths. Midlength strains for struts N-L show evidence of buckling well before failure, consistent with the displacement results.

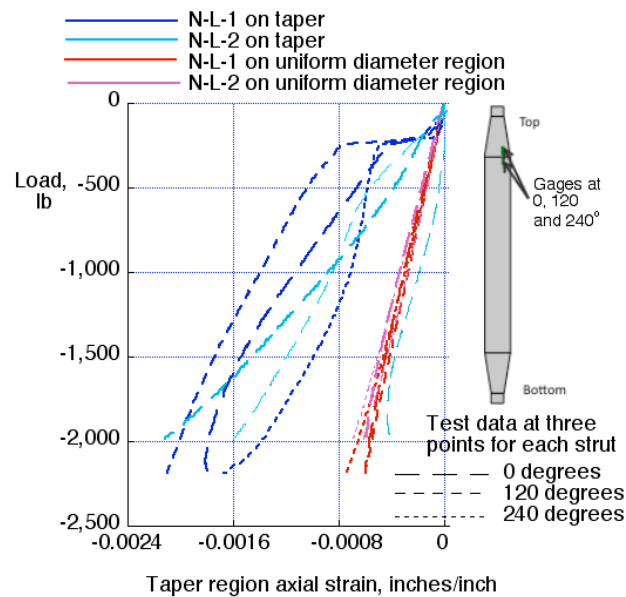
**Figure 27. Strain in taper region of struts of type N-L.**

The strains on the composite surface in the uniform diameter region near the taper region and in the taper region itself of struts N-L-1 and N-L-2 are shown in Fig. 27. The red lines represent strains in the uniform diameter region adjacent to the taper and the blue lines represent strains in the taper itself. The strains in the uniform diameter region are uniform around the circumference and consistent between the two struts until immediately before failure. Nonlinearities can be seen in the strains in the taper region for the full loading range suggesting a redistribution of load in the corrugations as load is increased.

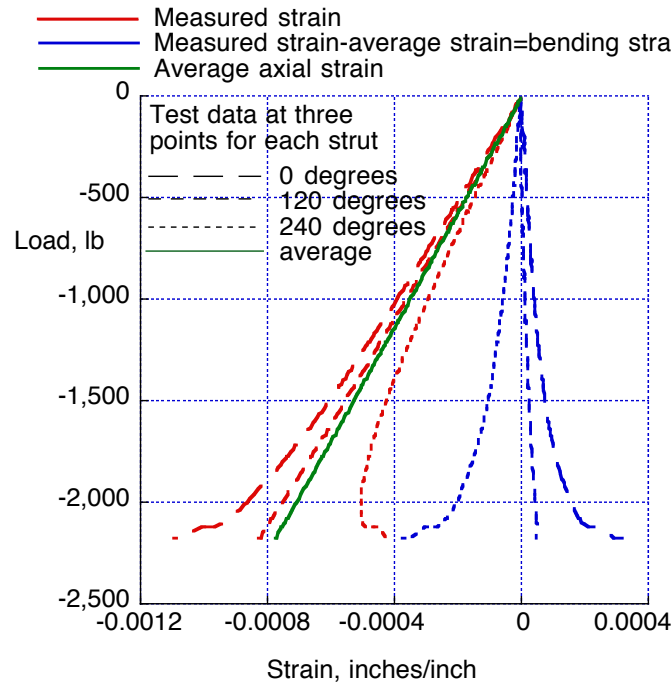
**Figure 28. Measured and bending strains for strut N-L-1.**

The bending component at the three circumferential locations for strut N-L-1 is shown in Fig. 28. The bending strain is small for low loads but up to approximately 50 percent of the total strains as the loading is approaching the buckling load. The nonlinear region of the curves represents post-buckling behavior, where bending strain has the largest magnitude.

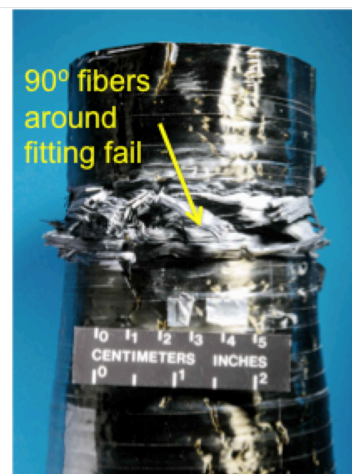
**Fig. 30. Failure of a corrugated fitting strut.**

Photographs of failed heavily loaded specimens are shown in Figs. 29 and 30. Both struts with the bonded end fittings failed the composite-to-fitting joint as shown in Fig. 29. The failure of the bond was evident around the entire circumference of the strut. Despite the fact that the bond area was maximized by locating it in the maximum diameter region of the strut, the adhesive bond did not sustain the required load. Visible failures in the corrugated-fitting struts were generally in the fitting region and of the type shown in

figure 30 but not all struts displayed visible failure. Failure of the corrugated fitting struts were all at loads greater than DUL. Lightly loaded specimens buckled when they reached their maximum load and left little evidence of fiber damage after loading was removed. Photographs of strut N-L-2 showing its buckling at its maximum loading are shown in Fig. 31. A summary of these failures is presented in Table 6. NDE was not conducted after test to find any non-visible damage.
