Wind Turbine Drivetrain Condition Monitoring During GRC Phase 1 and Phase 2 Testing

S. Sheng, H. Link, W. LaCava, J. van Dam,
B. McNiff, P. Veers, and J. Keller
National Renewable Energy Laboratory

Technical Report
NREL/TP-5000-52748
October 2011

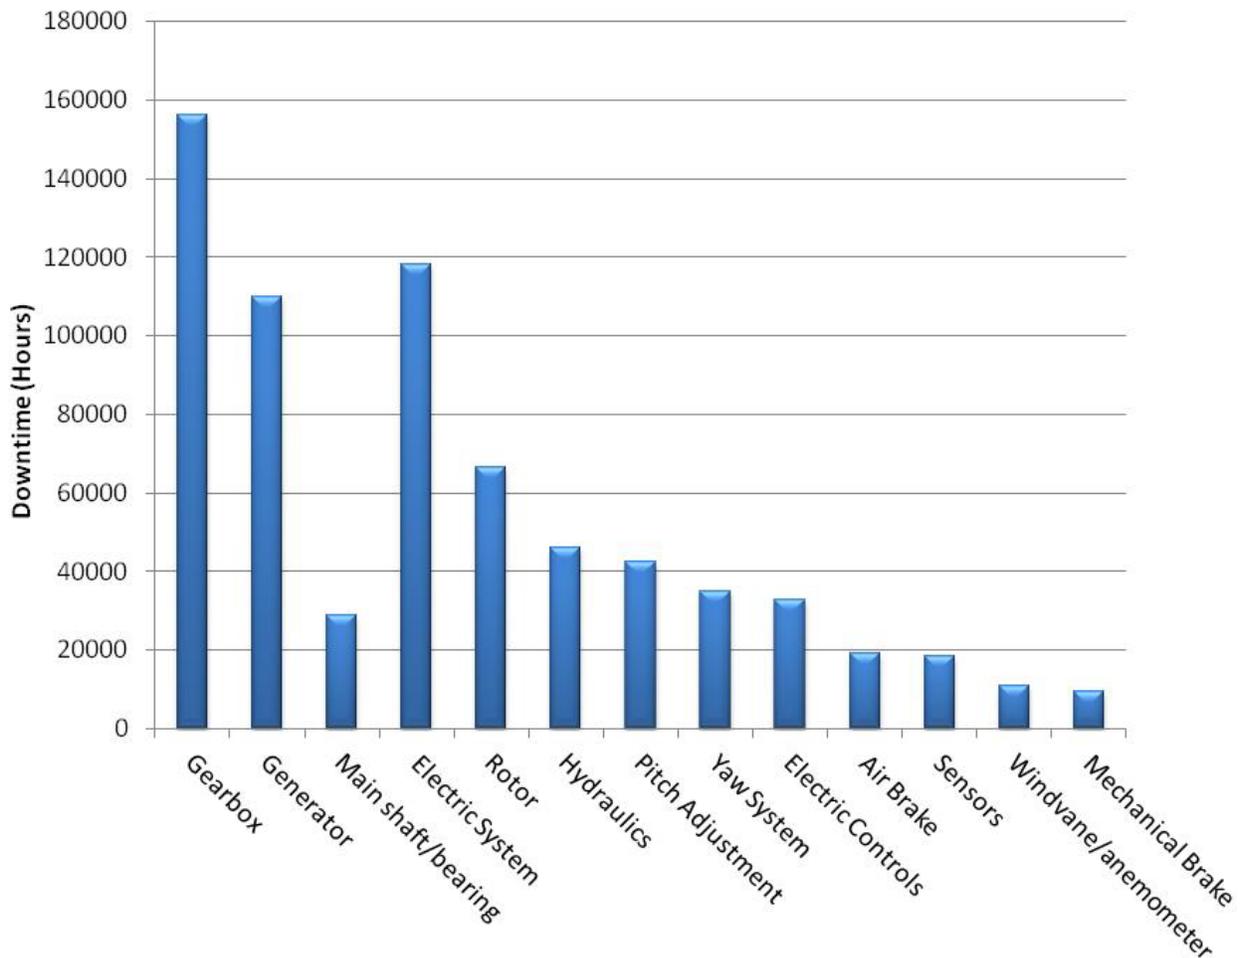
Figure 1. Downtime caused by turbine subsystems

Wind energy is currently the fastest growing energy source among various renewable energy options in the world [1]. By the end of 2010, the global cumulative installed wind power had reached more than 197 gigawatts (GW) [2]. However, the industry still experiences premature turbine component failures. A summary of the downtime of turbine components is plotted in Figure 1. The data represent about 27,000 turbines, ranging from 500 kW to 5 MW, for both onshore and offshore applications [3]. Three elements that comprise the wind turbine drivetrain - the gearbox, generator, and main shaft/bearing – together cause the majority of the total turbine downtime. The gearbox is the leading contributor to total turbine downtime.

When crane cost is taken into consideration, maintenance events for the gearbox, generator, rotor, and main shaft/bearing are the most costly. Among the aforementioned subsystems, the gearbox stands out as causing the most downtime as shown in Figure 1, failing second most frequently, as shown in Figure 2, and costing the most to maintain throughout a turbine's 20 years of design life [5]. Therefore, if only one subsystem can be targeted for a reliability

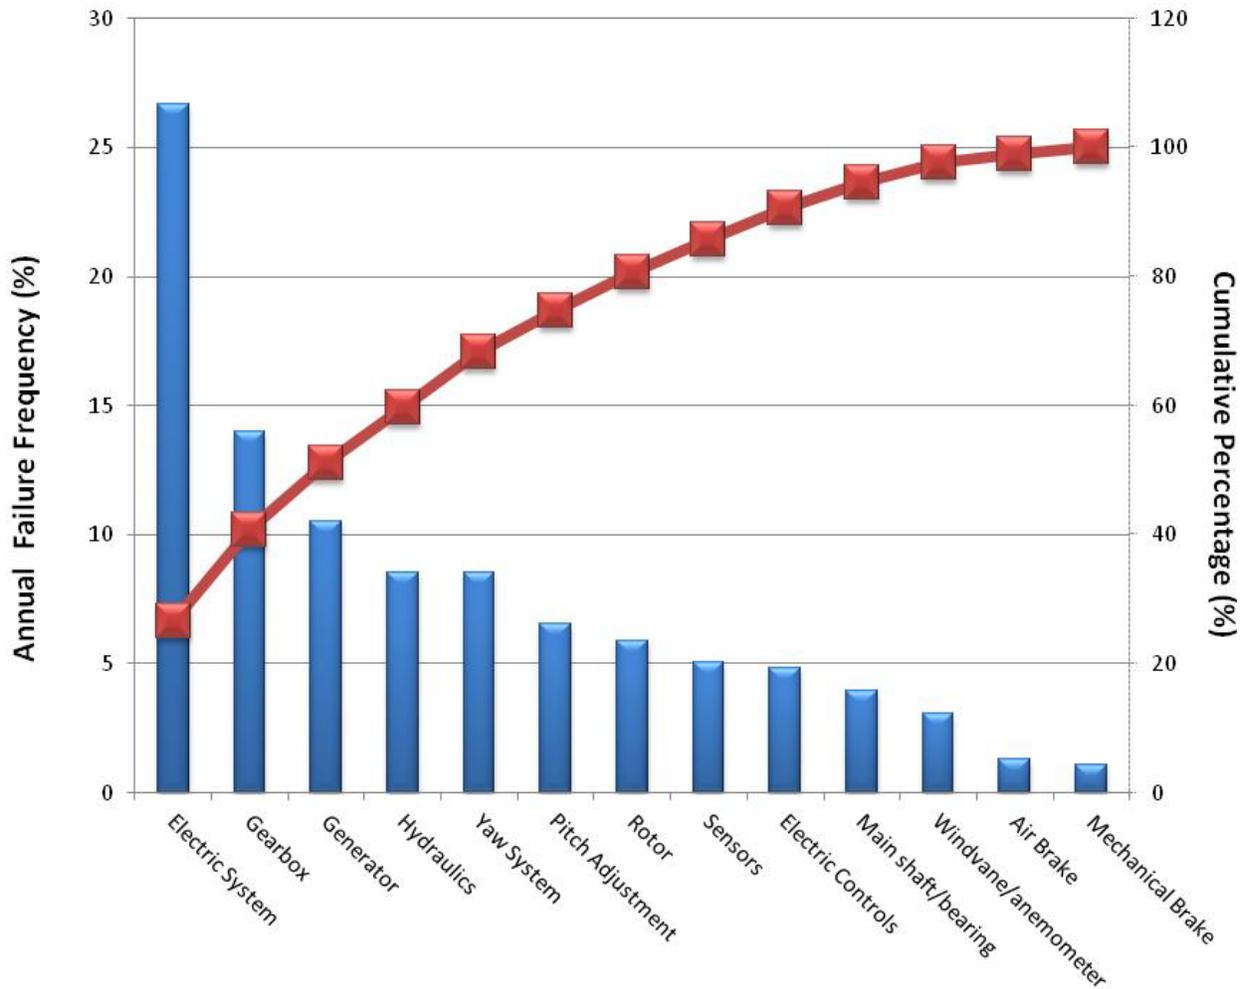
Figure 2. Annual failure frequency of turbine subsystems

Figure 2 illustrates the annual failure frequency of turbine subsystems based on the 2009 Wind Stats Newsletter data. The top three most frequently failed subsystems are electric systems, the gearbox, and the generator. The highest rate, at approximately 27%, is equivalent to about 0.6 failures for each turbine subsystem annually, based on data reported by Reliawind [4].

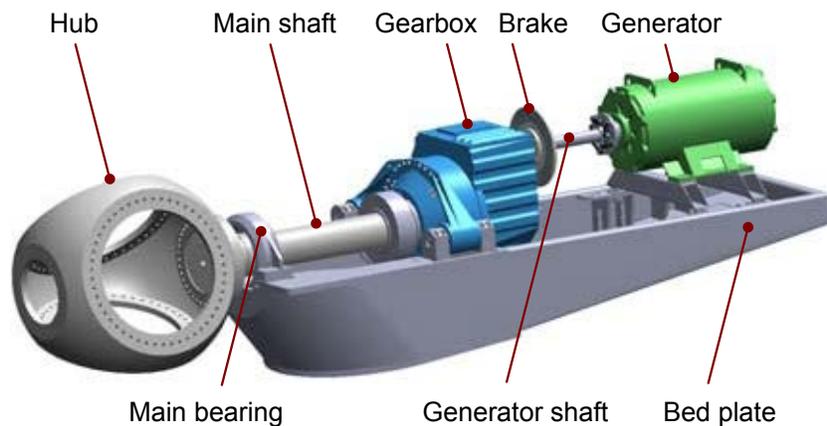
Figure 3. Typical utility-scale wind turbine drivetrain

The drivetrain of a typical utility-scale wind turbine is illustrated in Figure 3. The test gearbox was installed in a 3-point suspension drivetrain configuration, which is a typical configuration for MW class turbines. One suspension point is at the main bearing and the other two points are on the gearbox torque arm supports.

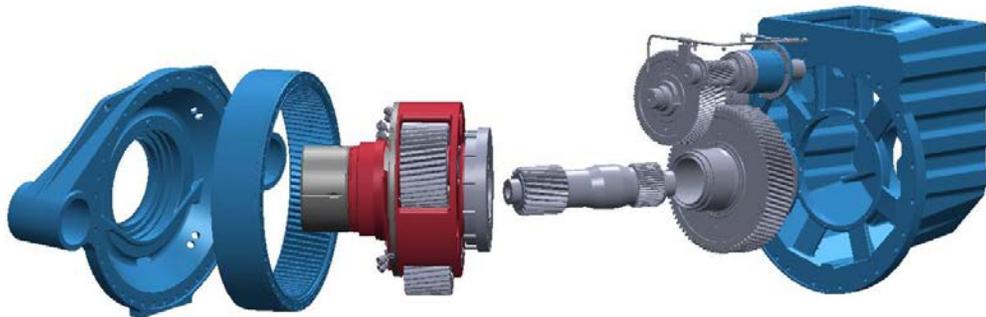
Figure 4. Exploded view of the GRC test gearbox

The test gearbox uses three stages to obtain an overall gear ratio of 1:81.491. As shown in Figure 4, it is composed of one low-speed planetary stage and two parallel shaft stages. The planetary stage accommodates three planet gears. The annulus gear of this stage also serves as part of the gearbox housing. The sun gear is set in a floating configuration, which improves the load distribution among the planets. To accommodate the floating sun arrangement, the low-speed shaft is hollow and has an internal spline that transfers the torsional loads to the parallel shaft stages. The low-speed planetary gears have a helix angle of approximately 7.5 degrees, and the intermediate speed and high speed gear sets have a helix angle of 14 degrees.

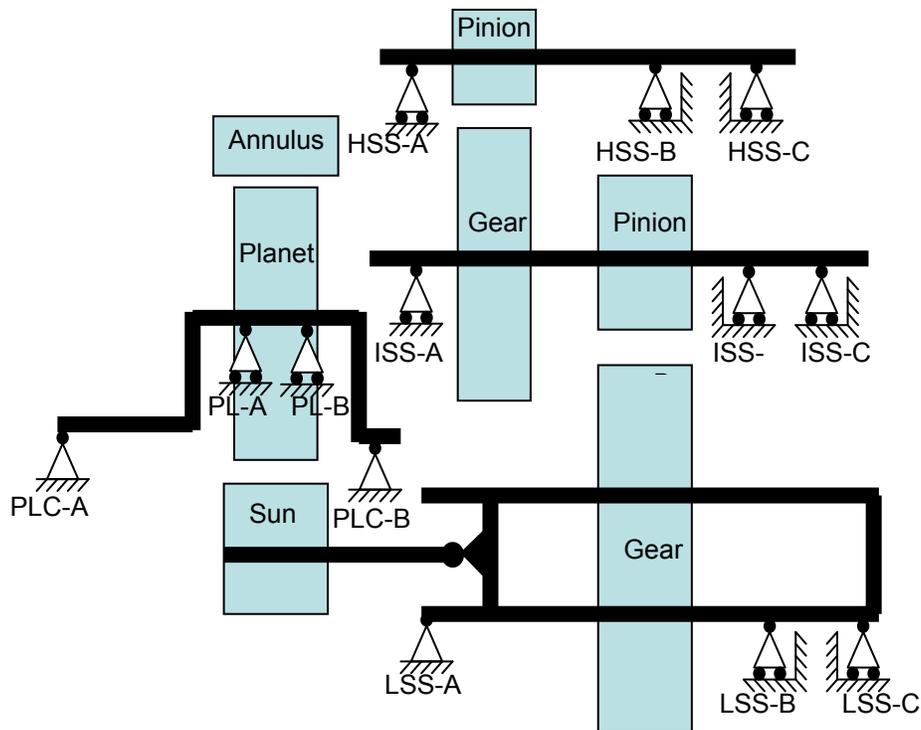
Figure 5. GRC gearbox layout and bearing nomenclature

Figure 5 shows a schematic of the internal components of the test gearbox, with nomenclature used to describe them. Other than gears, several types of bearings are employed in the test gearbox, according to the loading conditions and gearbox life requirements. The planet carrier (PLC) is supported by two full-complement cylindrical roller bearings (fcCRB). Each planet gear is supported by two identical cylindrical roller bearings (CRB). Each parallel shaft (i.e., low, intermediate, and high speed) in the gearbox is supported by a CRB on the upwind (rotor) side of the assembly, and by two back-to-back mounted, tapered roller bearings (TRB) on the downwind (generator) side. Lubrication oil is another important component in the test gearbox, although it is not shown in either Figure 4 or Figure 5. The main functions of lubricant are to [26]: 1) provide a lubricating film to reduce friction and wear between moving parts; 2) cooling to dissipate heat away from the critical parts of the equipment; 3) cleaning and suspending products, such as carbon, sludge and varnish, to facilitate smooth operation of equipment; and 4) protection to prevent metal damage due to oxidation and corrosion.

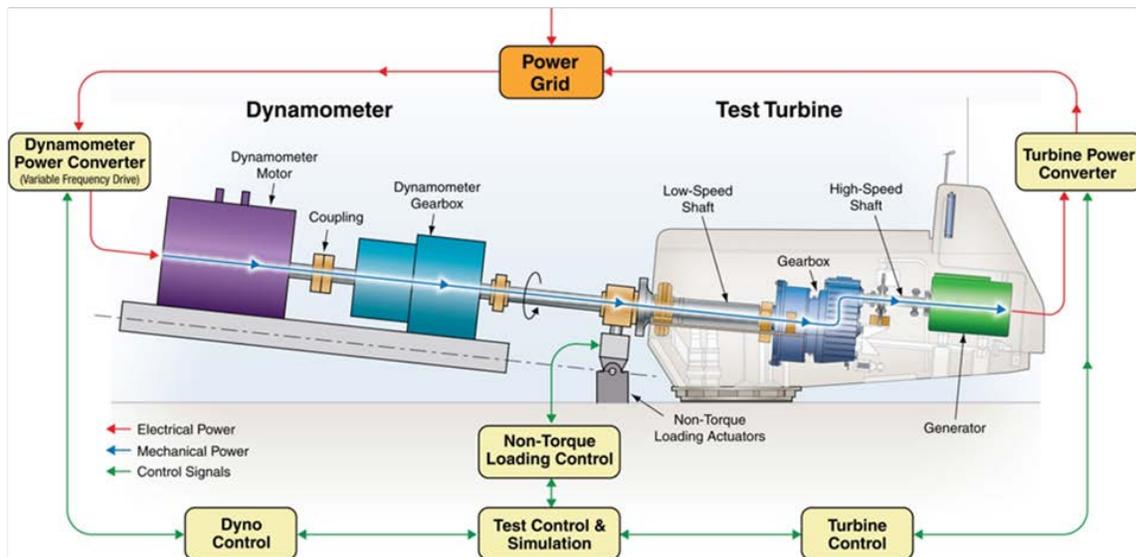
Figure 6. Diagram of NREL 2.5-MW dynamometer test facility

The NREL 2.5-MW dynamometer test facility was developed to conduct performance and reliability tests on wind turbine drivetrain prototypes and commercial machines [27, 28]. The facility is capable of providing static, highly accelerated life and model-in-the-loop tests. The prime movers of the dynamometer are a 2.5-MW induction motor, a three-stage epicyclical reducer, and a variable-frequency drive, with full regeneration capacity. The rated torque provided by the dynamometer to a test article can be up to 1.4 meganewton meters (MNm), with speeds varying from 0 rpm to 16.7 rpm. Non-torque loading actuators, rated up to 440 kilonewtons (kN) for radial load and 156kN for thrust load, also can be utilized in the dynamometer to apply thrust, bending, and shear loads similar to those typically generated by a wind turbine rotor. Figure 6 provides a diagram of the test facility. Figure 7 is a photo of the test implementation, with the test article installed.

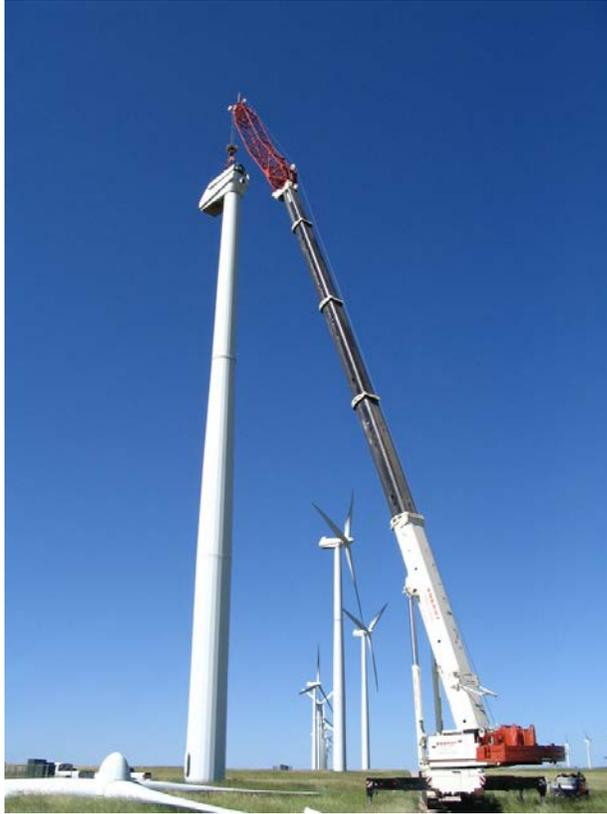
Figure 8. GRC test turbine at Xcel Energy's Ponnequin wind farm. PIX #19257.

The GRC test turbine (Figure 8) is a three bladed, up-wind, stall controlled turbine, with a rated power of 750kW. The generator has two sets of poles, which allow it to operate at two speeds. The turbine rotor operates at 22.4 rpm (1,810 rpm on the HSS) and 14.9 rpm (1,208 rpm on the HSS). The turbine has "pitchable" tip brakes and a high-speed shaft brake. For a normal shutdown, the tip brakes deploy first. Once the rotor has been slowed down enough, the high-speed shaft brake engages. For an emergency stop, tip brakes and high-speed shaft brakes are applied at the same time. For the transition from low speed to high speed, the turbine drops off-line, the rotor speeds up, and the turbine comes on line when the generator shaft reaches 1,800 rpm. For the transition from high speed to low speed windings, the turbine comes off-line and deploys the tip brakes to slow the rotor. Once the rotor is below the synchronous speed, the tips are returned to their un-deployed position and the rotor can accelerate again. The turbine comes online when the generator shaft reaches 1,200 rpm.

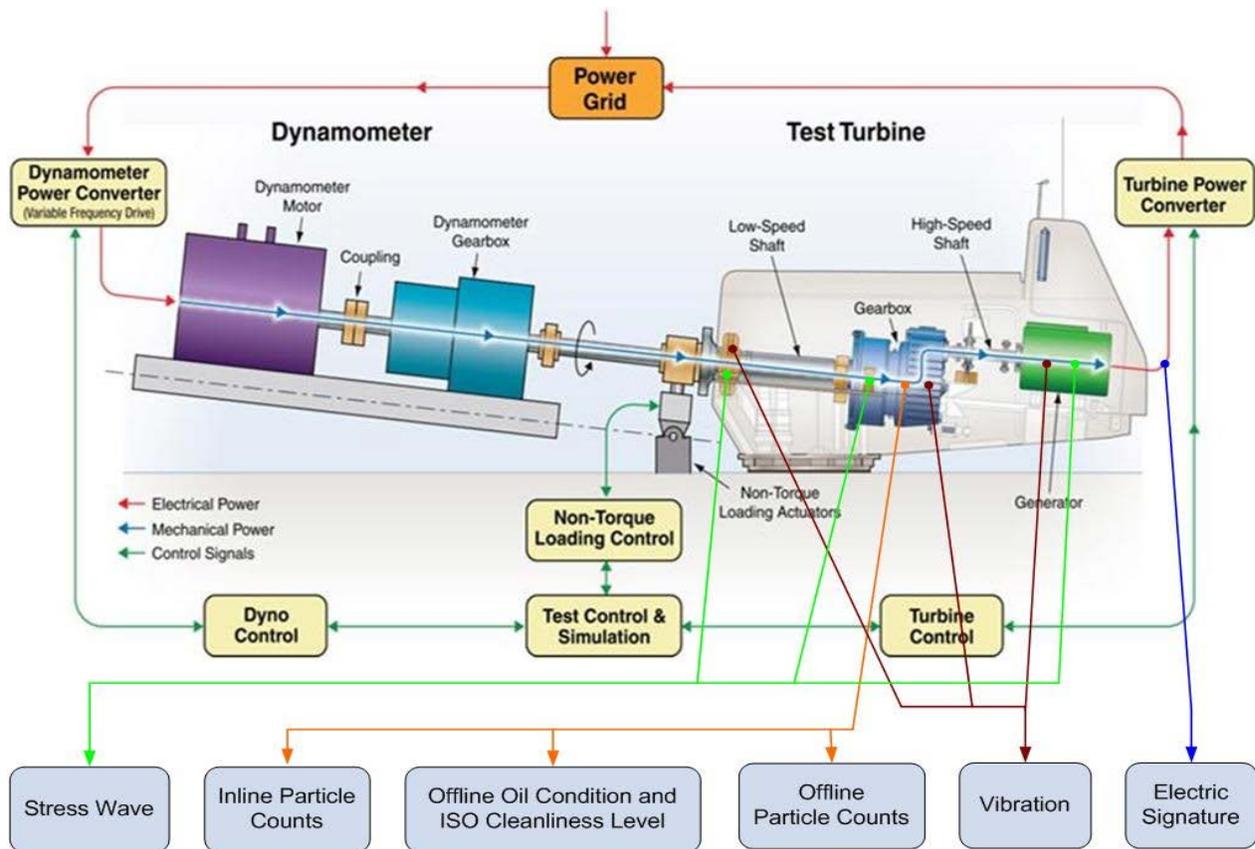
Figure 9. CM system configuration in Phase 2 Gearbox 1 Dynamometer Retest

For tests conducted in the dynamometer, the major change in the CM system configuration was the addition of new packages. The CM system configuration for Phase 2 Gearbox 1 Dynamometer Retest is illustrated in Figure 9, where the different types of monitoring techniques that these packages represent are indicated. It is worth noting that both inline and offline particle counts are referred to as oil debris monitoring; offline oil condition measurement refers to total ferrous debris, oil quality and moisture.

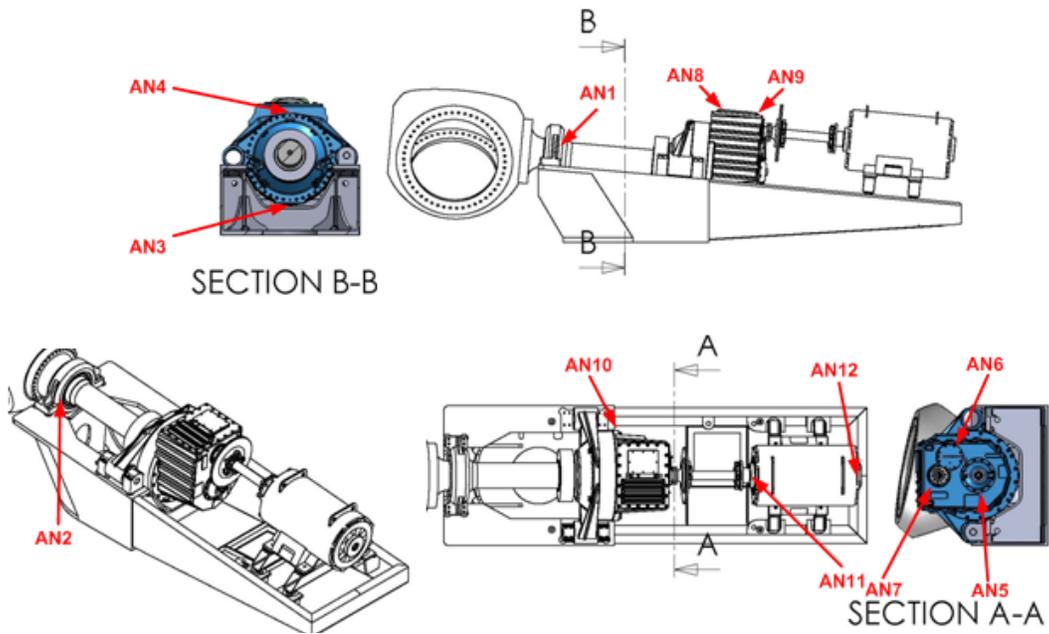
Figure 10. NREL customized vibration-based CM system sensor locations

Due to intellectual property constraints, detailed sensor locations for the commercial Stress Wave and Vibration-based monitoring systems cannot be disclosed. As a result, the setup used in NREL's customized vibration-based CM system is illustrated in Figure 10. It illustrates most of the typical accelerometer mounting locations for vibration-based CM systems seen in the wind industry today. The sensor notations are given in Table 4 and their physical installations are illustrated in Figure 11. It is worth noting that a typical commercial CM system uses only a portion of the 12 sensors listed in Table 4. One typical configuration consists of eight accelerometers: two on the main bearing, including one in the radial direction (AN1), and the other in the axial direction (AN2); four on the gearbox, including one for the planetary section in the radial direction (AN3 or AN4) and one for each stage of the gearbox, i.e. LSS (AN5), ISS (AN6), and HSS (AN7), all in the radial direction; and two on the generator, including one on the drive end (AN11) and the other on the non-drive end (AN12), both in the radial direction. The other typical configuration also consists of eight accelerometers and differs from the first by replacing AN5 through 7 with AN8 through 10.

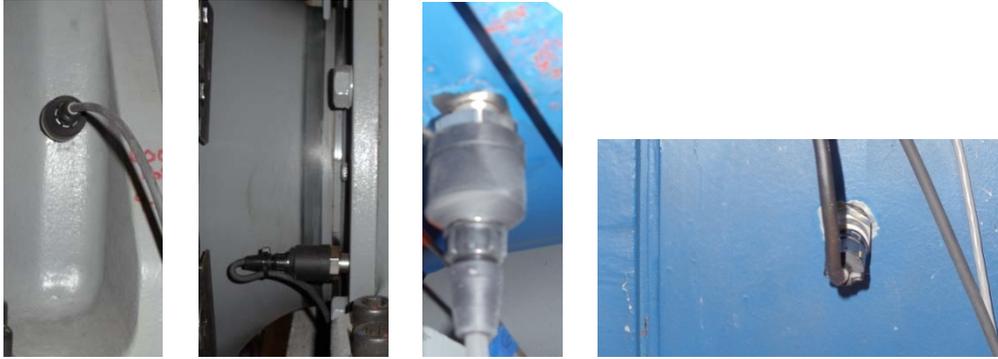
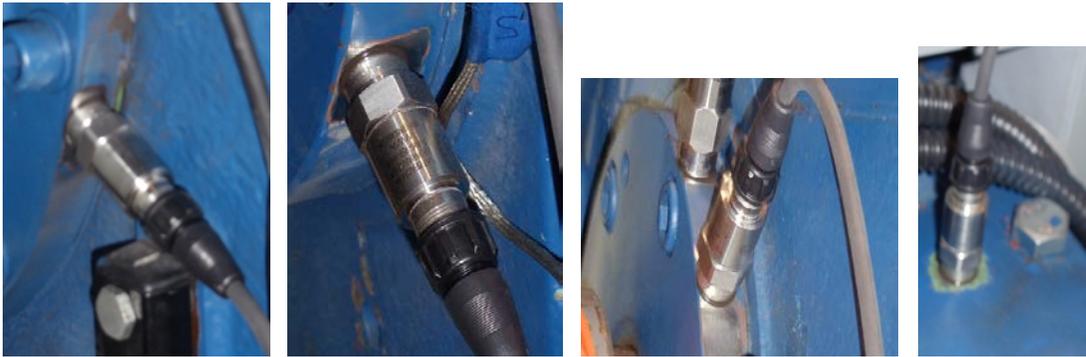
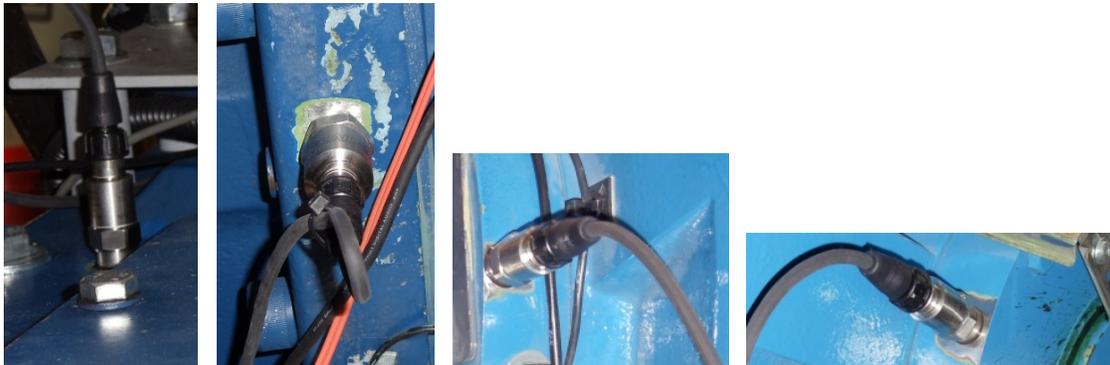
Figure 11. Accelerometer installation on NREL's customized vibration-based CM system

AN1, AN2, AN3, and AN4 (From left to right, PIX #19589, 19590, 19588, 19587)

AN5, AN6, AN7, and AN8 (From left to right, PIX #19591, 19592, 19594, 19593)

AN9, AN10, AN11, and AN12 (From left to right, PIX #19595, 19598, 19597, 19596)

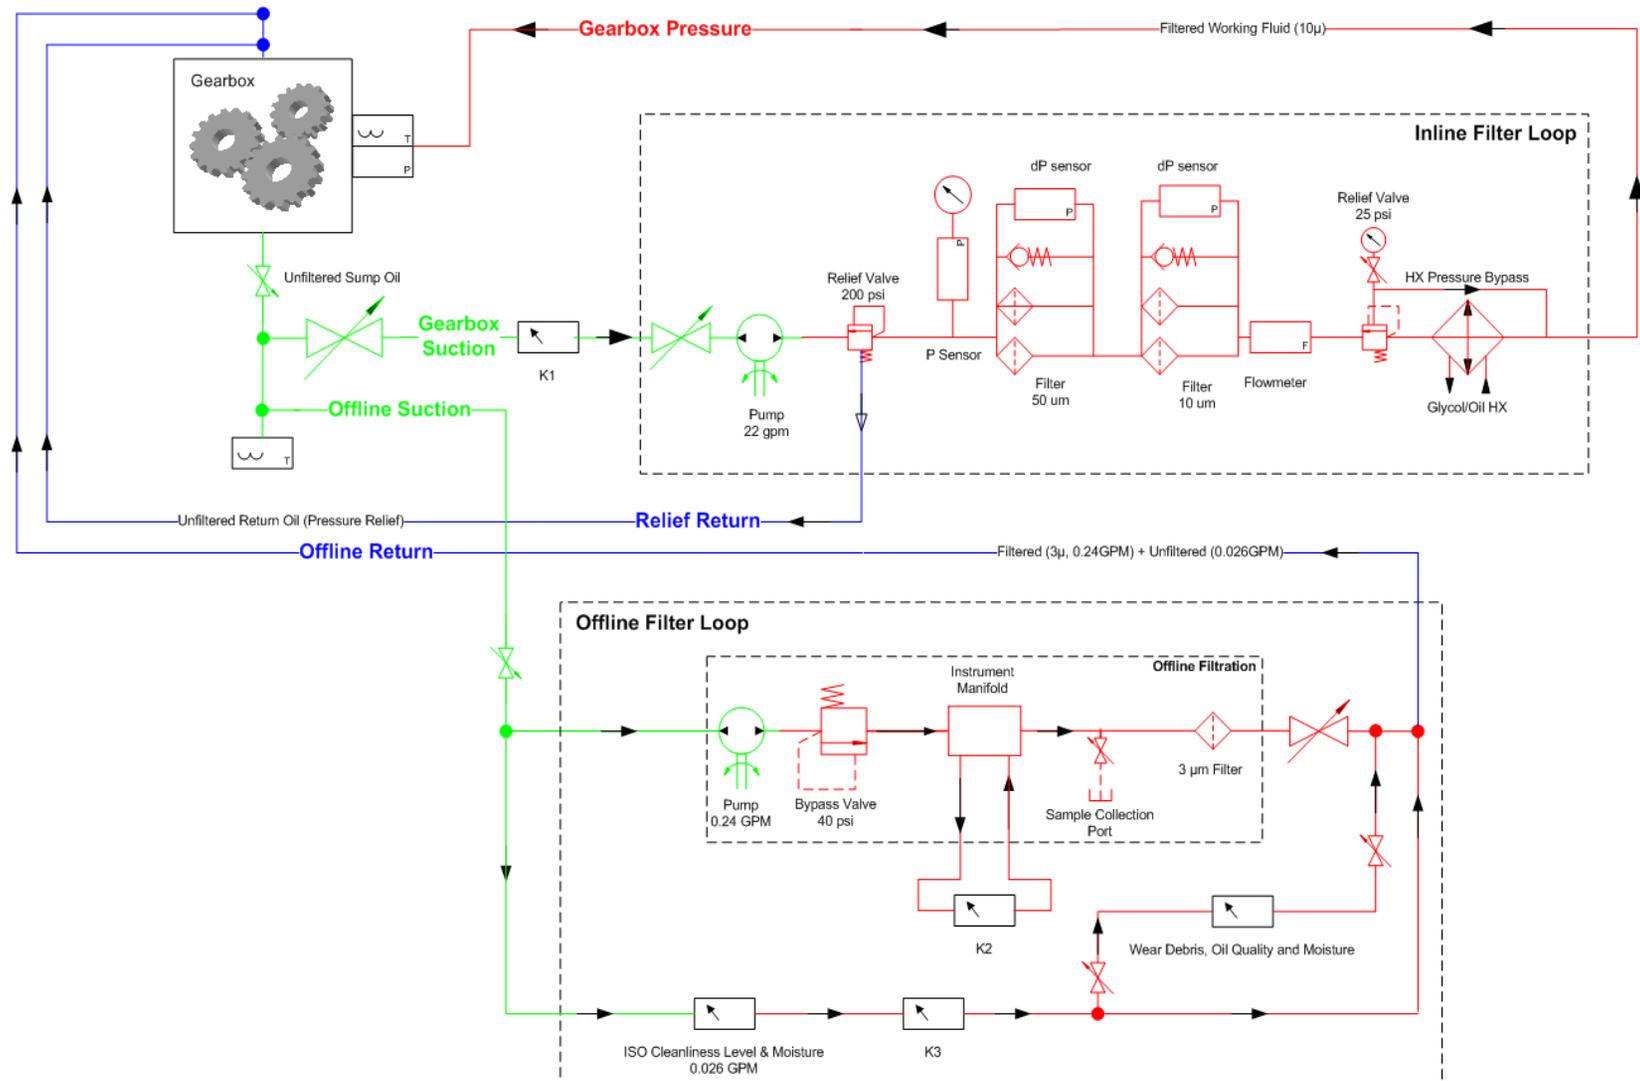
Figure 12. Lubrication system schematics for Phase 2 Gearbox 1 Dynamometer Retest

measurement system, and sensors for measuring oil condition, specifically wear (total ferrous) debris, oil quality, and moisture. It includes an inline filter loop and an offline filter loop. Within the inline filter loop, sensor K1 is located on the gearbox suction line before a pump and is followed by a two stage filtration system for contamination removal and a heat exchanger for oil temperature control. Within the offline filter loop, sensor K2 is located on one of the two branched lines off the offline suction line, between the offline filter pump and its filter cartridge. Sensor K3 is located in the other set of two branched lines off the offline suction line. The ISO cleanliness level measurement system and the wear (total ferrous) debris, oil quality, and moisture measurement sensors are located on the same line.

For the Phase 1 Gearbox 1 Field Test, it should be noted that only the commercial Stress Wave, Vibration-based CM system, sensor K2, and sensors for measuring wear (total ferrous) debris, oil quality, and moisture were deployed. Also, the filtration system schematic is different from what is shown in Figure 12, as the inline filter loop was from the field test turbine. The offline filtration loop is similar to what is shown in Figure 12.

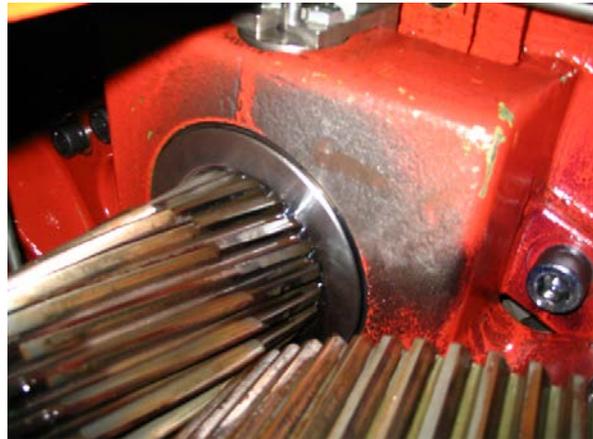
Figure 13. Gearbox 1 high speed stage (taken in field after second oil loss event). PIX #19600.

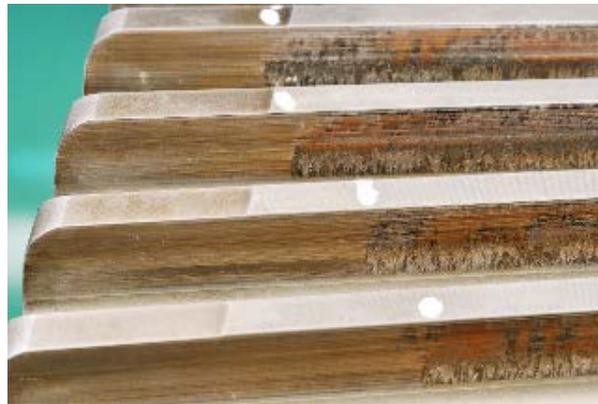
Figure 14. Gearbox 1 high speed stage gear damage (during Gearbox 1 disassembly). PIX #19599.

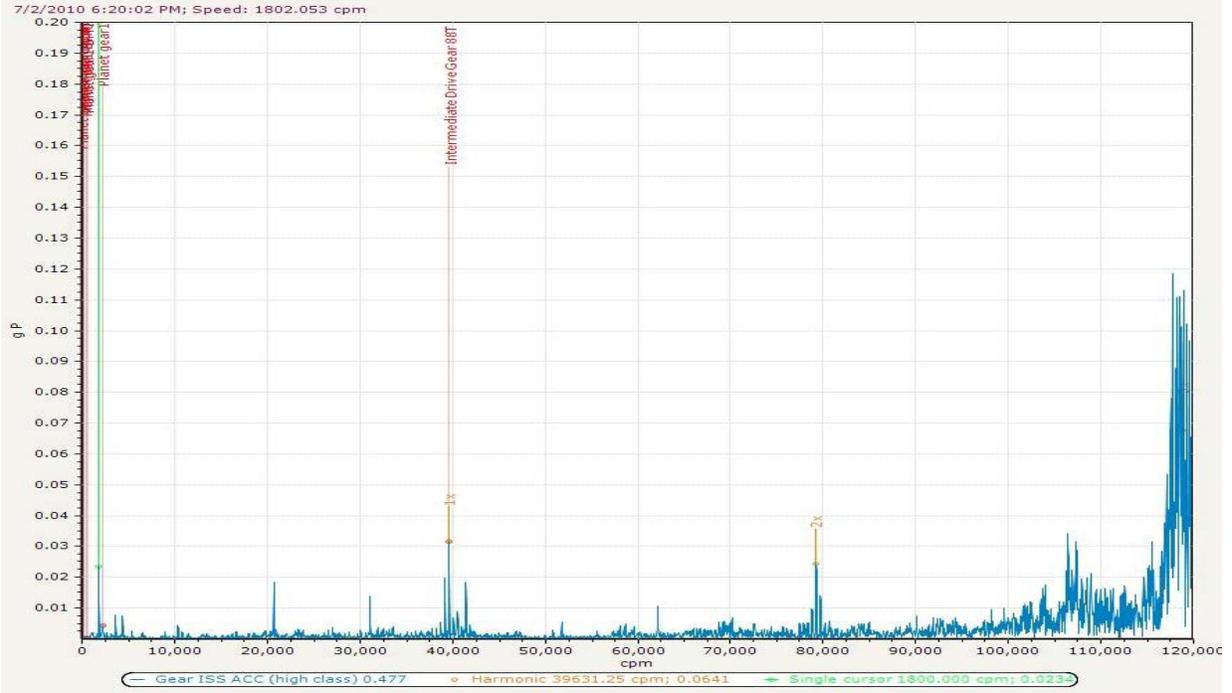
Figure 15. Results from a vibration-based CM system (healthy gearbox)

Figure 15 and Figure 16 show sample results obtained by the investigated vibration-based CM system from the GRC tests [31]. Figure 15 results were obtained during the Phase 1 Gearbox 2 Dynamometer Test. Figure 16 results were obtained during the Phase 2 Gearbox 1 Dynamometer Retest. They are spectra of vibration data collected by one accelerometer mounted to the Intermediate Speed Shaft on the back cover of the test gearbox. Figure 15 shows measurements from the healthy gearbox, while Figure 16 shows data collected from the damaged gearbox. For both figures, the horizontal axis shows frequency in counts per minute ($60 \text{ cpm} = 1 \text{ Hz}$) and the vertical axis shows acceleration in g ($1 g = 9.8 \text{ m/s}^2$). The fundamental high speed stage gear meshing frequency (GMF) of 39,600 cpm or 660 Hz, and its second harmonic are labeled in the figures. When comparing the figures, the damaged gearbox clearly has more frequency components and elevated amplitude for GMF sidebands. For illustration purposes, the ten sideband frequencies (five below and five above) of the second harmonic in the high speed stage GMF are labeled in Figure 16. The spectrum pattern illustrated in Figure 16 typically represents abnormal gear set behaviors. When the sideband frequencies are around 39,600 cpm, it is clear that the problem occurs during the high speed stage. In addition, the amplitude of the fundamental high speed stage GMF increased from 0.0325 g in the healthy gearbox to 0.0875 g in the damaged gearbox. Such an increase in GMF amplitude is another indication of abnormal gear set behavior. Even without a detailed calculation, it is obvious that the energy contained in the frequency spikes from the damaged gearbox is much higher than that of the healthy gearbox. This is a result of both increased amplitude of those frequencies already contained in the healthy gearbox and the additional energy caused by new frequency components in the damaged gearbox. Based on these findings, it is reasonable to conclude that the vibration-based monitoring technique can successfully diagnose such gear set damage.

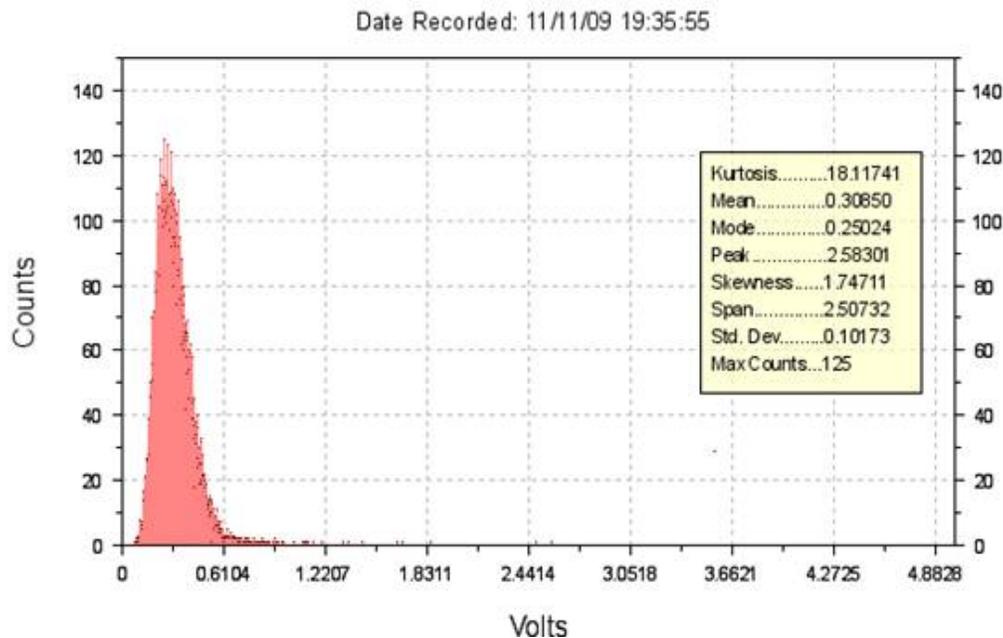
Figure 17. Stress Wave Amplitude Histogram (healthy gearbox)

Figure 17 and 18 show the results obtained by the AE-based CM technique (specifically, stress wave). The stress wave sensor was mounted axially in the middle of the three shaft ends on the back of the test gearbox. The sensor output is conditioned to generate a stress wave pulse train, which represents a time history of individual shock and friction events that have occurred in the monitored machine [15, 32]. By first finding the peak amplitude of each of the pulses in the stress wave pulse train, and then distributing these peaks into voltage bins that correspond to the value of each reading, the resultant diagram—called a Stress Wave Amplitude Histogram [32]—is generated. Two are shown in Figure 17 and Figure 18. In healthy machines, the distribution should be a narrow bell shape located at the lower end of the voltage scale, as illustrated in Figure 17. In abnormal machines, the distribution should be much broader and shifted to the right on the amplitude scale, as illustrated in Figure 18. Figure 17 was obtained during the Phase 1 Gearbox 2 Dynamometer Test and Figure 18 was obtained during the Phase 2 Gearbox 1 Dynamometer Retest. Figure 17 implies that the monitored gear sets were healthy and Figure 18 implies that the monitored gear sets were problematic. To identify whether the damaged gear set is at high speed, or at the intermediate speed stage, it is necessary to obtain some frequency domain information. Because spectra of stress wave time series are expected to be similar to those obtained from the vibration-based technique, they are not presented.

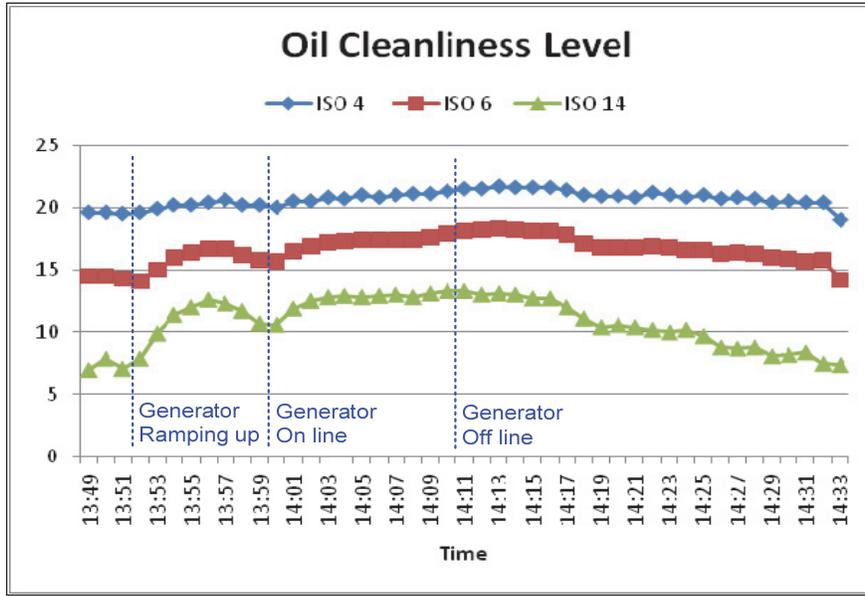
Figure 19. Oil cleanliness level (run-in)

The first subset of oil monitoring results was the oil cleanliness level measured during the Phase 1 Gearbox 1 Dynamometer Test, when the test gearbox was run-in at 25% of rated load level. The generator status is shown in Figure 19. The figure's horizontal axis is time and the vertical axis is the ISO 4406:1999 cleanliness code [17]. It is divided into three stages: around 13:51, the generator speed started ramping up; around 13:59, the generator was connected to the grid; and around 14:10, the generator went off the grid, but the lubricant CM system was left running. At around 14:34, the power supply to all CM systems shut off and all oil cleanliness level readings dropped to zero. This is not shown in the figure. As shown in Figure 19, a broad range of particle sizes were generated throughout the gearbox operational process, which is demonstrated by the increased oil cleanliness level in all three bins ($> 4 \mu\text{m}$, $> 6 \mu\text{m}$, and $> 14 \mu\text{m}$). This test verified that wind turbine gearboxes always emit particles. It is worth noting that the larger the number, the more contaminated the oil. The oil cleanliness level decreased when the generator speed was ramped up and increased when the generator was shut down and the offline filter loop filtration system was left running. Based on this observation, it can be inferred that the oil cleanliness level has the potential to be used to monitor and control the run-in of wind turbine gearboxes. The rationale is that the oil cleanliness level will increase when the run-in begins at a certain load level. As the run-in continues, the measured cleanliness level will gradually stabilize because contacted surfaces are smoothed through run-in and the continuously functional lubricant filtration system. These results can be used to determine when run-in of wind turbine gearbox may occur under a certain load level.

Oil cleanliness level results similar to Figure 19 also were obtained during the Phase 1 Gearbox 2 Dynamometer Test, when the test gearbox was run-in. Test data from both test gearboxes indicate that the cleanliness readings did, in fact, fall off at the 1+ hour range, depending on load and temperature. The industry has recognized that using cleanliness is a better approach than the time-at-load level since it verifies that run-in has actually occurred, and these results are good evidence to support that assumption.

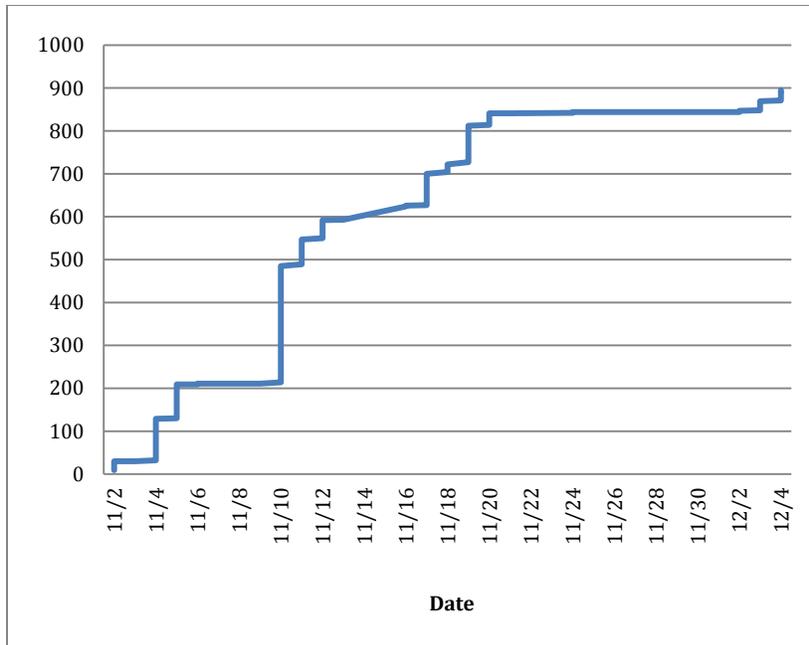
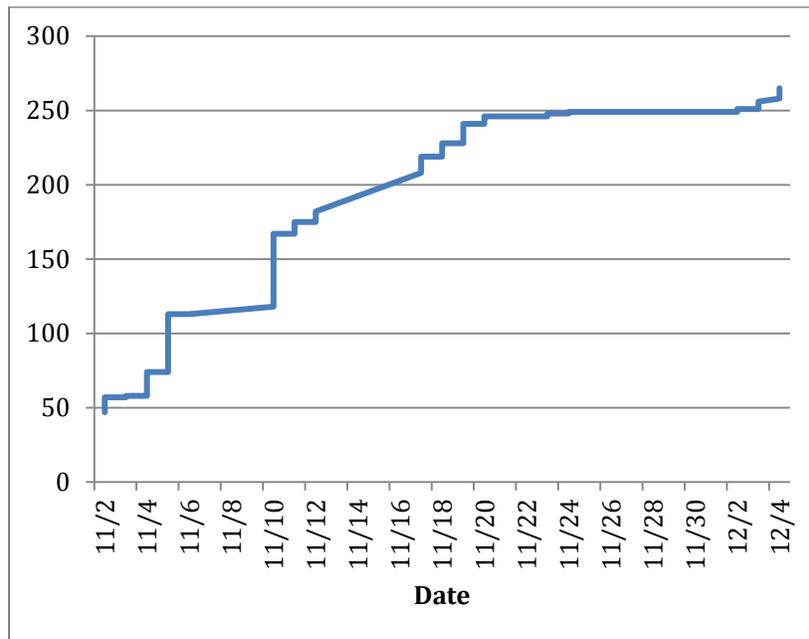
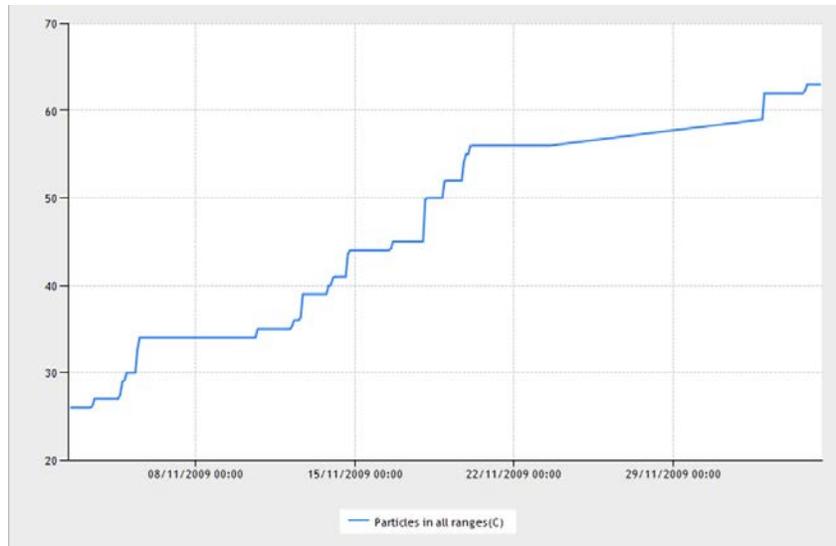
Figure 20-22 show results obtained during the Phase 1 Gearbox 2 Dynamometer Test, when the test gearbox was being run-in. The counts represent the total number of particles, ferrous or nonferrous, with a size greater than a certain size, varying from 35 μm to 300 μm depending on the sensor being used, and detected by the sensors throughout the entire test period. Test dates are plotted on the horizontal axis and the vertical axis plots cumulative particle counts detected by sensors K1 to K3. We observed that the total counts, at the end of the test, varied among the three sensors. The implication is that the sensor outputs are affected by measurement locations. However, their trends are similar. Note that sensor K1 is located in the inline filter loop and sensors K2 and K3 are located in the offline filter loop.

Figure 20. Cumulative particle counts obtained by sensor K1 (run-in)

Figure 21. Cumulative particle counts obtained by sensor K2 (run-in)

Figure 22. Cumulative particle counts obtained by sensor K3 (run-in)

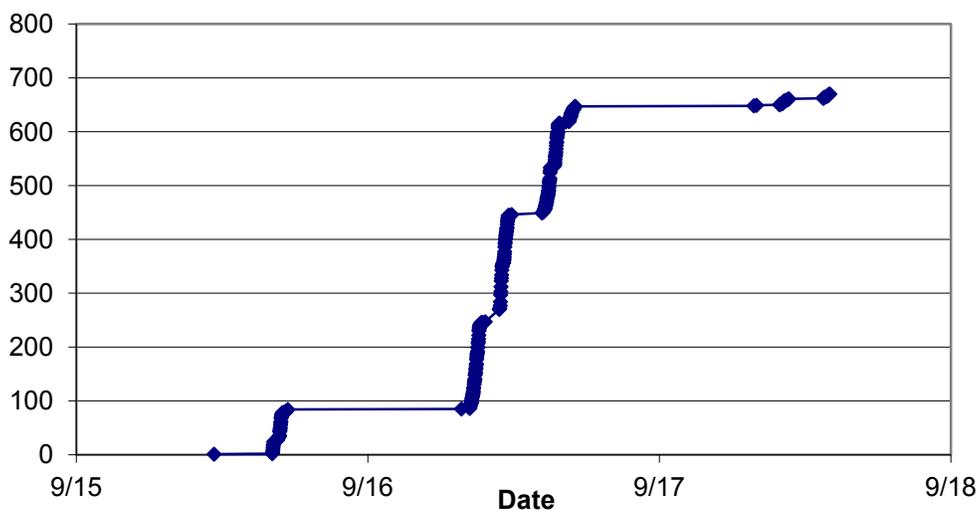
Figure 23. Cumulative particle counts obtained by sensor K1 (damaged gearbox)

Figure 23 shows the oil debris particle counts obtained during the Phase 2 Gearbox 1 Dynamometer Retest by sensor K1. The horizontal axis shows the date and the vertical axis lists the cumulative particle counts. Within three calendar days, the counts were increased from 0 to about 680. More specifically, the particle generation rate reached about 70 particles per hour on September 16. In comparison, about 11 particles were generated over a period of four hours from a healthy gearbox [35]. It is, therefore, reasonable to conclude that under similar environmental conditions, such as oil temperature, shaft rotational speed, and driven torque, a damaged gearbox has higher particle-generation rates than a healthy gearbox. It is worth noting that the lubricant used in this test is different from the oil used during the run-in, which does not have anti-wear additives. However, due to the lack of frequency information from the oil debris monitoring technique, it is difficult to tell where the damage occurred.

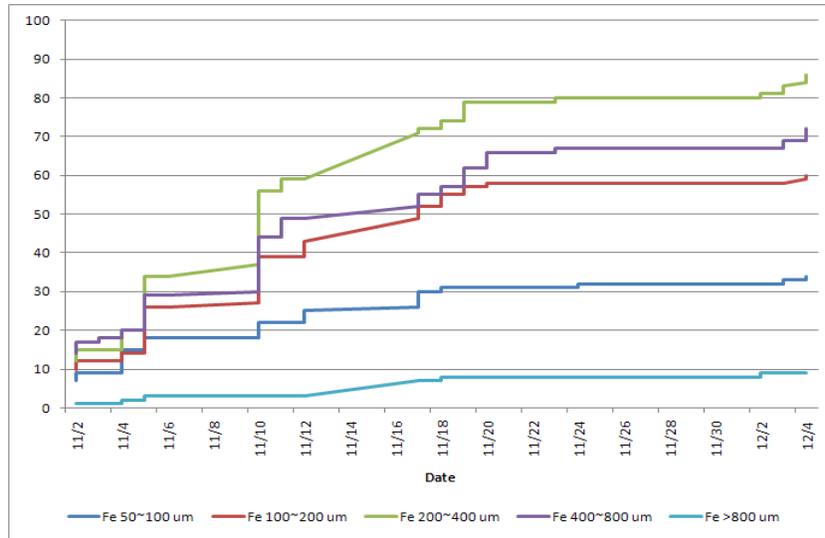
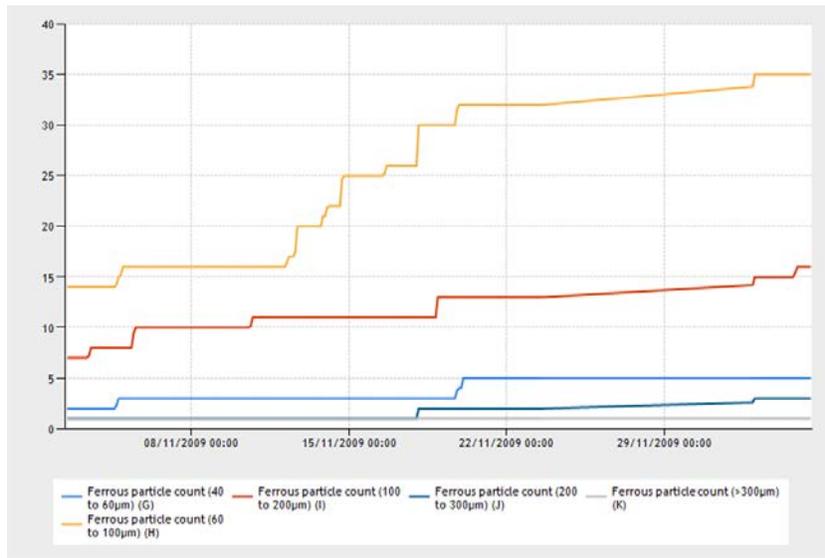
Figure 24 and 25 show the ferrous particle counts obtained from sensors K2 and K3 during the Phase 1 Gearbox 2 Dynamometer Test, when the test gearbox was being run-in. The horizontal axis of each figure is the date and the vertical axis shows particle counts. Each plot has five curves, which represent five different size bins. Assuming the test gearbox at the run-in stage was healthy, even large particles (greater than 100 μm) are generated. It is, therefore, not correct to claim large particles are only generated when the monitored gearbox has damaged internal components. On the other hand, since the counts within each size bin also vary, this demonstrates that the location of the sensor influences the readings.

Figure 24. Ferrous particle counts by sensor K2 categorized into five size bins (run-in)

Figure 25. Ferrous particle counts by sensor K3 categorized into five size bins (run-in)

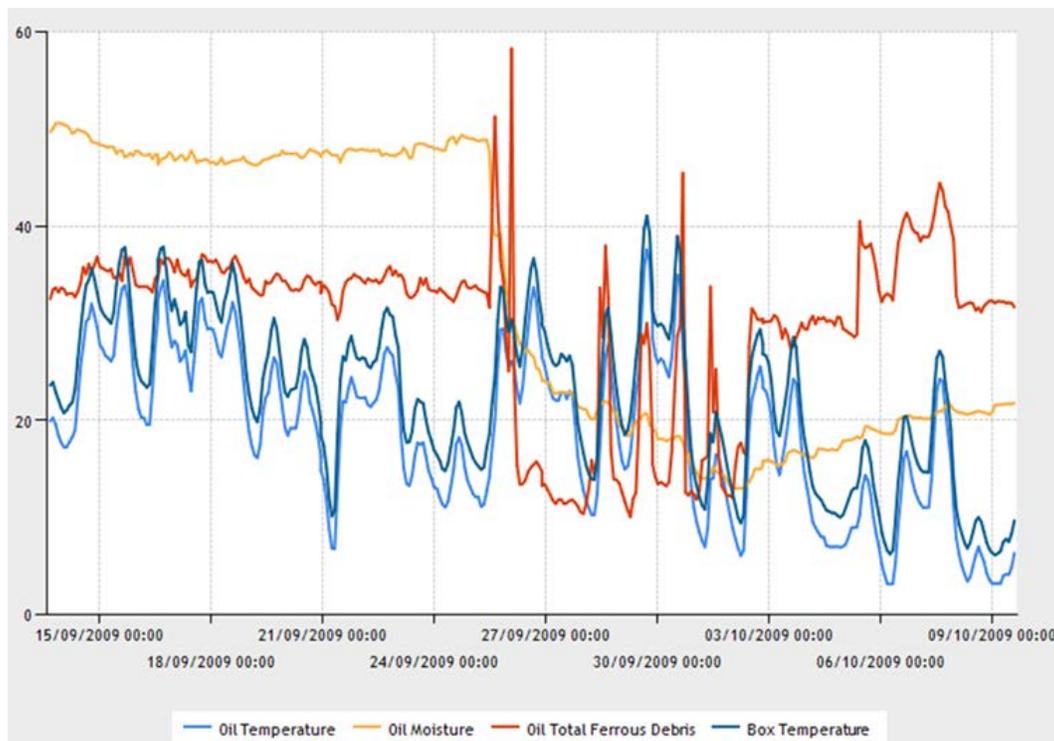
Figure 26. Oil condition sensor readings (field test)

Figure 26 shows that total ferrous debris has several spikes, which may be an indication of possible gearbox damage. The moisture was decreasing, which was reasonable since oil loss should have led to elevated oil temperature making the oil drier. However, wind speed information is needed to confirm whether the two temperature channels match the turbine operational conditions. Assuming a match, the data has demonstrated the complex dynamics that wind turbines may experience in the field.

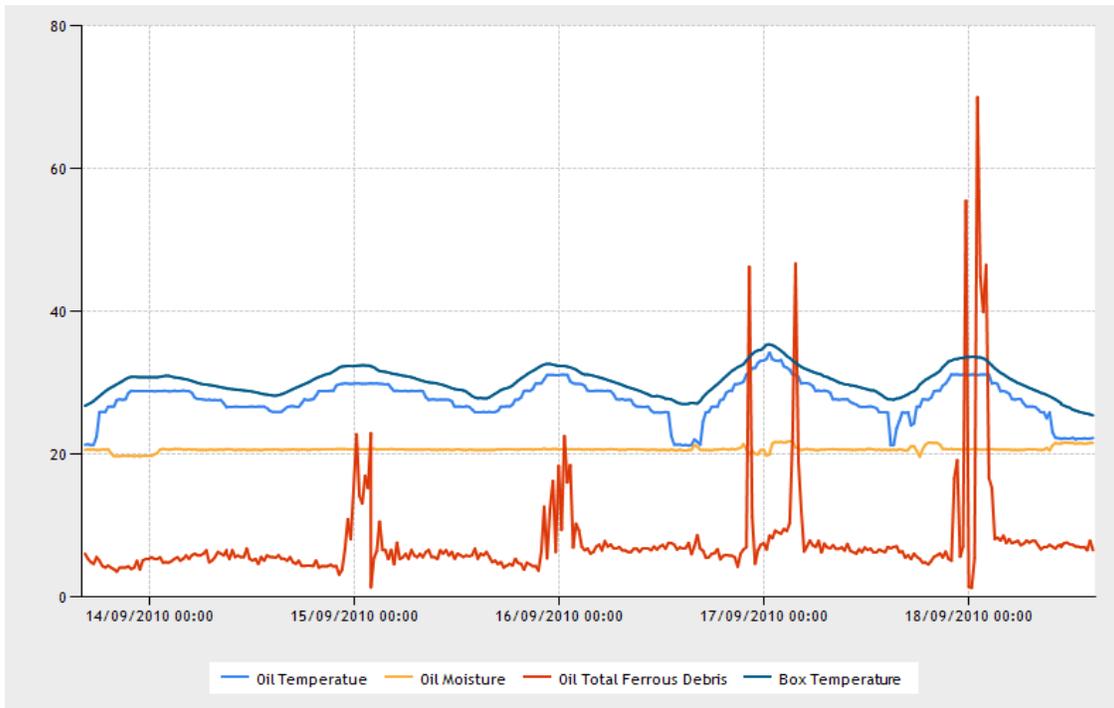
Figure 27. Oil condition sensor readings (dynamometer retest)

In Figure 27, the total ferrous debris channel also showed several spikes, which may be considered an indication of possible gearbox damage. It should be pointed out that the amplitude of these spikes increased as the test progressed. The reason is that both the testing load and shaft rotational speed were intermittently increased from the first to the last day of the test. The moisture level did not change much, which might be due to the short testing period. These much cleaner curves, with respect to those shown in Figure 26, demonstrate that the test conditions in the dynamometer were less dynamic, since they were purposely controlled.
