Gearbox Reliability Collaborative Bearing Calibration

Technical Report NREL/TP-5000-47852 October 2011

NREL has initiated the Gearbox Reliability Collaborative (GRC) to investigate the root cause of low wind turbine gearbox reliability.

One of the measurements the collaborative is targeting is the load distribution on the planet bearings. For this purpose, the planet bearings were instrumented with strain gages. The strain gages measure the roller load as the roller moves over an arch ground into the inner race of the planet bearings. The objective of the calibration was to measure the correlation between the load applied to the bearing and the strain gage response. This report documents the set-up, the calibration procedures, the issues, and the results.

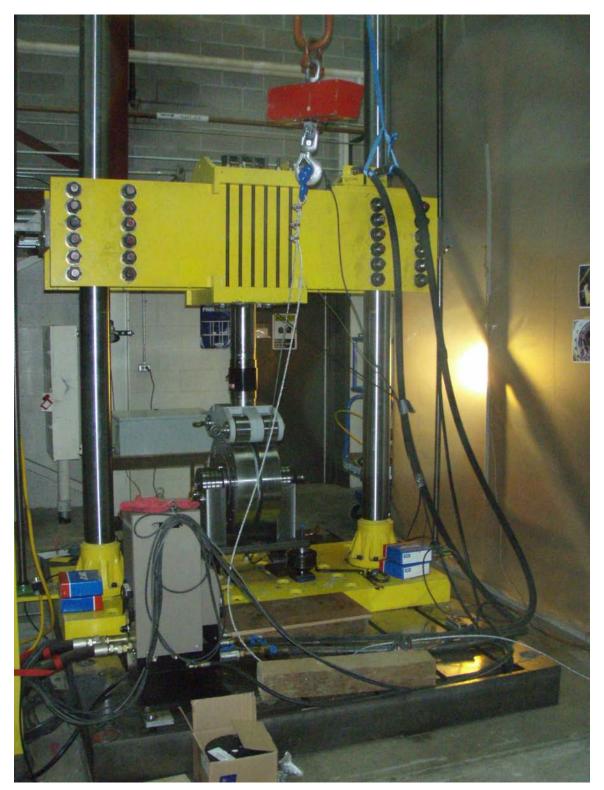
Figure 6. Calibration stand in the 100 kip load frame in the 251 highbay. PIX #19676.

A calibration fixture, shown in Figure 6, was designed by Powertrain Engineers (Figure 7). The idea behind the test stand is that it allows for independent rotation of the inner race and outer race of the bearings. This allows the grooves to be put in any orientation while rolling the roller elements over them when they are under load.

Pictures and drawings of the calibration fixture are shown in Figure 6 and Figure 9.

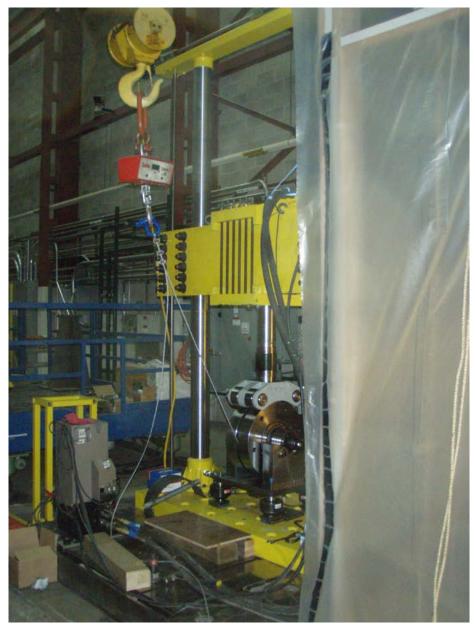
Figure 11. Crane calibration method set up. PIX #19677.

Dynamic effects were investigated using an overhead crane. For the crane calibration, a groove was put in the TDC position and a wire rope was wound around the rollers (Figure 11). The crane was used to unwind the wire rope and thus rotate the outer races of the bearings. The outer races of the bearings were allowed three full rotations, thus assuring each roller went past the groove at least once. This test was done for five load levels: 20, 35, 50, 65 and 80 kip (total load on the fixture).
