# **Assessment of Channel Changes, Models of Historical Floods and Effects of Backwater on Flood Stage, and Flood Mitigation Alternatives for the Wichita River at Wichita Falls, Texas**

Scientific Investigations Report 2011–5175

By Karl E. Winters and Stanley Baldys III

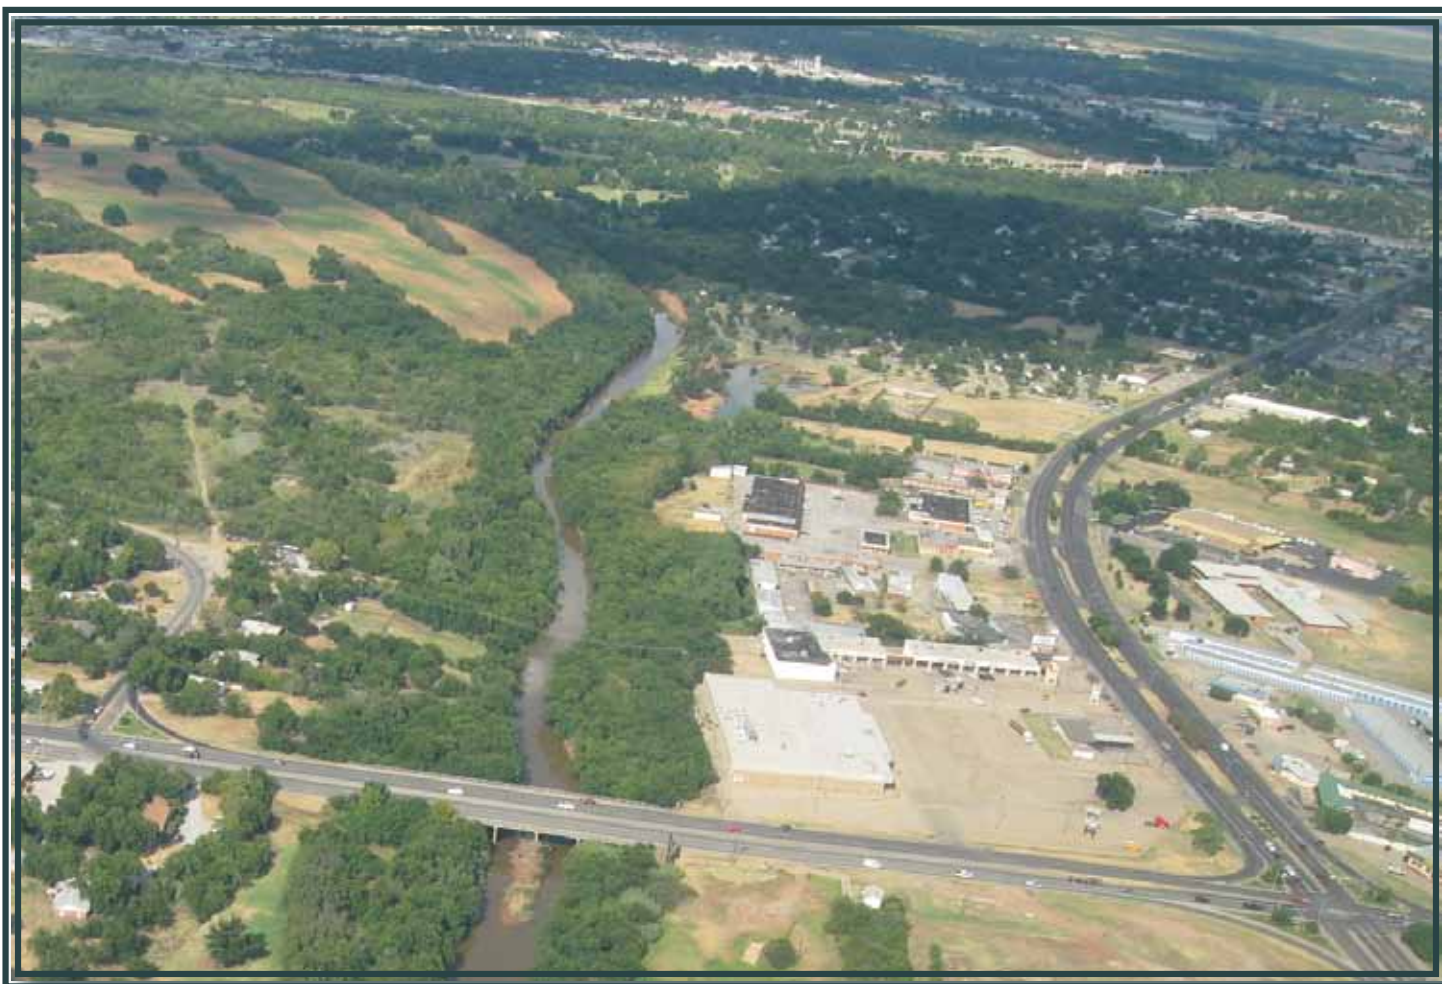
**Front cover:** Looking downstream from Loop 11 and U.S. Geological Survey streamflow-gaging station 07312500 Wichita River at Wichita Falls, Texas, August 23, 2010.

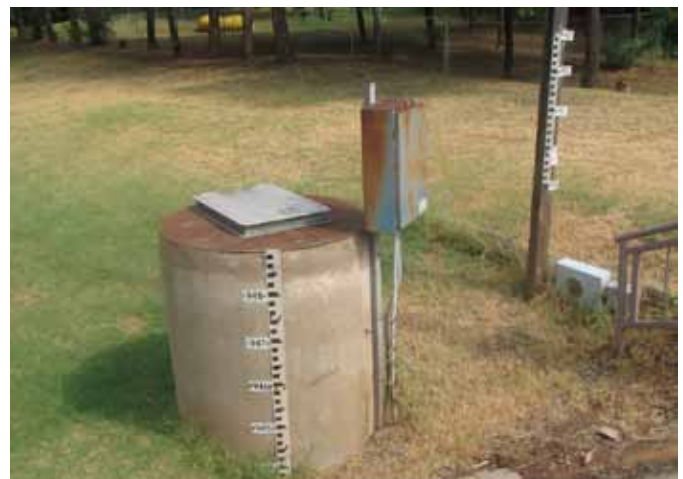
**Figure 2.** Staff gage operated by the City of Wichita Falls, Texas (photograph courtesy of Davis Powell, City of Wichita Falls).

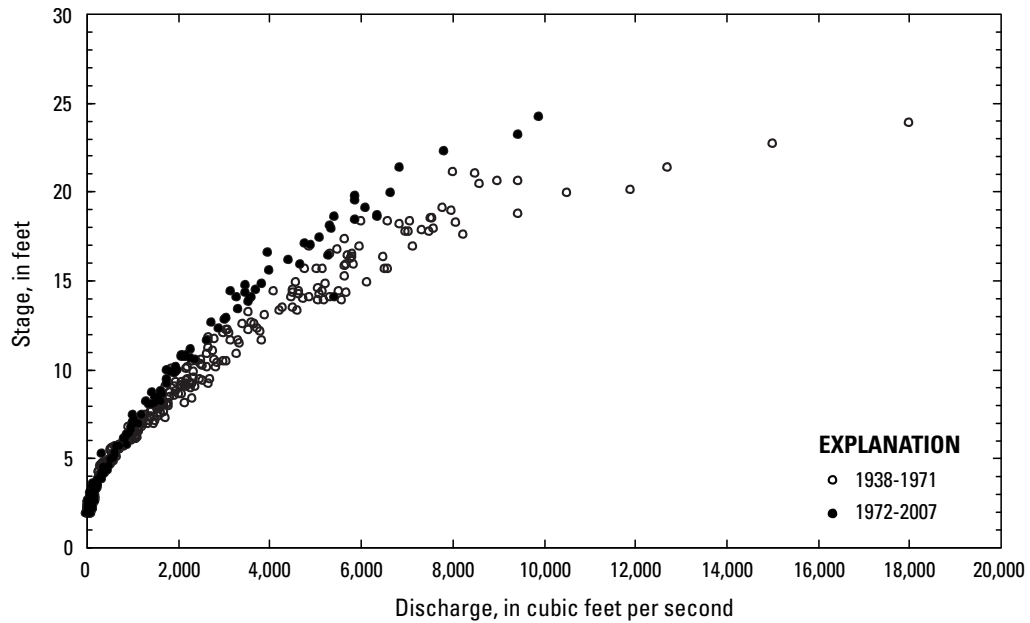
**Figure 3.** Changes in the stage-discharge relation indicated by measurements at U.S. Geological Survey streamflow-gaging station 07312500 Wichita River at Wichita Falls, Texas (Loop 11 gage).

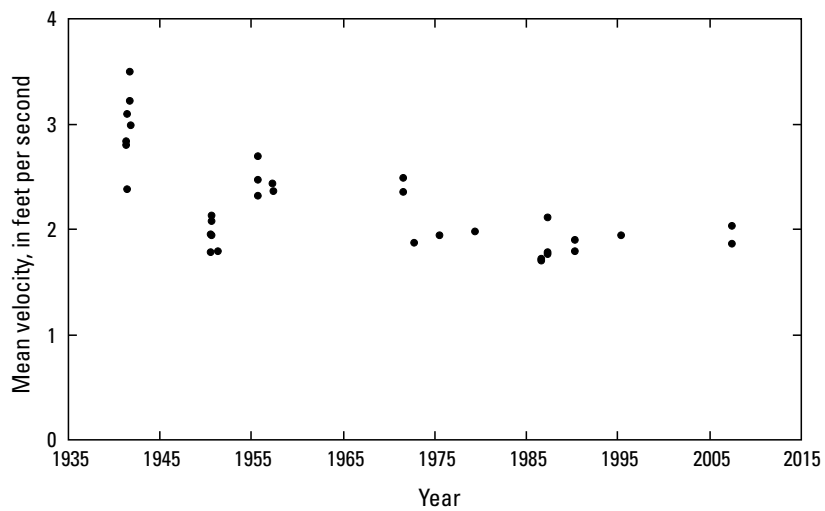
**Figure 4.** Mean velocities from measurements at U.S. Geological Survey streamflow-gaging station 07312500 Wichita River at Wichita Falls, Texas (Loop 11 gage).

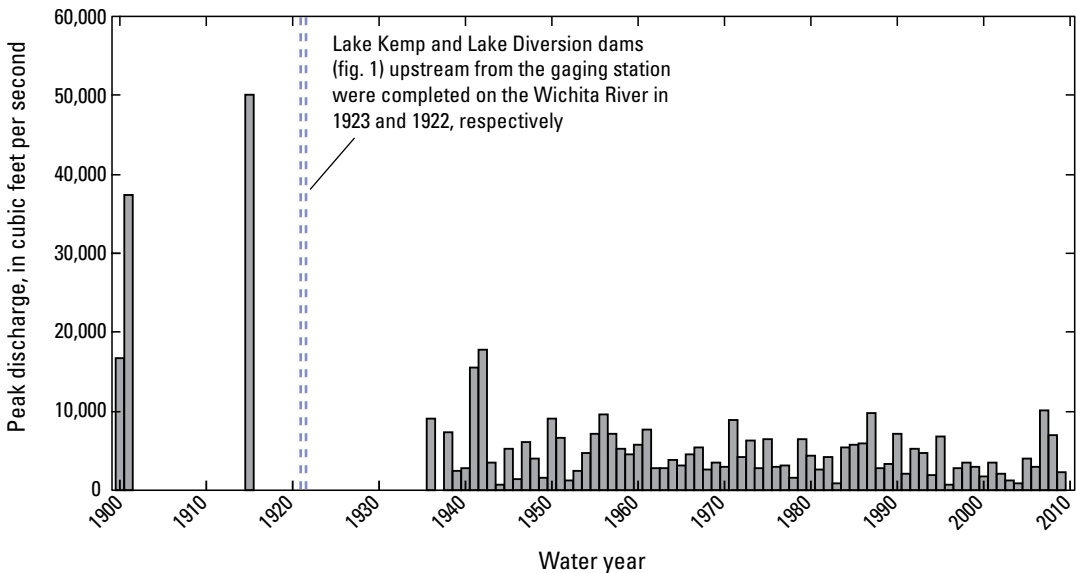
**Figure 5.** Annual peak discharges at U.S. Geological Survey streamflow-gaging station 07312500 Wichita River at Wichita Falls, Texas (Loop 11 gage).

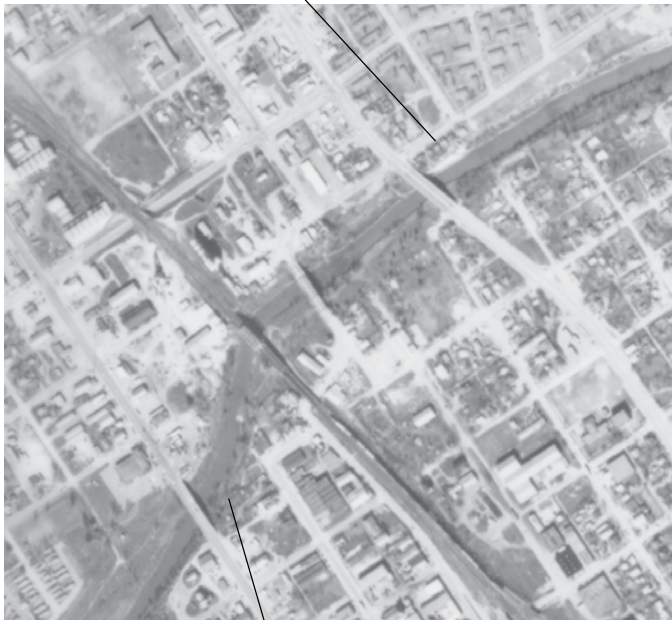
Houses were present on earth fill downstream from Martin Luther King Junior Boulevard when this photograph was taken.

Earth fill was not present downstream from Scott Avenue when this photograph was taken.

**Figure 6.** Scott Avenue and Martin Luther King Junior Boulevard bridges on the Wichita River, February 7, 1968 (photograph courtesy Tom Roehrig, Texas Natural Resources Information System).

Aerial photographs were examined for evidence of development in the flood plain and for general changes in the density of riparian vegetation. Notable changes within the study reach between 1953 and 2008 include a general increase in vegetation density in the riparian area along the Wichita River channel. The aerial photographs indicate an increase in vegetation between 1953 and 1991 along the banks and in the flood plain at Lucy Park, 1 to 2 mi downstream from Loop 11. Photographs from 1968 and subsequent years (including 1971 and 1979, not shown here) indicate fill was placed on the south bank immediately downstream from Scott Avenue between 1971 and 1979. A long-term resident of the area indicated that a substantial amount of fill also was deposited on the north bank of the channel downstream from the Scott Avenue bridge in the early 1960s (Peter Pullin, oral commun., June 23, 2009). Aerial photographs as recent as 1968 show houses on the north bank of the Wichita River immediately downstream from Martin Luther King Junior Boulevard built on earth fill in the channel (fig. 6). The earth fill placed at the downstream side of Martin Luther King Junior bridge is currently (2011) a vacant field.

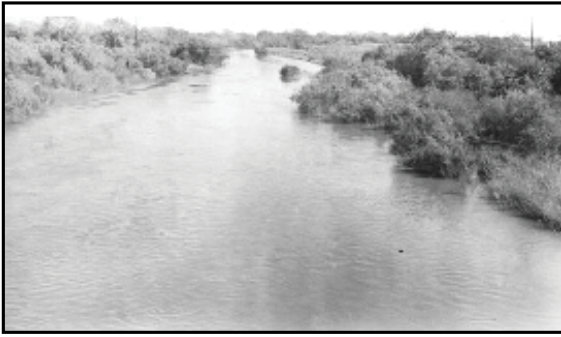
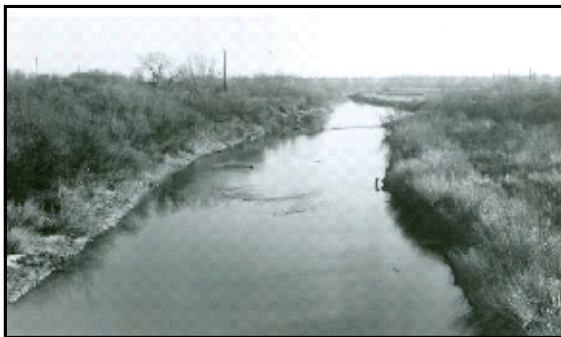
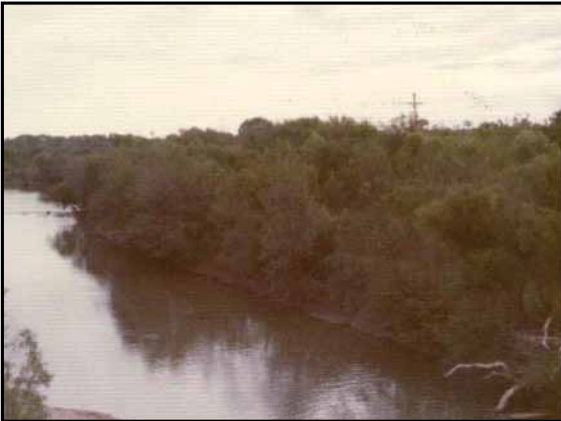
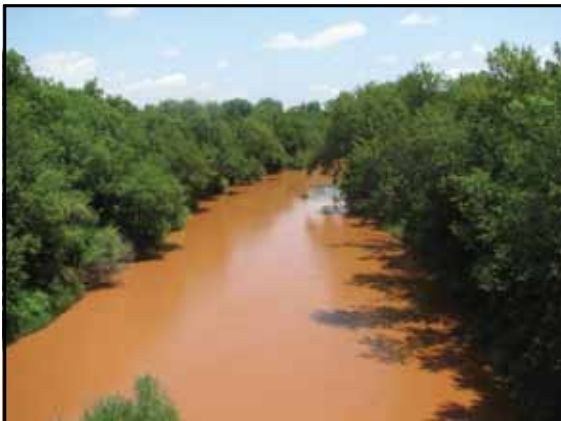
**Figure 7.** Wichita River looking downstream from Loop 11 in 1950, 1961, 1975, and 2009 at U.S. Geological Survey streamflow-gaging station 07312500 Wichita River at Wichita Falls, Texas.

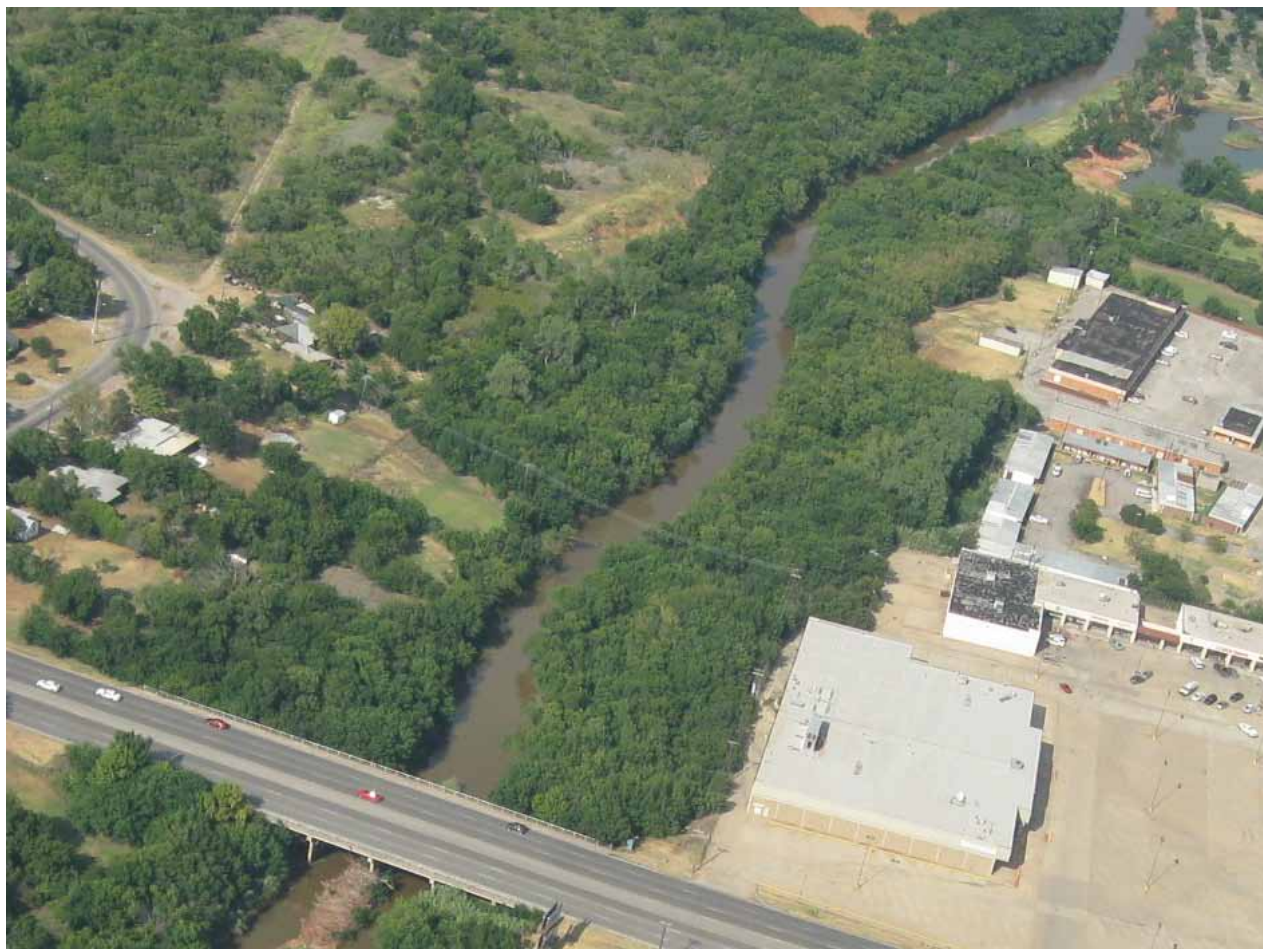
**Figure 8.** Wichita River looking downstream from Loop 11, August 23, 2010, Wichita Falls, Texas.

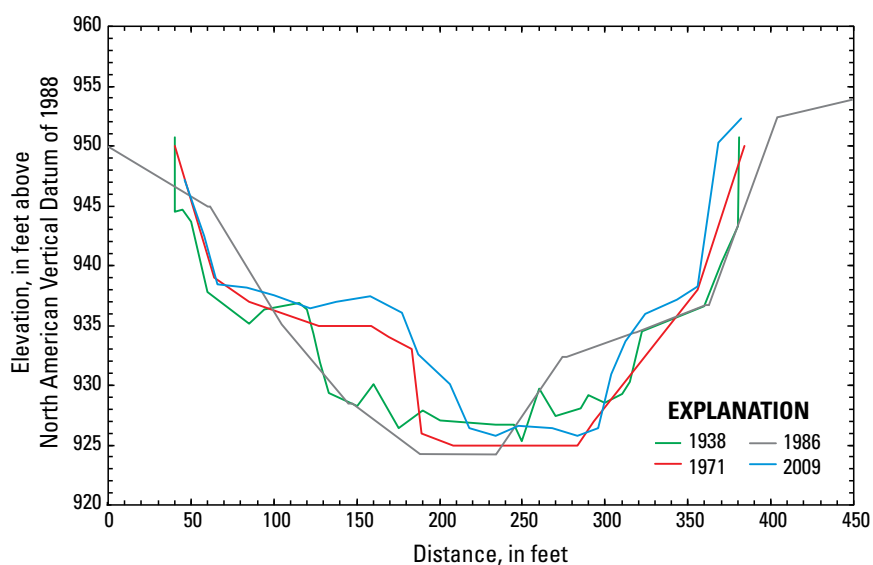
**Figure 9.** Historical channel cross sections of the Wichita River at U.S. Geological Survey streamflow-gaging station 07312500 Wichita River at Wichita Falls, Texas, 1938–2009.

Cross sections were used to assess the stability of the Wichita River channel in the study area. A plot of Loop 11 cross sections over time (fig. 9) indicates that, while minor changes in cross-section shape are observed, the thalweg (elevation of the flowline joining the lowest points along the streambed, thus defining the deepest channel of the stream) and the width of the channel are fairly stable. Most of the Wichita River cross sections surveyed in 2009 by the USGS compared favorably with those from the 1986 photogrammetric survey, indicating that much of the Wichita River channel in the study area appears to be fairly stable. However, four consecutive cross sections between 0.9 and 2.6 mi downstream from Martin Luther King Junior Boulevard indicated substantial narrowing (fig. 10). For those four cross sections, the loss in channel width was typically 30 to 50 ft.

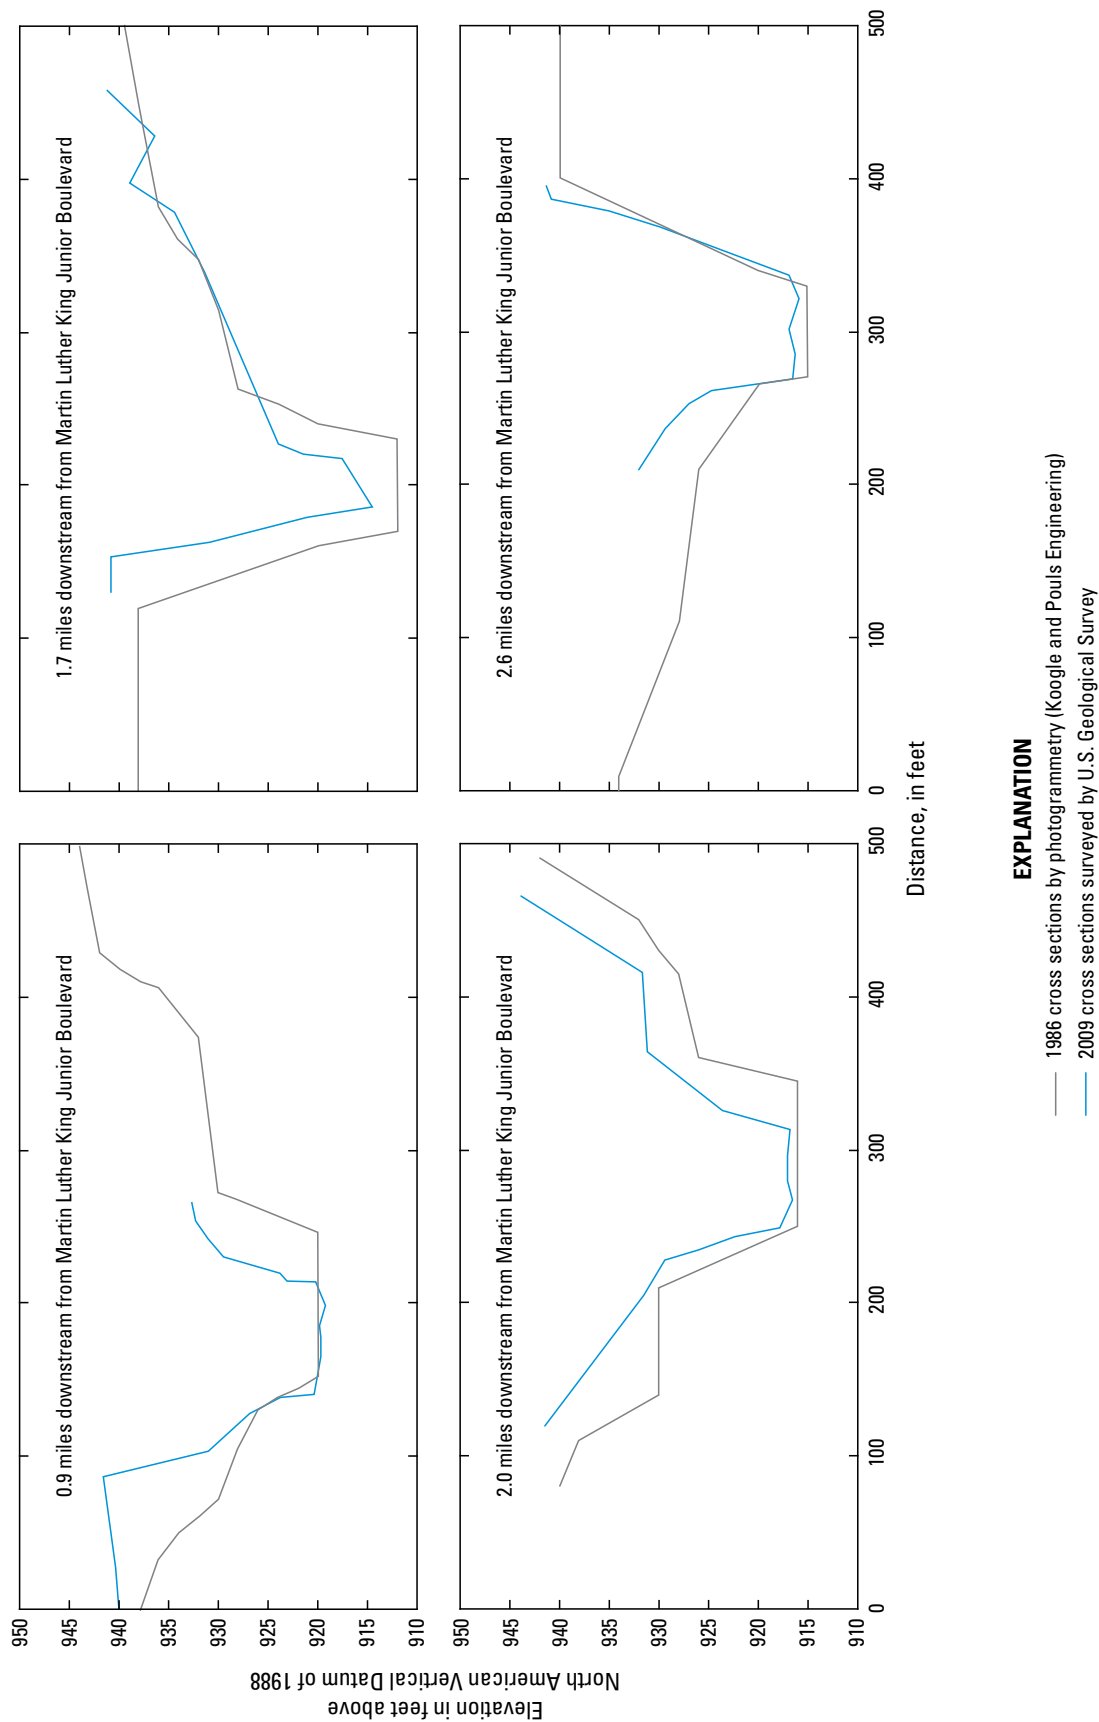
**Figure 10.** Channel cross sections of the Wichita River between 0.9 and 2.6 miles downstream from Martin Luther King Junior Boulevard, Wichita Falls, Texas, 1986 and 2009.

The 2007 flood discharge was modeled with the aggraded channel banks (as surveyed in 2009, fig. 10) removed in the channel reach between 0.9 and 2.6 mi downstream from Martin Luther King Junior Boulevard. On the basis of average channel characteristics in this part of the study reach for the 1986 and 2009 cross sections, the 2009 cross sections between 0.9 and 2.6 mi downstream from Martin Luther King Junior Boulevard were widened 40 ft at the top of the flood channel and 20 ft at the channel bed. The results of widening the channel downstream from Martin Luther King Junior Boulevard and removing obstructions near the Scott Avenue and Martin Luther King Junior Boulevard bridges are shown in figure 23. The greatest reduction in water-surface elevations was 1.1 ft, at the upstream end of the widened part of the reach near the Scott Avenue and Martin Luther King Junior Boulevard bridges.

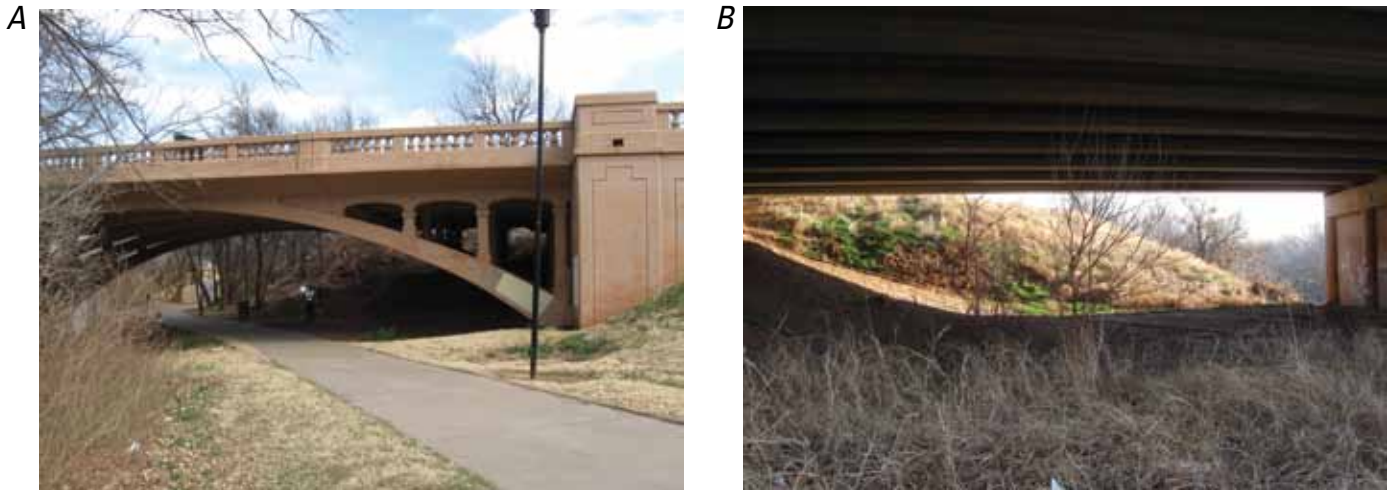
**Figure 11.** Wichita River obstructions A, on the right (south) bank at the downstream side of Scott Avenue bridge looking downstream and B, on the left bank at Martin Luther King Junior Boulevard bridge, looking downstream, February 23, 2009.

For most bridges, comparison of the 2009 surveys of the channels and bridge openings to the as-built bridge plans indicates no change in cross section. Obstructions caused by earth fill are evident in cross sections on the right bank at the downstream side of the Scott Avenue bridge (south span) and on the left bank at the Martin Luther King Junior bridge (north span). Obstructions in the cross section near the Scott Avenue bridge (fig. 11A; fig. 12) reduce the effective conveyance of the bridge section during floods. The obstruction at the Martin Luther King Junior bridge only partially blocks flow, reducing channel conveyance during floods (fig. 11B; fig. 13).

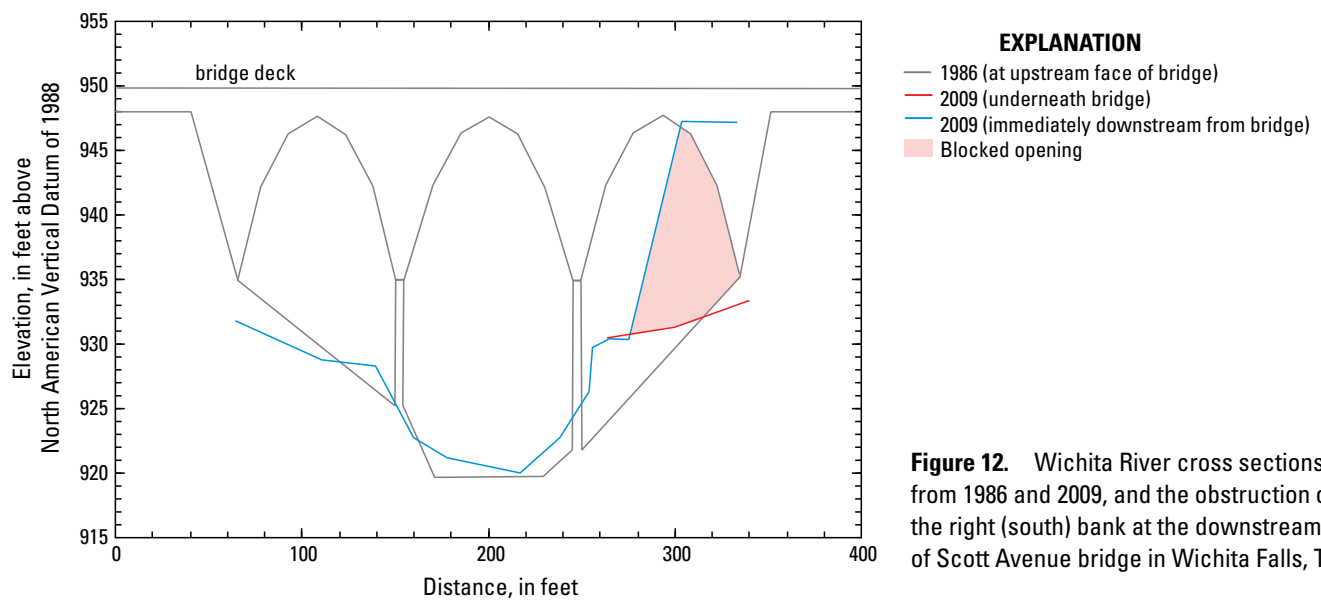
**Figure 12.** Wichita River cross sections from 1986 and 2009, and the obstruction on the right (south) bank at the downstream side of Scott Avenue bridge in Wichita Falls, Texas.

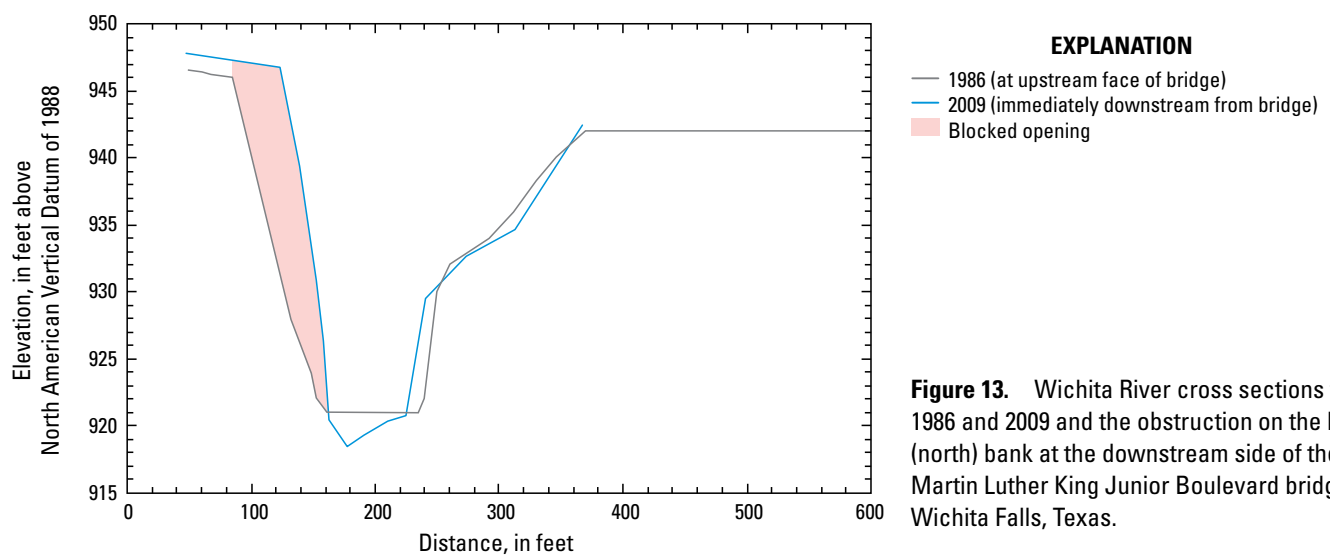
**Figure 13.** Wichita River cross sections from 1986 and 2009 and the obstruction on the left (north) bank at the downstream side of the Martin Luther King Junior Boulevard bridge in Wichita Falls, Texas.

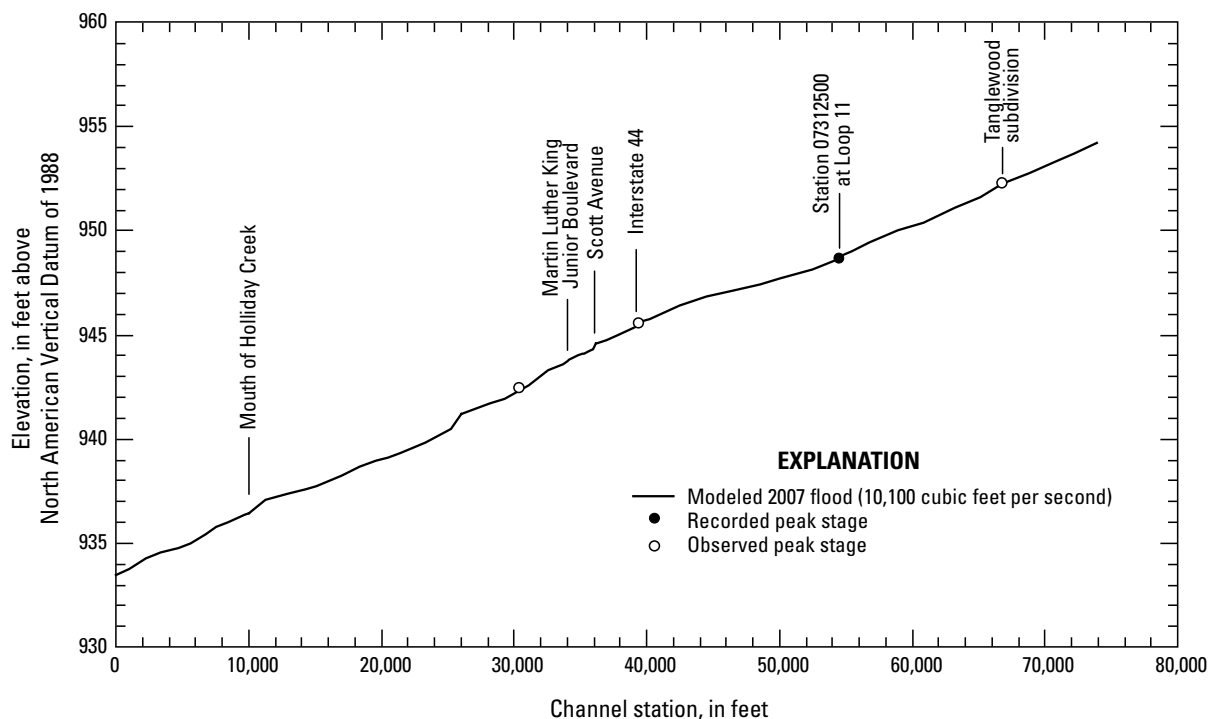
**Figure 14.** Calibrated water-surface profile for the 2007 flood on the Wichita River at Wichita Falls, Texas.

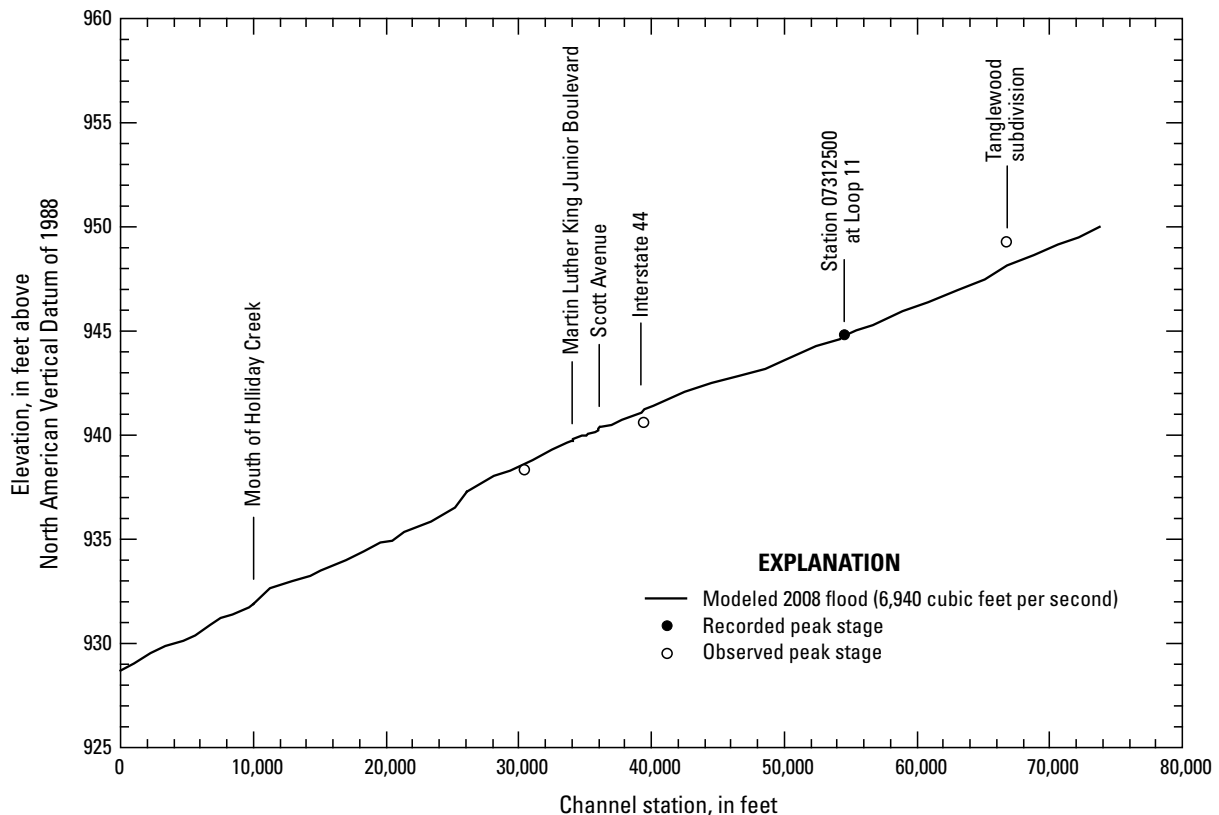
**Figure 15.** Calibrated water-surface profile for the 2008 flood on the Wichita River at Wichita Falls, Texas.

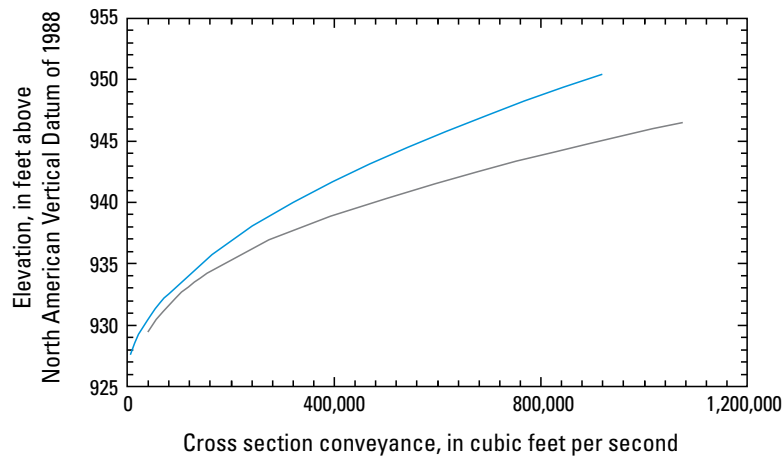
**Figure 16.** Cross-section conveyance computed from 1991 Federal Emergency Management (FEMA) HEC-2 model (1991 FEMA) and 2009 U.S. Geological Survey HEC-RAS model (2009 USGS) at U.S. Geological Survey streamflow-gaging station 07312500 Wichita River at Wichita Falls, Texas (Loop 11 gage).

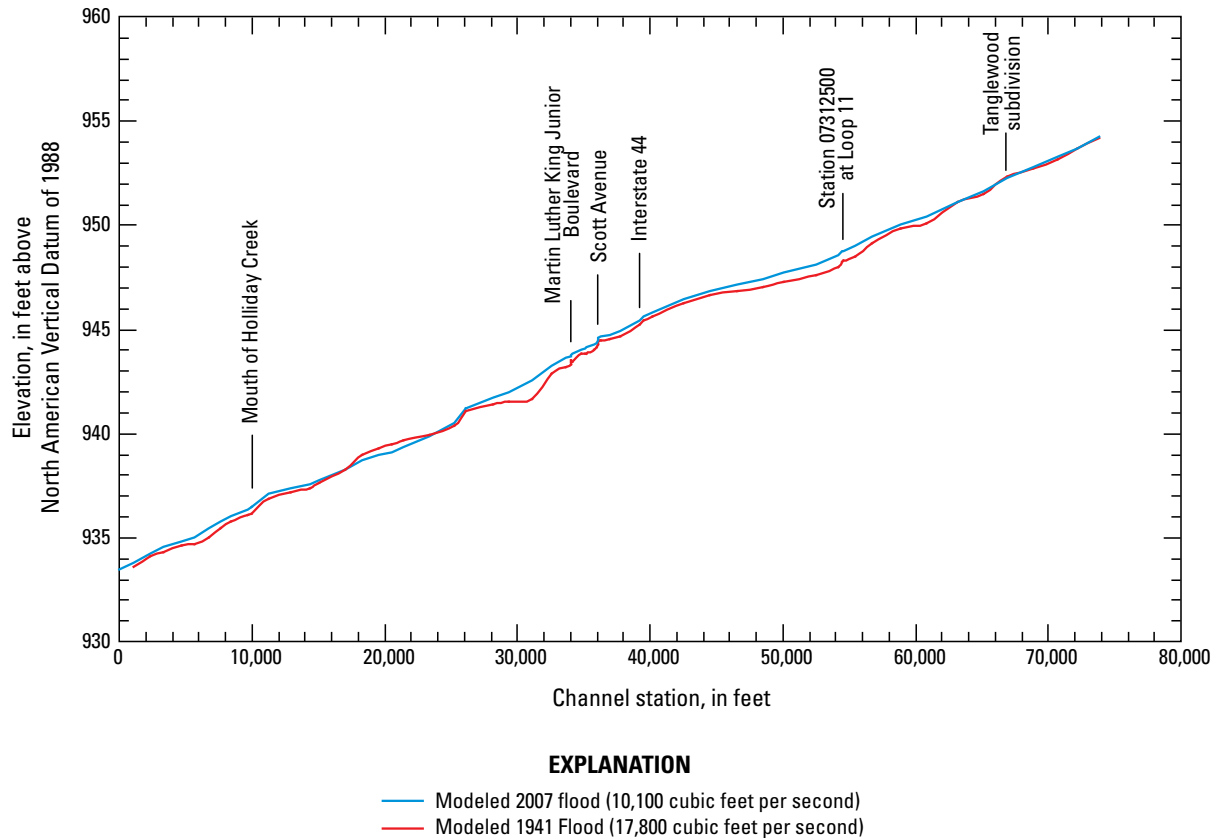
**Figure 17.** Calibrated water-surface profiles for the 2007 and 1941 floods on the Wichita River at Wichita Falls, Texas.

was the channel historically. The first steps in modeling the 1941 flood include the simulated removal of all bridge obstructions near Scott Avenue and Martin Luther King Junior Boulevard (figs. 11-13), and of the aggraded channel banks downstream from Martin Luther King Junior Boulevard (fig. 10). The extent of the earth-fill areas in cross sections near the Scott Avenue and Martin Luther King Junior bridges was determined from patterns in the 2-ft elevation contours, and these fill areas—as evidenced from aerial photographs, historical cross sections, and discussions with the owner of a business on Scott Avenue adjacent to the Wichita River (Peter Pullin, oral commun., June 23, 2009)—were most likely placed after the 1941 flood. These fill areas near the Scott Avenue and Martin Luther King Junior bridges were removed from the cross sections used to model the 1941 flood. The 1941 flood was calibrated solely on the basis of its recorded peak stage at the Loop 11 gage. The calibrated Manning’s  $n$  for the Wichita River channel for the 1941 flood is 0.030, which is a relatively small value for a natural channel, indicating that the channel was cleaner in 1941 compared to 2007 when the Manning’s  $n$  for the Wichita River was 0.048. The calibrated water-surface profile for the 1941 flood is shown in figure 17, along with the calibrated 2007 flood profile for comparison.

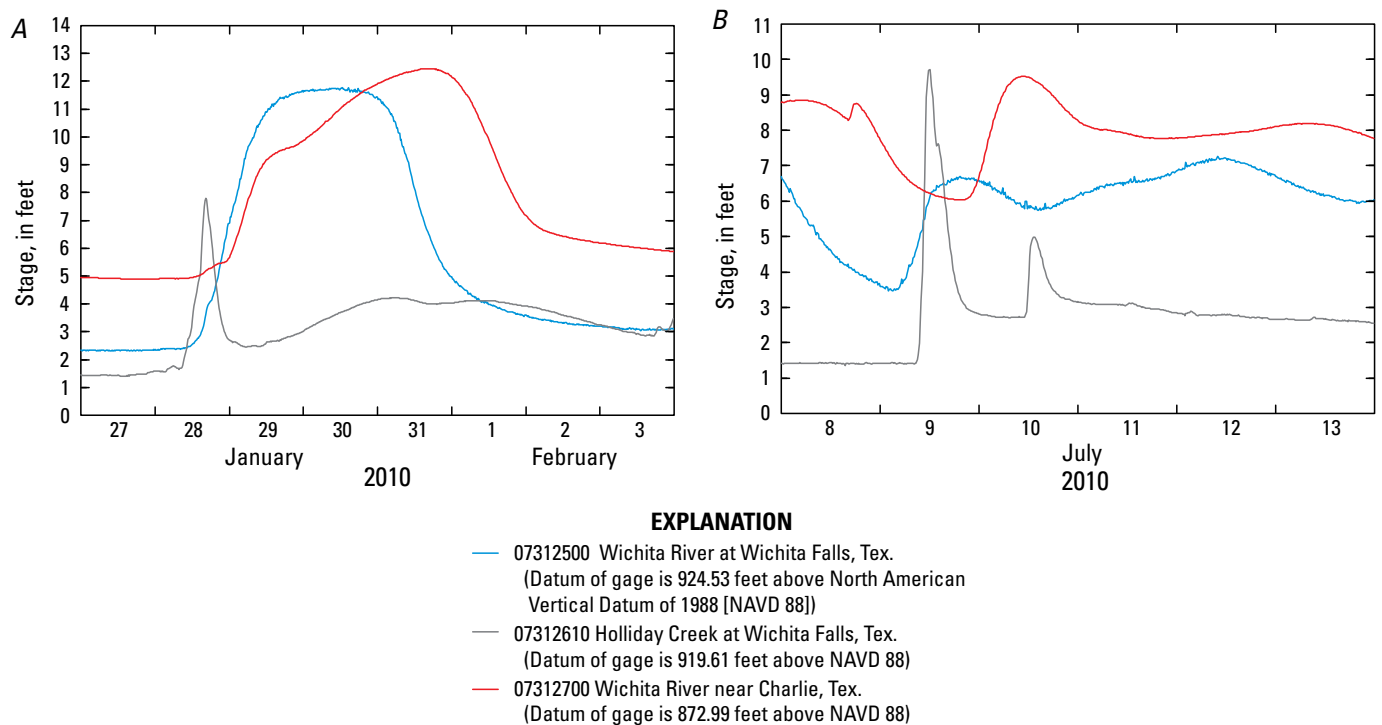
**Figure 18.** Stage hydrographs during A, January 2010, and B, July 2010 at U.S. Geological Survey streamflow-gaging stations 07312500 Wichita River at Wichita Falls, Texas (Loop 11 gage), 07312610 Holliday Creek at Wichita Falls, Tex. (Holliday Creek gage), and 07312700 Wichita River near Charlie, Tex. (Wichita River near Charlie, Tex., gage).

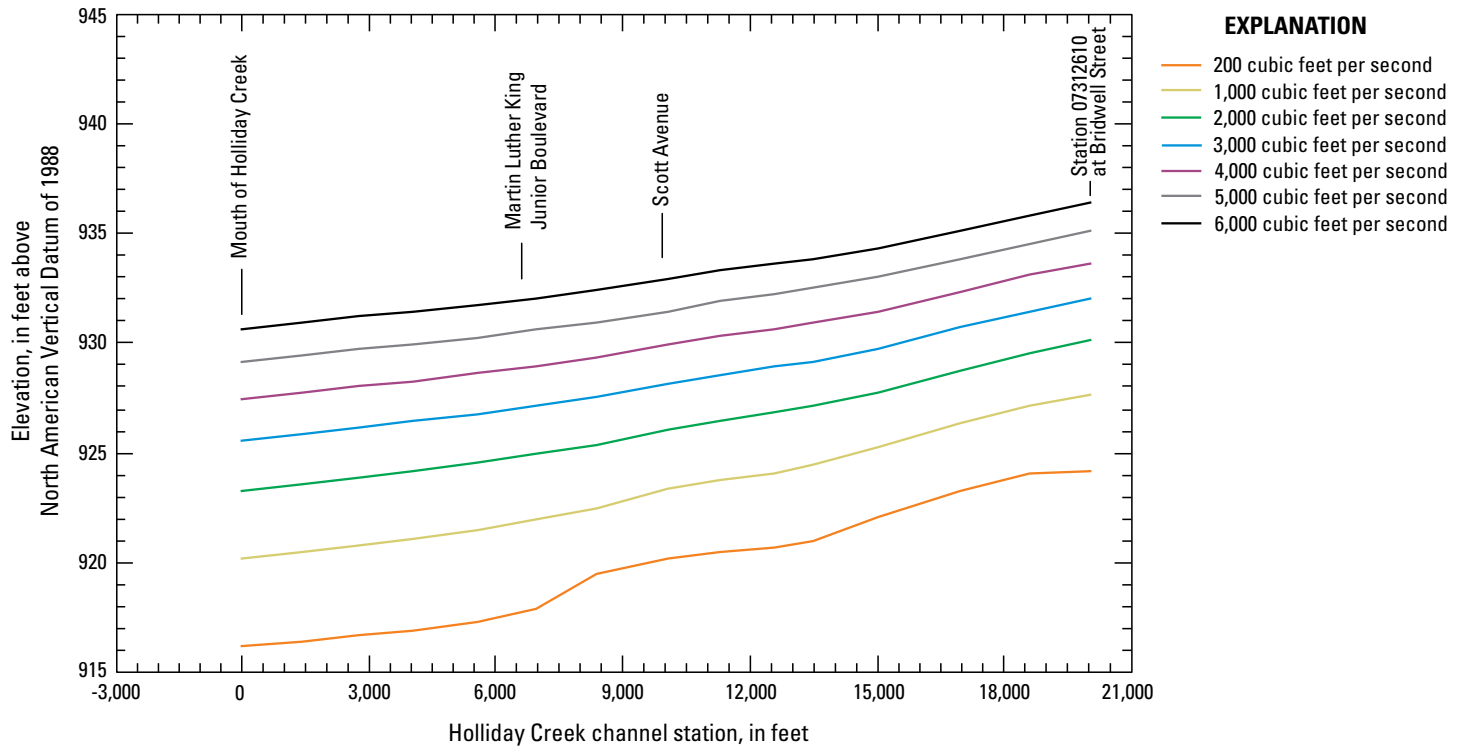
**Figure 19.** Water-surface profiles computed for various streamflow amounts in Holliday Creek, with no backwater from the Wichita River, Wichita Falls, Texas.

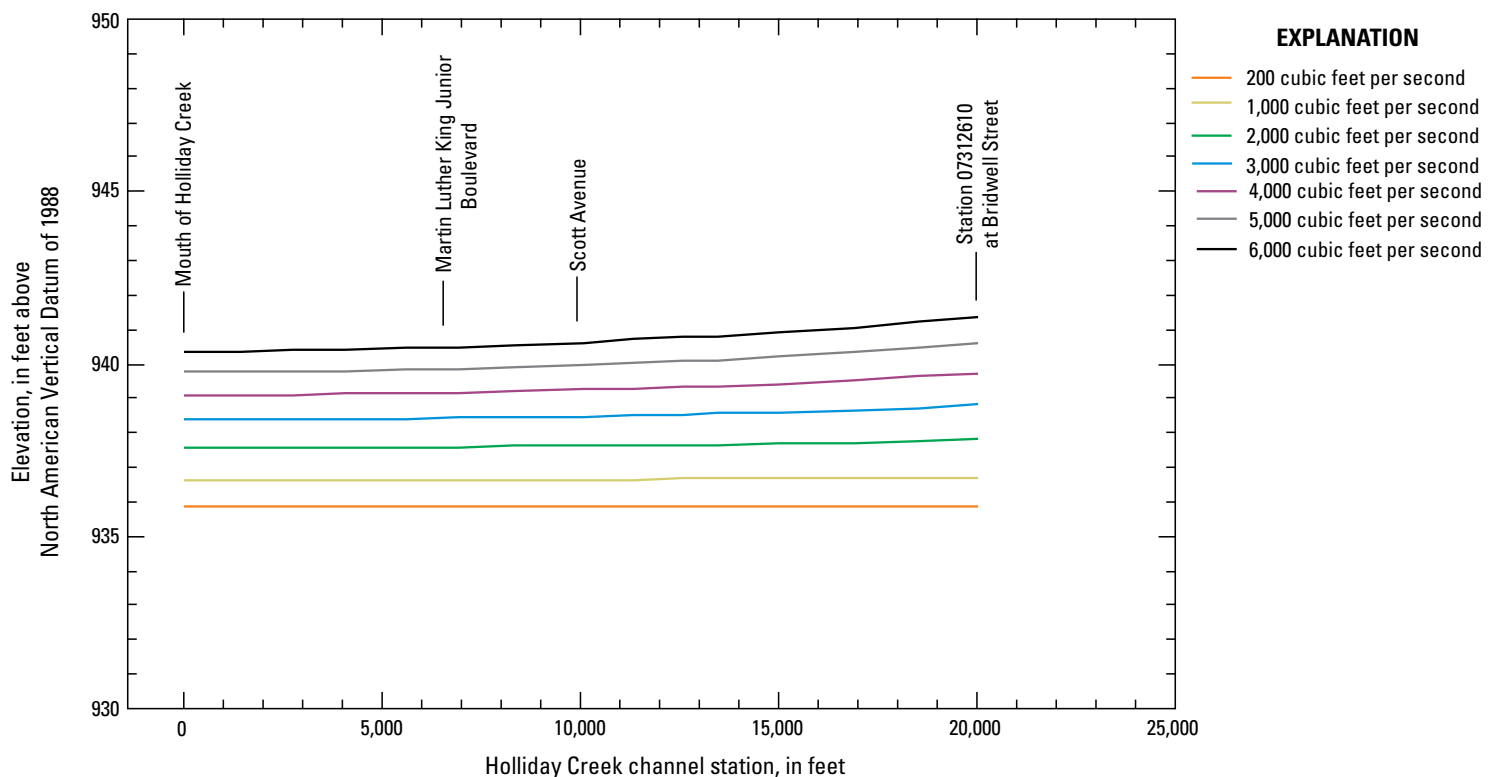
**Figure 20.** Water-surface profiles computed for various streamflow amounts in Holliday Creek, with backwater caused by streamflow of 10,100 cubic feet per second in the Wichita River (the 2007 flood peak), Wichita Falls, Texas.

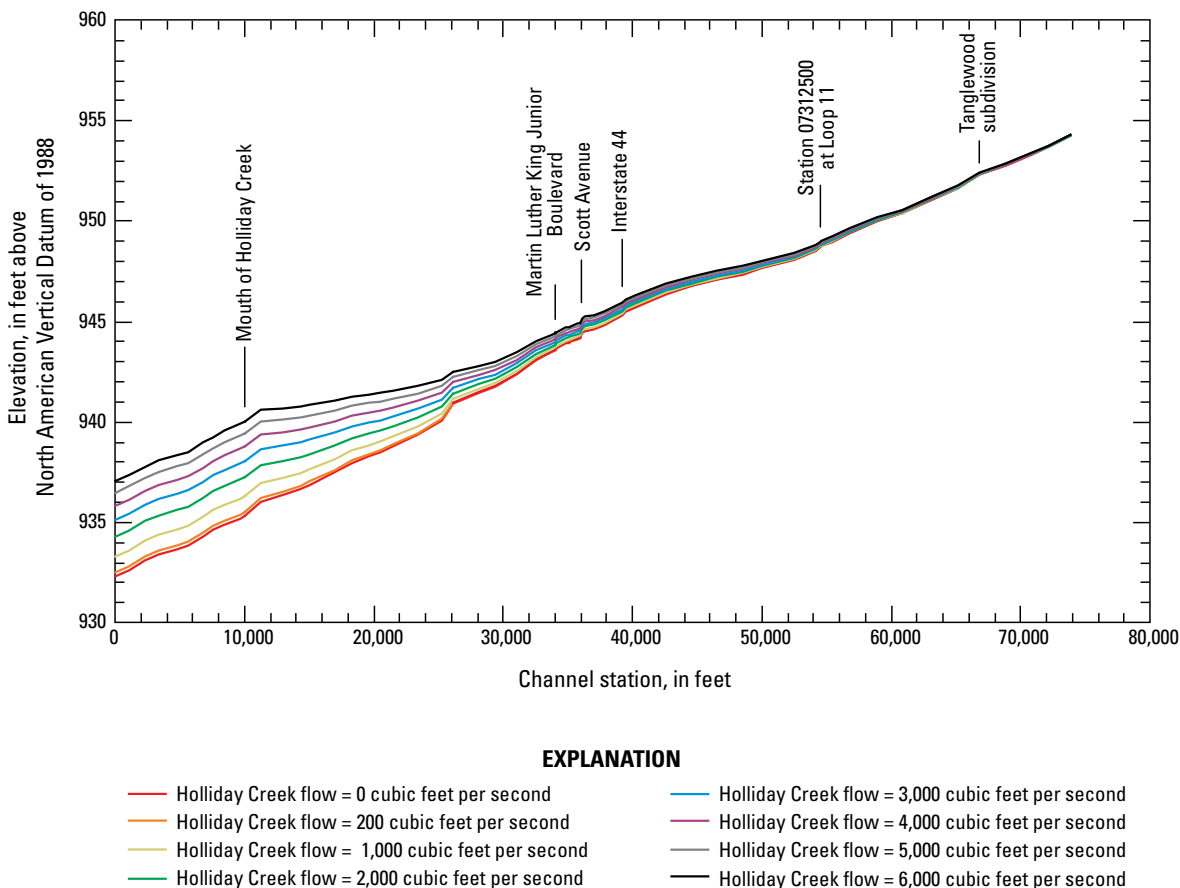
**Figure 21.** Computed water-surface profiles for streamflow of 10,100 cubic feet per second (the 2007 flood peak) in the Wichita River, with backwater caused by various streamflow amounts in Holliday Creek, Wichita Falls, Texas.

River and Holliday Creek. The effects of backwater decrease with distance upstream from the confluence (fig. 21). With 6,000 ft<sup>3</sup>/s of flow in Holliday Creek, computed water-surface elevations for the 2007 flood on the Wichita River at Loop 11 were 0.27 ft higher than those with no flow (0 ft<sup>3</sup>/s) in Holliday Creek.

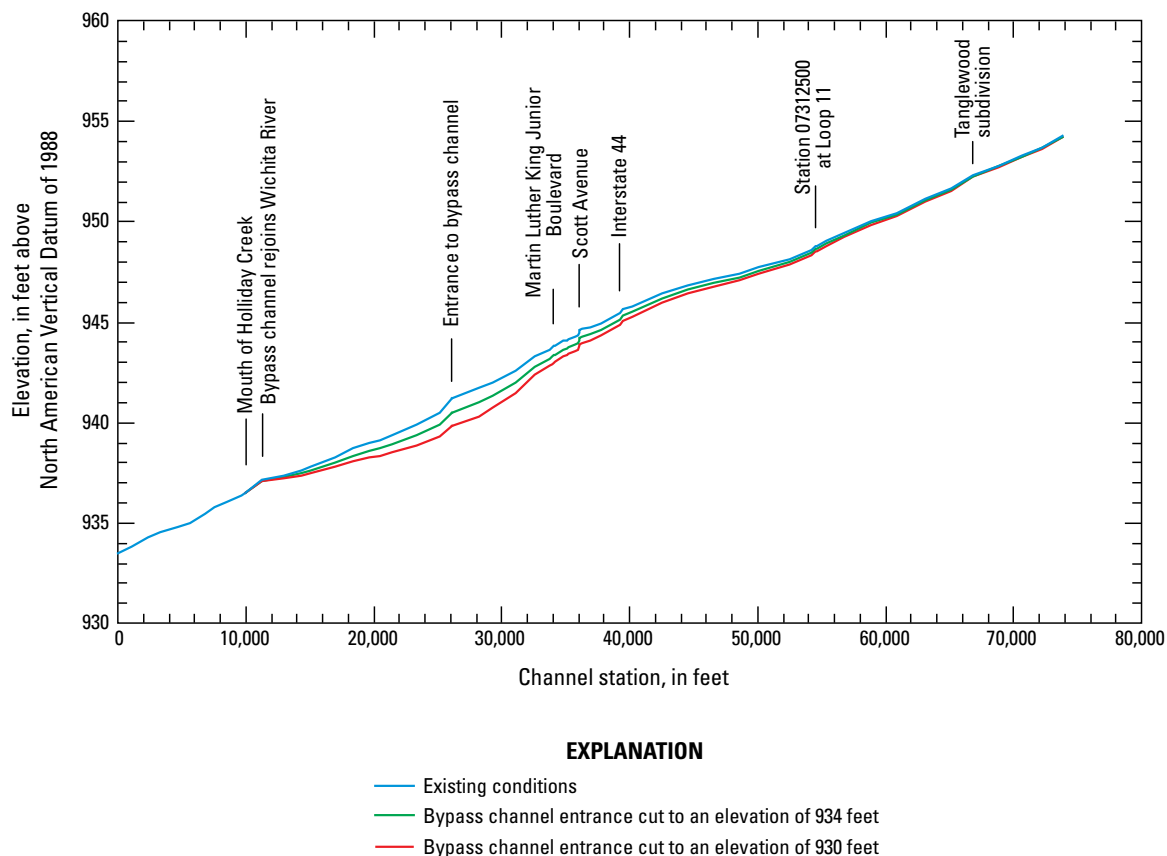
**Figure 22.** Computed water-surface profiles for streamflow of 10,100 cubic feet per second (the 2007 flood peak) in the Wichita River, with bypass channel cut deeper by 4 feet and 8 feet, Wichita Falls, Texas.

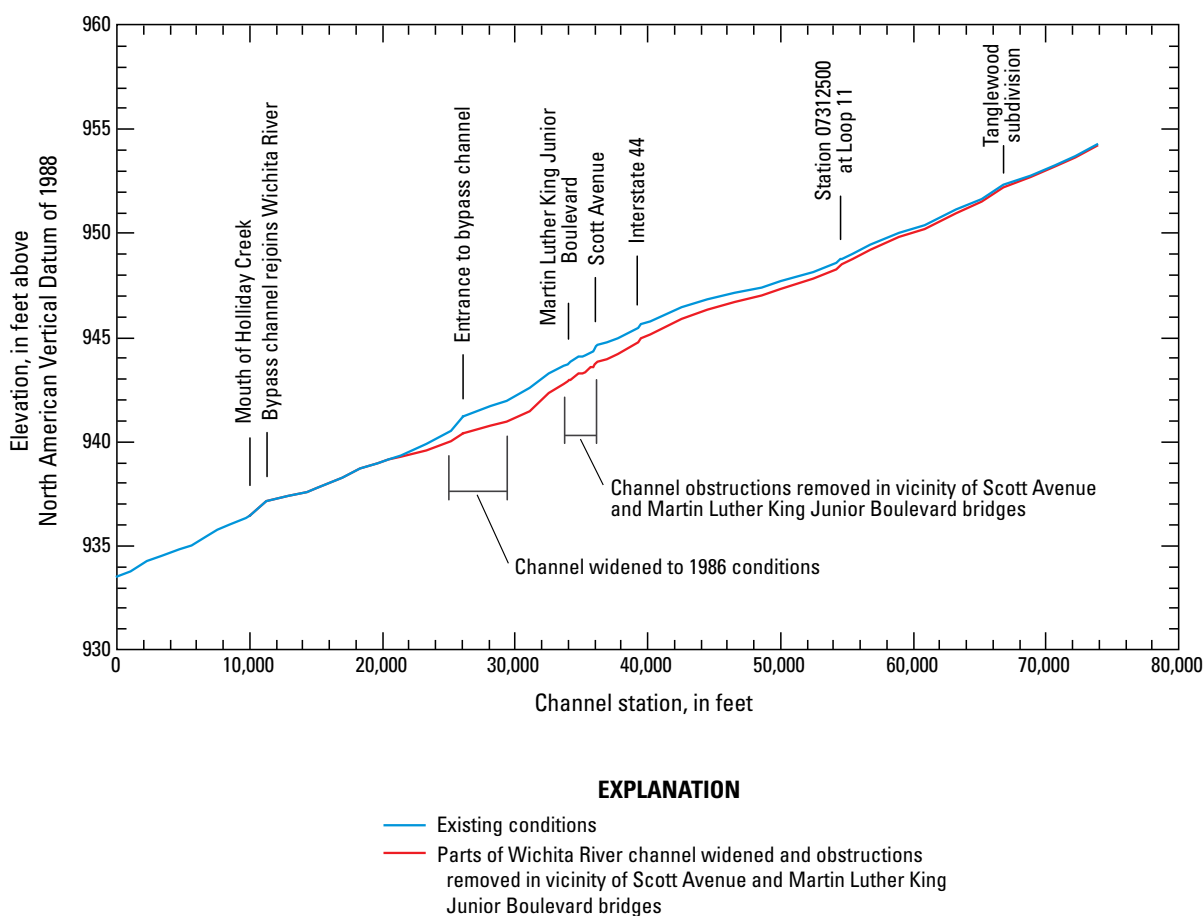
**Figure 23.** Computed water-surface profiles for streamflow of 10,100 cubic feet per second (the 2007 flood peak) in the Wichita River, with parts of the channel widened and obstructions near Scott Avenue and Martin Luther King Junior Boulevard bridges removed, Wichita Falls, Texas.
