# **Assessment of Channel Changes, Models of Historical Floods and Effects of Backwater on Flood Stage, and Flood Mitigation Alternatives for the Wichita River at Wichita Falls, Texas**

Scientific Investigations Report 2011–5175

By Karl E. Winters and Stanley Baldys III

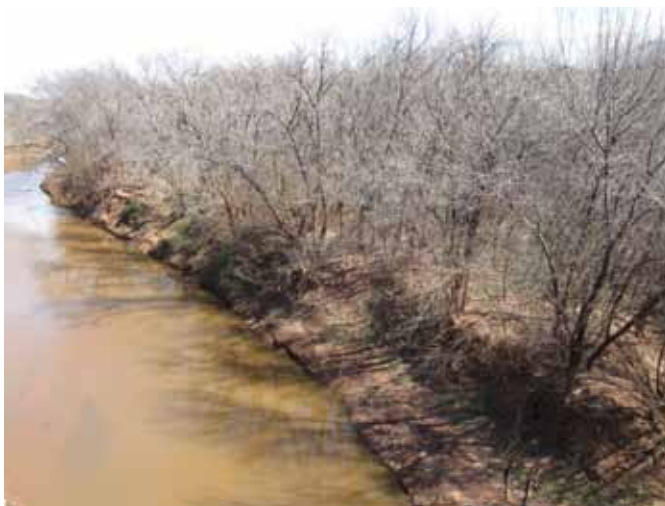
**Figure 24.** Looking downstream from Loop 11 at the U.S. Geological Survey streamflow-gaging station 07312500 Wichita River at Wichita Falls, Texas, February 25, 2009.

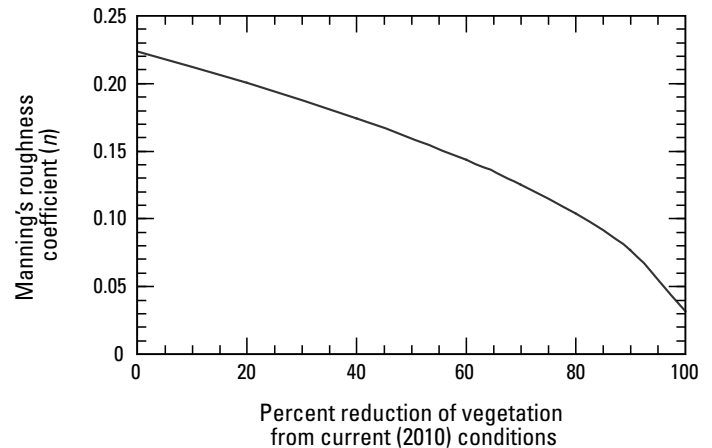
**Figure 25.** Reduction in Manning's roughness coefficient ( $n$ ) corresponding to a reduction in channel-bank and flood-plain vegetation, Wichita River at Wichita Falls, Texas.

the relation between vegetation density and Manning's  $n$  for the Wichita River at Wichita Falls, Tex. From figure 25, the Manning's  $n$  corresponding to a 20-percent reduction of vegetation is 0.20 (a 9-percent reduction in the roughness coefficient); the Manning's  $n$  corresponding to a 50-percent reduction in vegetation is 0.16 (a 27-percent reduction in roughness). Finally, the 2007 flood discharge is modeled for a 20-percent and a 50-percent reduction in vegetation. For a 20-percent reduction in vegetation, computed flood stages were reduced as much as 1.0 ft and, on average (for the entire modeled reach), 0.9 ft. For a 50-percent reduction in vegetation, computed flood stages were reduced as much as 3.0 ft and, on average, 2.6 ft (fig. 26).

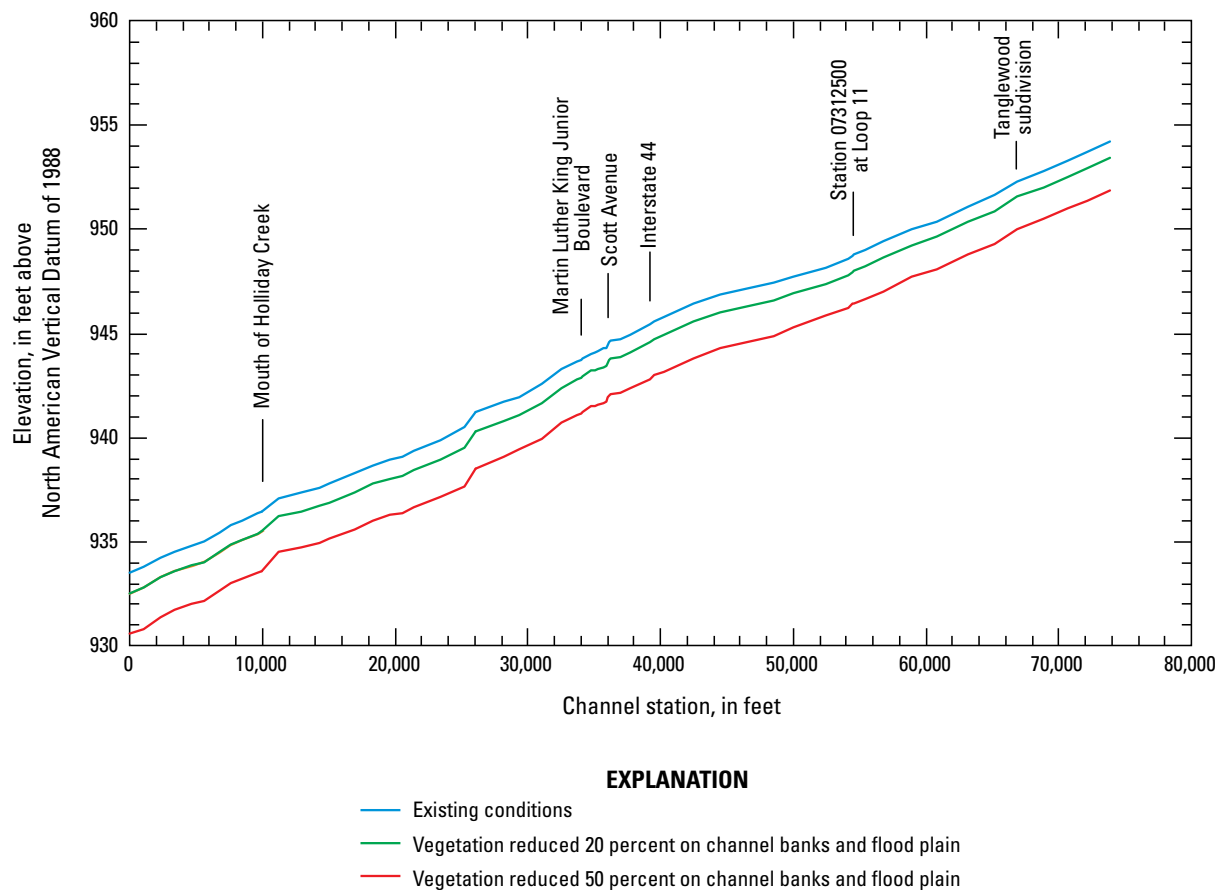
**Figure 26.** Water-surface profiles computed for streamflow of 10,100 cubic feet per second (the 2007 flood) in the Wichita River, with vegetation reduced 20 and 50 percent on the channel banks and flood plain, Wichita Falls, Texas.

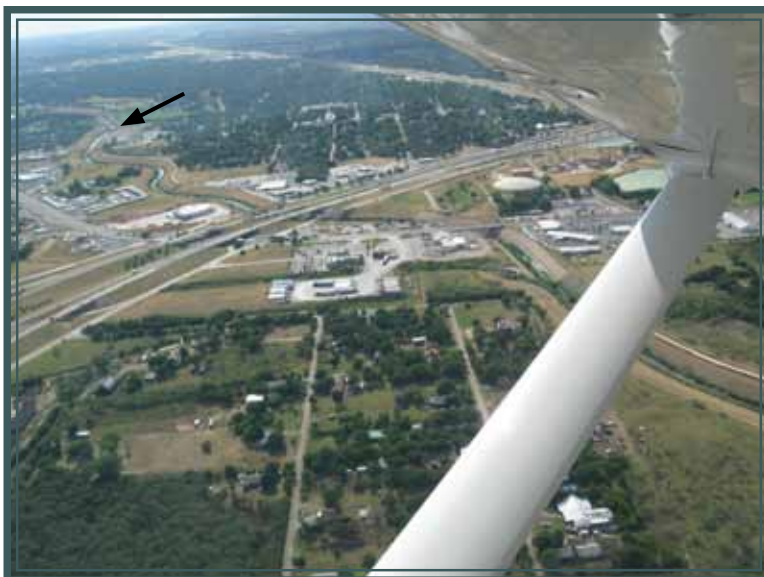
**Top photograph,** Looking upstream along Holliday Creek, August 23, 2010. The arrow indicates the location of U.S. Geological Survey streamflow-gaging station 07312610 Holliday Creek at Wichita Falls, Texas.
