NASA/CR-2005-213910

Transmitter Signal Measurements, Task 5C Report

*Kent Horton, Brian Eppic, Mitch Huffman, and Harrison White
Delta Air Lines, Technical Operations Center, Atlanta, Georgia*

NASA National Aeronautics and Space Administration (NASA) and Delta continue to collect quantitative data through the Cooperative Agreement NCC-1-381. Task 5C – Transmitter Signal Measurements was completed and this report summarizes the work accomplished, the findings, and data that were generated. Signal Measurements were obtained on four (4) different airport systems. Systems measured were Localizer (LOC), Very High Frequency Communication, (VHF), Glideslope, (G/S), and Global Positioning System (GPS). The task calls for path loss measurements to be taken at Hartsfield-Jackson International Airport (ATL) and one smaller airport which was Greenville/Spartanburg Airport (GSP) to determine relative signal strengths on the airport properties.

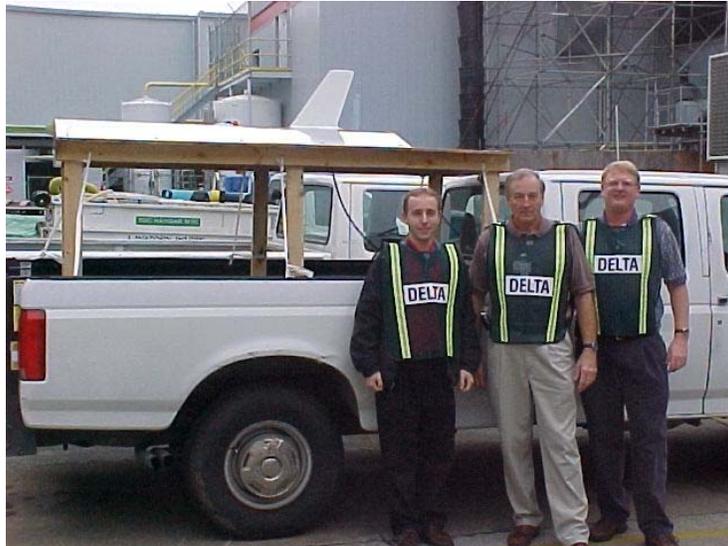
Figure 1 – Test Team and Antenna Mockup

A mock up aircraft fuselage was designed that housed the four particular antennas for Very High Frequency, Glide Slope, Localizer and Global Positioning System. These antennas were mounted on various positions of the exterior surface of the mockup, similar to the antenna configuration on aircraft. Figures 1, 2, and 3 show the layout of the antennas on the mockup. This mockup was placed on the bed of a truck which was positioned at different locations around the two airport properties collecting samples in the various frequency ranges.

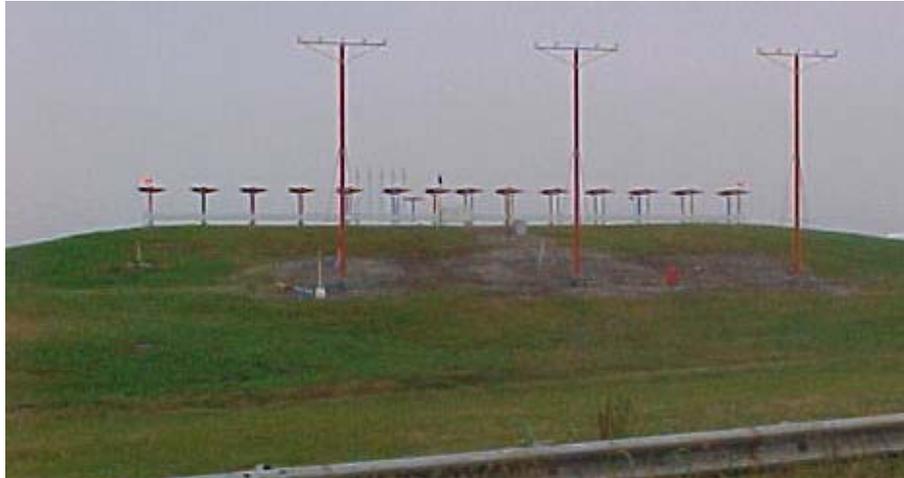
Figure 8 - Localizer Near Atlanta Test Point 2

LOC provides lateral guidance relative to the runway centerline in an ILS landing system. LOC is a highly directional signal using a multi-element phased antenna system that is horizontally polarized. Since we were limited to the elevation of the runway or below and due to the directivity of the LOC signal, it was impossible to measure the desired signal except at one or two test points.

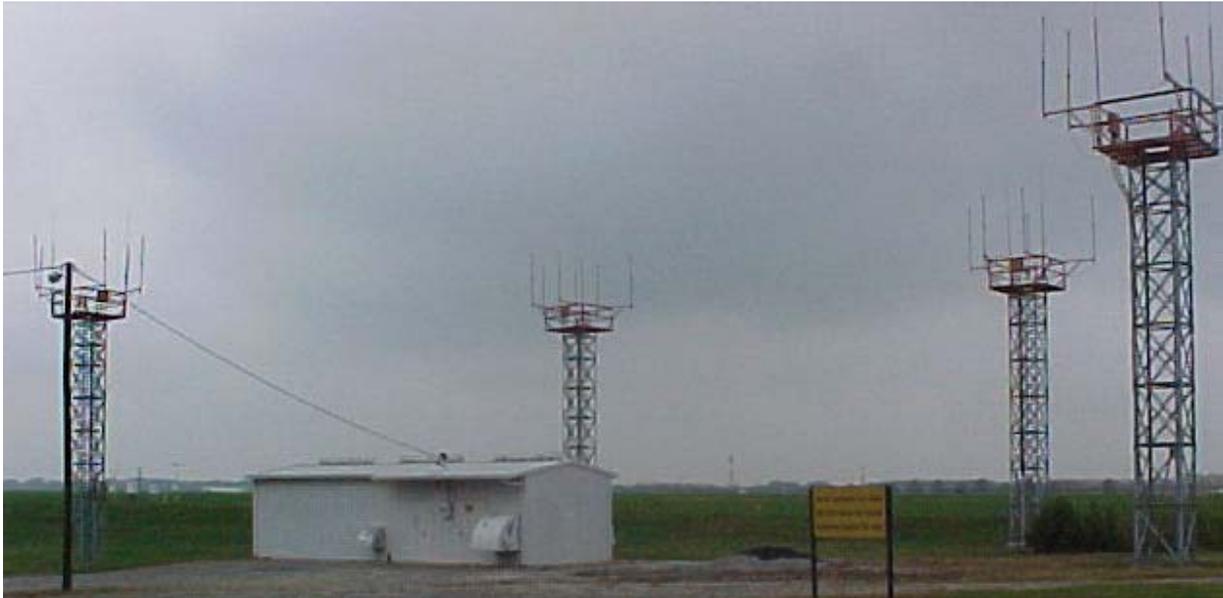
Figure 9 - VHF Antennas Near Atlanta Test Point 13

VHF data was collected over the complete commercial aviation VHF frequency range (116-138 MHz) and individual VHF frequency correlated with ground control or tower control. Since we were most interested in safe operations at the terminal environment, a ground control frequency was selected at each site (121.75 MHz-ATL, 121.9 MHz-GSP).

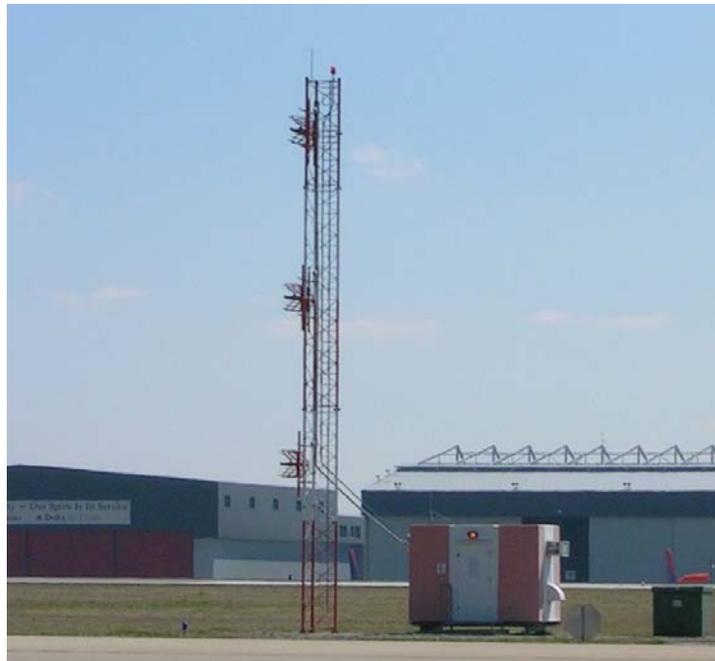
Figure 10 - GS Antennas Near Atlanta Test Point 3

GS data was taken around the frequency of 332 MHz. GLS is vertically directed and uses amplitude modulations of 90 and 150 kHz like the localizer. Glideslope provides vertical guidance in an ILS instrument landing system.
