FINAL REPORT

"DEVELOPMENT OF A CONTINUOUS SPINNING PROCESS  
FOR PRODUCING SILICON CARBIDE - SILICON  
NITRIDE PRECURSOR FIBERS"

CONTRACT NO. NAS8-34648

Bjorksten Research Laboratories, Inc.  
P.O. Box 9444  
Madison, Wisconsin 53715

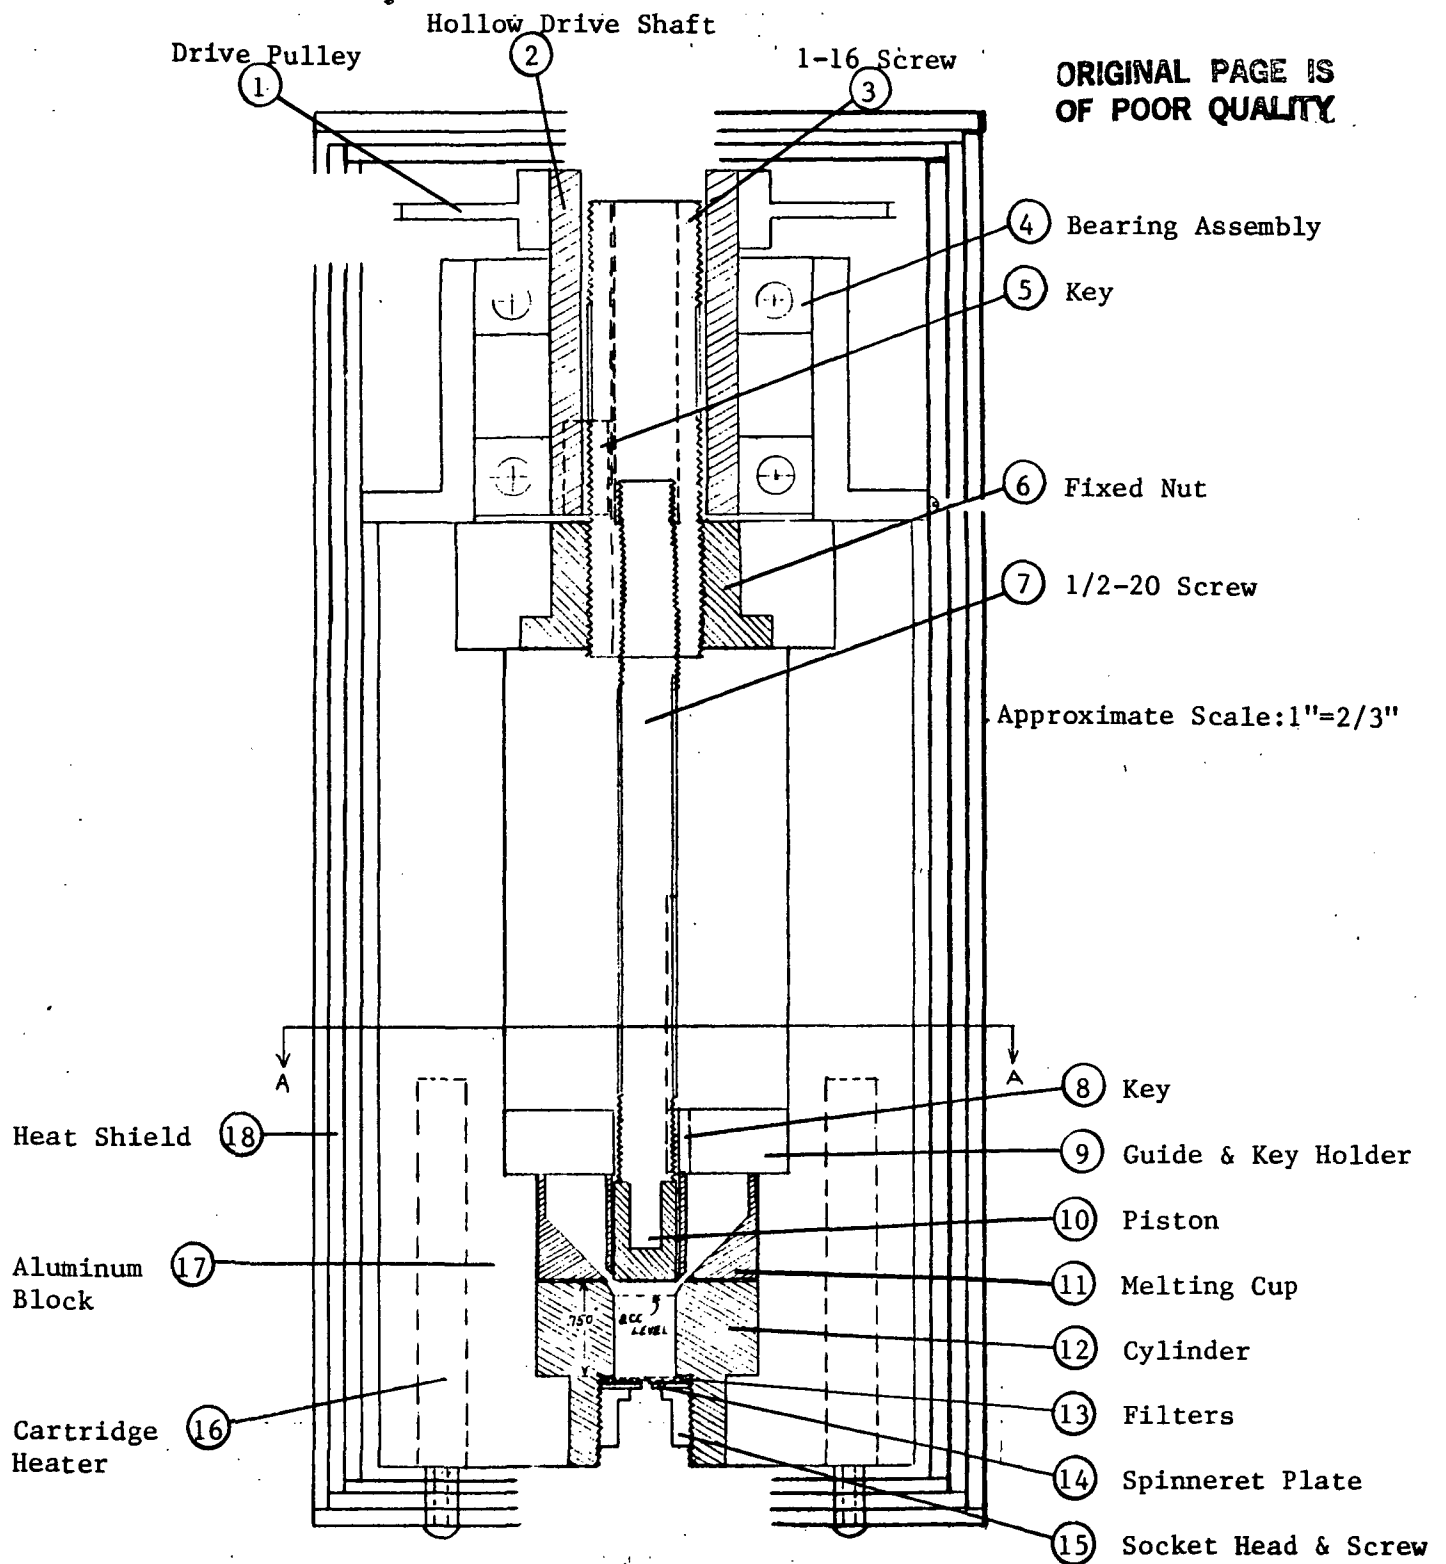
Figure 1. Extruder

Based on previous experience in these laboratories, a fiber extruder was designed. The operation of the design may be visualized by reference to Figure 1, a side view of the extruder.

The drive pulley (1) is powered by a main drive motor (not shown). A 1-16 screw (3) is locked to the drive shaft (2) by a key (5). Rotation of the pulley and drive shaft drives the 1-16 screw downward through the fixed nut (6). A 1/2-20 screw (7) with a removable piston (10) is threaded into the core of the 1-16 screw and restricted from rotation by a key (8). As the 1-16 screw is driven downward by the drive motor, the 1/2-20 screw is simultaneously withdrawn upward. The 1-16 screw advances downward 0.0625" per driveshaft revolution, while the 1/2-20 screw withdraws 0.0500". The net result is a 0.0125" per revolution piston advance.

By removing the heat shields (18), the main drive assembly (secured by four screws not shown), and withdrawing the 1/2-20 shaft key (8) the entire drive unit and piston can be removed from the extruder block. This permits manual loading of the resin in the melting cup (11).

Resin melting is accomplished by cartridge heaters (16) installed in the aluminum block (17). Temperature is maintained by a temperature controller unit (not shown) and thermocouples positioned in the melting pot and at the spinneret orifice. Hollow heat shields (18) thermally insulate the apparatus. A removable

socket head screw (15) secures the spinneret plate (14) and optional filters (13) at the base of the melting pot/extrusion cylinder cavity.

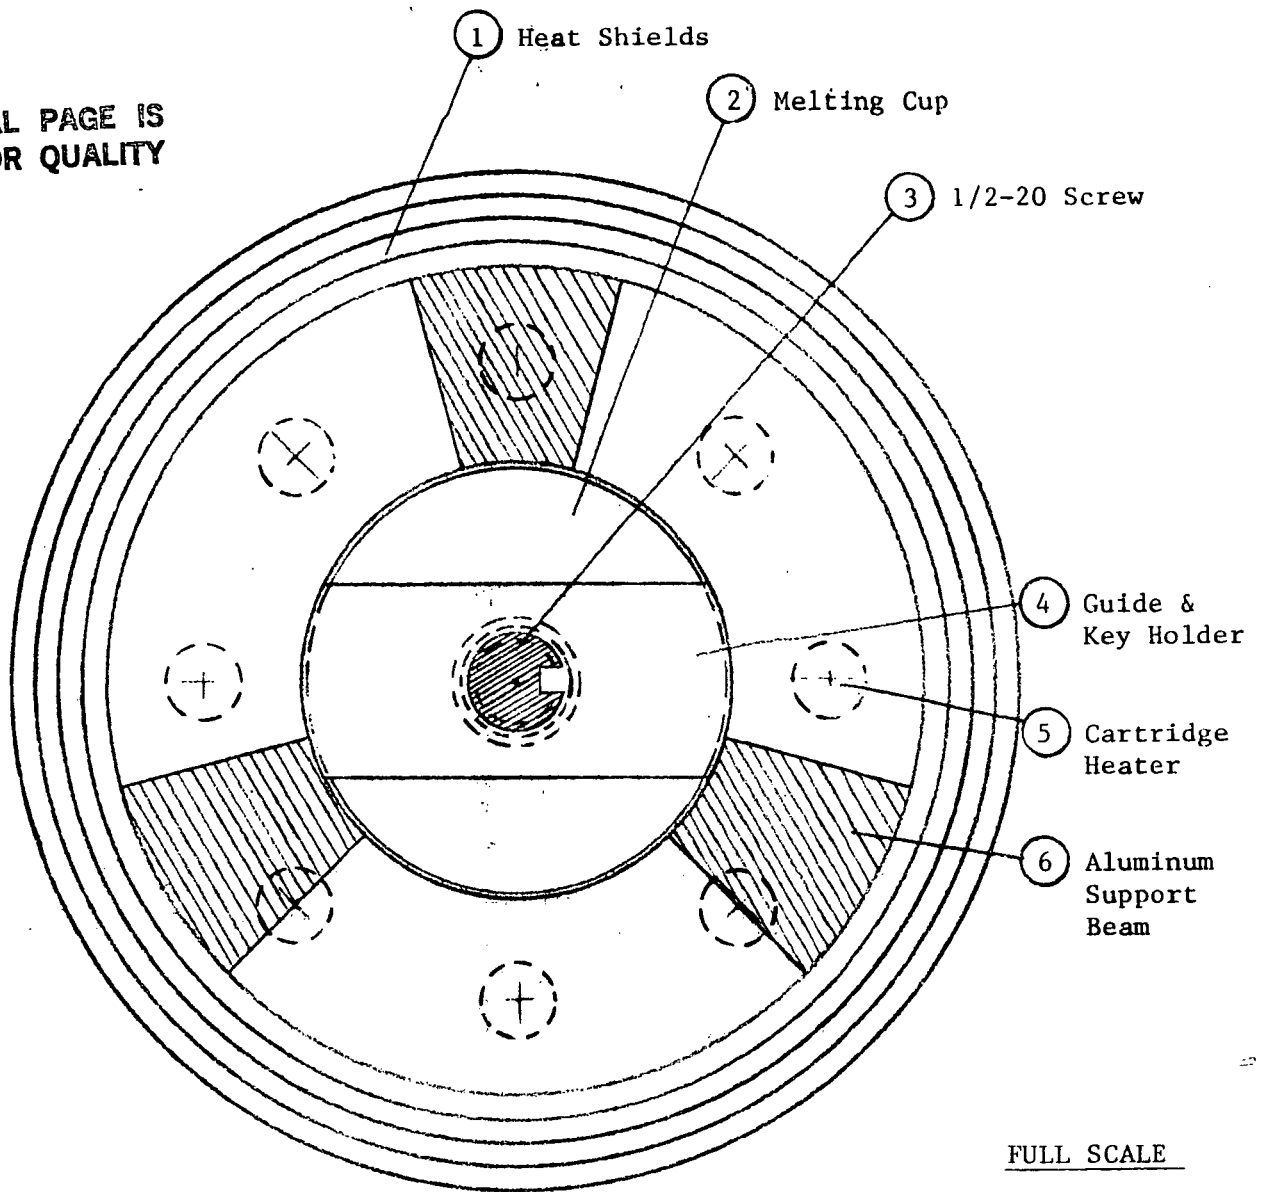
Figure 2. Cross-Section AA

Figure 2 is a cross-sectional view of the unit (at Section AA in Figure 1). It illustrates positioning of the aluminum support beams (6) which span from just above the screw guides and key holder (4) to the 1-16 fixed nut (Figure 1). The gaps between beams allow access to the melting pot when the piston and drive unit are removed.

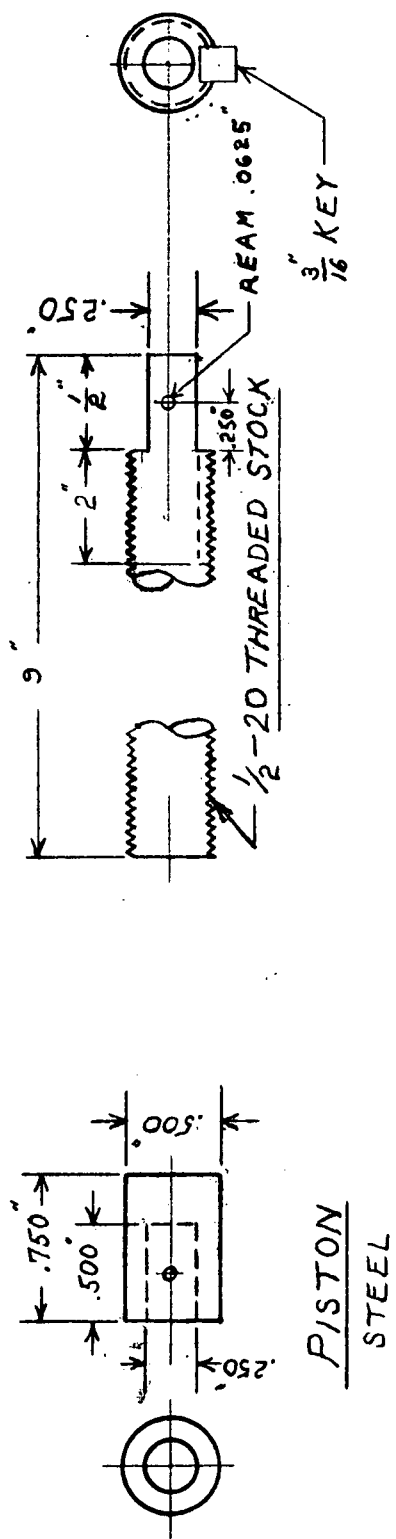
Figure 3.  
Differential Screw  
Full Scale

- Figure 3 - Differential screw and piston
- Figure 4 - Melting cup
- Figure 5 - Cylinder
- Figure 6 - Nut and holder
- Figure 7 - Lower guide and key holder
- Figure 8 - Body
- Figure 9 - Body
- Figure 10 - Bearing mount
- Figure 11 - Coupler assembly
- Figure 12 - Body - bottom view
- Figure 13 - Body - bottom view
- Figure 14 - Body - top view
- Figure 15 - Coupler, coupler sleeve and drive tube

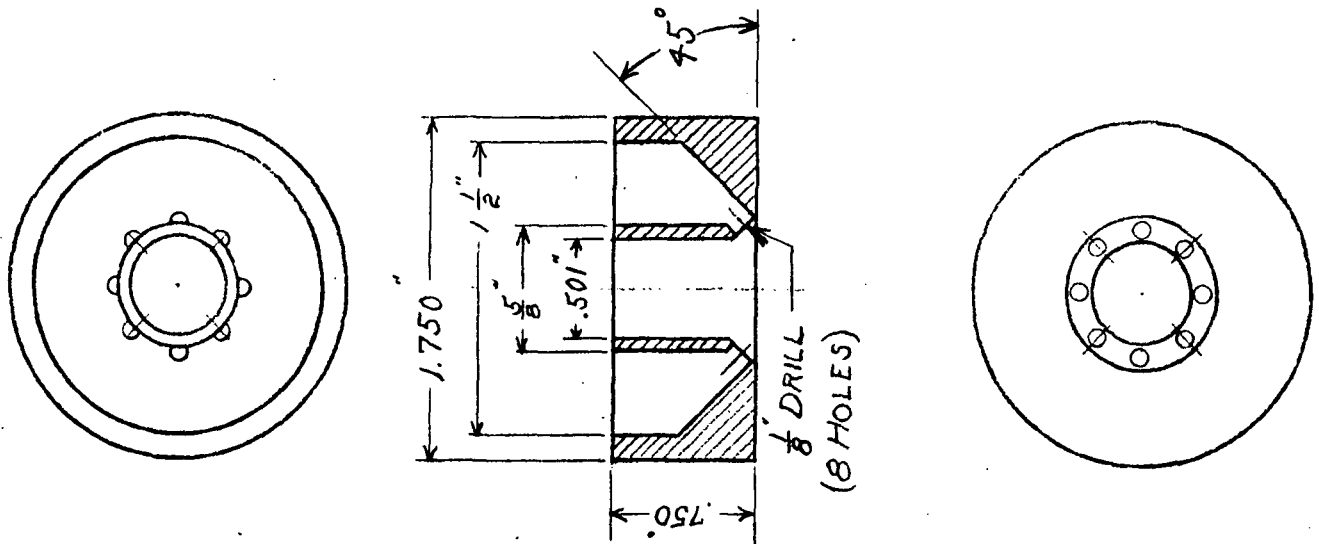
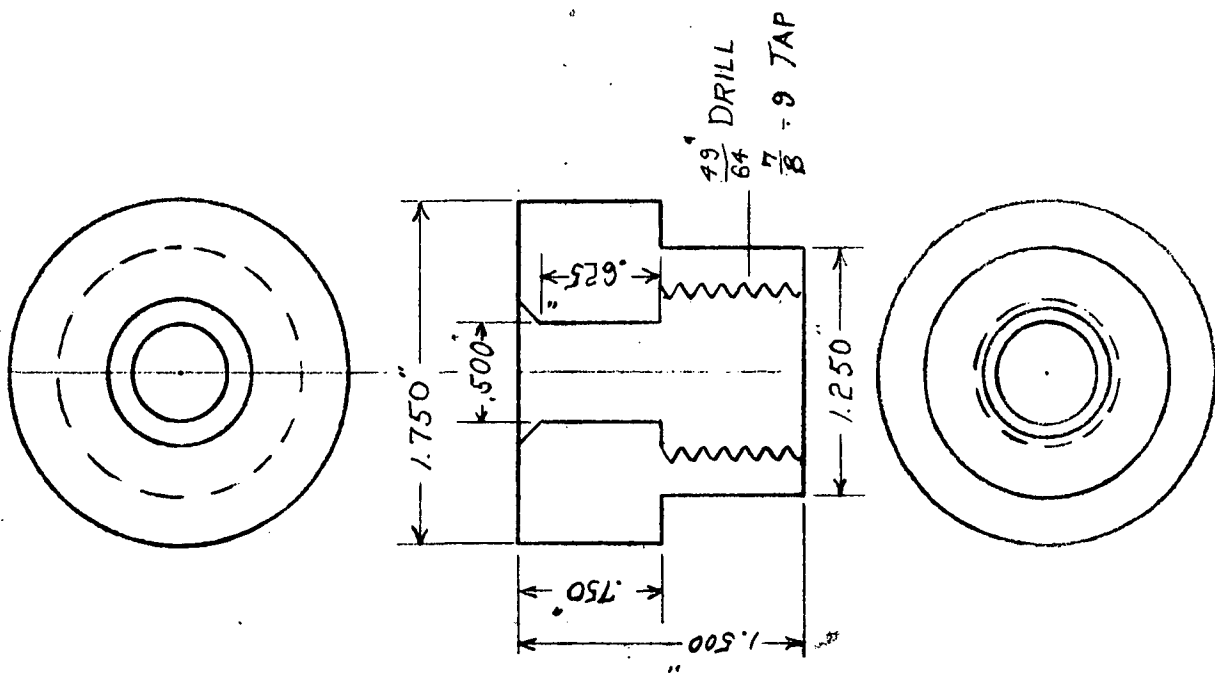
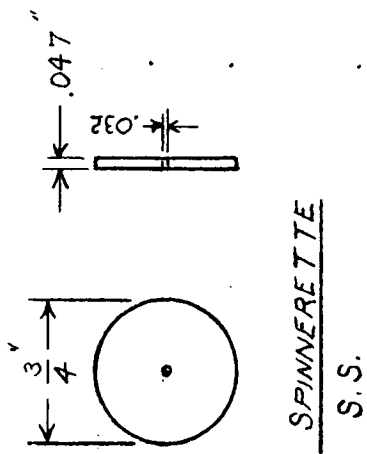
Figure 5.

Cylinder

Full Size

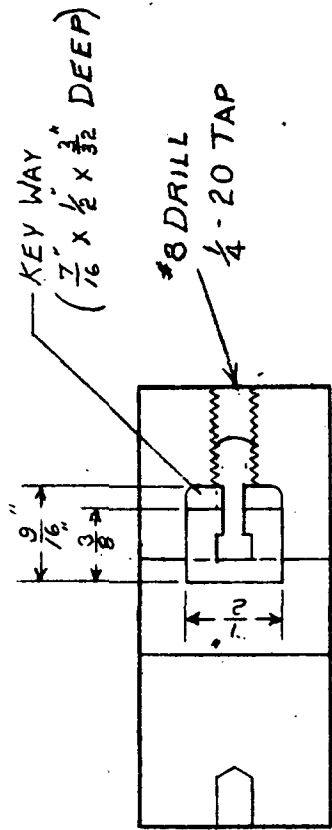
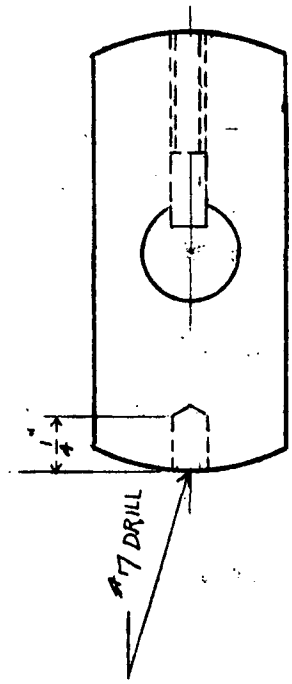
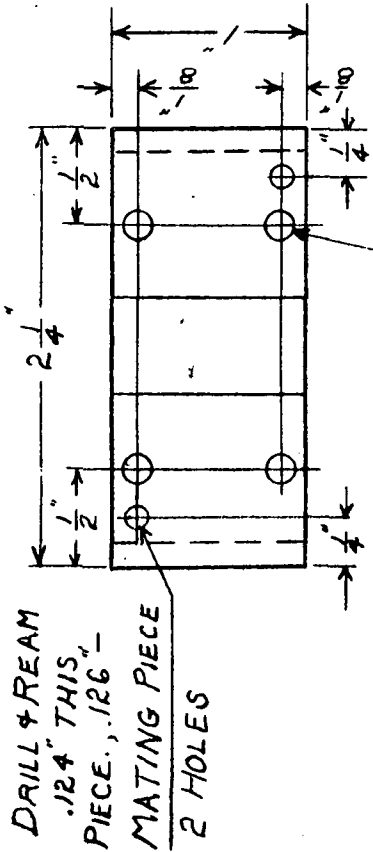
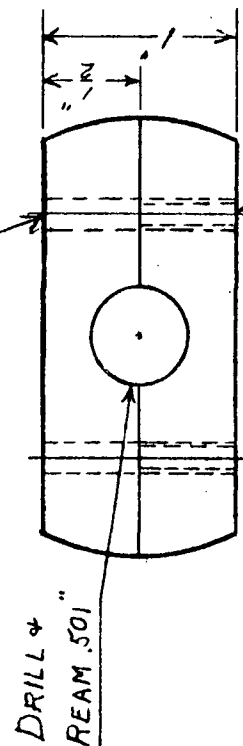
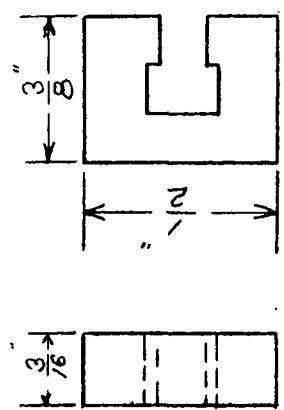
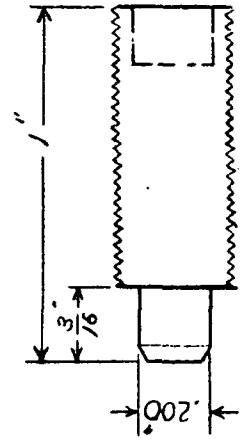
Figure 7.

LOWER GUIDE & KEY HOLDER  
A.L. FULL SCALE

#19 DRILL (4 HOLES)

#29 DRILL, 8-32 TAP  
(4 HOLES)

BRASS KEY

KEY SCREW

5/16 - 18 ANCHOR SCREW

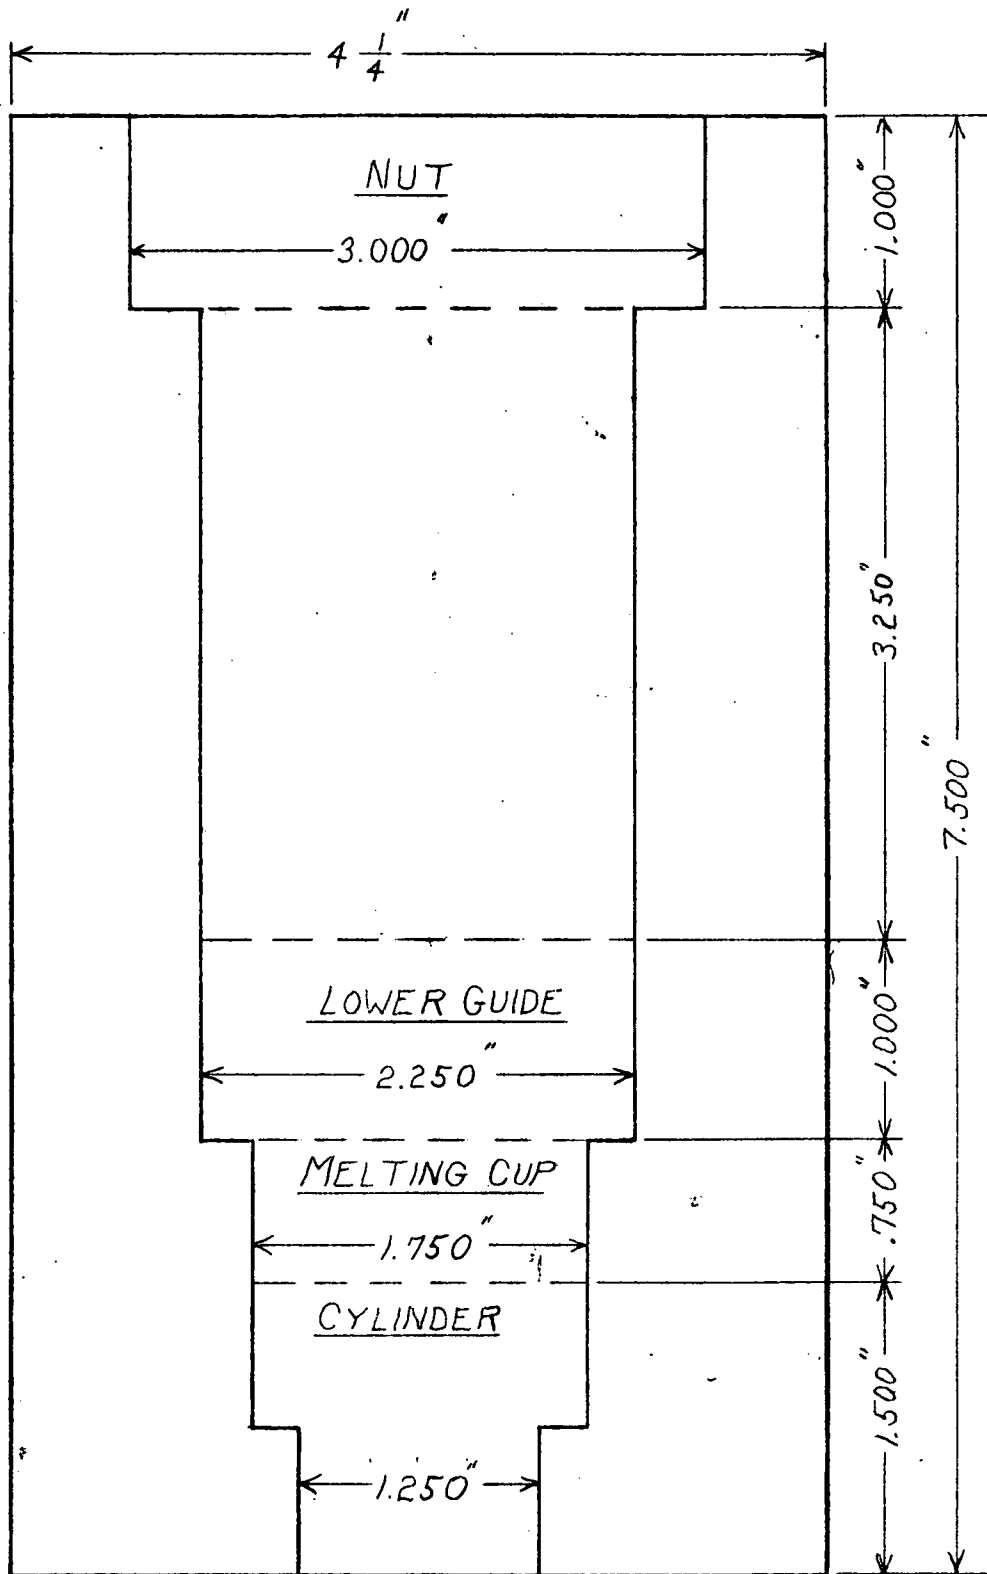
Figure 8.

Body

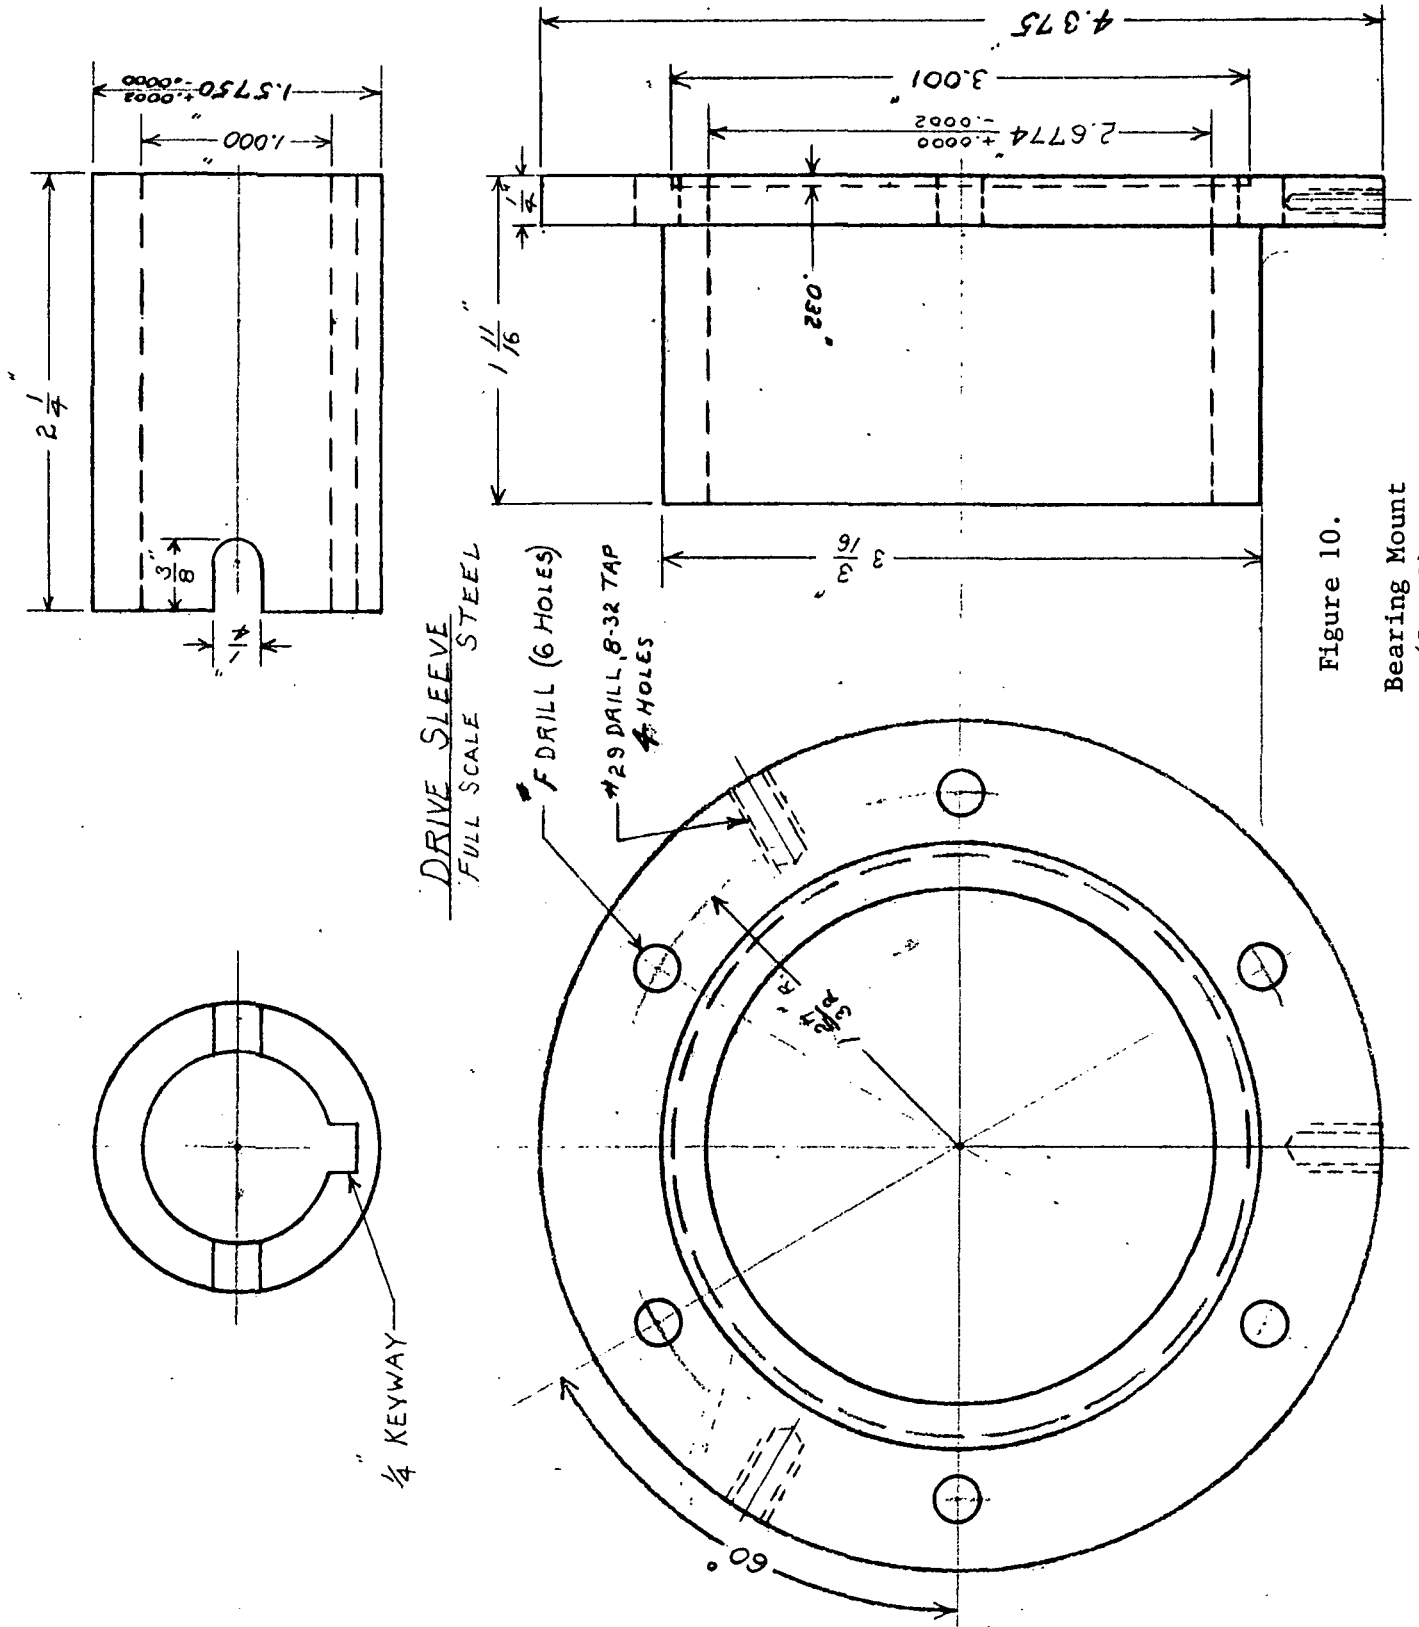
Figure 10.

Bearing Mount  
(Steel)

Full Scale

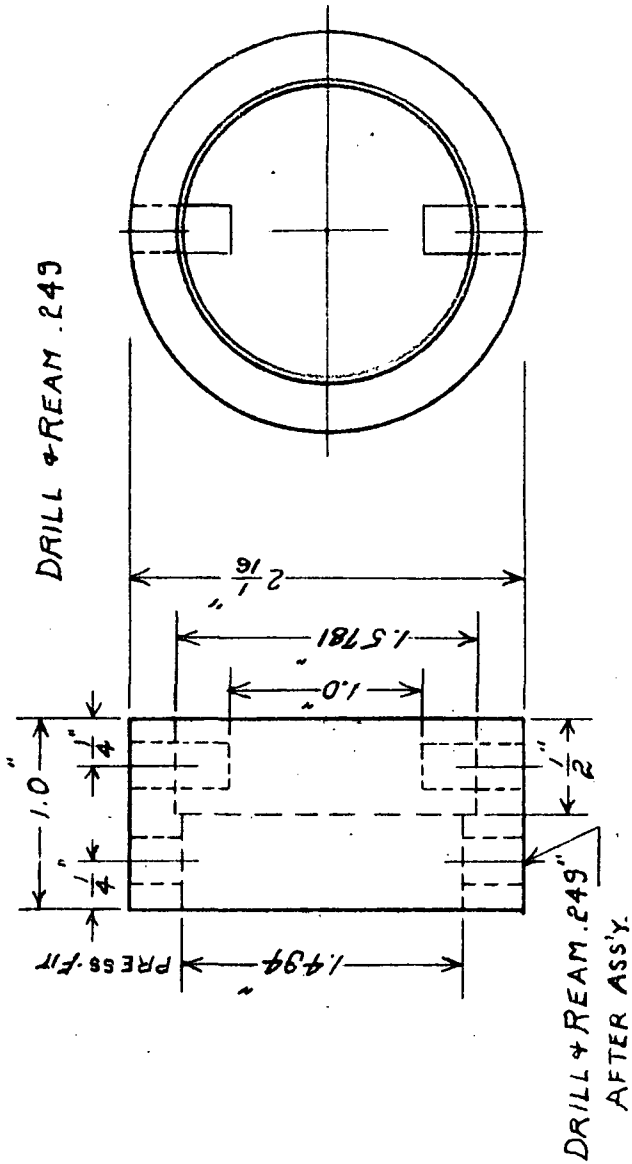
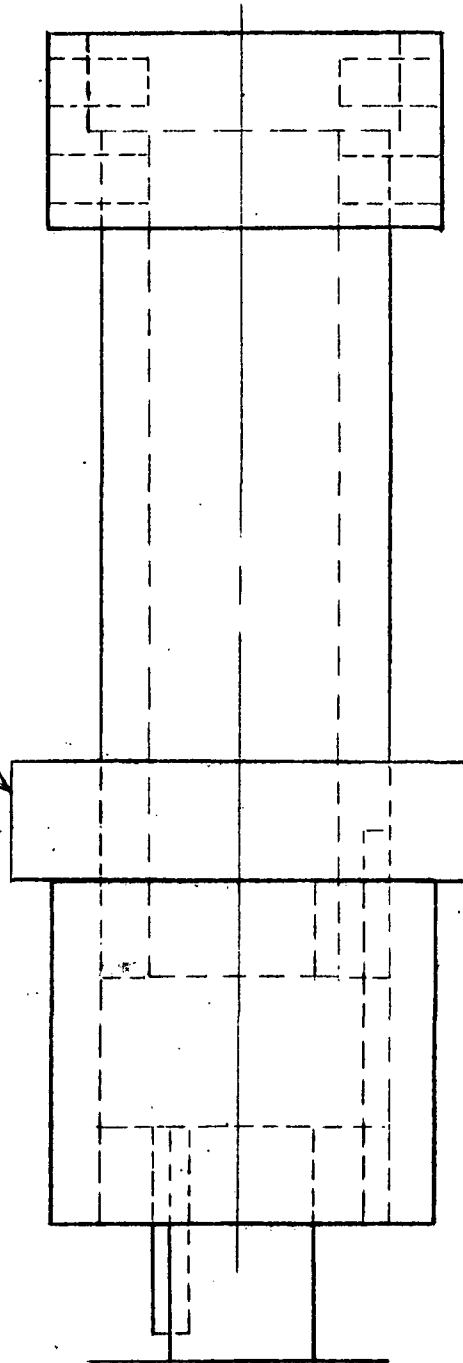
Figure 11.

COUPLER SOCKET  
STEEL 1:1

HOLD-KROME #15046

Coupler Assembly

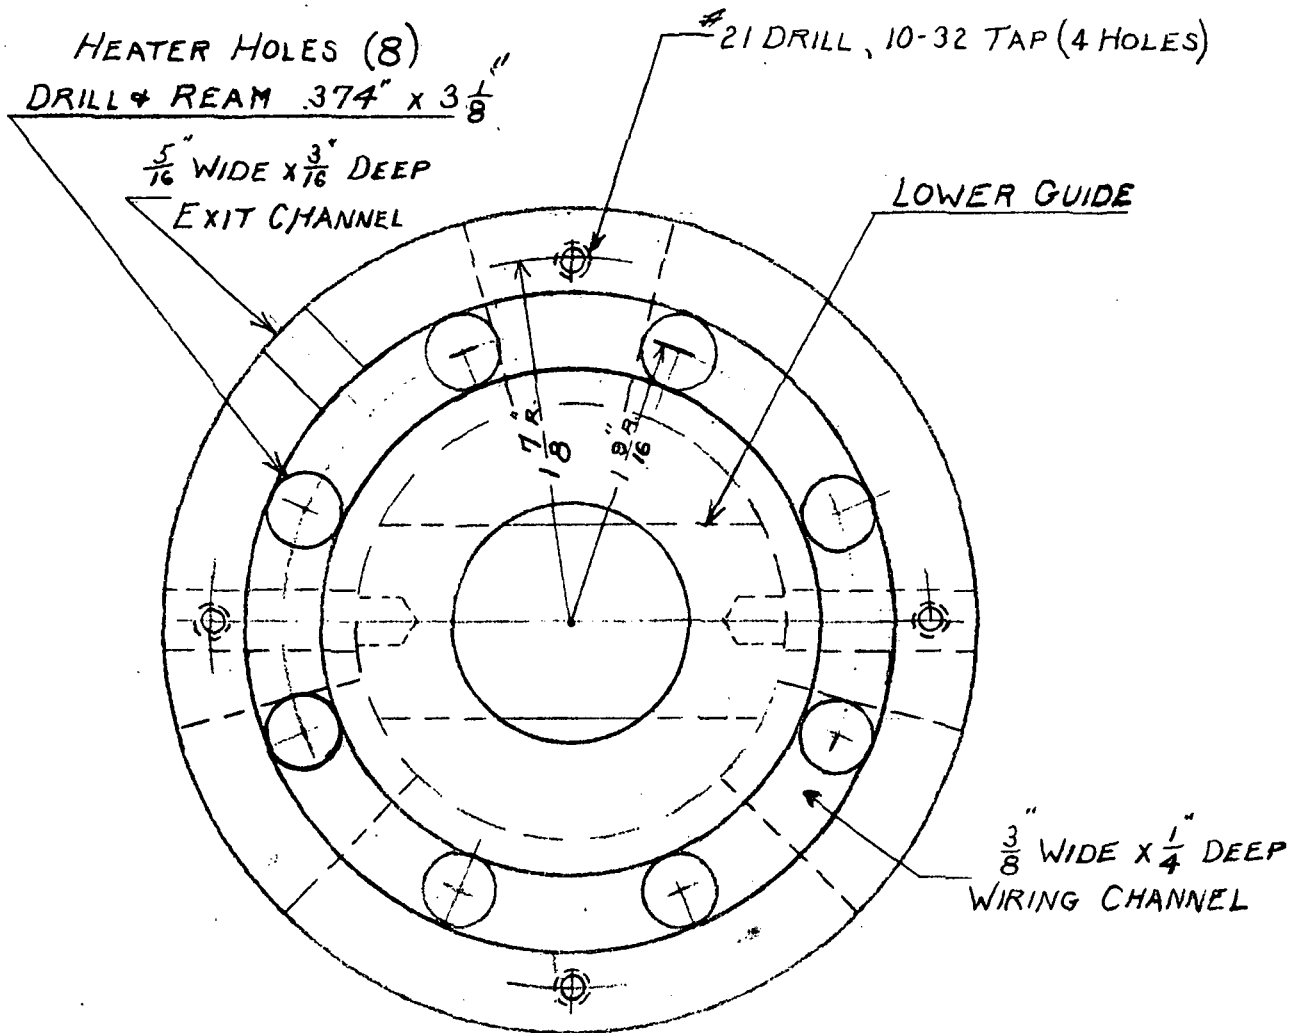
Figure 12.

Body

Bottom View  
See Sheet "A" for Heater  
Angular Location

Heat was supplied to the extruder by eight 100 watt cartridge heaters in the main extruder body (see Figure 12). These were controlled by an Omega model 149 proportioning temperature controller. Temperature control of the extruder was found to be excellent, the maximum excursion from the control point being no more than 1°F (either with or without the annular and top heat shields in place).

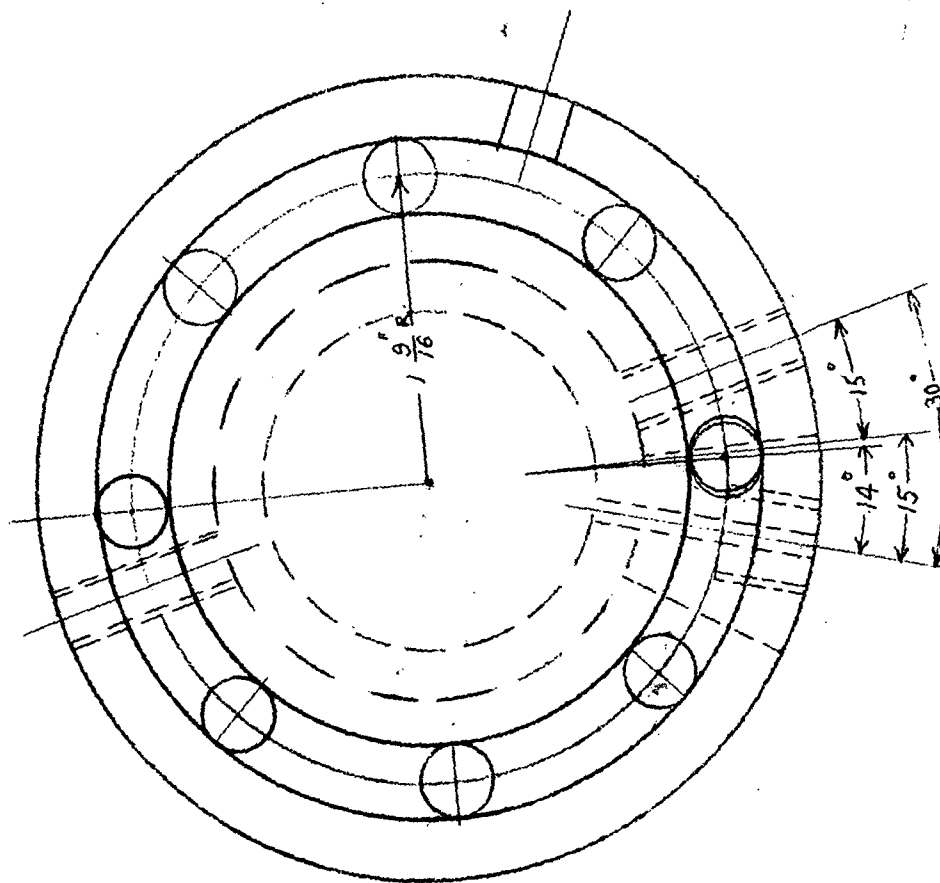
Figure 13.

Body

"Sheet A"  
Bottom View

#8 DRILL x 1" DEEP  
(8 HOLES)  
 $\frac{1}{4}$  - 20 TAP x  $\frac{3}{4}$

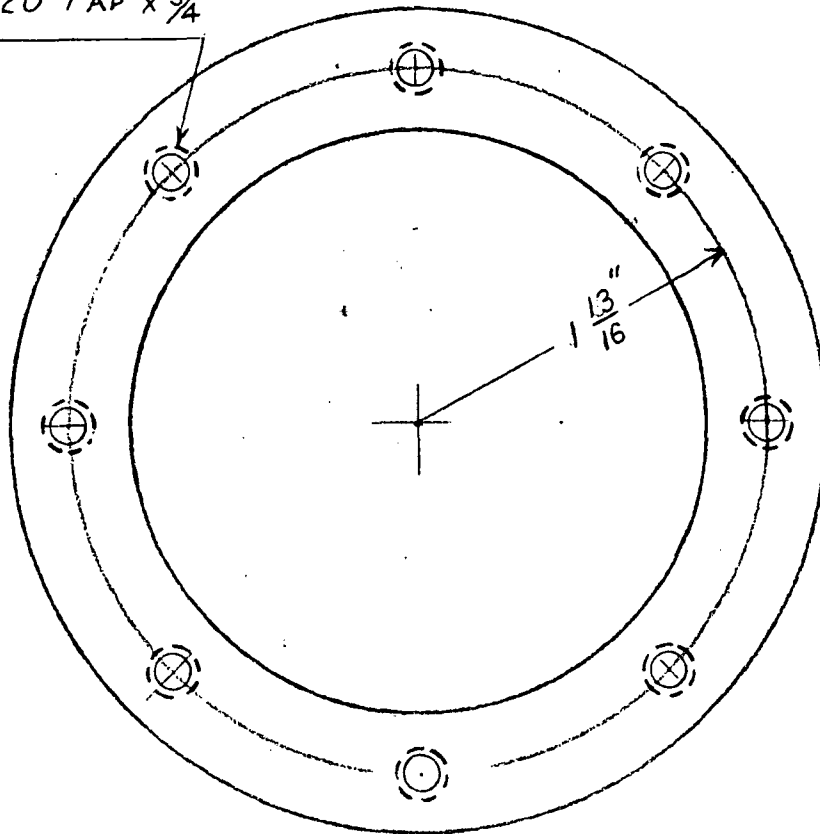
Figure 14.

Body

Top View

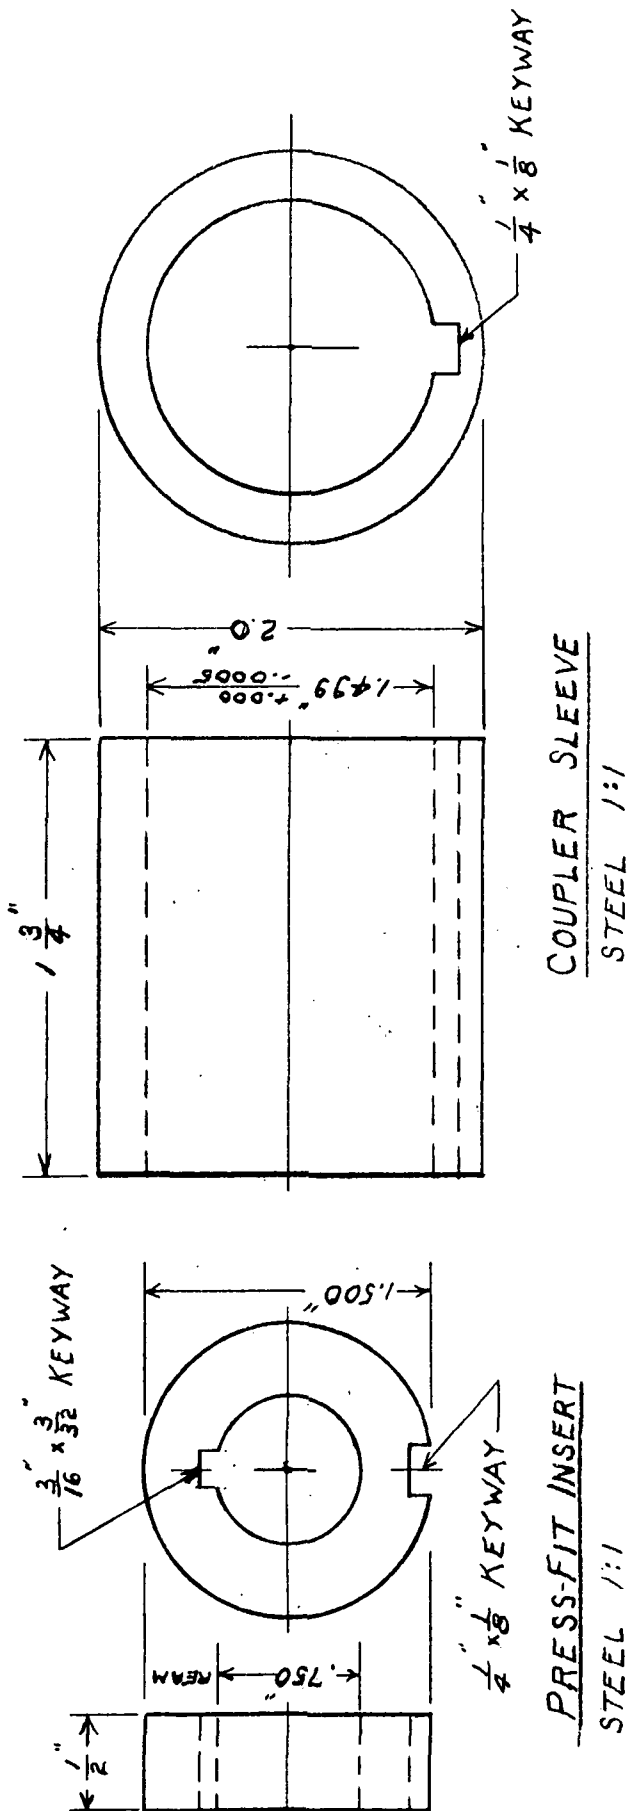
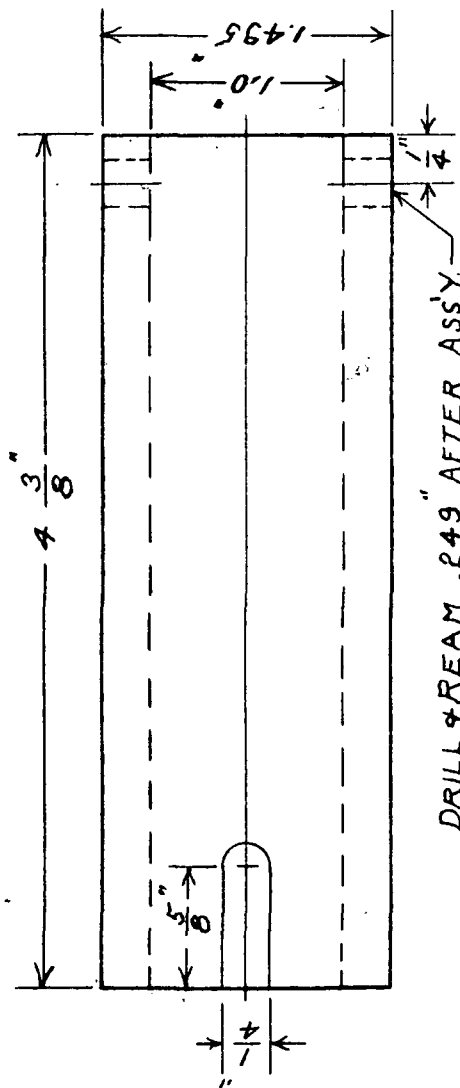
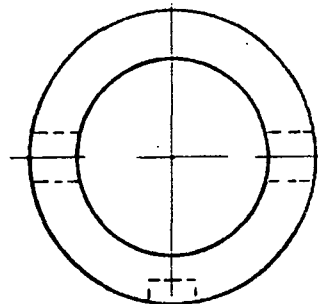
Figure 15.

Coupler

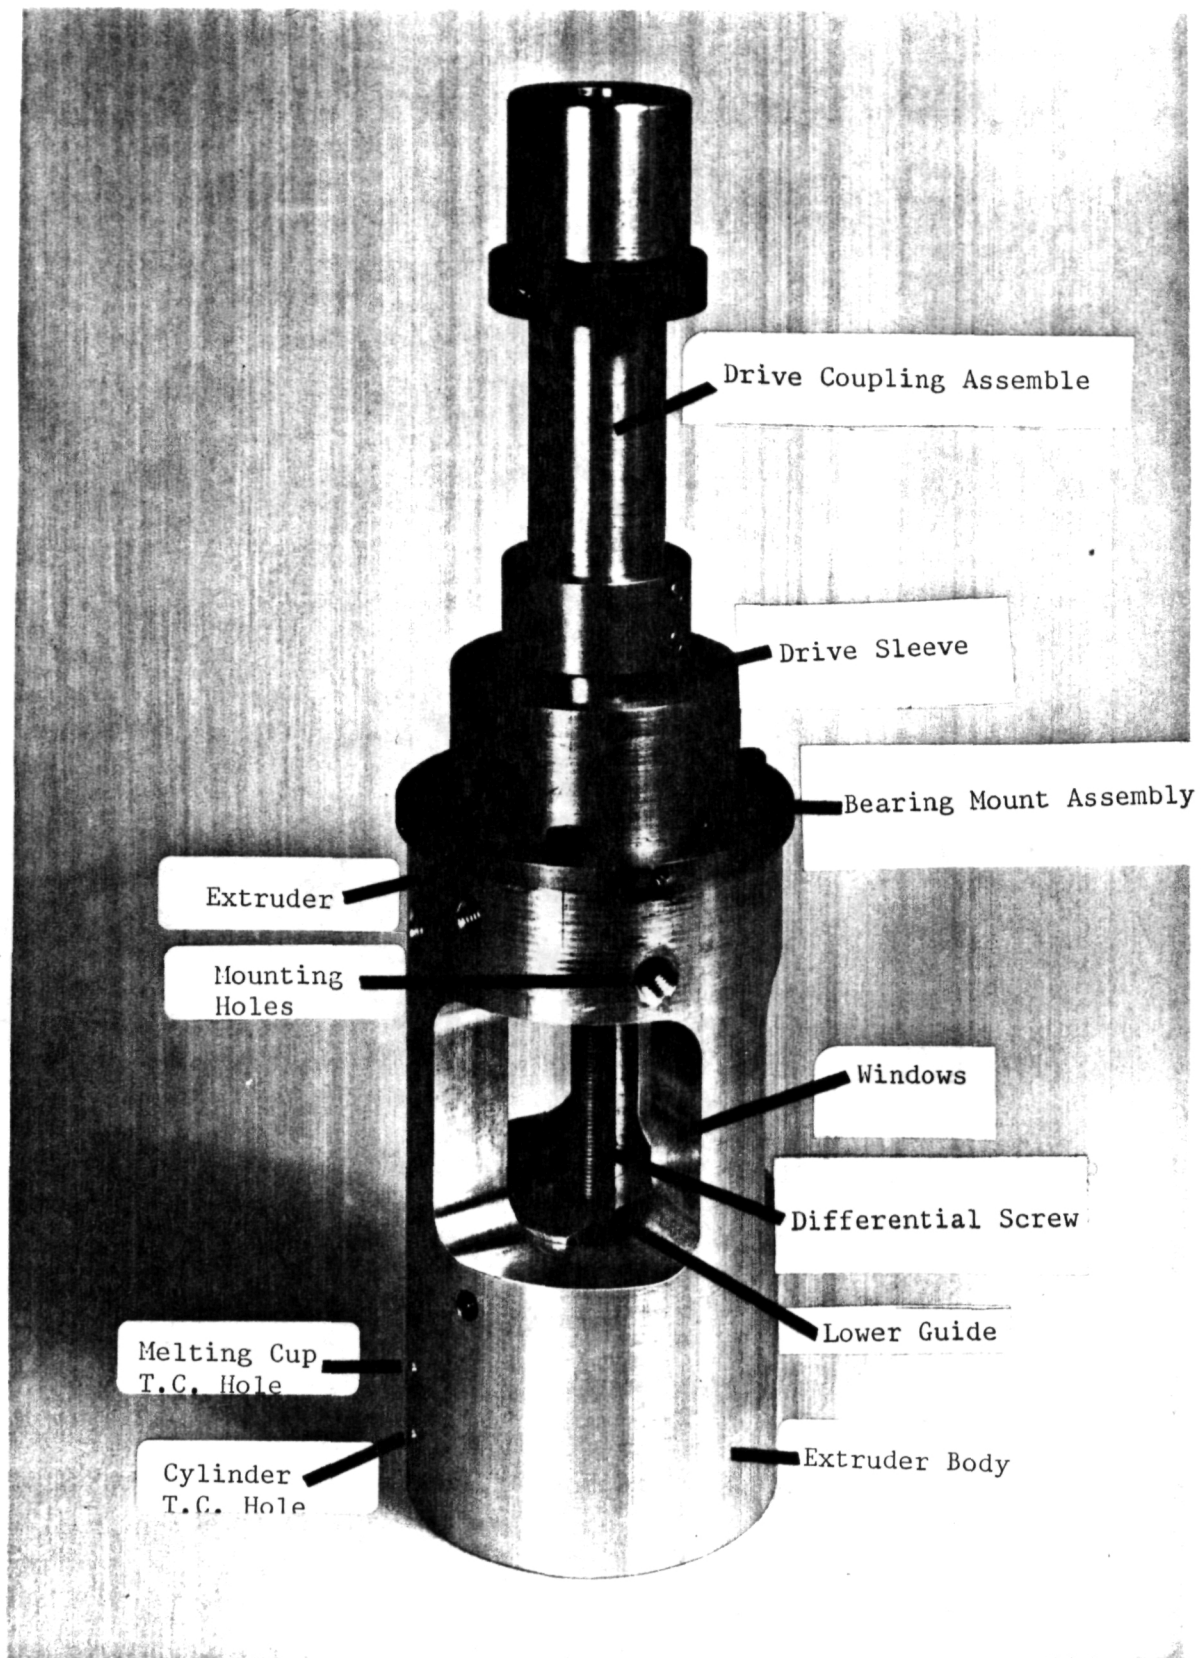
Figure 16.

Finally, Figures 16 and 17 depict the extruder in, respectively, assembled and disassembled states.

Assembled Fiber Extruder

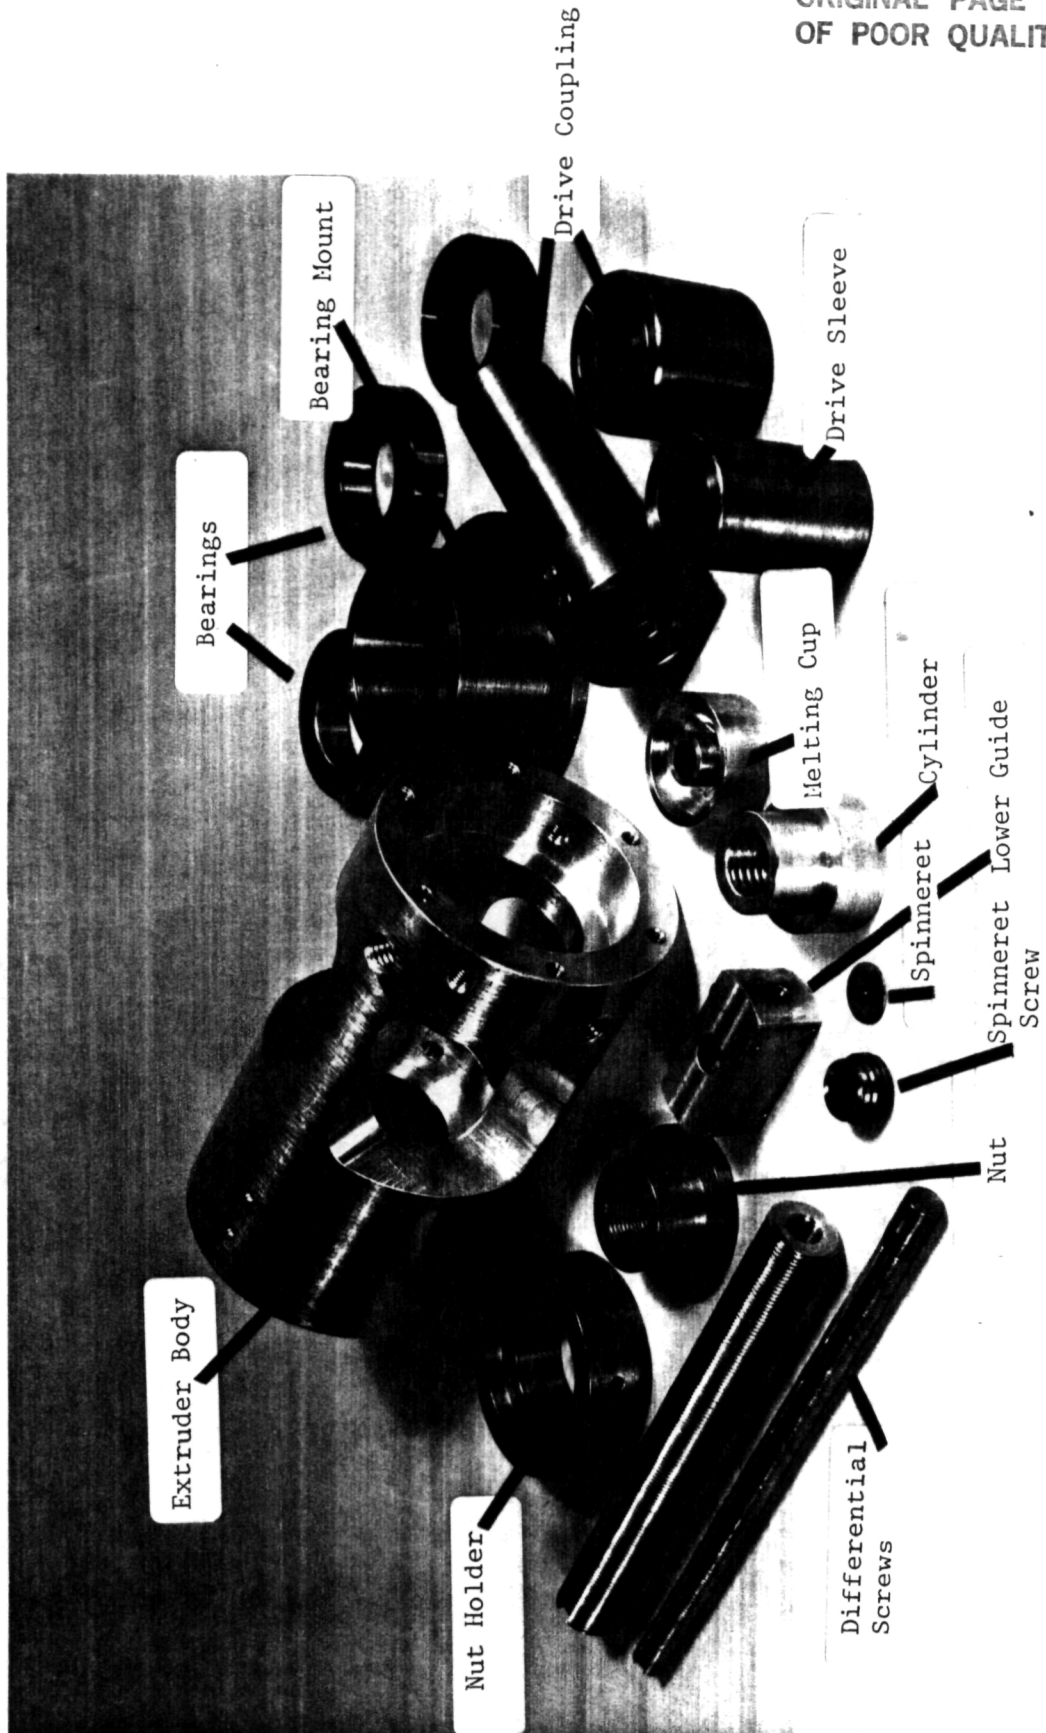
Figure 17.

Extruder Components
