FINAL REPORT

"DEVELOPMENT OF A CONTINUOUS SPINNING PROCESS  
FOR PRODUCING SILICON CARBIDE - SILICON  
NITRIDE PRECURSOR FIBERS"

CONTRACT NO. NAS8-34648

Bjorksten Research Laboratories, Inc.  
P.O. Box 9444  
Madison, Wisconsin 53715

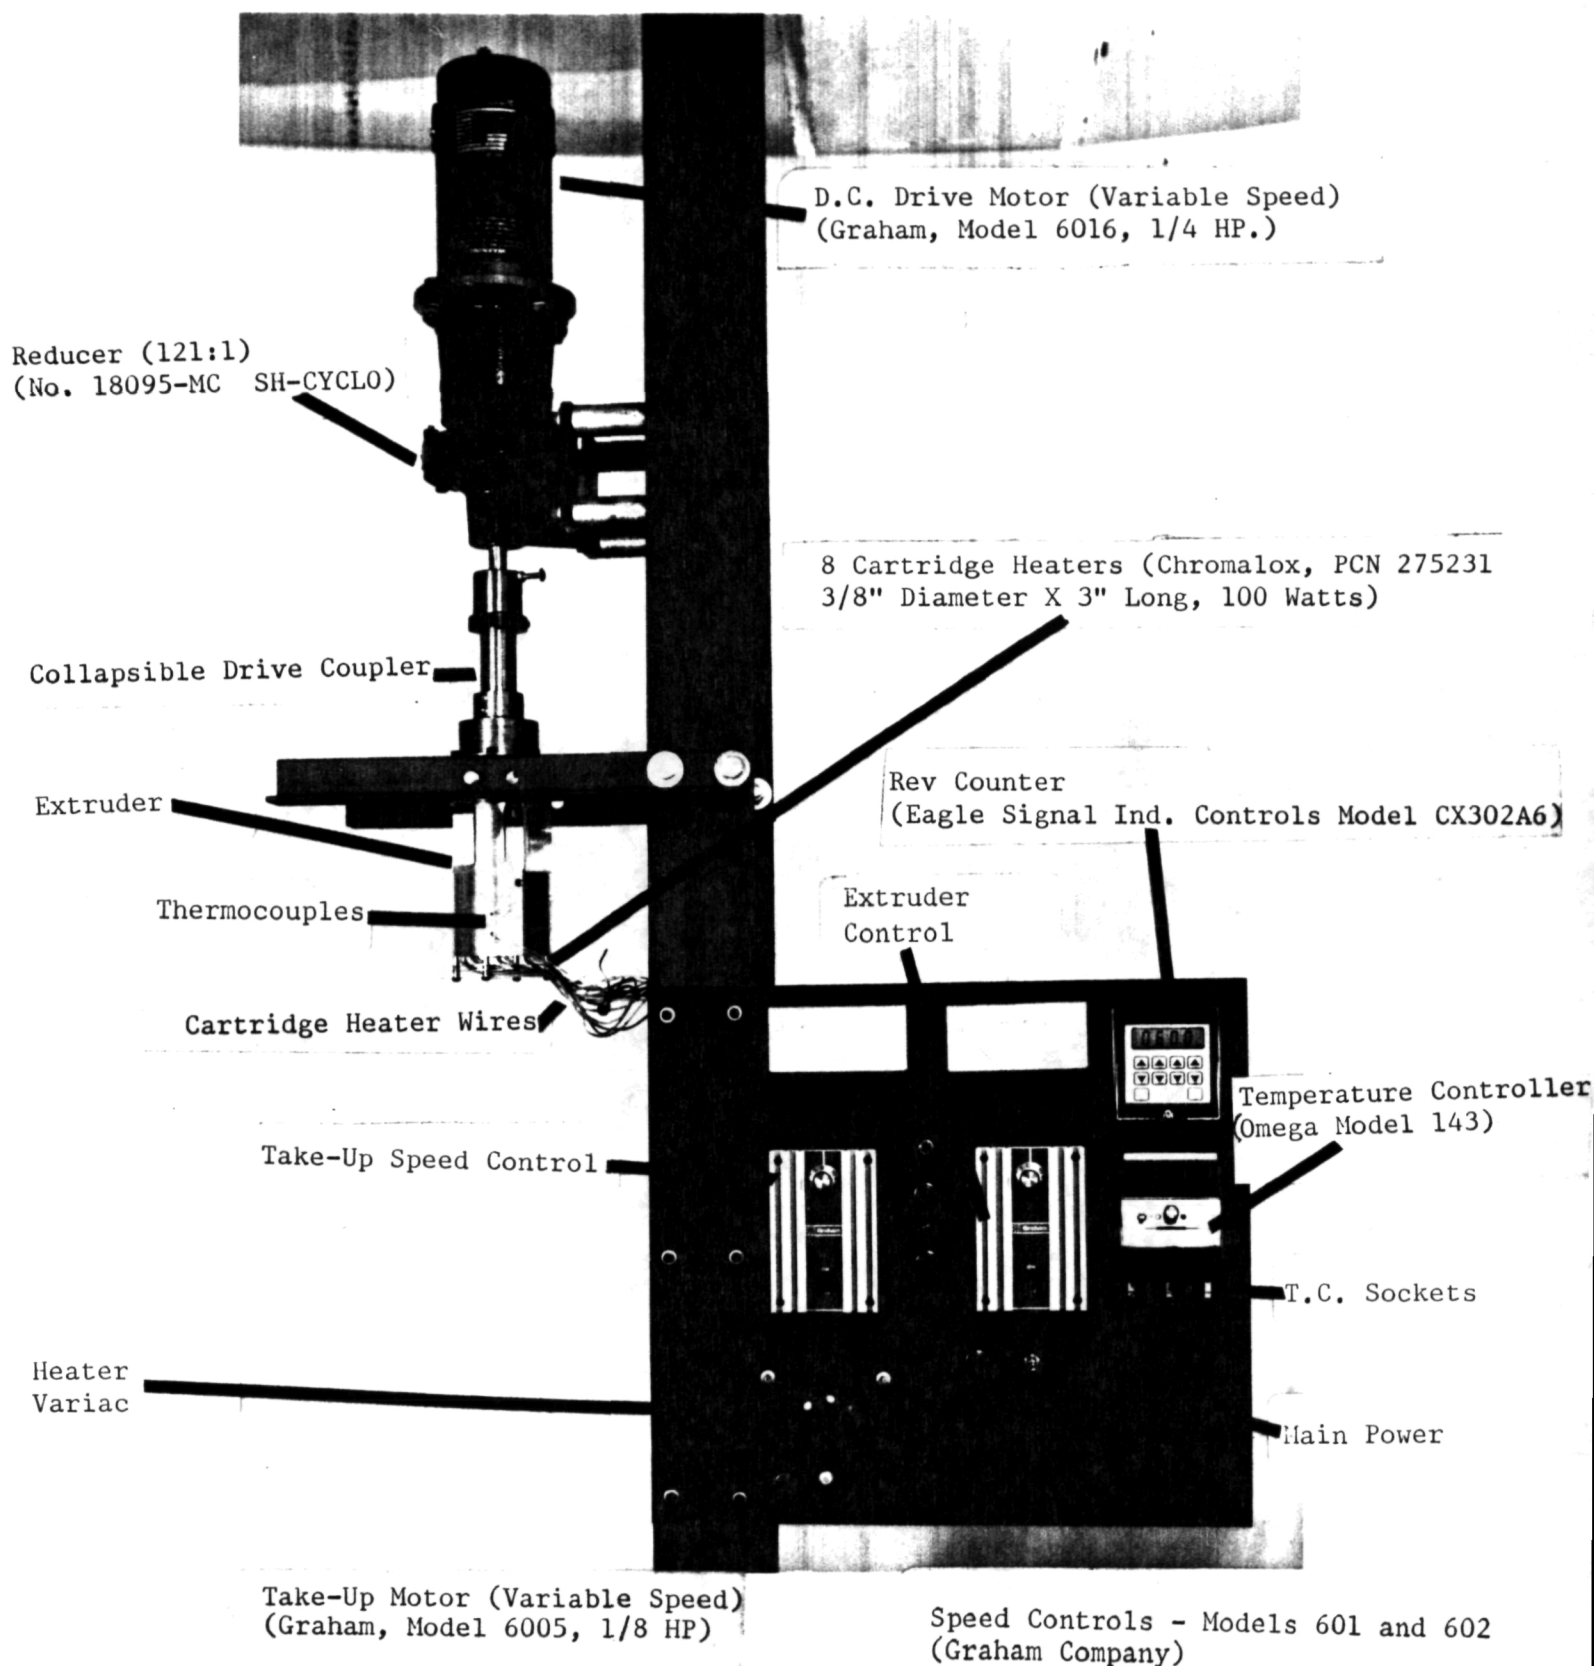
The entire extruder assembly, without heat shields but with the control panel, is depicted in Figure 19.

Extruder Assembly With Control  
Panel (Heat Shields Removed From  
Extruder Body)

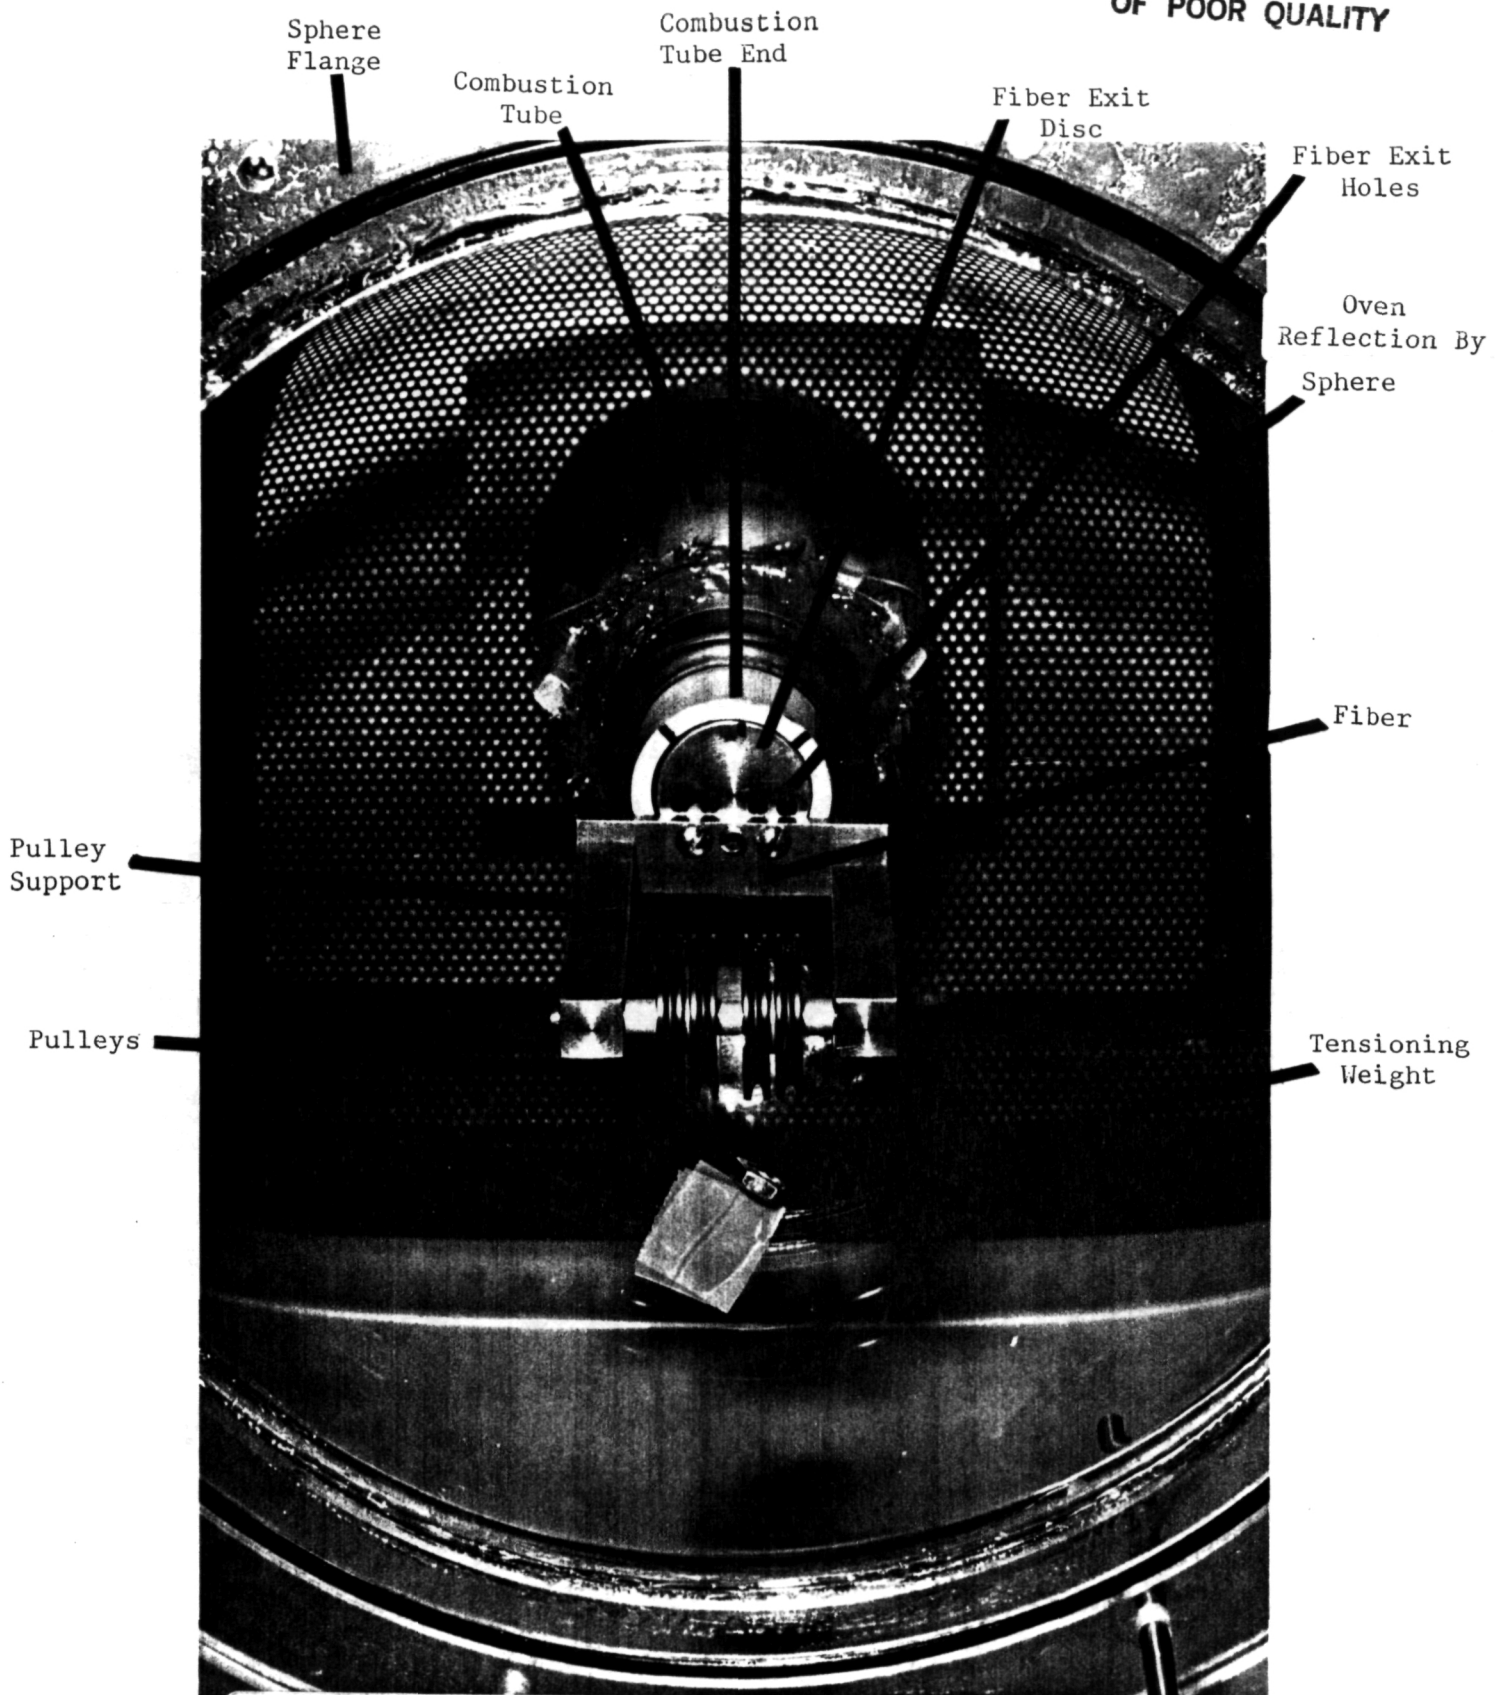
Figure 22.

facilitate tensioning of the short fibers during pyrolysis. The entire bundle was tensioned as a whole in this first experiment because the brittleness of the fibers made individual handling very difficult. A steel machine nut weighing approximately 1.3 grams was attached to the tungsten wire on one end of the fiber bundle and the wire on the other end was secured to a fiber guide. The weighed end was suspended over a pulley in the guide system, thus positioning the fibers within the heat zone while maintaining them under tension (Figure 22 ). Fiber shrinkage due to pyrolysis was monitored by following the height of the suspended nut with a cathetometer.

Weight Attached to Tungsten  
Wire to Tension Fiber Bundle  
During Pyrolysis

\* 2 Mil  
Tungsten Wire  
Interface  
Between Fibers  
and Weight

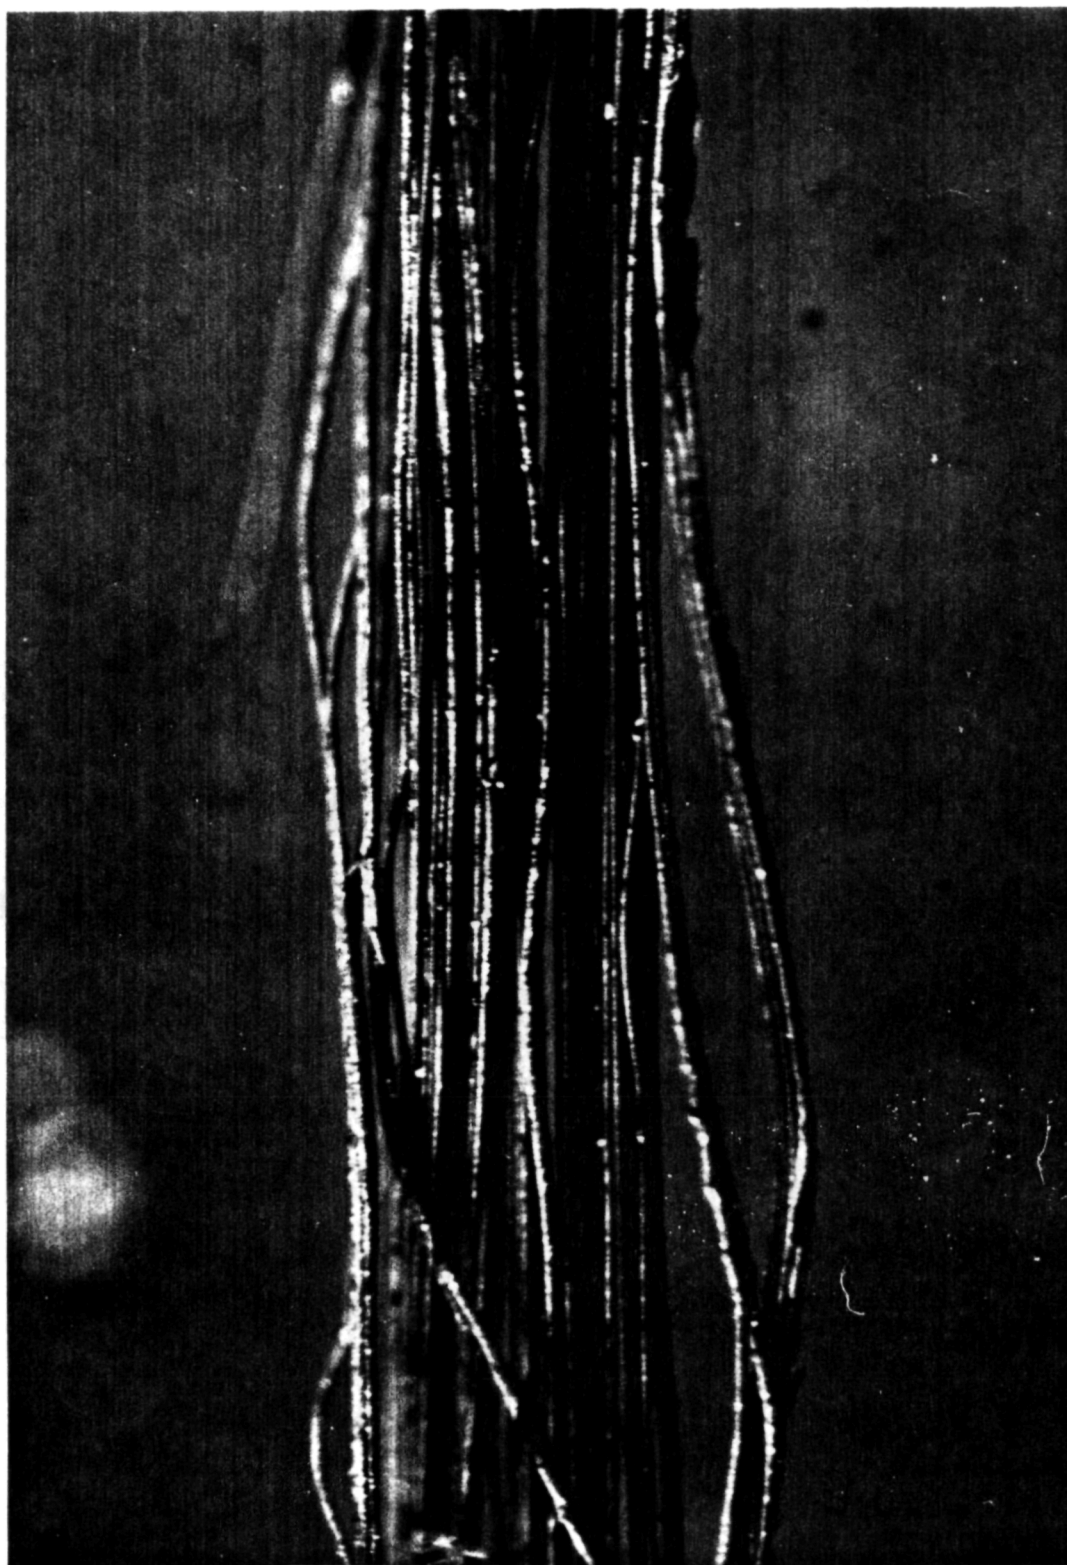
Figure 23.

During initial heating the fiber expanded approximately 0.5 centimeters. The fiber began to shrink at a center temperature of approximately  $650^{\circ}\text{C}$  and continued to do so at a fairly constant rate as the temperature approached  $900^{\circ}\text{C}$ . At  $900^{\circ}\text{C}$  the rate of shrinkage decreased, but shrinkage continued as pyrolysis extended to the material in the heating zone boundaries. Total fiber shrinkage was approximately 3.5 centimeters at the  $1000^{\circ}\text{C}$  shutdown point. Microscopic examination revealed a 20% decrease in fiber diameter accompanying pyrolysis; 25 to 30 micron diameter fibers decreased to 20 to 24 microns. This examination also showed crystals present on the straight metallic black fiber (Figure 23 ).

Fiber Bundle Pyrolyzed Under  
Tension 65X Magnification
