# Damp-Heat Induced Degradation of Transparent Conducting Oxides for Thin-Film Solar Cells

## Preprint

**Conference Paper**  
**NREL/CP-520-42525**  
**May 2008**

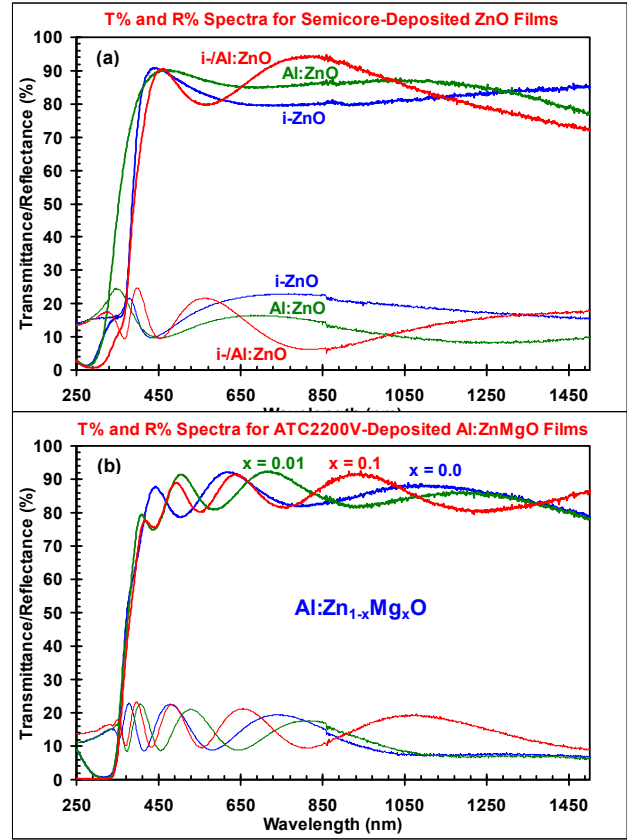
**Fig. 1.** Transmittance and reflectance spectra for (a) single-layer intrinsic, Al-doped, and intrinsic/Al-doped ZnO (i-ZnO, Al:ZnO, and i-Al:ZnO), and (b) Al-doped  $\text{Zn}_{1-x}\text{Mg}_x\text{O}$  films sputter-deposited on 1-mm-thick 7059 glass plates.

The single-layer intrinsic and Al-doped ZnO showed apparent difference from their combined bi-layer i/Al:ZnO in transmittance and reflectance spectra as seen in Fig. 1a. The  $\text{Al:Zn}_{1-x}\text{Mg}_x\text{O}$  also showed variation in T% and R% spectra, being influenced by the content concentration ( $x = 0, 0.01$ , or  $0.1$ ) of MgO in the alloy, as seen in Fig. 1b. More detailed material information of the tested specimens is given in the upper half of Table 1, which includes type of TCO, MgO content, substrate temperatures during deposition, and film thickness if available. The initial and subsequent changes of sheet resistance ( $R_{\text{sh}}$ ) from Hall measurements as a function of DH exposure time are given in the lower half. For the purpose of convenience to compare the degradation rate, as given in the bottom row, a linear degrading relationship was assumed. After 480 h DH exposure, all Al-doped ZnO films, including  $\text{Al:Zn}_{1-x}\text{Mg}_x\text{O}$ , became either insulating or highly resistive ( $> 1$

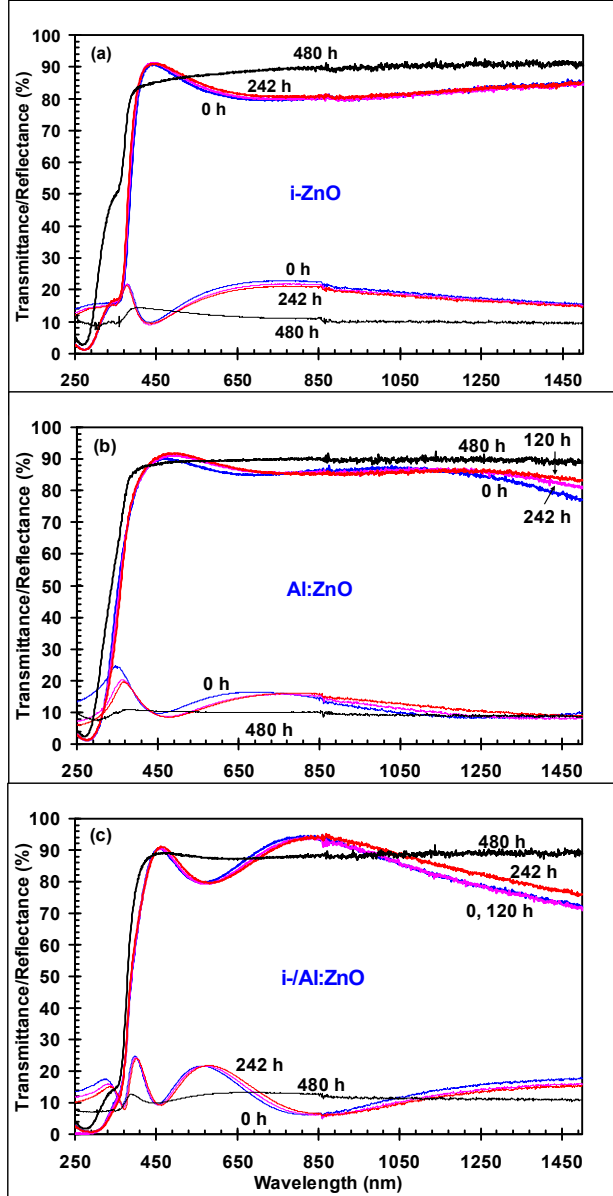
**Fig. 2.** Transmittance and reflectance spectra for (a) single-layer intrinsic ZnO (IZO-11), (b) single-layer Al-doped ZnO (AZO-21), and (c) bi-layer i/Al:ZnO (BZO-31) before ( $T_0 = 0$ h) and after accumulating 120 h, 242 h, and 480 h DH exposure.

The single-layer i-ZnO, Al:ZnO, and their combined bi-layer i-/Al:ZnO did not show substantial changes in transmittance and reflectance spectra until after 480 h DH exposure, whereas the hazy films exhibited essentially the same flat curves losing the characteristic features of Al-doped conducting ZnO as shown in Fig. 2. This is also evidenced by the corresponding decrease in the mobility, determined by Hall measurements, as seen in Fig. 3a. One notable observation is that the degradation rate would be greater if the Al:ZnO specimens (not given in Table 1) were exposed in the DH chamber continuously for 240 h.

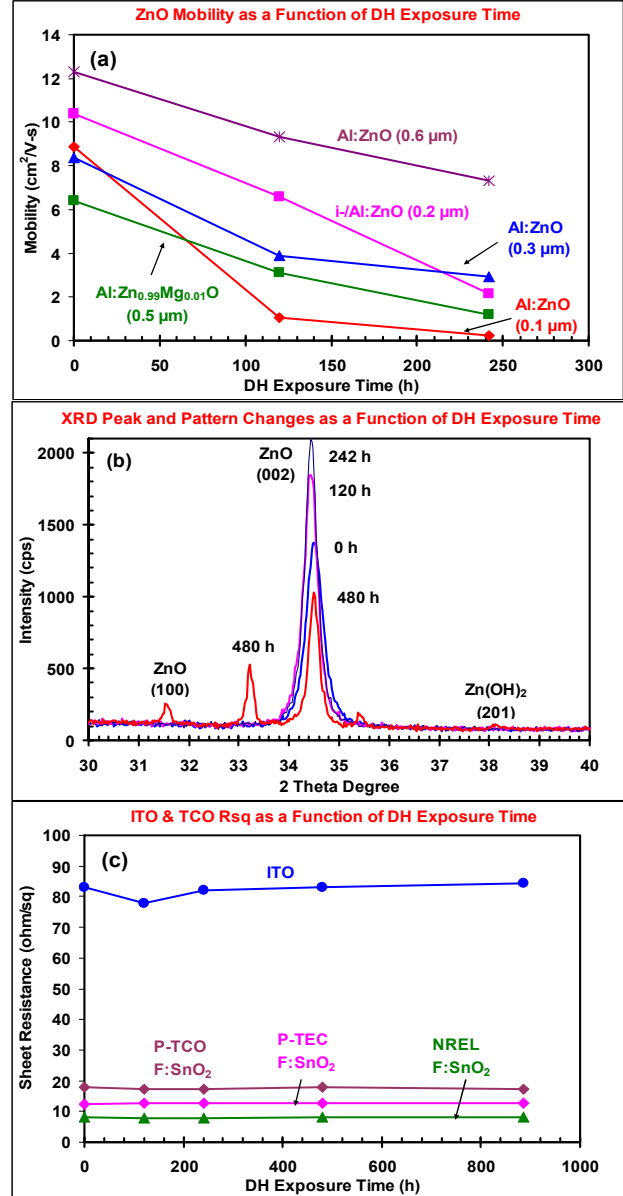
**Fig. 3.** (a) Decrease in mobility of mono- and bi-layer Al-doped ZnO films as a function of DH exposure time, (b) change in XRD feature for IZO-11 DH-exposed upto 480 h, and (c) sheet resistance of ITO and F:SnO<sub>2</sub> DH-exposed to 886 h.

The sample set would become insulating with a white hazy appearance, the same as those in Table 1 for 480 h with periodic removal from the DH chamber for measurements. This suggests that the films removed from the DH chamber were capable of recovering their physical properties to some extent, as also indicated by the gradual change to a somewhat less cloudy appearance after ~2 days in the air. One likely reason is the loss of water molecules from the hydrated or hydrolyzed film bulk and film/glass interface. Another interesting observation is that a bi-layer i-/Al:ZnO sample was highly resistive when it was still moist just after being taken out from a bottle filled with moisture in the DH chamber, and then became conducting as expected for a film with DH=94 h exposure after drying naturally in the air for some minutes. In comparison to the ZnO-based films, the optical property of the ITO and F:SnO<sub>2</sub> films were essentially unchanged in transmittance and reflectance spectra after 886 h DH exposure.

The structural changes by DH exposure are also reflected in the XRD patterns, per the example shown in Fig. 3b for the sample of intrinsic ZnO (IZO-11). Except for the bi-layer BZO-31, all single-layer ZnO films show an increase in (002) peak intensity at 34.50° (2 theta) up to DH 242 h, possibly a result of morphological changes (see below), before exhibiting a moderate to large decrease at DH 480 h due to structural disintegration. For the Al:Zn<sub>0.9</sub>Mg<sub>0.1</sub>O (AZO-501) alloy, a main peak appeared at 34.12° with a long tail. The main peak shifted to ~33.95° upon DH exposure up to 242 h and then back to 34.12° at 480 h. IZO-11 and AZO-471 were the two samples that produced four new peaks at DH 480 h (Fig. 3b), possibly a consequence of structural degeneration effected by the hot moisture-induced degradation. The peaks at 31.38°, 33.22°, and 35.38° are assigned, using PDF#89-0510, 65-2880, and 75-1533 index references for ZnO, to be hexagonal (100), cubic (111), and hexagonal (101),

respectively. The peak at 38.12° may be from cubic (200) or Zn(OH)<sub>2</sub> (201), as referred to PDF #65-2880 and 89-0138. Additionally, the peak width at half height for some samples showed notable narrowing at DH 480 h (e.g., Fig. 3b), but its cause is not yet clearly understood. These results suggest the ZnO might have undergone structural degeneration from original highly (002) preferential orientation to a more disordered state with some transformation from original hexagonal to cubic, in addition to the formation of insulating ZnO and Zn(OH)<sub>2</sub>. Meanwhile, it is not clear yet on the fate of the Al dopant upon DH exposure, although it is possible that the Al was also readily transformed into Al(OH)<sub>3</sub>.

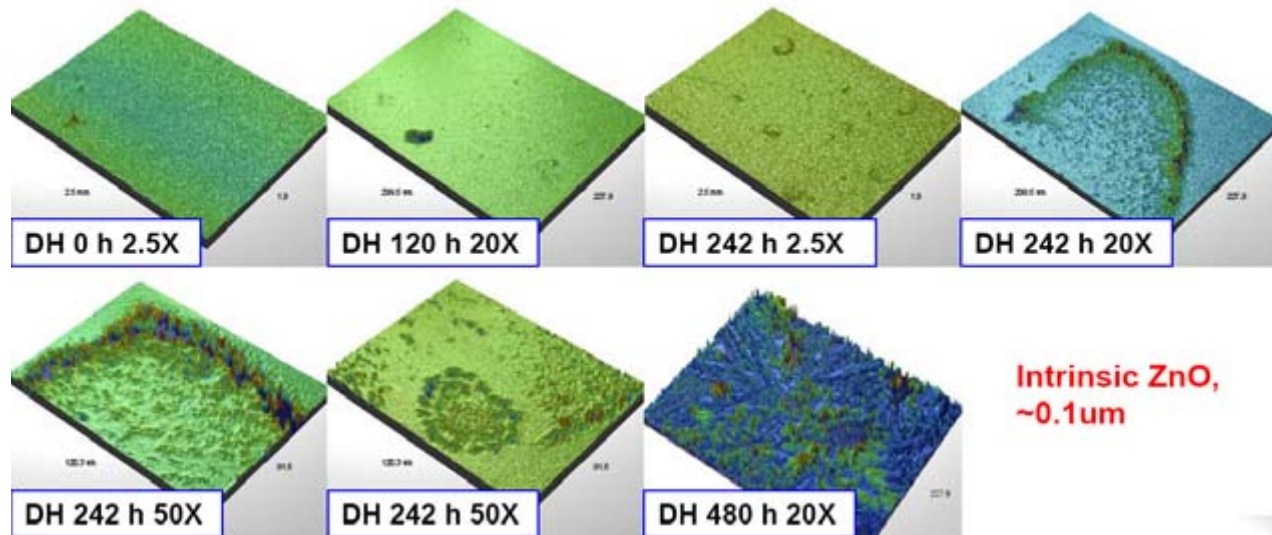
**Fig. 4.** Optical micro-images for the sample of intrinsic ZnO (IZO-11), showing the progressive morphological degradation as the DH exposure time increased to 480 h. The magnification factors are also indicated.

The surface morphology of the various TCO films was also examined periodically for the initiation and propagation of the defecting patterns and regions as a function of DH exposure time by using the WYKO interference optical microscope. More than 1000 micro-images were taken. A few of the images are illustrated in Fig. 4 for the IZO-11 sample at four stages, showing the progressive morphological degradation as the DH exposure time increased to 480 h. The initially grainy but fairly smooth surface started to show some small spikes that appeared in a random manner upon exposure to DH in the first ~100 h. The number of spikes increased along with the appearance of full or partial ring-like features that showed ditch-like cutting into the depth of the film as the DH time increased (e.g., 240 h). The ring features are suspected to arise from the finite water droplets condensed from the moisture, which was the case observed when the cool films were just loaded into the hot steamy DH chamber. As the degradation progressed further, the film disintegrated greatly into fabrics-like features at DH 480 h and was difficult to be micro-photographed because of large loss of light reflection from the rough surface. This morphological degradation process and pattern development was essentially the

inferred from optical micro-imaging observations. In general, the first sign of degradation started at a few small spots or areas with appearance of irregular circles and spikes (e.g., Figs. 4 and 6 at 120~242 h); as the DH exposure increased, the hydrolysis-induced corrosion circles, spikes, and pop-ups increased and became more widely spread (e.g., Figs. 4 and 6 at DH 242 h), and finally, especially for ZnO-based films, severe disintegration resulted (e.g., Fig. 4 at DH 480 h). This thermal hydrolytic process might have started from the surface of the film as well as at the grain boundary and progressed downward and inward. If this was the case, then it would take longer exposure time to allow the "ditches" (e.g., Fig. 4, leftmost figure at the bottom row) to grow deeper to break up the electrical conducting path on a thicker ZnO film, and to break up the better grain crystallites on a ZnO film made at higher temperature. In addition, visible delaminations were seen on some ZnO films after 480 h DH exposure, suggesting the destruction of the bonding at the interface between the ZnO layer and glass substrate. On the other hand, with extended DH exposure to 886 h, the ITO (AFL-1) film showed two large and some small insulating regions, while F:SnO<sub>2</sub> films remained *visibly* intact. Accordingly, based on all the optical, electrical, structural and morphological observations, the temporal process of DH-induced degradation is proposed to involve first hydrolysis of the oxides at some sporadic "weak" spots, swelling and popping of the hydrolyzed spots due to volume increase, "segregation" of hydrolyzed regions causing discontinuity of electrical path, hydrolysis of the oxide-glass interface, and finally formation of insulating M(OH)<sub>2</sub> along with visible delamination over larger areas.

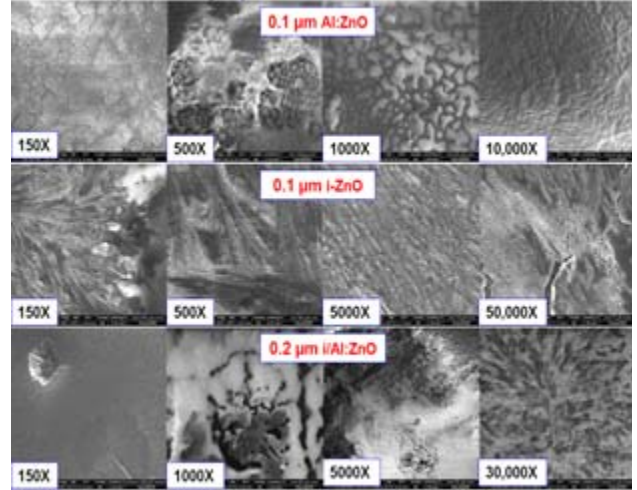
**Fig. 5.** SEM topographical microimages for the samples of Al:ZnO (AZO-21), i-ZnO (IZO-11), and bilayer i-/Al:ZnO (BZO-31) at DH exposure of 480 h. The magnification factors are also indicated.

same for all ZnO-based films as observed in this study. While starting with grainy surfaces for the Semicore-deposited Al:ZnO, the DH exposure at 480 h resulted in obvious morphological differences for the single-layer i-ZnO and Al:ZnO, and bi-layer i-/Al:ZnO, as shown by SEM topographs in Fig. 5. Similar surface morphological degradations for the two samples of Al:Zn<sub>1-x</sub>Mg<sub>x</sub>O alloy (top row), ITO and the experimental P-TCO F:SnO<sub>2</sub> (bottom row) at DH 242 h are illustrated in Fig. 6. The T-PEC F:SnO<sub>2</sub> also exhibited a similar pattern of changes as ITO and P-TCO (not shown). At 10% of MgO, the Al:Zn<sub>0.9</sub>Mg<sub>0.1</sub>O (AZO-501) was originally insulating and, upon DH exposure, exhibited localized spot-wise material loss (see the third image on the top row of Fig. 6), suggesting the MgO-ZnO was not fully alloyed during co-sputtered process.

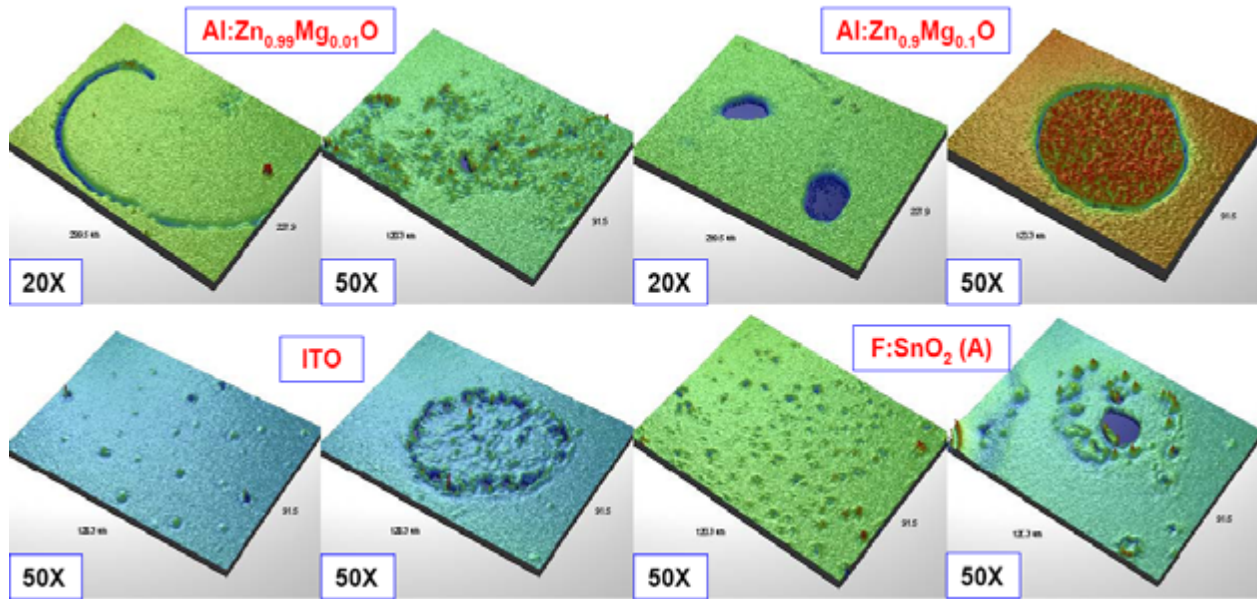
**Fig. 6.** Optical micro-images for the samples of (top row) Al:Zn<sub>1-x</sub>Mg<sub>x</sub>O ( $x = 0.01$  and  $0.1$ ); and (bottom row) ITO, and P-TCO F:SnO<sub>2</sub>, showing morphological degradations at DH 242 h exposure. The magnification factors are also indicated.
