# **Damp-Heat Induced Degradation of Transparent Conducting Oxides for Thin Film Solar Cells**

**33<sup>rd</sup> IEEE PVSC, 5/12/2008, San Diego, CA**

NREL/PR-520-43256

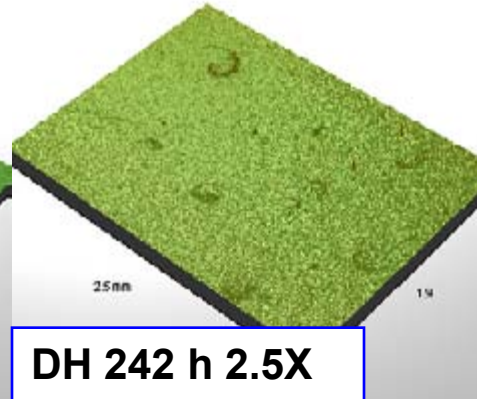
# 3D Images of Surface Morphology for i-ZnO upon DH Exposures (WYKO Optical Interferometer)

**Intrinsic ZnO,  
~0.1μm**

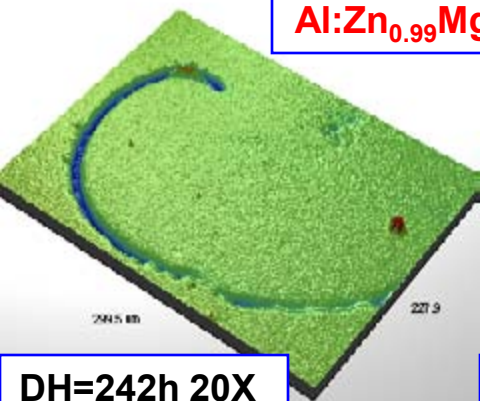
$\text{Al:Zn}_{0.99}\text{Mg}_{0.01}\text{O}$

DH=242h 20X

50X
