Winchester/Camberley Homes New Construction Test House Design, Construction, and Short-Term Testing in a Mixed-Humid Climate

D. Mallay, J. Wiehagen, and A. Wood
NAHB Research Center Industry Partnership

October 2012

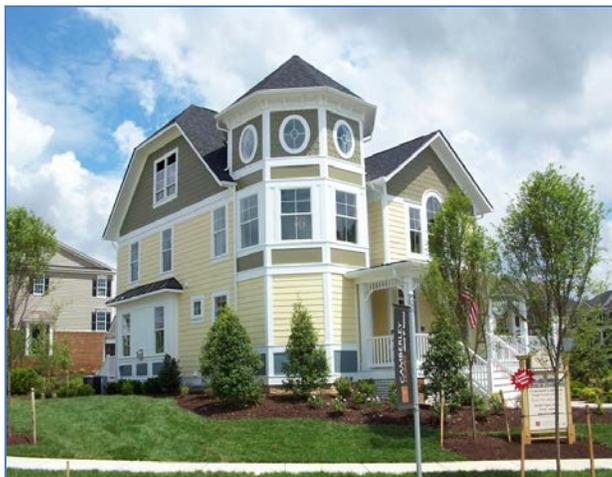
Figure 1. Winchester/Camberley NCTH

The NCTH, shown in Figure 1, was built in the Poplar Run subdivision in Montgomery County, Maryland, a suburb of Washington, D.C. This subdivision will eventually contain 700 homes, 100 of which are expected to incorporate the energy efficient design of this house. Based on consumer acceptance and measured performance of this research project, some of the remaining 600 homes may also include these advanced energy features.

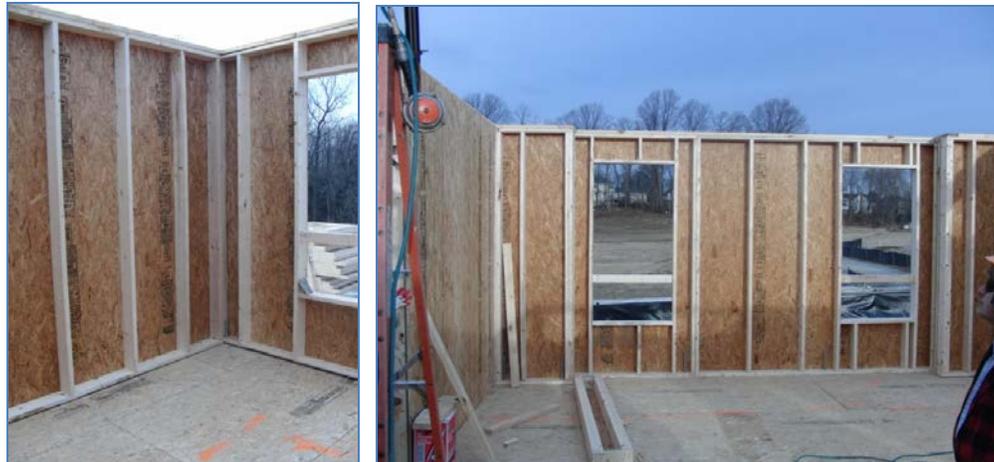
Figure 2. Advanced wall framing

2-in. × 4-in. wall cavity would require higher density insulation such as closed-cell spray polyurethane foam (SPF) insulation. After evaluating the cost for a 2-in. × 4-in. wall with SPF, this option was ruled out in favor of a 2-in. × 6-in. frame wall with batt or blown insulation. Once this decision was made, the wall panels were redesigned to optimize performance, including engineered structural rim boards, elimination of nonstructural nailers where possible, and other advanced framing techniques (detailed in Table 2) to increase room for insulation and provide a higher level of air sealing. To avoid nonstandard length studs and maintain ceiling heights, a conventional second top plate was included in this new design. Figure 2 shows the construction of the wall design using this advanced framing technique.

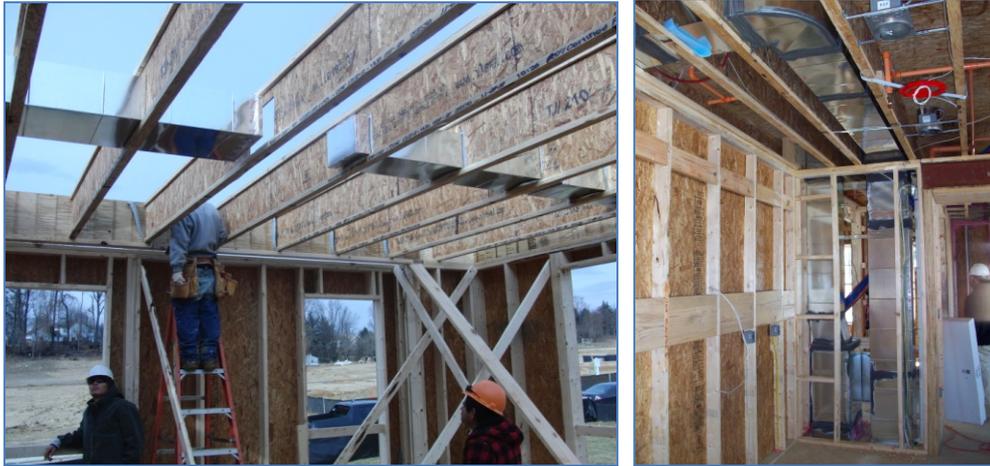
Figure 3. Supply trunk through floor joists and central duct chase

Specialized design software was used to prepare accurate drawings showing exact locations of the mechanicals (including plumbing and sprinkler piping) within the floor system, including the central duct chase. These drawings were then used at the factory to number and cut all joists and rim boards to exact lengths, and to precisely cut openings through the I-joists as required. Figure 3 shows the central duct chase and integrated duct and floor-joist design. This high-level integration of structural and mechanical systems required a complete duct design during the

planning stage to size the chase and joist openings. Similar planning was necessary for the plumbing and sprinkler piping.

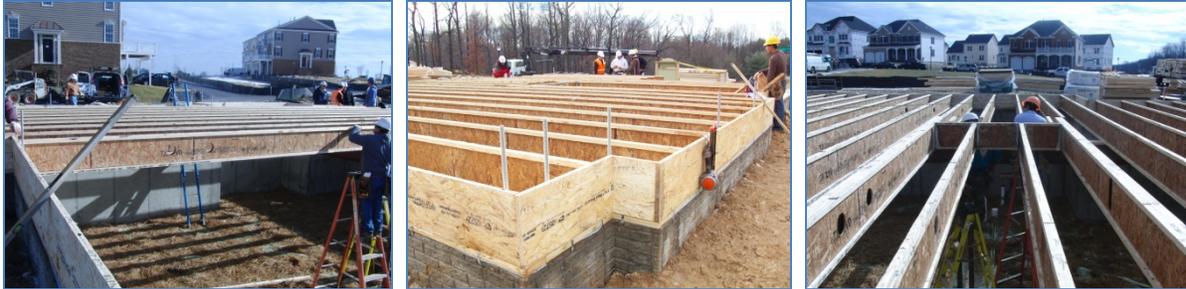
Figure 4. Floor framing

Floor framing was optimized using I-joists, 24-in. on center as shown in Figure 4. The reduced cost of fewer floor joists was partly offset by selecting 7/8-in. floor decking (instead of 3/4-in.) to ensure rigid floors. Floor joists and rim boards were cut to exact lengths and numbered at the factory for efficient installation. Cutouts through the joists for the HVAC duct, the plumbing, and the sprinkler piping were also made at the factory.

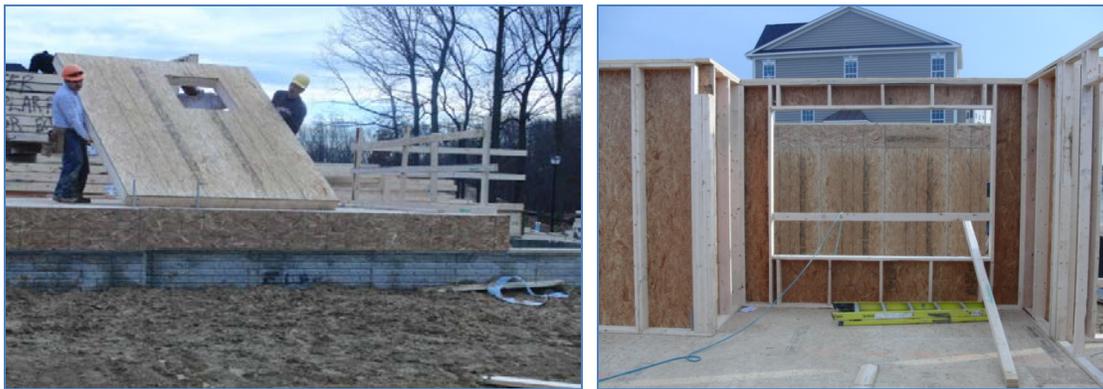
Figure 5. Wall panels

The factory-built wall panels shown in Figure 5 were redesigned to reduce thermal bridging and increase insulation volume. Walls were 2-in. × 6-in. wood frame, 24 in. on center, with ½-in. OSB sheathing. Structural rim headers eliminated first-floor headers and jack studs; unnecessary blocking, studs, and cripples were also eliminated. Second-floor headers were engineered to minimize dimensions to reduce initial cost, reduce thermal bridging, and increase wall insulation. Second top plates and a house wrap were installed in the field. Cladding was fiber cement siding.

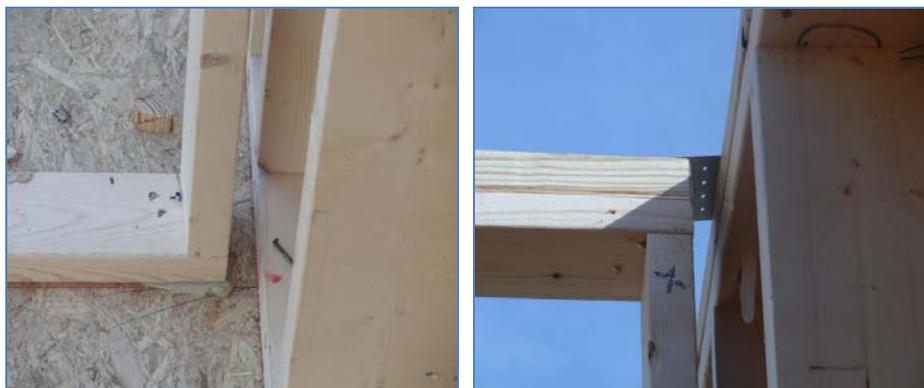
Figure 6. Continuous drywall method

The continuous drywall method was specified to further reduce framing air losses. All interior partition walls were installed 1 in. from the exterior walls, allowing the wallboard to be slid through this space along the exterior walls shown in Figure 6. These walls were structurally attached using metal plates above the top plates. Electric and plumbing trade partners' specifications required that electric wiring or pipes were not to be installed in this space.

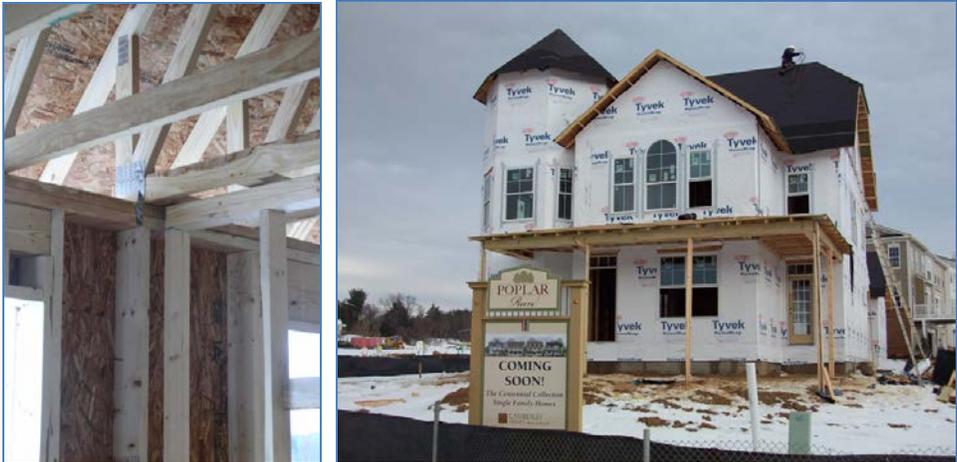
Figure 7. Raised heel truss with increased overhang at eaves

In the basement, wood frame walls were site-built and held 1 in. from the poured foundation. In the attic, raised heel roof trusses with the 2-ft overhangs shown in Figure 7 accommodated full-depth insulation and insulation baffles at the eaves and notably at the sloped ceilings of the third floor.

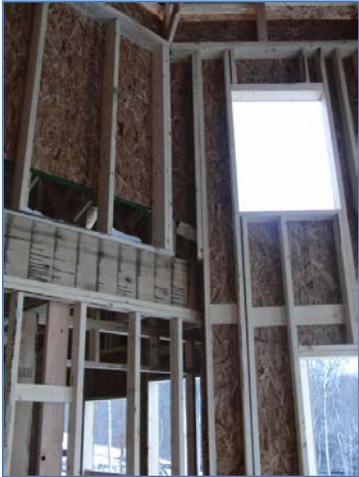
Figure 8. Complex thermal air boundary (1 of 3)

To achieve very low infiltration rates given the frame walls and complex thermal boundary, identifying critical areas for air sealing was essential. This house design was considered architecturally complex to air seal primarily because of the third floor and turret as shown in Figure 8, Figure 9, and Figure 10. The third floor had front and rear knee wall attics, partially sloped ceilings, and a separate attic above the flat ceiling. The top of the turret and the third floor were separated by the front attic. Additionally, the following were all adjacent to the same attic: the stairs to the third floor, the HVAC chase, a knee wall framed cavity, a gable knee wall for a second-floor bedroom with a cathedral ceiling, and two closets with lower ceilings. This complex design created the need for the installation and sealing of numerous air barriers including the blocking of floor joists below third-floor knee walls.

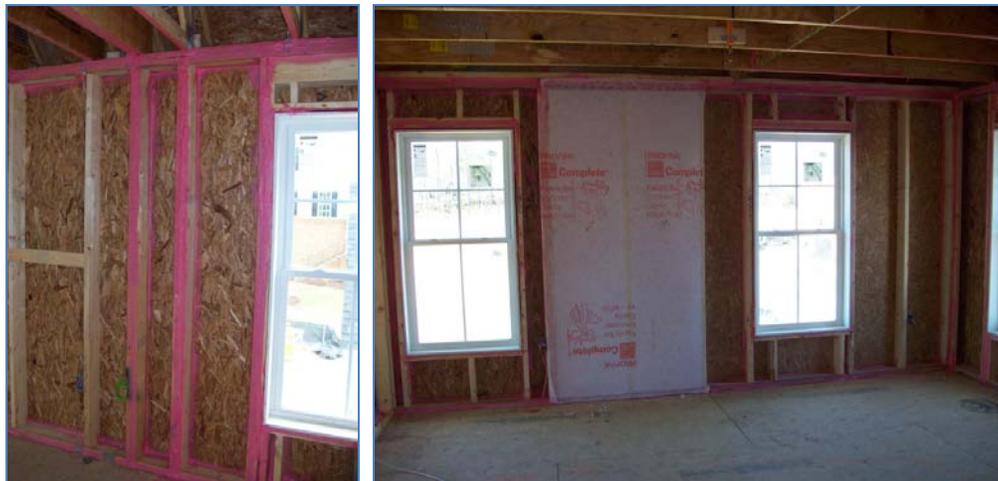
Figure 11. Air sealing

The primary air sealing strategy was to create an effective air barrier exterior to the insulation. A secondary strategy was to provide an interior air barrier using the airtight drywall approach (ADA). The product selected for both was a spray-applied, low-expanding, water-soluble, elastomeric sealant (sealant) applied at all critical area seams of the wood frame. Table 3 outlines the critical areas where the sealant was applied, and Figure 11 shows examples of air sealing.

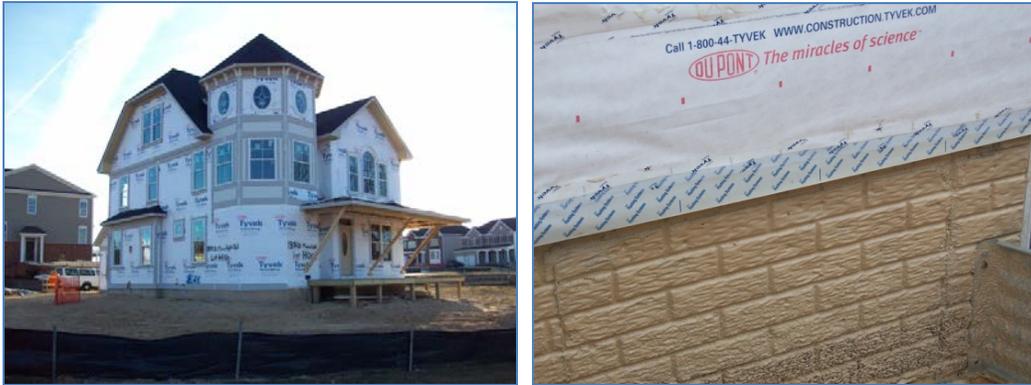
Figure 12. House wrap installed as air barrier

As a tertiary air sealing strategy, house wrap was installed as a secondary exterior air barrier, which also serves as the drainage plane. All house wrap seams were taped, and the top and bottom edges were sealed to the frame. To seal the bottom edge, first flashing tape was applied to the sheathing with a 1-in. overhang below the sill plate, and then house wrap was shingled

over and sealed to the flashing tape as shown in Figure 12. To seal the top edge, house wrap was held 2 in. from the top of the sheathing and then covered with flashing tape. The flashing tape was also mechanically secured with staples.

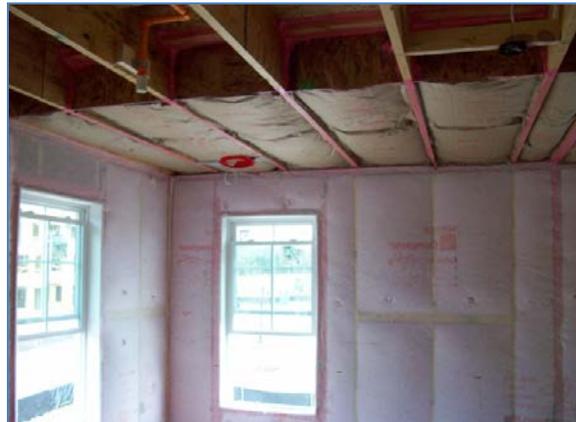
Figure 13. Wall and attic insulation

After air sealing, above-grade wall cavities were netted and blown using R-24 dense-pack fiberglass insulation. The triangular voids between the wall panels of the octagonal turret were filled using spray foam insulation from a can because these walls had been installed with a $\frac{3}{4}$ -in. gap between panels to allow for the installation of the spray foam. Basement walls were insulated using R-13 fiberglass batts. Attic insulation, including the sloped ceilings of the third floor, was increased to R-49 by using fiberglass batt insulation in some

sloped ceiling locations and blown fiberglass insulation in other locations. Attic insulation in a few locations was installed before drywall using netting because access to these attic areas would be very limited after drywall installation. Windows were double hung, vinyl, and improved to low-e, a U-value of 0.31, and an SHGC of 0.28. Figure 13 shows the installed insulation and fenestration.

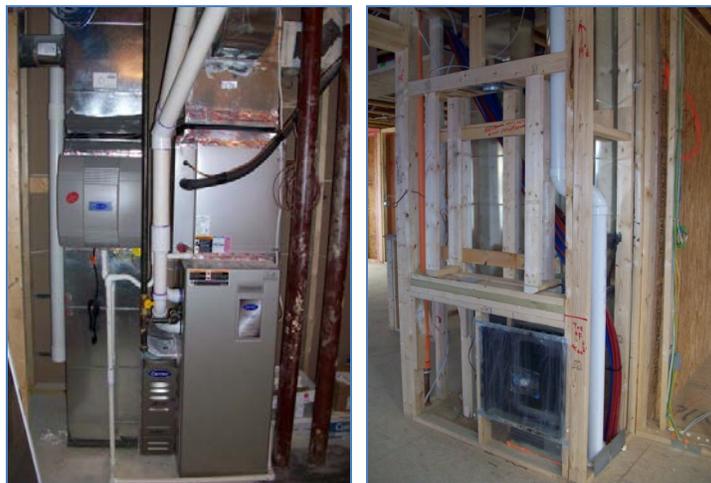
Figure 14. Furnace and first-floor return grille at central chase

High-efficiency equipment was specified: a 15 SEER cooling system and a 92.5% AFUE natural gas furnace. The furnace shown in Figure 14 was direct vent (a two-pipe design that uses outdoor air for combustion) with a two-stage gas valve and an ECM air drive. The furnace was selected based on the cooling air flow requirements. In high-heat mode the furnace output was much higher than the design load; in low-heat mode, however, the output matched much more closely with the calculated load. The programmable thermostat with its integral humidistat had the capability of running the furnace in dehumidification mode (reduced blower speed) to improve moisture control during the cooling season. Electronic zone dampers were specified to ensure occupant comfort in this four-level house design. Load calculations, equipment selection, and duct design were in accordance with the recommendations of the Air Conditioning Contractors of America's (ACCA's) Manual J (2006), Manual S (2004), Manual T (1992), and Manual D (2009).

The centrally located duct chase shown in Figure 14 served all four levels. A simplified return duct system, consisting of one central return per level, was installed in the chase. Bedroom transfer grilles, baffled to minimize light and noise, provided a return air pathway. The return duct was intentionally sized in accordance with ACCA Manual D, Table A1-1, Air Velocity for Noise Control recommendations and acoustically lined to ensure quiet operation, an important consideration with the furnace installed in the basement directly below the first-floor return grille.

Figure 14 shows how the vertical section of the upstairs (second and third floors) supply trunk duct was also installed in the chase. The horizontal sections of the upstairs supply trunk duct were integrated within the second-floor framing as shown in Figure 15. Supply branch ducts were installed between the joists, and vertically through interior walls for the third floor, to perimeter floor registers.

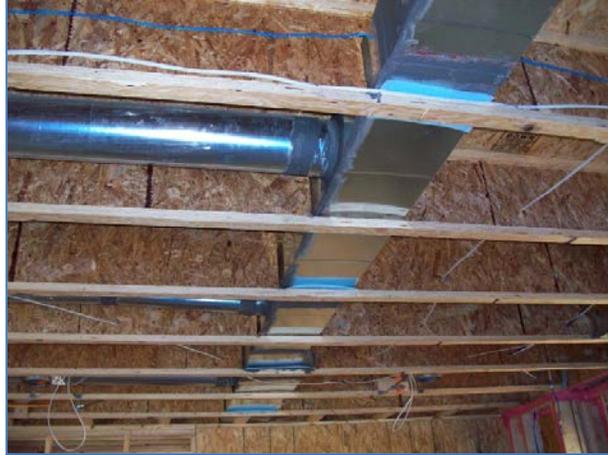
Figure 15. HVAC supply trunk installed in second-floor framing

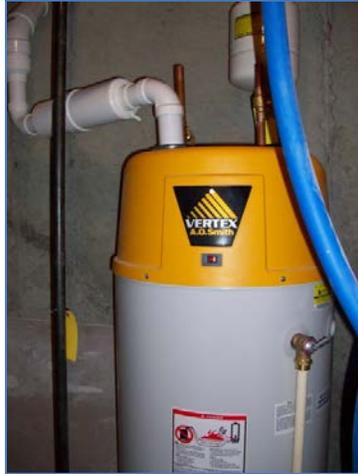
Figure 16. High-efficiency water heater

Domestic hot water was provided by the 50-gallon, natural gas, power vented water heater shown in Figure 16. The estimated EF was 0.74 (manufacturers are not required to provide EF ratings for units with inputs exceeding 75,000 Btu/h). The water heater was centrally located, low-flow plumbing fixtures were installed, and a PEX manifold distribution system was installed to minimize energy and water use.

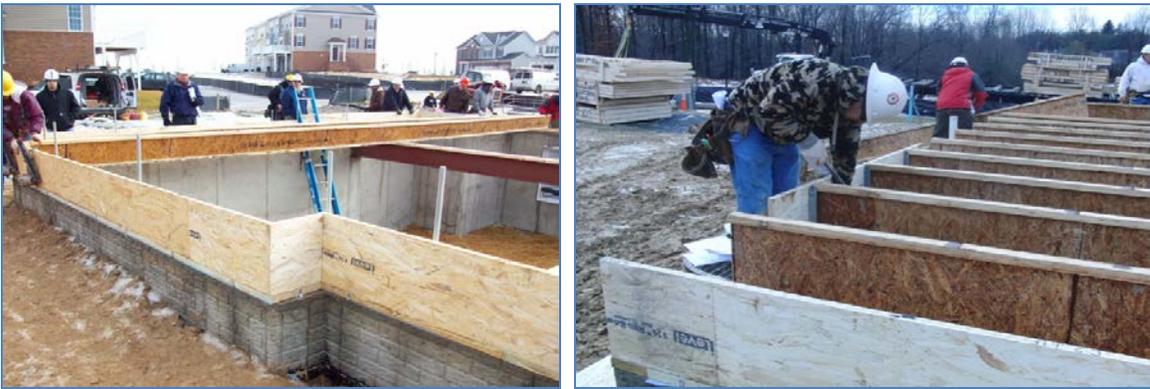
Figure 17. Floor framing

The floor component manufacturer conducted an on-site installation review the morning of floor framing to ensure that the numbered joists and rim boards shown in Figure 17 and Figure 18 were efficiently and accurately installed. Two components were missing from the delivery and some minor field modifications were required, but this did not appear to affect the construction schedule. The floors and numbered wall panels shown in Figure 19 and Figure 20 were installed in 2 days. The roof trusses and framing were also numbered for efficient installation. After framing was complete, WHI staff observed and corrected some rim, header, and wall nailing issues. The $\frac{7}{8}$ -in. floor decking, which was installed over the 24-in. on center floor joists, resulted in an observably stiff floor.

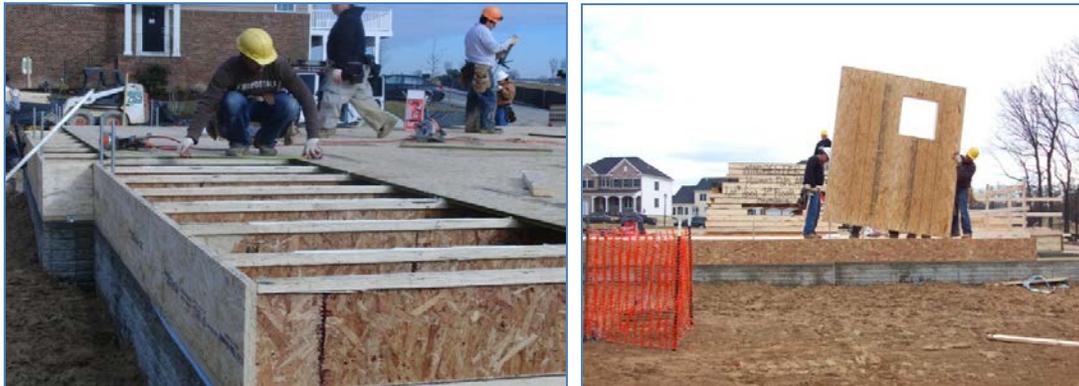
Figure 18. Floor framing and wall panels

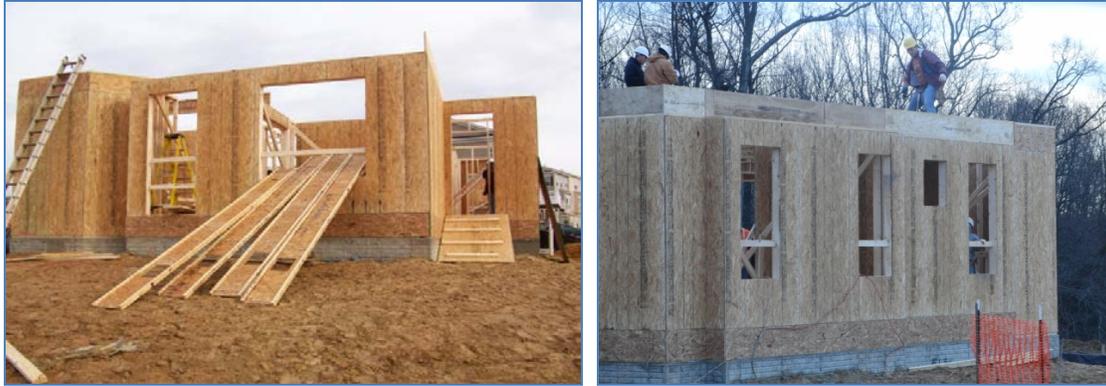
Figure 19. Wall panels

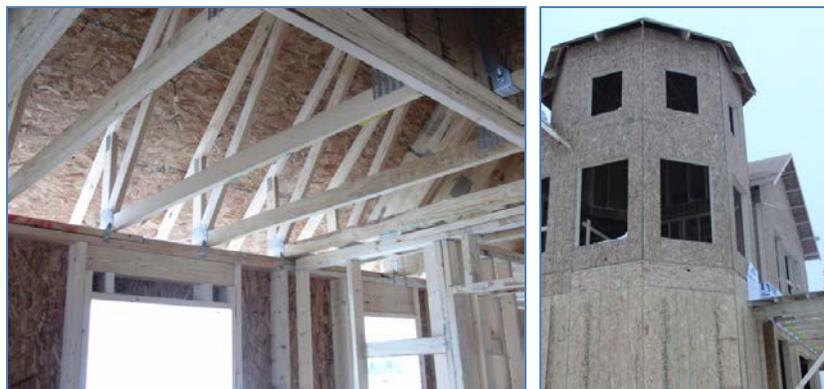
Figure 20. Wall panels and trusses

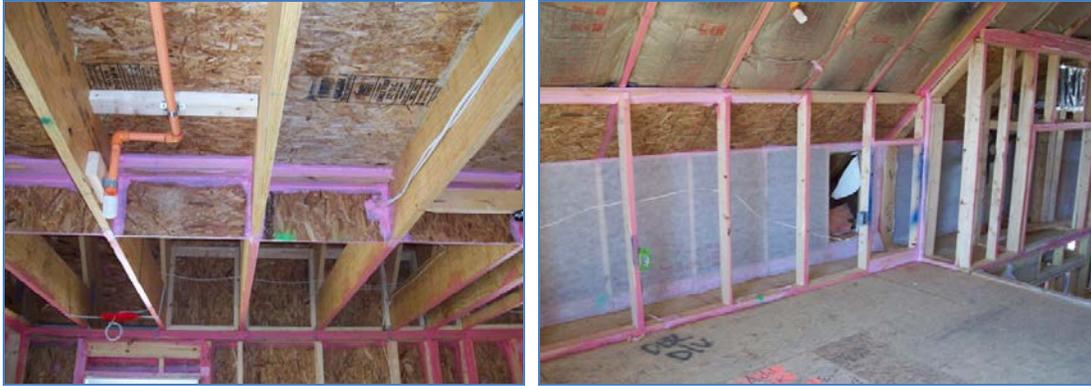
Figure 21. Air sealing at blocking below third-floor knee wall and knee walls

After air sealing, a walk-through showed that the majority of critical areas had been sealed. Because of the high expectations for this house, a number of areas needed to be touched up before installing insulation, including portions of top plates and header cavities, and portions of air barriers at knee walls, joist blocking, and framed cavities. Identifying areas that needed to be touched up was not intended as criticism of the product or trade contractors; instead, it was intended to highlight the challenge of identifying a continuous thermal and air barrier with such an architecturally complex design. A key advantage of using a product and method such as this sealant was the ability to visually inspect after air sealing and, if necessary, make corrections before insulation and drywall installation. Figure 21 shows an example of the complexity of air sealing these areas.

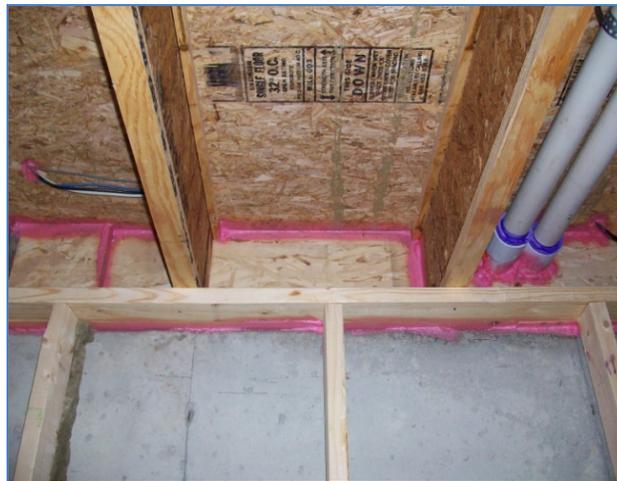
Figure 22. Air sealing at basement rim area

Sealant was not consistently applied to the faces of the framing at the bottom plates and around windows and doors (although bottom plates were sealed at the floor deck). These areas were specified to be sealed in accordance with the ADA, but the contractor did not consider this necessary. Although sealant was applied in the gap between the rough framing and the windows and doors, these gaps might have been more effectively sealed using low-expansion spray foam insulation instead. Research Center personnel did not consider it necessary to apply sealant to the interior faces of the bottom cords of second- and third-floor roof trusses (although it would not have been detrimental). The sill plate at the foundation wall could not be sealed from the interior because the basement wall framing had already been installed (see Figure 22); instead, sealant was applied from the exterior at this critical area.

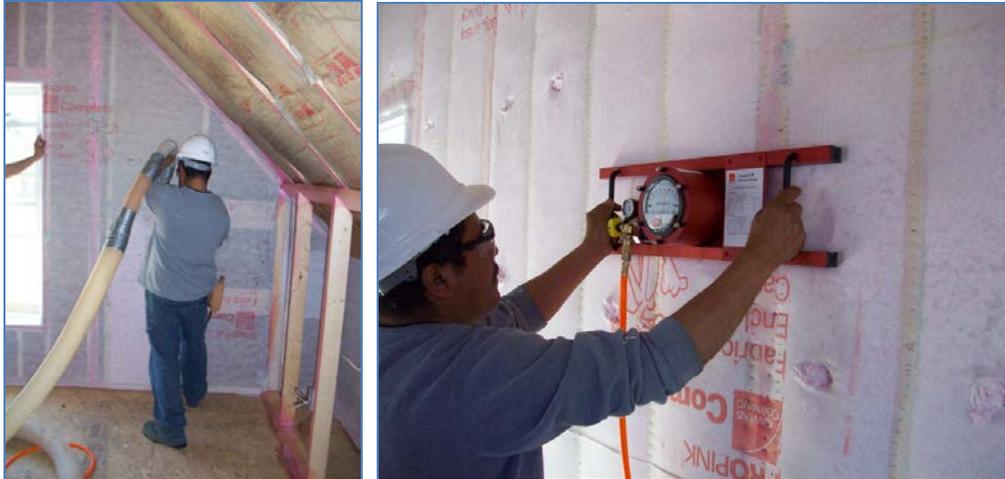
Figure 23. Installing wall cavity blown insulation and checking density

To insulate the wall cavities, netting was stapled to the faces of all exterior wall framing. Next, the loose fiberglass insulation was blown into each cavity, using a hose from a truck outdoors, through one slit in the netting (see Figure 23). Wall cavity density was measured as the work

progressed to ensure that the target insulation levels were achieved (see Figure 23). For attic insulation, netting was installed at the ceiling plane where fiberglass batts had not already been installed. Next, loose fiberglass was blown into these areas. All wall and ceiling insulation was complete before drywall installation.

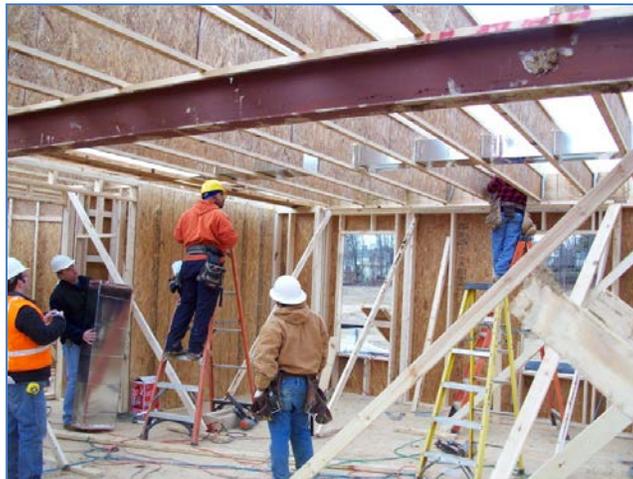
Figure 24. Installing HVAC trunk through floor joists

During the design phase, the participants did not consider it acceptable to cut openings through the second-floor structural rim boards to allow the upstairs supply trunks to be slid into place. For this reason, the HVAC trade contractor installed these trunks in sections, through the joist cutouts, as the second-floor joists were being installed. This implementation approach required an additional site trip for the HVAC contractor.

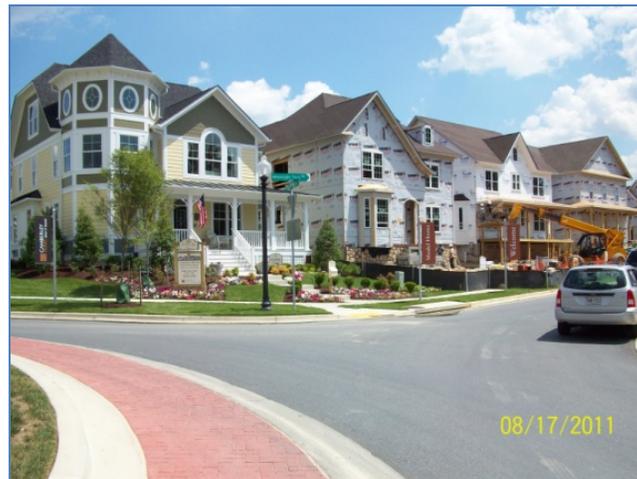
Figure 26. Three additional houses built using the NCTH features

The specific energy efficiency goals established during the planning stage for this NCTH were largely achieved. The project may have fallen short of the 30% energy efficiency goal because of builder substitutions. All of the permanent features, though, including optimized framing, insulation, windows, plumbing piping, and a single HVAC system with interior ducts were implemented. The substituted features (e.g., the cooling system condensing unit) may be easily changed in future homes. WHI considered all the permanent features to be cost effective, and the builder incorporated them into at least three additional houses of similar design as shown in Figure 26.

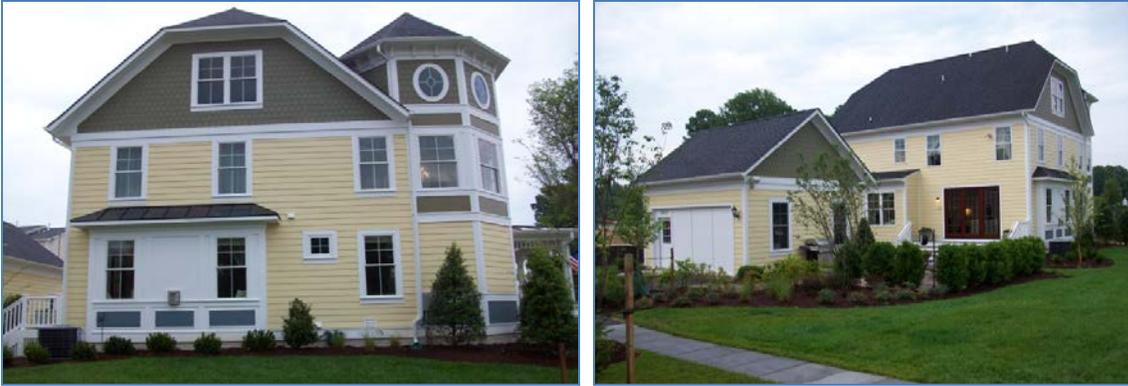
Figure 27. Completed test house

The thermal envelope design successfully incorporated advanced framing techniques and high insulation levels. Short-term testing indicated a very tight thermal envelope. The HVAC system was successfully installed entirely within conditioned space, and short-term testing indicated that the heating and cooling system was operating efficiently and effectively. The completed NCTH is shown in Figure 27.

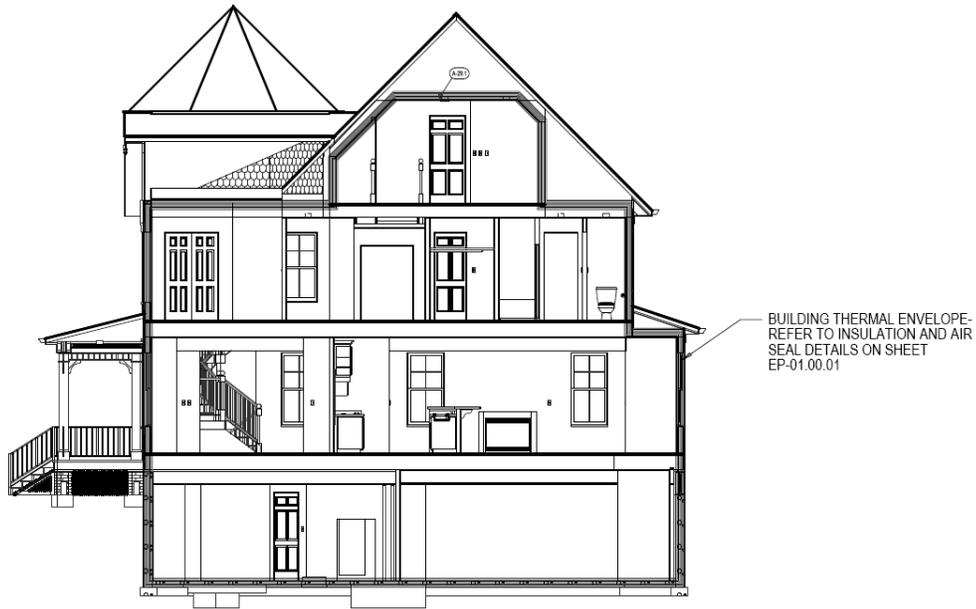
THERMAL ENVELOPE

BUILDING SECTION B-B

Figure 34. NCTH thermal envelope, Section B-B

Figure 33 through Figure 35 show three different views of the house's thermal boundary.

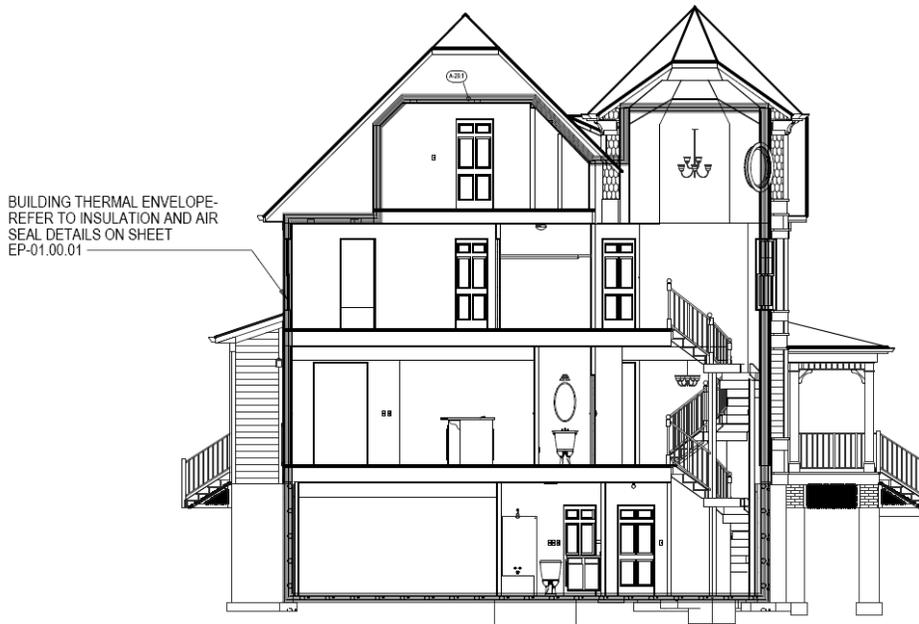
THERMAL ENVELOPE

BUILDING SECTION C-C
