# Structural Analysis Peer Review for the Static Display of the Orbiter Atlantis at the Kennedy Space Center Visitors Center

# **Structural Analysis Peer Review of the Kennedy Space Center Visitors Center Orbiter Atlantis Static Display**

**March 14, 2013**

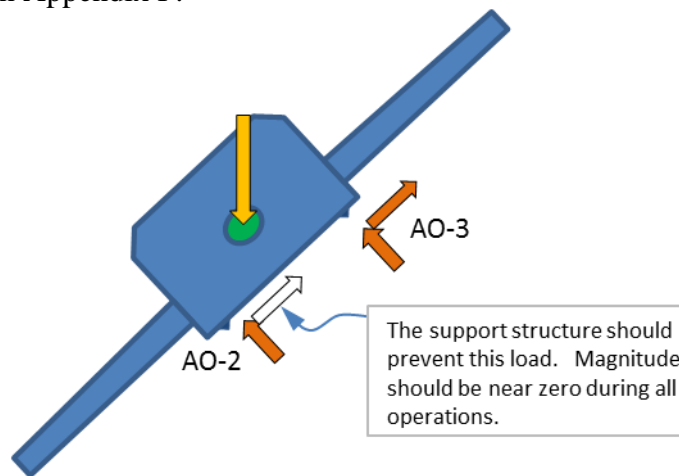
***Figure 7.1-1. Orbiter Attach Point Compliance (Weight and Reaction Loads)***

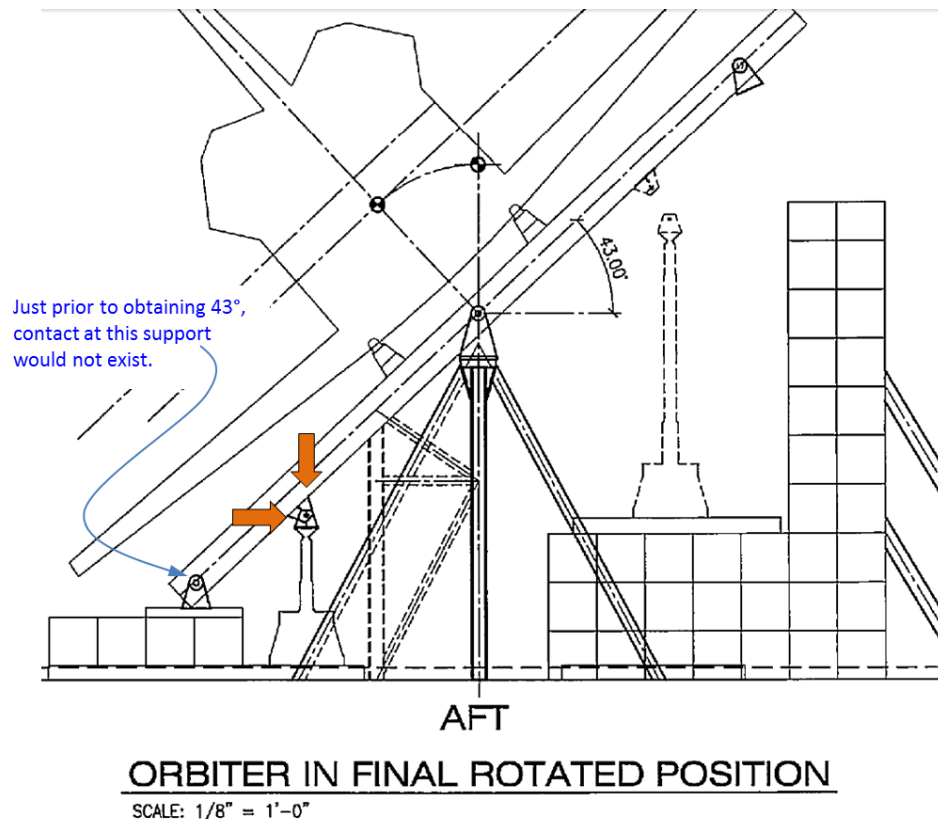
**Figure 7.2-3. BRPH Drawing of Orbiter in Final Rotated Position with Loads Applied to Jacks**

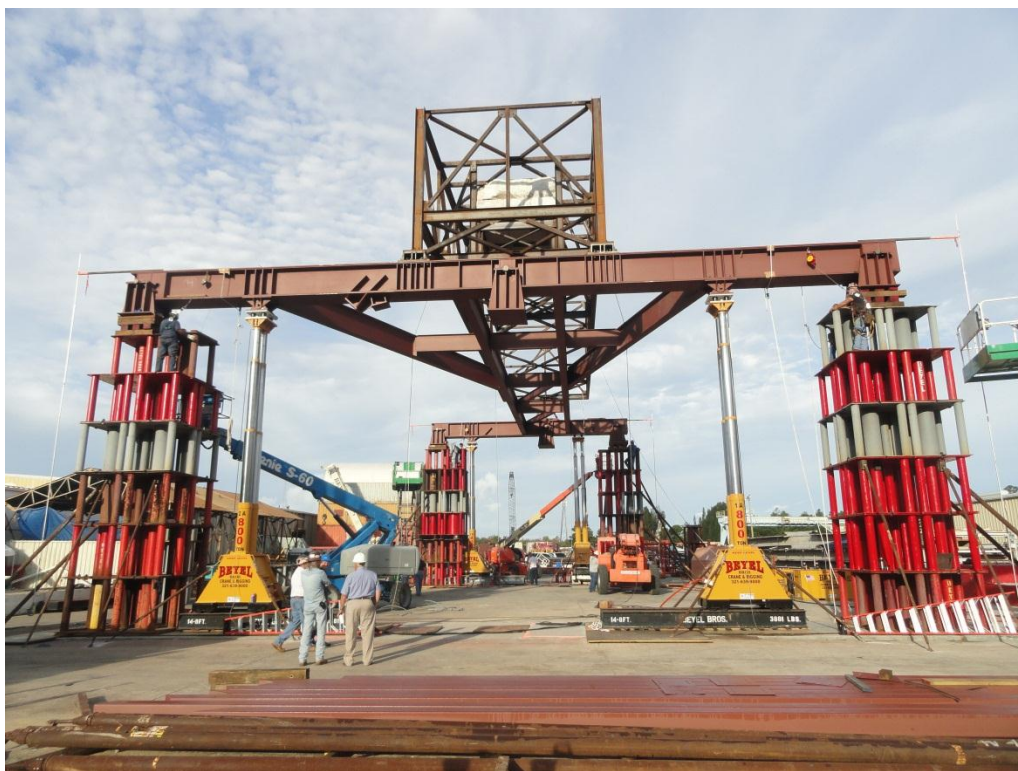
***Figure 7.2-4. Pathfinder Demonstration – Initial Lift***

BRPH Engineering incorporated bracing, sliding tracks for jacks, dunnage, and moved in 2-inch increments to control the load. (Figures 7.2-4, 7.2-5, and 7.2-6)

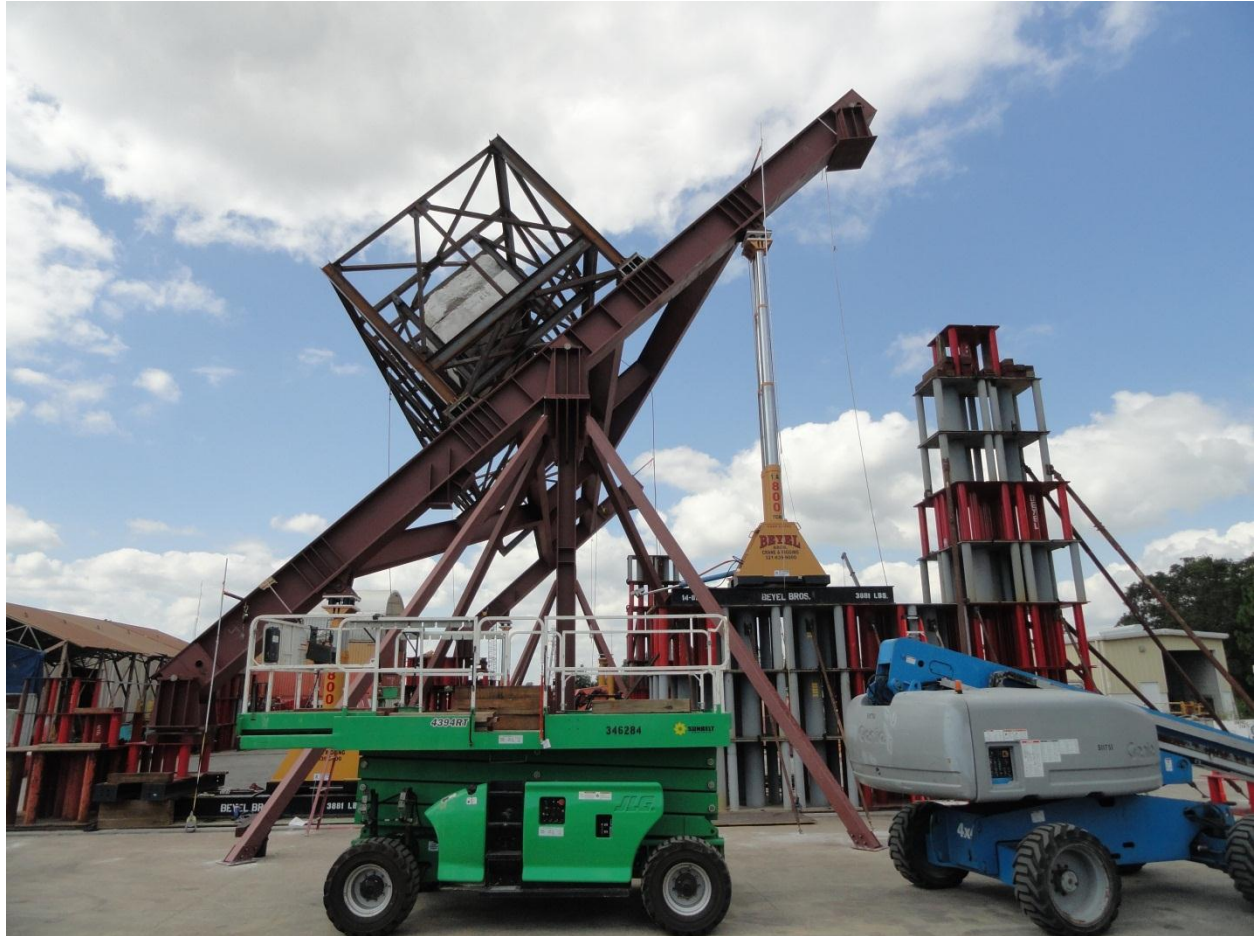
***Figure 7.2-5. Pathfinder Demonstration – Rotation (aft view)***

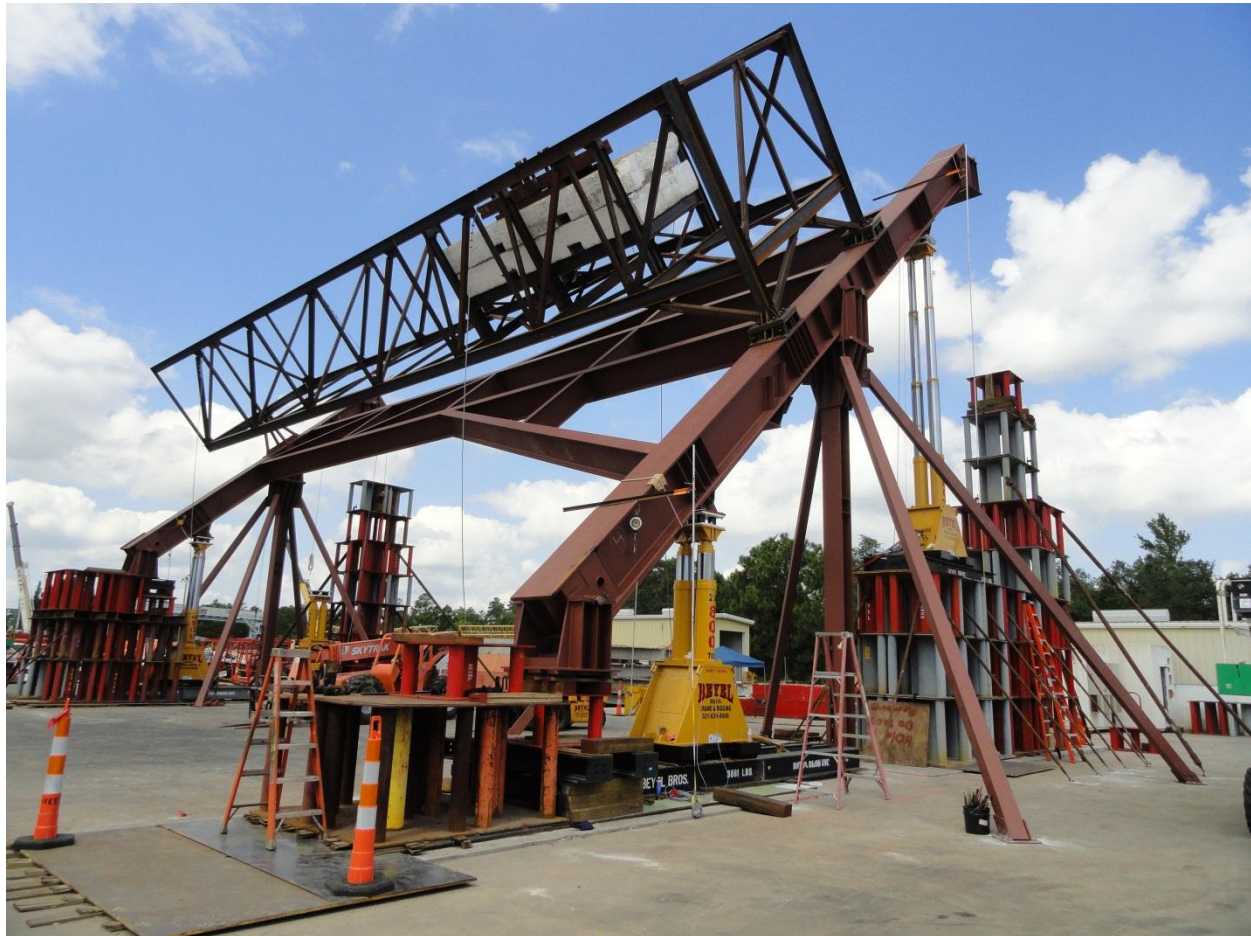
***Figure 7.2-6. Pathfinder Demonstration – Rotation (side view)***

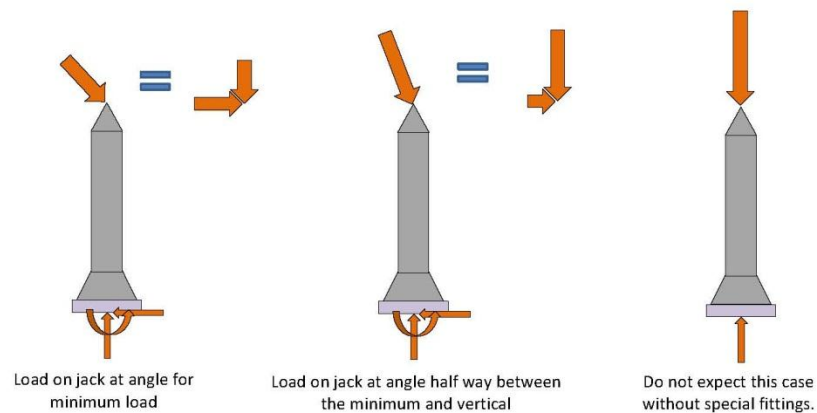
Load at top of left side jack depending on interaction of jack to frame:

If the jack is on a slide, then the horizontal component would be zero?

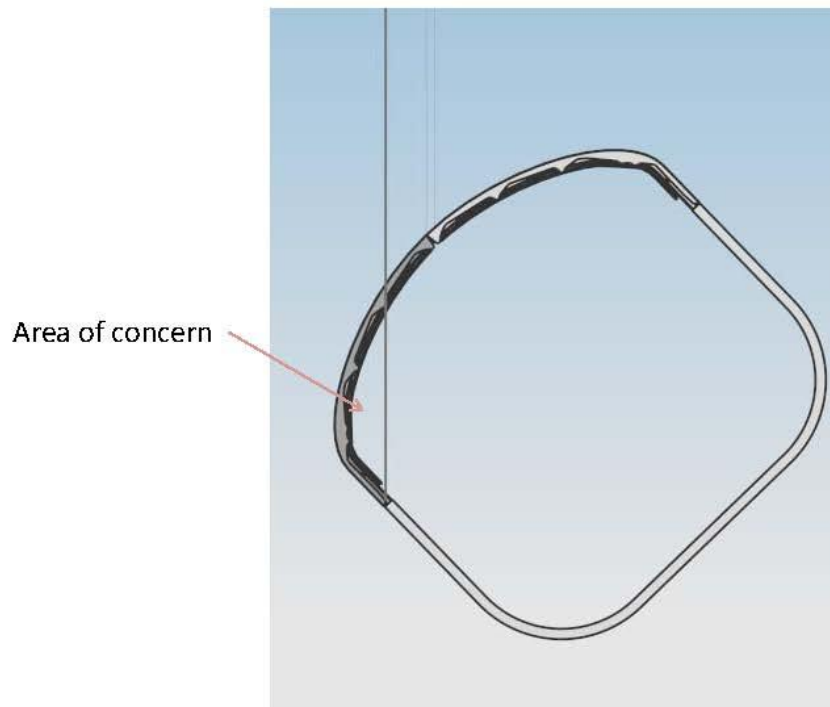
## Center of Mass for Lower Door

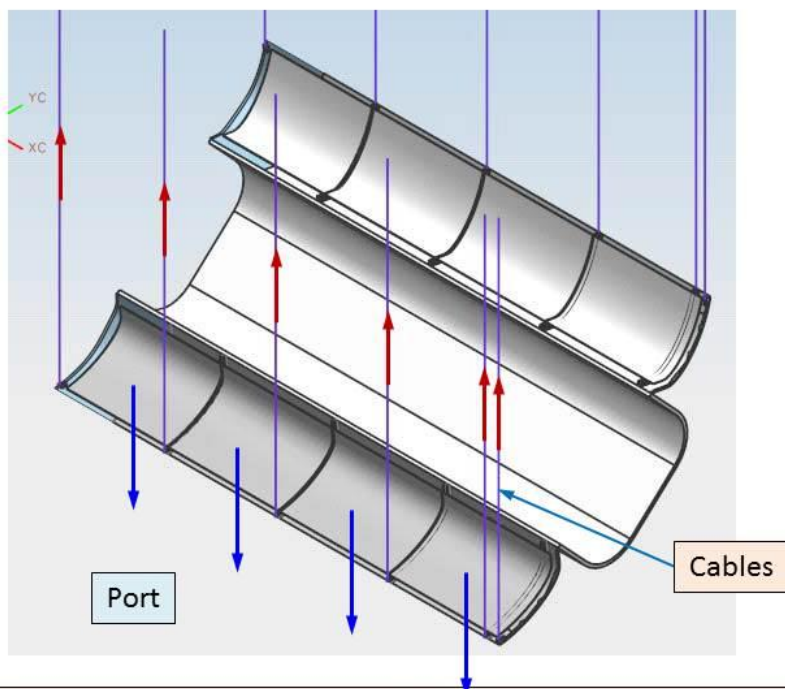
## Door Open and Supported

How are the turnbuckles adjusted to provide the proper load per cable? If one turnbuckle is adjusted  $\frac{1}{4}$ " shorter than needed, that turnbuckle/cable picks up additional load from the adjacent cables. Analysis *assumes* uniform distribution.
