Integrating Condition Indicators and Usage Parameters for Improved Spiral Bevel Gear Health Monitoring

Paula J. Dempsey, Robert F. Handschuh, and Irebert R. Delgado
Glenn Research Center, Cleveland, Ohio

Prepared for the
69th Annual Forum and Technology Display (Forum 69)
sponsored by the American Helicopter Society (AHS)
Phoenix, Arizona, May 21–23, 2013

1. REPORT DATE (DD-MM-YYYY) 01-06-2013		2. REPORT TYPE Technical Memorandum		3. DATES COVERED (From - To)	
4. TITLE AND SUBTITLE Integrating Condition Indicators and Usage Parameters for Improved Spiral Bevel Gear Health Monitoring		5a. CONTRACT NUMBER			
		5b. GRANT NUMBER			
		5c. PROGRAM ELEMENT NUMBER

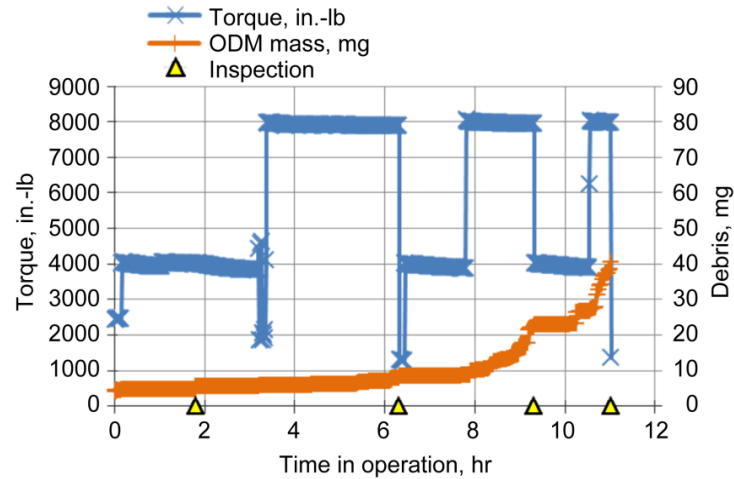
Figure 4.—Debris generated and torque during test 1.

Figure 4 to Figure 9 are plots of the damage progression to the gear teeth and the effect of torque during the testing of the three gear sets. The first plot in Figure 4, Figure 6 and Figure 8, torque, in inch-pounds (in.-lb), plotted in blue per the left y-axis. Debris generated in milligrams, an indication of fatigue damage progressing, is plotted in orange per the right y-axis. The yellow diamonds on the x-axis indicate hours for gear teeth inspections. Representative photos of gear and pinion teeth damage modes and their progression at the inspections intervals are shown in the second figure. The six figures will be discussed in the following paragraphs.

For test 1, Table 5 displays the rate of debris generation measured was at 8.96 mg/hr when progressive macropitting (4.3.2) was first observed on several teeth as seen in Figure 4 and Figure 5. The rate decreased to 3.75 mg/hr when the torque dropped to 4000 in.-lb. The debris generated then increased from 3.75 to 27.69 mg/hr when torque increased from 4000 to 8000 in.-lb, and spalling macropitting (4.3.4) was observed on five gear teeth as seen in Figure 5.

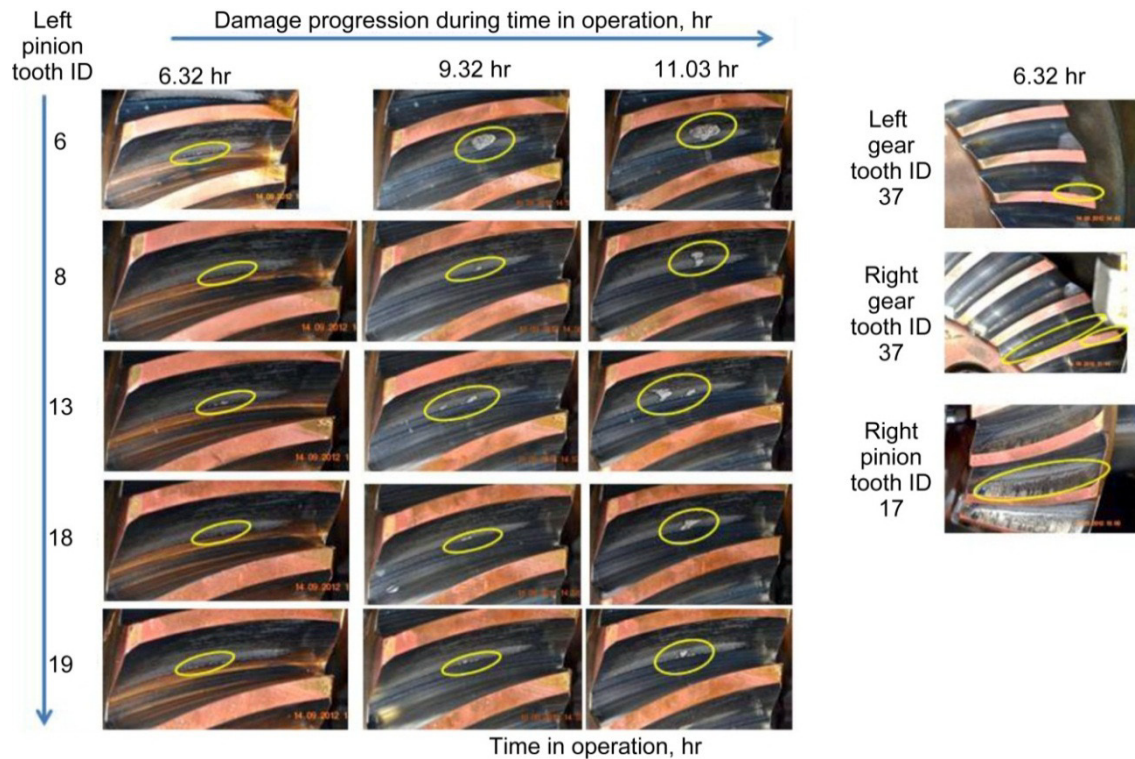
Figure 5.—Damage conditions on teeth during test 1.

For test 1, Figure 5 illustrates the progression of damage to five left pinion teeth. The other photos are representative pictures of one left gear tooth, on right gear tooth and one pinion tooth. The damage to these gears did not change after the initial inspection. For the left pinion, no macropitting was

observed on the pinion teeth 6 hr into the test. Nine hours into the test, 4.3.4 was observed on two pinion teeth. Eleven hours into the test, 4.3.4 was observed on five teeth.

Gear and pinion temperatures and applied loads have significant effects on gear and pinion life. The effect of load on the progression of damage to the gear teeth was observed in Figure 5, Figure 7 and Figure 9. The applied torque affects contact and bending stresses on all spiral bevel geared systems. In many cases the gears must operate at elevated temperatures. Elevated temperatures can also have detrimental effects on the aspects of a design that have to do with bending fatigue (material capability to carry load at elevated temperatures), contact fatigue (pitting—surface degradation) and scoring (surface interaction through the lubricating film thickness) that decrease the life of the gears.

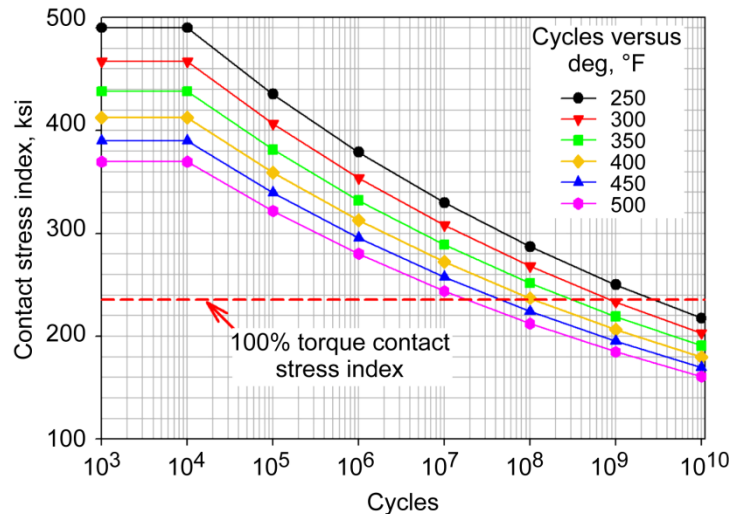
Figure 10.—Blank temperature effects on allowable contact stress, 99 percent reliability.

Per the highlighted line in Table 9 at 100% torque (8000 in.-lb gear torque), the life cycles at 500 °F pinion temperature is significantly lower than at 400 and 300 °F. An S-N curve of cycles versus allowable stress index was generated for the contact fatigue reliability based on blank or gear tooth temperatures for this gear design and is shown in Figure 10. The number of cycles is shown on the x-axis and the contact stress index is shown on the y-axis. The red dashed horizontal line is the contact stress index at 8000 in.-lb gear torque, 3707 in.-lb pinion torque. The blank temperature is the pinion tooth temperature. During the three gear tests the inlet oil temperatures ranged from 240 to 265 °F. The gear and pinion temperatures can be significantly higher than the inlet oil temperatures. Pinion tooth root temperatures were measured in this test rig on another gear design with 100 °F oil inlet temperatures at comparable load that ranged from 200 to 225 °F, over 100 °F above the oil inlet temperature (Ref. 11).
